RESERVOIR HYDRAULICS AND BERM STABILITY INVESTIGATION

BoRiT ASBESTOS SUPERFUND SITE, AMBLER, PA

U.S. Army Corps of Engineers

SEPTEMBER 2013

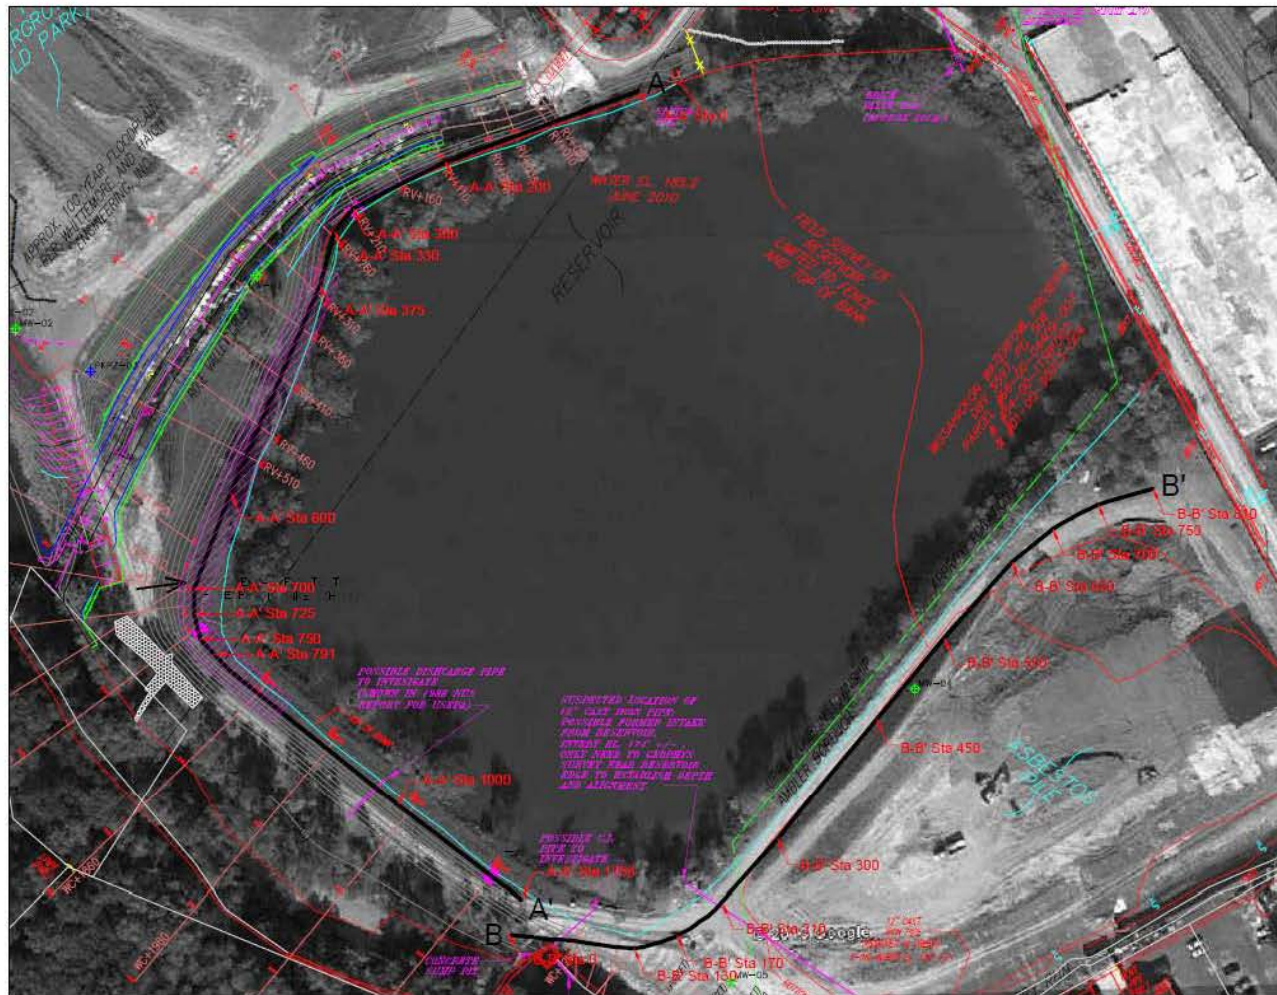
Figure 2.2

The MASW survey showed low shear wave velocities in the southwestern corner of the reservoir at the area where there has been seepage in the past (See Figure 2.2). The low velocities are indicative of soils mixed with ACM representing a loose condition, which could be a concern for slope stability. The MASW also showed a cut into the bedrock beneath the gravel road on the eastern side of the reservoir (See Figure 2.3). This square notch in the bedrock is consistent with historical accounts that suggest the site was previously used as a quarry. The geophysical investigation did not identify any previously unknown pipes leading into or out of the reservoir.

Zone of Weak Material in SW Berm BoRit Asbestos Superfund Site Ambler, PA

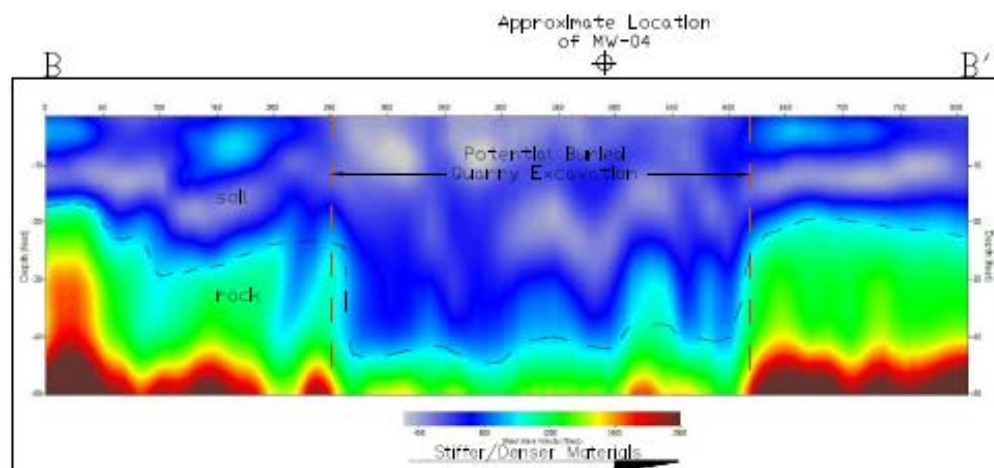
Figure 2.3

Note: MW-04 reports BACS (bulk asbestos containing waste) debris mixed with soil 2-18 ft bgs. Apparent weathered rock of variable density 18-29 ft bgs.

Notch in Bedrock
BoRit Asbestos Superfund Site
Ambler, PA

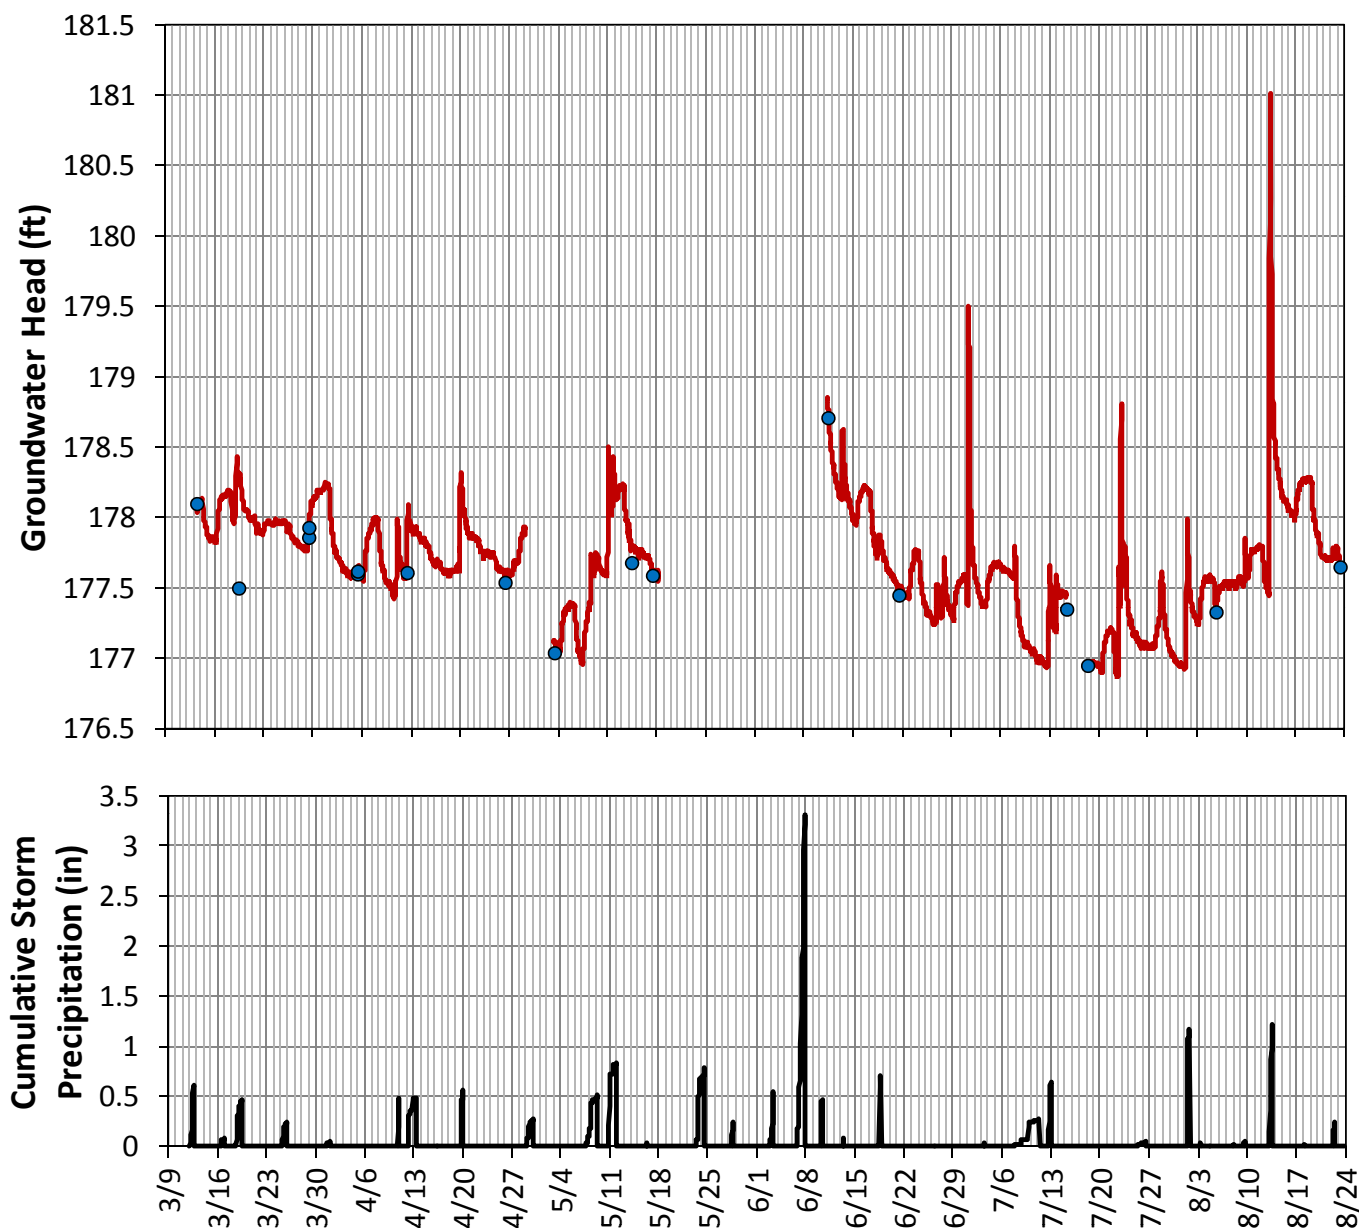
Figure 3.5

MW-03 (Figure 3.5) clearly shows an interesting phenomenon each weekend. Note that the dark vertical lines on the plots are placed between Friday and Saturday. Nearly every weekend, a significant head rise is noted on Friday or Saturday. The head remains high through the weekend and then drops back to previous trends on Monday or Tuesday. This occurs on weekends when there was no rain. Occasionally weekend rain masks part of the signal. Note the following examples on Figure 3.5:

The breaks in data at MW-03 were due to the build-up of condensation on the transducer housing, which caused the battery to die. Additionally, the transducer was removed for approximately 9 days in May and 3 days in July for sampling.

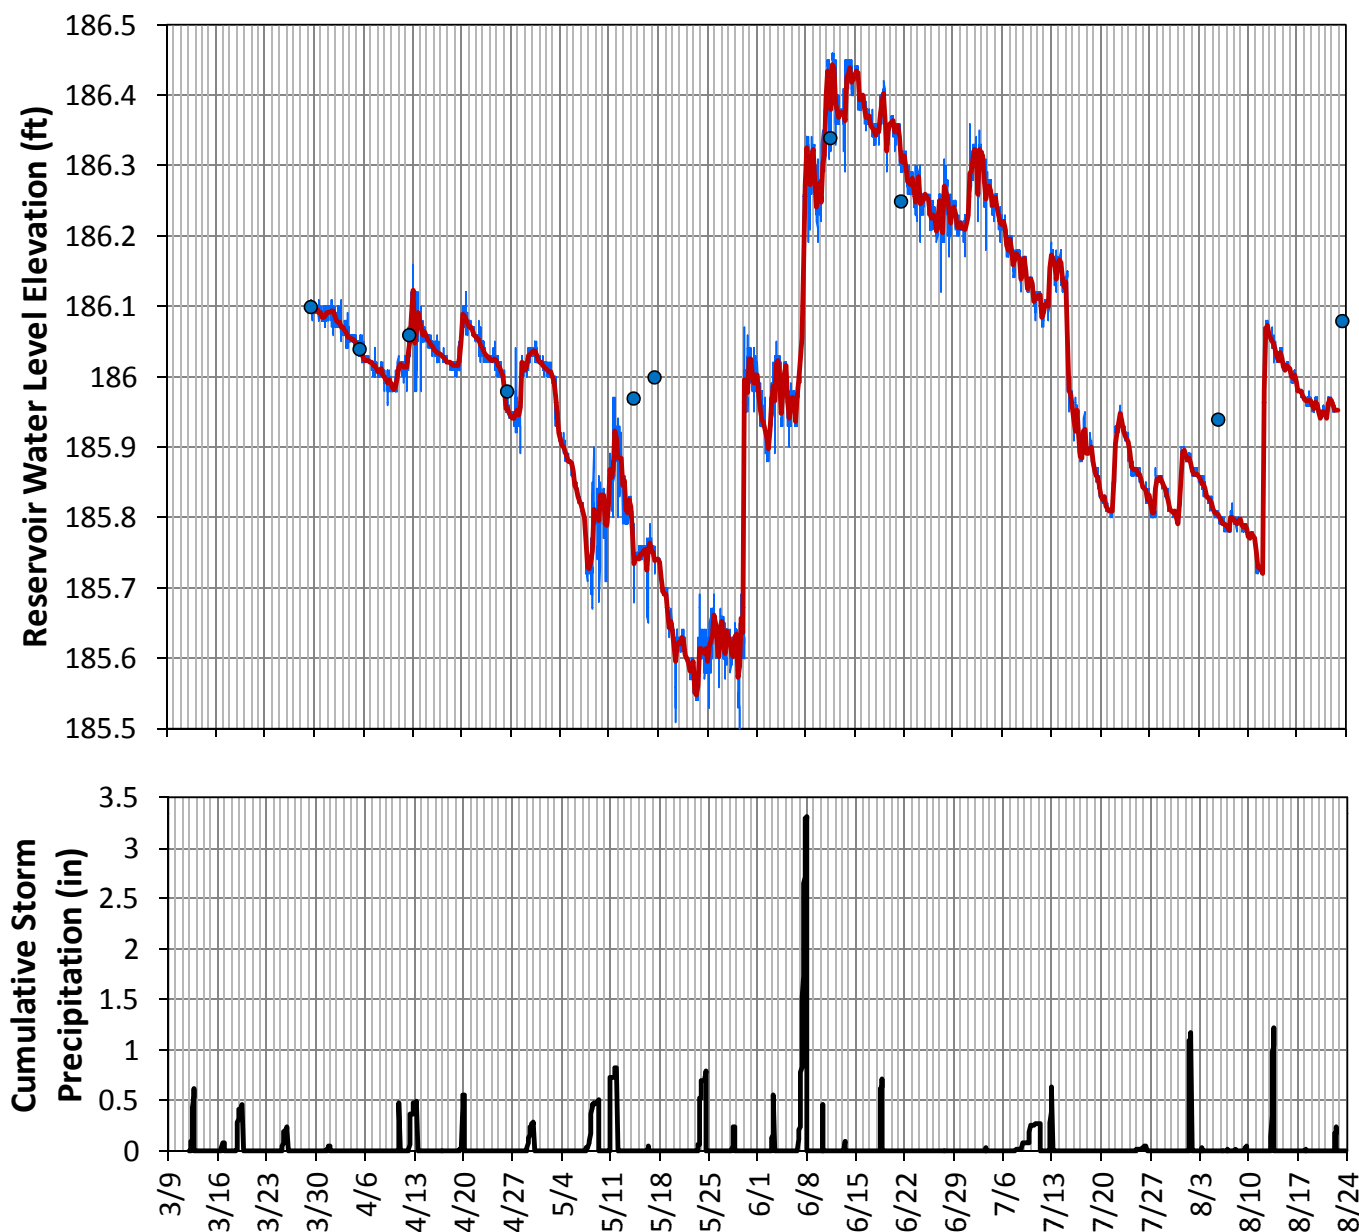
Figure 3.8

The reservoir data is shown on Figure 3.8. Note that the scale on this figure is much smaller than those on previous figures since the reservoir water level changes very slightly during the data period. This data is much noisier (i.e., contains occasional spike anomalies) than the groundwater data, possibly due to water movement caused by wind. The head changes are also much closer to the precision of the transducer, which may make the data seem noisier. The noise was filtered slightly by providing a 6-hour average water level throughout the monitoring period. Notice that, like the groundwater wells, the reservoir head levels are immediately impacted by falling rain. Generally, the rise in water level is close to the depth of rain measured at the weather station. The recovery to pre-storm levels seems to be slower in the reservoir than in the groundwater. Between the storms, reservoir head levels tend to slowly drop. This could be due to seepage from the reservoir (due to higher heads than those measured in the surrounding groundwater) or due to evaporation. It may also be a combination of the two. Recovery slopes seem to be steeper during May, June, July and August than during March and April. Because air temperatures were higher as summer approached, this slope change could be caused by greater evaporation.

On May 31, there was a sudden, large head increase of nearly 0.4 feet in just 90 minutes. The reason for this sudden change is unclear as there was no rain during this period. This increase would equate to a 15,000 gpm inflow of water over the 10 acres of the reservoir's water surface, which is unlikely to have been caused by a release from an undiscovered pipe. It seems to have been a permanent change in the location of the transducer, possibly caused by wildlife disturbing

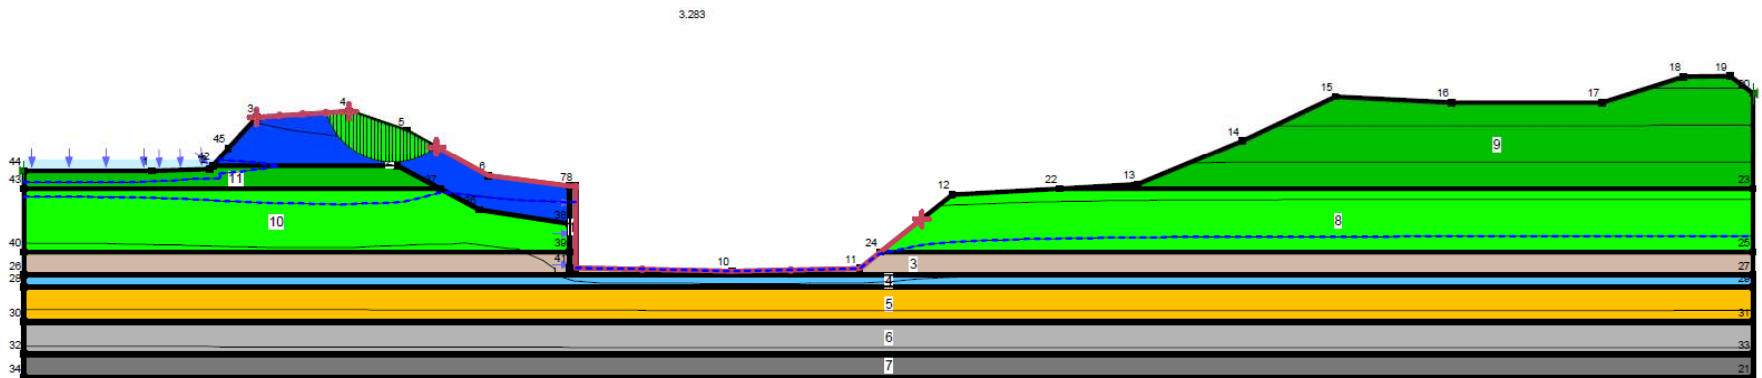
Figure 4.1

The results of the analyses show that the cross-sections in the area of BOB-1 and BOB-3 meet the minimum factor of safety required under normal water levels. However, the cross-section in the area of BOB-2 at the Southwestern corner of the berm need improvement to meet the required FS of 1.4. The results at cross section BOB-3 indicate that some improvement may be required to meet the goal of 1.3 during high pool conditions. These findings are consistent with what was observed in the field during the filling of the reservoir in March 2011. The berm in the BOB-2 area is not in immediate danger of a major failure from normal water levels in the reservoir. During the March 2011 reservoir filling, excess seepage occurred in the BOB-2 area, but no issues occurred at BOB-1 and BOB-3. The lower FS in the BOB-2 area is likely due to the fact that it was constructed using a mix of soil and ACM debris in the early 1900s and the berm fill materials may have only been nominally compacted. The results of the geophysical and geotechnical analyses indicate that the berm adjacent to the Wissahickon and approximately 150 feet north along the Rose Valley Creek side from the reservoir's southwest corner require stabilization, with no further action necessary on the remaining berm extents. Further action to stabilize the berm is necessary in the area of BOB-2 and BOB-3 on the Wissahickon Creek berm because of the lower factor of safety.

FS= 3.28

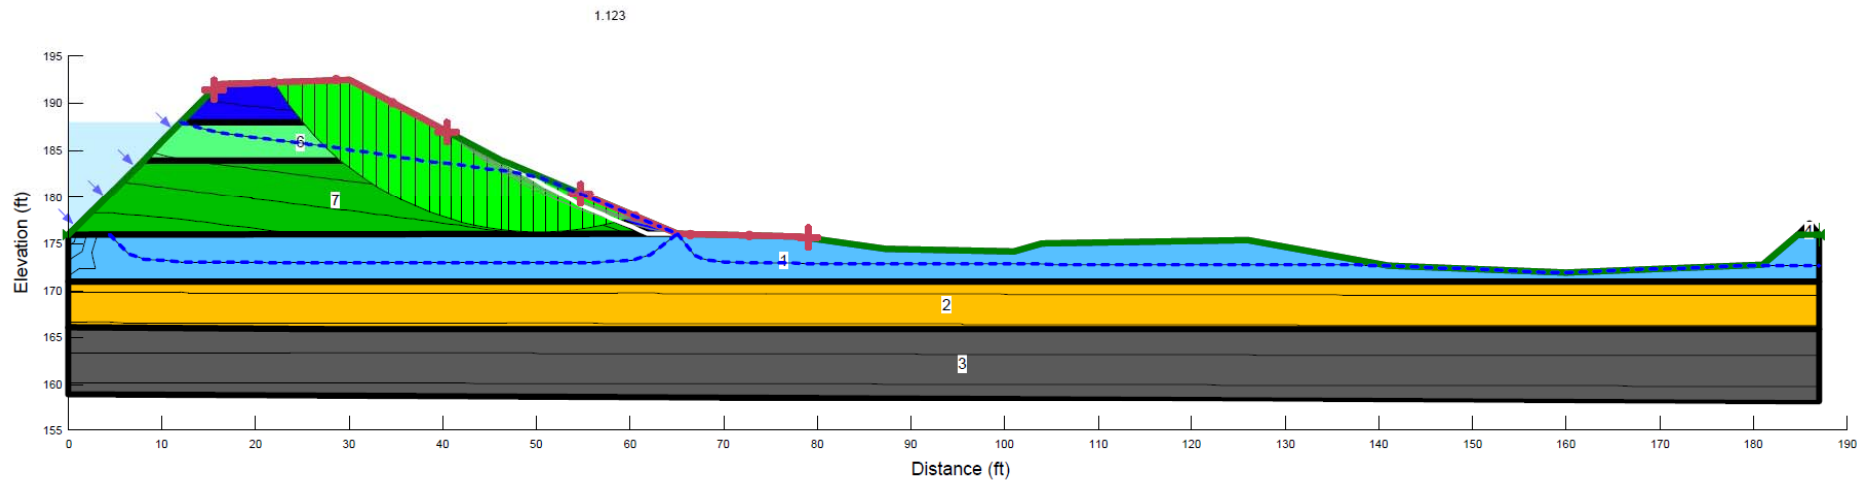
Figure 4.2

FS= 1.12

Stabilization Option 3, the backfilling of the interior of the Wissahickon Creek side berm and part of the Rose Valley Creek side berm with 30 feet of material for a new average width of 40 feet is the recommended solution. It will cap the ACM material on the inside of the reservoir while improving the FS to current guidelines and not impact the exterior of the berm. Although it is not strictly necessary to extend the thirty feet of fill completely to BOB-3, as the section at BOB-3 appears to be stable in its existing condition, it is recommended due to the variable nature of the bank constructed with the asbestos fill. The 30-foot berm width expansion should also wrap around the southwest reservoir corner and continue north along the Rose Valley Creek side berm about 150 feet to cover the zone of weak material found in the MASW survey. If laboratory testing results indicate that the material available for backfill does not meet the minimum required hydraulic conductivity of $1 * 10^{-6} cm/s$, it is recommended that this backfill method be used in conjunction with a GCL to ensure proper reduction of seepage or the berm width be increased accordingly without the use of a GCL.

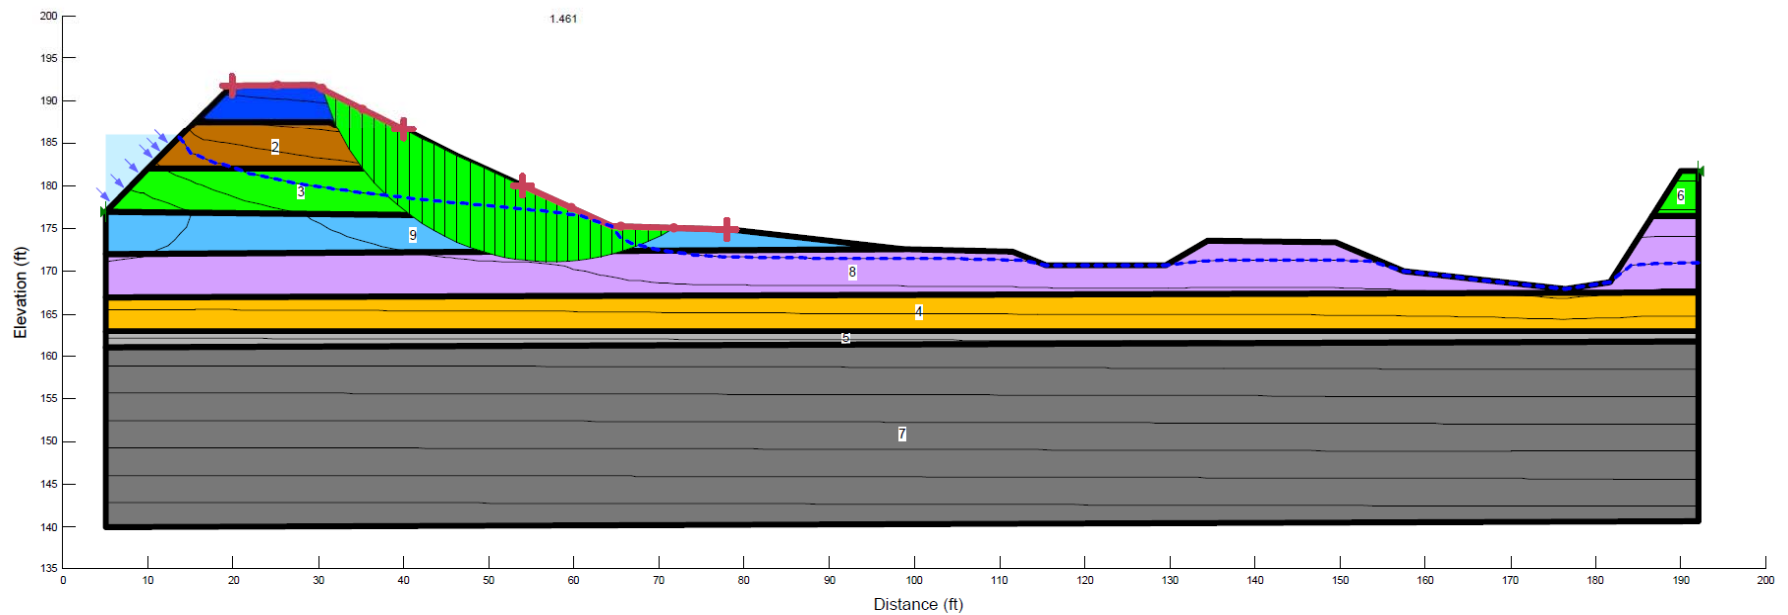
Figure 4.3

FS= 1.46

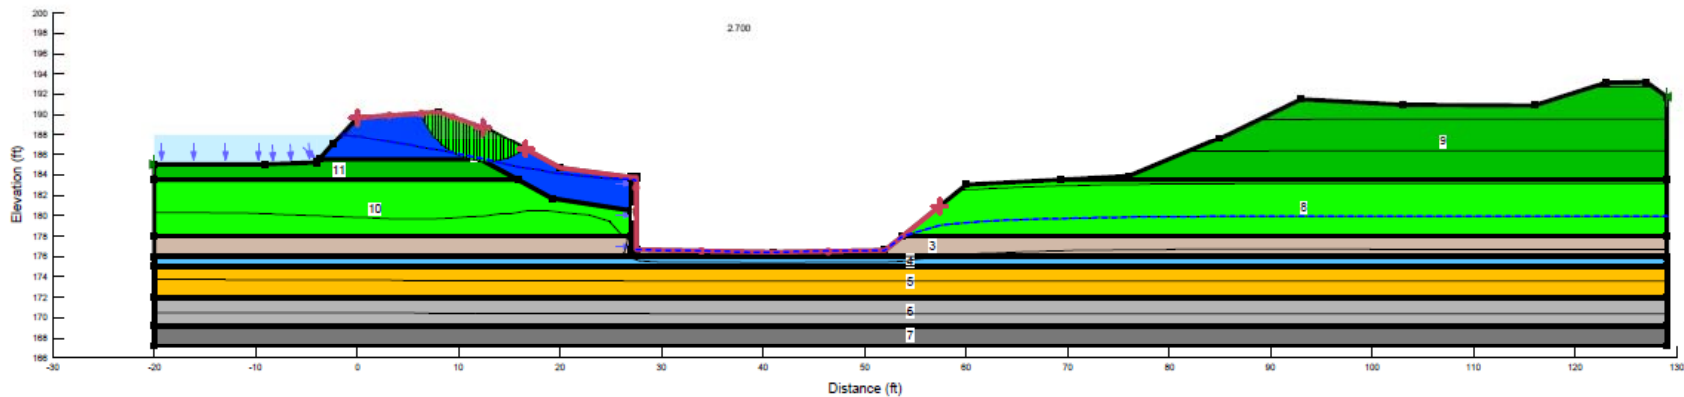
Figure 4.4

FS= 2.70

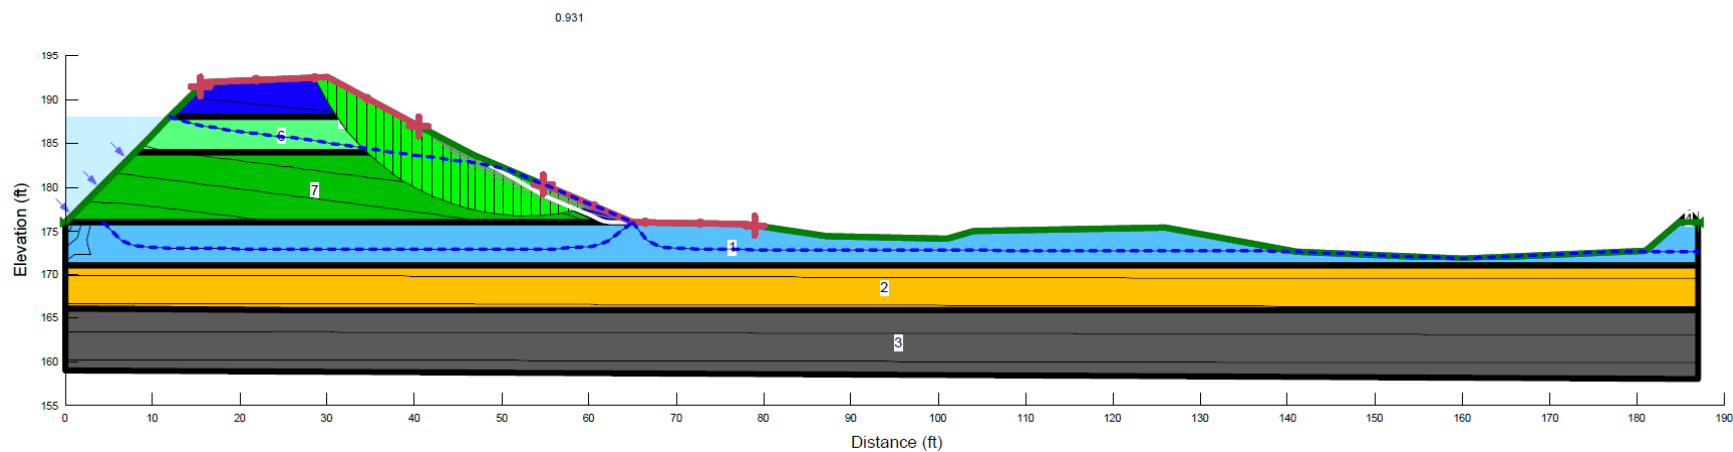
Figure 4.5

FS= 0.93

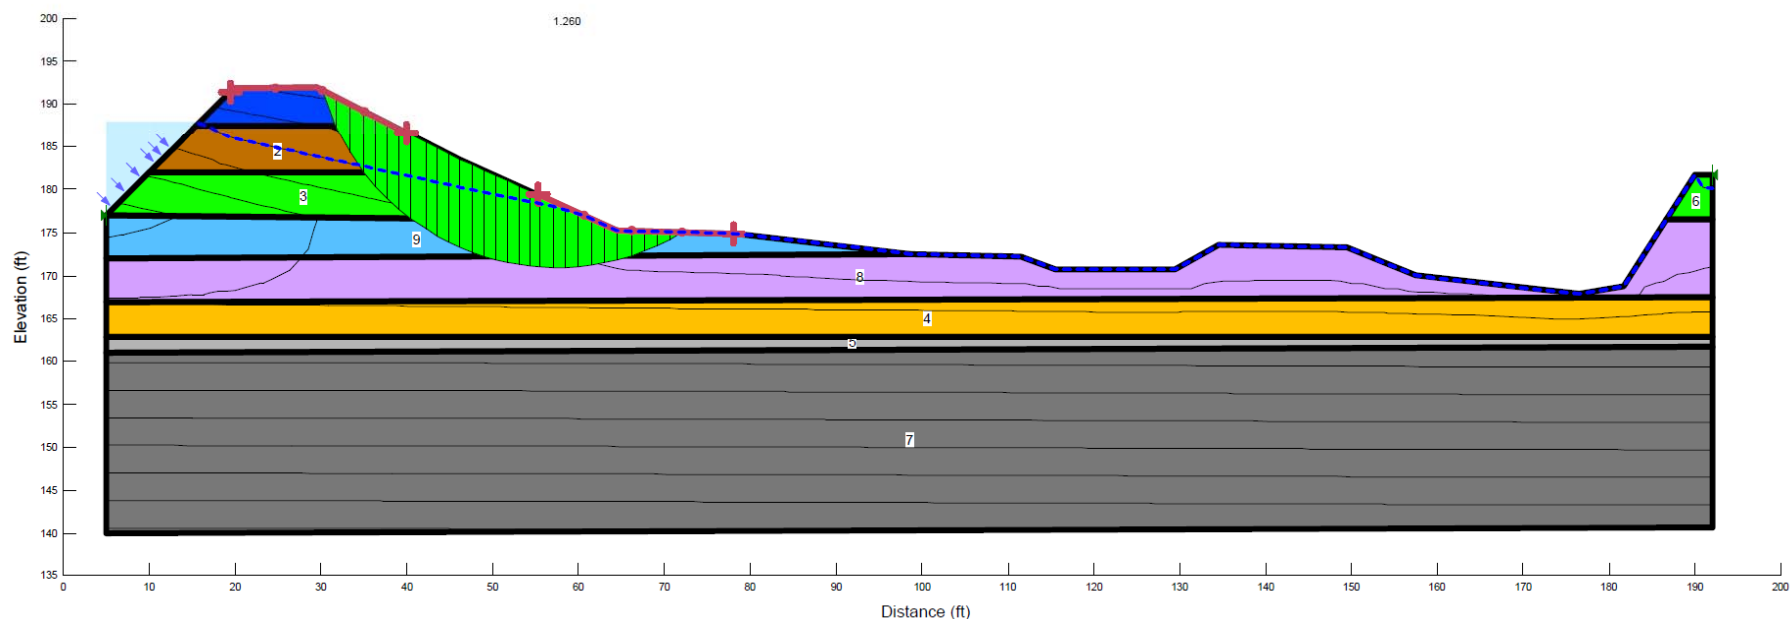
Figure 4.6

FS= 1.26
