FIVE-YEAR REVIEW REPORT FOR LORD-SHOPE LANDFILL SUPERFUND SITE ERIE COUNTY, PENNSYLVANIA

September 2014

Prepared By:
United States Environmental Protection Agency
Region 3
Philadelphia, Pennsylvania

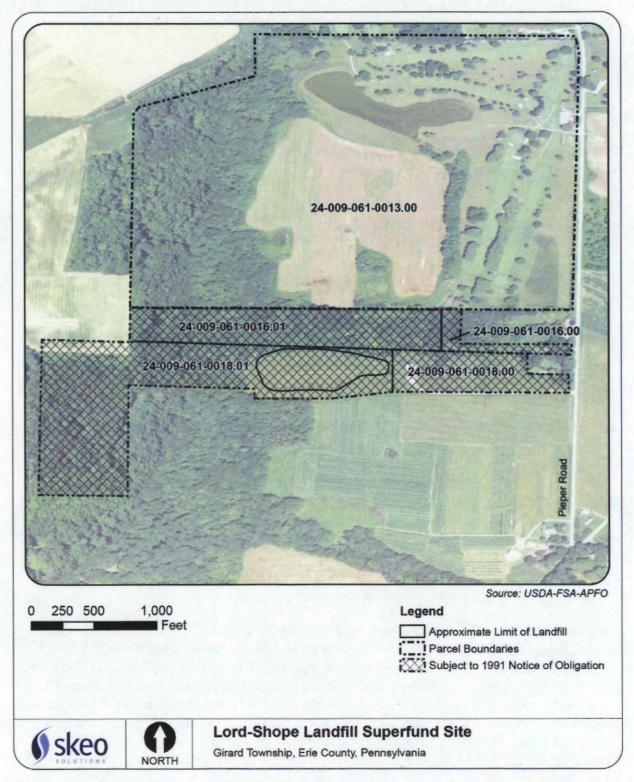
Figure 3: Institutional Control Map

The 1990 ROD specifies that the remedy include institutional controls to prevent the use of contaminated ground water; no instrument is in place for this restriction for the property on the northern portion of the Site. The ROD did not specify institutional controls to restrict activities that could damage the cap, but these controls are in place through the CD and the 1991 Notice of Obligation. The 1991 Notice of Obligation states that:

According to the Notice of Obligation, these restrictions apply to the site parcels (24-009-061-0016.01, 24-009-061-0018.00, 24-009-061-0018.01) and any other properties located adjacent or contiguous to the site parcels that are subsequently acquired or controlled by Lord Corporation (24-009-061-0016-00) (Figure 3).

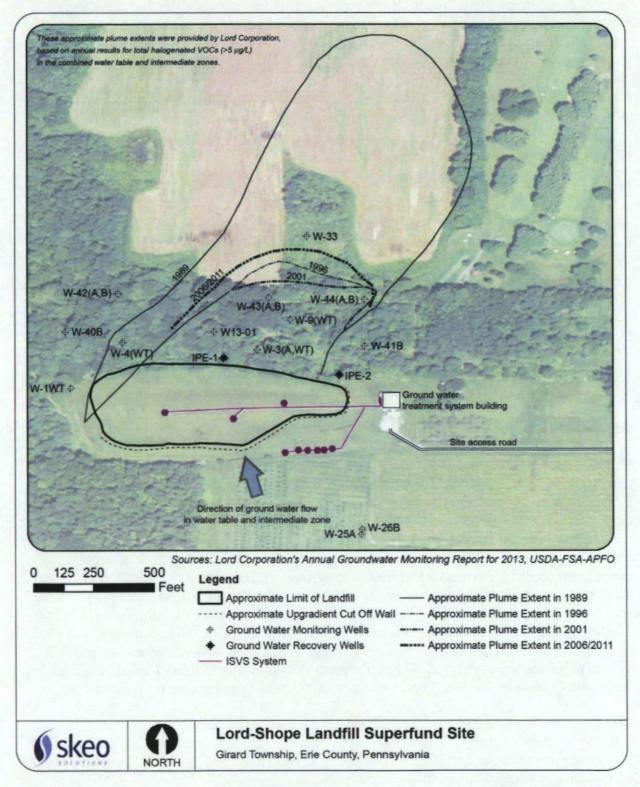
Figure 4: Approximate VOC Plume Extents Over Time

However, exceedances of the MCLs were observed at three on-property intermediate zone wells in 2012 and 2013 (W-3A/3AR, W-3/3R and W-43B). In 2013, W-3A/3AR, which was not sampled in 2012, had vinyl chloride (6,100 µg/L) and cis-1,2-dichloroethene (1,100 µg/L) concentrations above the MCLs (2 µg/L and 70 µg/L, respectively). In W-3/3R, the 2012 and 2013 concentrations of cis-1,2-dichloroethene were 510 µg/L and 780 µg/L, respectively (MCL = 70 µg/L) and vinyl chloride concentrations were 2,900 µg/L and 3,900 µg/L, respectively (MCL = 2 µg/L). W-3/3R and W-3A/3AR are located between the two extraction wells; these high and increasing concentrations indicate an area of the plume that is not being captured by the recovery system. In W-43B, the 2012 and 2013 vinyl chloride concentrations were 62 µg/L and 250 µg/L, respectively (MCL = 2 µg/L). Lord Corporation agreed to complete a supplementary sampling event of wells W-43A and W-43B on July 25, 2014 which resulted in vinyl chloride concentrations of 8.5 µg/L and 160 µg/L, respectively

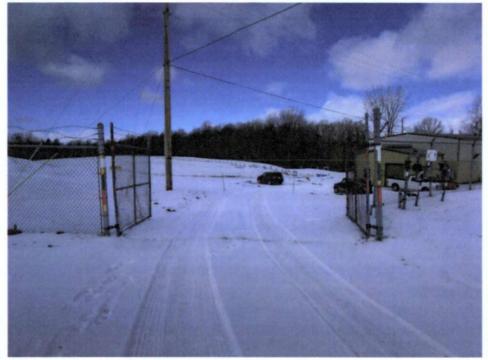
Site entrance (gate is normally locked)

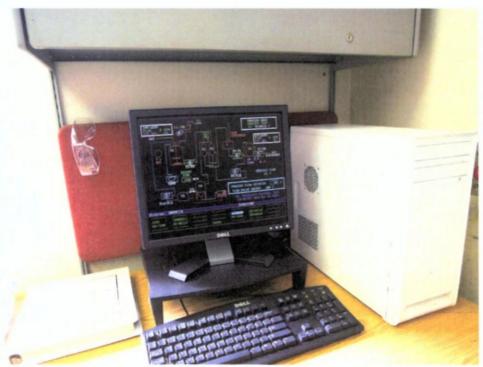
Control system for treatment systems

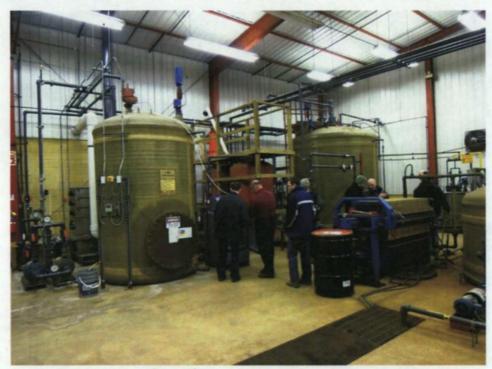
Ground water treatment system

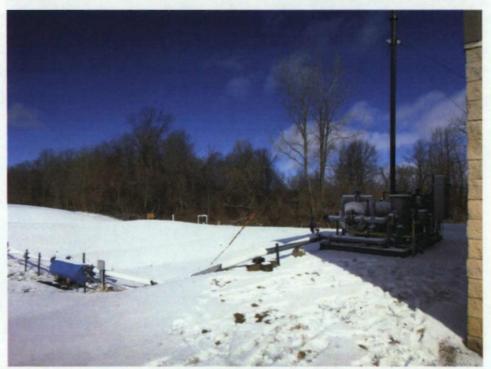
Thermal oxidizer and landfill

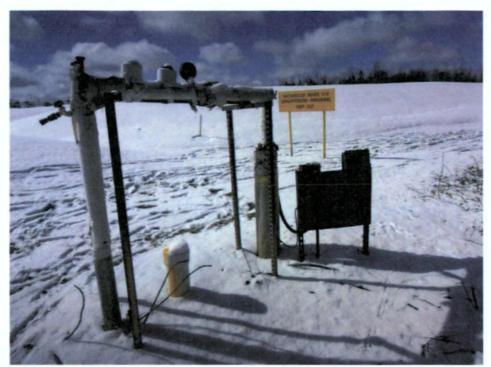
IPE-2 extraction well

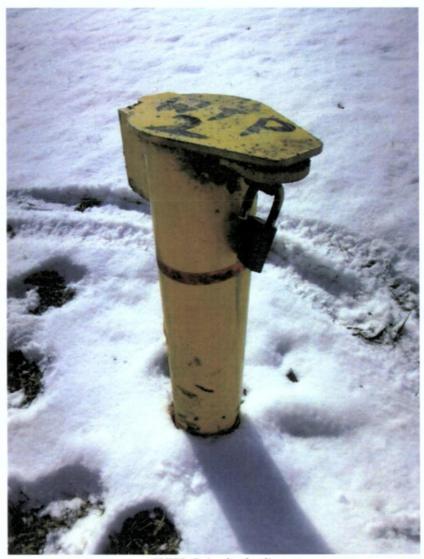
5. Treatment Building(s)	J
□ N/A ☐ Good condition (esp roof a	nd doorways)
☐ Chemicals and equipment properly stored	
Remarks	
6 Monitoring Wells (pump and treatment remedy)	
☐ Properly secured/locked ☐ Functioning ☐	Routinely sampled Good condition
	e N/A
Remarks Some wells were not locked.

WTP-2 (unlocked)

EPA recommends that Lord Corporation ensure that all monitoring wells are secured and labelled.
