Second Five-Year Review

**Norfolk Naval Shipyard
Portsmouth, Virginia**

August 2016

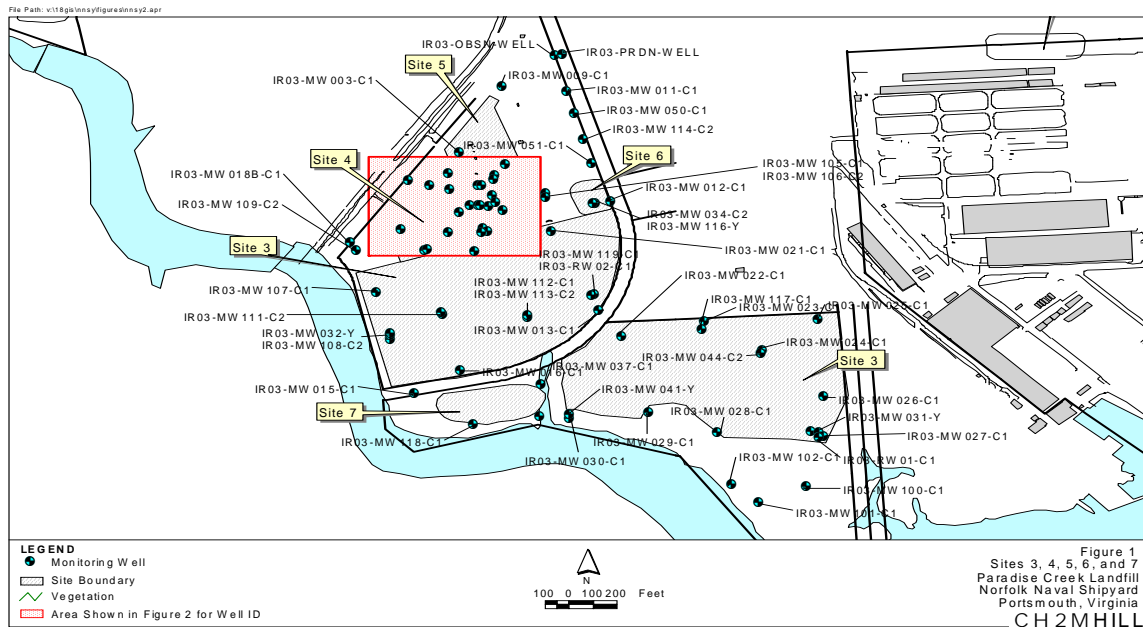
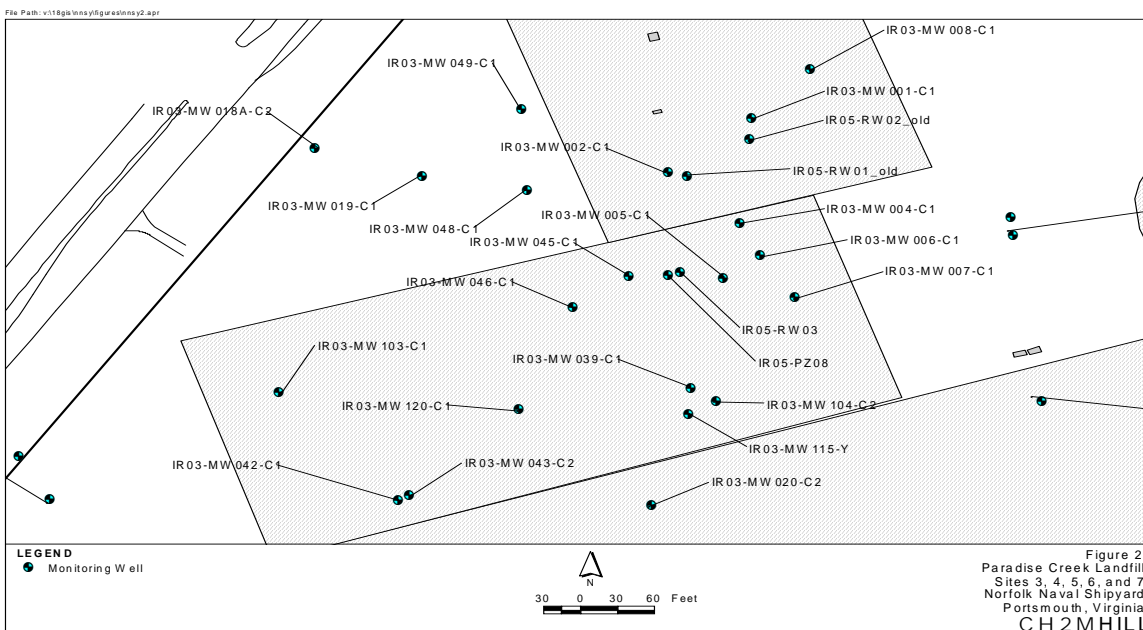
5) Fence panel in western corner tilted at a 45 degree angle
9) Some settling of the landfill cap observed throughout Site 3
(Enter suggested improvements to this form)
