THIRD FIVE-YEAR REVIEW REPORT FOR  
Moyer's Landfill Superfund Site  
Montgomery County, Pennsylvania

U.S. Environmental Protection Agency  
Region III  
Philadelphia, Pennsylvania

JUN 27 2017

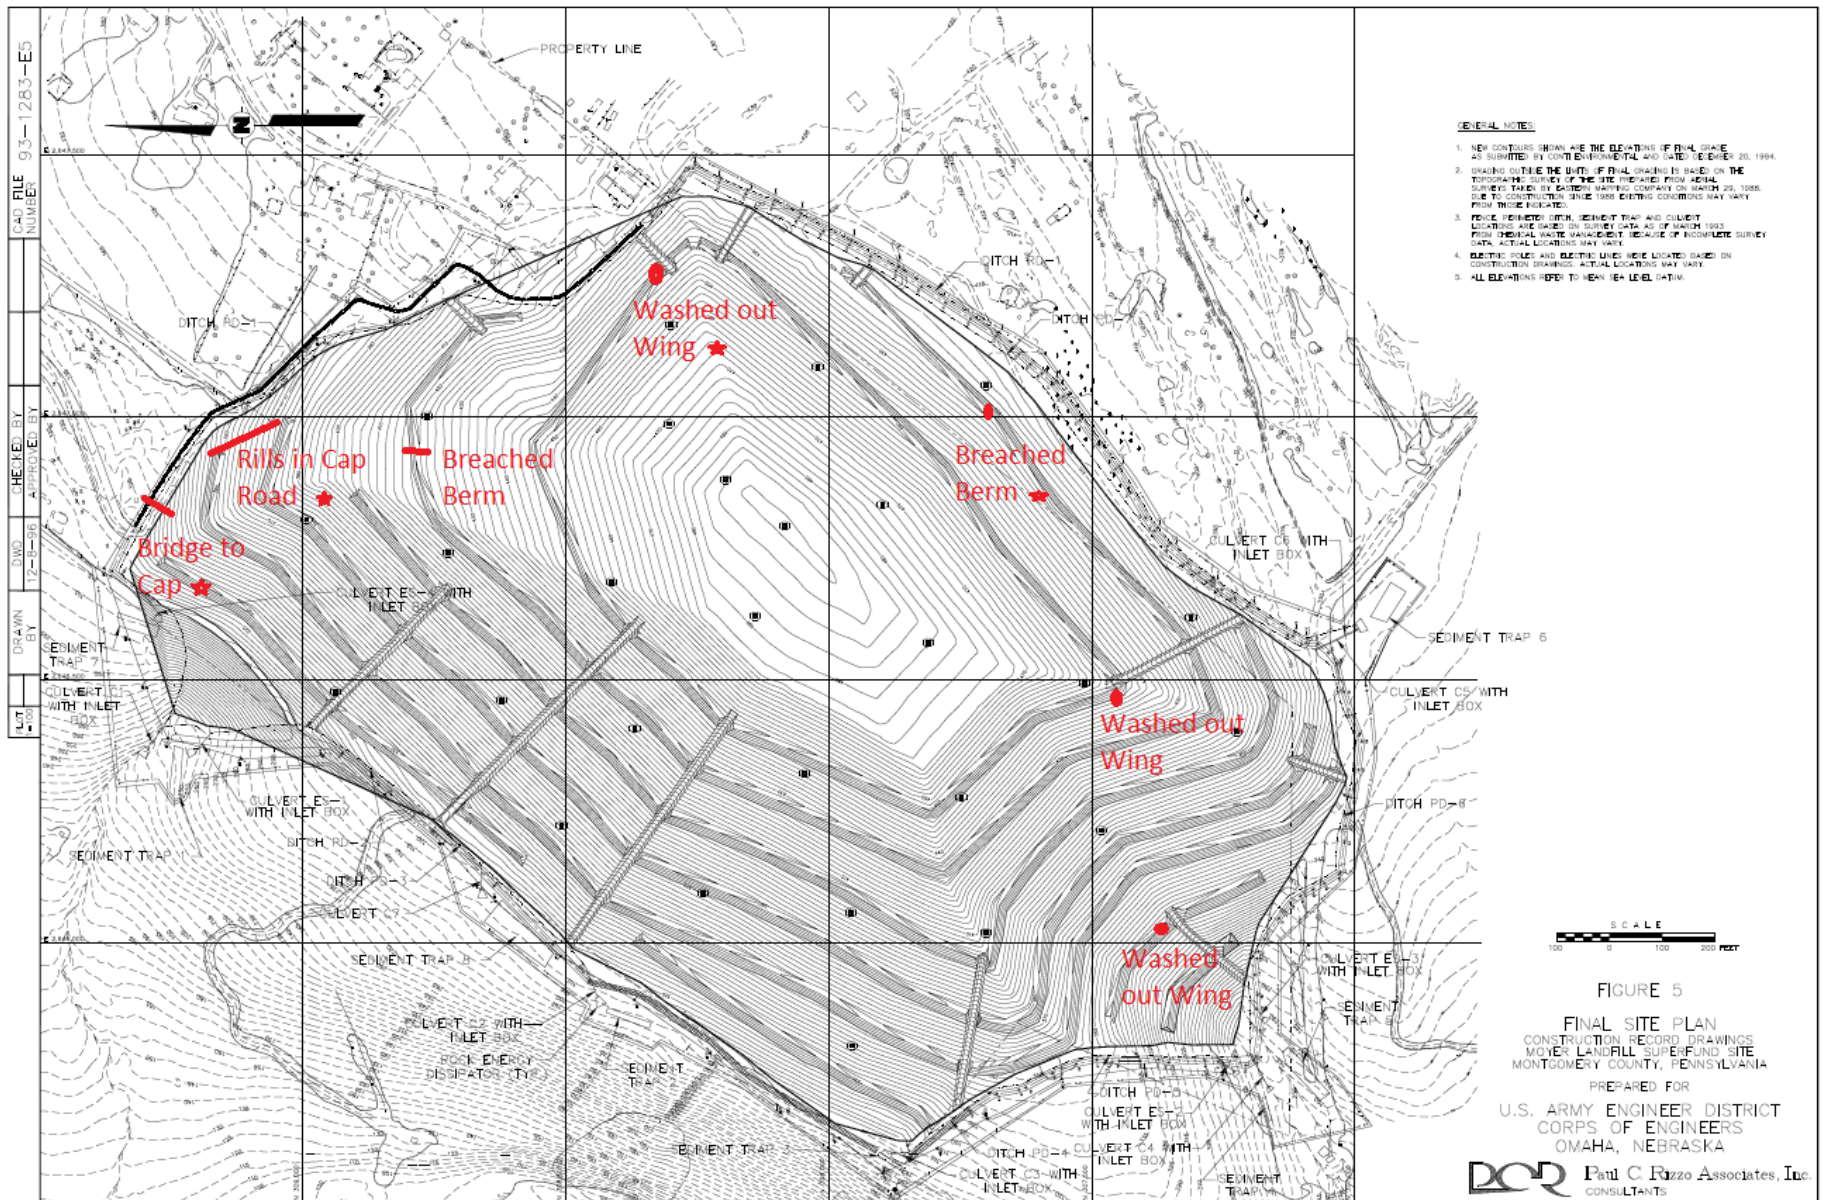
Figure 3  
Erosion Repair Areas 2014  
Moyers Landfill Superfund Site

- 5) Cap Repairs: In the Spring of 2014, PADEP performed extensive repairs to erosion issues on the cap (Figure 3). Soil onsite and imported stone were used to repair the cap and the areas were re-graded and seeded. During the site inspections, pooling water was observed along the berms near the access road going across the cap. This may require attention in the near future in order to prevent any issue before they happen.

Two specific locations were identified for repairs: (1) severe erosion issues in the North Valley and (2) a large seep located near the South Valley pumping station. A large drainage feature installed in the North Valley had failed due to the high velocity of surface water draining off the cap. The repairs included the removal of sediment and stone that had washed down into the drainage feature and clogged a storm drain and culvert at the bottom. After removing the sediment and stone, the drainage feature was reconstructed and widened. Stone removed from the drainage feature was repurposed in the repairs, and new large rip rap stone was brought in to develop the drainage feature. Preventative maintenance features within the reconstructed drainage feature also helps to slow the velocity of surface water as it enters the North Valley. The second area of concern was a seep area noted near the leachate tank farm in the South Valley. Large rip rap stone was used to cover the area and create a small drainage feature to alleviate any standing water present in this area. Minor grass repairs on bare spots located throughout the cap were also addressed with grass seed and straw.

There are also some areas that may require attention in the near future in order to prevent any issues before they happen. Some small washed out areas near the grout pillow drainage features throughout the Site have been noted. These repairs have been planned for Spring of 2017.

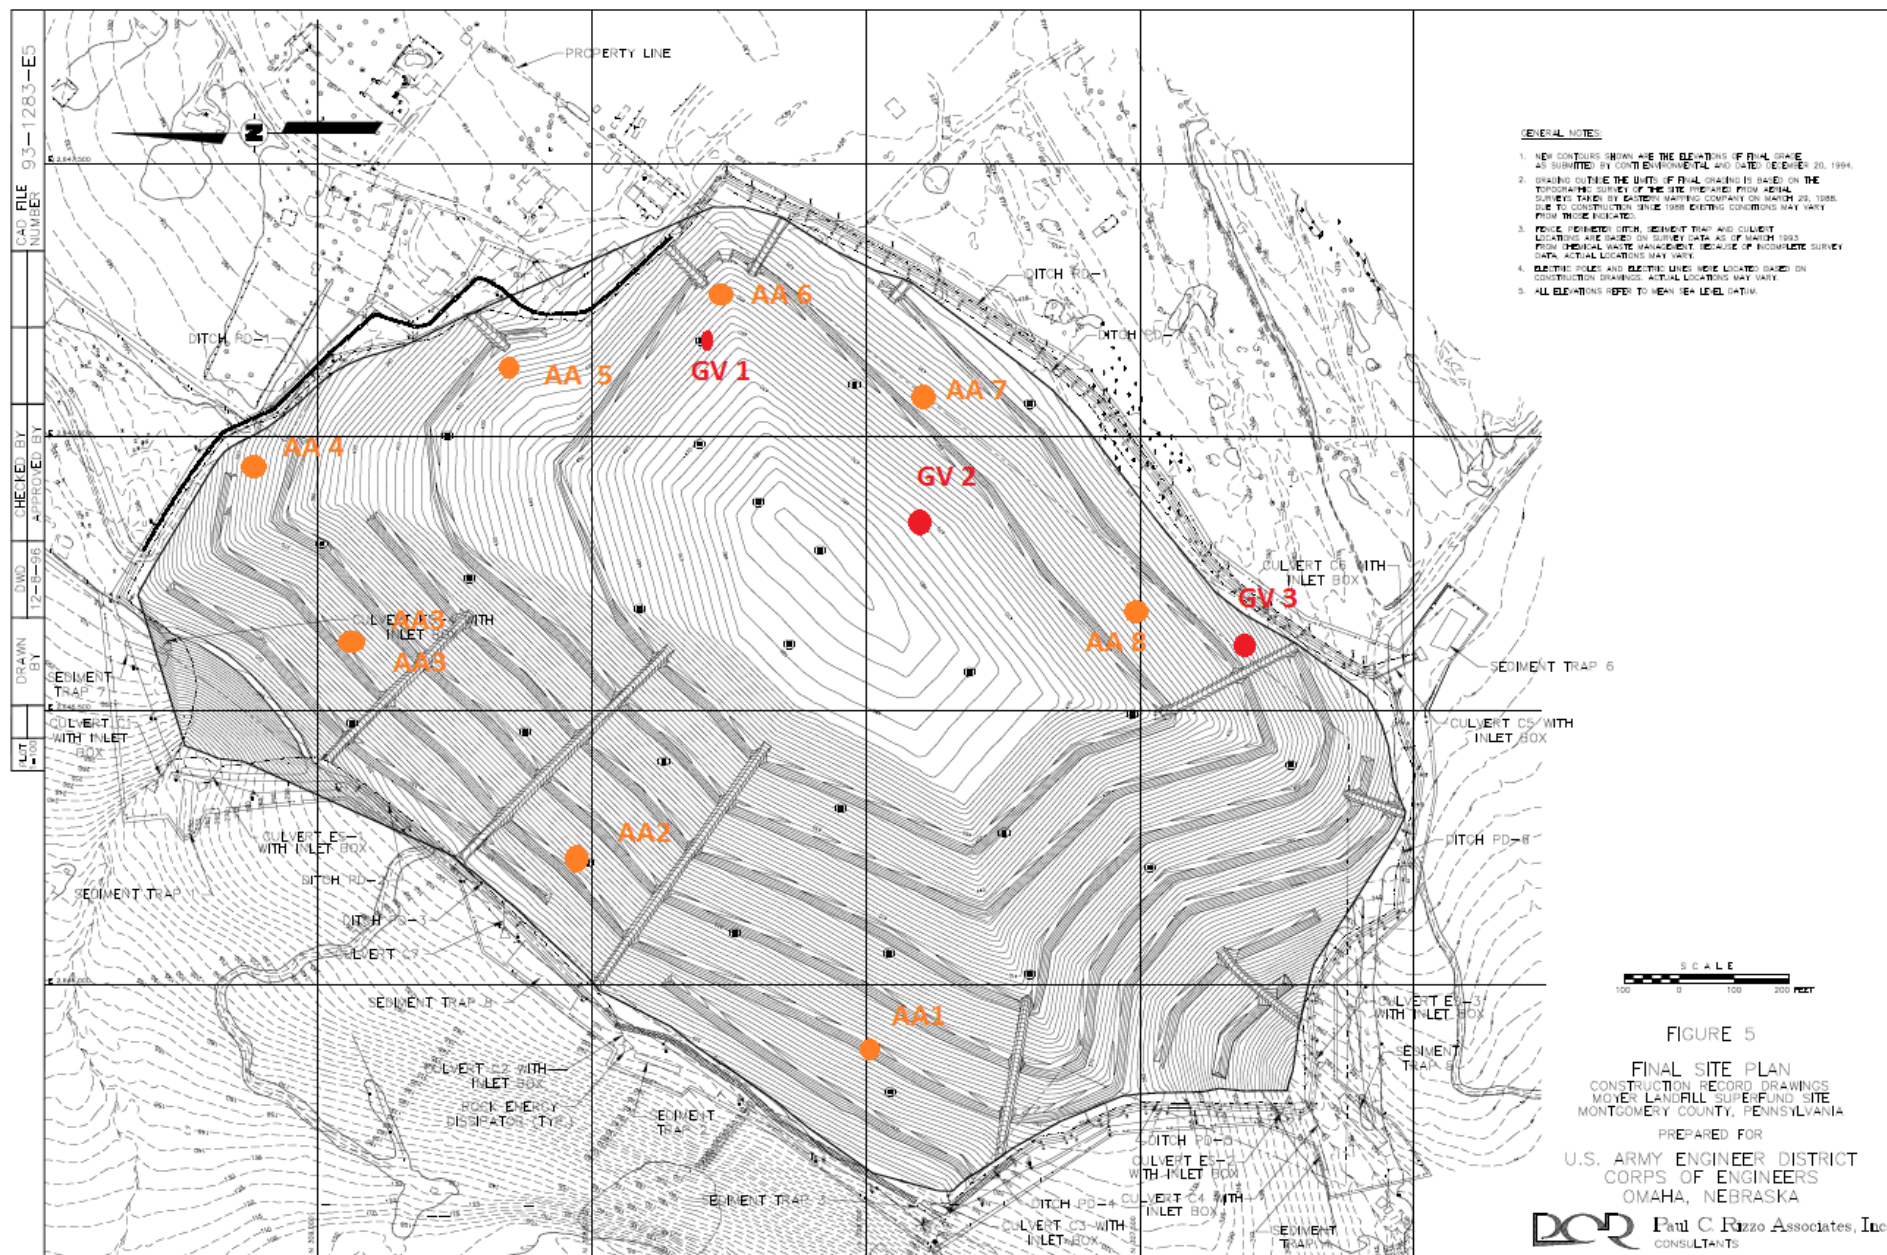
Figure 4  
Gas Vent & Ambient Air Sampling Locations 2014  
Moyers Landfill Superfund Site

In April 2014 and June 2016, PADEP performed ambient air sampling at eight locations around the perimeter of the landfill using stainless steel Summa<sup>®</sup> canisters. Sampling locations are rotated every sampling event with a bias toward the nearby residential community. See Figure 4 for 2014 monitoring locations and Figure 6 for 2016 monitoring locations. All samples were analyzed for EPA Method TO-15 VOCs in Air. In 2016, one of the canisters “Summa 8,” malfunctioned during the sampling event, and results are available for only the remaining 7 samples. Tables 4 and 5 provide a summary of the results of the 2014 and 2016 ambient air monitoring events. Only detected compounds are summarized in these tables, i.e. if a compound was not detected in any of the samples in a particular event, the compound is not listed in Tables 4 and 5.

Although exceedances of RSLs were noted for a few of the VOCs, no chemicals were detected in any ambient air samples at concentrations that would pose an unacceptable risk under a residential exposure scenario. Several chemicals measured directly at the on-site gas vents exceeded RSLs, sometimes by two orders of magnitude or more. However, these concentrations are not indicative of exposure under current land use conditions. Dilution of the vent gases appears to be occurring rapidly, as demonstrated by ambient air samples collected at the landfill. In summary, the results of PADEP's sampling of the landfill gas vents and perimeter ambient air monitoring at the Site show that the landfill gas emissions are not adversely impacting the ambient air quality.

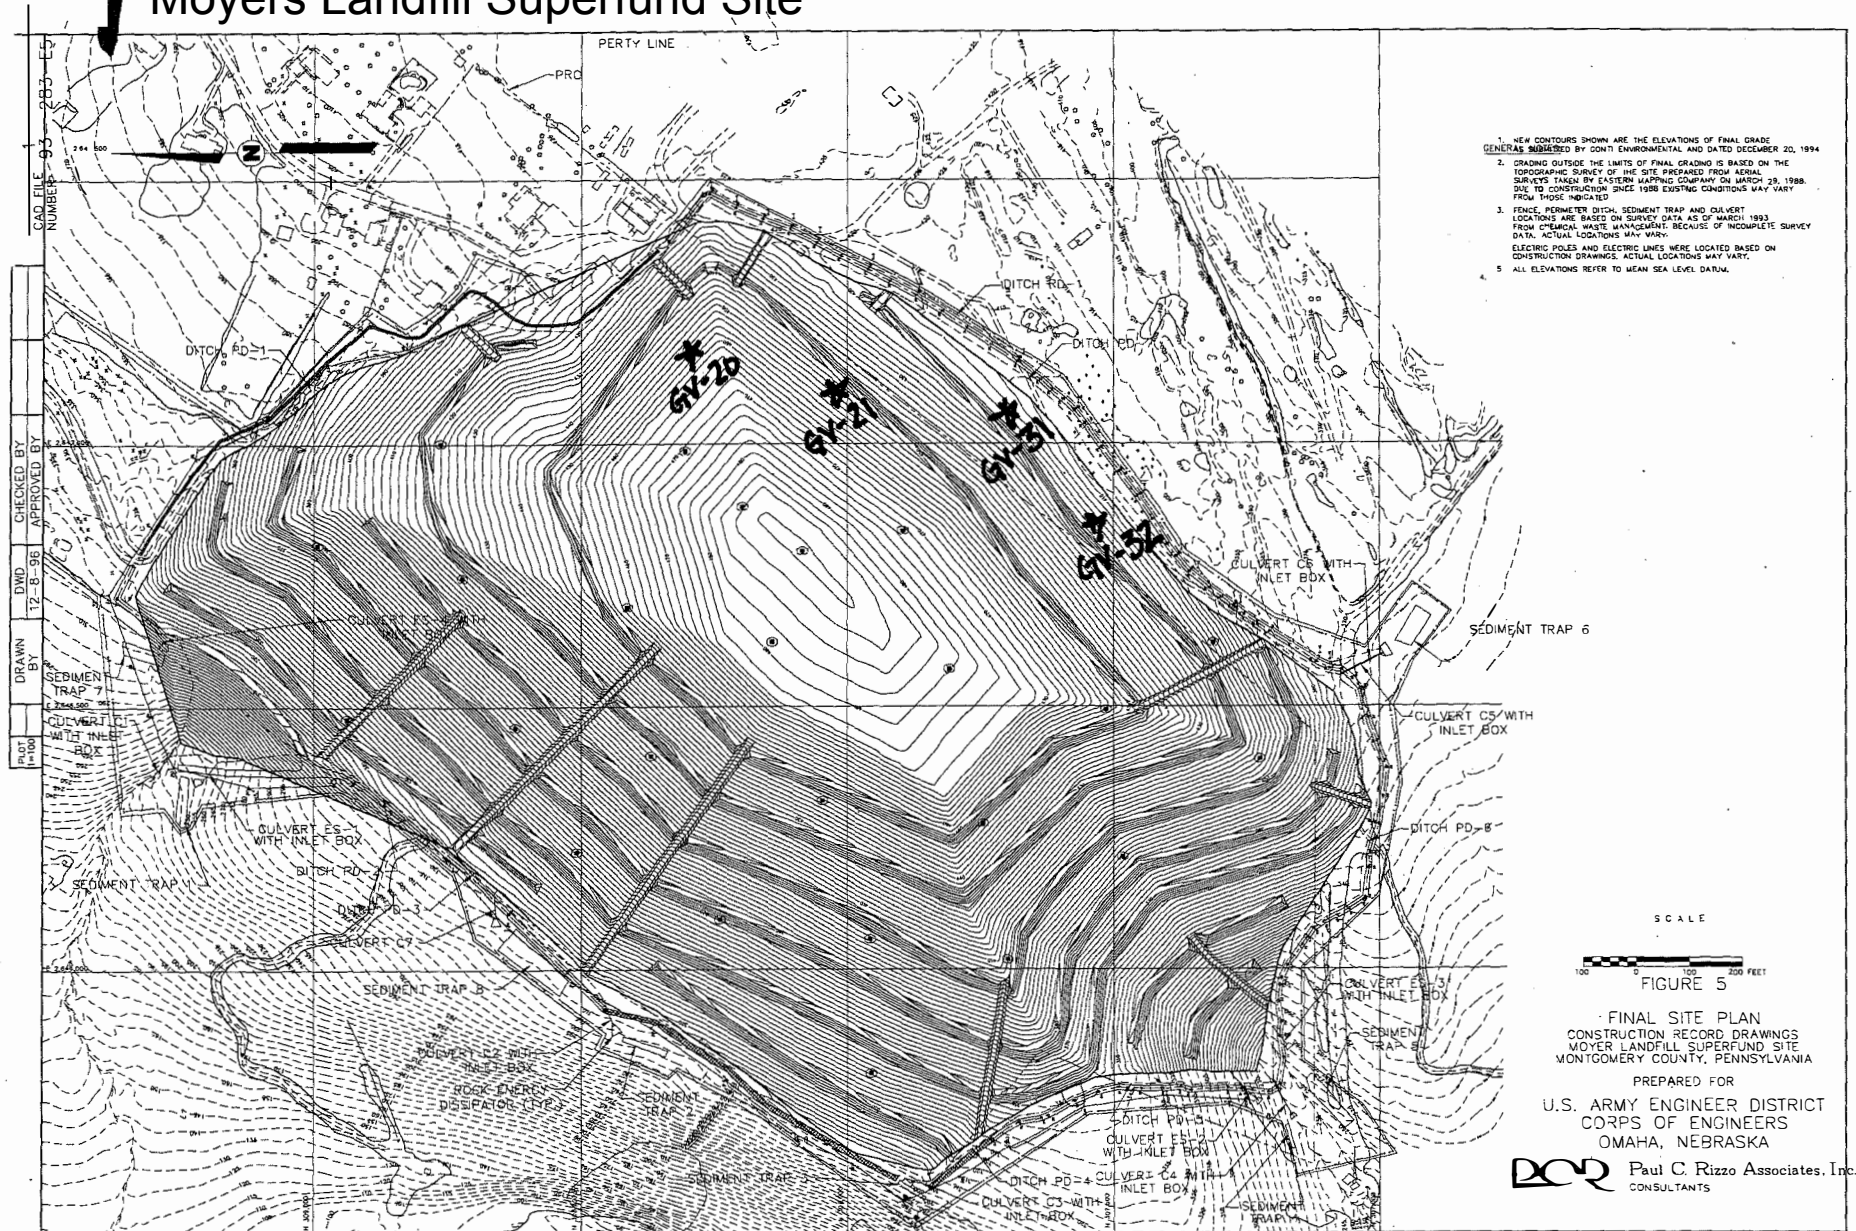
Figure 7  
Gas Vent Sampling Locations 2017  
Moyers Landfill Superfund Site

At EPA's request, PADEP completed methane sampling of four passive gas vents closest to the residents at Moyers on May 16, 2017. Table 6 shows there were no detectable levels of methane found at these gas vents. Therefore, the landfill gas is not migrating beyond the landfill perimeter, and there is no risk to nearby residents.
