Former Frenchtown Mill	Observer: D. Hoffman
Project 350.0065.001	Date / Time: 4/19/17 1200 - 1730
Clark Fork River Berm	Weather: Sun, 52 F
Clark Fork Discharge at USGS Gage 12353000 (cfs): 8,400

Clark Fork River Stage Monitoring Sites
Former Frenchtown Mill Site
Missoula County, Montana
FIGURE 1

PHOTO LOG

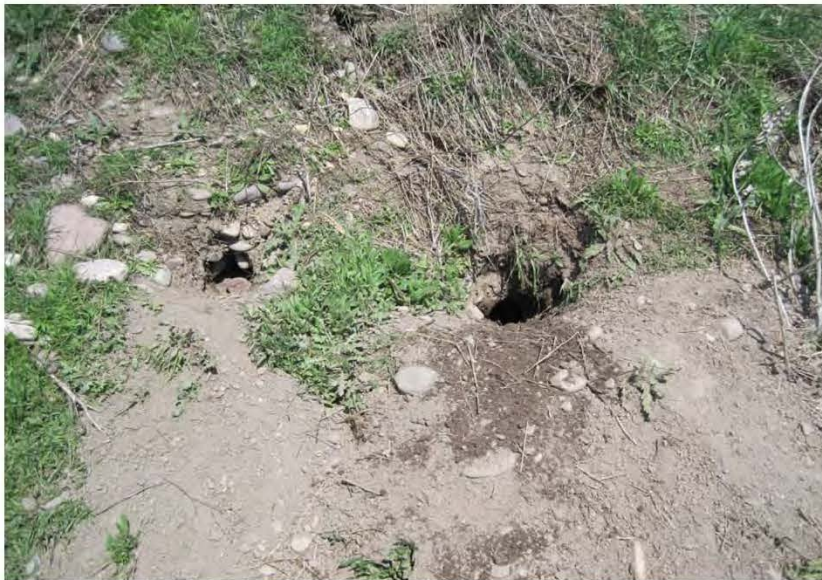
Site: HP1a

Photo 1- Looking north. Animal burrows in berm.

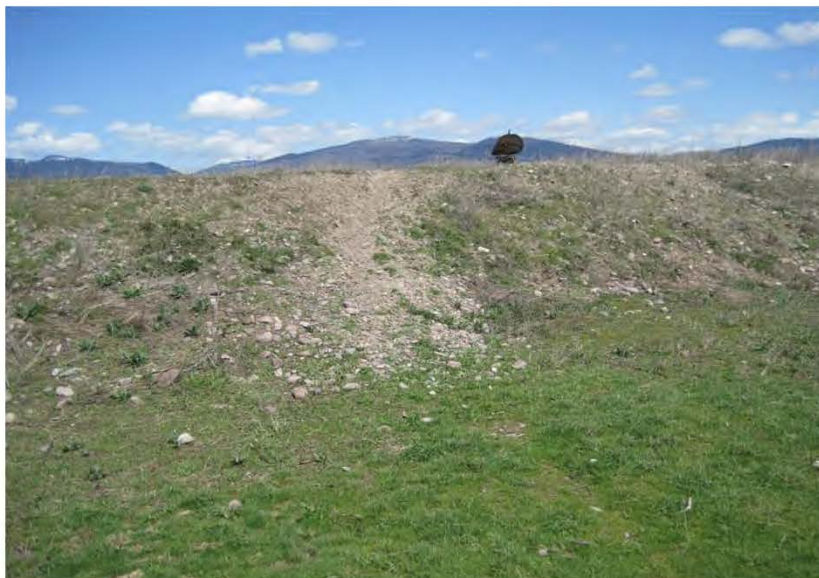
Site: HP2

Photo 2- Looking north. Cattle trail leading to mineral station on south side of HP2.

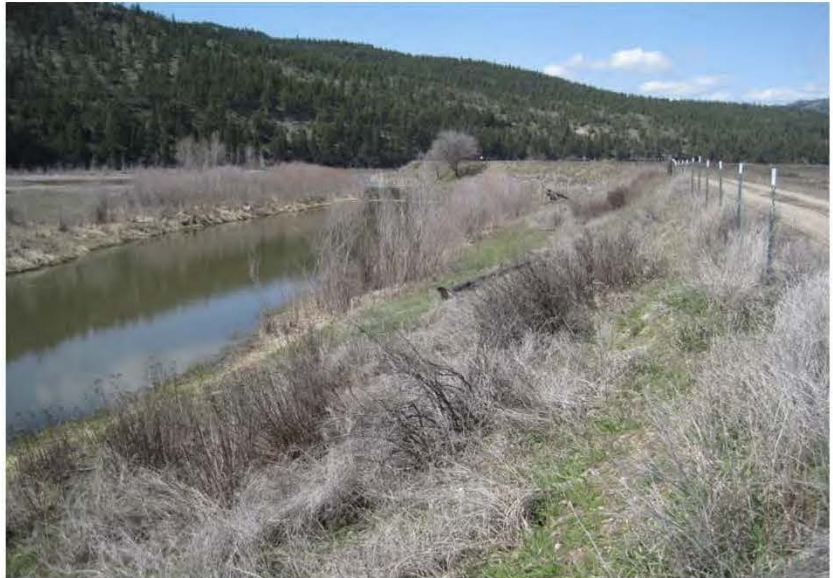
Site: Photo Point 1

Photo 3- Looking northwest.
Southwest corner of HP2.

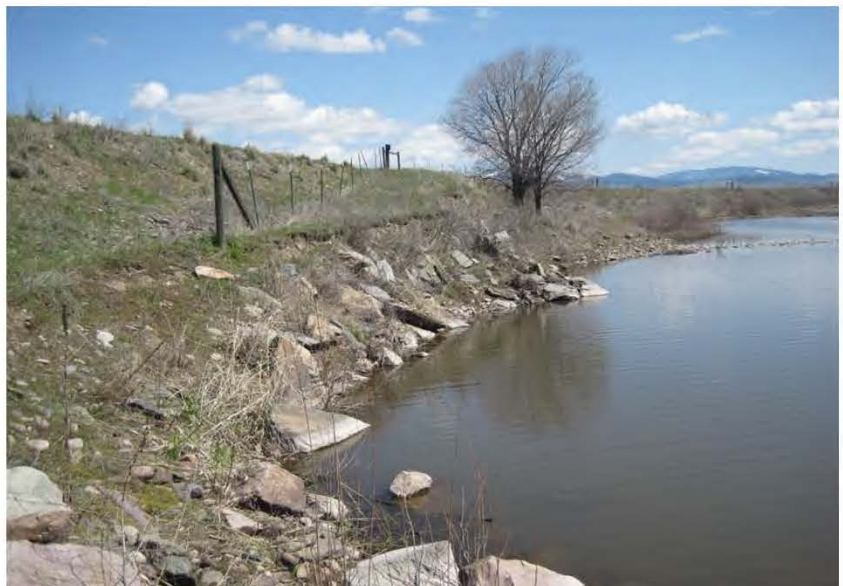
Site: Photo Point 2

Photo 4- Looking east. Bank erosion
and rip rap in poor condition should
continue to be monitored.

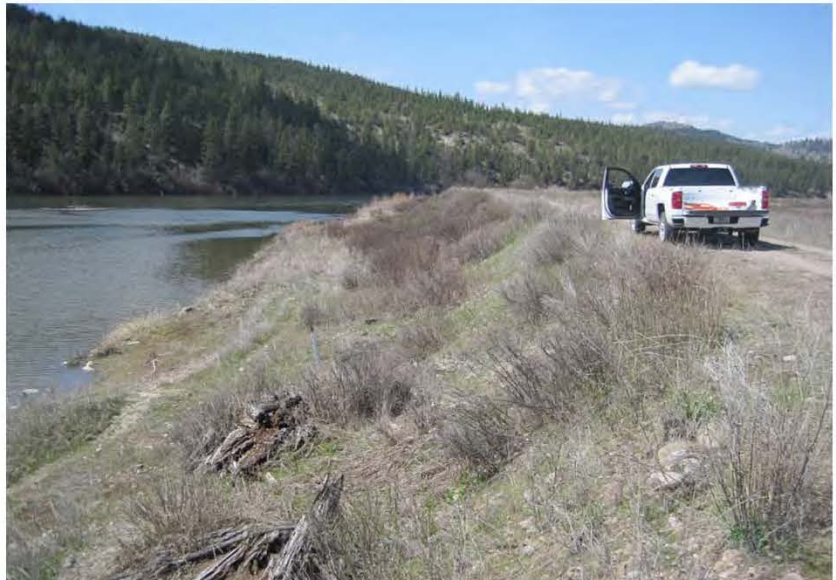
Site: Photo Point 3

Photo 5- Looking northwest. West side of HP2, new staff gage installed.

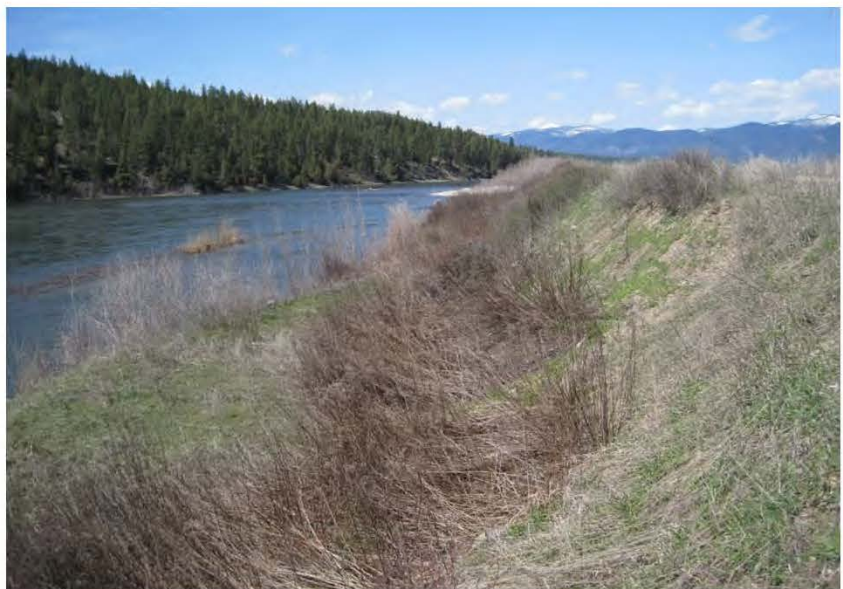
Site: Photo Point 4

Photo 6- Looking north. West side of HP2.

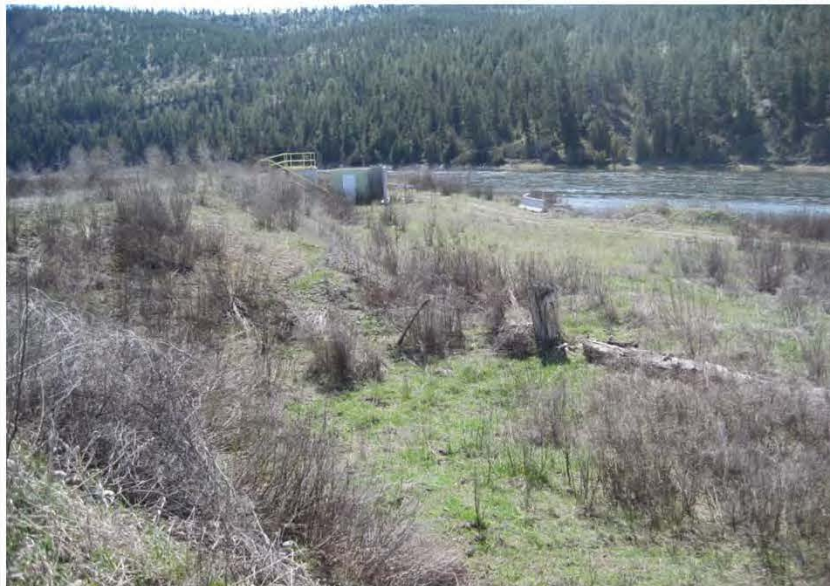
Site: Photo Point 5

Photo 7 - looking south. Located at outfall 2, west side of HP2/HP7. Gage will be installed on concrete structure.

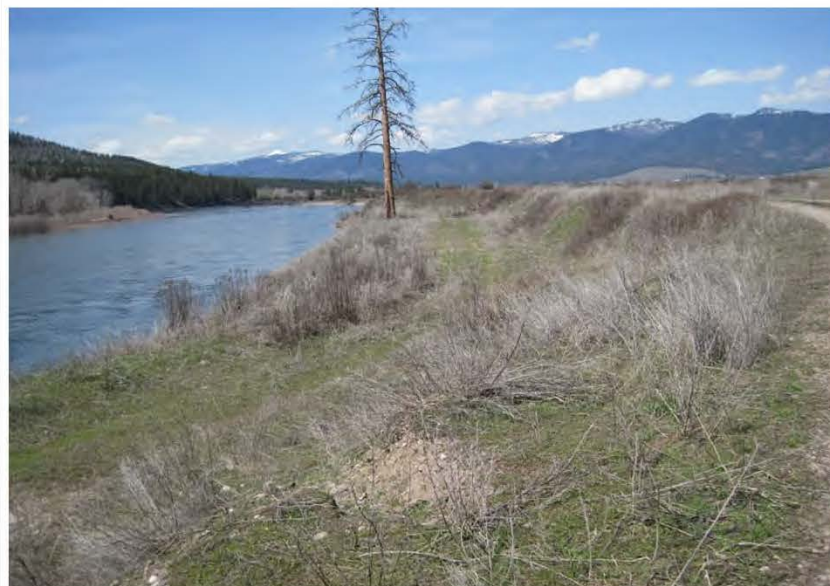
Site: Photo Point 6

Photo 8- Looking north. Southwest side of HP11.

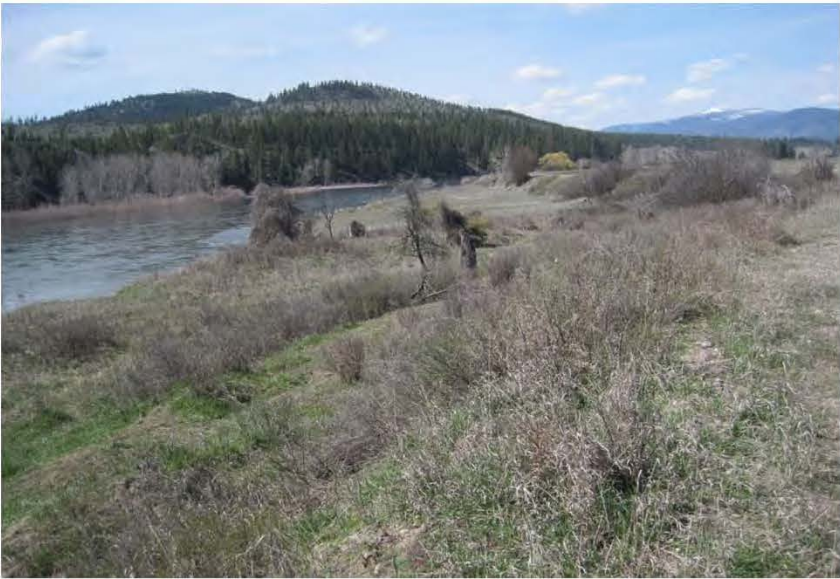
<p>Site: Photo Point 7 Date/Time: 4/19/17 1515 Staff Gage (ft): N/A</p> <p>Location: N 46.96448 W 114.22173</p> <p>Comments: Photo 9- Looking north. West side of HP11.</p>

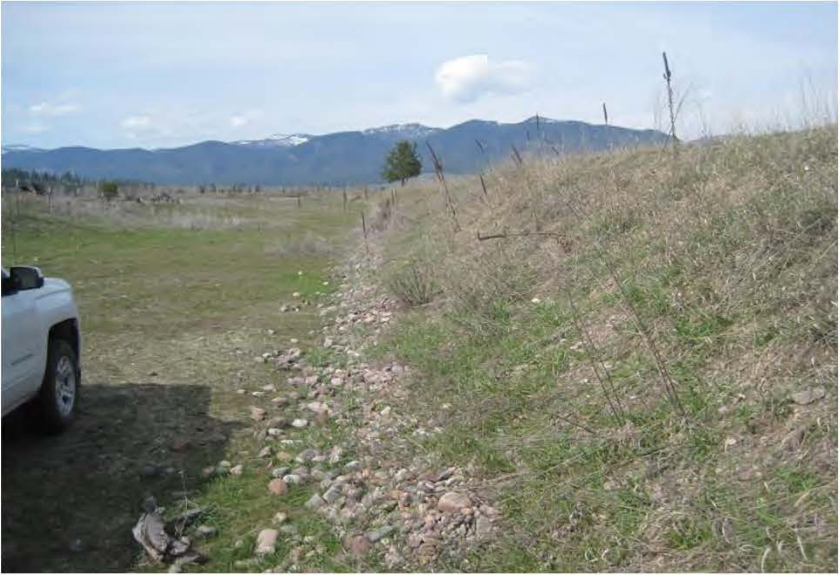
<p>Site: Photo Point 8 Date/Time: 4/19/17 1600 Staff Gage (ft): Below gage</p> <p>Location: N 46.97270 W 114.22433</p> <p>Comments: Photo 10- Looking north. West side of HP12.</p>

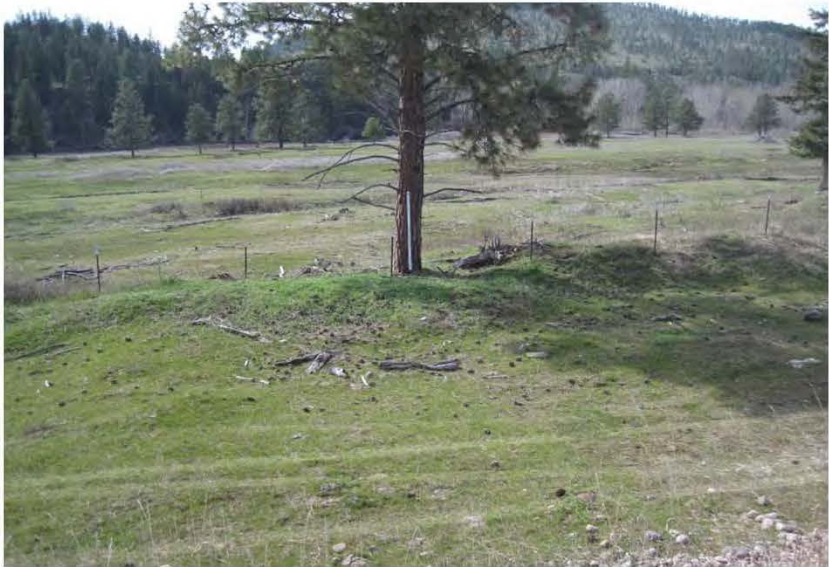
<p>Site: West side of HP12 Date/Time: 4/19/17 1600 Staff Gage (ft): Below gage</p> <p>Location: N 46.97270 W 114.22433</p> <p>Comments: Photo 11- Looking west. Staff gage at PP8</p>
