SITCUM WATERWAY REMEDIATION PROJECT

CLEAR CREEK HABITAT IMPROVEMENT PROJECT MONITORING REPORT, 2008

JANUARY 2009

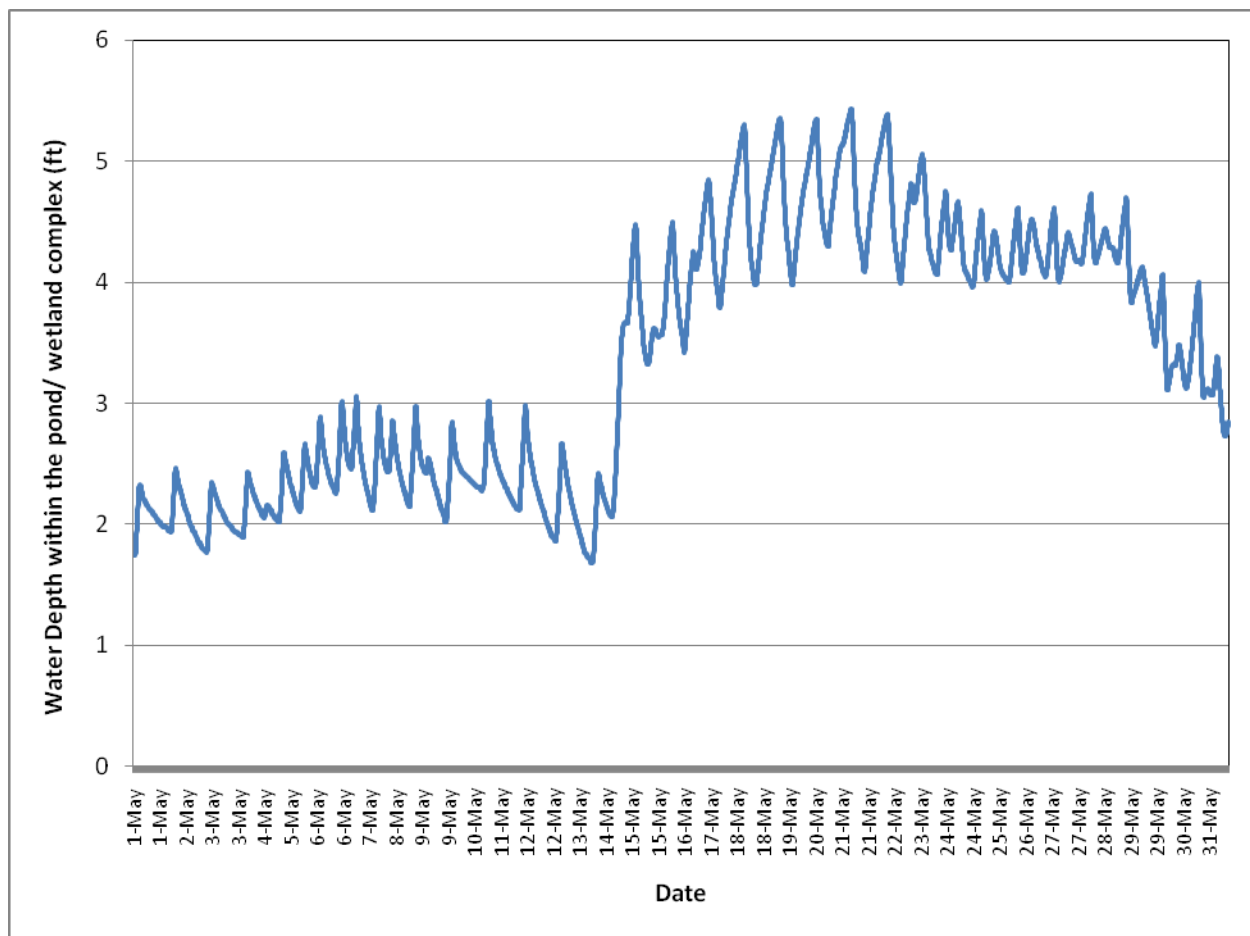
Figure 1. Tidally Induced Water Level (ft; NGVD) for the Clear Creek Habitat Improvement Project Site Pond/Wetland Complex during May 2008.

The results from May 2008 show that regular tidal-induced water level fluctuations occurred during Year 10 monitoring of the pond/wetland complex (Figure 1). The steep leading edge of each tidal curve shows that tidal flooding was unrestricted. The extended trailing edge of each tidal curve demonstrates the weirs’ effectiveness at controlling water retention within the pond/wetland complex.
