SYOSSET LANDFILL

2017 ANNUAL POST-CLOSURE SUMMARY REPORT

TOWN OF OYSTER BAY

SYOSSET LANDFILL
2017 ANNUAL POST-CLOSURE
SUMMARY REPORT

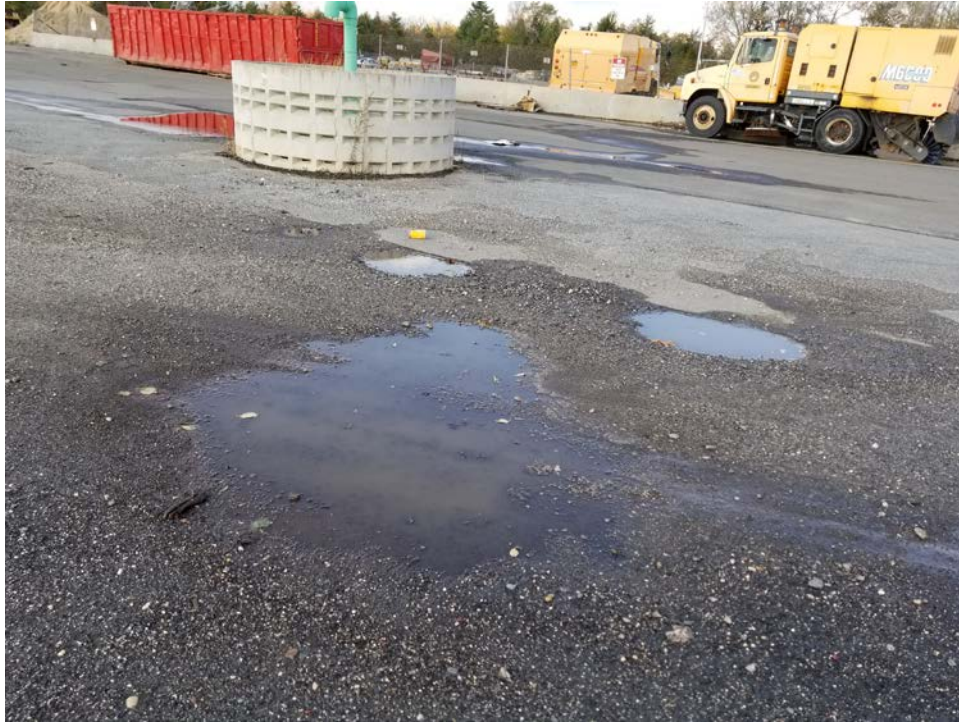
Ponding in Area A/C Border

It is recommended that surface grading within the RCA material in Area A should be routinely adjusted to remove low points that occur. The asphalt section in Areas C and E experiencing ponding should be restored in accordance with the original Capping Contract specifications as discussed in Section 1.5 when routine pavement repairs are performed in the future in these areas.

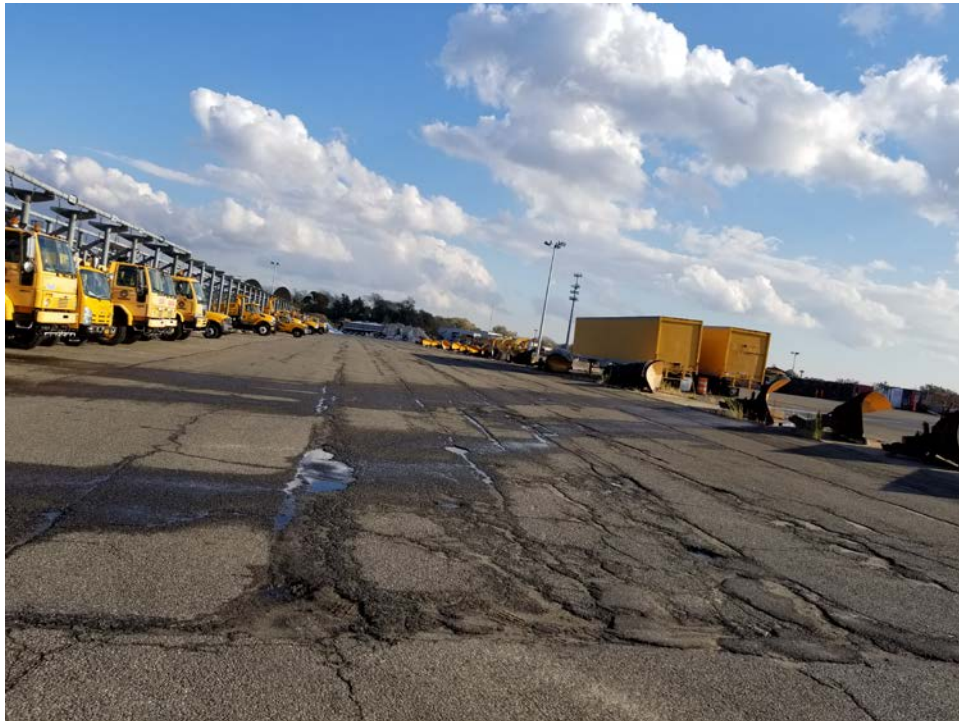
Asphalt Surface Cracks Area C

It is recommended that these areas continue to be repaired on a regular basis as part of routine yard maintenance. The joints should be cleaned and sealed to prevent further weathering damage in accordance with the New York State Department of Transportation (NYSDOT) Standard Specifications, Construction and Materials, Section 633-3.02, "Cleaning, Sealing and Filling Joints and Cracks". It is recommended that the cracks in the asphalt pavement be cleaned and sealed as per the NYSDOT Pay Item for Cleaning and Sealing Cracks in Hot Mix Asphalt Pavement using Hot Applied Sealant, ITEM 402.7602 08. Cracks in the concrete pavement should be cleaned and sealed as per the NYSDOT Pay Item for Crack Repair by Epoxy Injection (Restoration), ITEM 01555.8002 M.

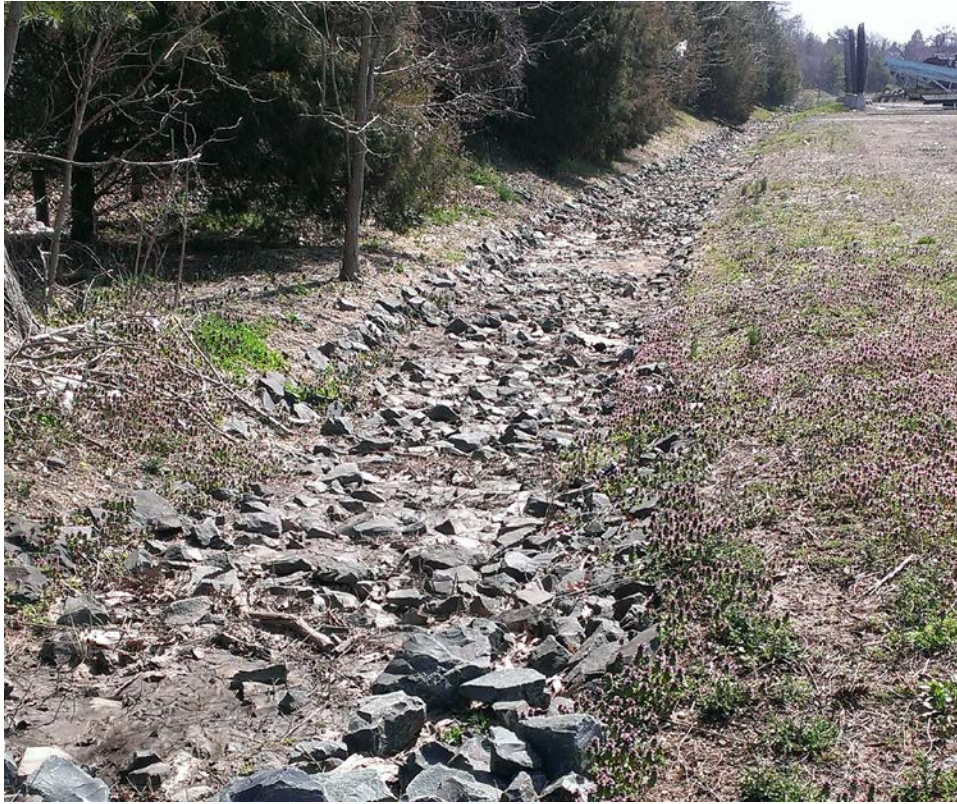
Siltation – DS#3

The drainage ditches should receive routine maintenance to prevent future sediment accumulation and vegetation growth conditions. The apparent

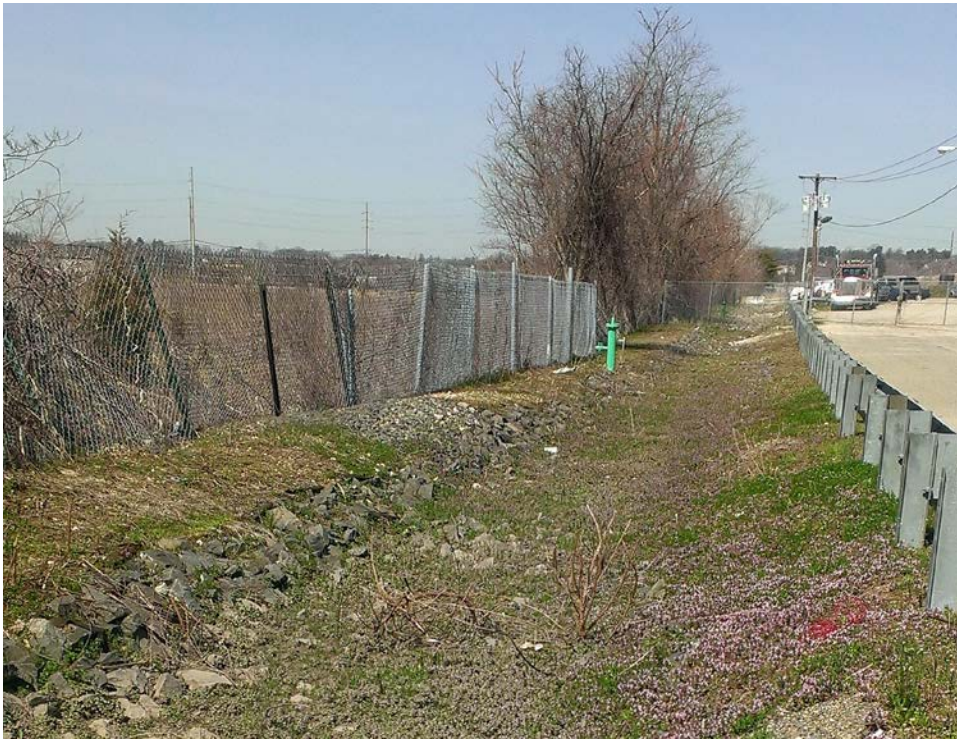
Vegetative Growth – DS#7

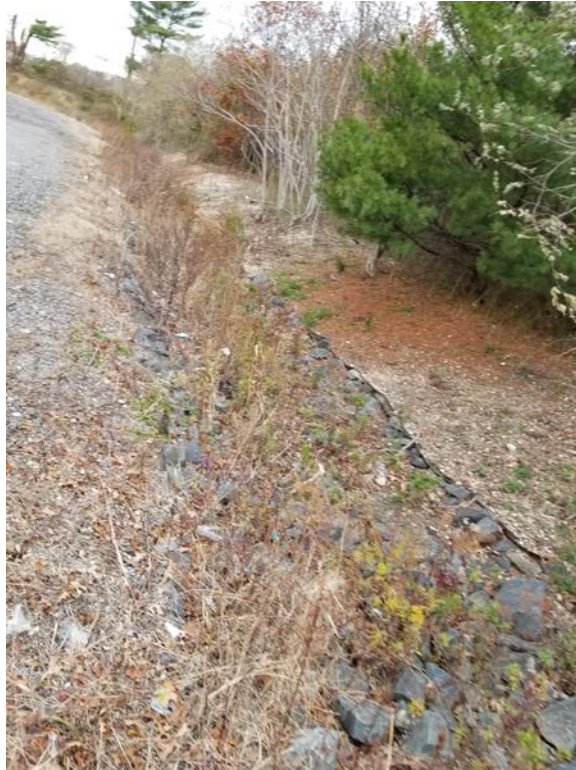
Vegetative Growth – DS#4

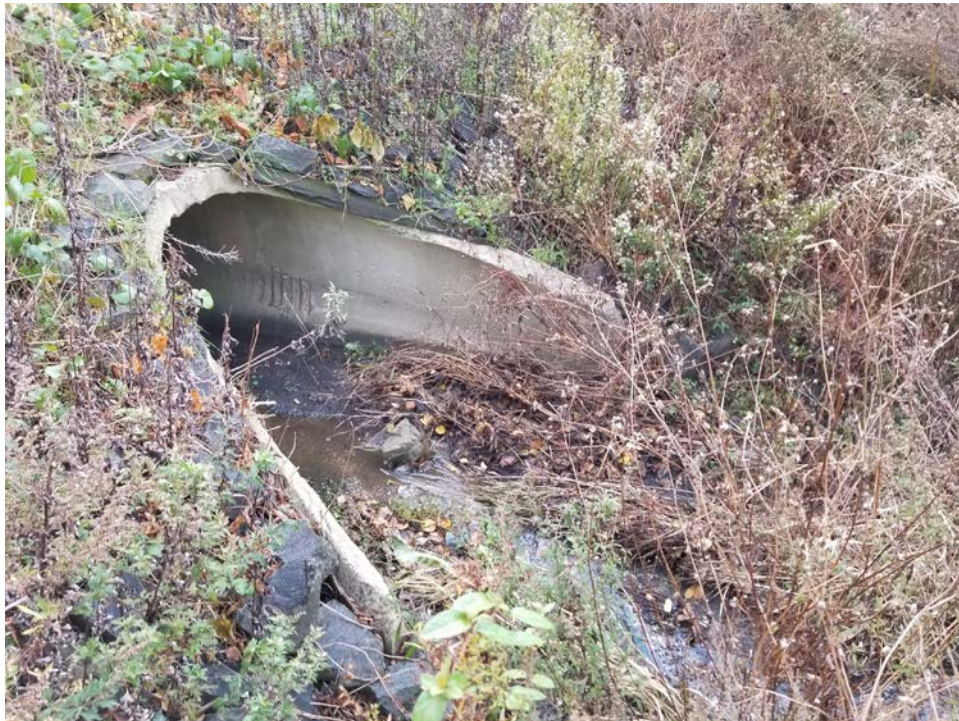
The storm drainage pipes were inspected at the drainage structure locations and only minimal sedimentation and some vegetative growth were noted at the entrance to the end section located adjacent to the Animal Shelter (ES #1, see Figure 2) during the 2017 reporting period.

Some Siltation and Vegetative Growth – ES#1 (DS#8)

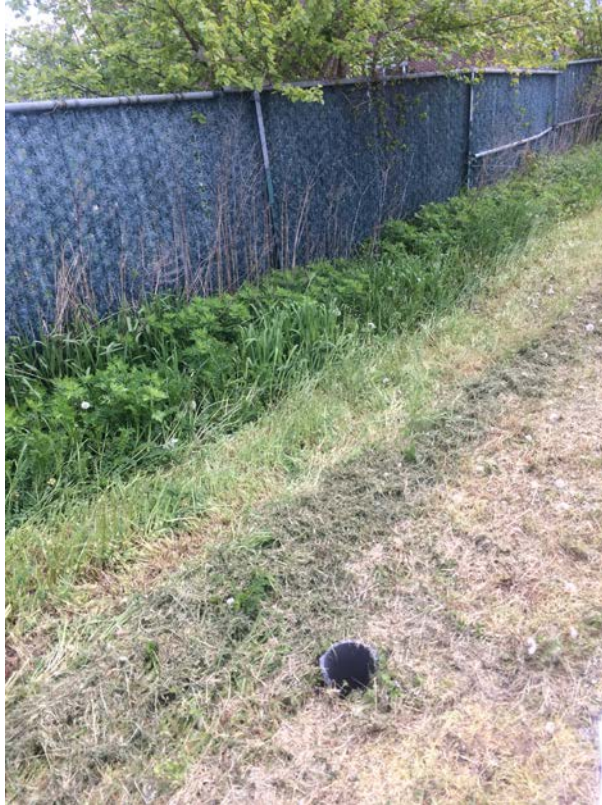
Inspection of each gas vent well was performed prior to each round of gas monitoring. Of the 54 property line and perimeter gas vent wells inspected in the first and second inspection rounds, only NE-16, NW-3, and SW-6 were damaged (the upper sections of the gas vent wells were detached from the well casing pipes at grade) during this reporting period. The three wells are secured with a temporary protective cover to prevent debris from entering the wells. Machinery used in this area combined with overgrown vegetation may have been the cause of the damage. During the post-closure period to date, methane has not been detected at Well NE-16, and has only been detected twice at Well NW-3 and four times at Well SW-6. However, these detections were all below the 6NYCRR Part 360 regulatory limit of 5% and no detections at these wells have occurred since the second quarter of 2013. While Well NE-16, NW-3, and SW-6 are still capable of venting and being monitored in their current condition, when necessary, it is recommended that the upper section of the casing pipe be reattached and the wells restored to their original configuration during the next well repair contract. It is recommended that vegetation near the gas vent wells be carefully maintained on a regular basis to improve visibility and help prevent damage to vent wells in the future.

Well Casing Broken at Grade – NE-16

- Recommended that stockpiles not be placed within 25 feet of the ridge vent wells to prevent trucks from damaging the wells in the future.
- Wells NE-16, SW-6, and NW-3 should be repaired during the next well repair contract.
- The damaged protective concrete rings at Ridge Vents R-6 and R-26 should be replaced.

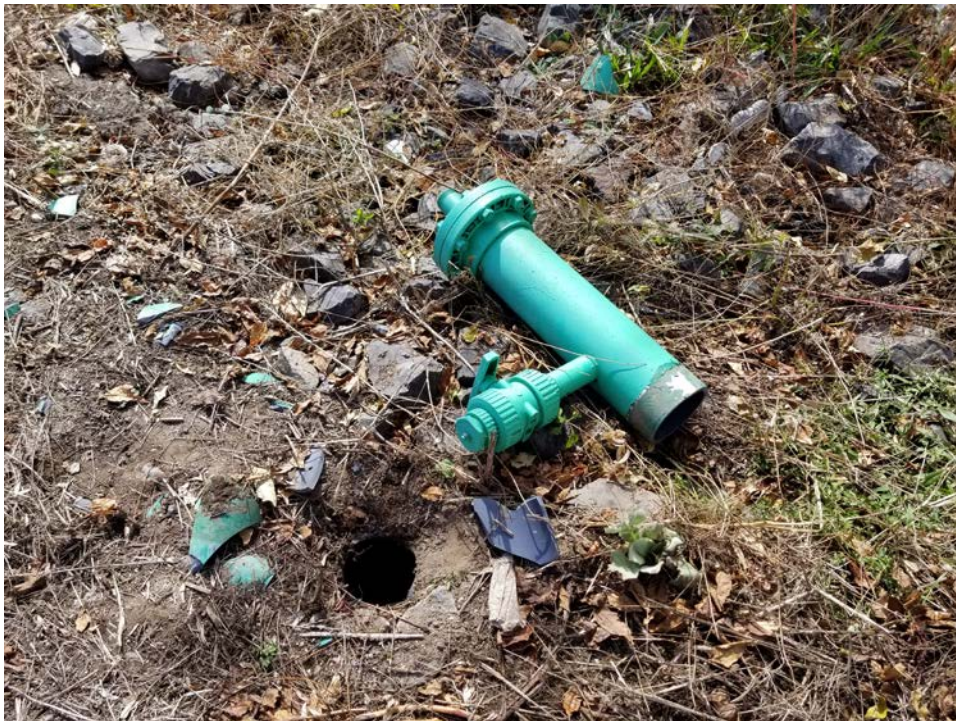
Well Casing Broken at Grade – SW-6

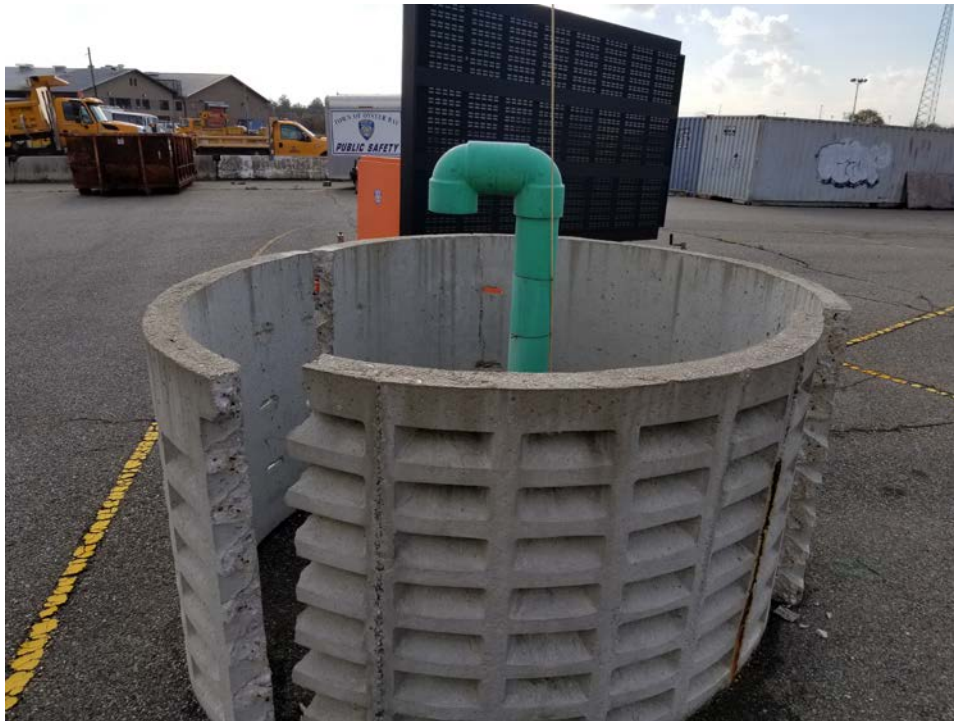
The 2017 ridge vent well inspections conducted during the first and second inspection rounds showed only damage to the Well R-6 and the Well R-26 ten foot diameter concrete ring. It is recommended that the damaged concrete rings be replaced with ten foot diameter concrete rings. Historically, the leading cause of damage to the ridge vent well casings and protective concrete rings has been attributed to impact with trucks or other vehicles used onsite. It is recommended that stockpiles not be placed within 25 feet of the ridge vent wells to prevent trucks from damaging the wells in the future.

Ridge Gas Vent Well Broken Ring – R-26
