**General Electric Company
Pittsfield, Massachusetts**

2008 Annual Monitoring Report

**Upper ½-Mile Reach of the
Housatonic River**

January 2009

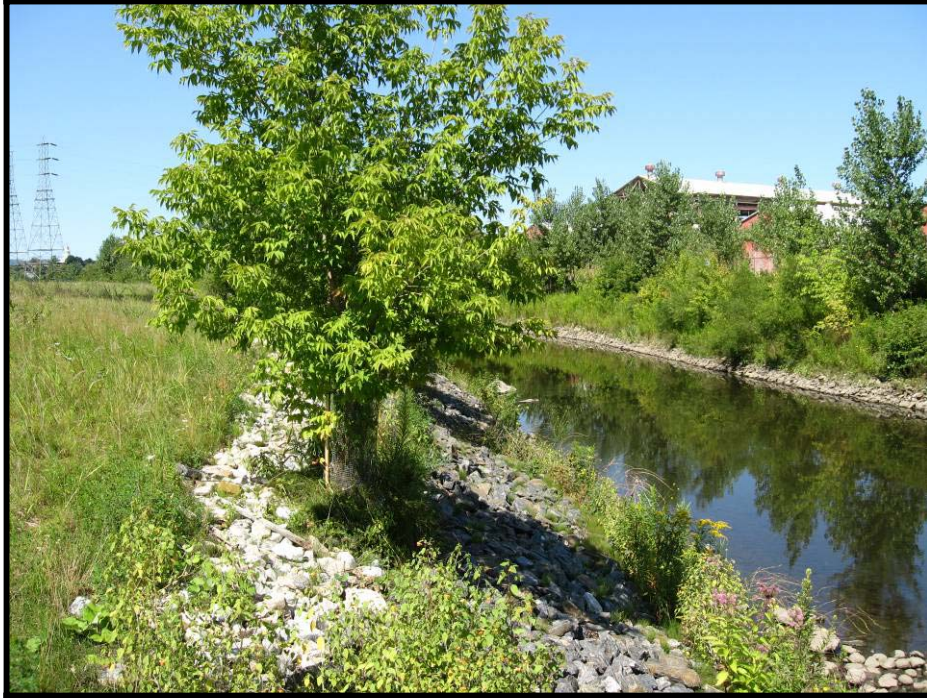
Photograph 7: Planting Area 8, 9, 9A, 11, and 11A

As noted above, composite planting area 8, 9, 9A, 11, & 11A did not meet the performance standard for understory specimens, with a variance of 19 specimens. In addition, the 2007 Annual Report stated that replanting activities would be performed in spring 2008 at planting areas 5 and 16, which were found in the 2007 inspection not to meet their performance standards for canopy and/or understory species. However, seasonal constraints related to the timing of the completion of the remedial activities and riprap placement and the ensuing need for coordination with various contractors involved with the plantings delayed the planting schedule beyond the optimal planting season, resulting in the proposed replanting being postponed. As a result, planting area 5 is still missing 4 canopy specimens and 36 shrub specimens, and planting area 16 is still missing 2 canopy specimens. Supplemental planting associated with these previously identified variances – anticipated to include planting of 8 additional canopy specimens and 36 shrub specimens at planting area 5 and 4 additional canopy specimens at planting area 16 – will be included for performance with the proposed 2008 corrective measures.

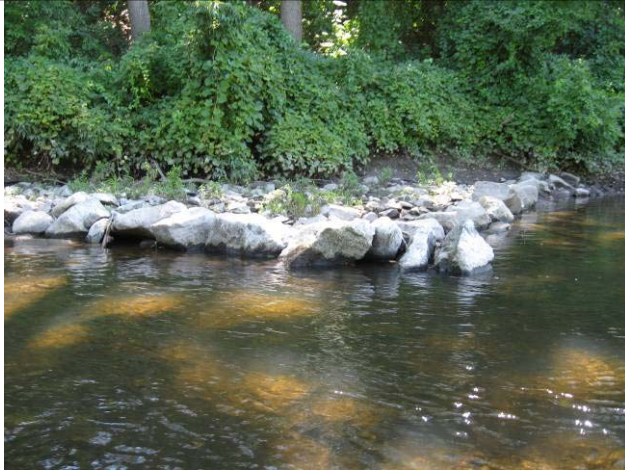
Cell	Aquatic Structures	Armor Stone Condition/General Biological Observations	
B	1. Single wing deflector

<div style="border: 1px solid black; padding: 10px;"> <ol style="list-style-type: none"> 1. Structures appear stable 2. Structure induced variations observed in areas immediately downstream of the deflector </div>

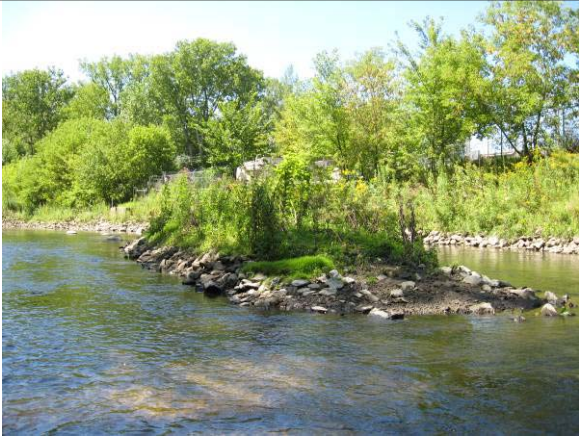
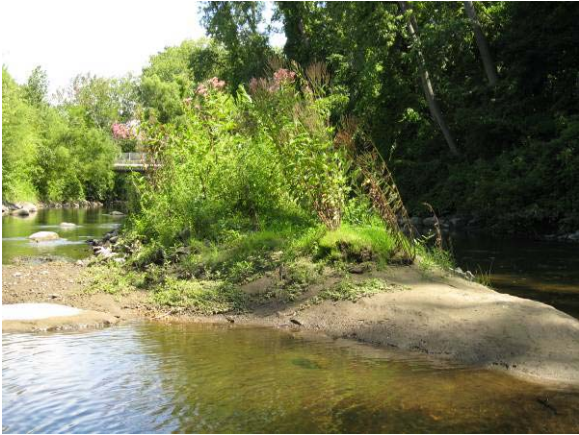
Cell	Aquatic Structures	Armor Stone Condition/General Biological Observations	
C	1. Boulders 2. Island

<div style="border: 1px solid black; padding: 10px;"> <ol style="list-style-type: none"> 1. Structures appear stable 2. Structure induced variations observed in areas immediately downstream of the island 3. The island appears to be well vegetated with wetland herbaceous species 4. Boulders near island appear to be causing scour in the immediate area; good cover </div>

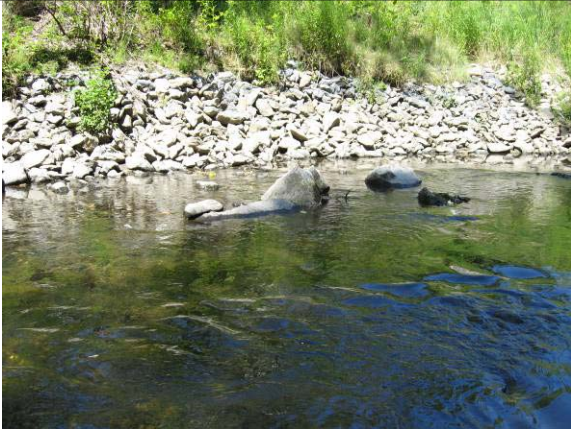
Cell	Aquatic Structures	Armor Stone Condition/General Biological Observations	
D	1. Boulders

<p>1. Structures appear to be functional and providing variation in habitat</p>
G1	1. Boulder Cluster

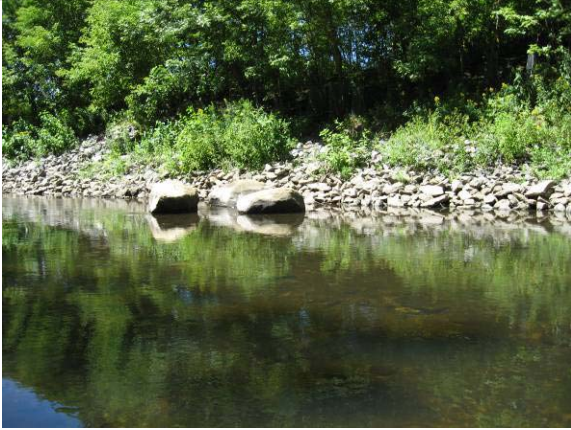
<p>1. Structures appear to be functional and providing variation in habitat</p>

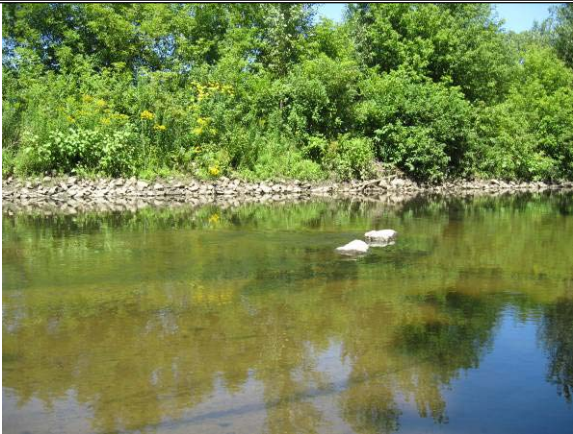
Cell	Aquatic Structures	Armor Stone Condition/General Biological Observations	
G2/F2	1. W-weir

<p>1. Much of the weir is buried in soft silt/sand; portion that is present appears to offer good cover for aquatic organisms</p>
G3	1. Three-boulder cluster

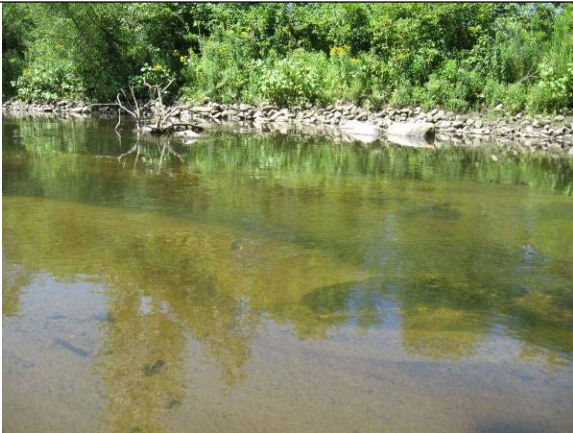
<p>1. Structure appears stable, no issue or concern</p> <p>2. Structure appears to be functional and providing variation in habitat</p>

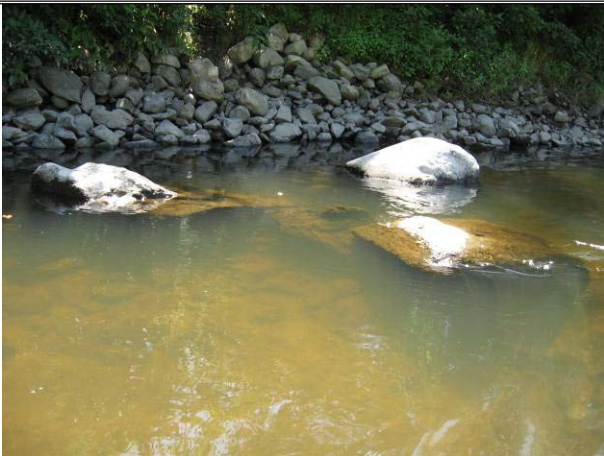
Cell	Aquatic Structures	Armor Stone Condition/General Biological Observations	
F3	1. Three-boulder cluster 2. Two-boulder cluster 3. Three-boulder cluster

<div style="border: 1px solid black; padding: 10px;"> 1. All structures in this cell appear stable. 2. Structures appear to be providing diversity in habitat </div>
H1	1. Boulder cluster	1. Structure appears to be stable and providing diversity in habitat 2. Good habitat, variations in velocity around structure and related variations in stream bottom topography

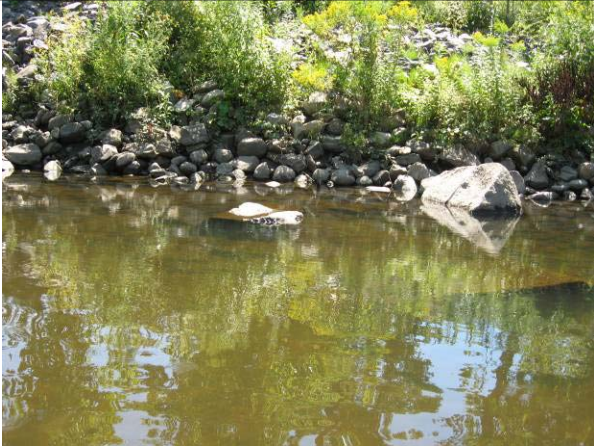
Cell	Aquatic Structures	Armor Stone Condition/General Biological Observations
I1/J1	1. Vortex weir

<div style="border: 1px solid black; padding: 5px; margin-top: 10px;"> <ol style="list-style-type: none"> 1. Much of the weir is buried in soft silt/sand 2. Structure appears to be stable and providing diversity in habitat 3. Good habitat, variations in velocity around structure and related variations in stream bottom </div>
H2	1. Single boulder	<ol style="list-style-type: none"> 1. Structure appears to be stable and providing diversity in habitat 2. Good habitat, variations in velocity around structure and related variations in stream bottom topography

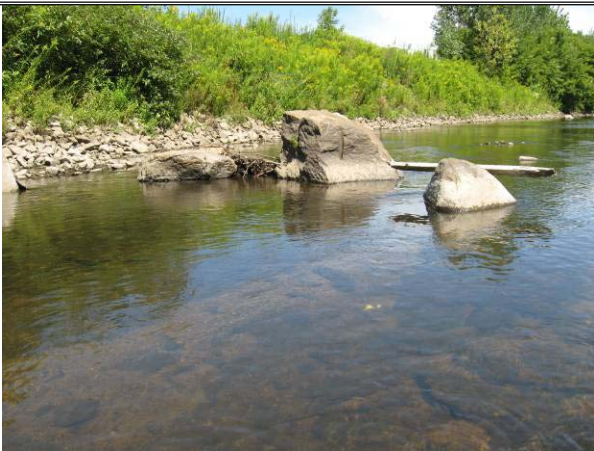
Cell	Aquatic Structures	Armor Stone Condition/General Biological Observations	
J1	1. Two-boulder cluster 2. Three-boulder cluster 3. Single-boulder

<ol style="list-style-type: none"> 1. Structures appear to be stable and providing diversity in habitat 2. Good habitat, variations in velocity around structures and related variations in stream bottom topography 3. Boulders observed to be being used as perches for feeding birds
J2	1. “J”- boulder formation

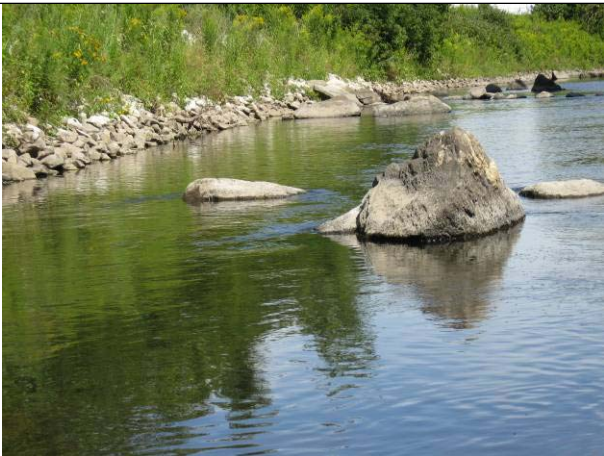
<ol style="list-style-type: none"> 1. Structure appears to be stable and providing diversity in habitat 2. Good habitat, variations in velocity around structure and related variations in stream bottom topography

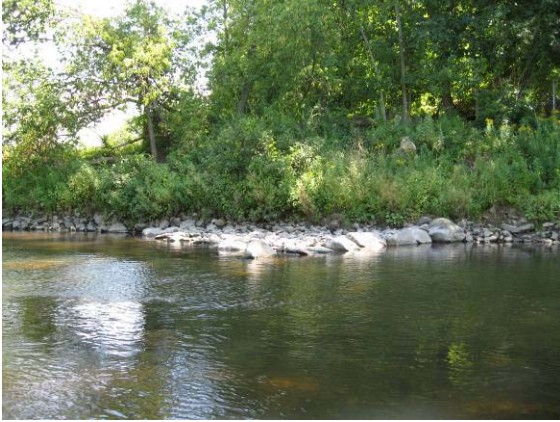
Cell	Aquatic Structures	Armor Stone Condition/General Biological Observations	
I3	1. Single-wing deflector

<ol style="list-style-type: none"> 1. Structure appears to be stable and providing diversity in habitat 2. Good habitat, variations in velocity around structure and related variations in stream bottom topography
I3/J3	1. Vortex rock weir

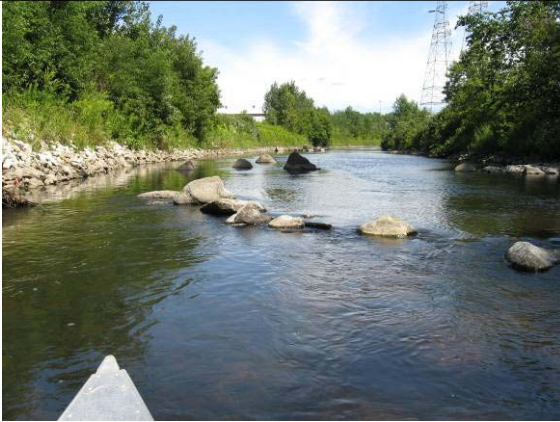
<ol style="list-style-type: none"> 1. Structure appears to be stable and providing diversity in habitat 2. Good habitat, variations in velocity around structure and related variations in stream bottom topography

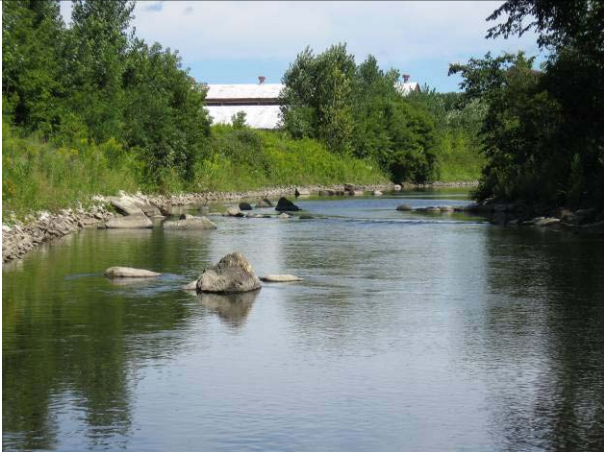
Cell	Aquatic Structures	Armor Stone Condition/General Biological Observations	
J3	<ol style="list-style-type: none"> 1. Boulder cluster 2. Three-boulder cluster 3. Three-boulder cluster

<ol style="list-style-type: none"> 1. Structures appear to be stable and providing diversity in habitat 2. Good habitat, variations in velocity around structures and related variations in stream bottom topography
