RE: Auburn Road Landfill, Administrative Order,
Docket Number I-90-1092, Londonderry, New Hampshire

**2013 SOURCE CONTROL
OPERATION & MAINTENANCE REPORT
AUBURN ROAD LANDFILL**

**FOR
TOWN OF LONDONDERRY, NEW HAMPSHIRE**

FEBRUARY 2014

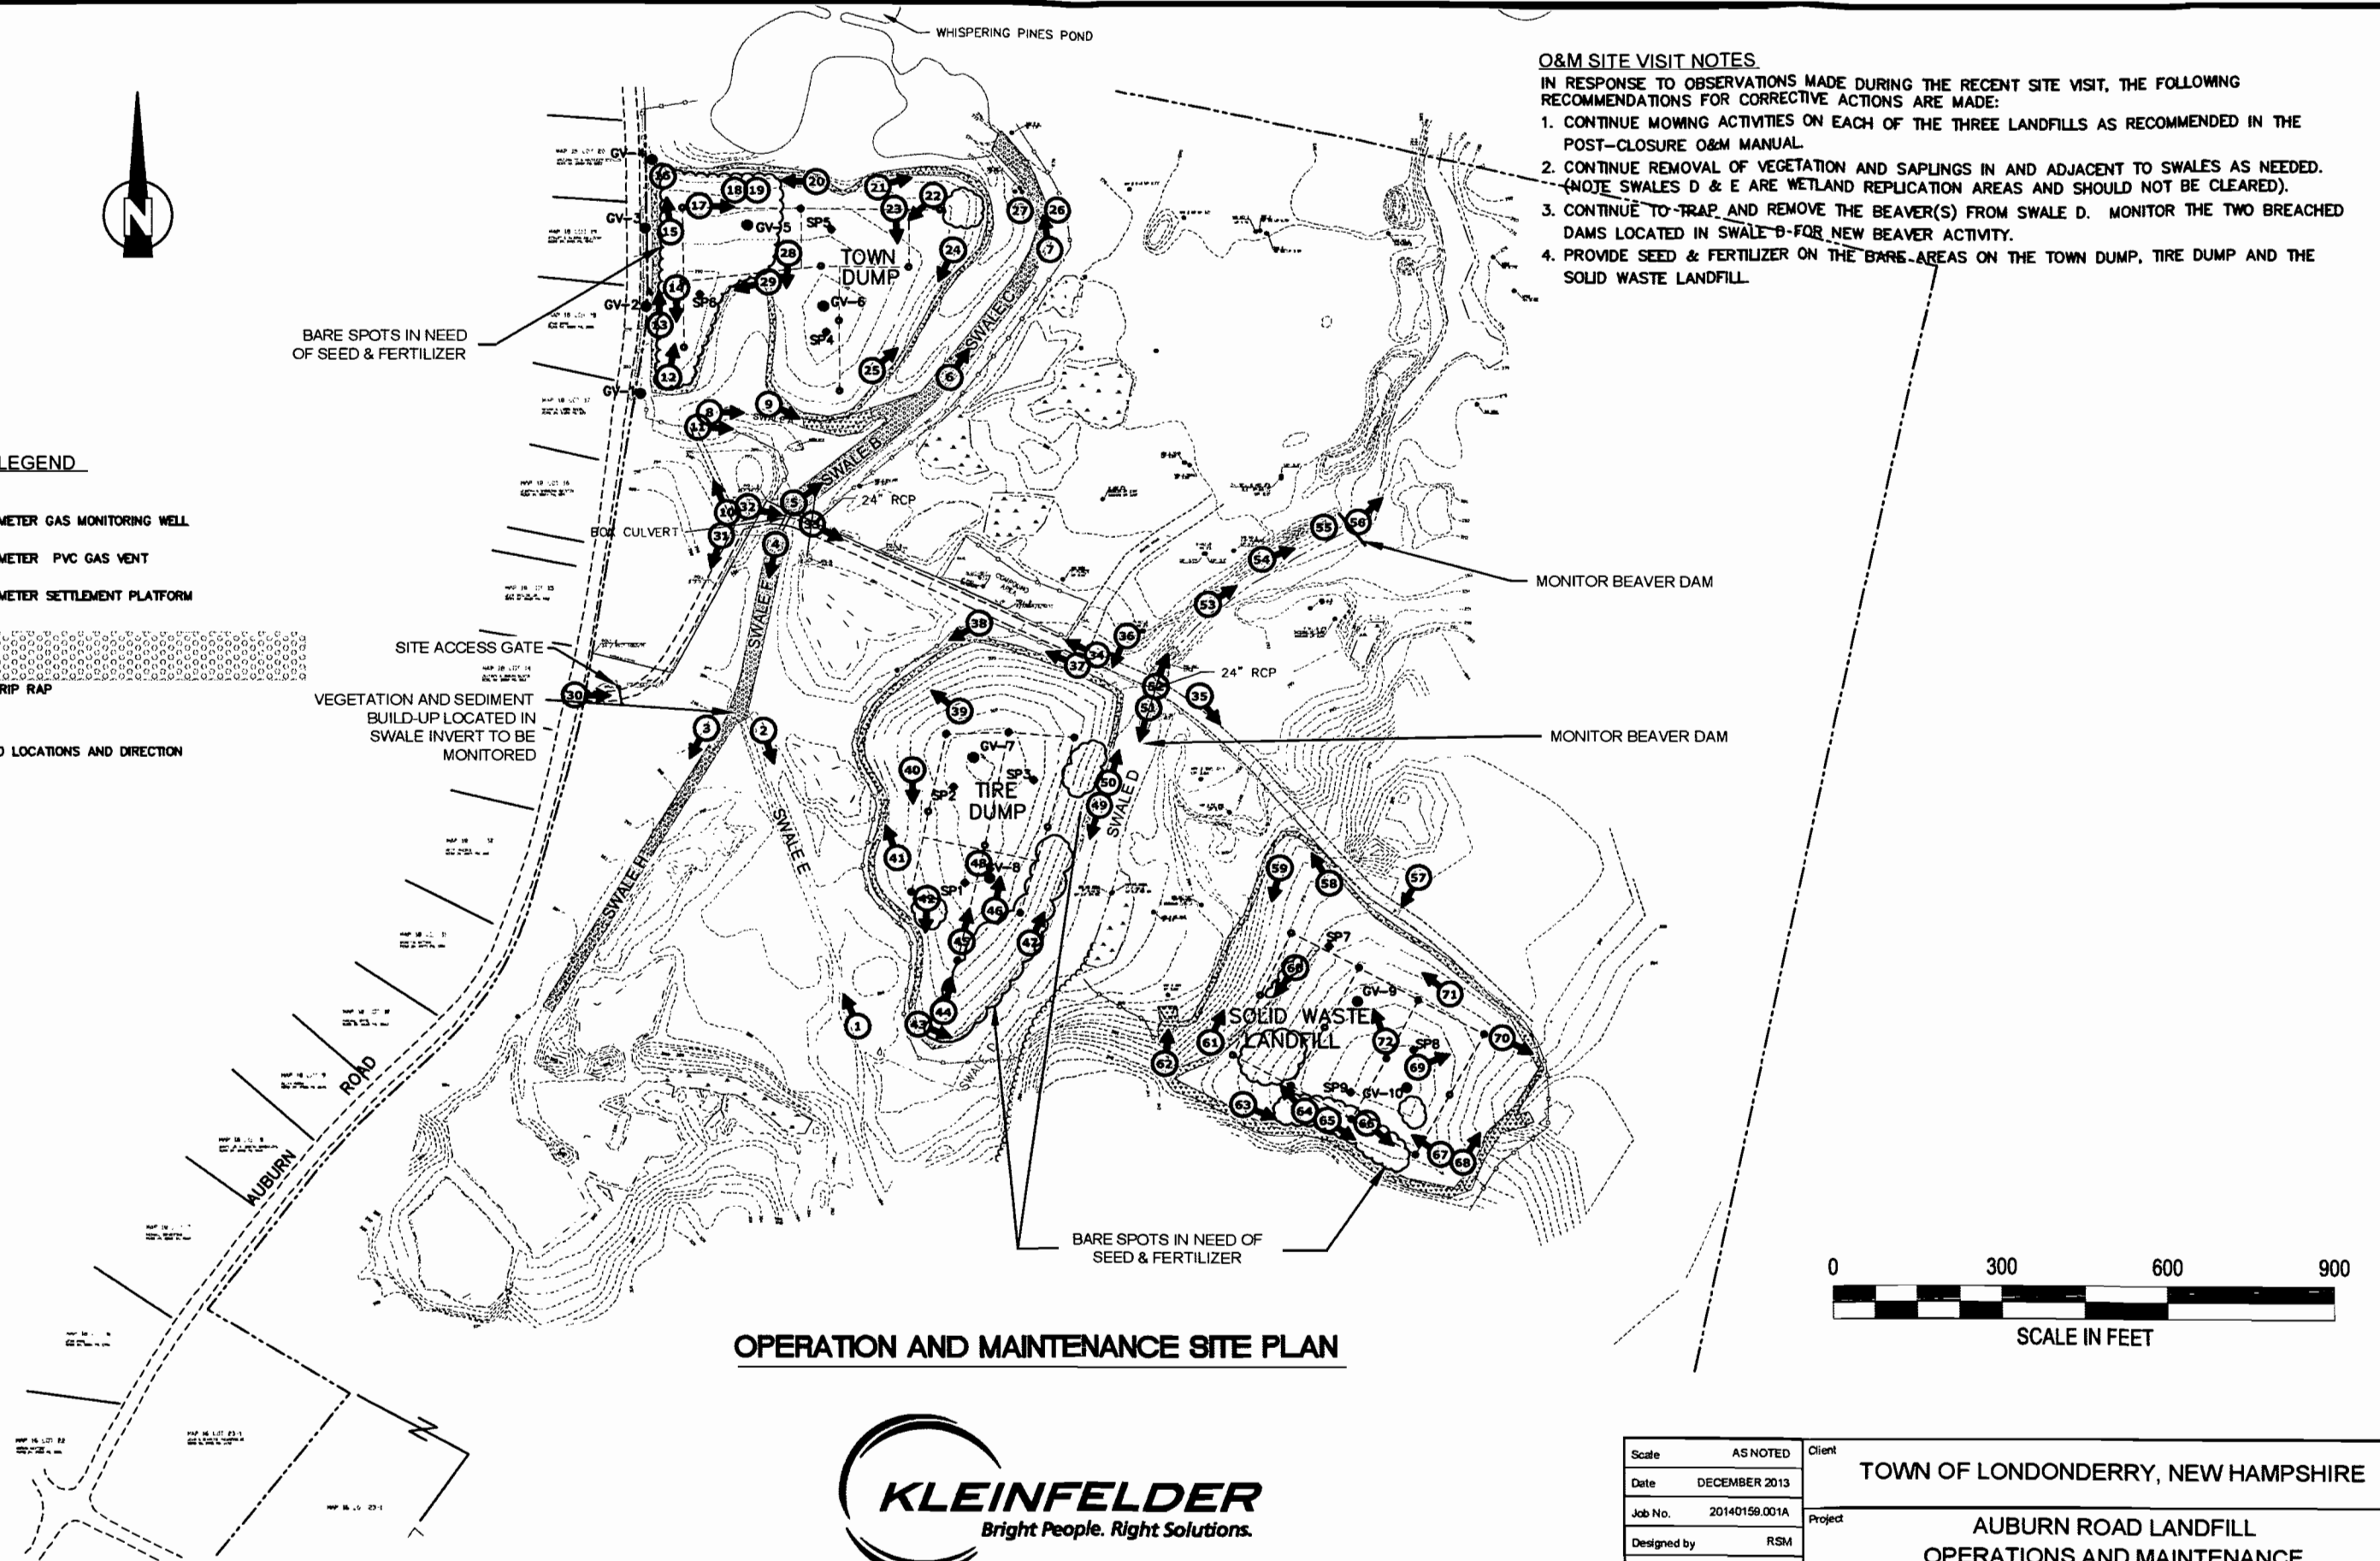
Bare spots on the vegetated landfill caps are noted in this inspection report in generally the same areas as previously reported. These areas are identified on Figure 1 and are generally located on shallow sloped areas. These areas should reseeded and fertilized.

RECOMMENDATIONS FOR CORRECTIVE ACTIONS

In response to observations made during the recent site visit, the following recommendations are made:

1. Continue mowing activities on each of the three landfills as recommended in the post-closure O&M manual.
2. Continue removal of vegetation and saplings located in and adjacent to swales as needed. (Note Swales D & E are wetland replication areas and should not be cleared)
3. Continue to trap and remove the beaver(s) from Swale D. Monitor the two breached dams located on the southern and northern side of the access road in Swale D for new beaver activity.
4. Provide seed and fertilizer to the bare areas on the Town Dump, Tire Dump and the Solid Waste Landfill surfaces.

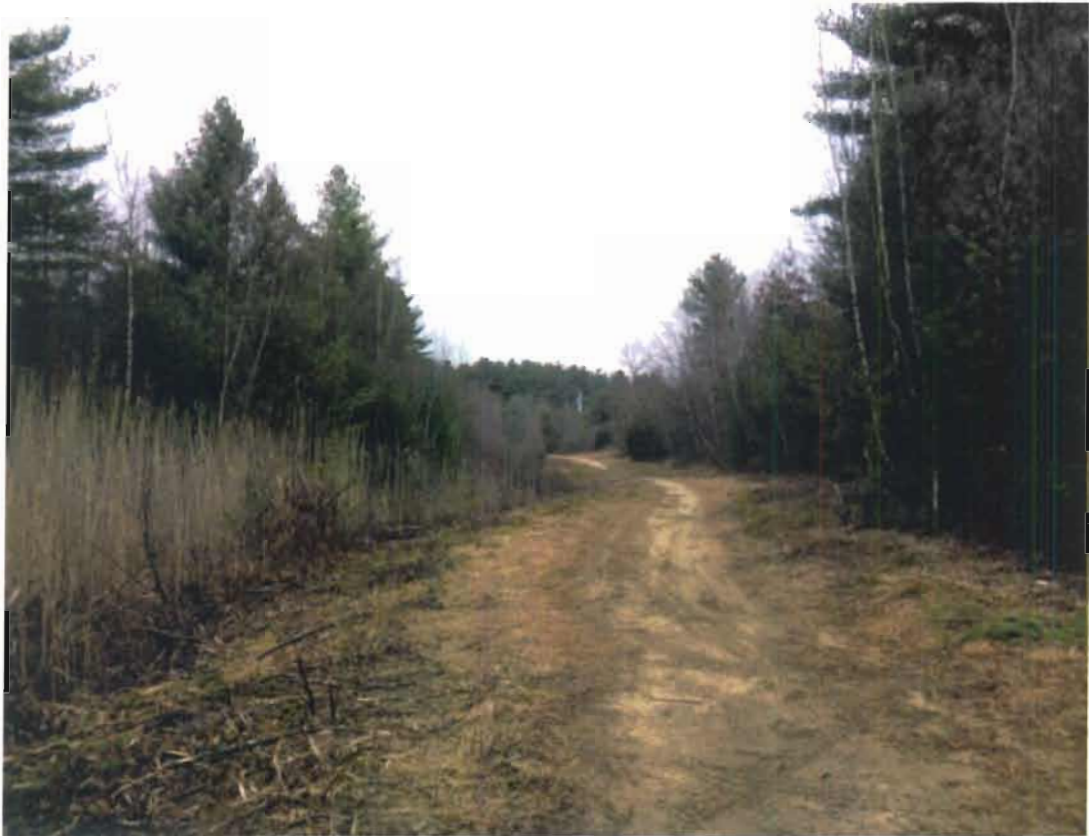
Photo No. 1: Swale E

(e.) Swale E (Tire Dump)	The Town has removed the beaver dam. The swale appears to be operating as designed. No standing water was observed during this site visit.		√
(f.) Swale F	In general the swale appears to be operating as designed. In the invert of Swale F near the confluence of Swale E and H, a pocket of sediment and grass build up was found. No standing water was observed, however this area could pose as a restriction to flow from swale H. Sediment build up in this area should be monitored and removed if ponded water is observed in Swale H. The fallen tree reported in the previous report has been removed.		√
(g.) Swale H	The swale is functioning as designed. Sediment build up in the swale should be monitored and removed if ponded water is observed.		√
(h.) Concrete Culverts	The concrete culverts were observed to be in good condition.		√

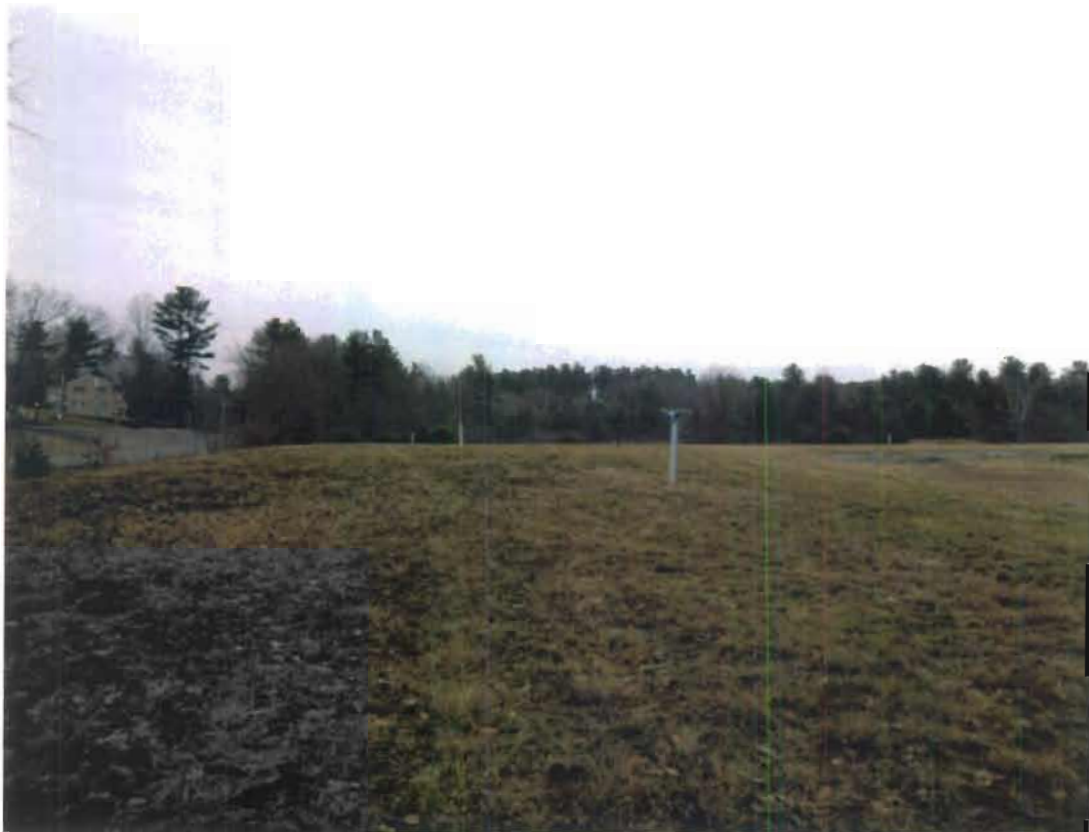
Photo No. 12: Town Dump Western Surface

(7.) LCRA	Comments on the LCRA are provided in items (7a) through (7c).		
(a.) Town Dump	The vegetation on western lobe of the landfill needs to be re-seeded and fertilized. There are large areas of sparse grass. The Town has cleared of vegetation to reveal gas monitoring well GV-4 which was overgrown. The eastern lobe of the landfill appears to have better vegetation since the last inspection. No depressions or obvious erosion channels were observed. The gas monitoring wells, and settlement platforms were intact. The security fence around the Town Dump appeared to be in good condition.	√	
(b.) Tire Dump	The vegetation on eastern slope of the landfill needs to be re-seeded and fertilized. There are large areas of sparse grass. No depressions or obvious erosion channels were observed. The gas vents and settlement	√

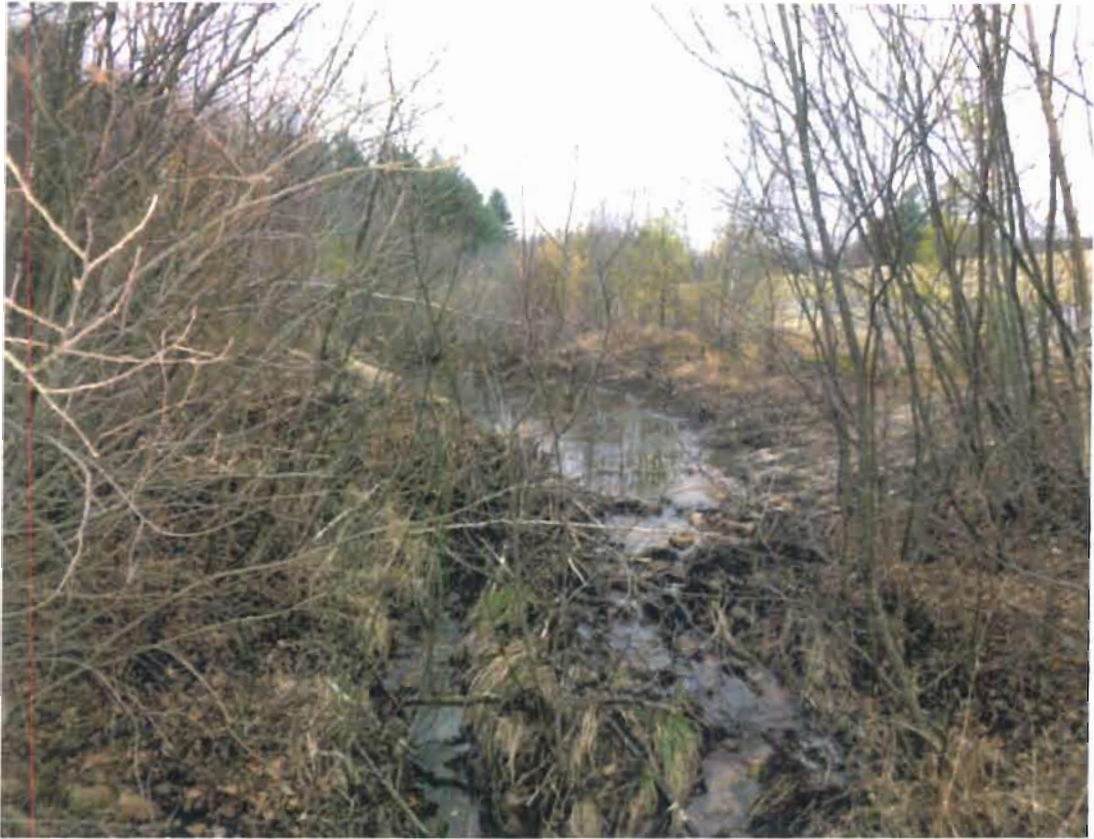
Photo No. 51: Swale D – Breached Beaver Dam (South)

(6.) LRDIRA	Comments on the LRDIRA are provided in items (6a) through (6h).		
(a.) Swale A (Town Dump)	This swale appears to be operating as designed.		√
(b.) Swale B (Town Dump)	This swale is operating as designed. Brush has been cut back within the swale and on the banks. Town crews on-site during inspection.		√
(c.) Swale C (Town Dump)	This swale is operating as designed. Brush has been cut back within the swale and on the banks. Town crews on-site during inspection.		√
(d.) Swale D (Tire Dump)	Two (2) beaver dams were observed; one on the southern side of the access road and one on the northern side of the access road. Both dams have been breached to permit stream flow. Continue to trap and remove the beaver(s) from the area and then breach the beaver dams as necessary. The southern beaver dam has been breached; alleviating ponded water. The northern beaver dam has not been breached but water levels were low.		√
