**Re: GE-Pittsfield/Housatonic River Site
1½-Mile Reach of the Housatonic River (GECD820)
2014 Annual Monitoring Report**

2014 Annual Monitoring Report

**1½-Mile Reach of the Housatonic
River**

January 2015

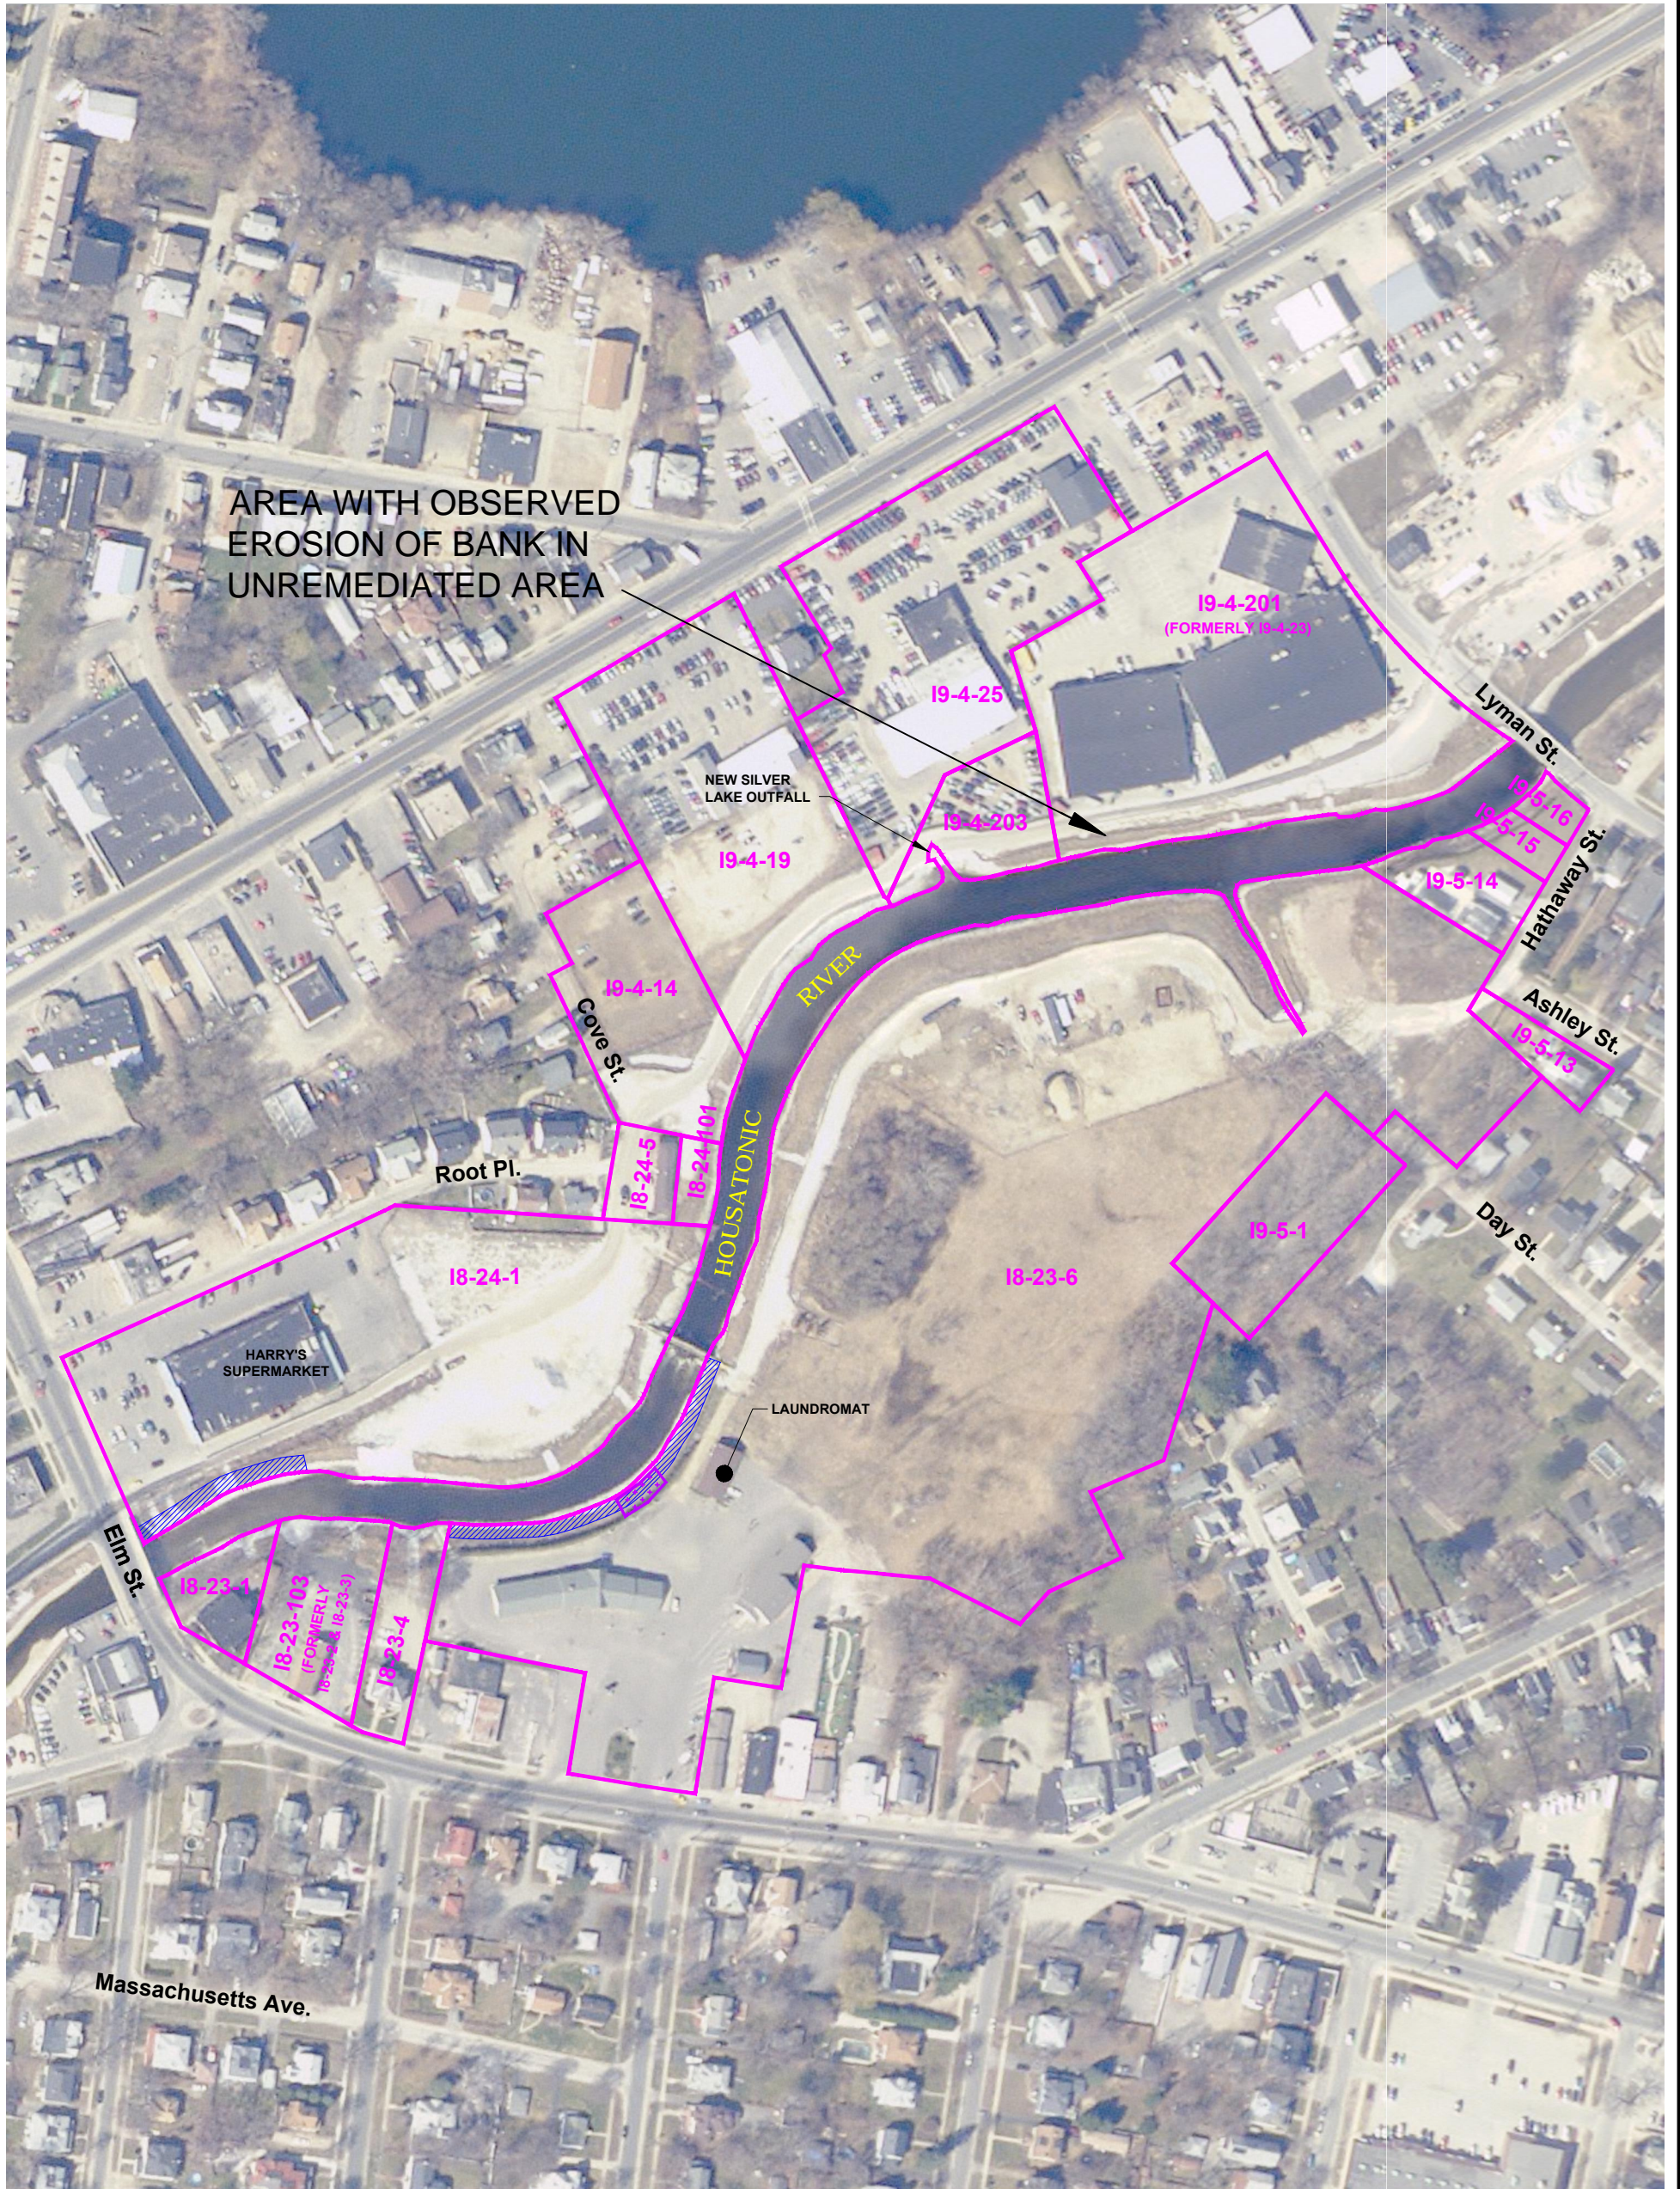
ARCADIS | **FIGURE 3-1**

An area of minor erosion was observed in an unremediated area near the top of the bank on Parcel I9-4-201, as illustrated on Figure 3-1. Since this area was not remediated as part of the 1½-Mile Reach Removal Action, it is not subject to any Maintenance Standard; but it was noted in the October 8, 2014 trip report at EPA’s request and is likewise noted herein. At EPA’s direction, that area will be monitored again in 2015, as discussed in Section 8.2.

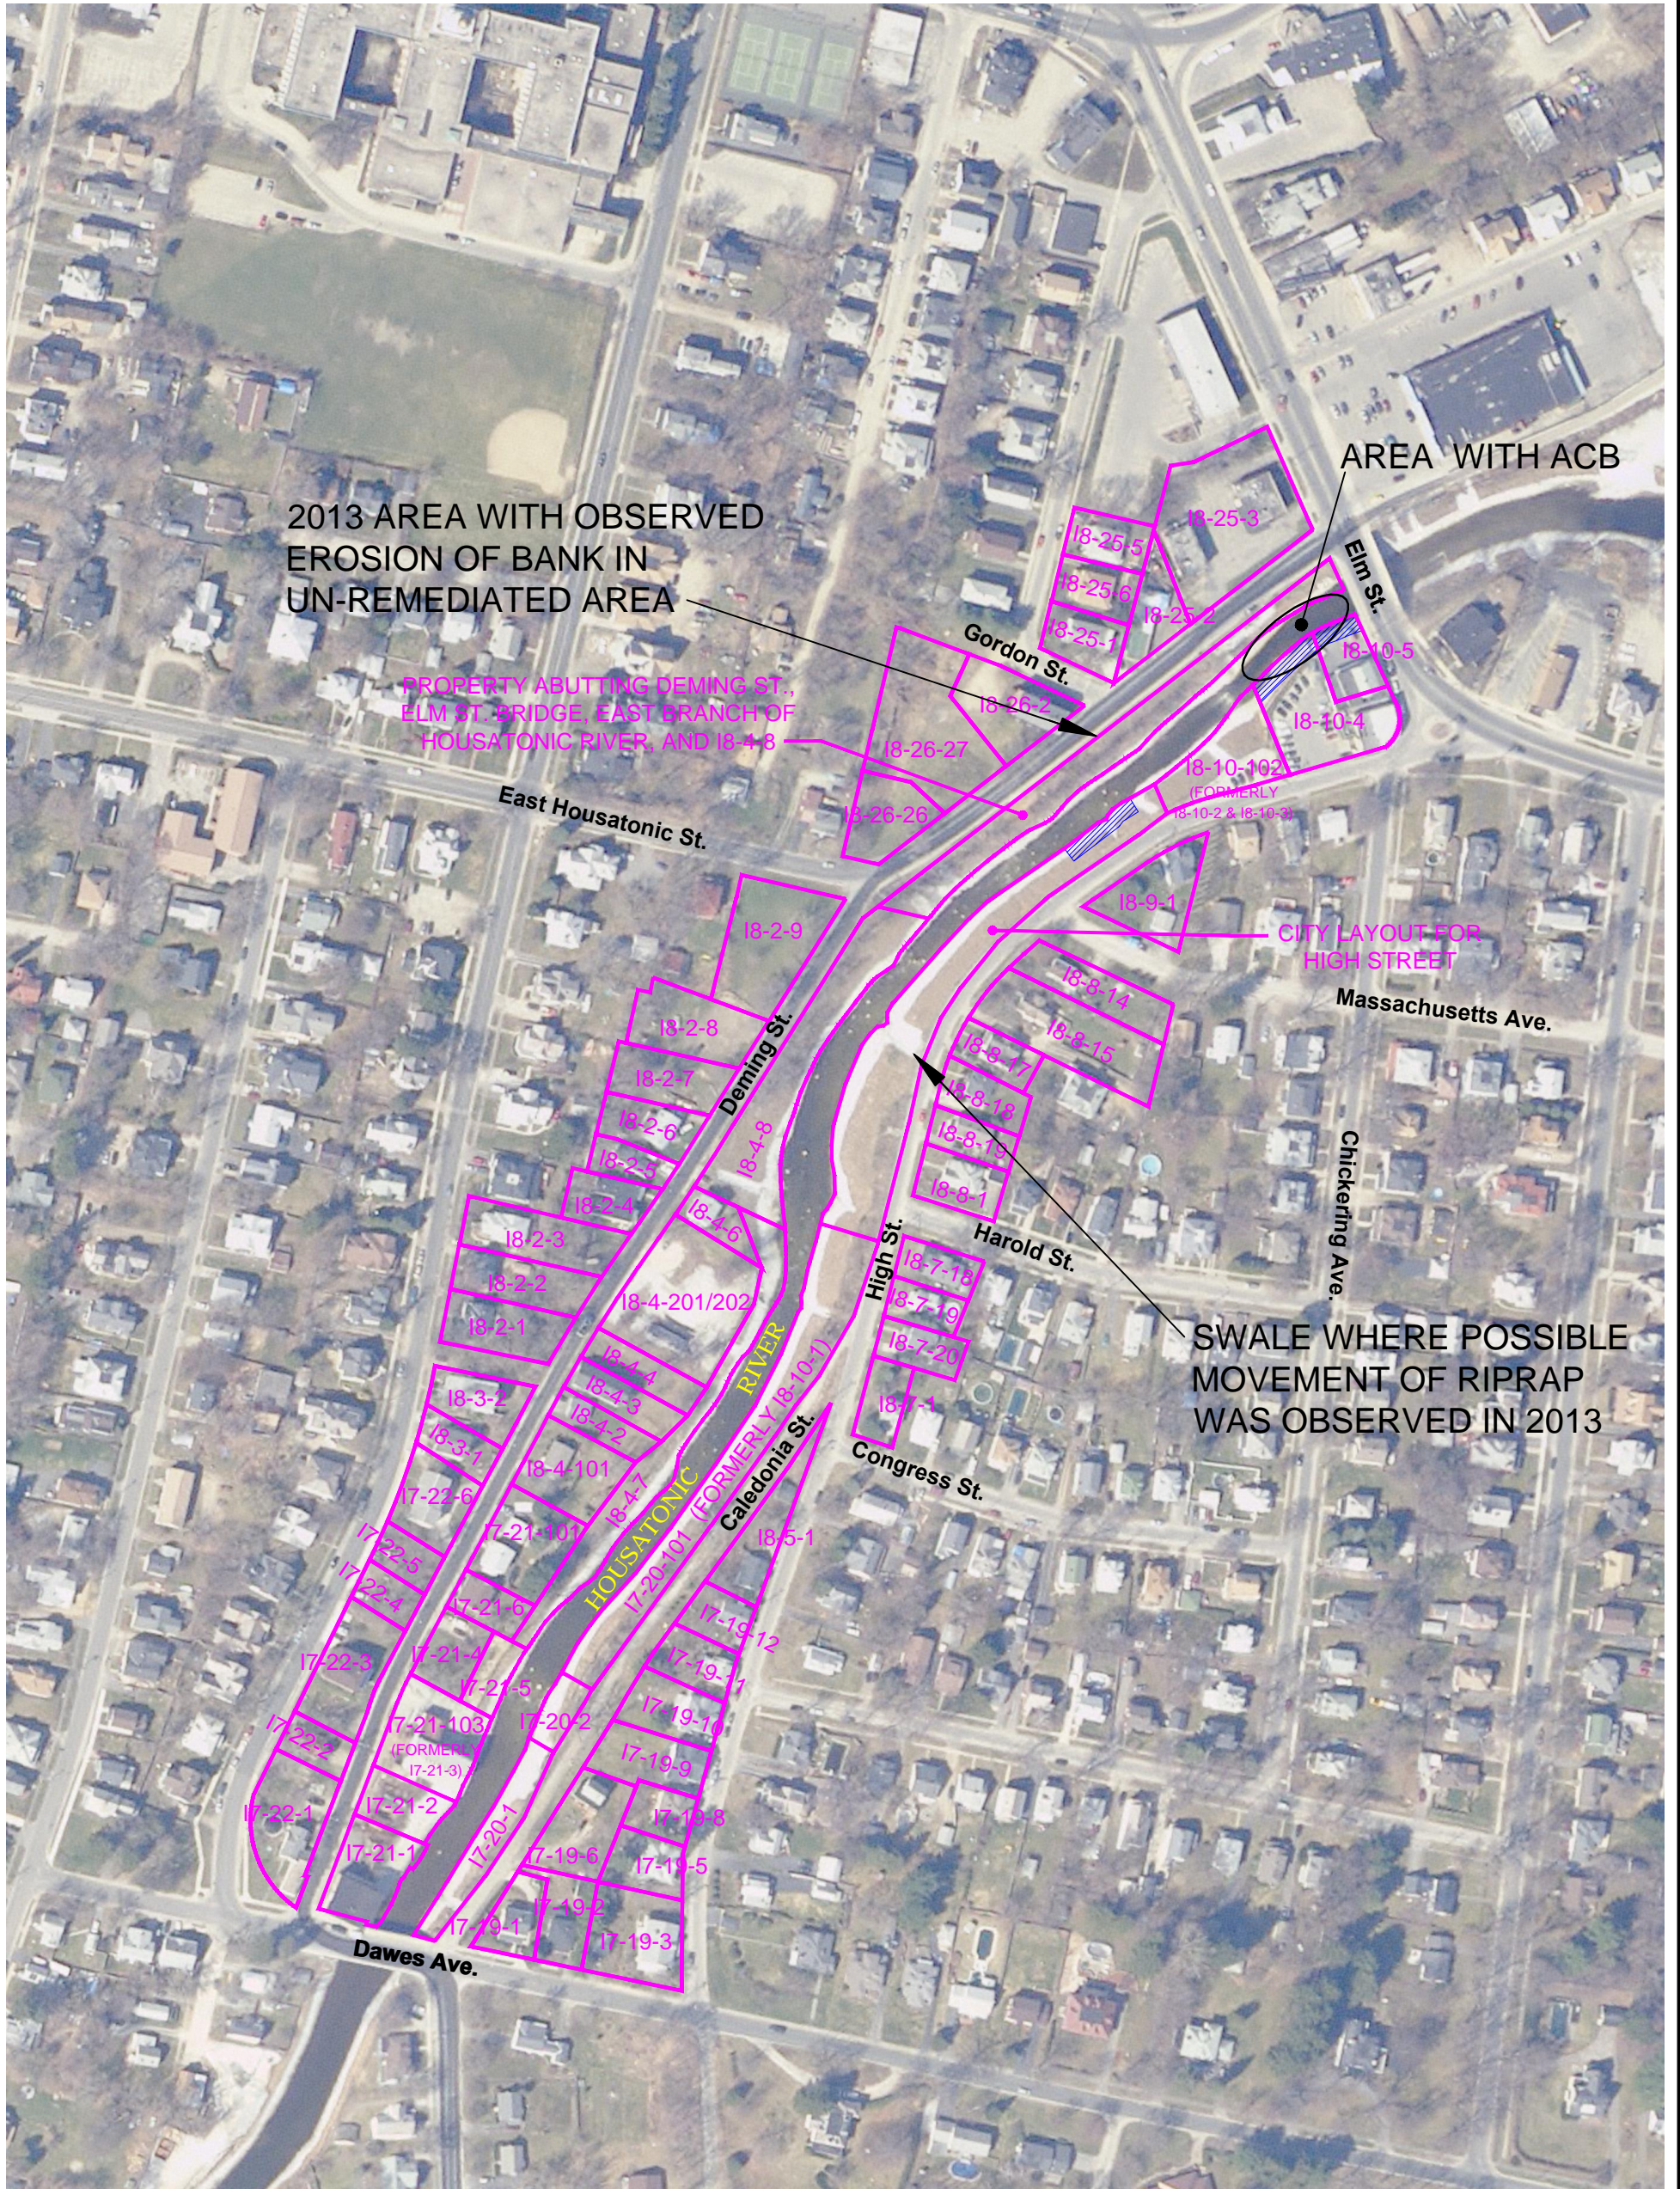
FIGURE
3-2

The 2014 inspection included a visual assessment of an area where some potential minor movement of riprap was observed in 2013. As illustrated on Figure 3-2, this area is located in an area of the EPA-installed swale on the City Layout for High Street parcel that is near the outfall pipe draining from the City catch basin that was repaired by GE in 2011. During the September 16 monitoring event, it did not appear that any significant movement of riprap occurred during the period of time between the 2013 and 2014 inspections.
