Two shoreline cleanups to discuss

Pierce Mill Cove remediated 2016/17, restoration now underway

Marsh Island remediation to start fall 2017

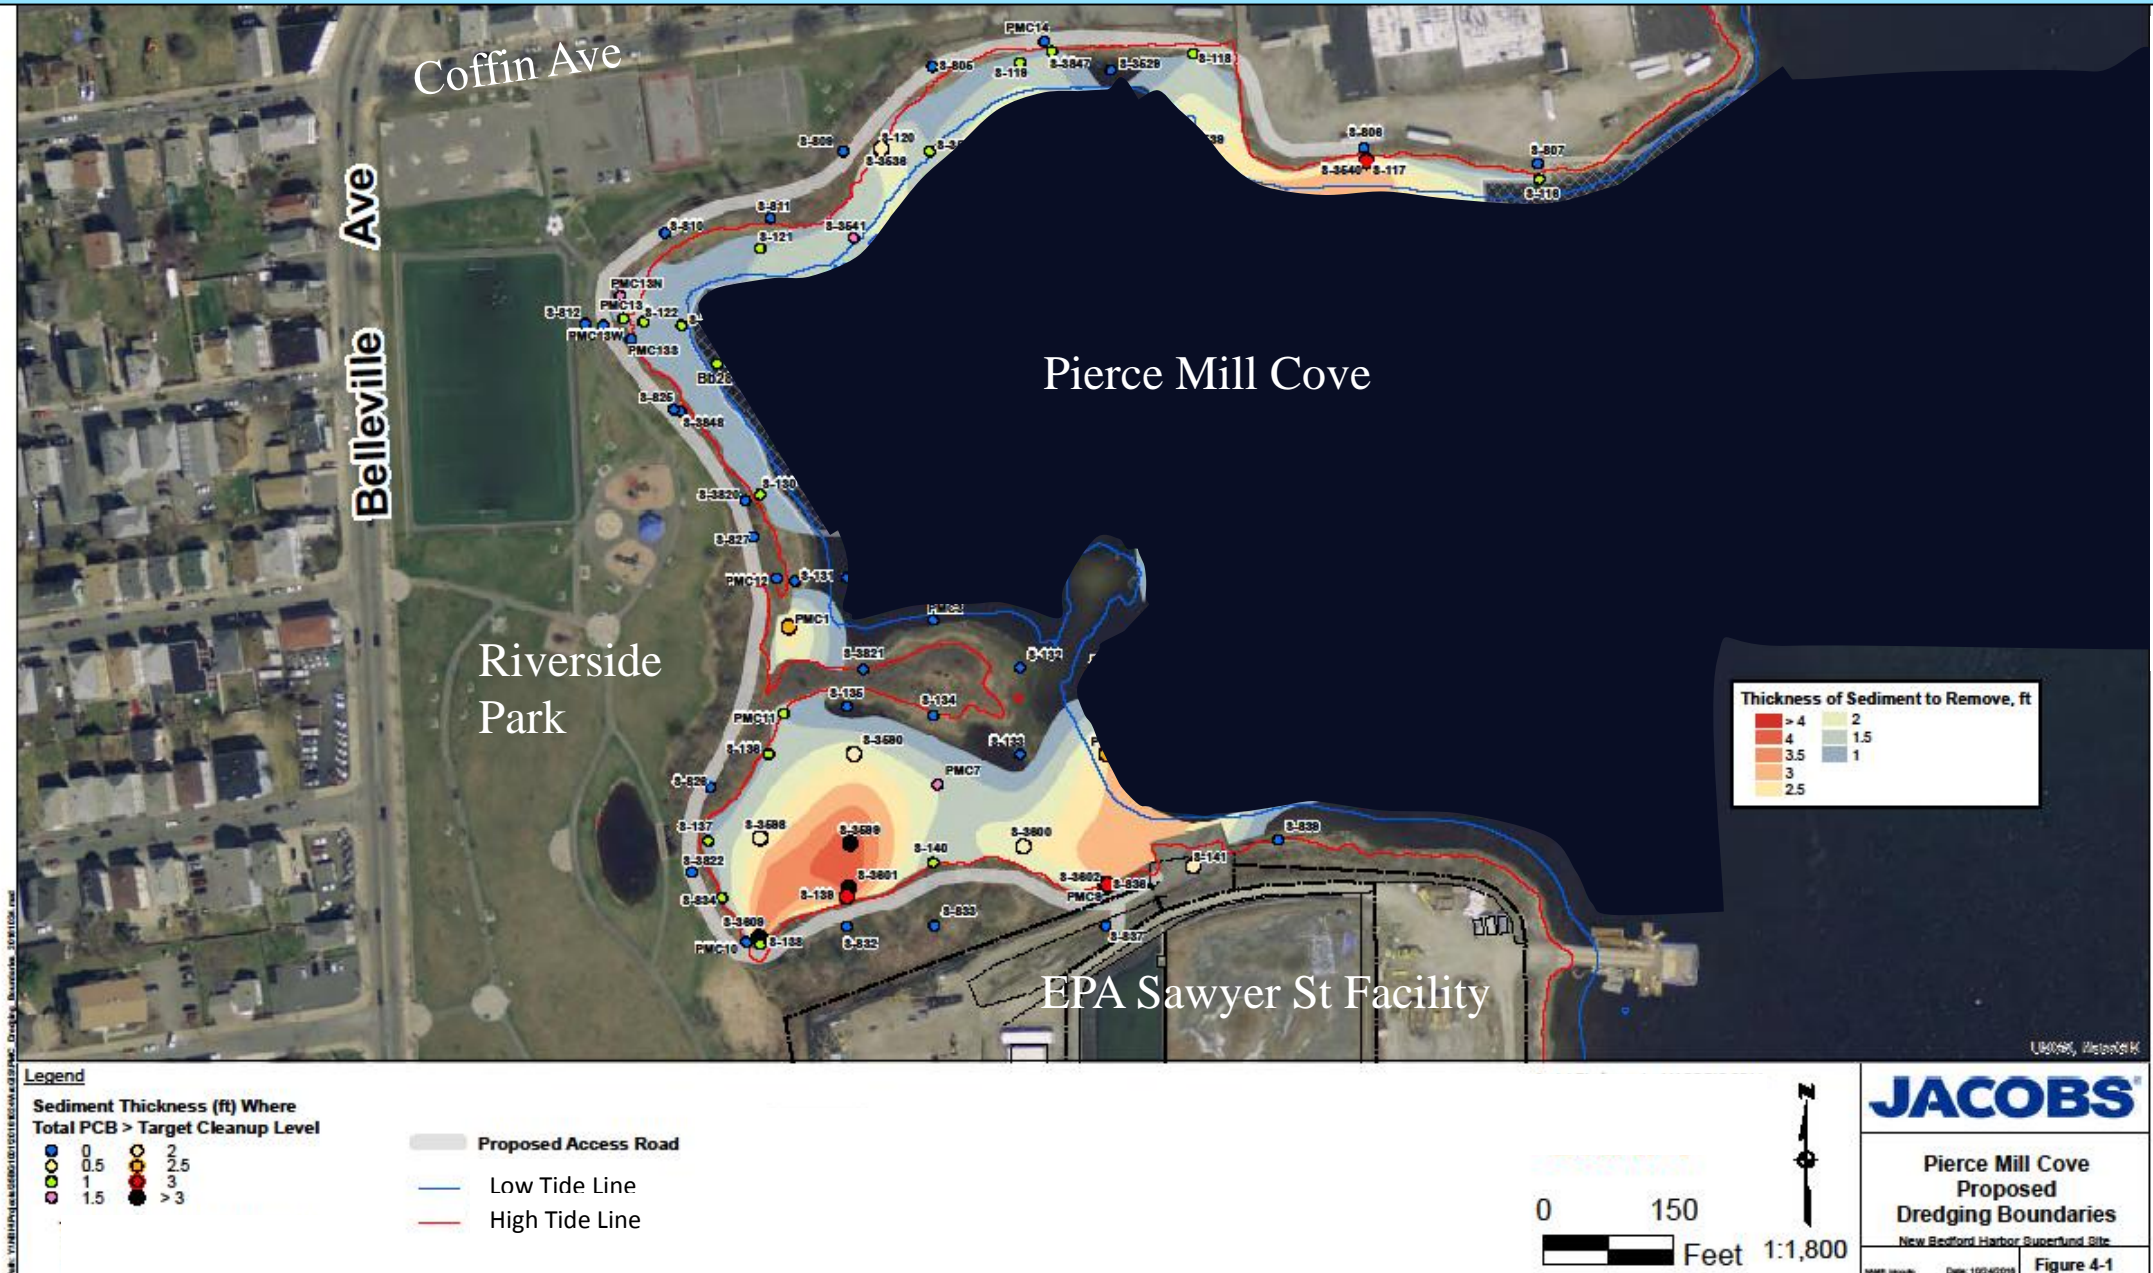
Prior to remediation

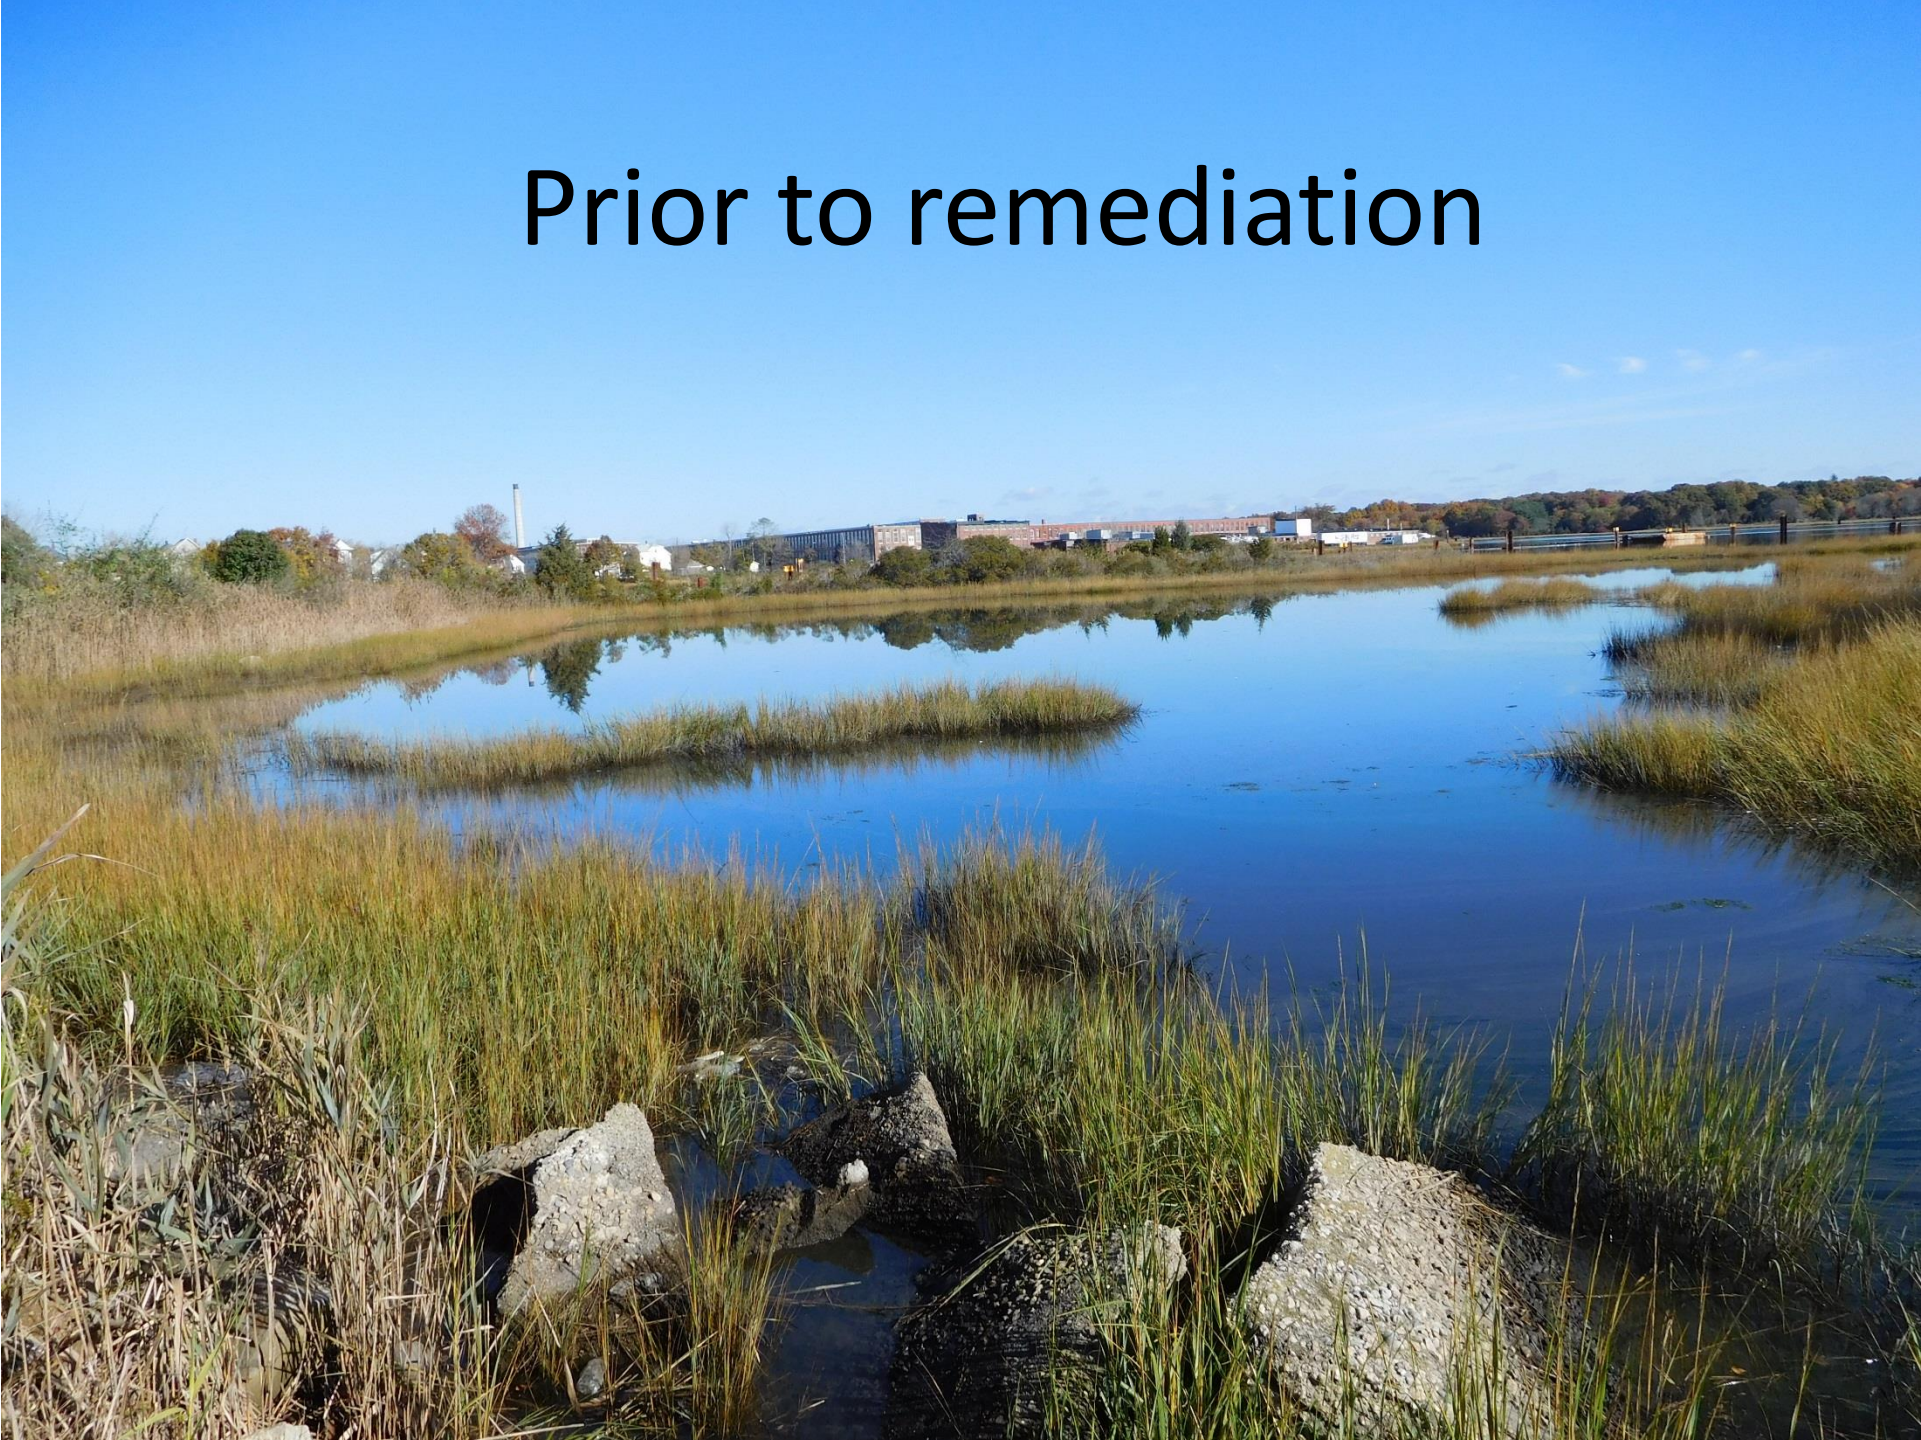
Excavating contaminated soil and sediment

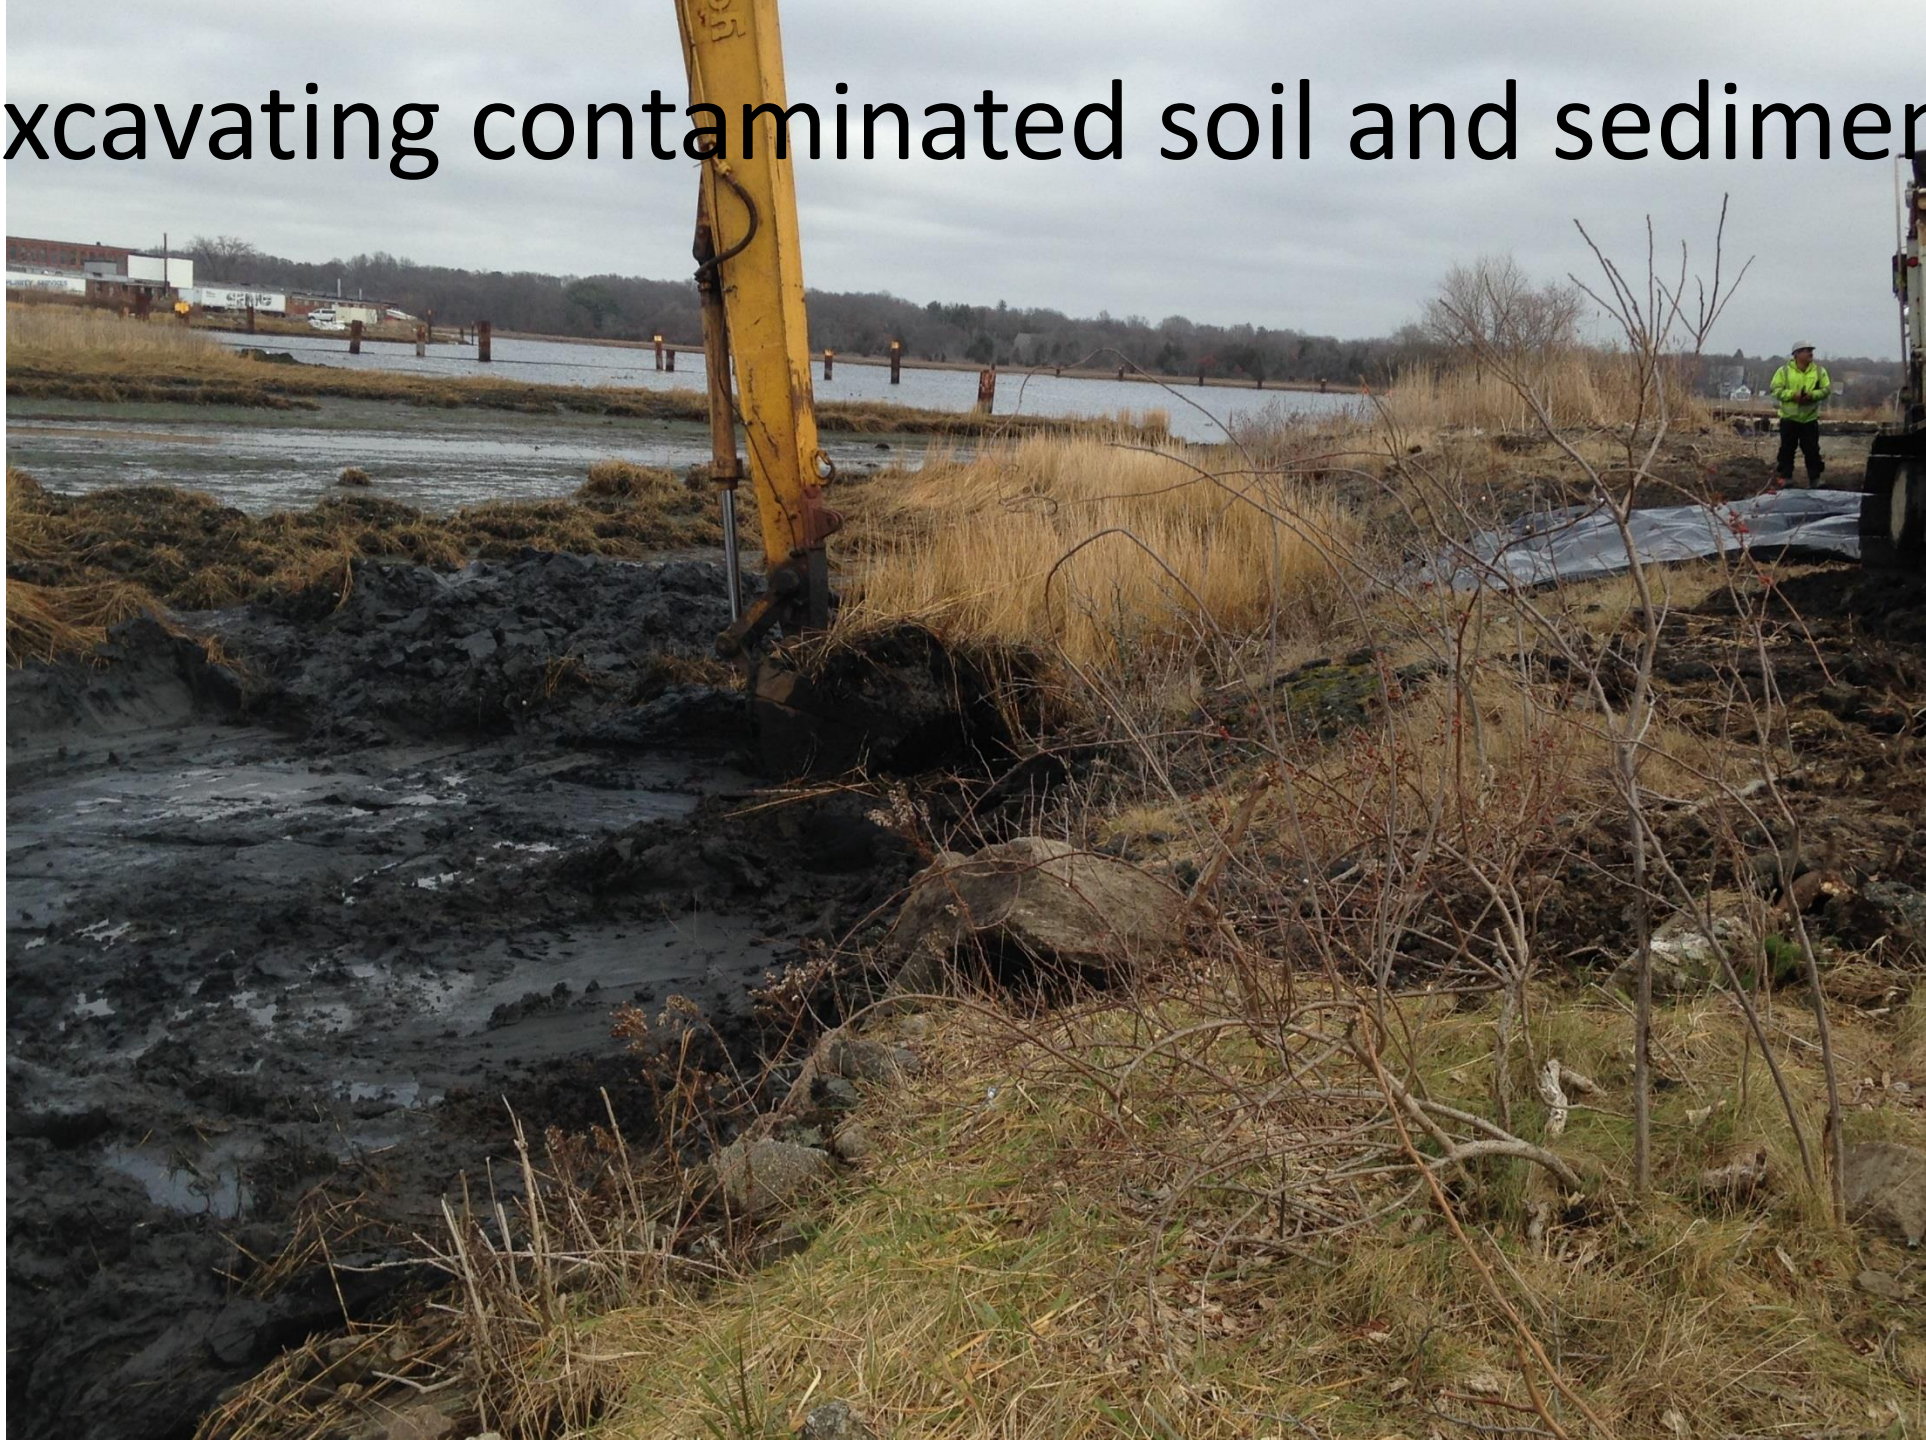
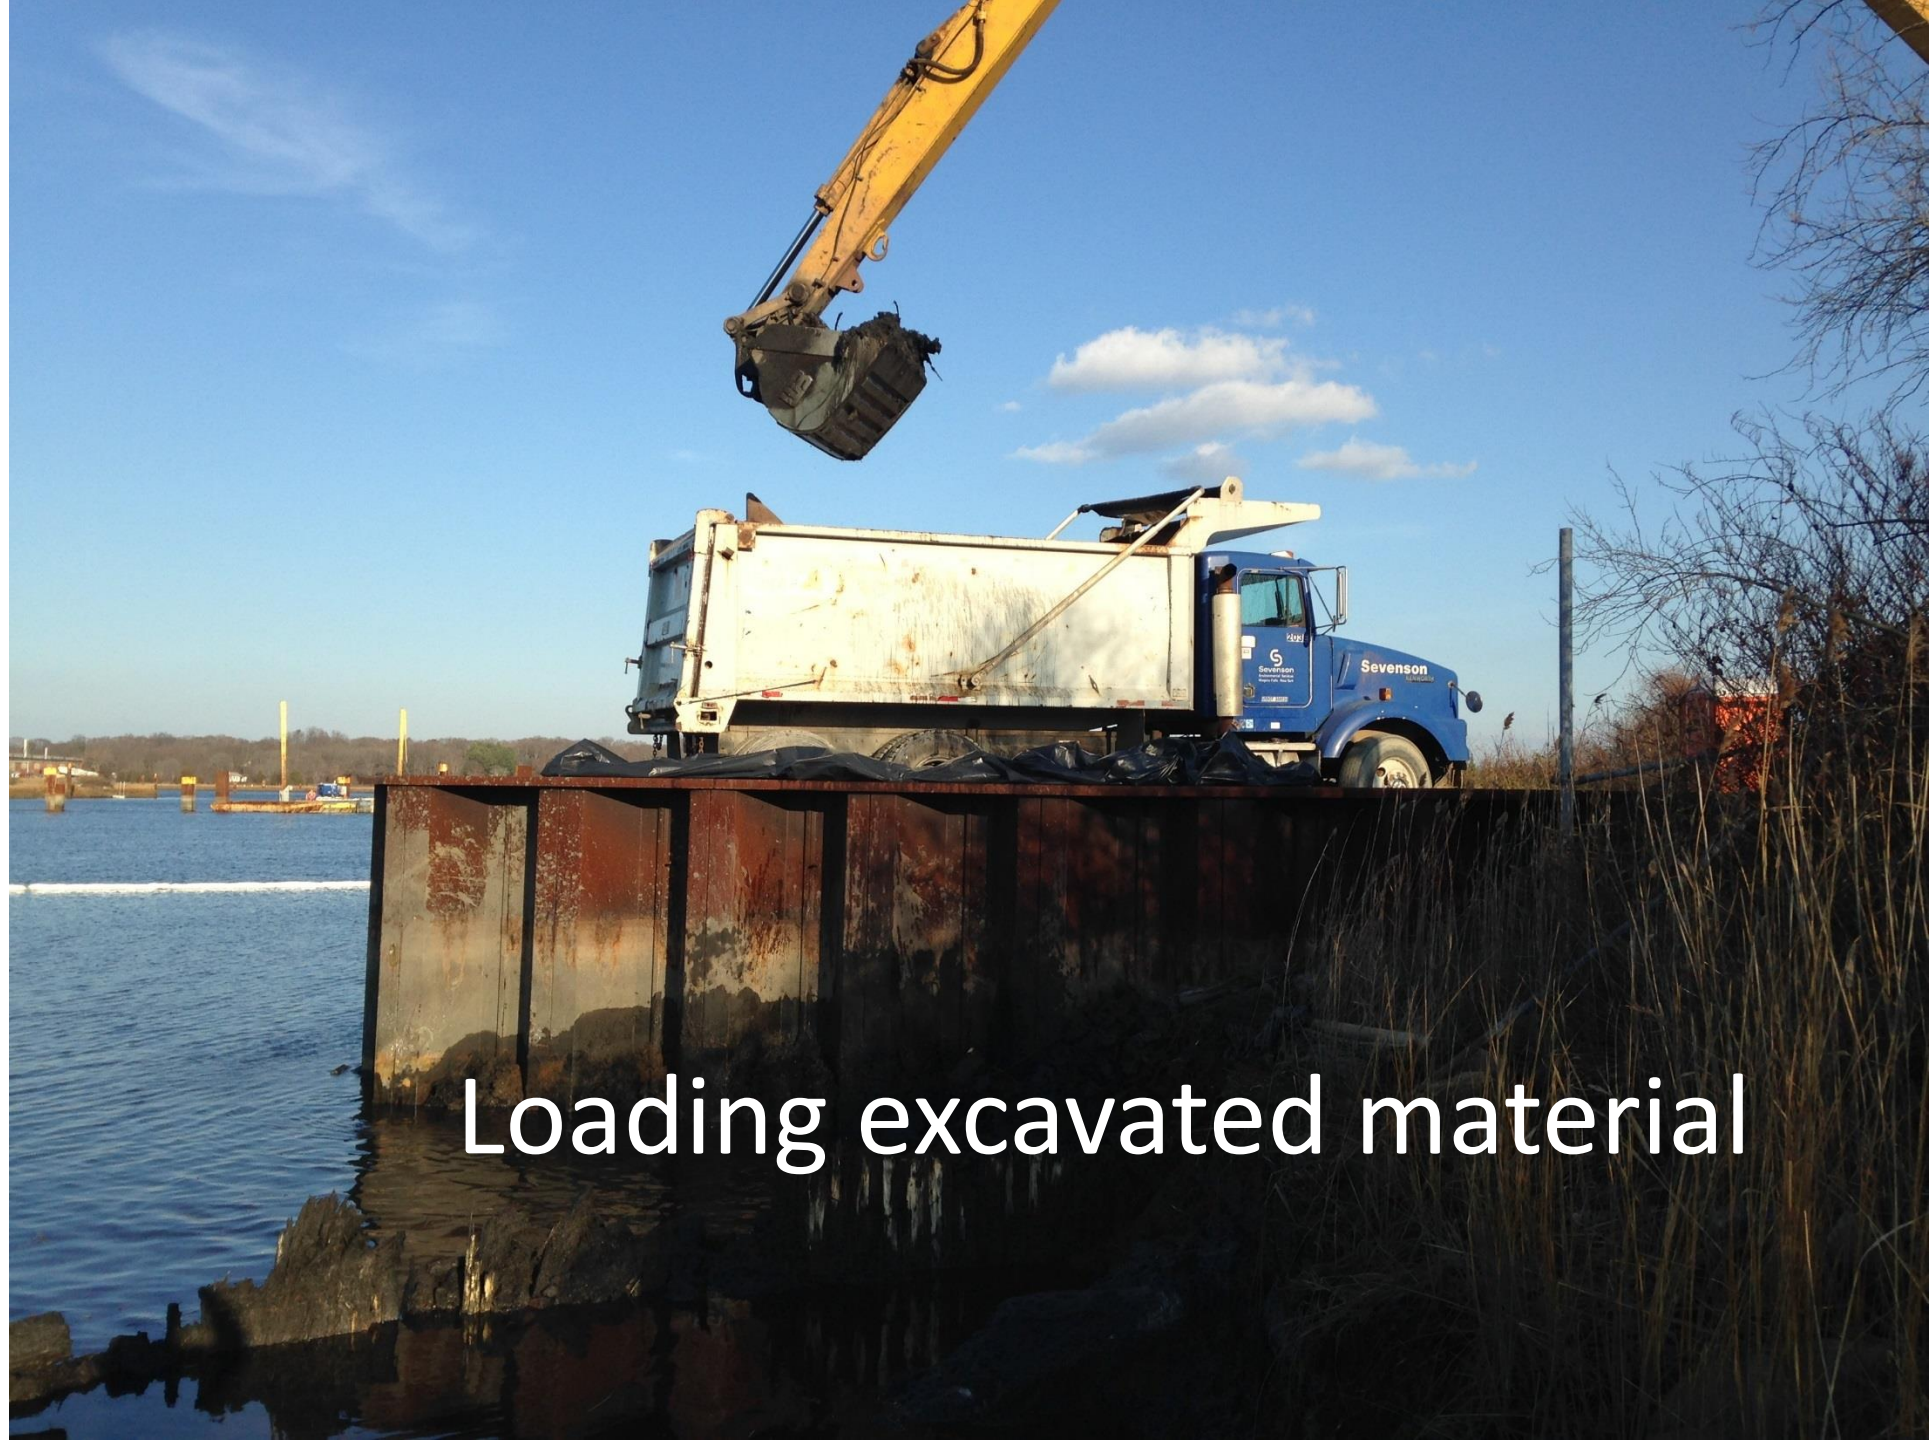
Loading excavated material

Restored banks prior
to replanting

Temporary sheet-pile wall

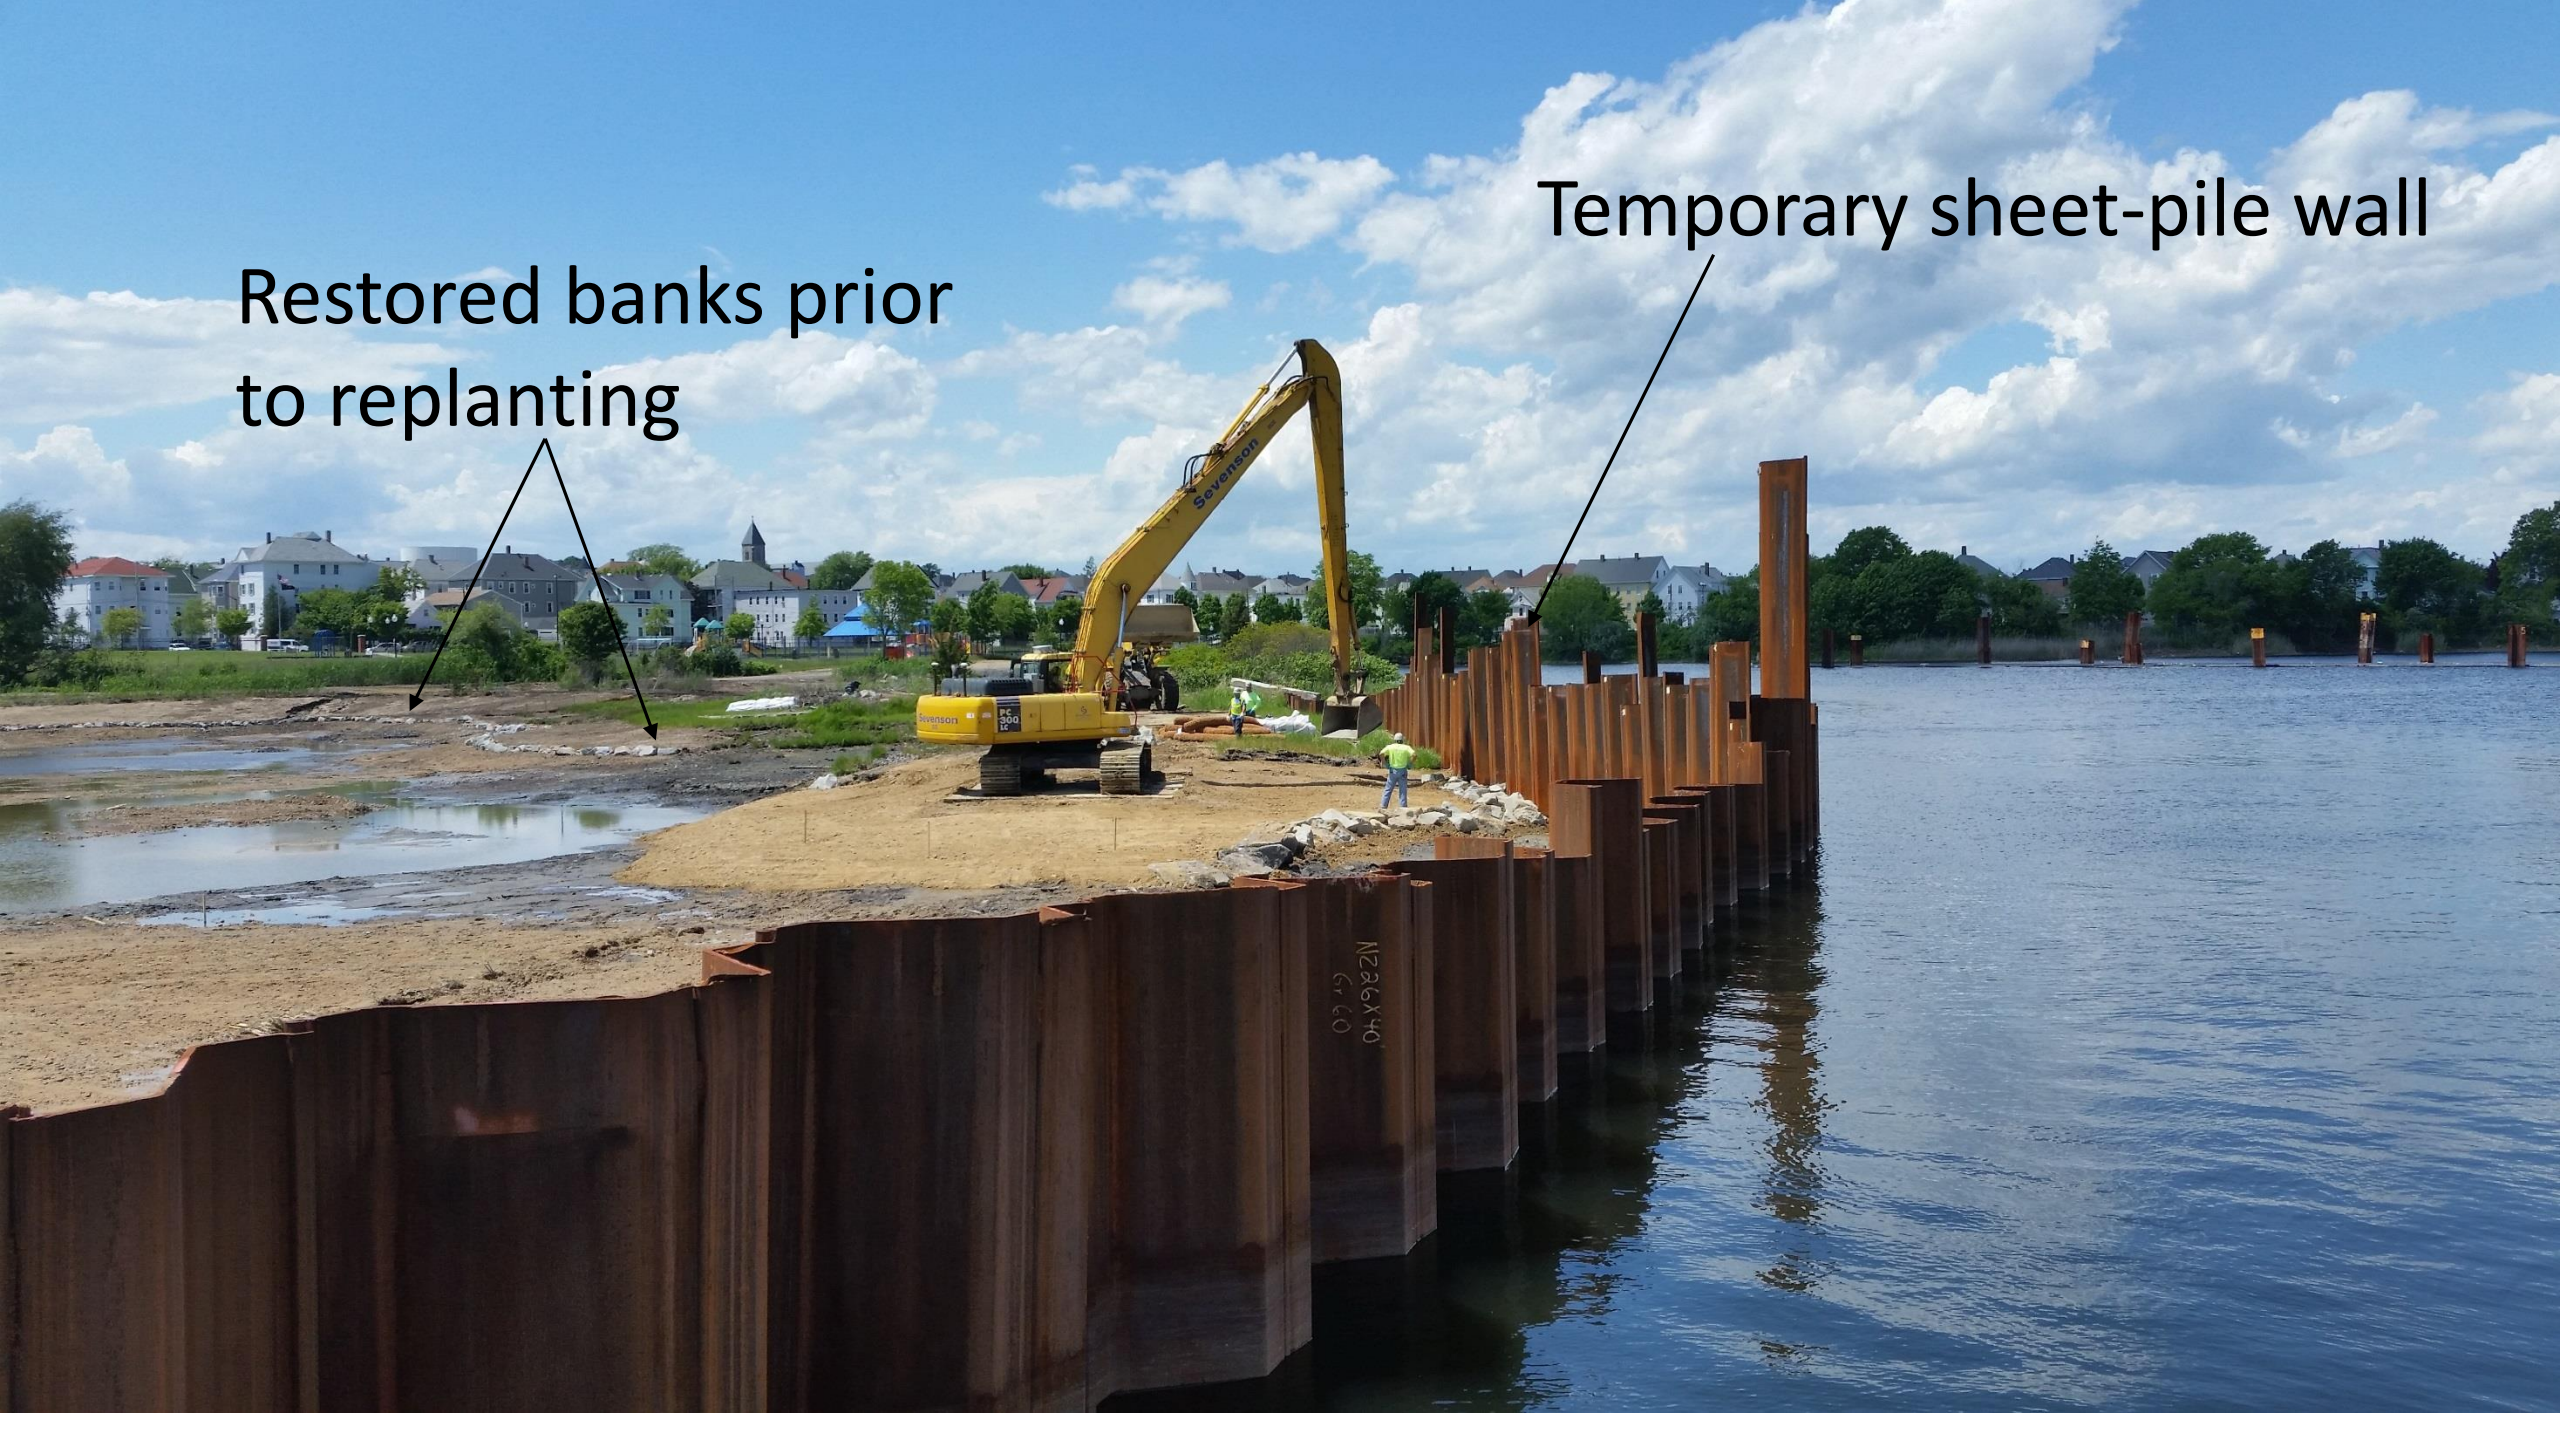
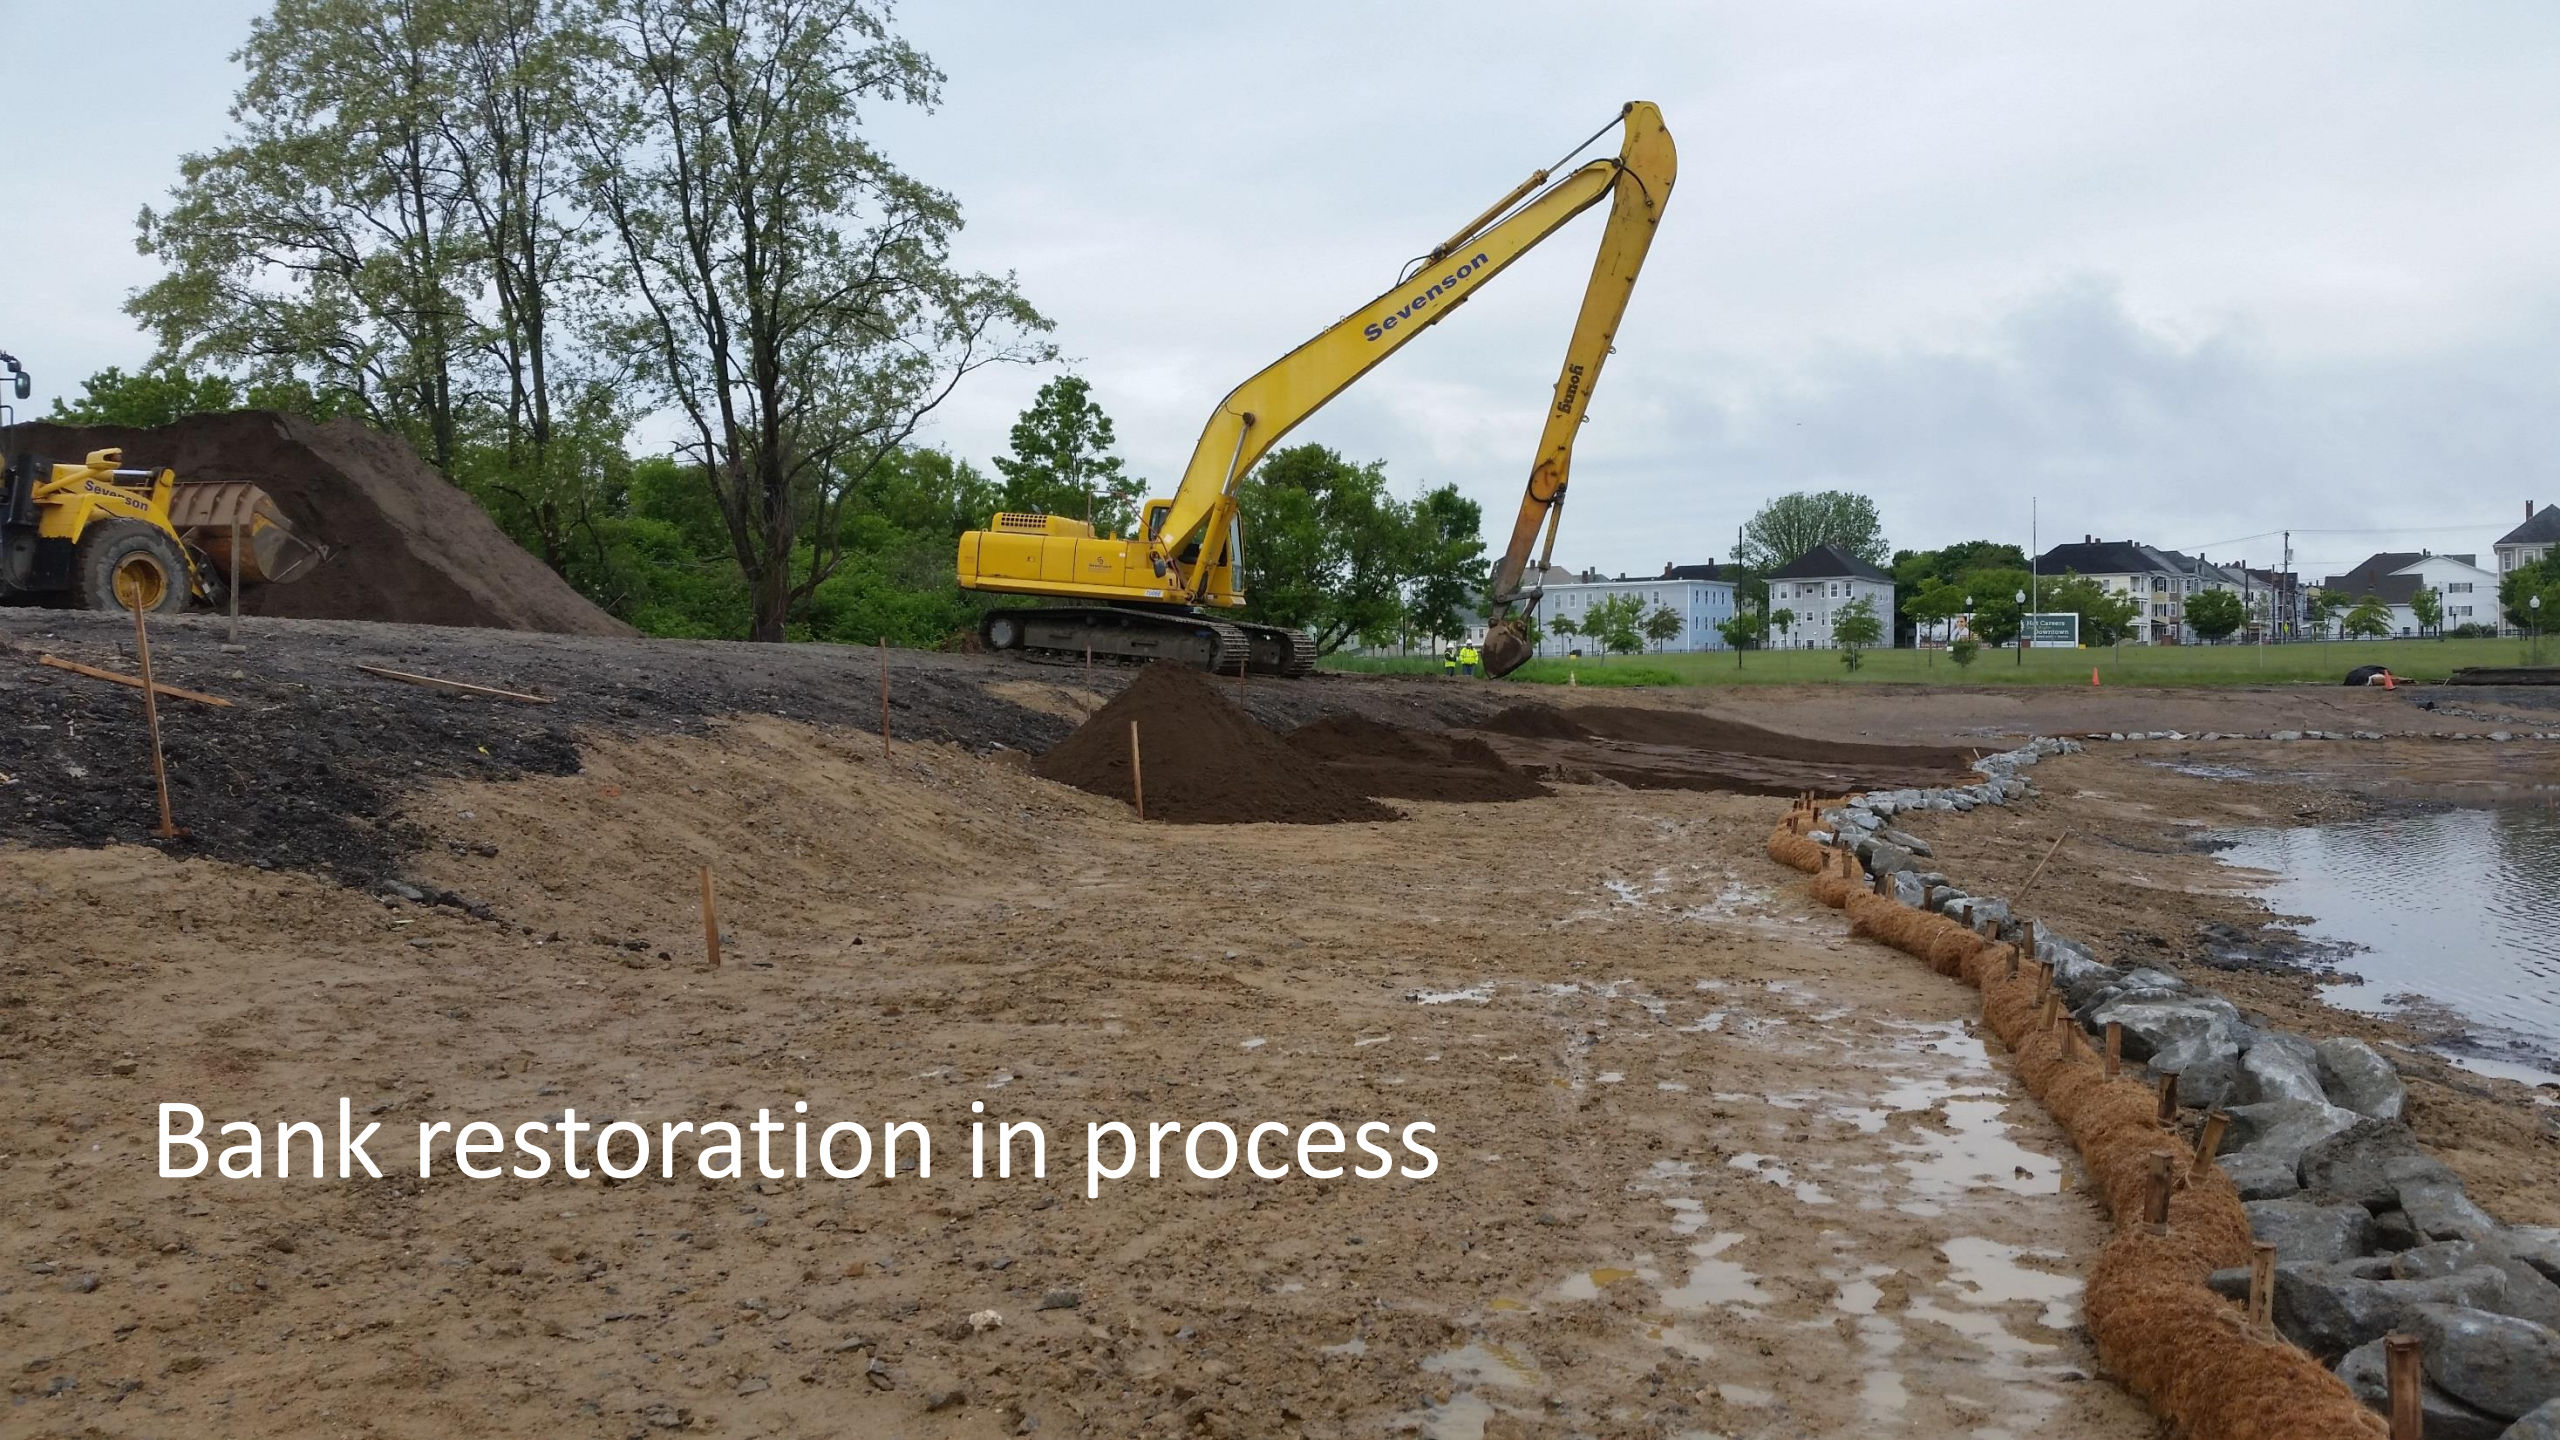
Bank restoration in process

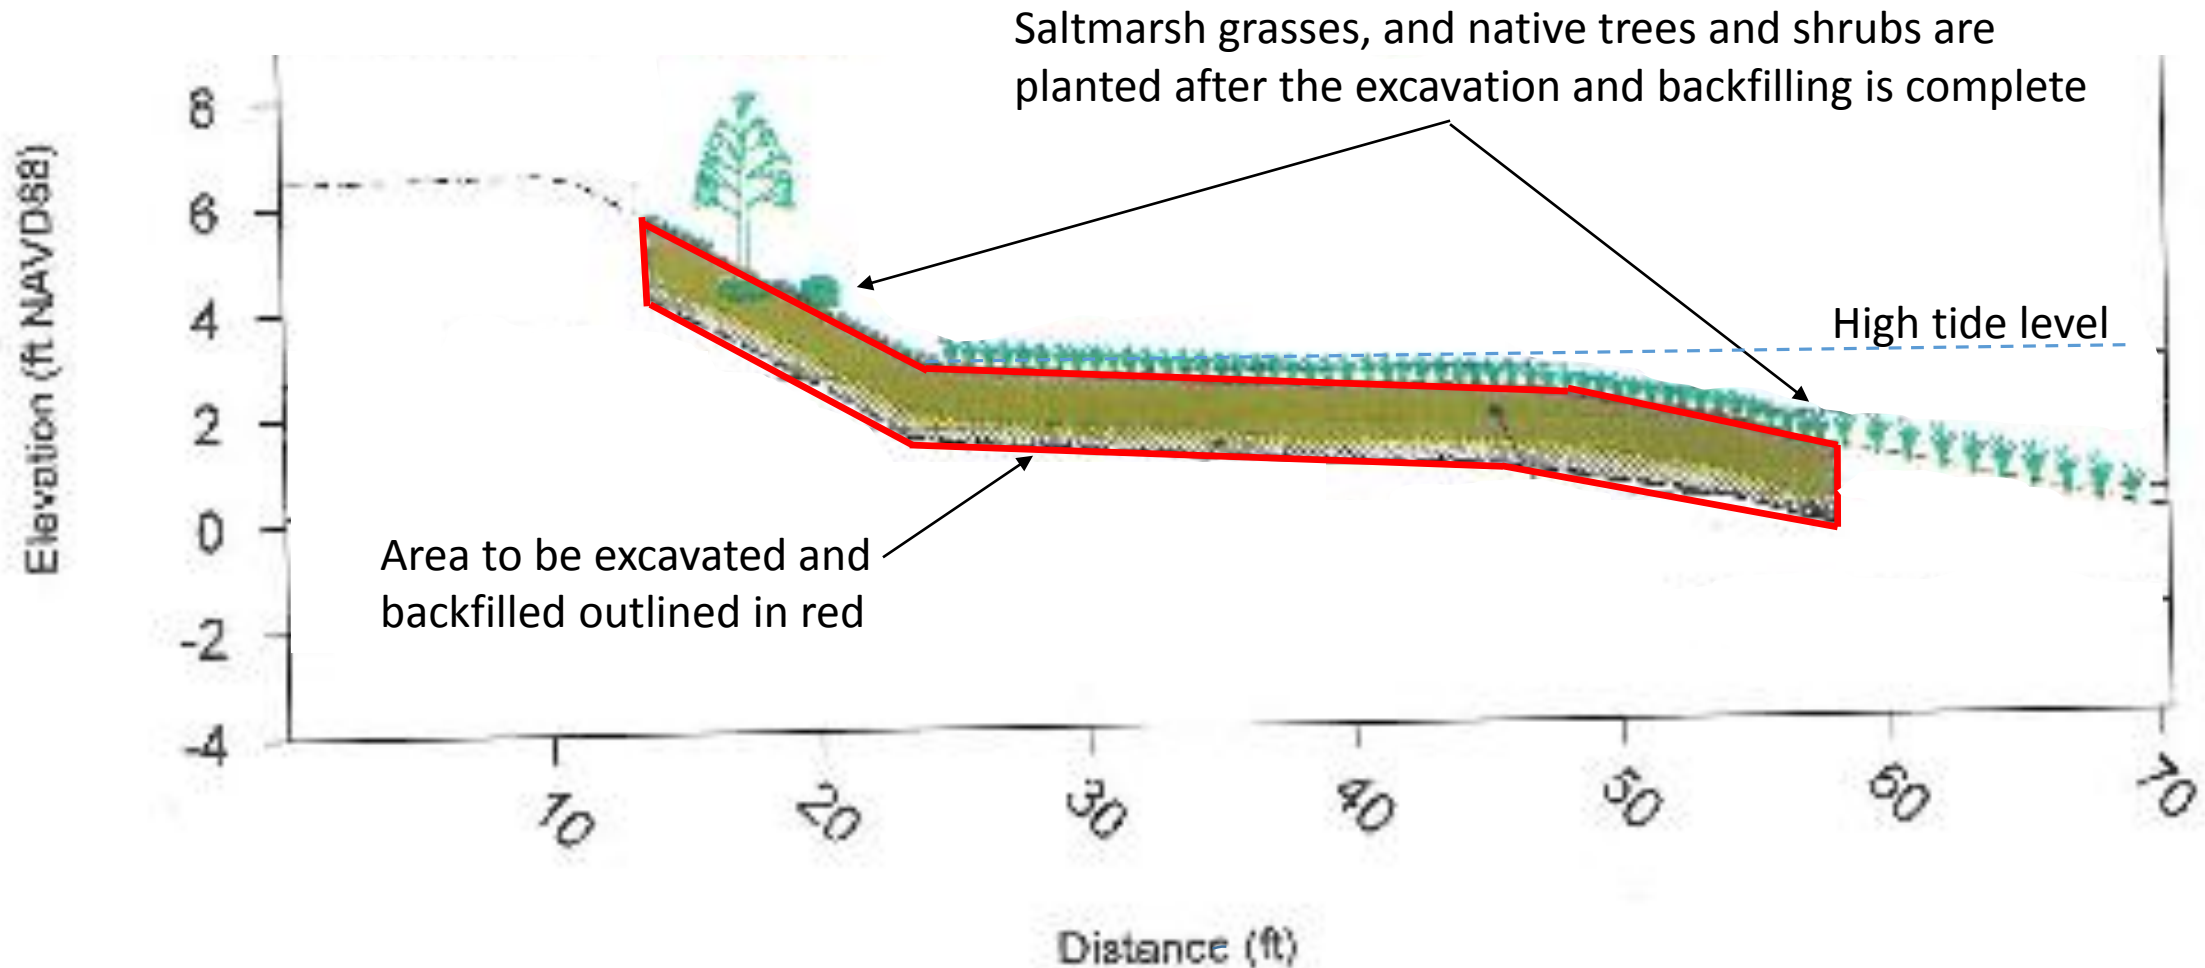
Cross-section view of Marsh Island remediation and restoration (with vertical exaggeration)

Before and After Average PCB Levels 12 Marsh Island Inter-tidal Areas

TCL = 25 ppm (recreational/beachcombing, first foot)

Before: 25 to 676 ppm

After: 0 ppm (non-detect, clean backfill)

NOTE: 4.3 ppm at depth prior to placement of 1 foot
of clean backfill
