**GE-PITTSFIELD/HOUSATONIC RIVER SITE
May 2016 Post-Remediation Inspection
Various Removal Action Areas**

Prepared for General
Electric Company
Pittsfield, Massachusetts

Prepared by
Tetra Tech, Inc.

July 2016

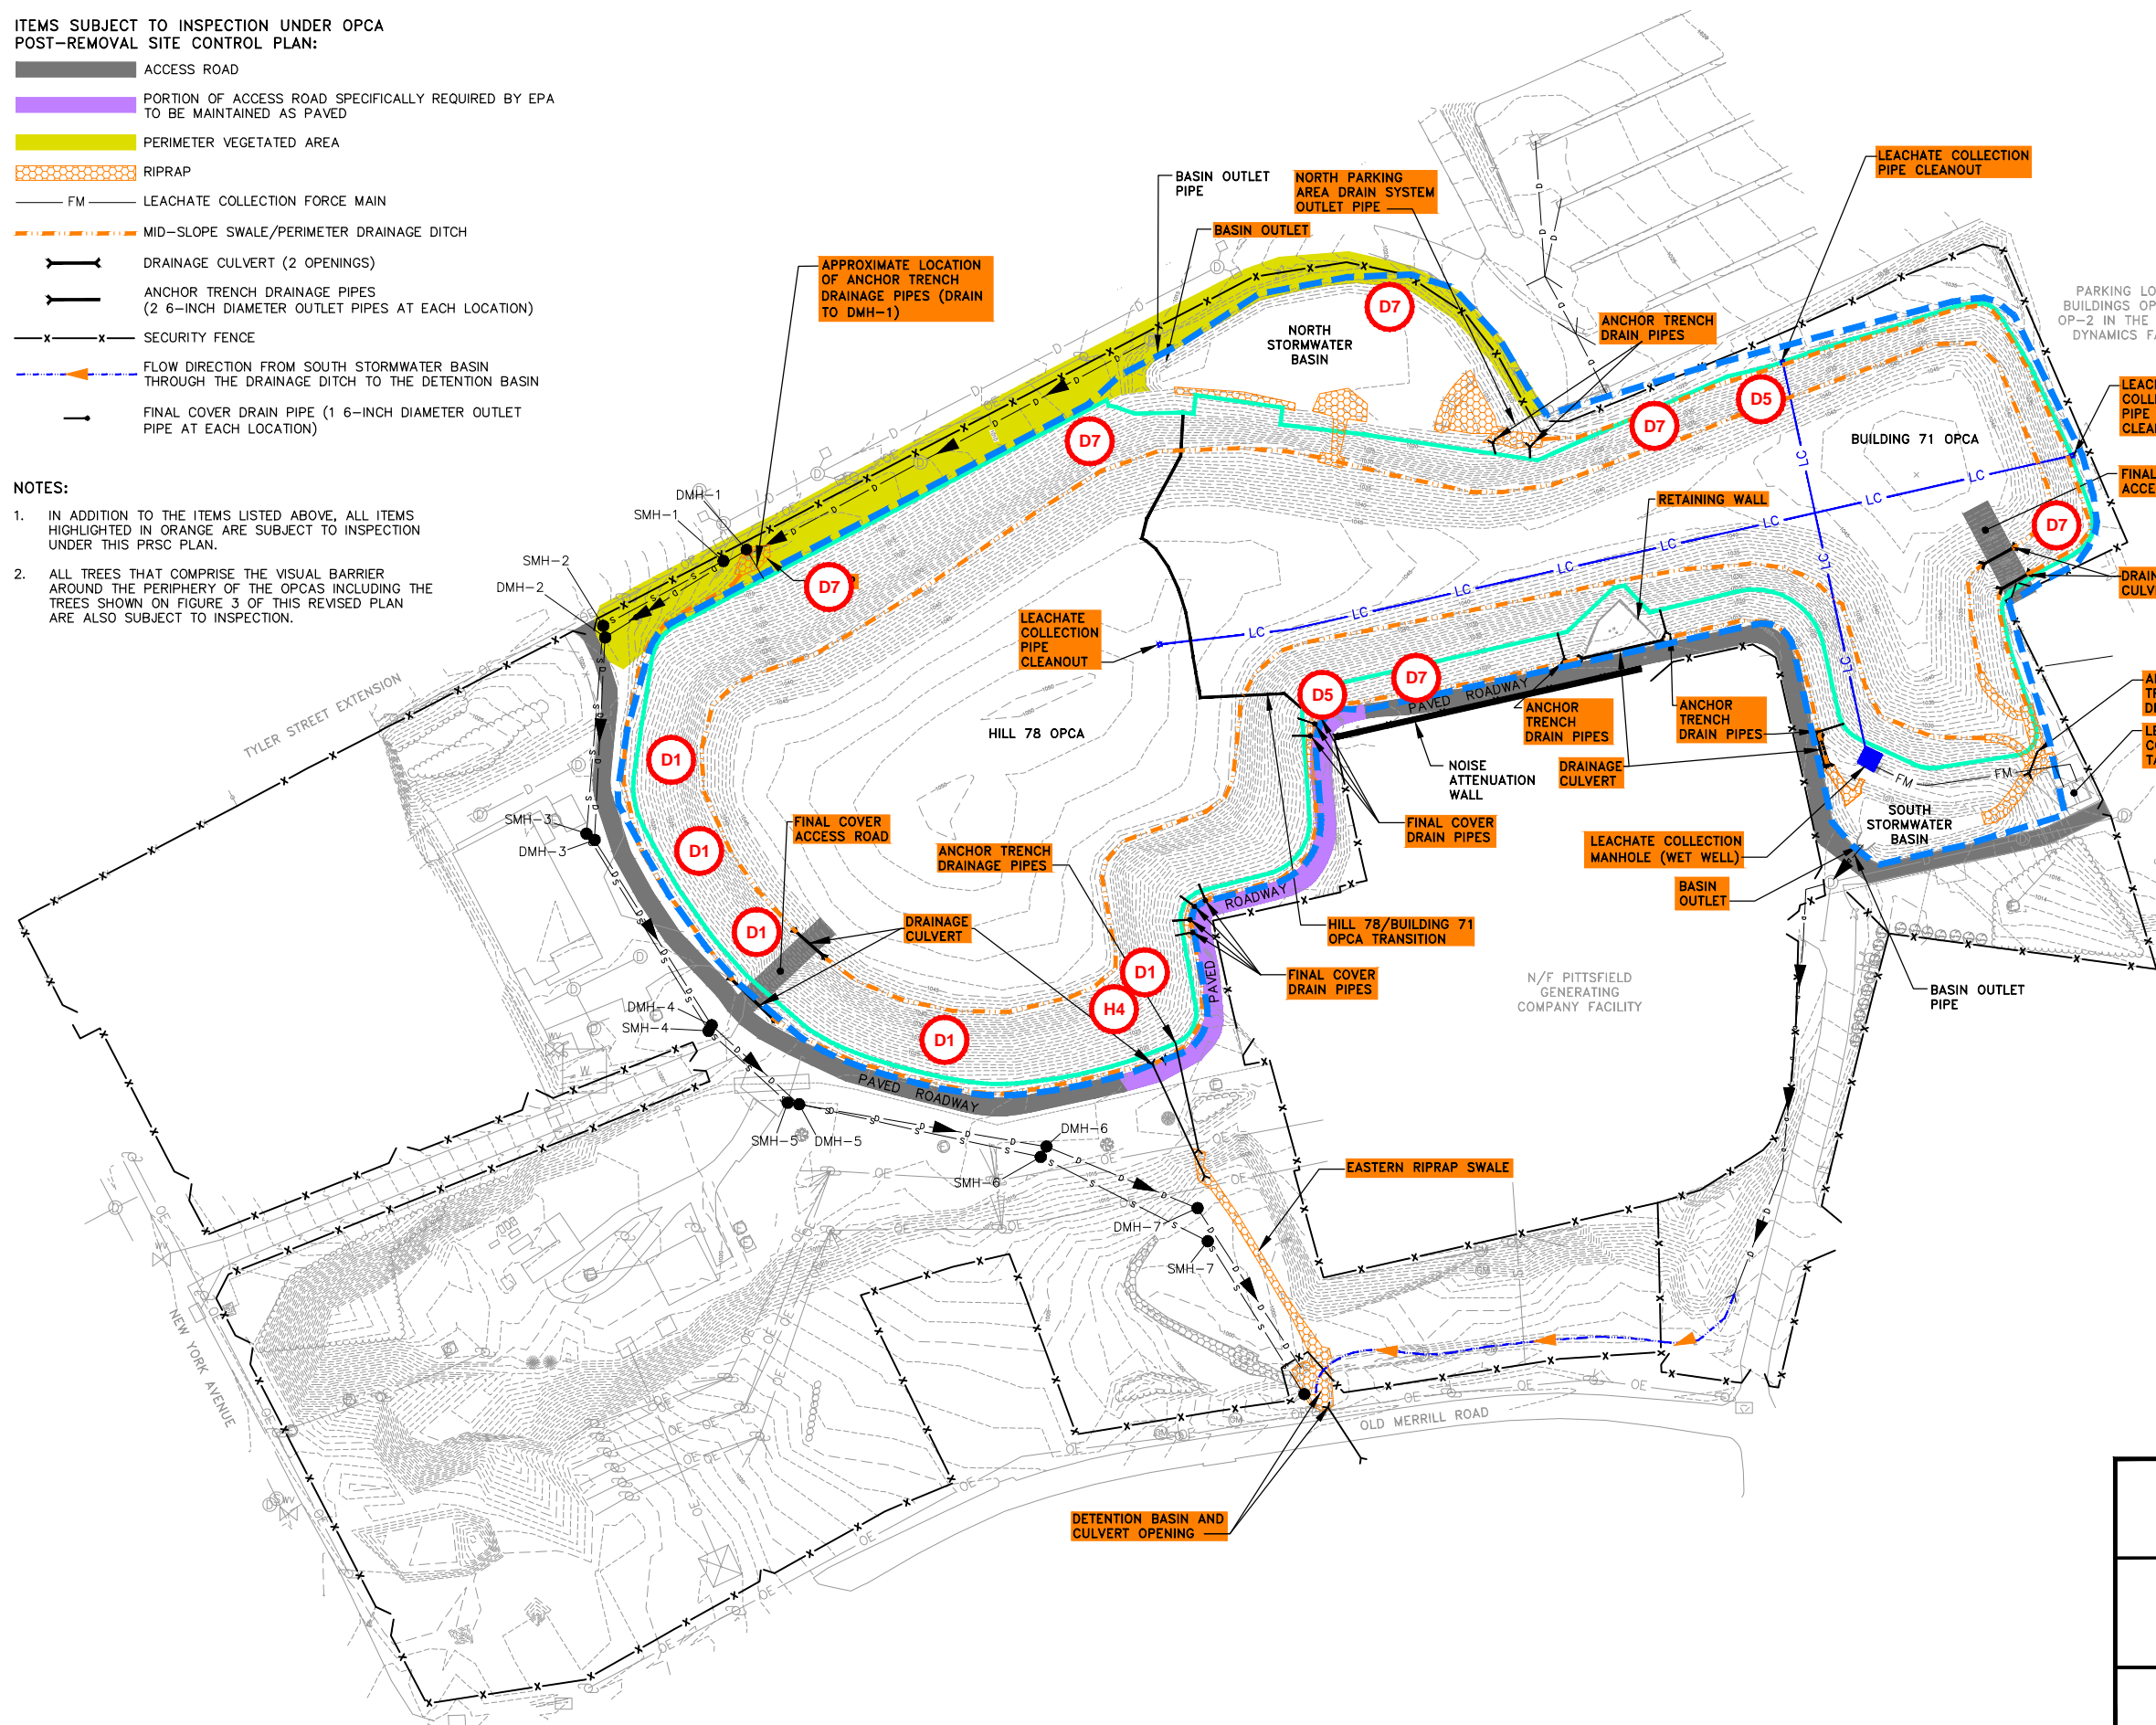
**OPCA COMPONENTS SUBJECT TO
POST-CLOSURE INSPECTION**

approximate locations of the items identified as requiring maintenance or repair are shown (by reference to the number on the Inspection Form) on Figure 5.

As indicated in Section IV of the attached Inspection Form, the areas of sparse vegetation on the western and southwestern sideslopes of the Hill 78 OPCA will be monitored again in the October 2016 inspection, and if growth is not observed, those areas will be re-seeded and mulched in November 2016. The burrowing woodchucks will be removed from the OPCAs and the burrow holes filled with topsoil, seeded, and mulched. The two trees growing on Hill 78 and Building 71 OPCAs will be removed. The erosion/sedimentation control logs located on the southern sideslope of Hill 78 OPCA will be removed. These maintenance activities will be conducted this summer.

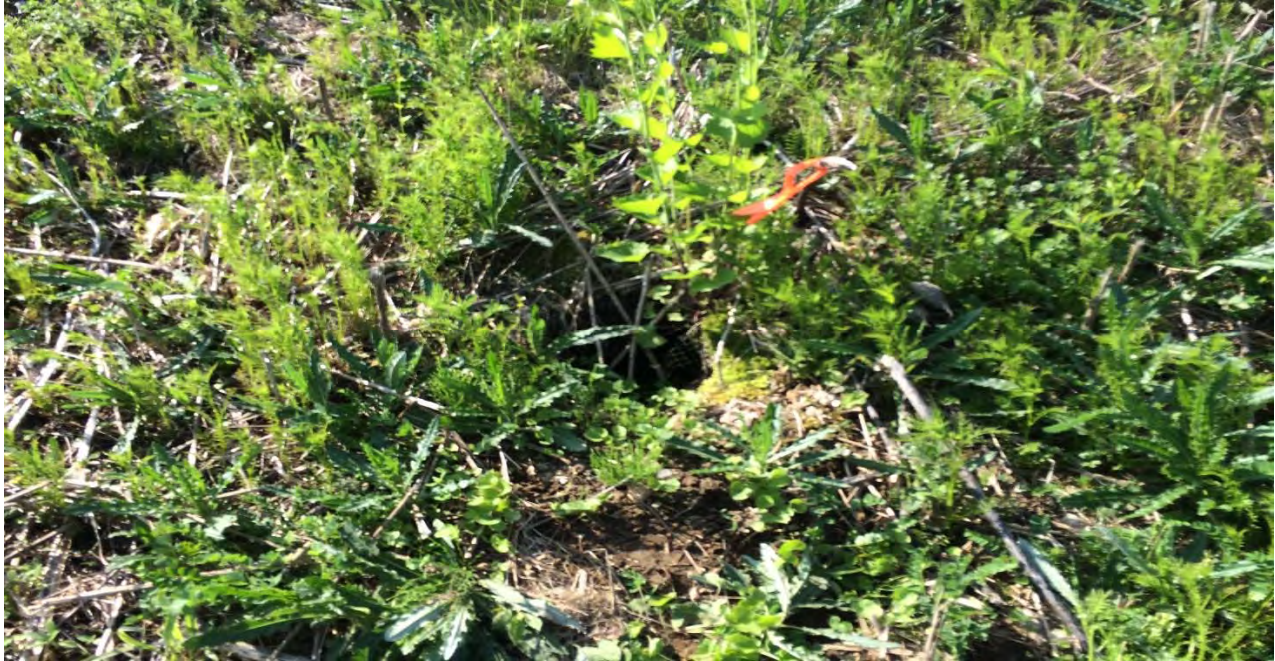
Photo #1: View of Woodchuck hole in the western berm of the Building 71 OPCA (photo direction West).

- D1. Observed areas of bare/sparse vegetation were reseeded and mulched.
- D7. Woodchuck was removed and the borrow hole was filled, topsoiled, re-seeded.

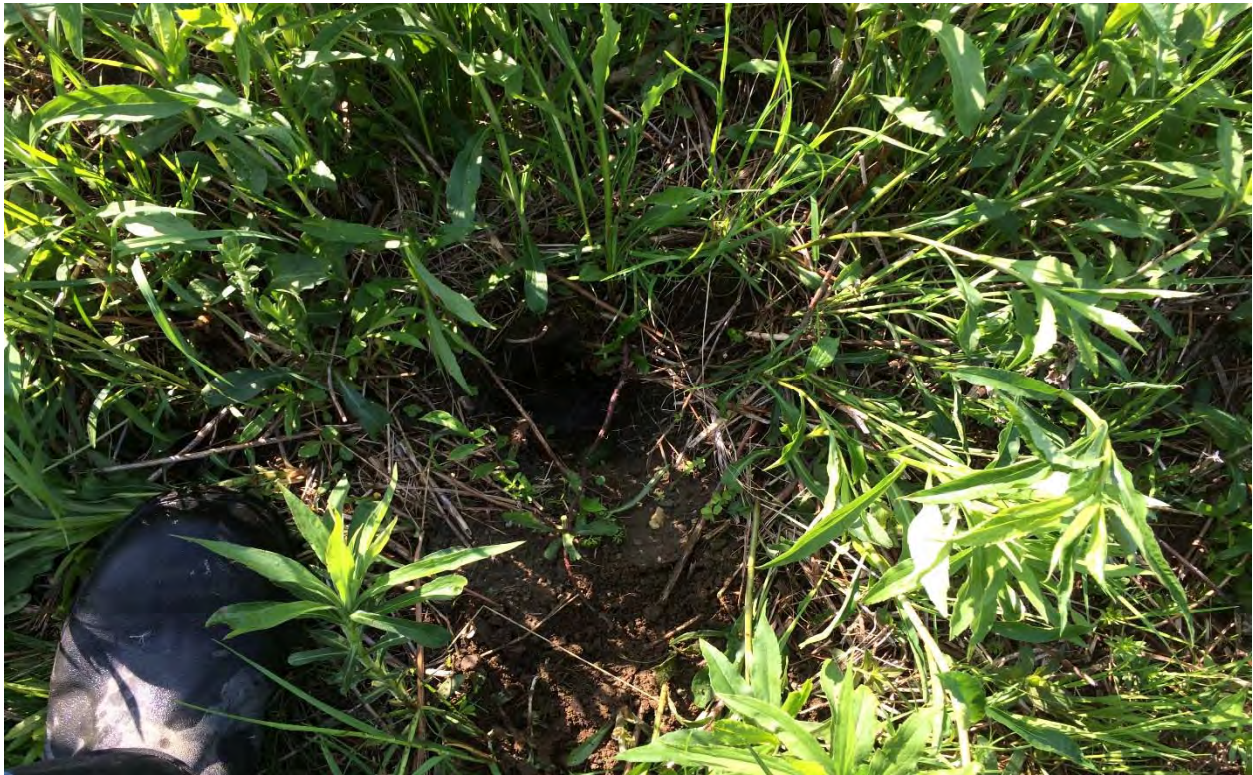
Photo #2: View of Woodchuck hole in the western berm of the Building 71 OPCA (photo direction West).

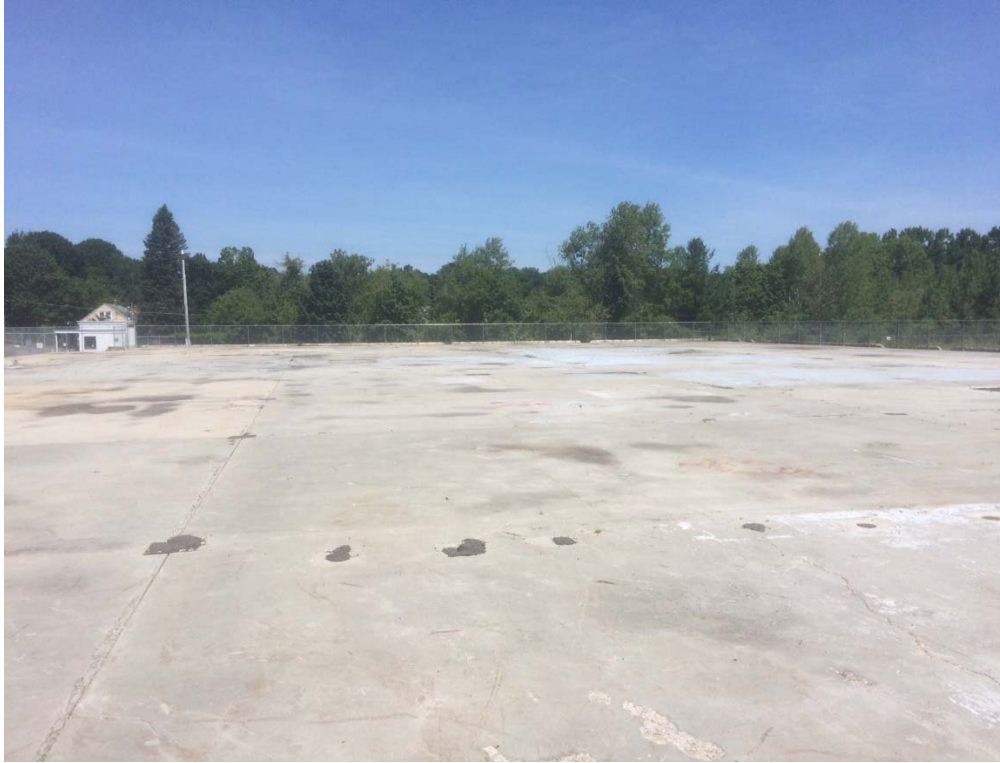
- All maintenance items identified during the May 2015 inspection, as described in GE's June 12, 2015 report, had been completed.
- Saplings were observed growing on the former Building 9-B slab.

Photo #17: View of Building 9B Slab-Vegetation Removed.

All maintenance activities (i.e., repair of the above-listed paved areas and removal of the saplings) will occur before the end of this summer. A summary of needed maintenance activities and a schedule to complete those activities is included in Table 2.

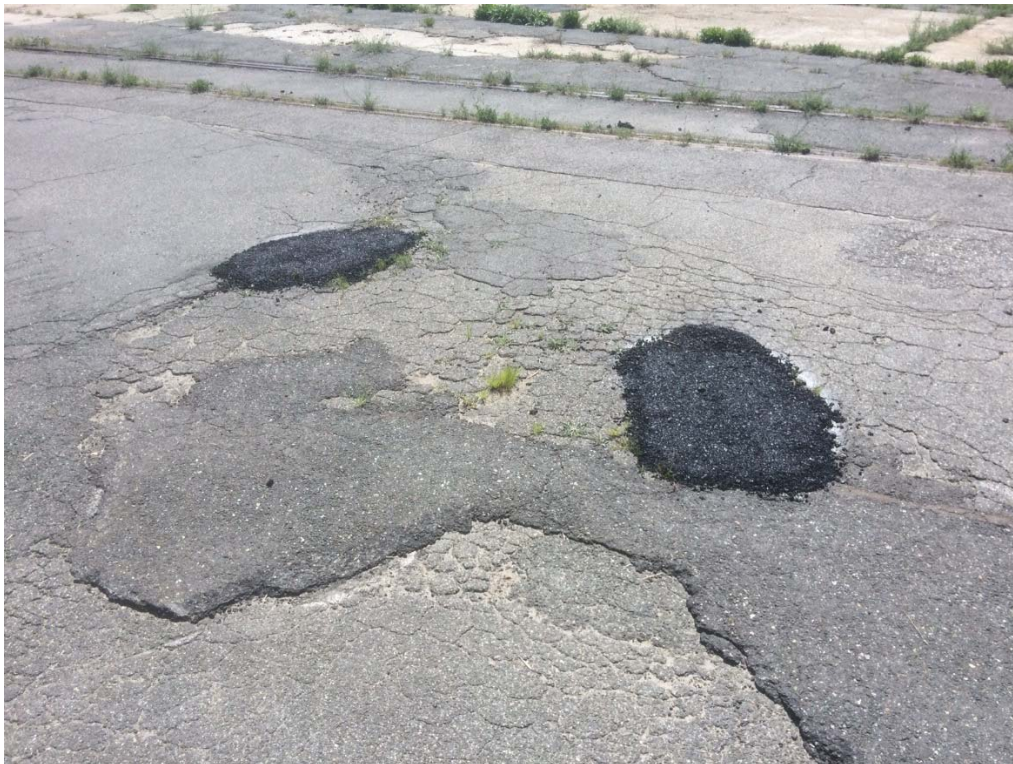
The following locations in paved and concrete areas were identified as needing repair by patching.

Photo #18: East Street Area 2 North Pavement Repair.

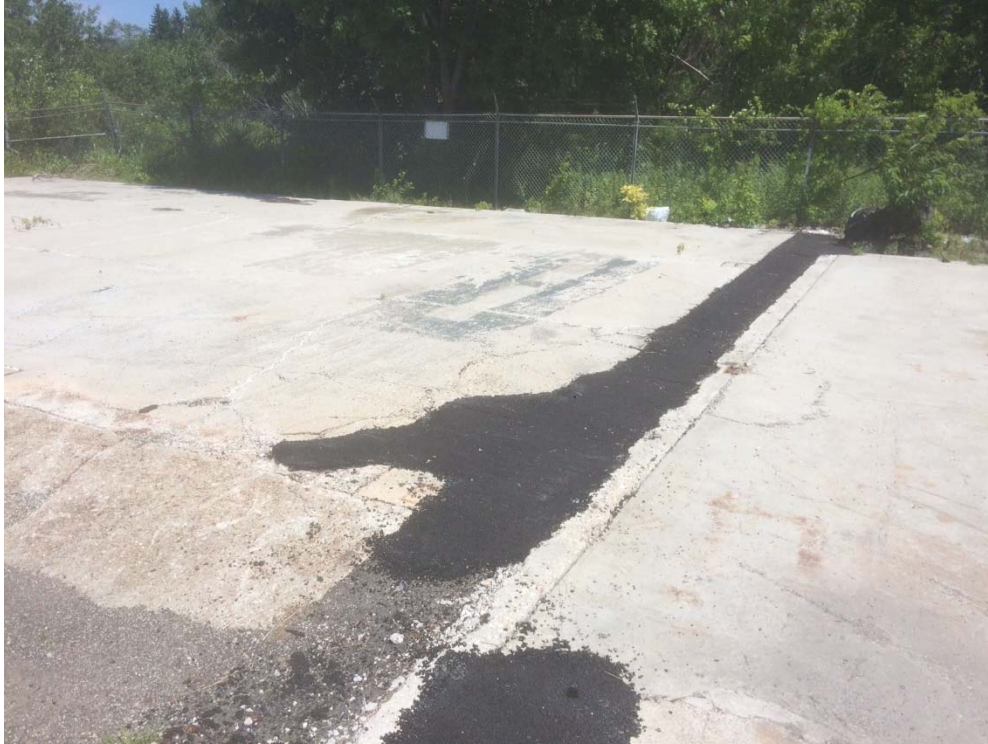
Photo #19: Pavement Repair Between Buildings 9B and 9F.

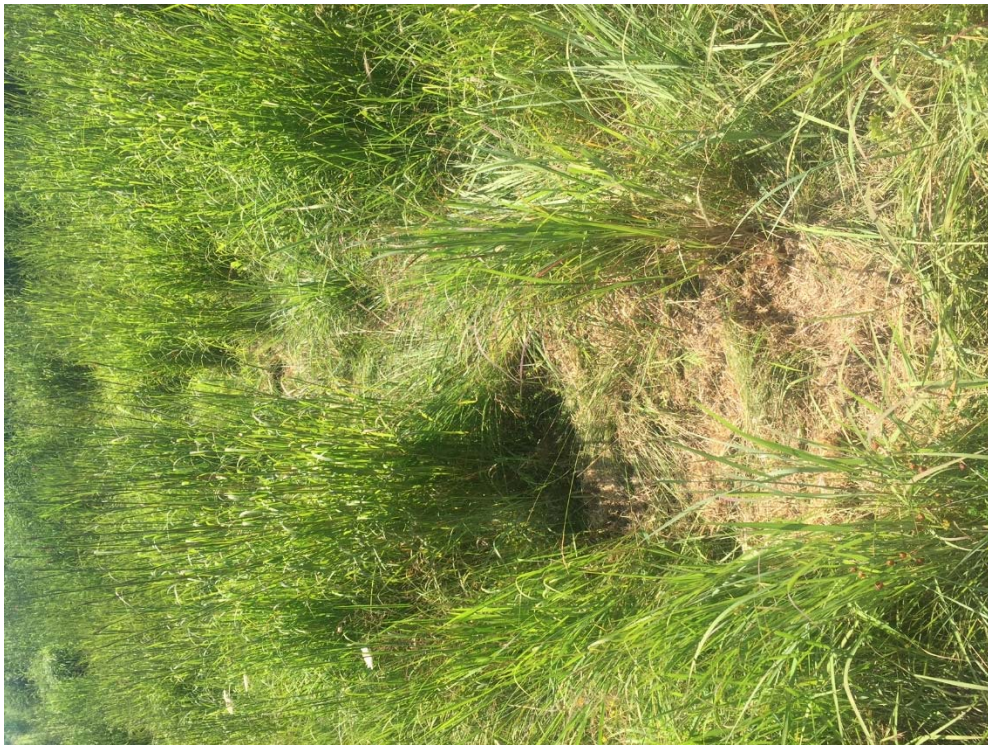
Photo #20: OPCA Erosion Control Removed.

Area	Parcels Subject to Inspection	Inspection Type	Observed Maintenance Items	Maintenance Status (including timetable if not complete)	Next Inspection
GE Plant Area					
East St. Area 2-North	Parcel J10-9-2	Backfilled/restored areas; Other Ground-Covering Feature Area; Slab Area; Building Demolition Barrier Area	<ul style="list-style-type: none"> - 19 locations in 9 paved area show damage to pavement; need patching - Small saplings observed on former Bldg 9-E slab; need removal 	Completed (Photos 17, 18, and 19)	May 2017
East St. Area 2-South	Averaging Areas 4B, 4C, & 4E	10 trees planted in 2014	None (all trees in good condition)	N/A	October 2016
Building 71 & Hill 78 OPCAs	N/A	Post-closure	<ul style="list-style-type: none"> - Areas of sparse vegetation on western & southwestern slideslopes; need monitoring - Nine woodchuck burrows observed; need removal of woodchucks and repair of holes - 2 small trees growing on OPCAs; need removal - Cypress spurge present at Hill 78 OPCA; need spraying outside NRRE area - Sedimentation control logs remaining on southern sideslope of Hill 78 OPCA; need removal 	<ul style="list-style-type: none"> - Areas of sparse vegetation to be monitored in October 2016 inspection. If growth not observed, re-seed and mulch in November 2016 - Woodchuck control activity on-going - Small trees removed when OPCAs are mowed in October - Sedimentation control logs have been removed (Photo 20) - Other item to be conducted in summer 2016 	October 2016
