**Kevin Mooney**  
Senior Project Manager  
Corporate Holdings, GE Aerospace

1 Plastics Ave.  
Pittsfield, MA 01201

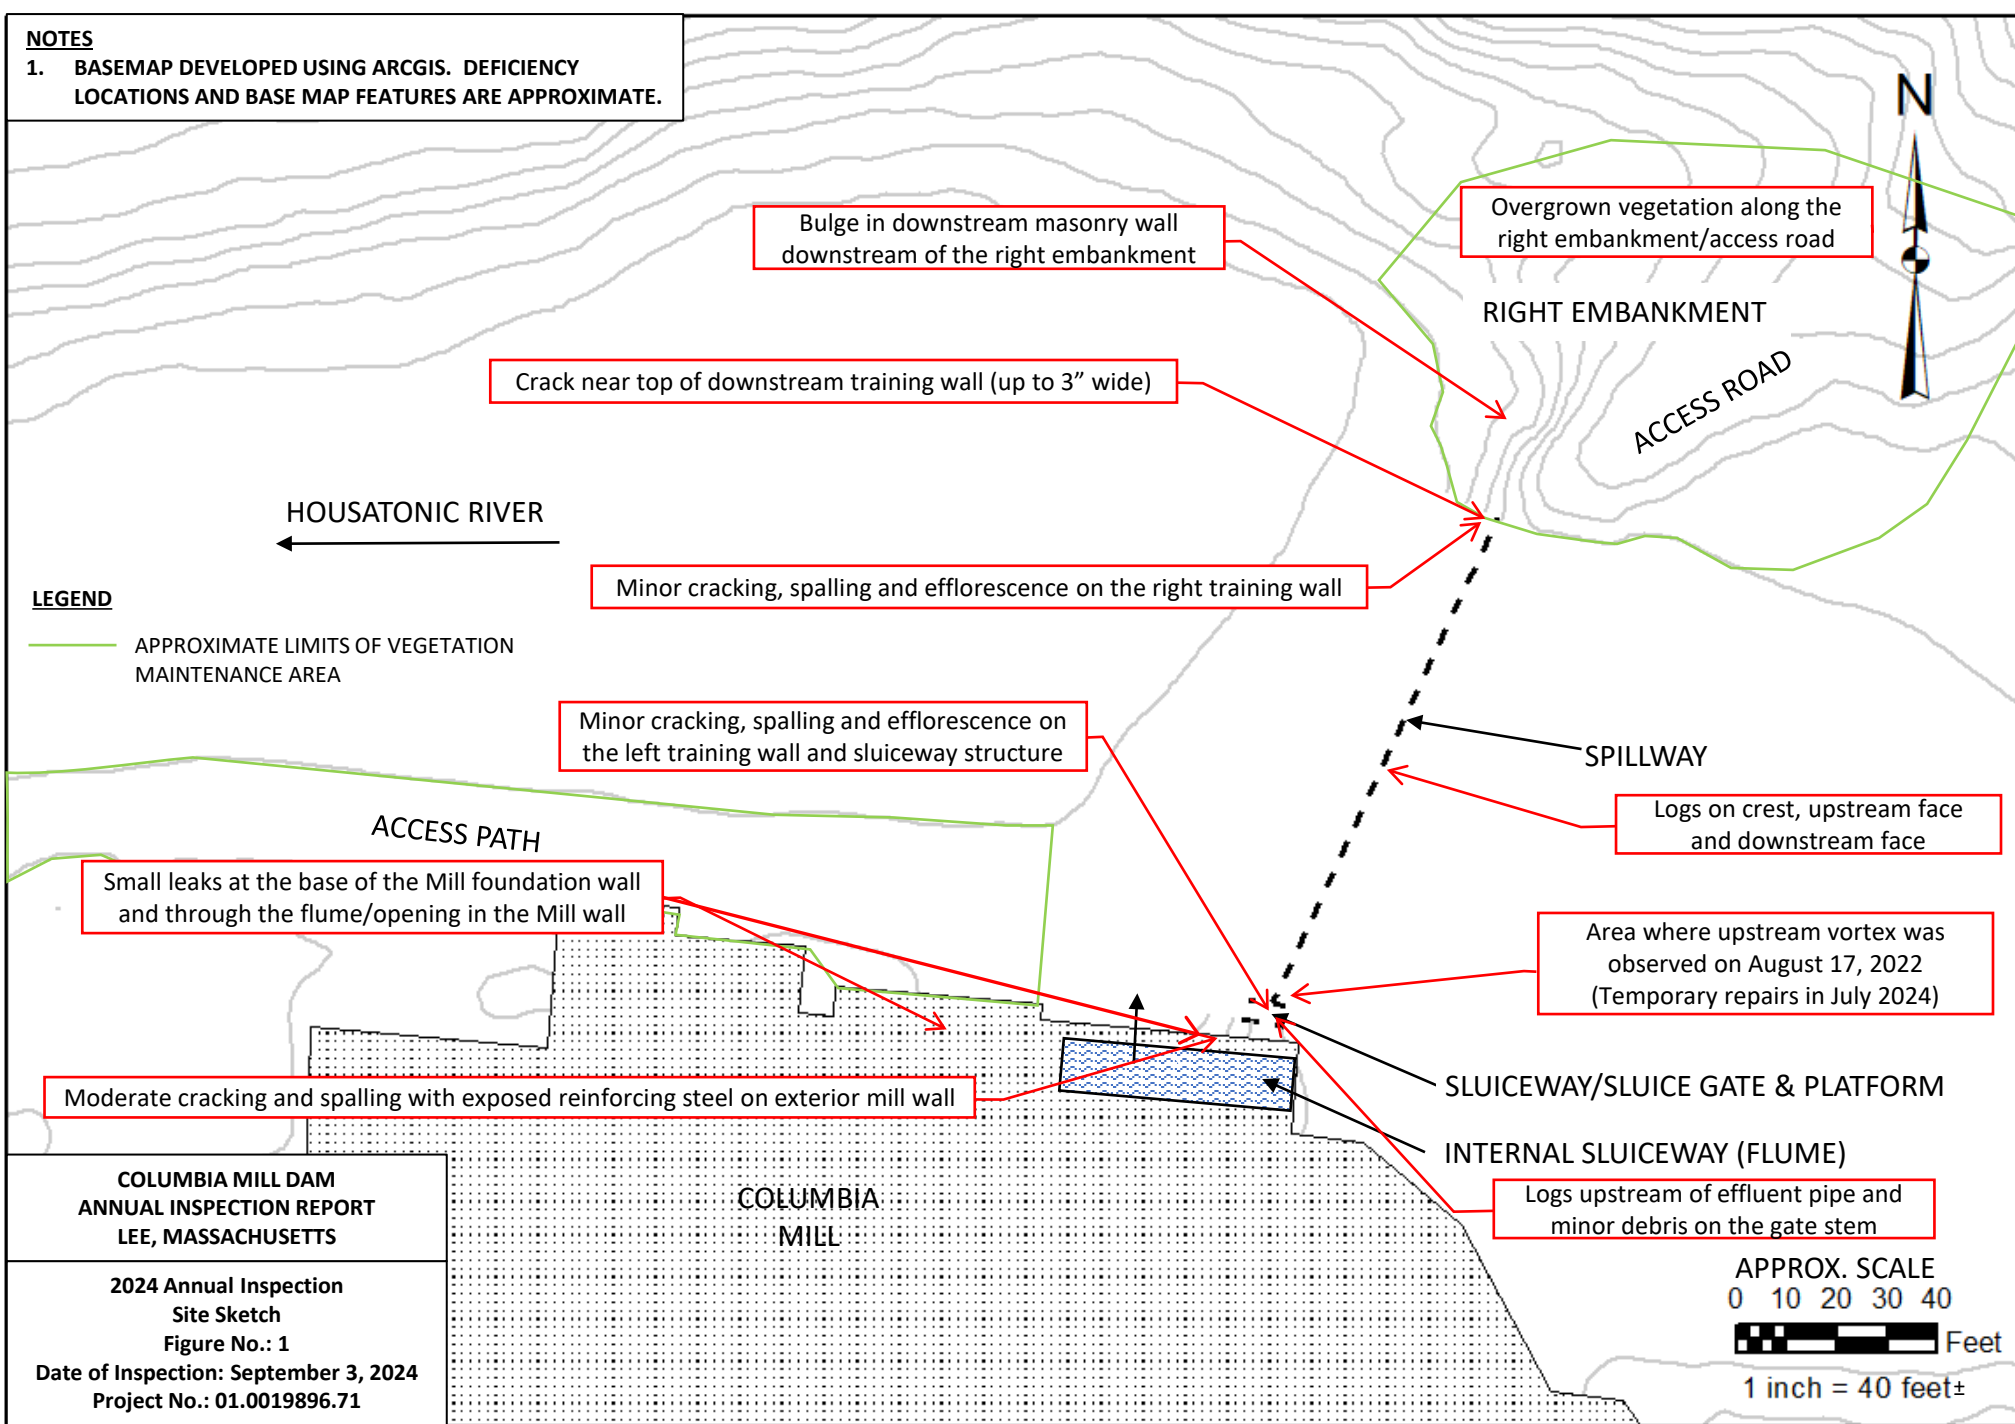
1. BASEMAP DEVELOPED USING ARCGIS. DEFICIENCY LOCATIONS AND BASE MAP FEATURES ARE APPROXIMATE.

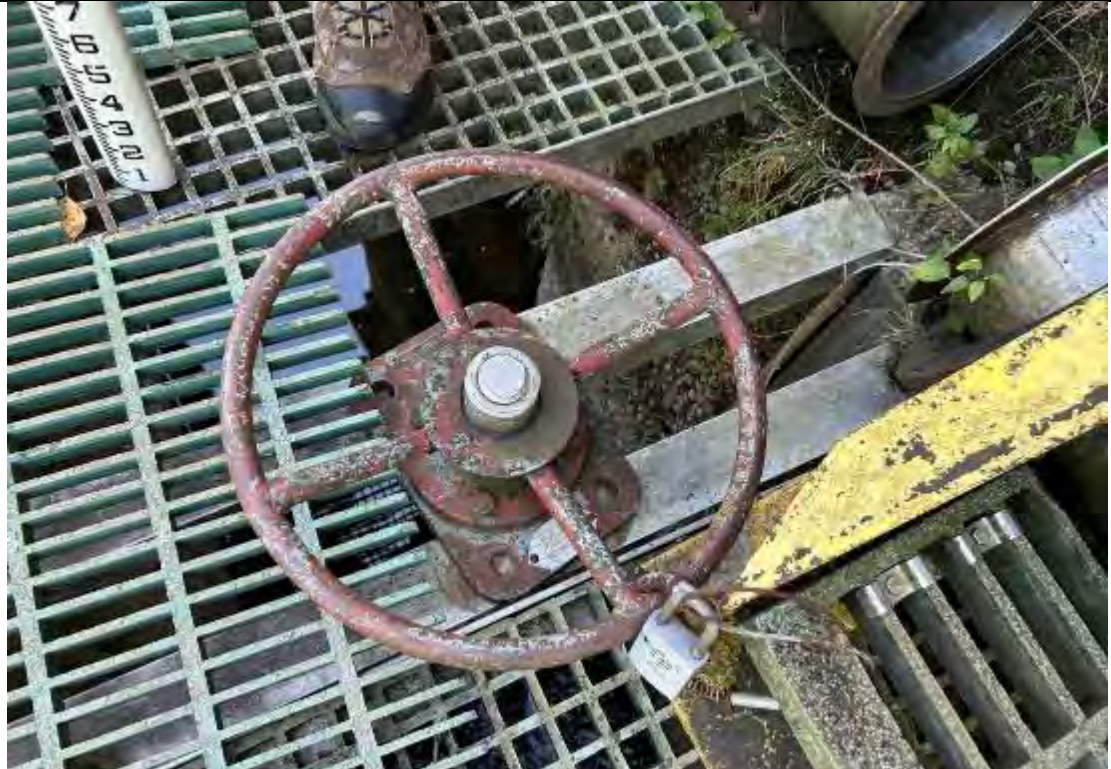
<b>Direction Photo Taken:</b> Upstream.		
<b>Description:</b> Sluiceway gate operator. Gate in the fully closed position during the current inspection.  Gate was last operated in July 2024 to its full open height. No issues noted during the July 2024 gate operation.

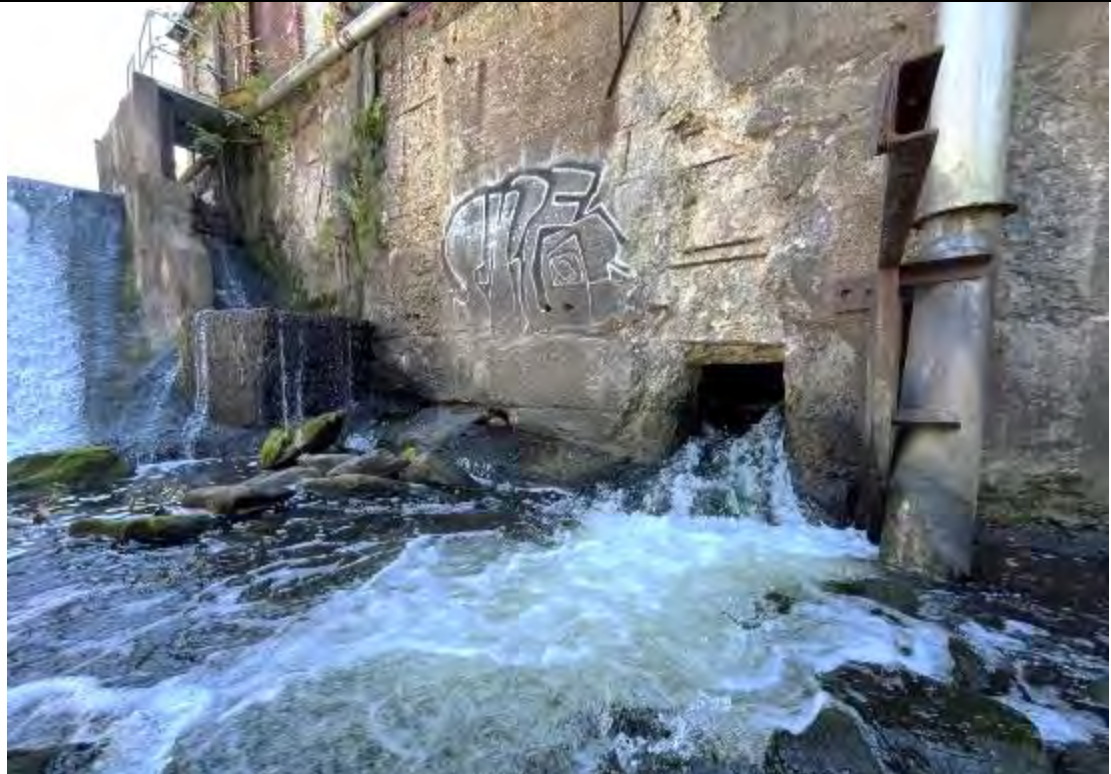
<b>Direction Photo Taken:</b> Upstream and to the left.			
<b>Description:</b> Closeup of the sluiceway and mill building exterior wall downstream of the dam.  Note moderate spalling of the concrete and exposed reinforcing steel of the mill building wall.

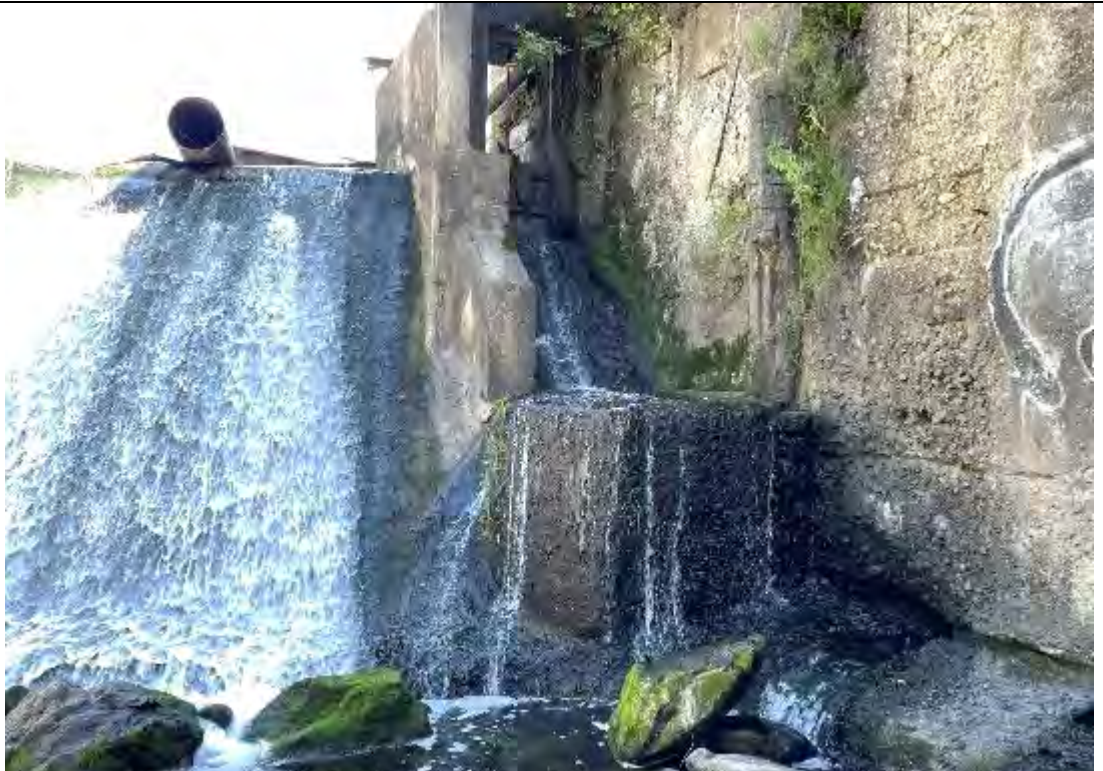
<b>Direction Photo Taken:</b> Upstream.			
<b>Description:</b> Downstream side of the sluiceway.  Note: Previously observed diagonal crack on downstream face obscured by flow.

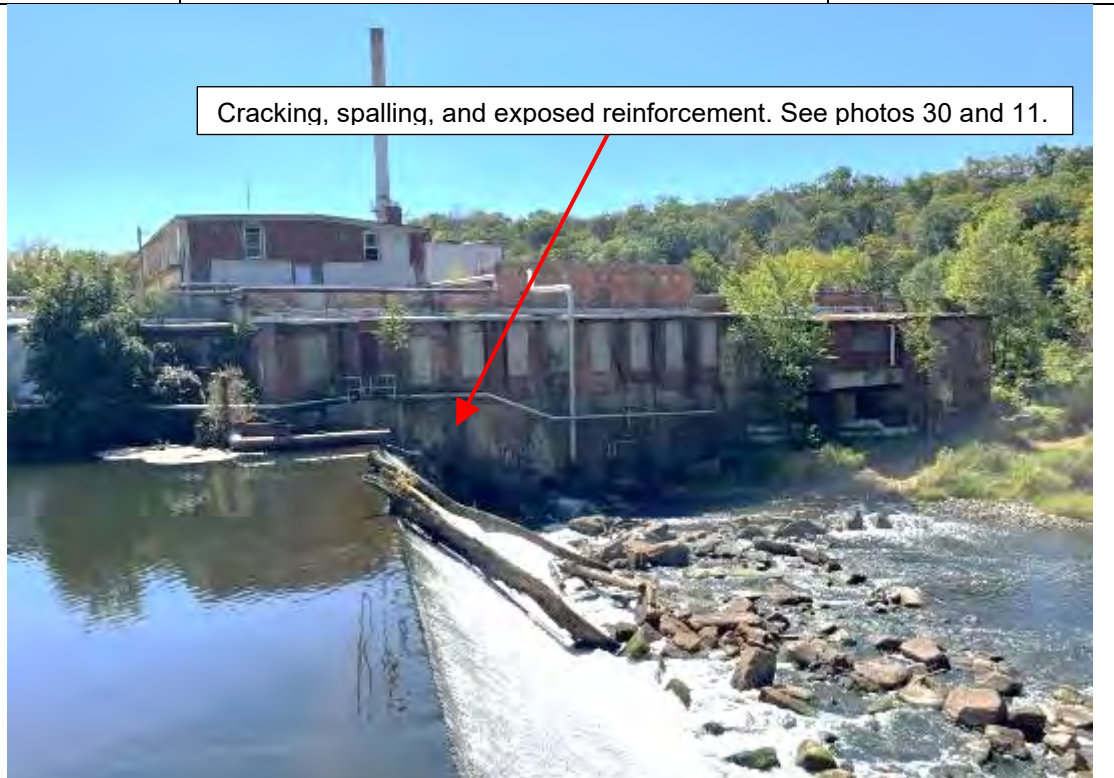
<b>Photo No.</b> 30	<b>Date:</b> 09/03/2024
------------------------	----------------------------

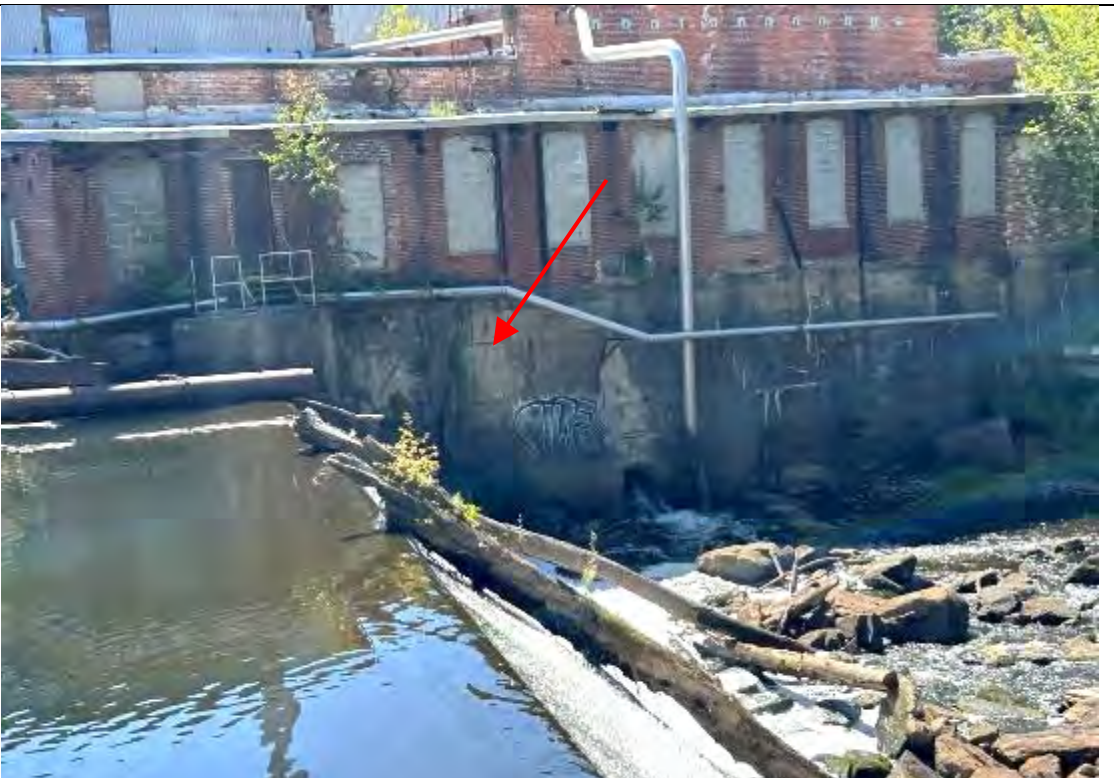
Note moderate cracking, spalling, and exposed reinforcement of the mill building wall concrete.

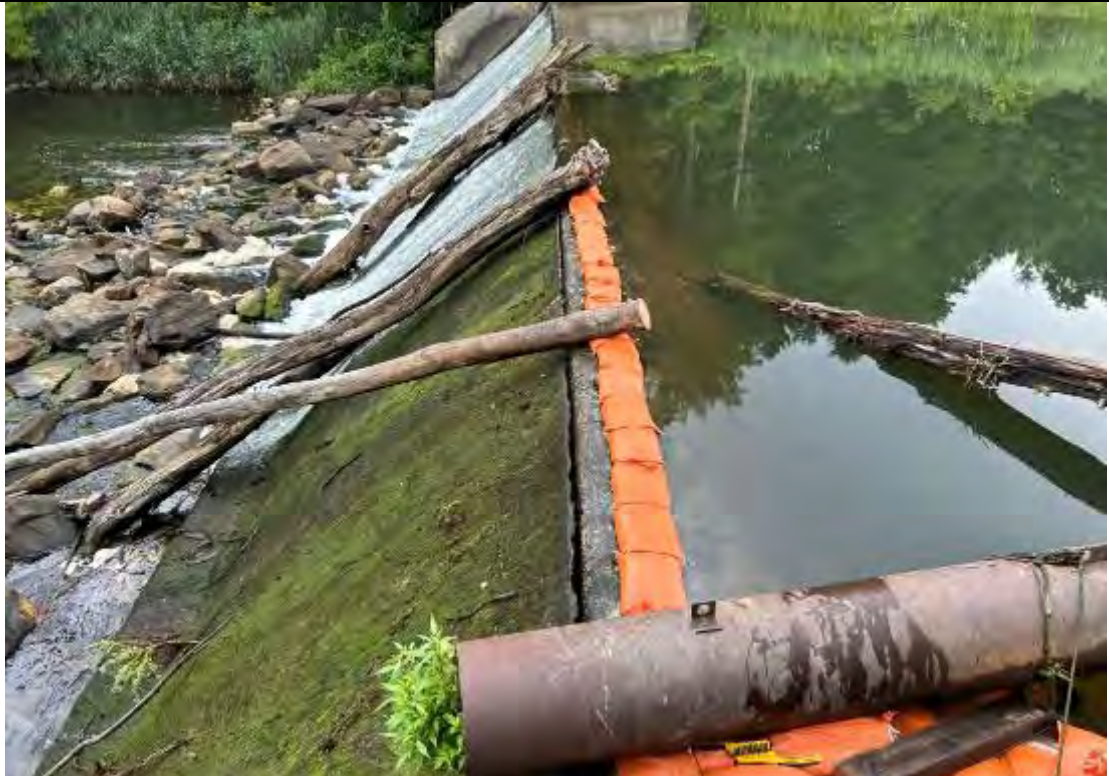
<b>Direction Photo Taken:</b> Right			
<b>Description:</b> Spillway in the nearly dewatered state during the temporary repair program.

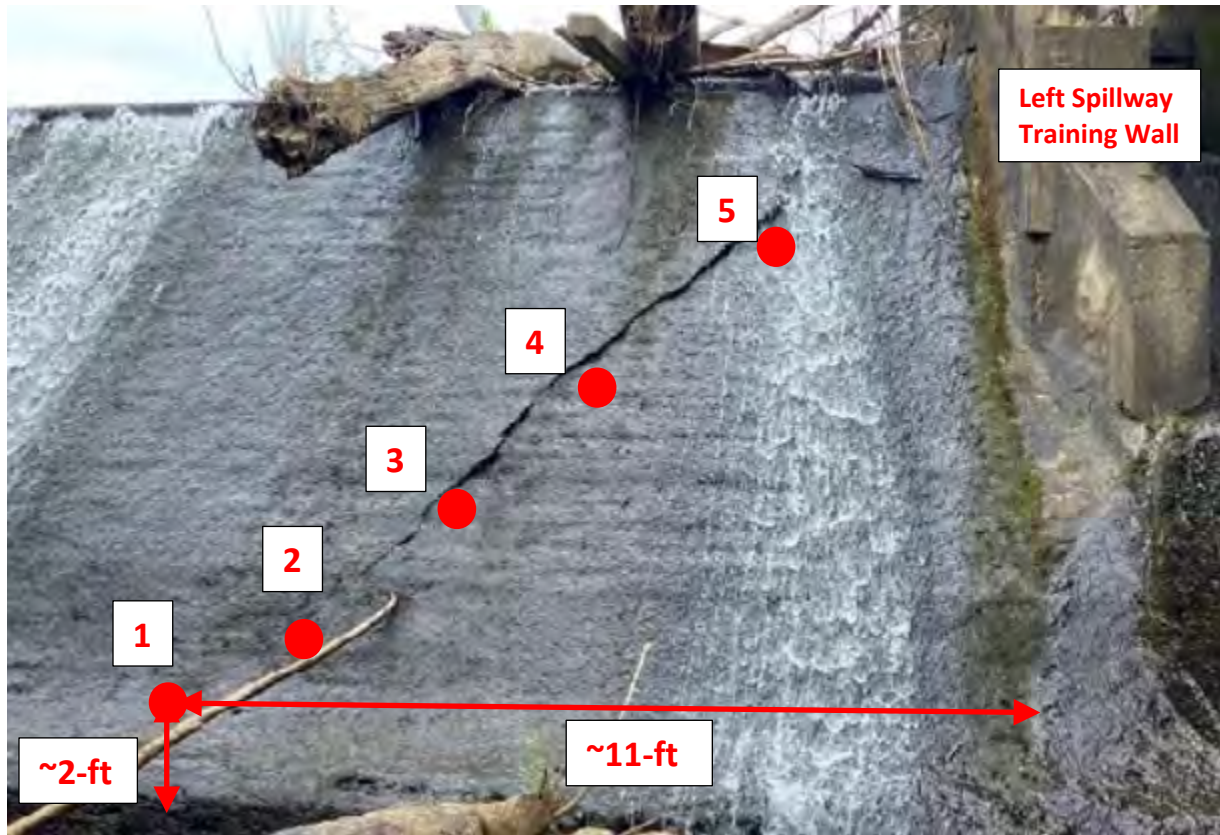
**Figure 1. Approximate Locations of Downstream Diagonal Crack Measurements.**

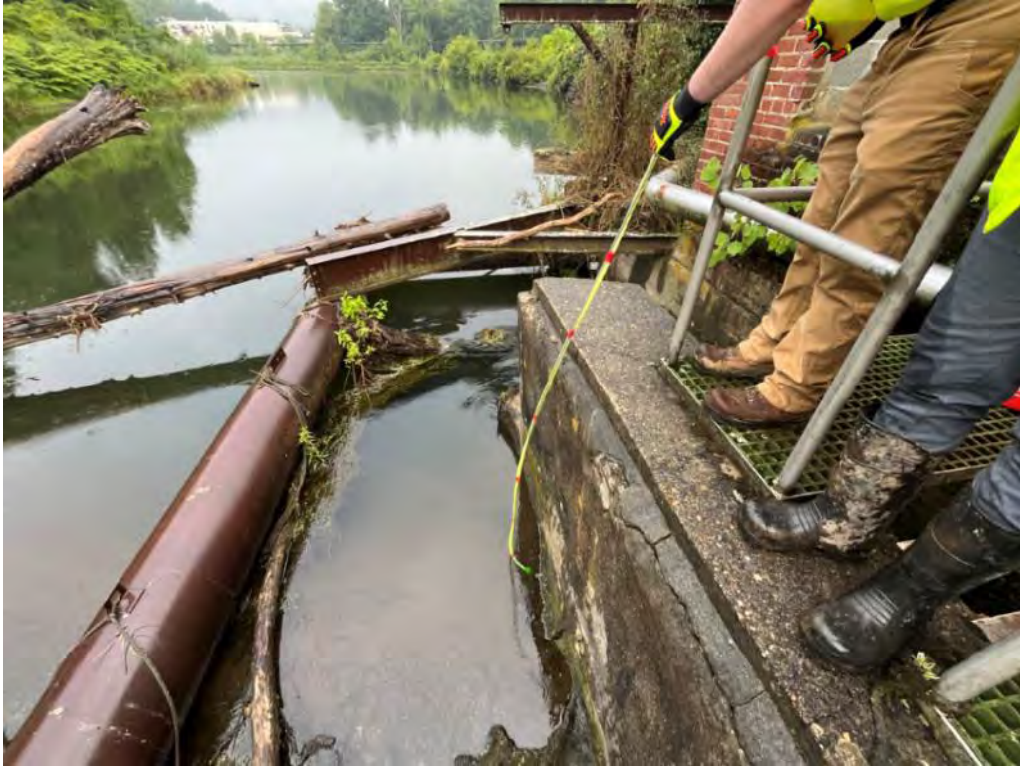
*Photo 1. Introducing tracer dye into the crack/void at the former vortex location.*

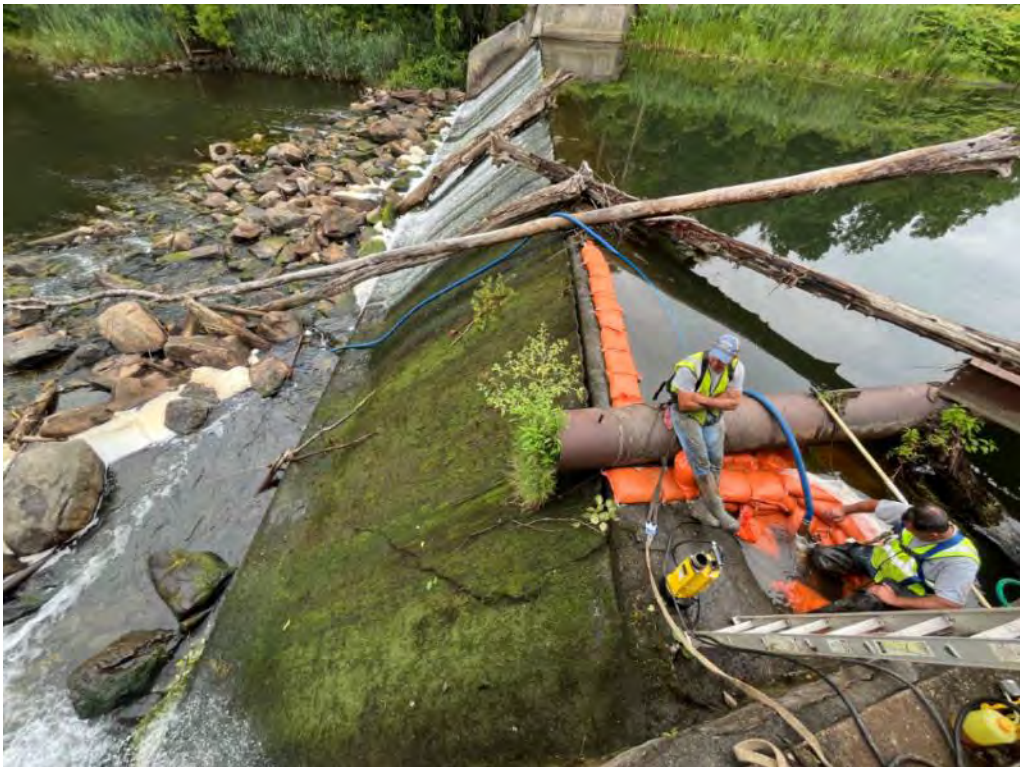
*Photo 2. Temporary sandbag cofferdam installed. Installing dewatering pumps.*

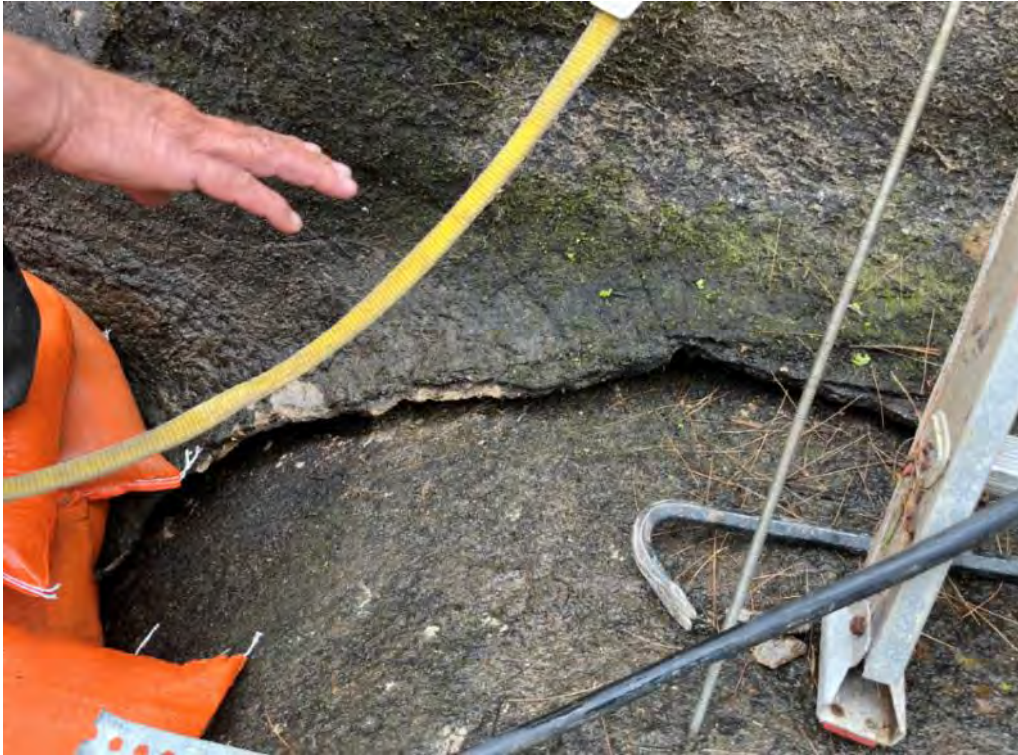
*Photo 3. Former vortex repair area prior to repairs.*

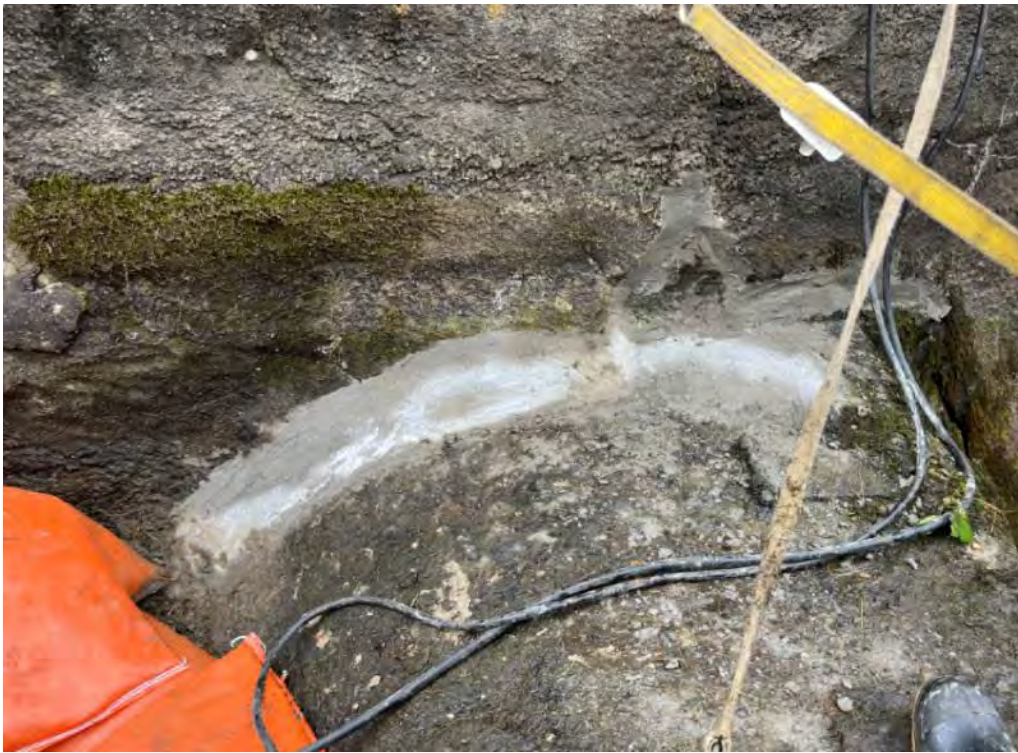
*Photo 4. Former vortex repair area after repairs.*

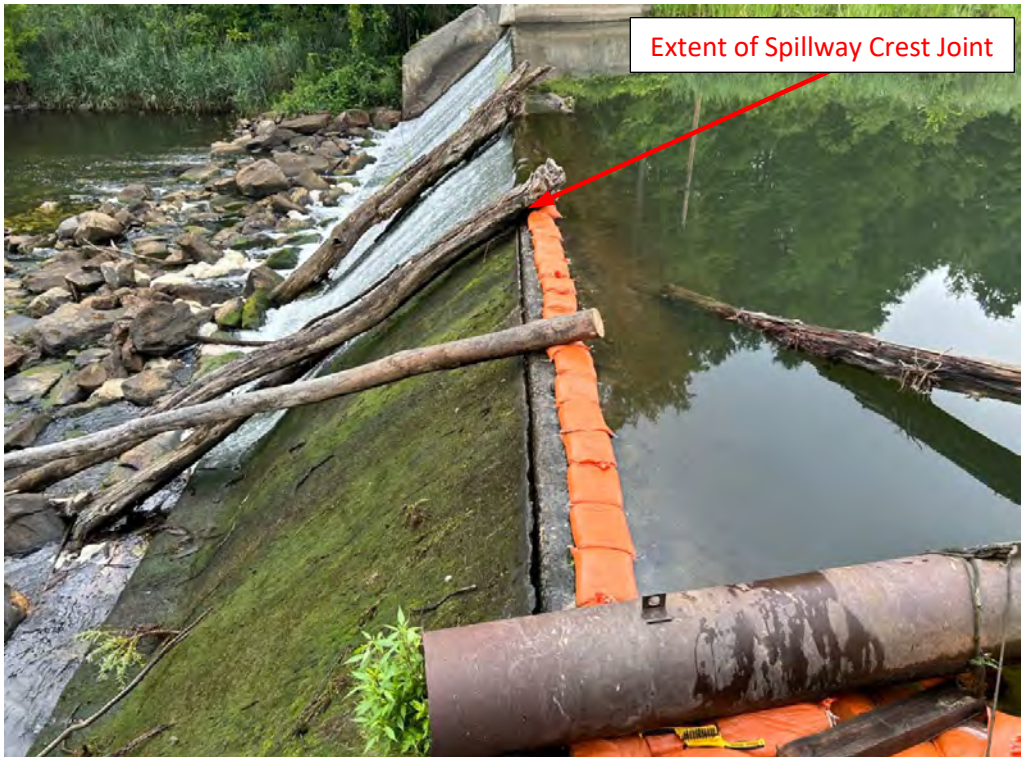
Photo 5. Spillway crest joint before repairs; extent determined by probing.

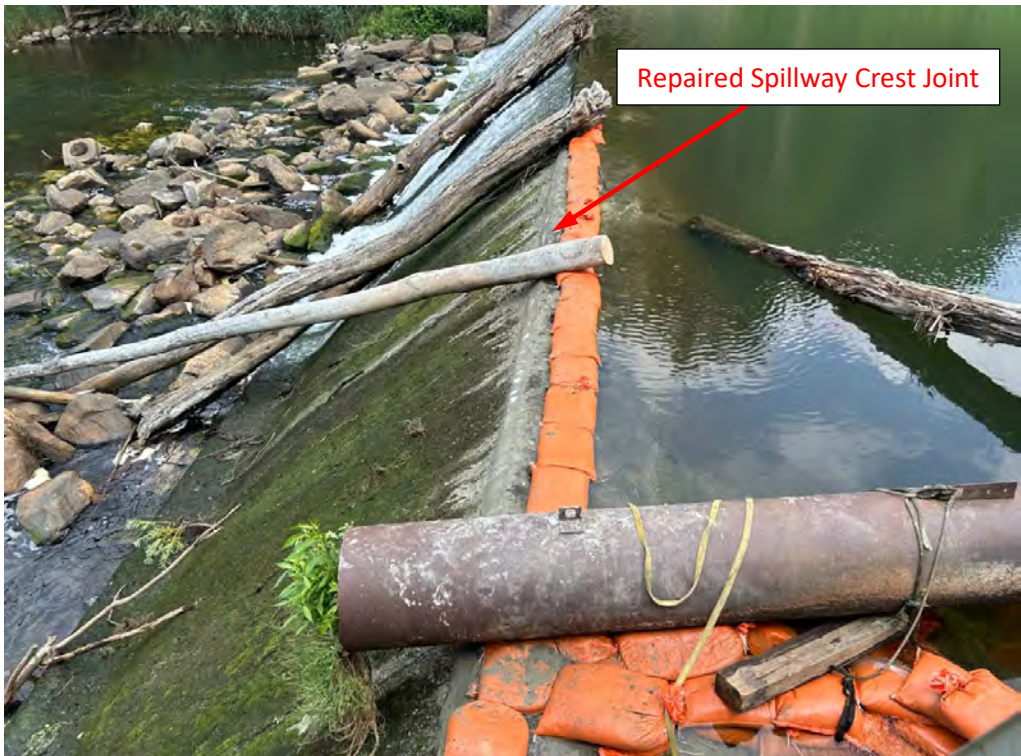
Photo 6. Spillway crest joint after repairs.

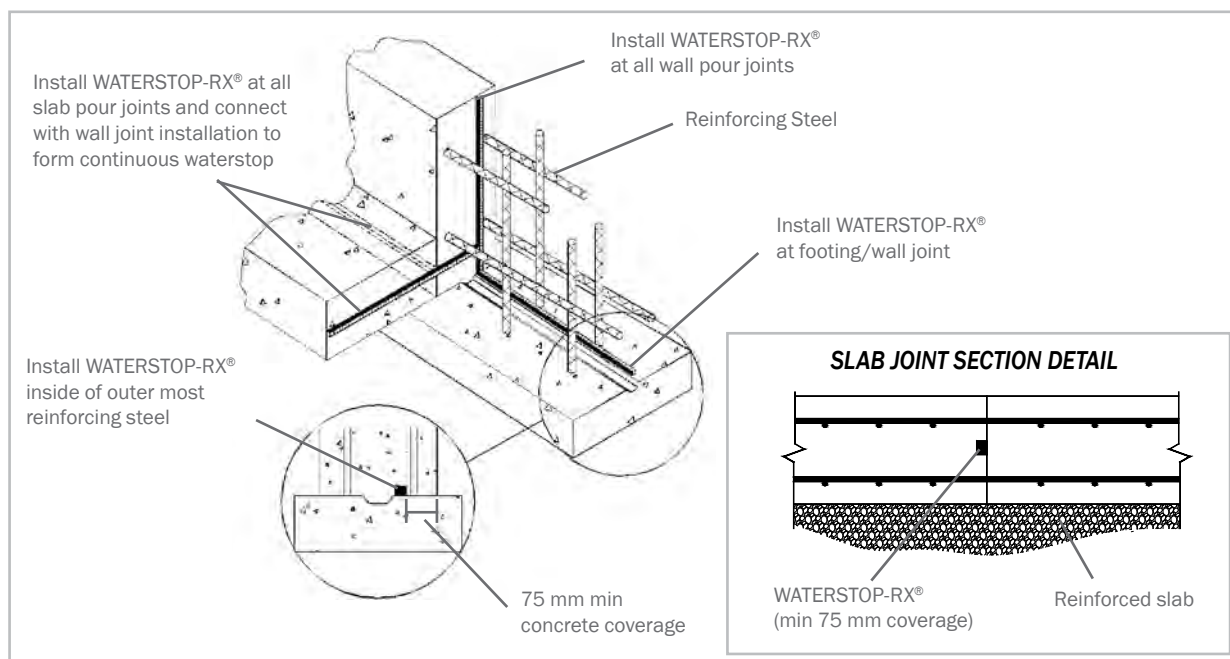
Typical WATERSTOP-RX® Foundation Detailing

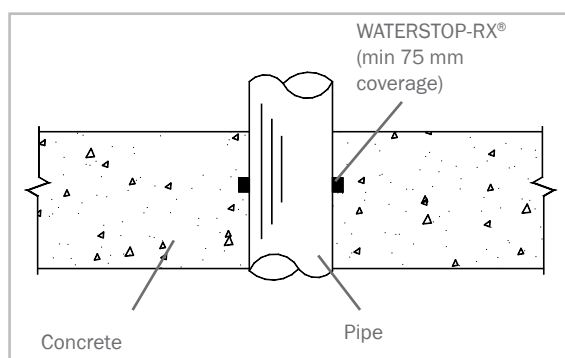
Cast-in-Place Penetration

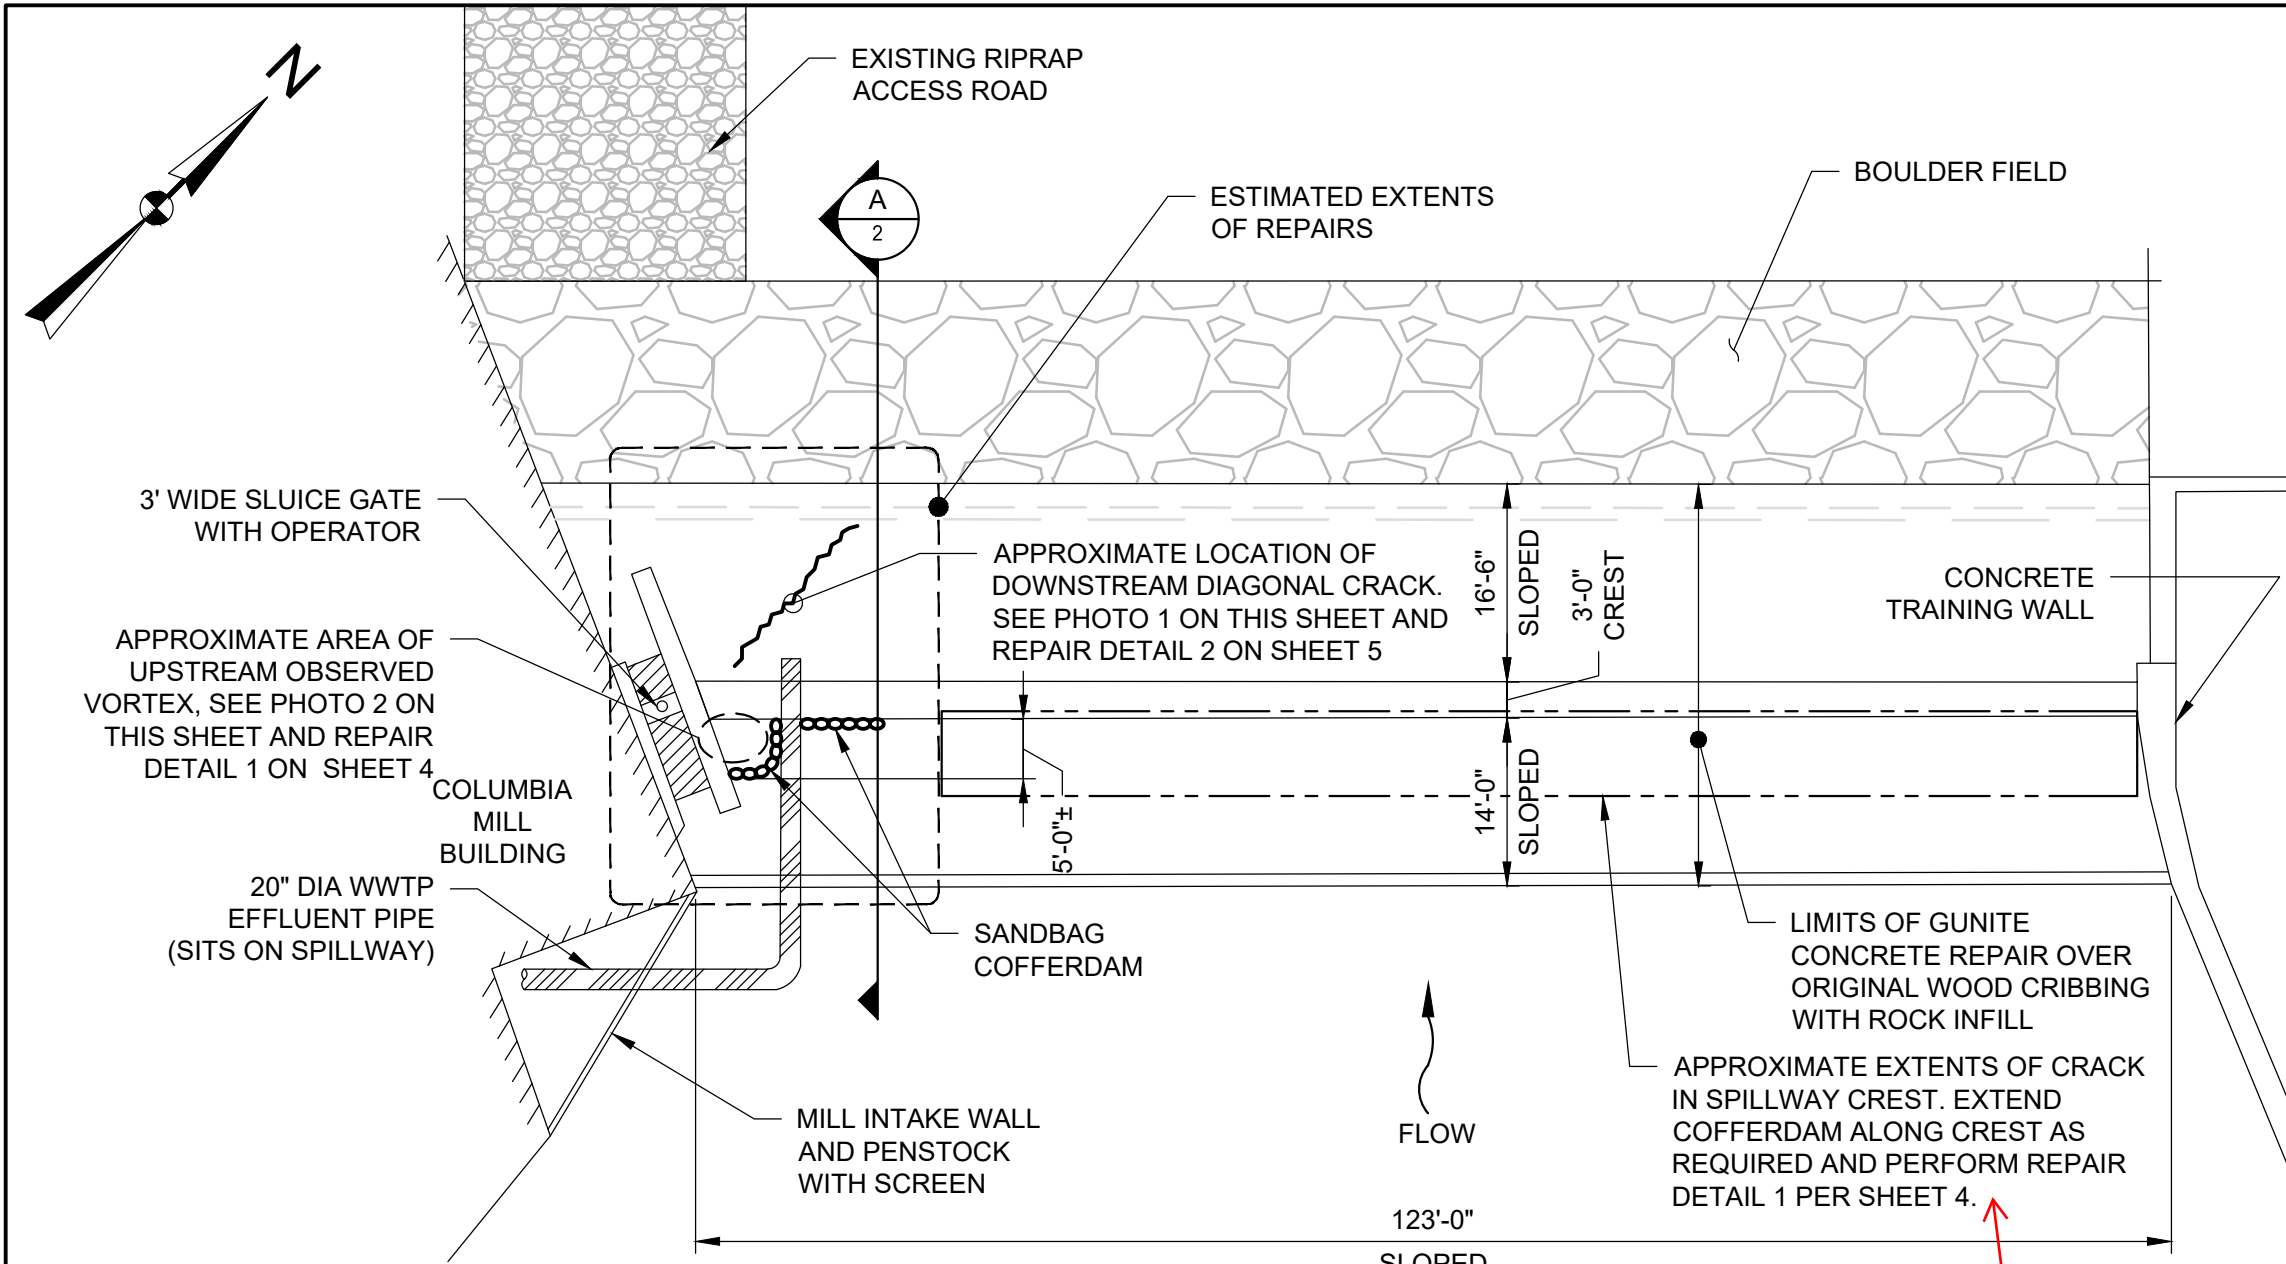
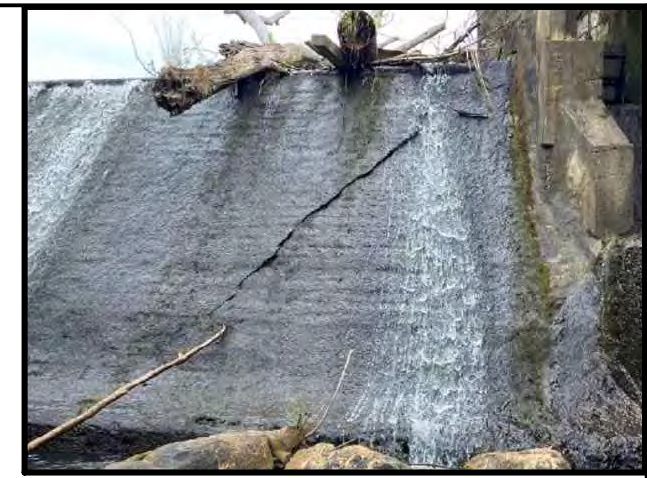
**PHOTO 1 - DOWNSTREAM  
DIAGONAL CRACK**

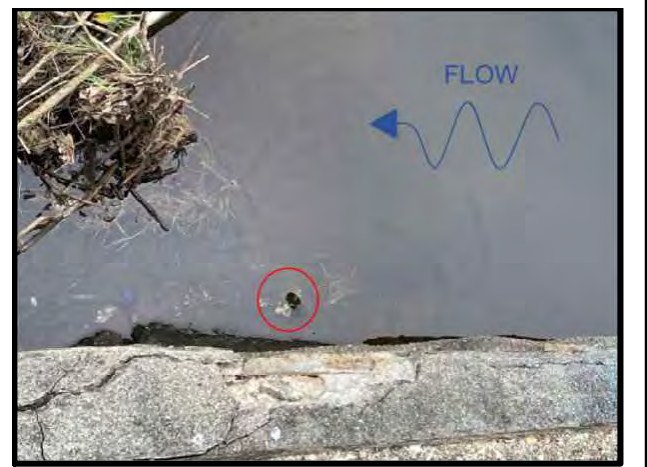
**PHOTO 2 - UPSTREAM  
OBSERVED VORTEX**

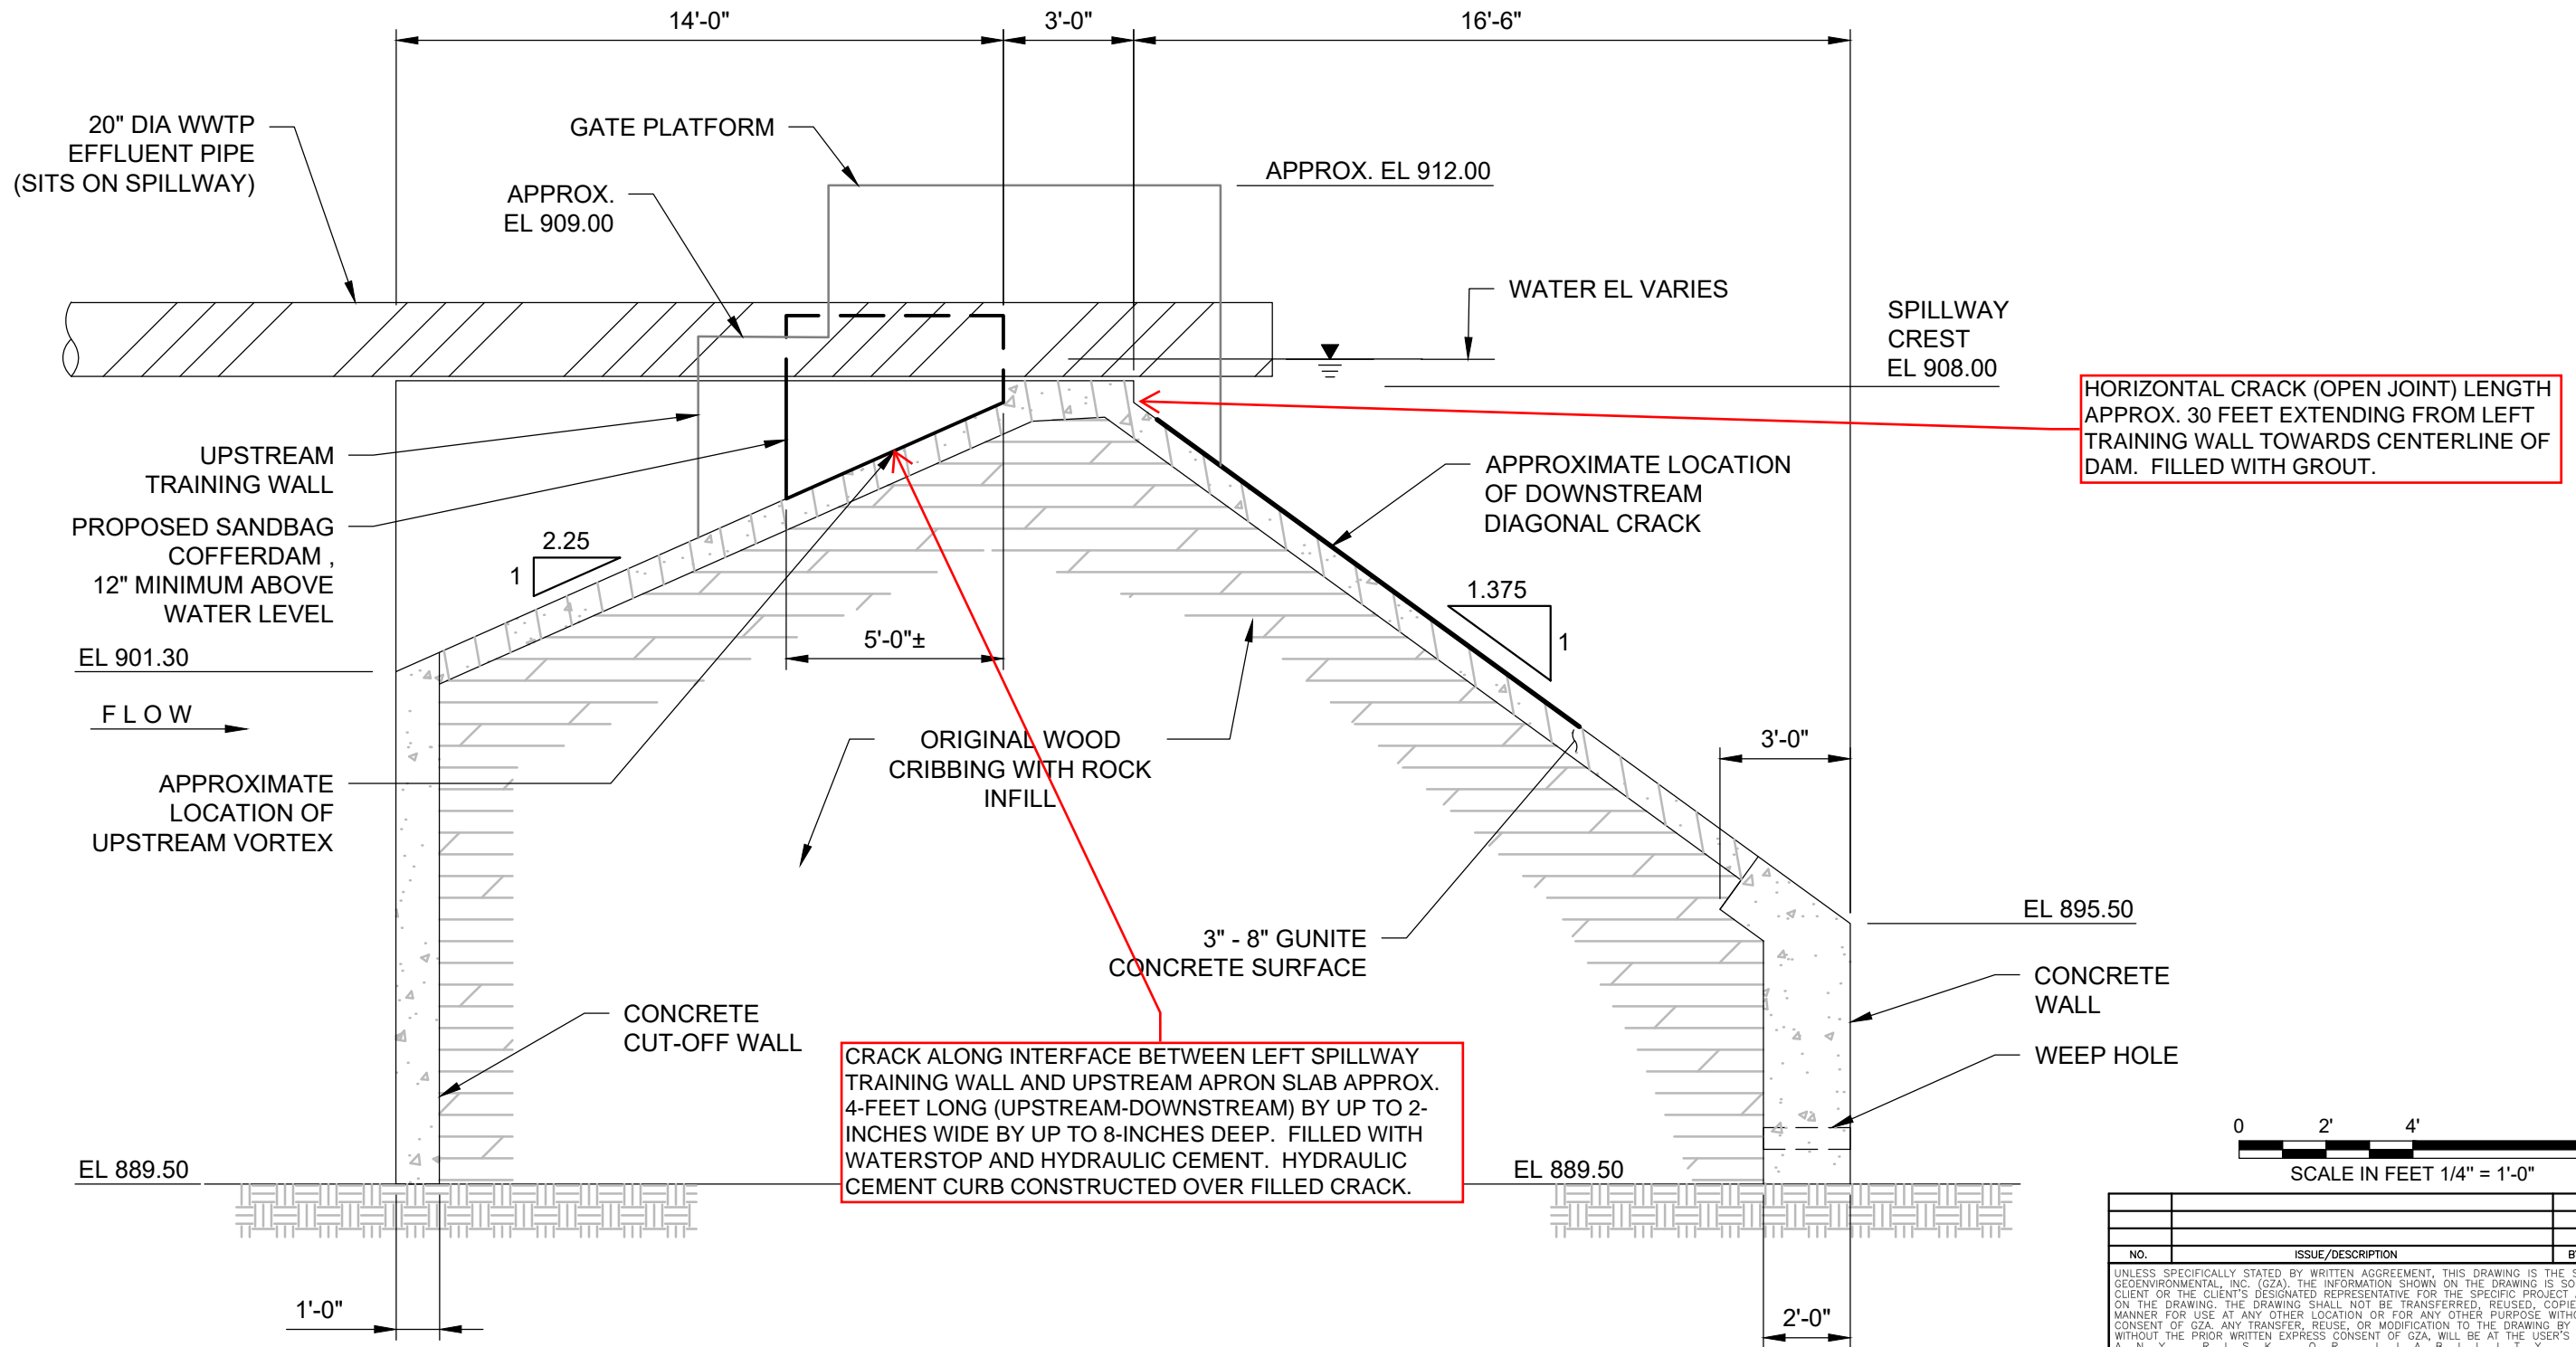
HORIZONTAL CRACK (OPEN JOINT) LENGTH APPROX. 30 FEET EXTENDING FROM LEFT TRAINING WALL TOWARDS CENTERLINE OF DAM. FILLED WITH GROUT.
