**Kevin Mooney**  
Senior Project Manager  
Corporate Holdings, GE Aerospace

1 Plastics Ave.  
Pittsfield, MA 01201

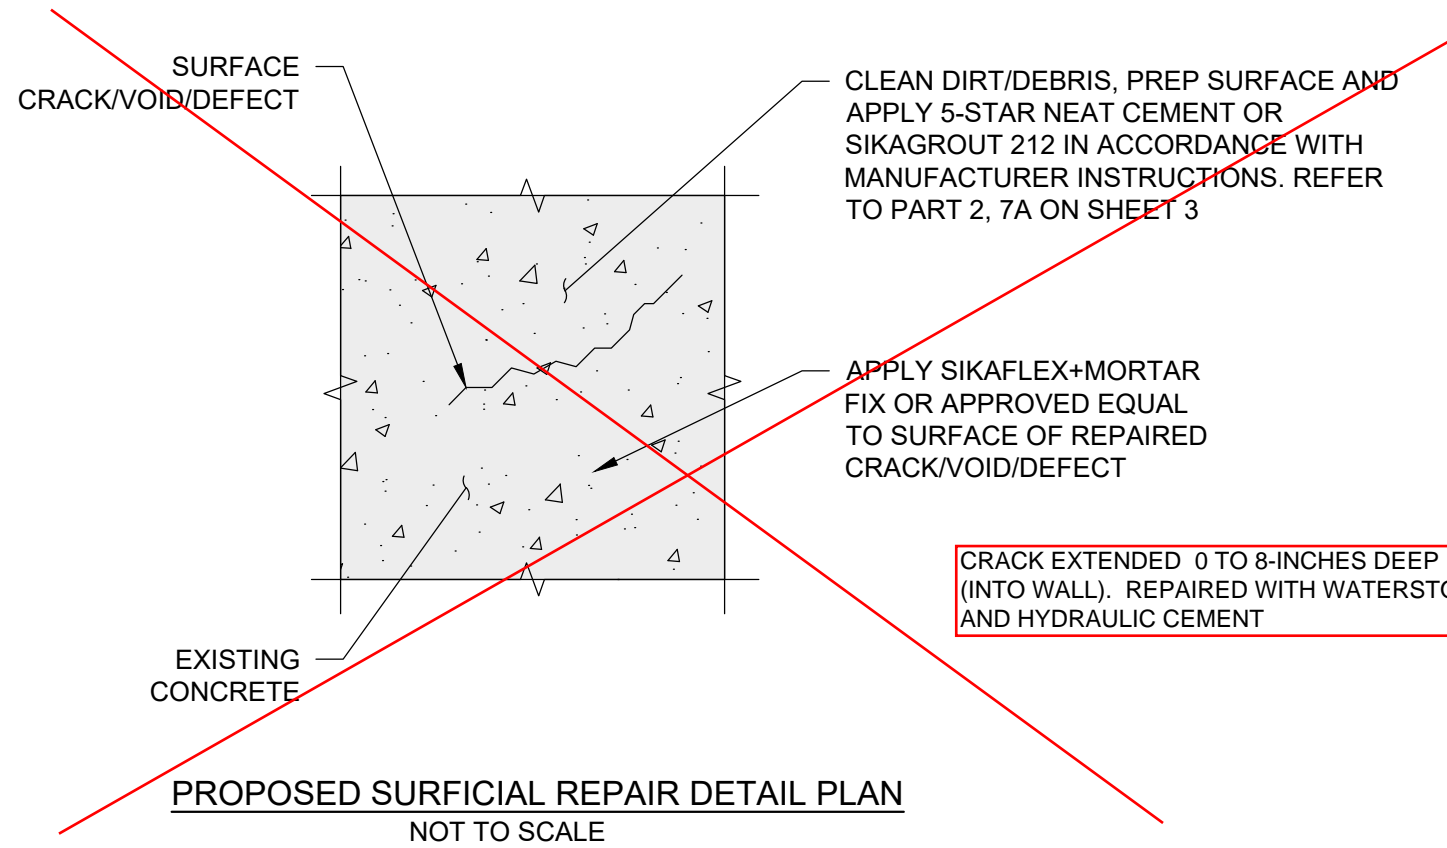
**PROPOSED SURFICIAL REPAIR DETAIL PLAN**  
NOT TO SCALE

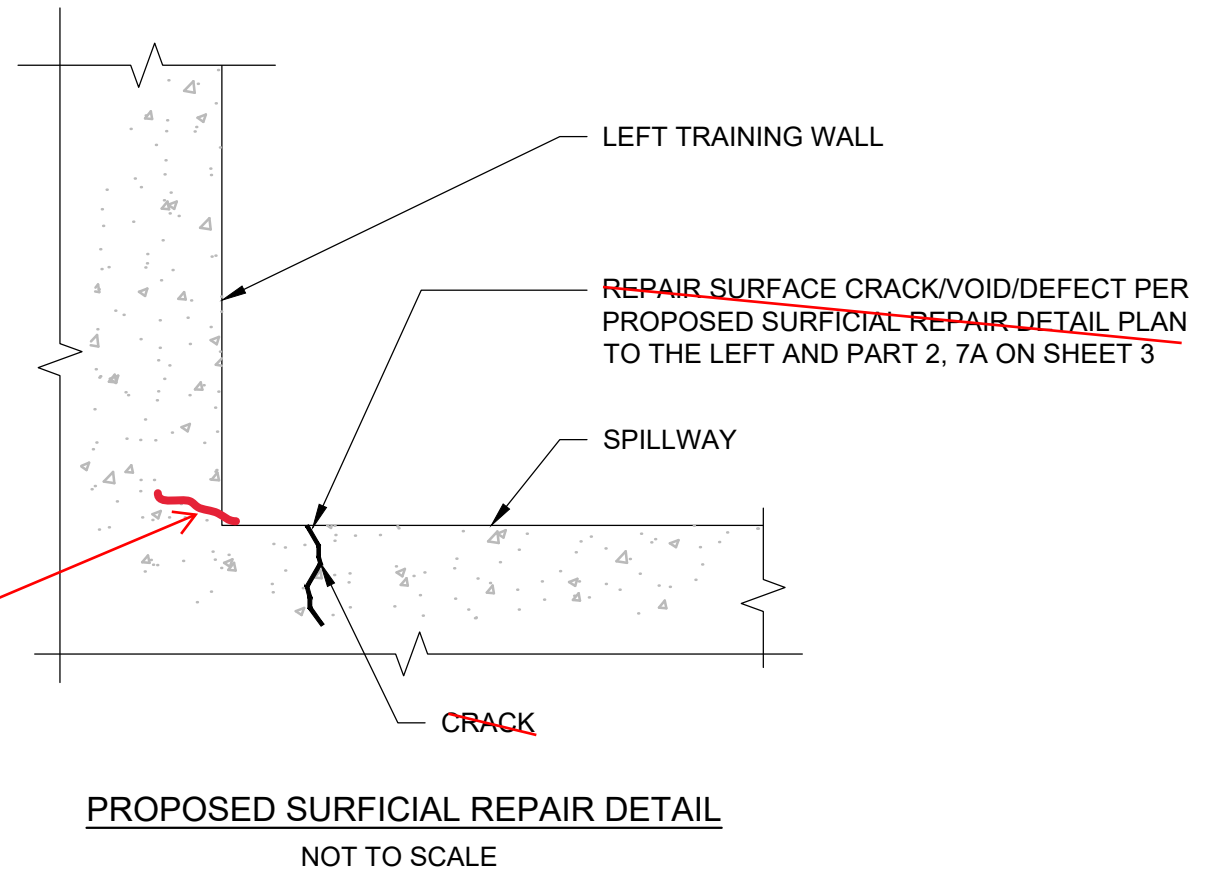
**PROPOSED SURFICIAL REPAIR DETAIL**  
NOT TO SCALE

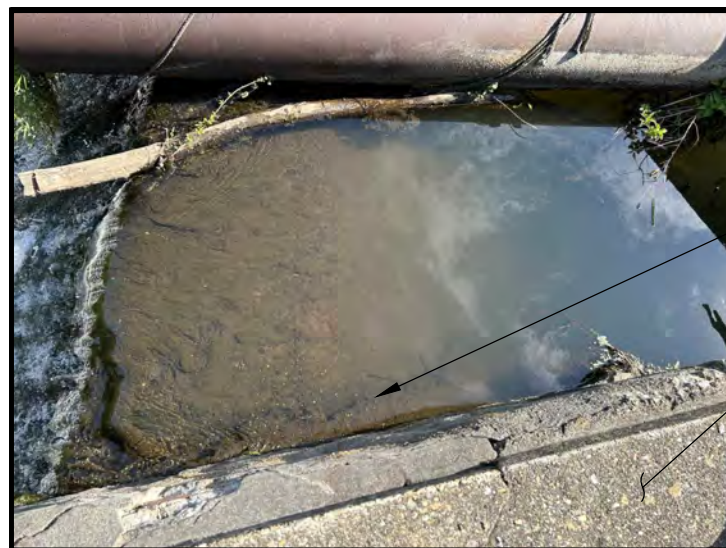
**PHOTO 3 - EXISTING CONDITIONS CONCRETE SURFICIAL CRACK/VOID**  
NOT TO SCALE

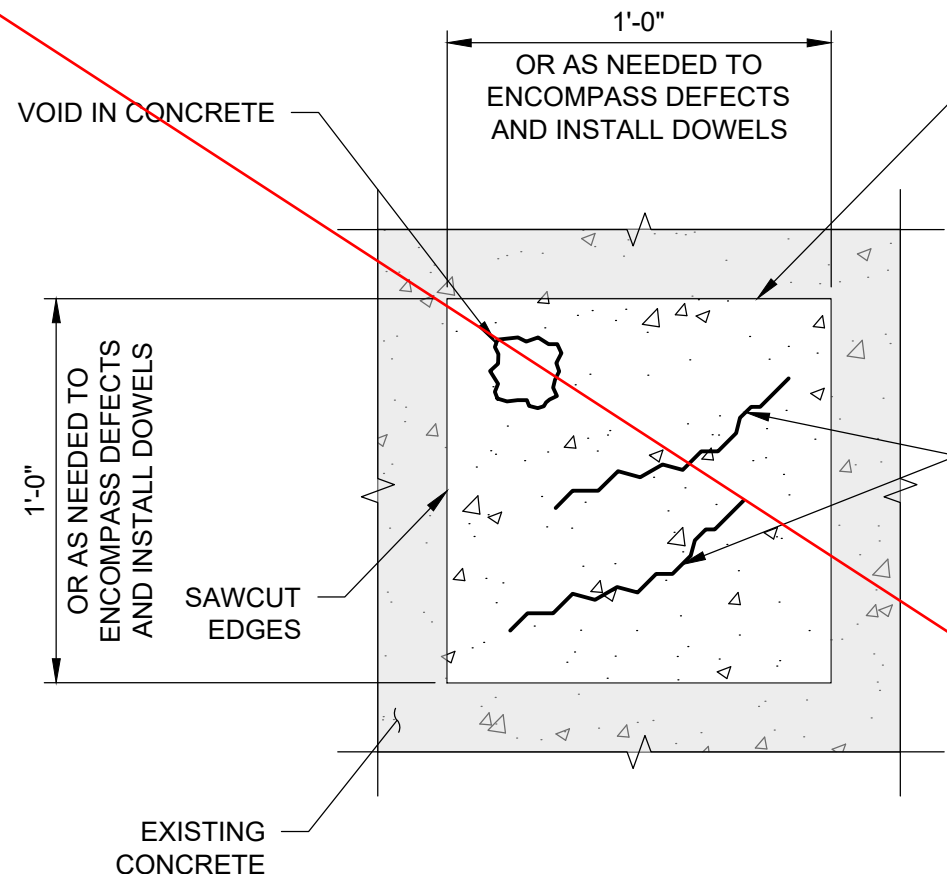
**PROPOSED DEEP REPAIR DETAIL PLAN**  
NOT TO SCALE

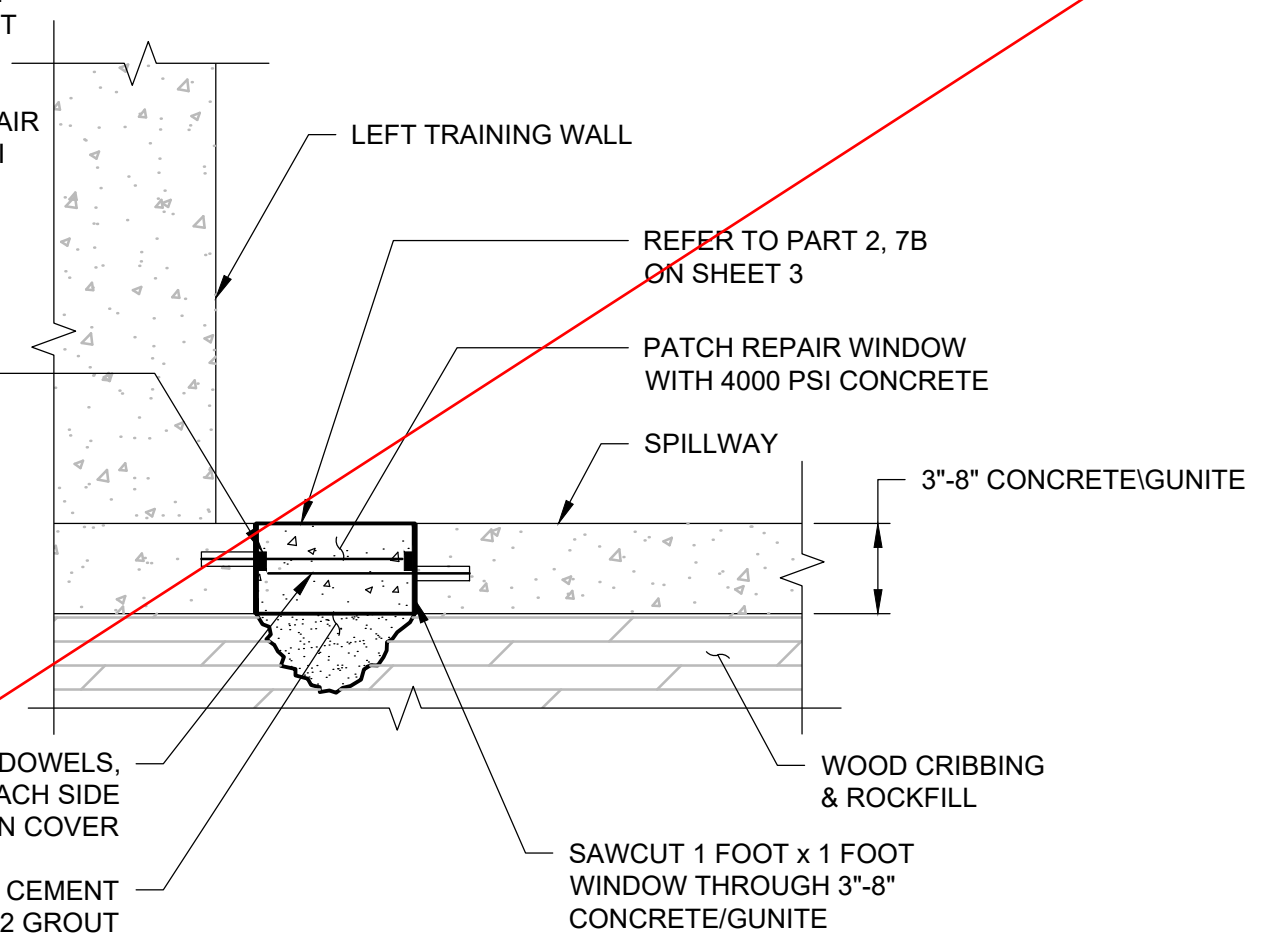
**PROPOSED DEEP REPAIR DETAIL SECTION**  
NOT TO SCALE

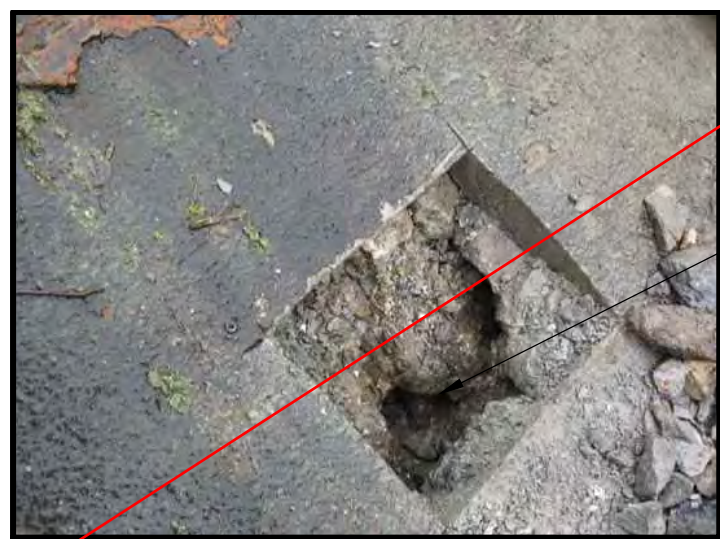
**PHOTO 4 - PROPOSED DEEP REPAIR WINDOW**  
NOT TO SCALE

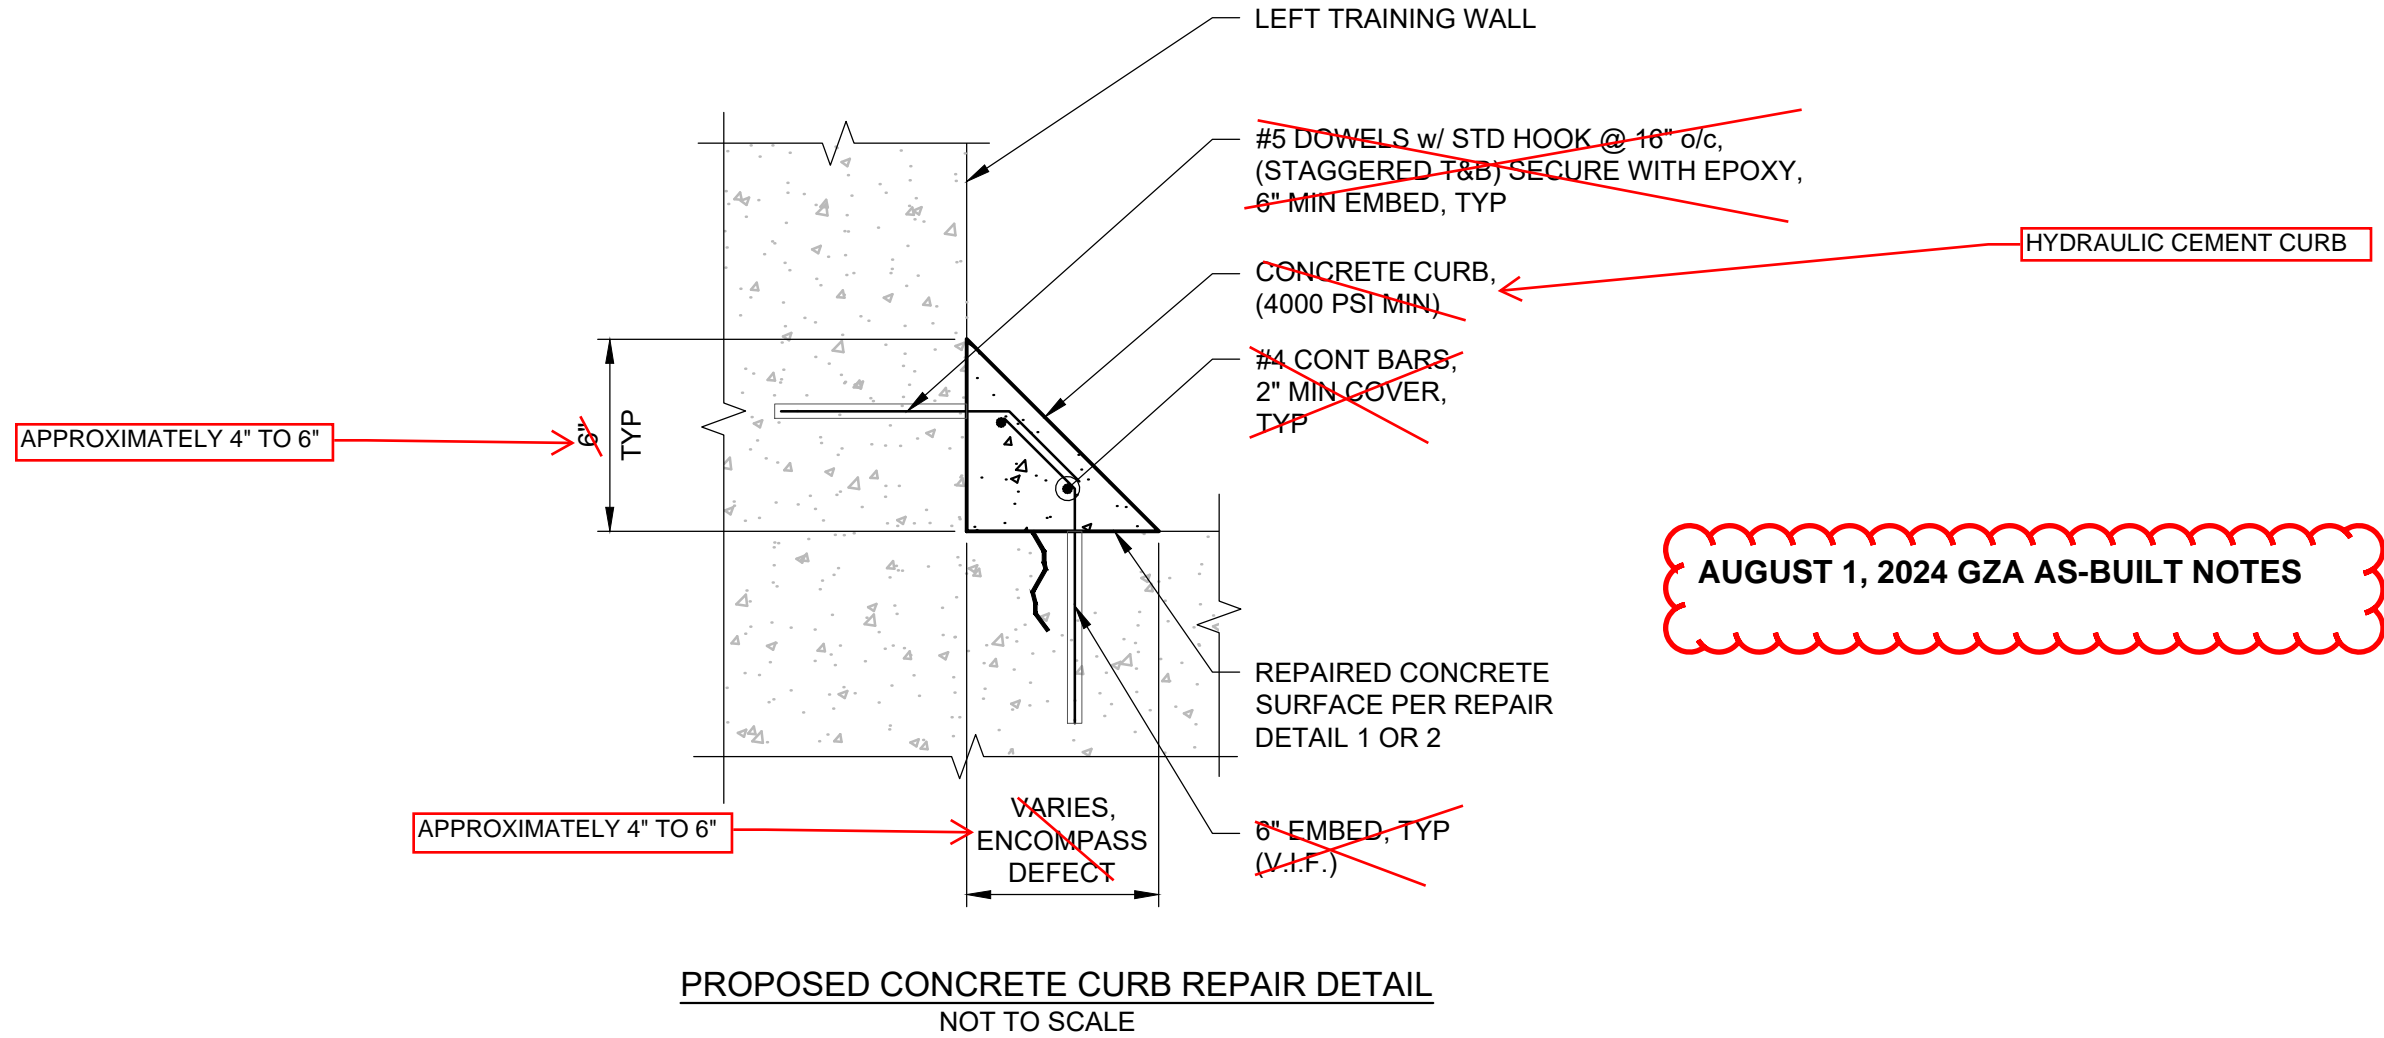
PREPARED BY: <b>GZA</b> GeoEnvironmental, Inc. www.gza.com	PREPARED FOR: GENERAL ELECTRIC COMPANY
PROJ MGR: SDK DESIGNED BY: TJS DATE: JULY, 2024	REVIEWED BY: SDK DRAWN BY: BM PROJECT NO. 01.0019896.70
CHECKED BY: JDA SCALE: AS NOTED REVISION NO. 0	SHEET <span style="font-size: 24px; font-weight: bold;">5</span>

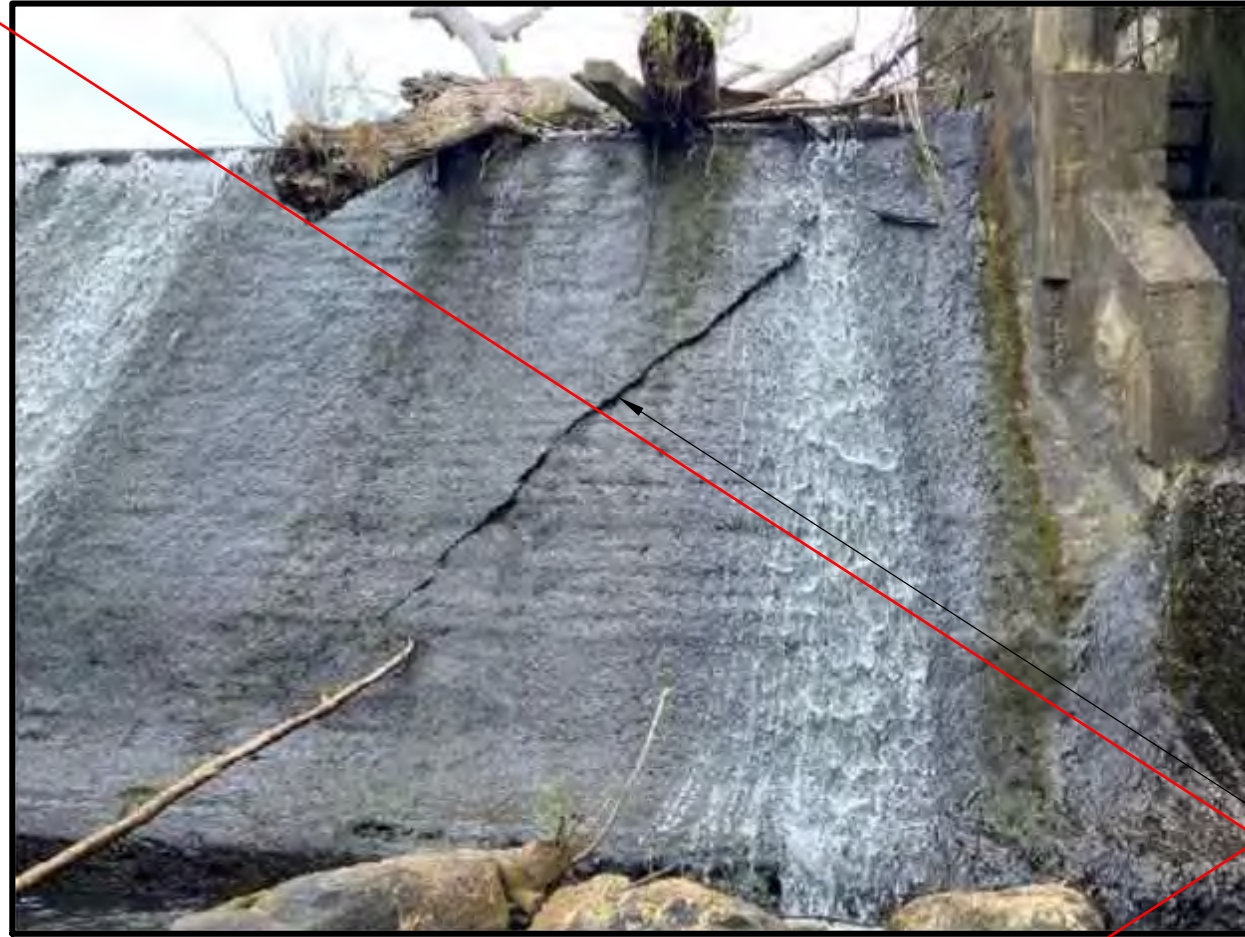
REPOINT DOWNSTREAM DIAGONAL CRACK  
 NOT TO SCALE

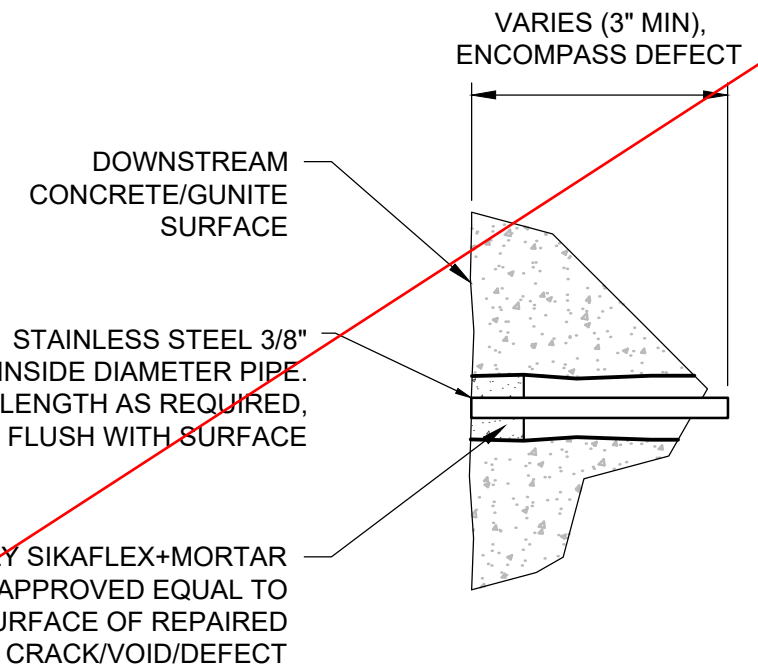
WEEPHOLE IN REPOINTED CRACK DETAIL  
 NOT TO SCALE

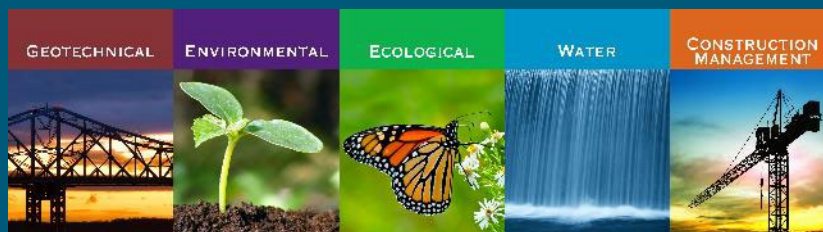
GZA GeoEnvironmental, Inc.
