**Re: GE-Pittsfield/Housatonic River Site  
Rest of River (GECD850)  
2024 Annual Visual Inspection Report for Willow Mill Dam**

# 2024 Annual Visual Inspection Report Willow Mill Dam (MA00262) South Lee, Massachusetts

Date of Inspection: September 3, 2024

Date of Report: November 1, 2024

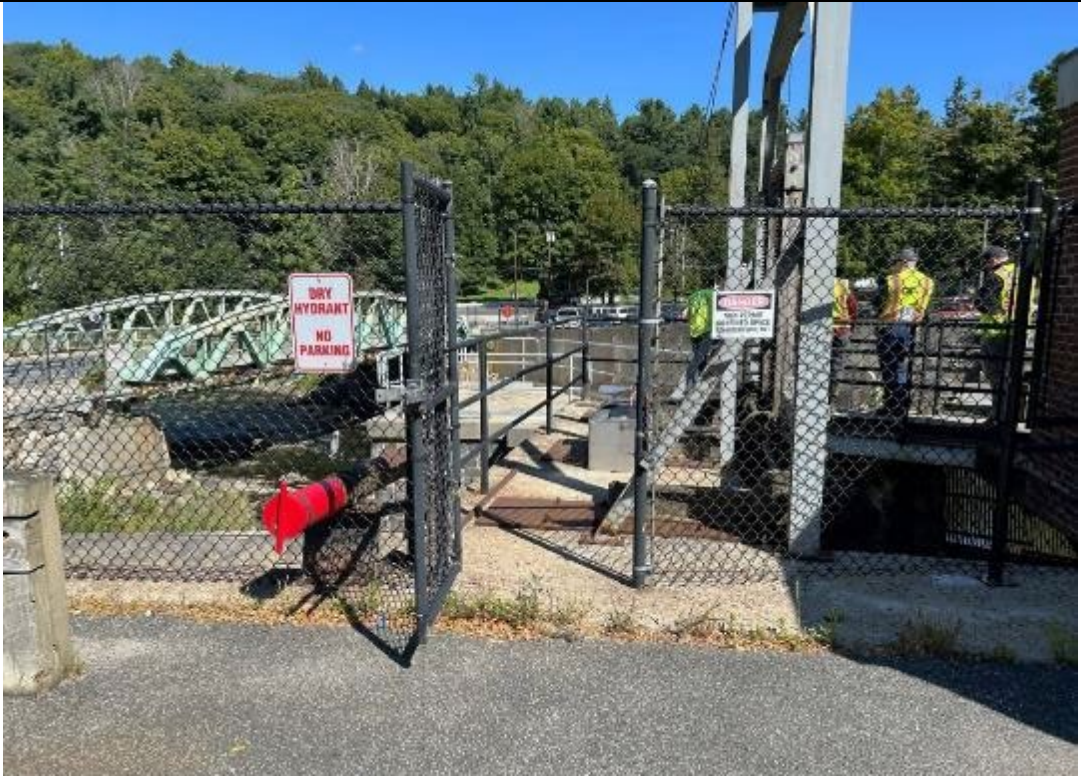
**Description:**  
Canal sluice gates and intake structure from left abutment parking lot.

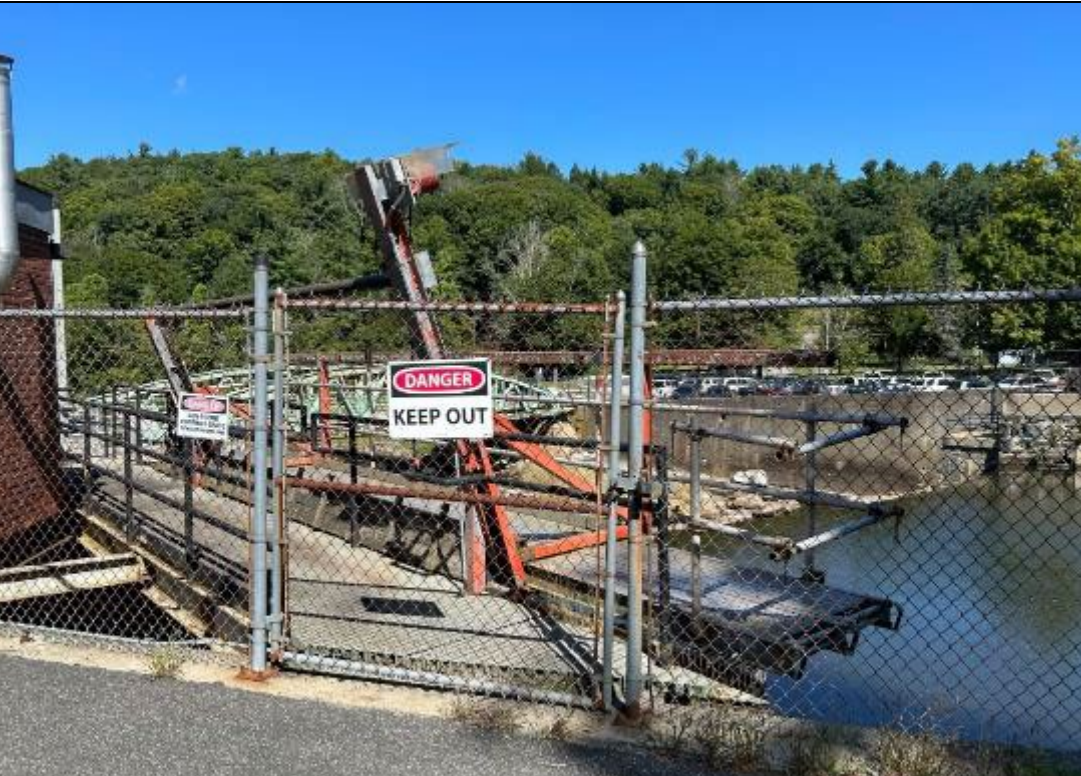
<b>Photo No.</b> 2	<b>Date:</b> 9/3/2024
-----------------------	--------------------------

**Description:**  
Fish screen (trash rack) platform from left abutment parking lot.

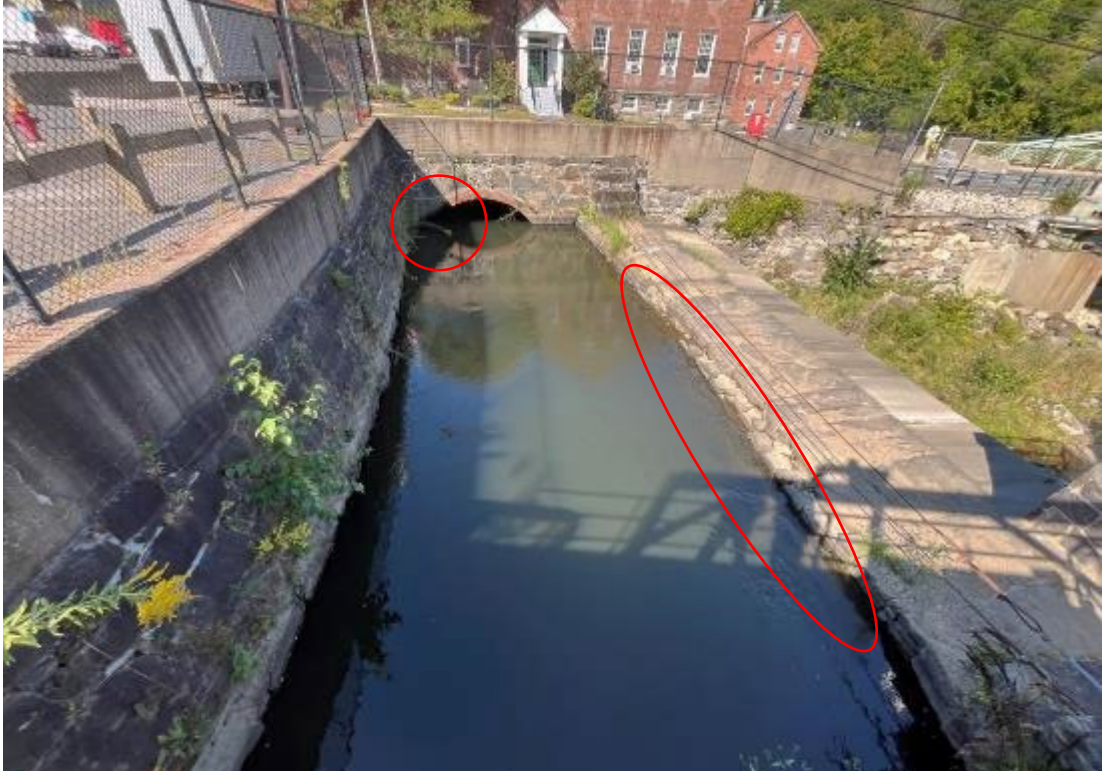
<b>Client Name:</b> General Electric Company		<b>Site Location:</b> Willow Mill Dam (MA00262) South Lee, MA	<b>Project No.</b> 01.0019896.71
<b>Photo No.</b> 5	<b>Date:</b> 9/3/2024

<b>Direction Photo Taken:</b> Downstream.			
<b>Description:</b> Canal and auxiliary spillway (waste weir) structure.  Note broken masonry near water level below the auxiliary spillway crest (circled – photo right) and missing bricks from arched entrance to the headrace tunnel (circled – photo left).

1. The masonry joints in deteriorated areas at the auxiliary spillway / headrace wall and the canal walls should be repointed during the next scheduled planned maintenance activities. Missing stone masonry pieces, including missing brick at the headrace channel arched tunnel entrance, should be replaced during the planned maintenance activities. In the interim, these conditions should be monitored, and if they are observed to worsen, expedited repairs should be made on a case-by-case basis. [Checklist Items 69, 72, 76, 79, 82, 86, 89.]

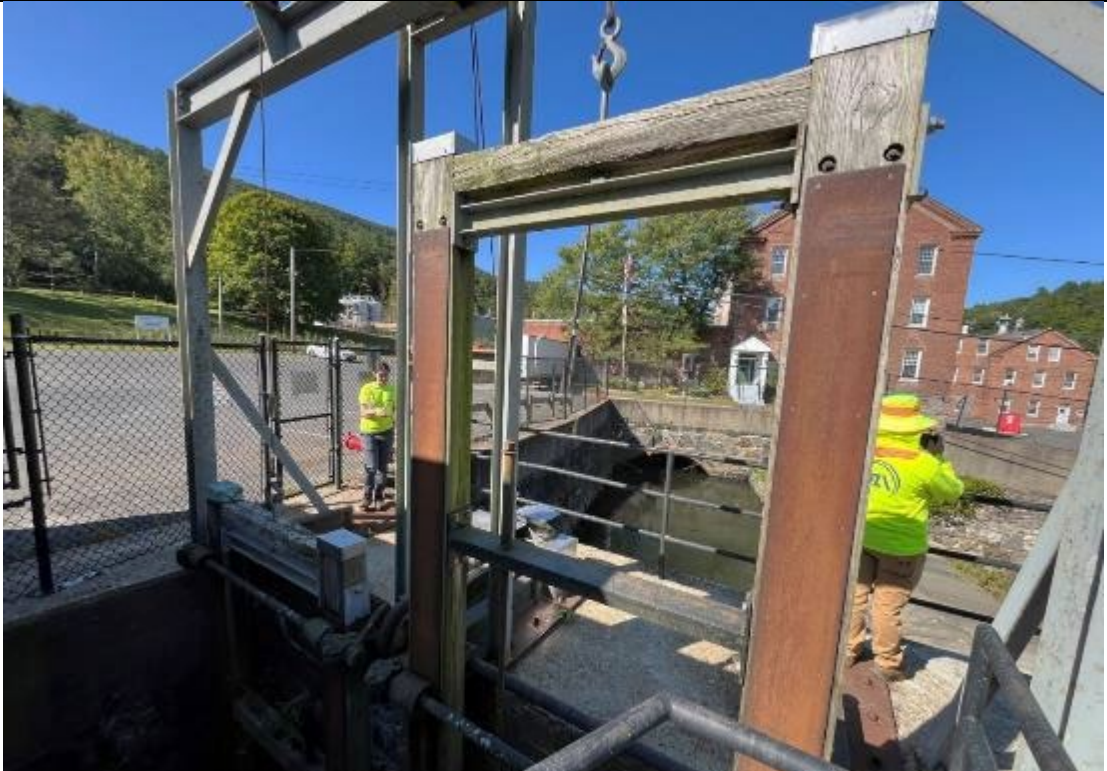
<b>Photo No.</b> 6	<b>Date:</b> 9/3/2024

<b>Direction Photo Taken:</b> Downstream.		
<b>Description:</b> Canal sluice gates (Gate 3 to the right and Gate 4 to the left) and operators.  Left gate appeared closed and the right gate was open.

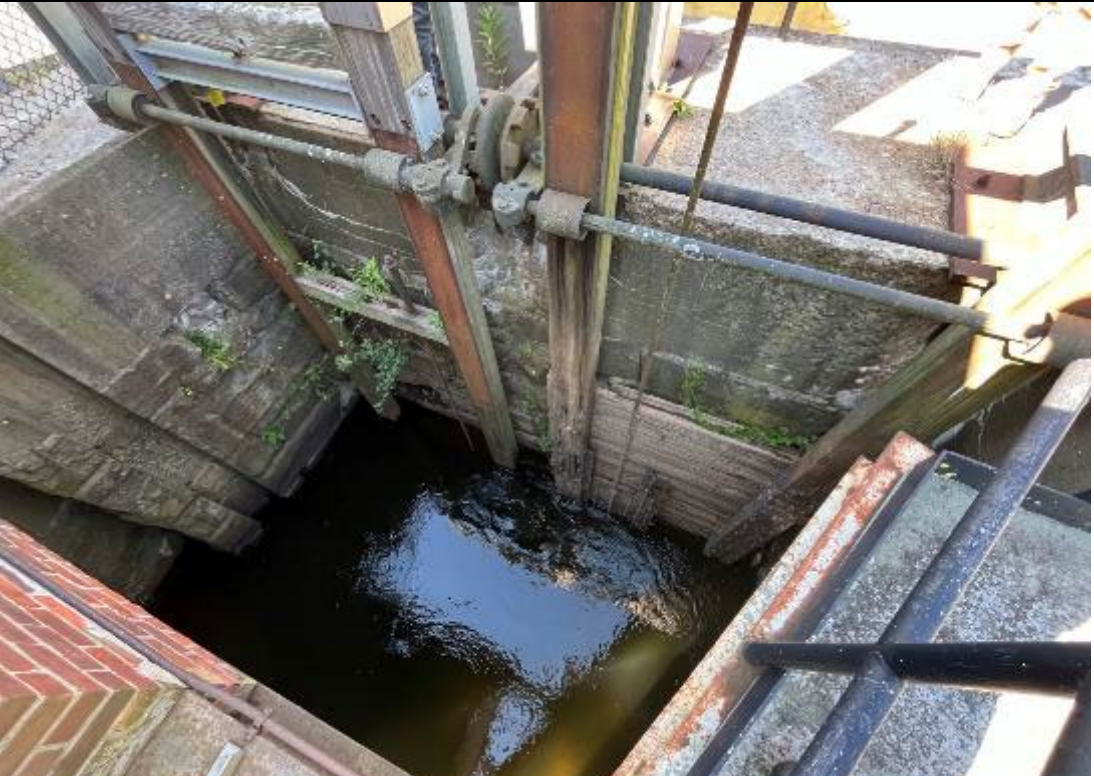
<b>Client Name:</b> General Electric Company		<b>Site Location:</b> Willow Mill Dam (MA00262) South Lee, MA	<b>Project No.</b> 01.0019896.71
<b>Photo No.</b> 7	<b>Date:</b> 9/3/2024

The right canal sluice gate (Gate #3) was nearly full open, and the left canal sluice gate (Gate #4) was fully closed at the time of the inspection. The timber skin of Gate #3 was partially exposed above water and showed some deterioration. No gates were operated during the annual inspection. A review of the plant log books indicated that the gates have been operated since the 2023 annual inspection, and the August 2024 quarterly observation checklist indicated that both gates were last operated on July 5, 2024. GZA probed for sediment upstream of the canal sluice gates. Probing indicated there was about two to four inches of sediment present upstream of the canal sluice gates.

<b>Direction Photo Taken:</b> Downstream facing down.			
<b>Description:</b> Upstream side of the canal sluice gates.  Note missing mortar between the stone masonry blocks.  Based on probing, about 2-to-4-inches of sediment was measured upstream of the gates.

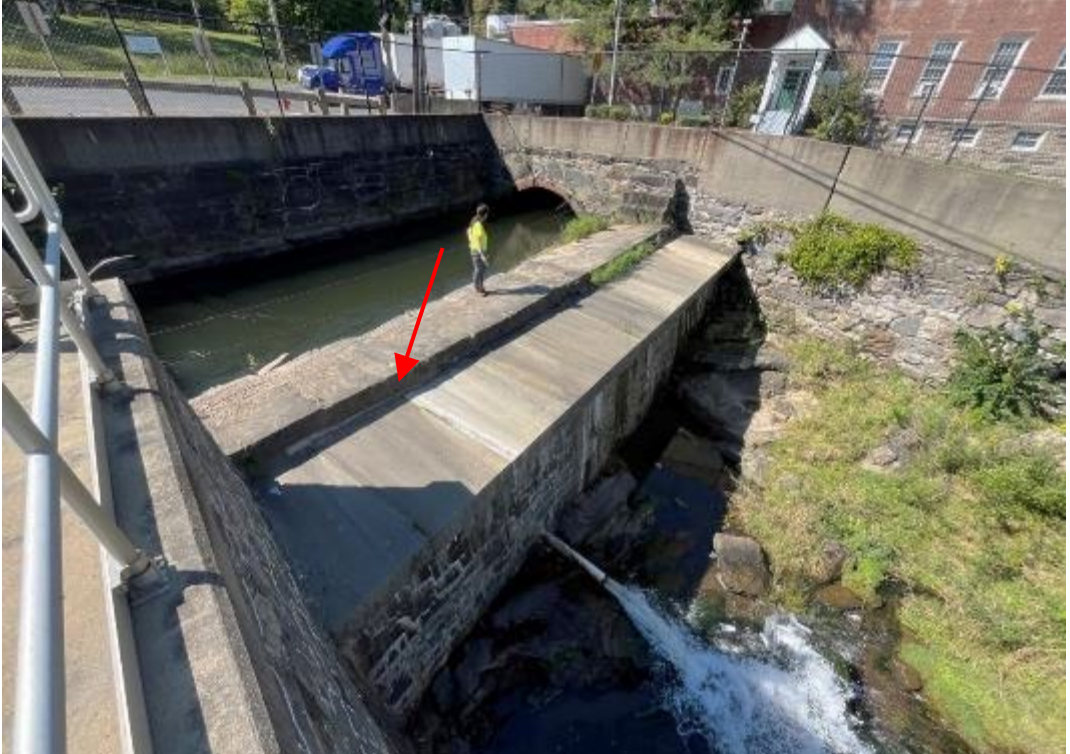
<b>Client Name:</b> General Electric Company		<b>Site Location:</b> Willow Mill Dam (MA00262) South Lee, MA	<b>Project No.</b> 01.0019896.71
<b>Photo No.</b> 9	<b>Date:</b> 9/3/2024

<b>Direction Photo Taken:</b> Downstream and left.			
<b>Description:</b> Overview of the auxiliary spillway (waste weir) from the canal sluice gate platform.  Missing mortar observed along the horizontal joint of the masonry cap (red arrow at joint between upper "original" crest masonry and lower ca. 2004 buttress). Also note vegetation growth in the joint.  Clear flow from PVC drainpipe at downstream toe (also see photo 30).

6. Continue to monitor the flow from the six-inch canal drainpipe at the auxiliary spillway [Checklist Item 75].
7. Monitor the leakage through the auxiliary spillway stone masonry [Checklist Item 76].

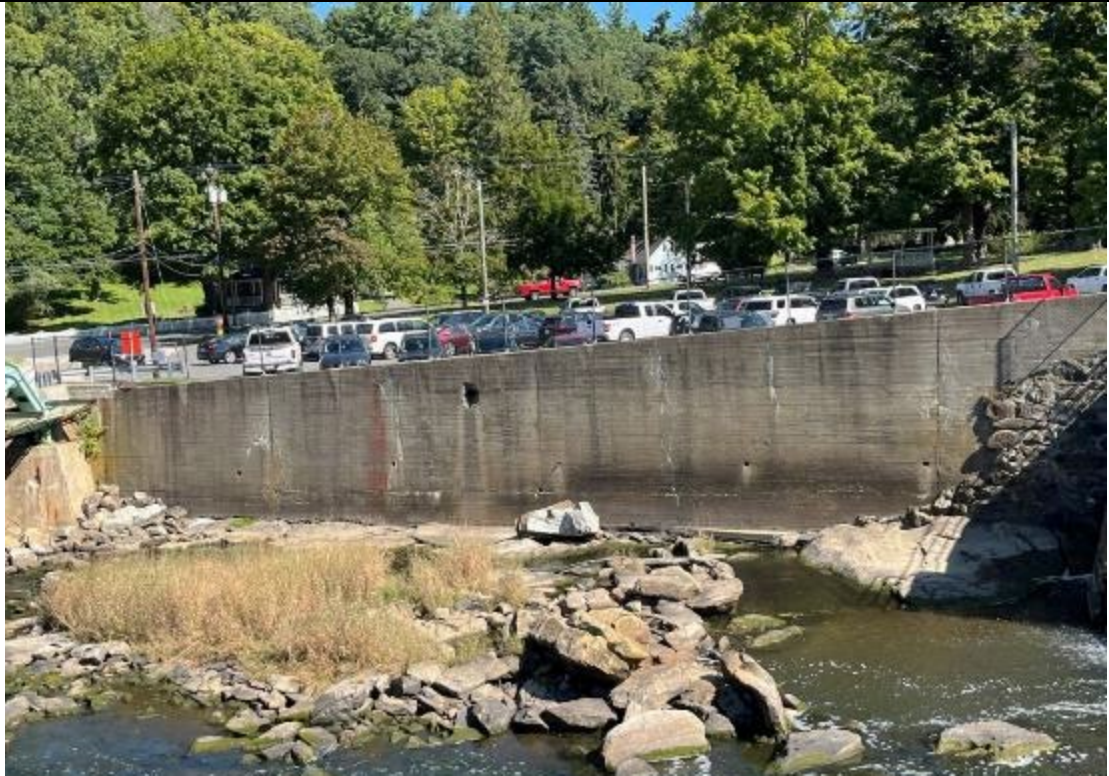
<b>Client Name:</b> General Electric Company		<b>Site Location:</b> Willow Mill Dam (MA00262) South Lee, MA	<b>Project No.</b> 01.0019896.71
<b>Photo No.</b> 13	<b>Date:</b> 9/3/2024

Minor cracking and efflorescence were observed in the right-side training wall downstream of the river outlet control structure.

<b>Direction Photo Taken:</b> Downstream and right.			
<b>Description:</b> Right downstream concrete training wall.  Minor cracking and efflorescence of the concrete observed.

8. Monitor the cracking and efflorescence in the downstream right-side concrete training wall [Checklist Item 111].
9. Monitor the mortar joints and loose stone in the roadway masonry retaining wall downstream of the dam at the left-side bridge abutment [Checklist Item 114].

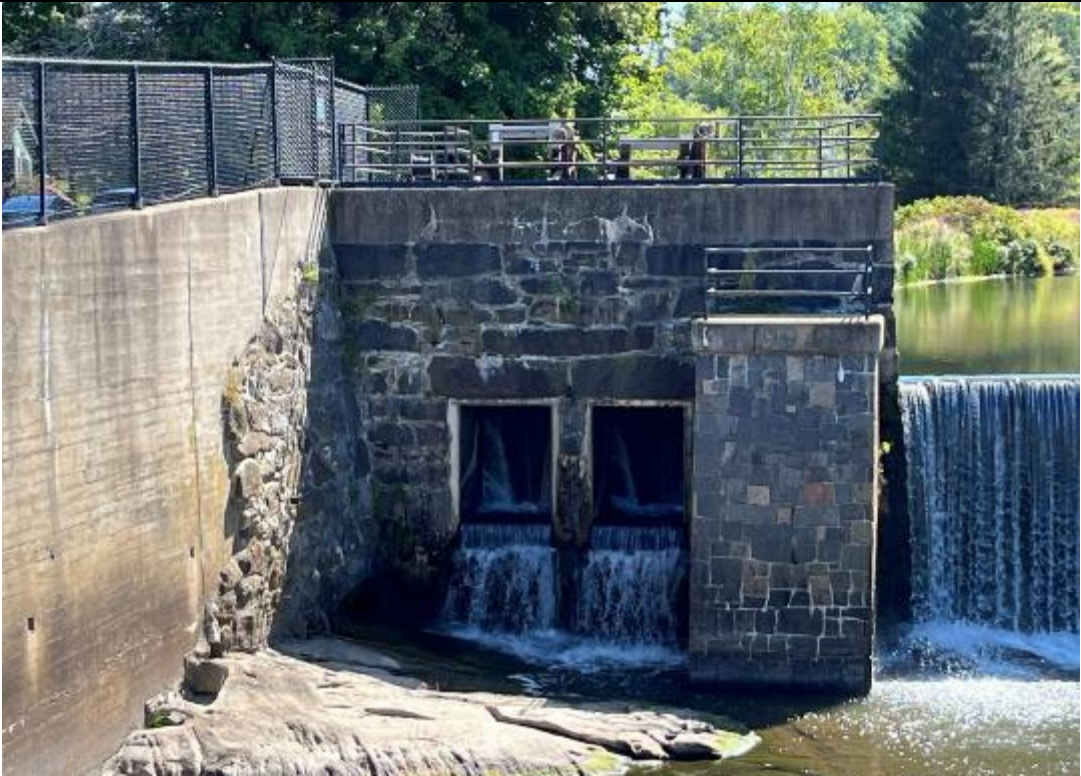
Minor leakage through Gate #1 and Gate #2 was observed during the inspection. The leakage appeared greater than that observed during the 2023 Annual inspection, but similar to photographs contained in the 2022 Phase I Inspection Report.

**Description:**  
Downstream side of the river outlet control structure.

Note minor leakage through both gates.

2. Monitor the left upstream training wall for missing masonry, as noted in the 2022 Phase I Inspection Report [Checklist Item 27].
3. Monitor the leakage observed through the river outlet control structure gates [Checklist Items 48 and 53].

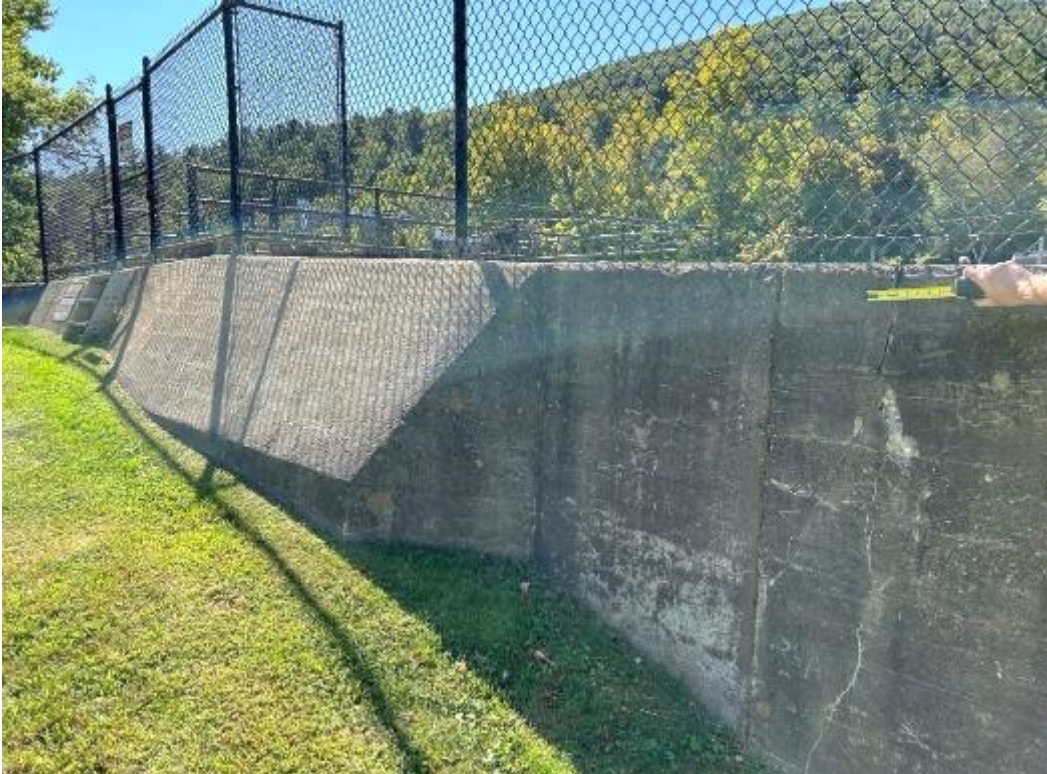
<b>Client Name:</b> General Electric Company		<b>Site Location:</b> Willow Mill Dam (MA00262) South Lee, MA	<b>Project No.</b> 01.0019896.71
<b>Photo No.</b> 19	<b>Date:</b> 9/3/2024

<b>Direction Photo Taken:</b> Upstream and left.			
<b>Description:</b> Right side of right concrete training wall adjacent to the outlet control structure.  Note vertical crack.

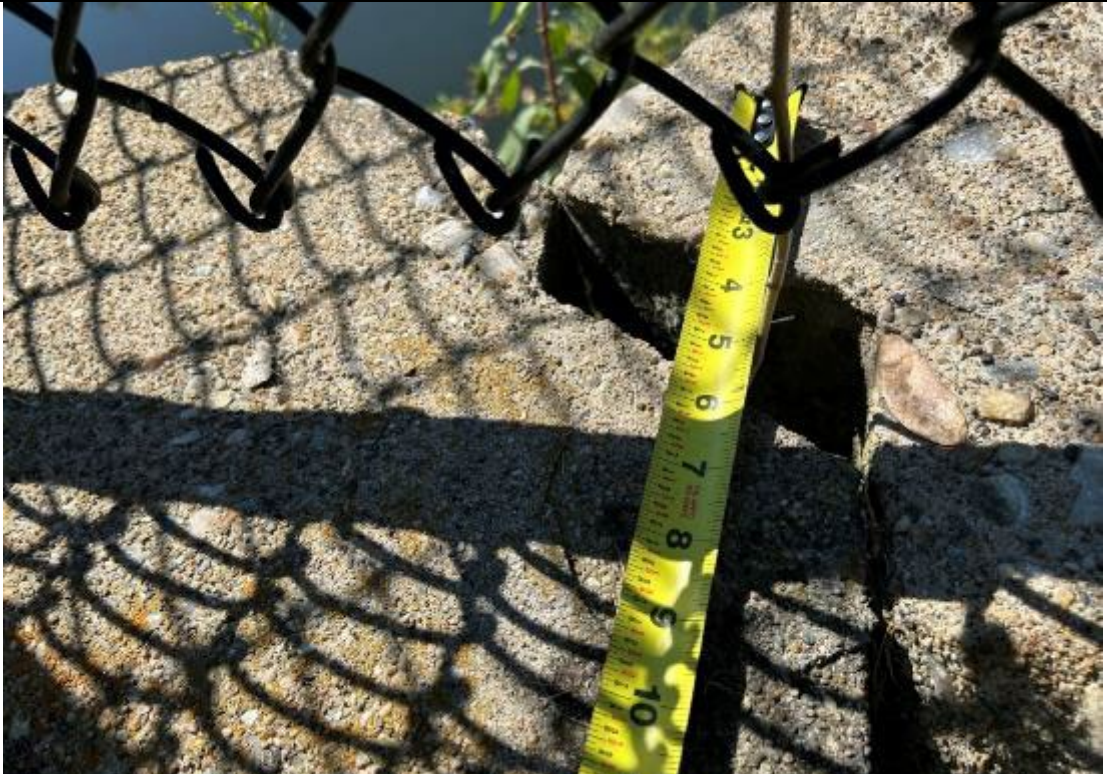
<b>Client Name:</b> General Electric Company		<b>Site Location:</b> Willow Mill Dam (MA00262) South Lee, MA	<b>Project No.</b> 01.0019896.71
<b>Photo No.</b> 21	<b>Date:</b> 9/3/2024

An offset vertical joint in the right concrete training wall was observed just upstream of the river outlet control structure. The offset was measured to be about two inches longitudinally (perpendicular to the flow of the river). A small vertical crack in the right training wall was observed just downstream of the river outlet control structure. Both features appeared similar to those observed during GZA's 2023 Annual Inspection and in photographs included in the 2022 Phase I Inspection Report.

<b>Direction Photo Taken:</b> Left.			
<b>Description:</b> Closeup of the vertical joint offset in the right concrete training wall upstream of the outlet control structure (also see photo 20).

4. Monitor the deteriorated mortar joints, minor cracking, and efflorescence at the outlet control structure [Checklist Items 56, 57, 58].
5. Monitor the offset vertical joint in the right upstream concrete training wall adjacent to the outlet control structure [Checklist Item 63].

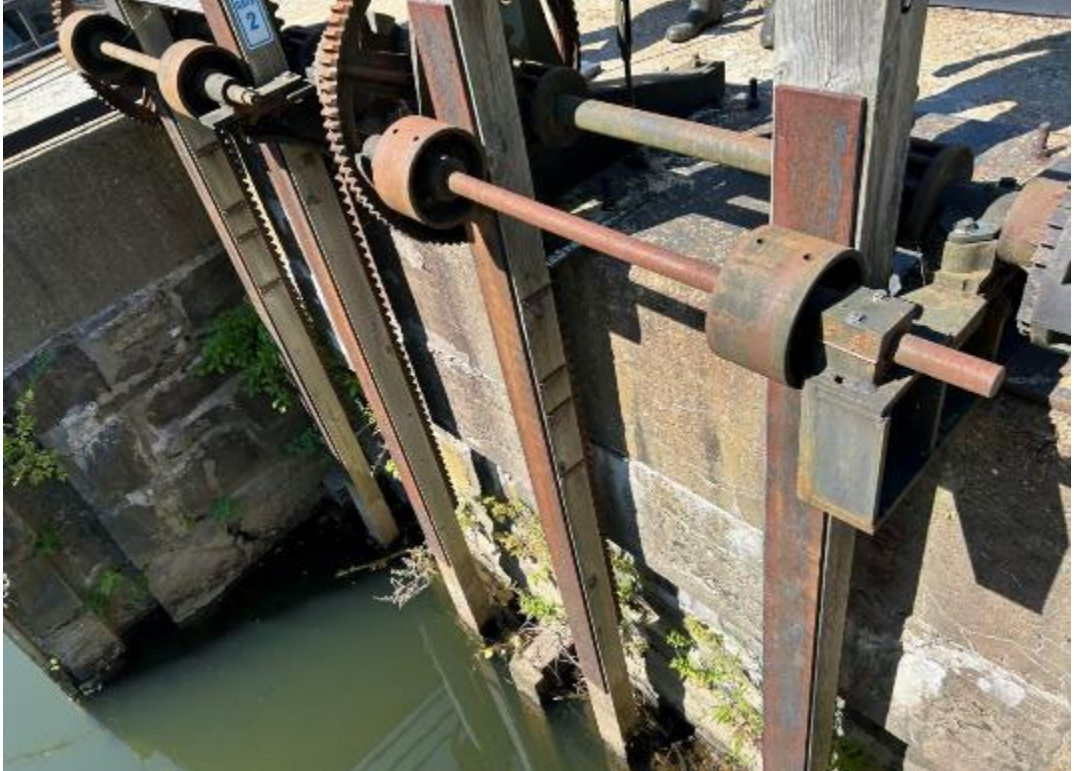
<b>Client Name:</b> General Electric Company		<b>Site Location:</b> Willow Mill Dam (MA00262) South Lee, MA	<b>Project No.</b> 01.0019896.71
<b>Photo No.</b> 25	<b>Date:</b> 9/3/2024

<b>Direction Photo Taken:</b> Downstream and left.			
<b>Description:</b> Upstream side of the river outlet control structure gate operators (Gate 1 on the right and Gate 2 on the left).  Based on probing, no sediment was measured upstream of the gates.

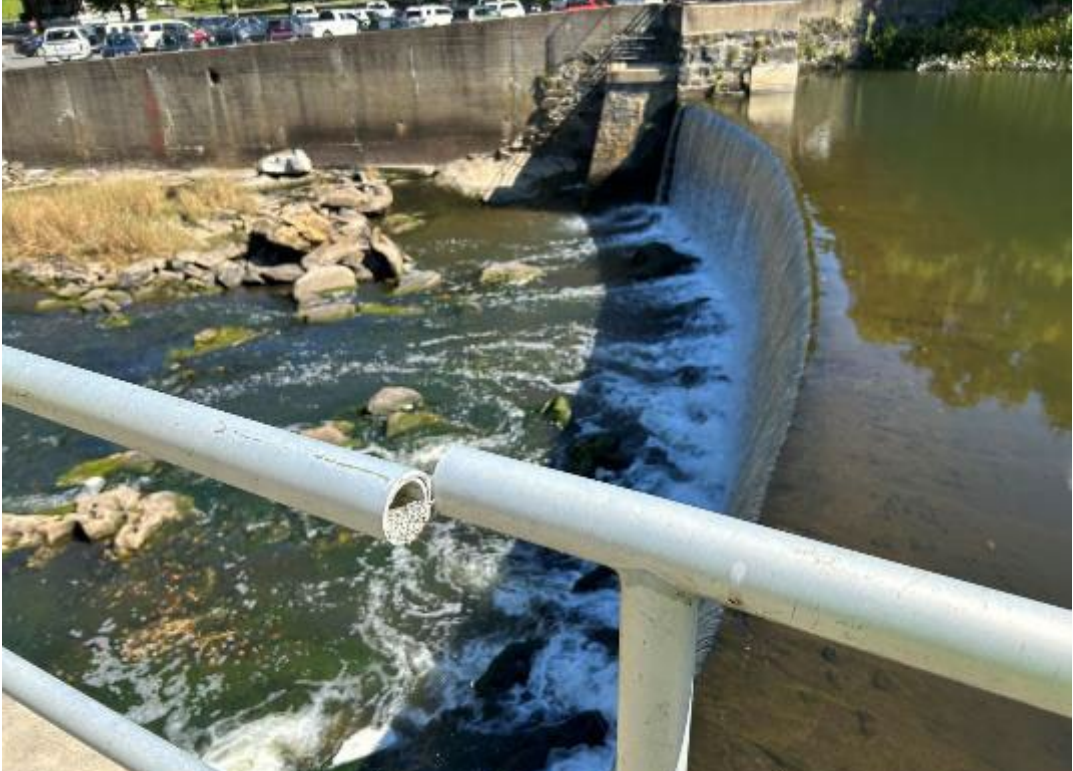
<b>Client Name:</b> General Electric Company		<b>Site Location:</b> Willow Mill Dam (MA00262) South Lee, MA	<b>Project No.</b> 01.0019896.71
<b>Photo No.</b> 27	<b>Date:</b> 9/3/2024

Some railing sections were observed to be broken at the left spillway abutment/canal intake structure.

<b>Direction Photo Taken:</b> Right.			
<b>Description:</b> Broken handrail along the sluice gate platform.

4. The broken and missing handrails around the sluice gate platform should be repaired during the planned maintenance activities [Checklist Item 122].

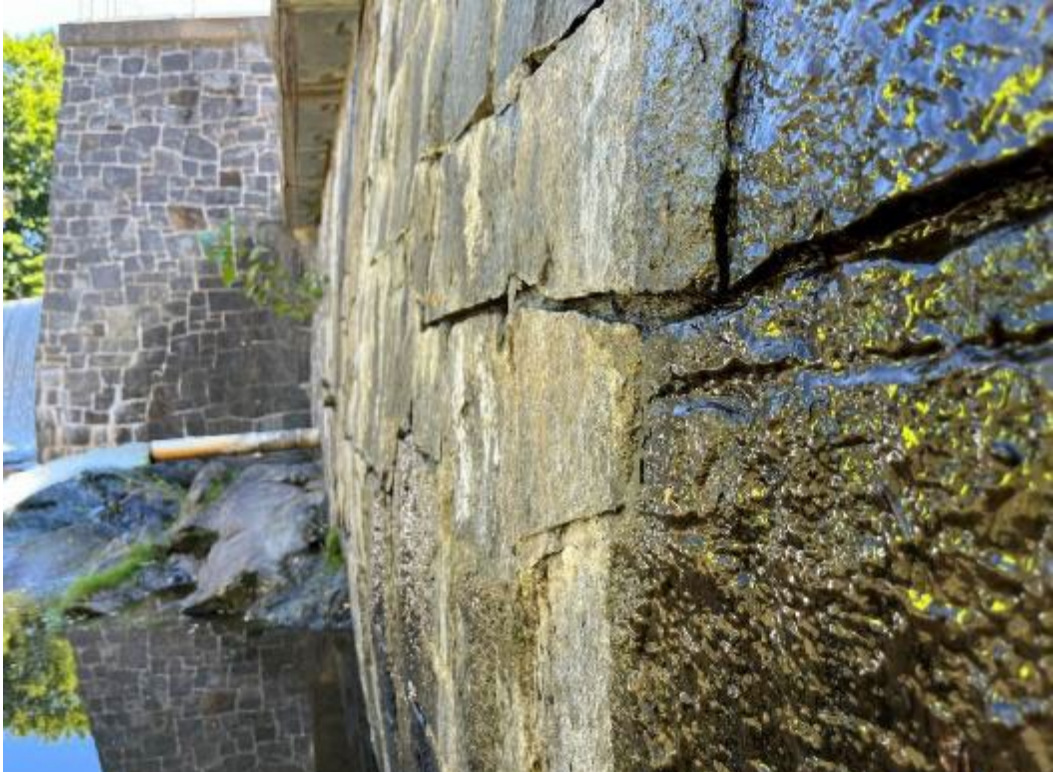
<b>Client Name:</b> General Electric Company		<b>Site Location:</b> Willow Mill Dam (MA00262) South Lee, MA	<b>Project No.</b> 01.0019896.71
<b>Photo No.</b> 31	<b>Date:</b> 9/3/2024

No distress, cracking, offsets, or signs of displacement of the auxiliary spillway were observed. Note that the downstream face of the auxiliary spillway was constructed with a slight angle or bulge.<sup>1</sup>

<b>Direction Photo Taken:</b> Upstream.			
<b>Description:</b> View parallel to the downstream face of the auxiliary spillway. Slight as-constructed bulge observed in the center of the structure. No cracking of the façade was observed, indicating little to no displacement since the ca 2004 repairs.
