**UNITED STATES ENVIRONMENTAL PROTECTION AGENCY**  
**Region 1**  
**5 Post Office Square, Suite 100**  
**Boston, MA 02109-3912**

Memorandum

SUBJ: 5/26/2021 Aerovox interim sediment cap inspection

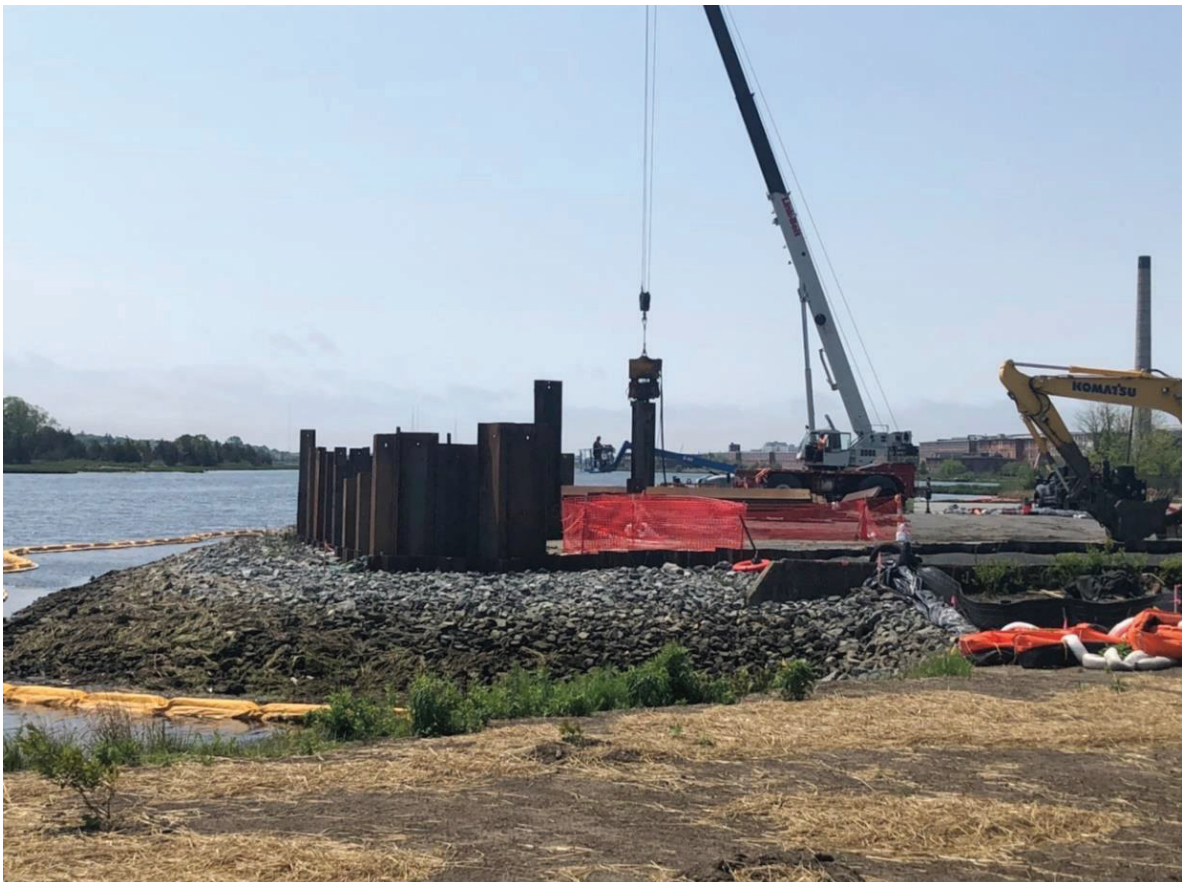
Photo #1: View from Precix looking south. Armor stone on bank remains in good shape. The temporary 21E sheeting is being put in place (to allow for upland soil excavation).

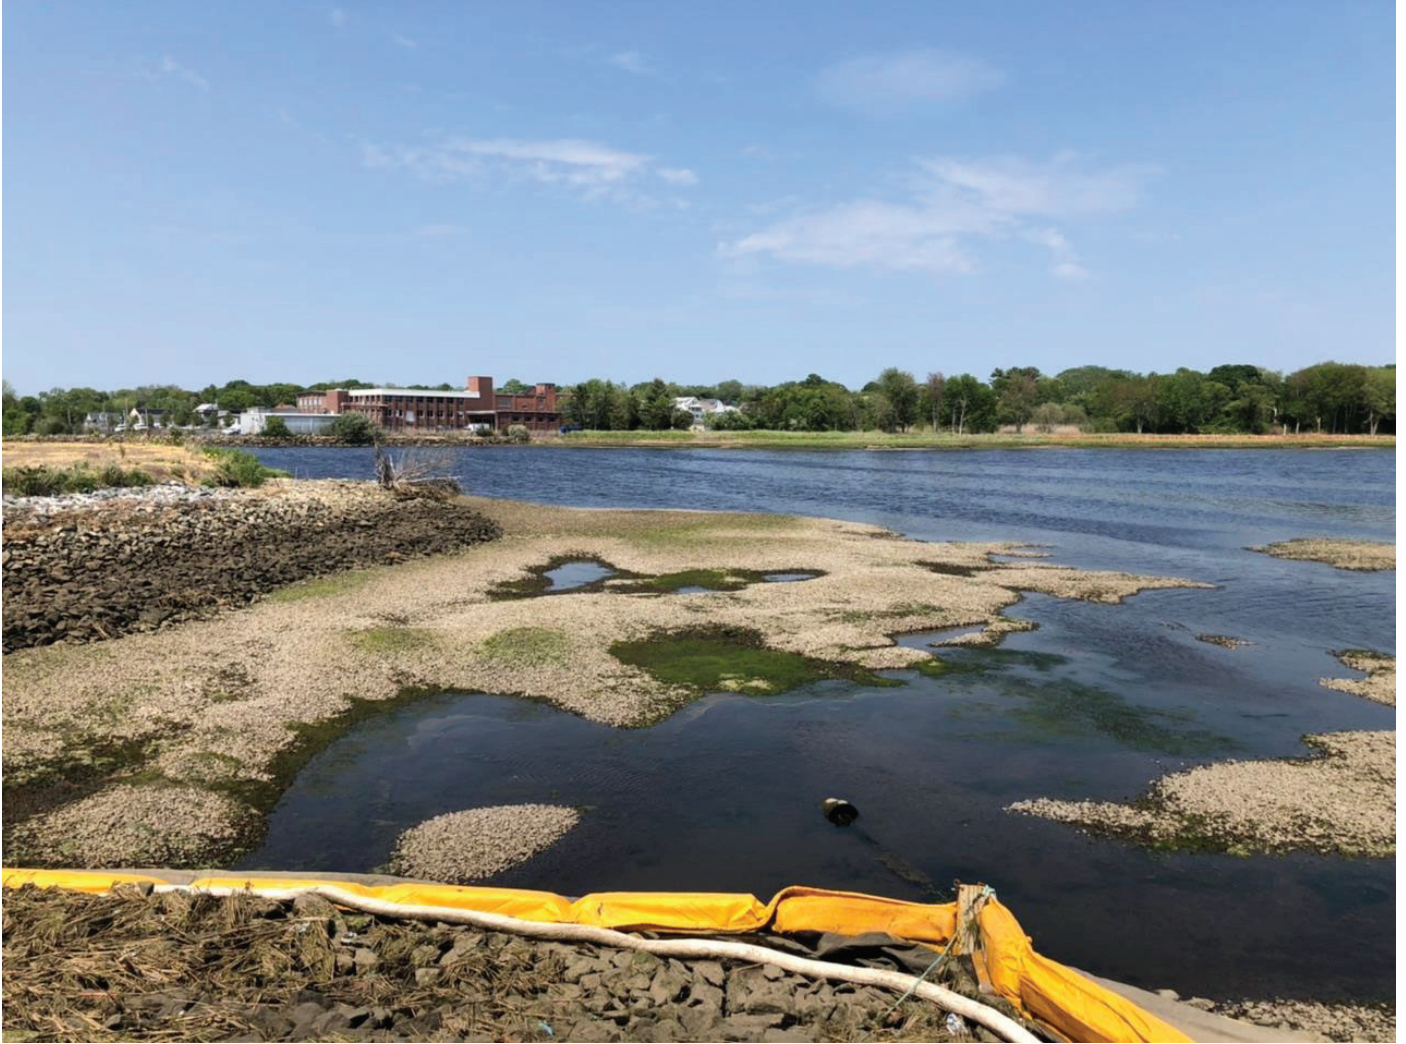
Photo #2: Northern part of the sediment cap, taken from the NE corner of the former Aerovox site, looking north. The extreme low tide allowed larger areas of the cap to be seen.

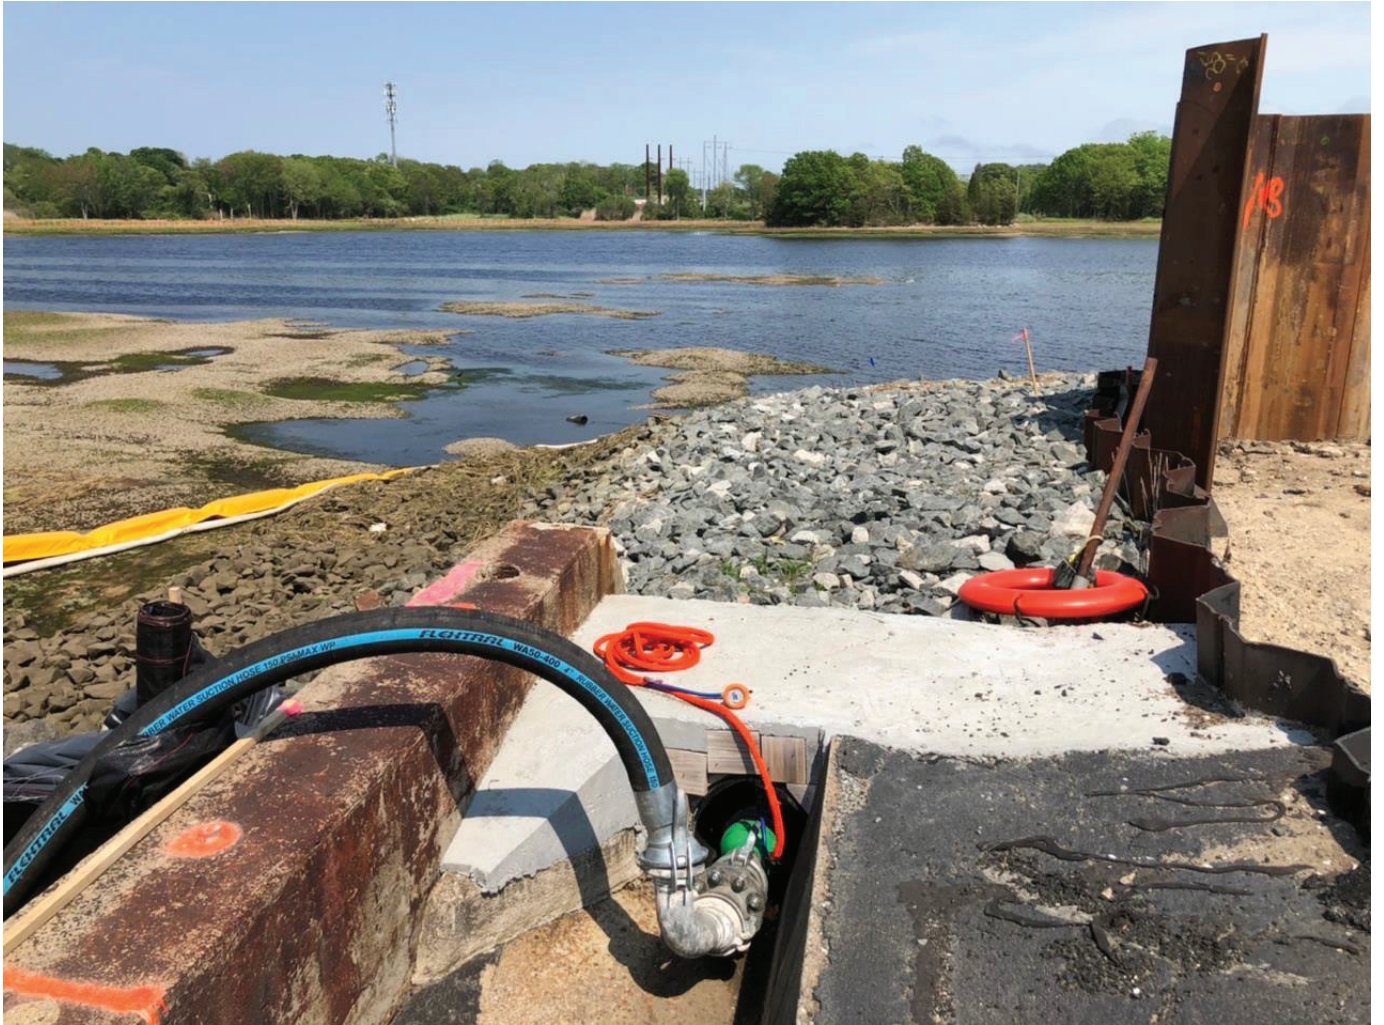
Photo #3: The landward side of the north trench discharge pipe has been temporarily plugged as part of the 21E cleanup's stormwater controls. View looking east. One can see the temporary (raised) sheeting installed just inside/landward of the original permanent sheeting.

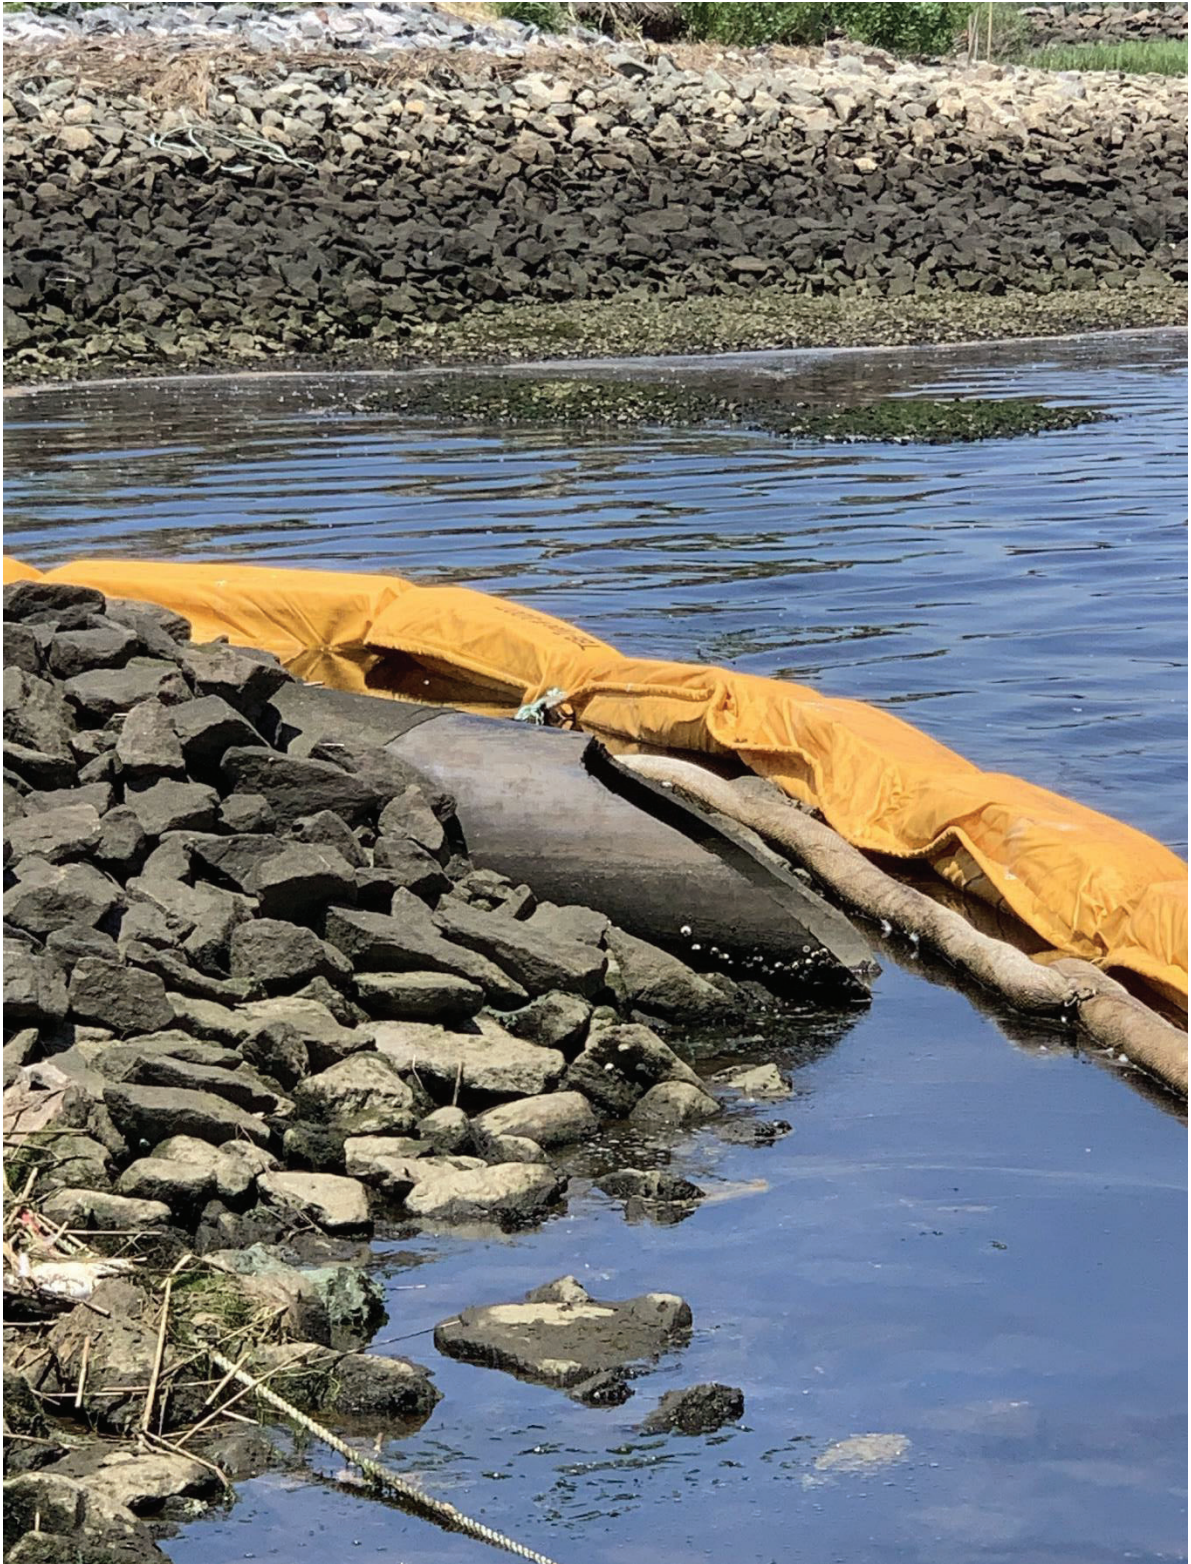
Photo #4: This photo shows the discharge/seaward end of the north trench stormwater pipe; view looking north (the northern bank of the sediment cap is in the background).

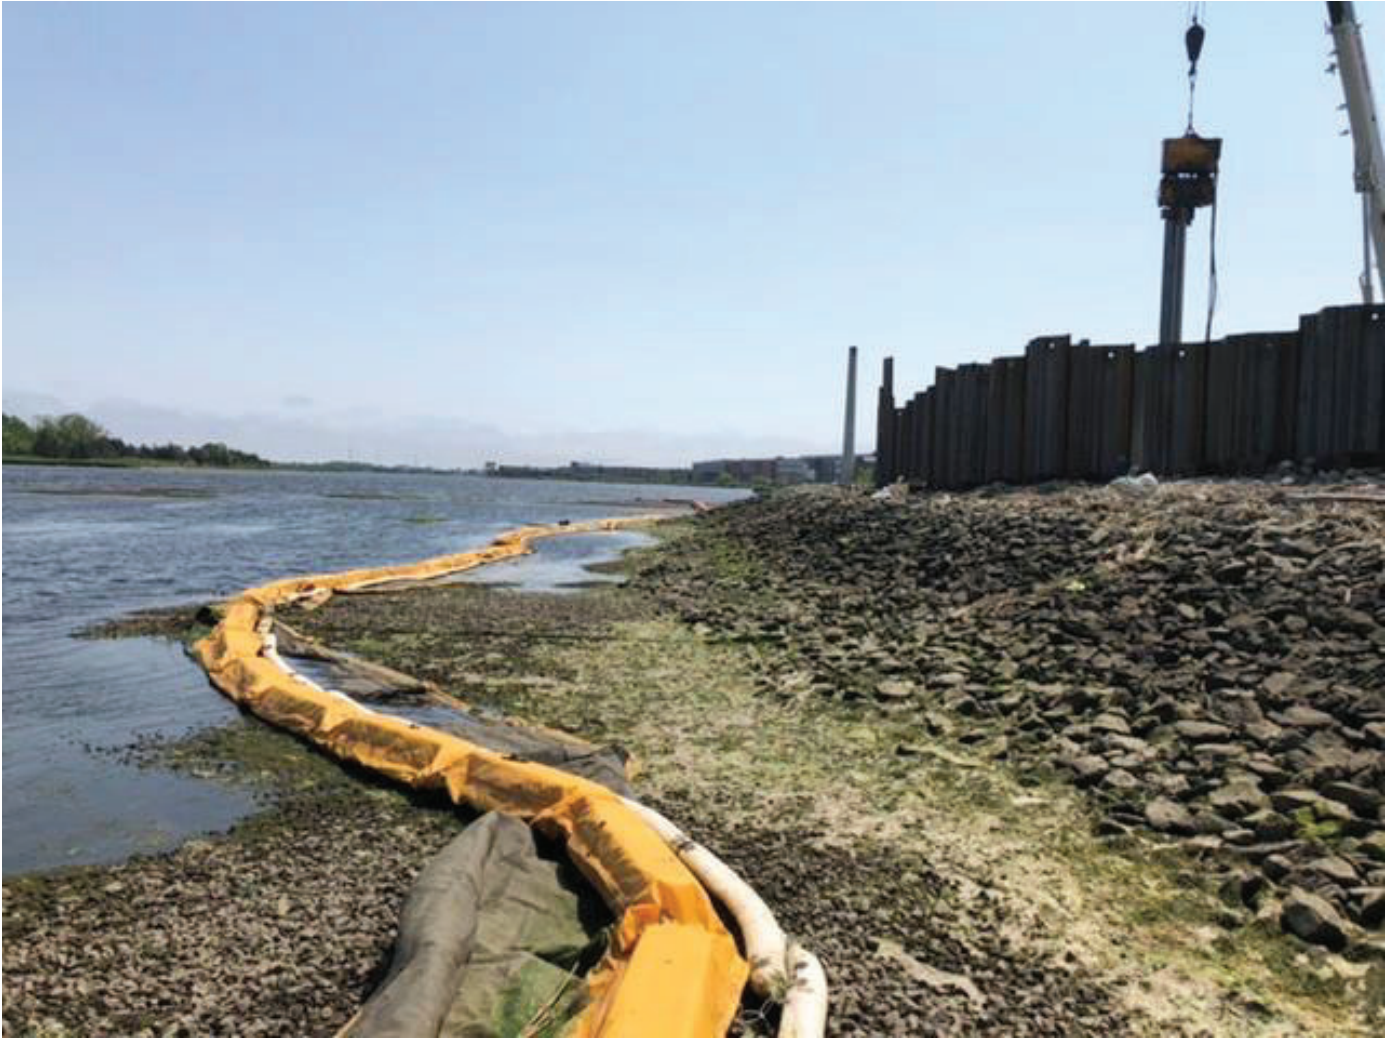
Photo #5: Looking south showing the larger stone/riprap on the bank and the smaller-stone on the lower portions of the sediment cap. The silt curtain and raised (temporary) sheet piles are part of the state 21E upland cleanup.

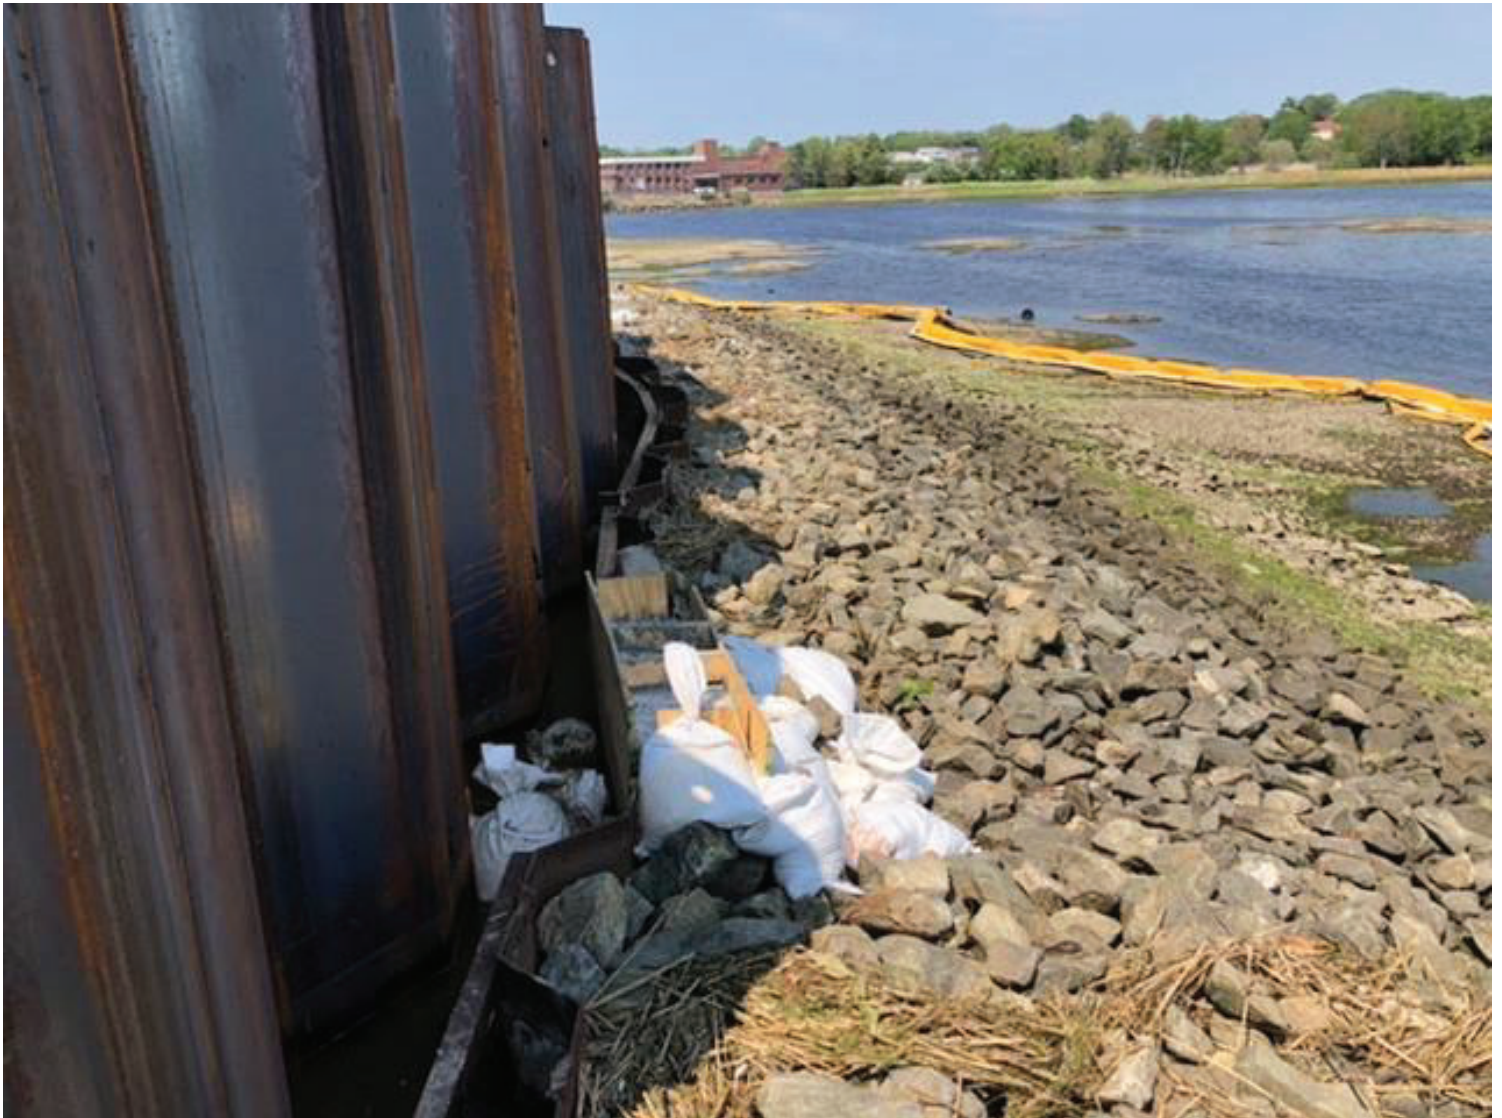
Photo #6: Looking north; the south trench drainage outfall has been temporarily dammed as part of the 21E cleanup. Note the horizontal angle-iron that has been installed along the top of the original sheet-pile wall to provide support/strength/protection during the driving of the temporary 21E sheeting.

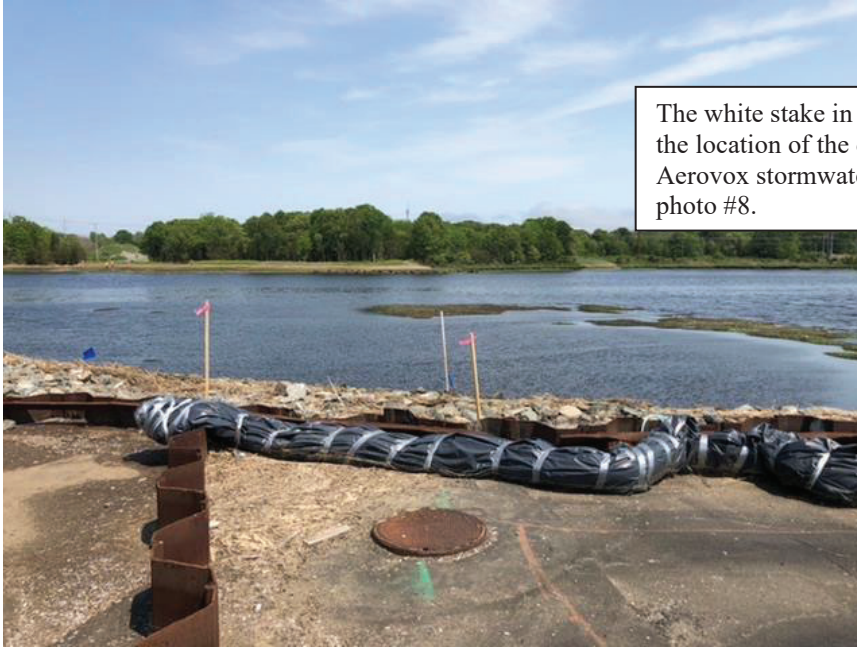
Photos #7 and #8: Top photo #7 looking east from the end of the Aerovox site's subsurface stormwater drainage system. Bottom photo #8 is a close-up view of the discharge outfall of this system (a small flow of water was flowing out of this outfall at the time of the inspection).

The white stake in the middle of the photo marks the location of the discharge outfall of the Aerovox stormwater system, shown below in photo #8.

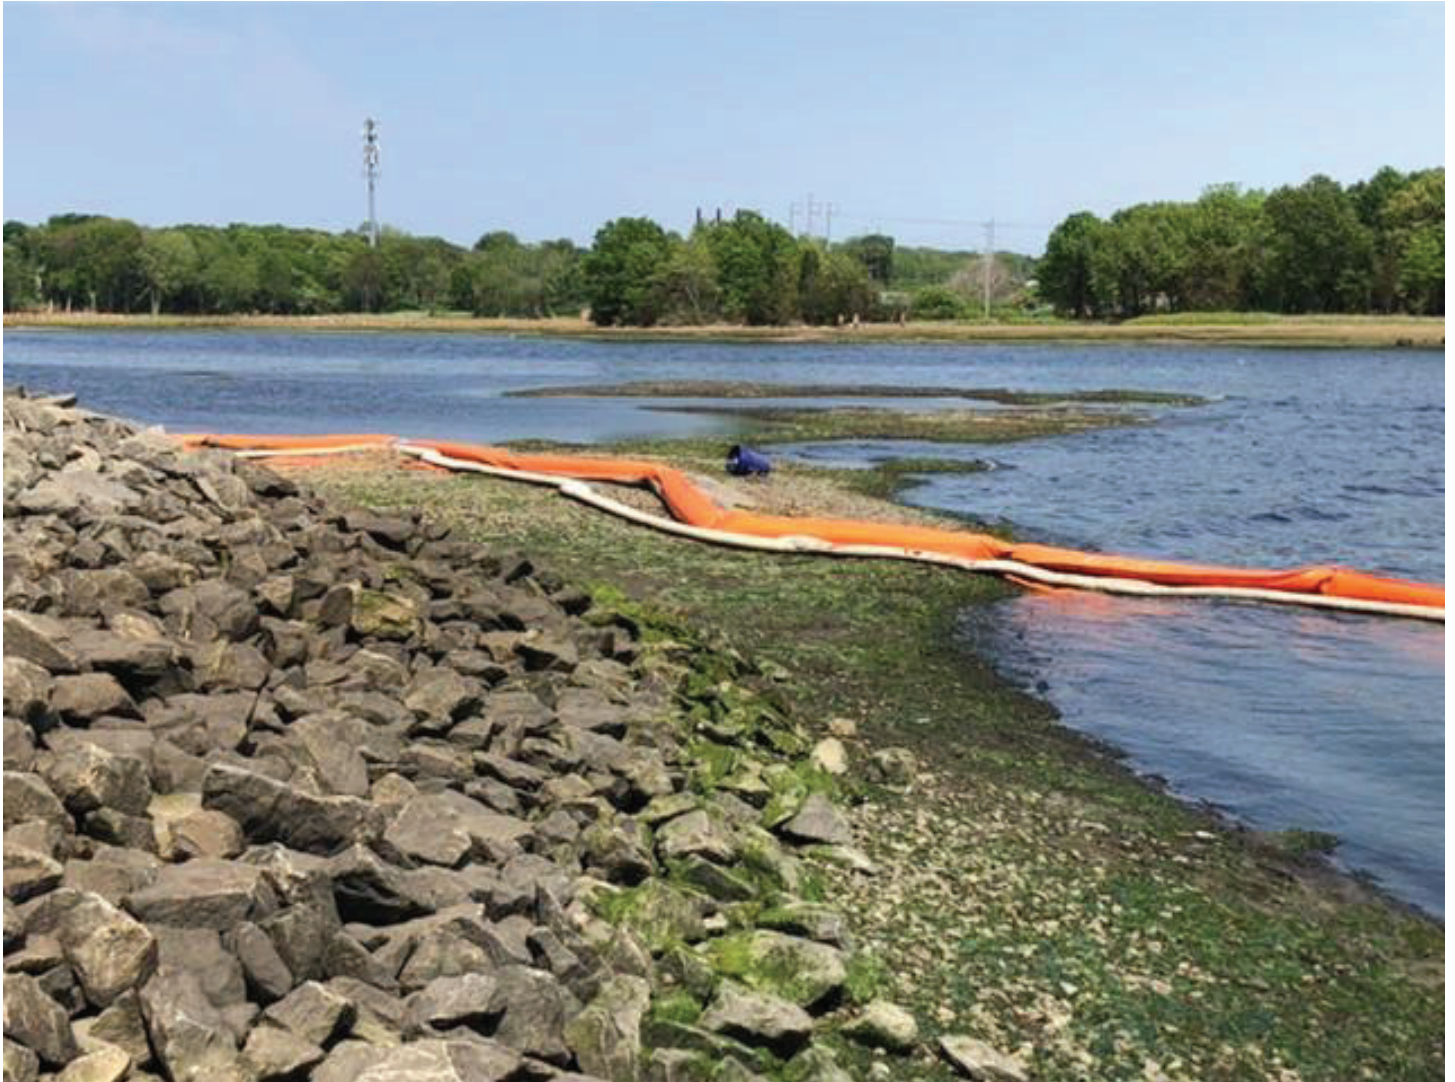
Photo #9: Looking east, showing the corner of the bank where it turns from running north-south to running east-west in the southern area of the sediment cap. Undulating surface of the smaller stone of the lower/offshore portions of the cap can be seen given the extreme low tide.

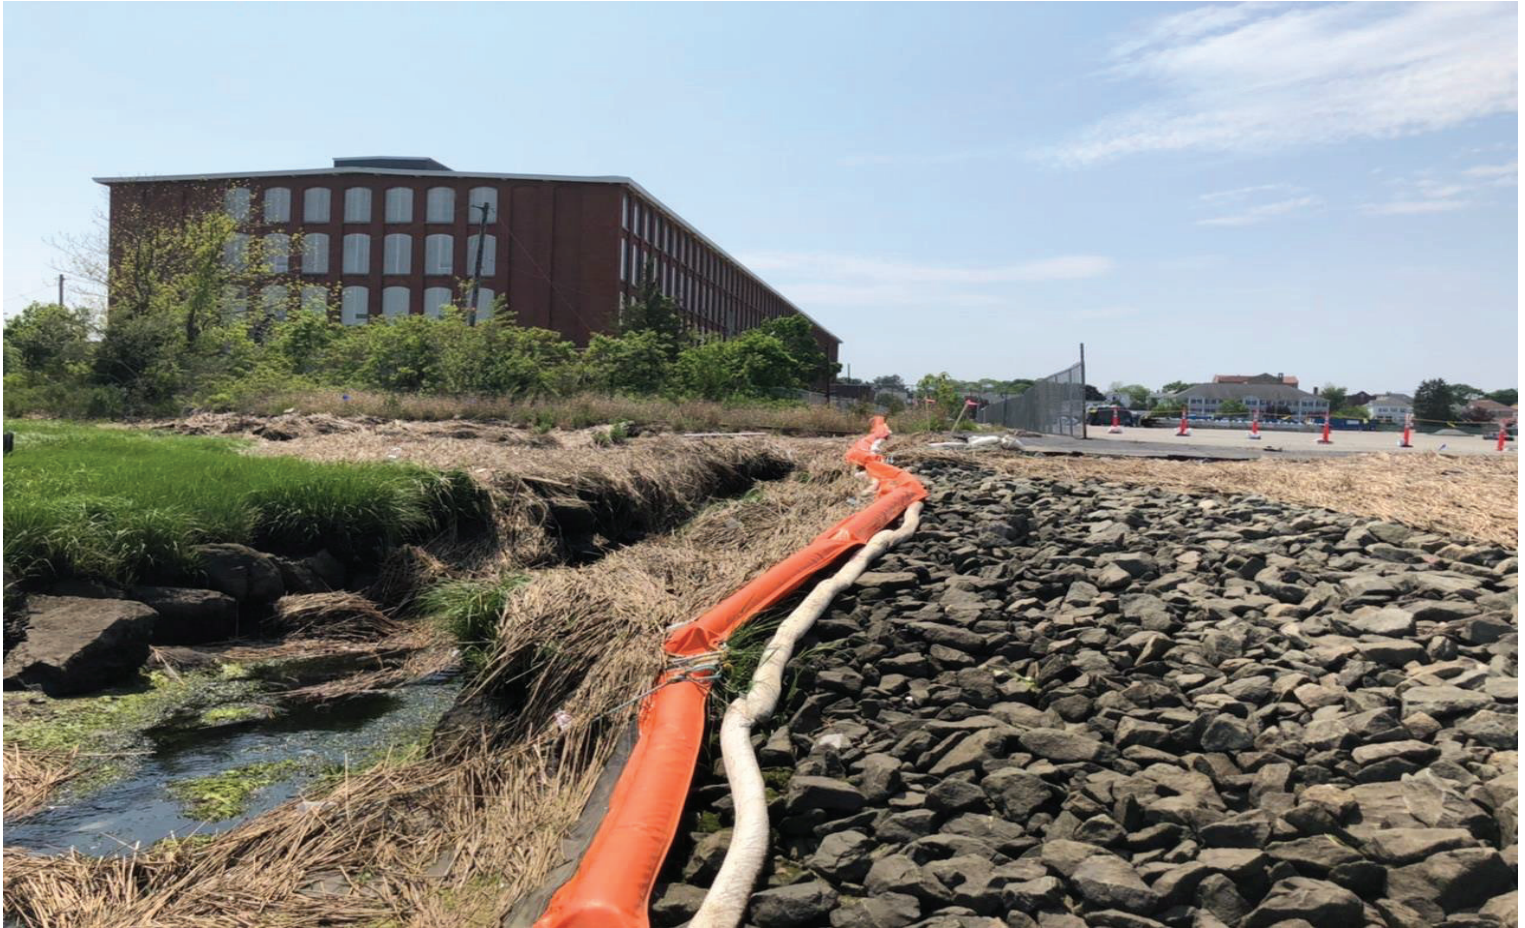
Photo #10: Looking west along the southern edge of the sediment cap. City storm drain outfall to the left; Titleist facility in background. Note marine rack line at the top of the stone bank as well as along the 21E silt curtain.
