UNITED STATES ENVIRONMENTAL PROTECTION AGENCY

Memorandum

SUBJ: 12/3/2021 inspection of Upper Harbor sediment caps, NBHSS

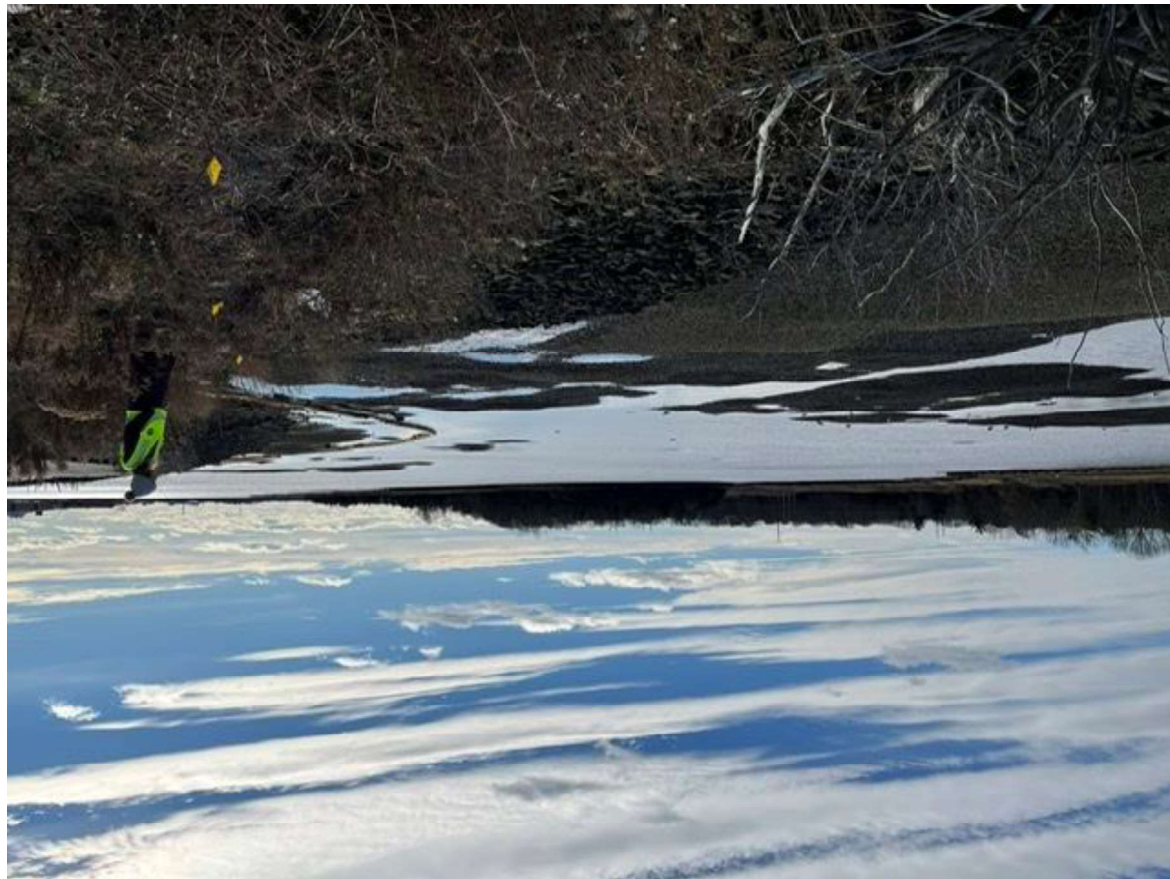
Figure 2:  
Aerovox cap  
looking south  
from the  
northern edge.  
The boom in the  
background is  
from the  
Aerovox 21E  
work.

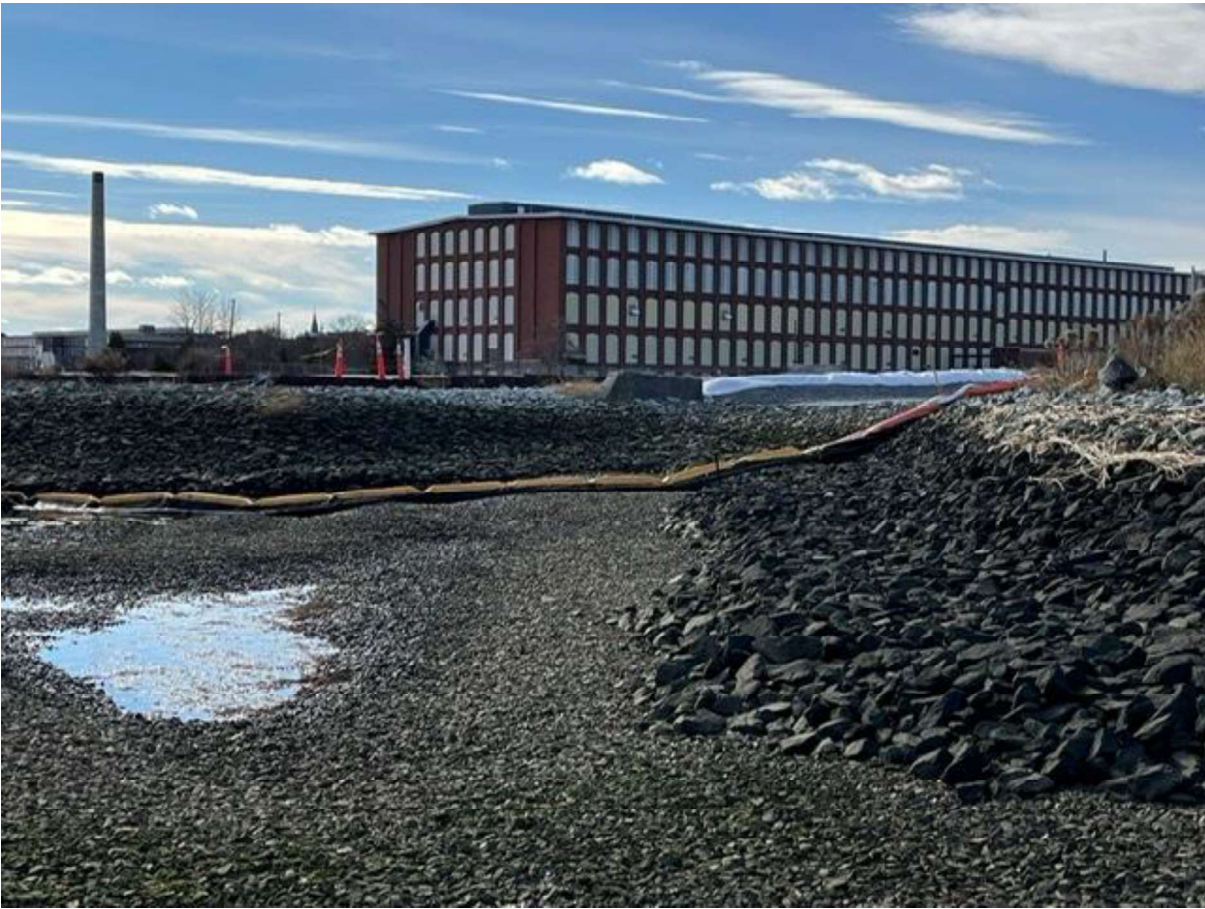
Figure 3:  
**Aerovox cap**  
looking south  
showing  
“capacitor  
cove.” Titleist  
building in  
background.

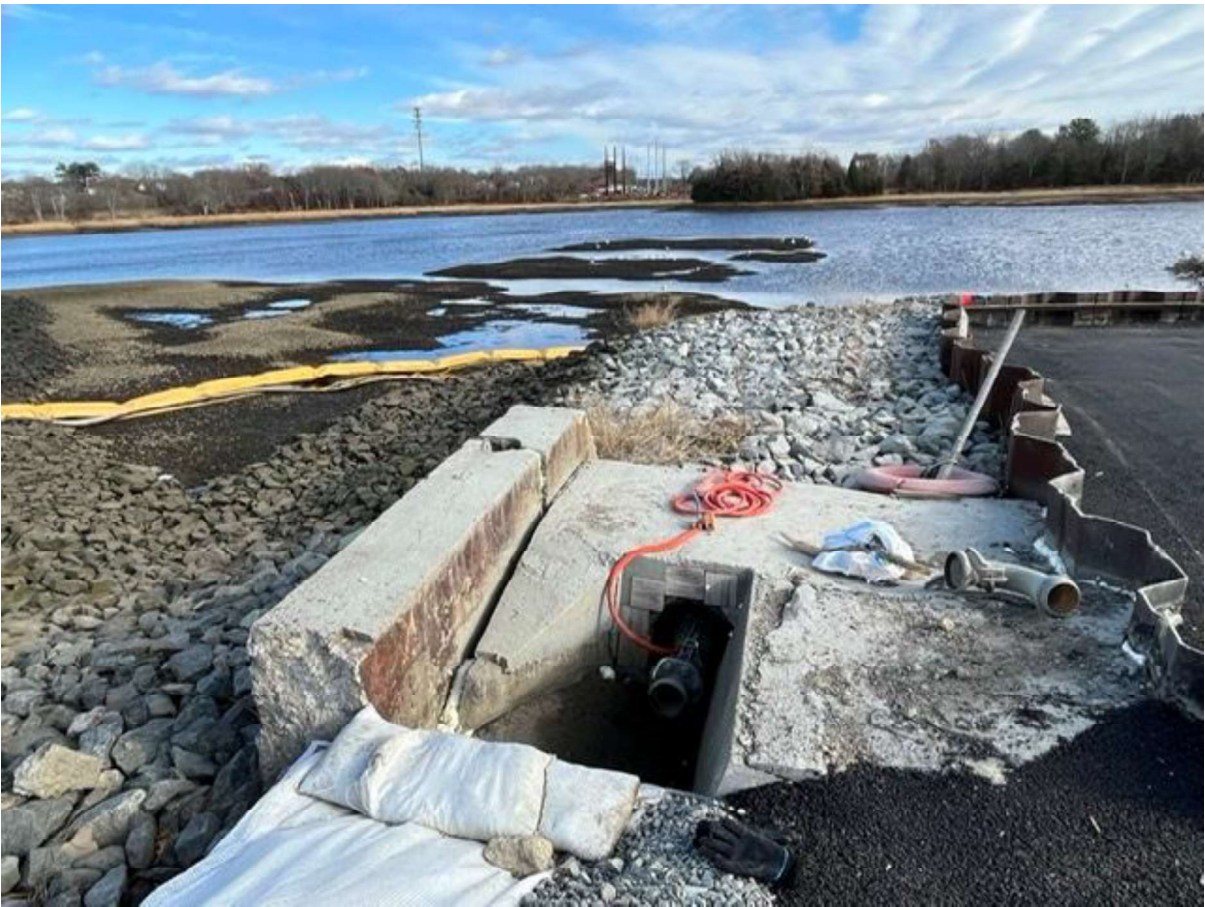
Figure 4:  
**Aerovox cap**  
looking east  
showing the  
North Trench  
storm drain  
(plugged as part  
of 21E cleanup).

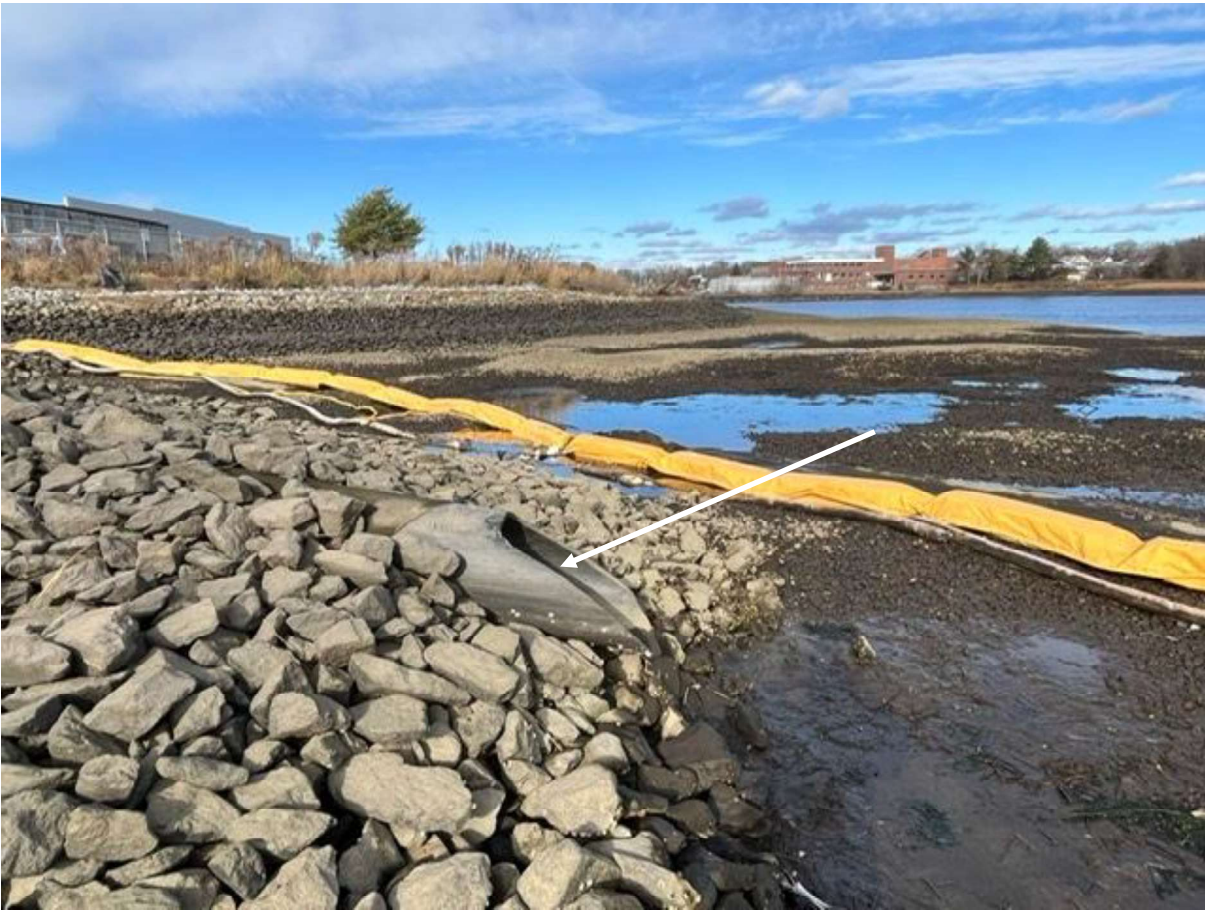
Figure 5:  
**Aerovox cap**  
looking north  
showing the  
North Trench  
outfall.

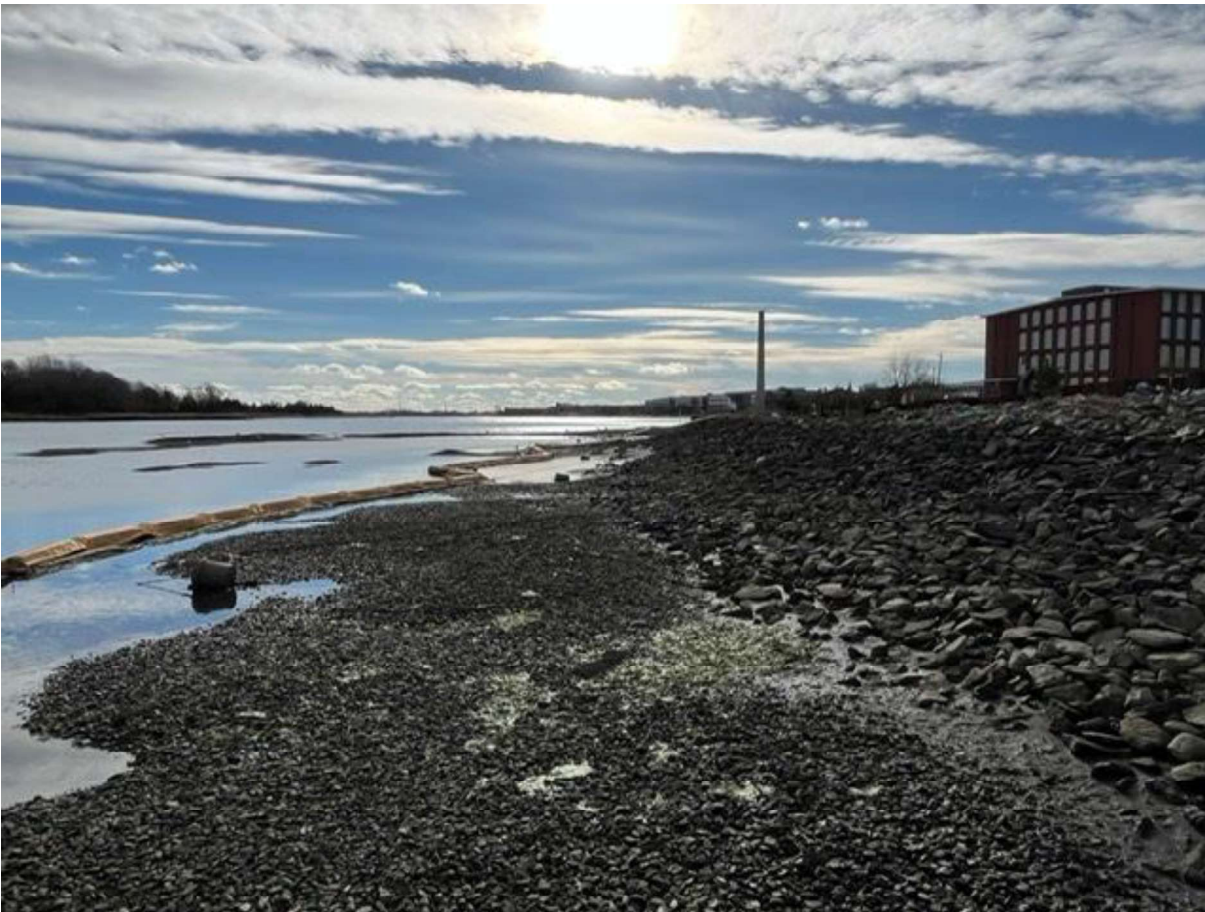
Figure 6:  
**Aerovox cap**  
looking south.  
The 5-gallon  
bucket is a  
cement anchor  
for the 21E silt  
curtain.

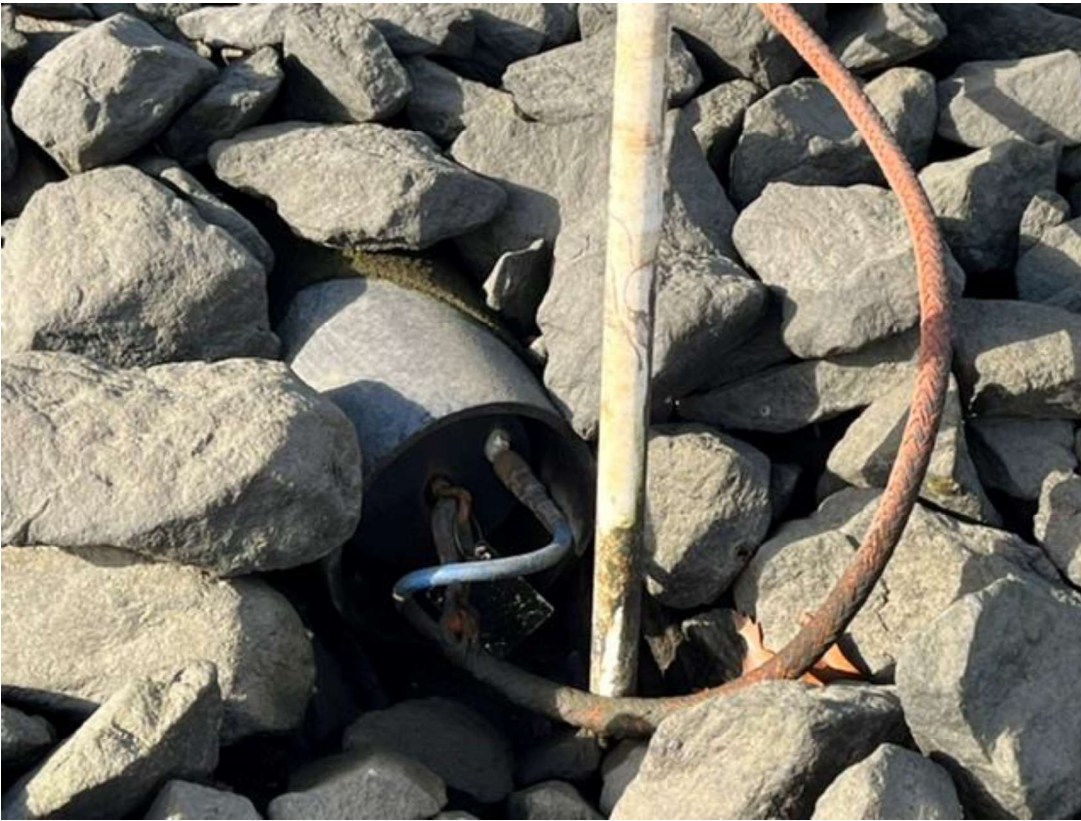
Figure 7:  
**Aerovox cap**  
showing the  
plugged South  
Trench outfall.

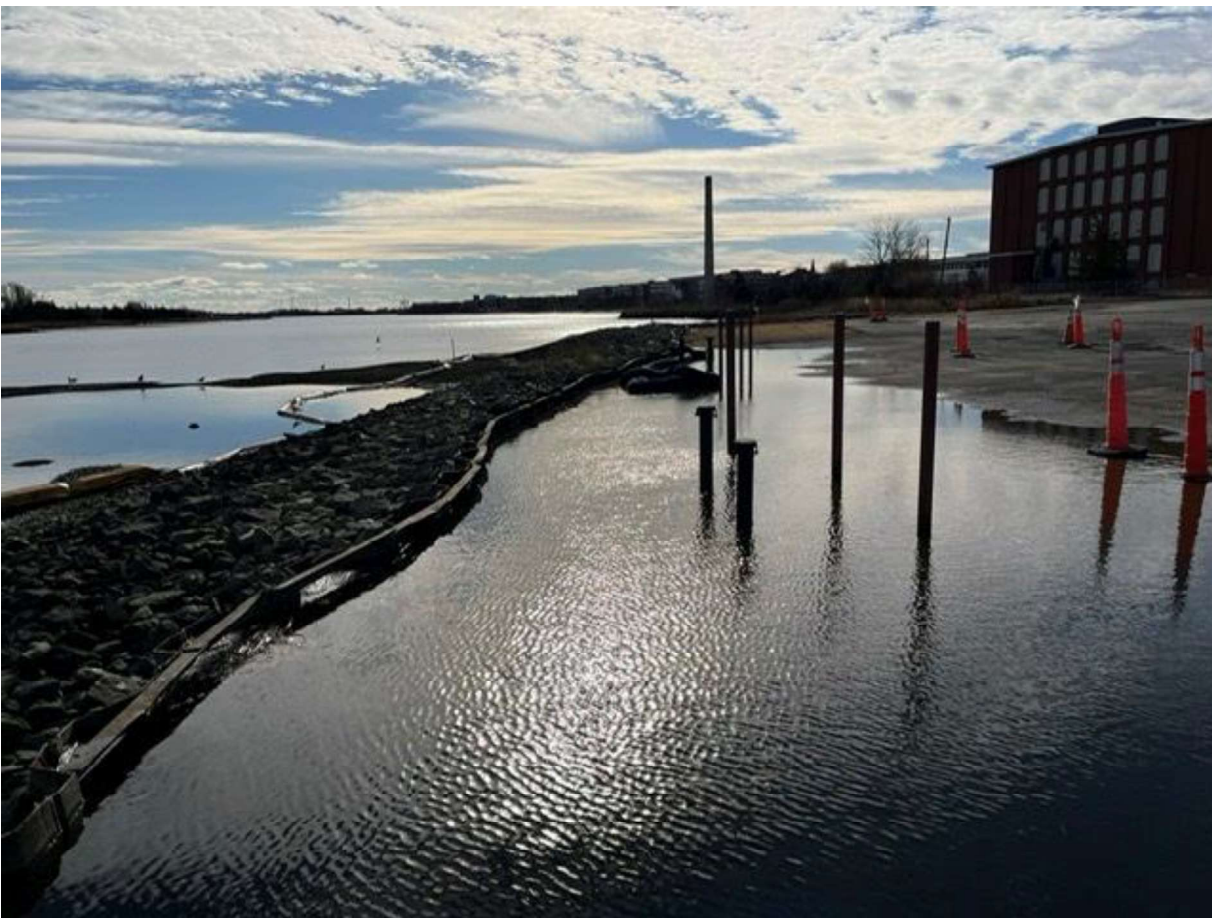
Figure 8:  
**Aerovox cap,**  
looking south.  
Ponded runoff  
is due to the  
storm drains  
and scuppers  
being plugged  
for the 21E  
cleanup. (Water  
gets pumped  
through an on-  
site treatment  
plant prior to  
discharge to the  
City sanitary  
sewer.)

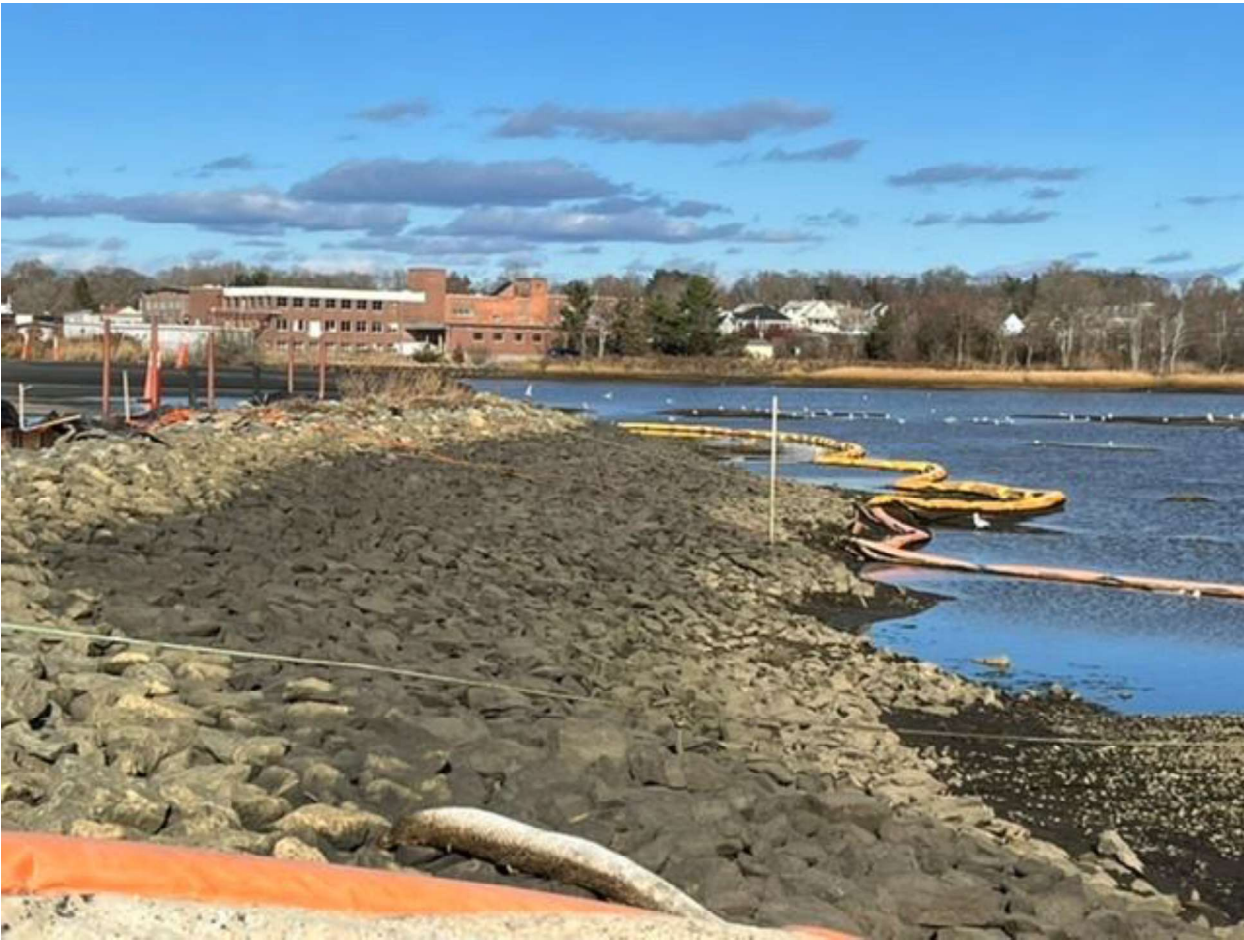
Figure 9:  
**Aerovox cap**, southern E/W leg, looking east. Note the serrated pattern at the lower edge of the bank armor stone.

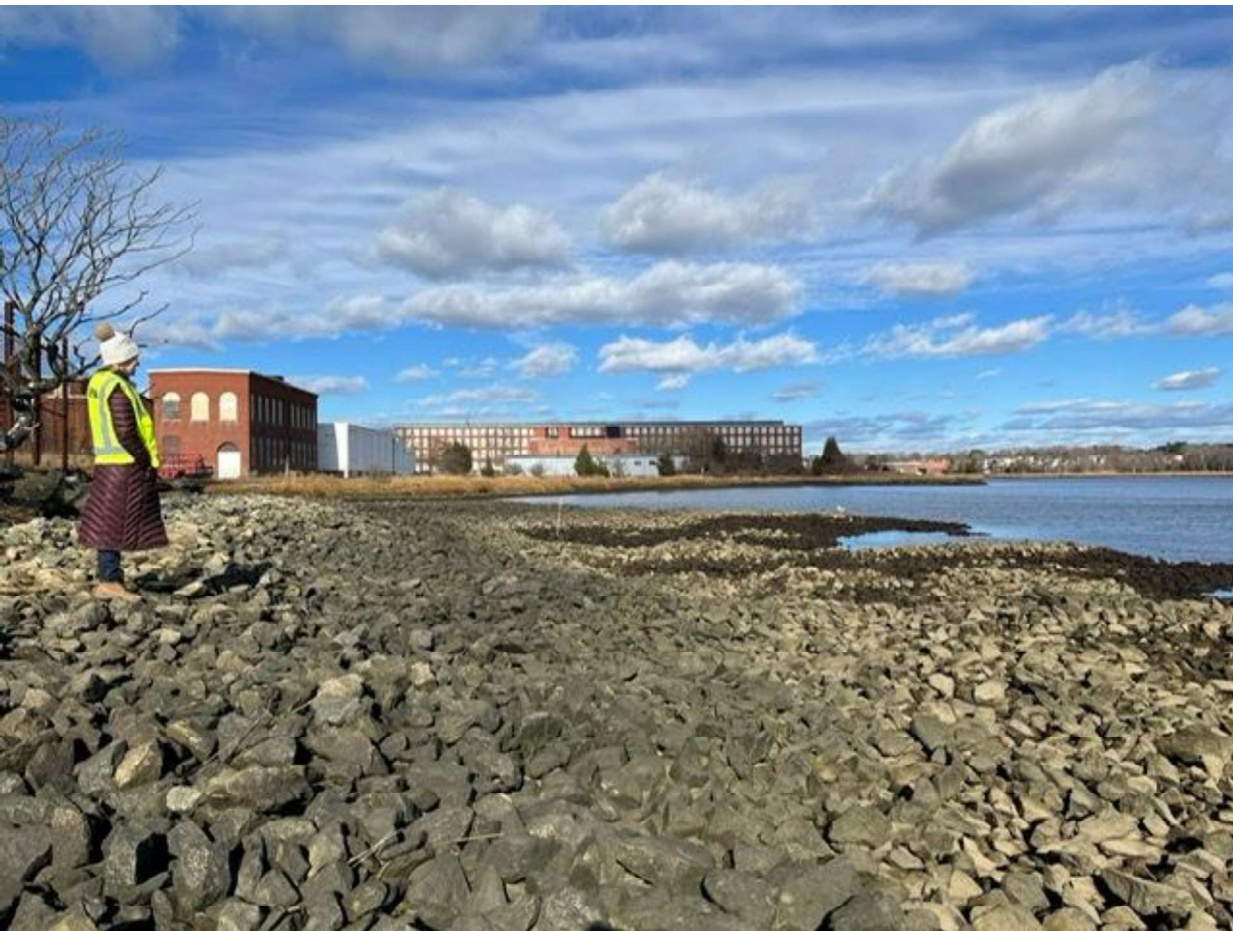
Figure 10:  
**Crib cap** looking north. White stake in middle is a stormwater outfall (see Figure 12).

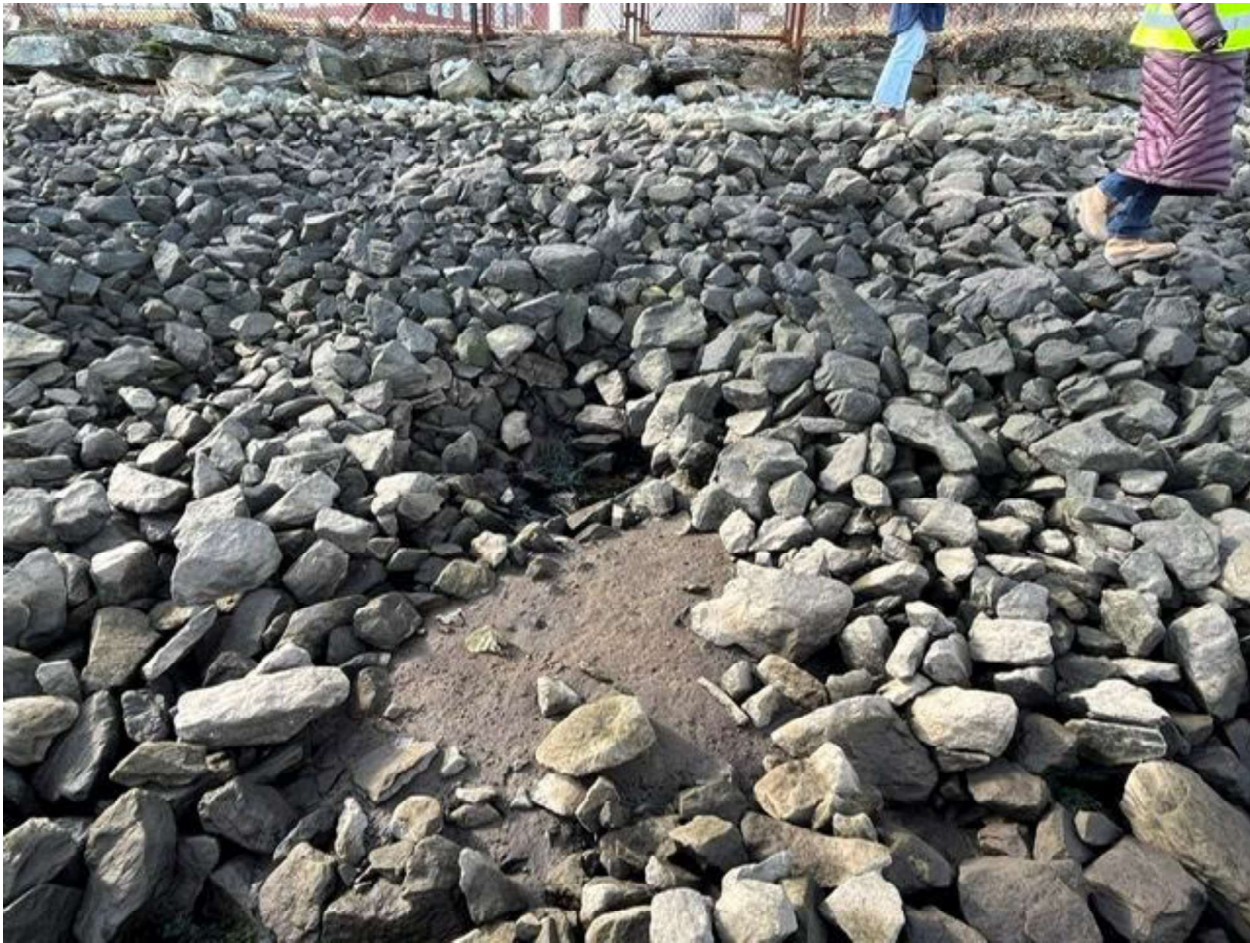
- 1 - At one small (~5 sf) area closer to the landward boundary of the **Crib cap**, the armor stone was missing and the underlying sand layer was visible (Figure 11). Armor stone needs to be placed within this area.
- 2 – At the **L-014 cap**, stone displacement along the seaward edge of the cap may have occurred, possibly from wave energy during the prolonged pre-Halloween nor'easter (Figure 16).
- 3 – At the pilot CDF shoreline cap, remove dredging-related cable/turnbuckle/shackle remaining on the armor-stone near the former Area C dock area.
- 4 – Also at the pilot CDF shoreline cap, remove an empty blue plastic drum near North Dock.

Figure 11:  
**Crib cap**  
showing the  
small area in  
need of armor  
stone.

All of these action items except #2 (L-014 cap) have been addressed. As part of the spring 2022 topsoil repair at West Zone 4, additional armor stone will be placed at the L-014 cap to smooth the surface and edges of the cap. This will allow any future erosion/displacement of the stone surface to be readily visible.

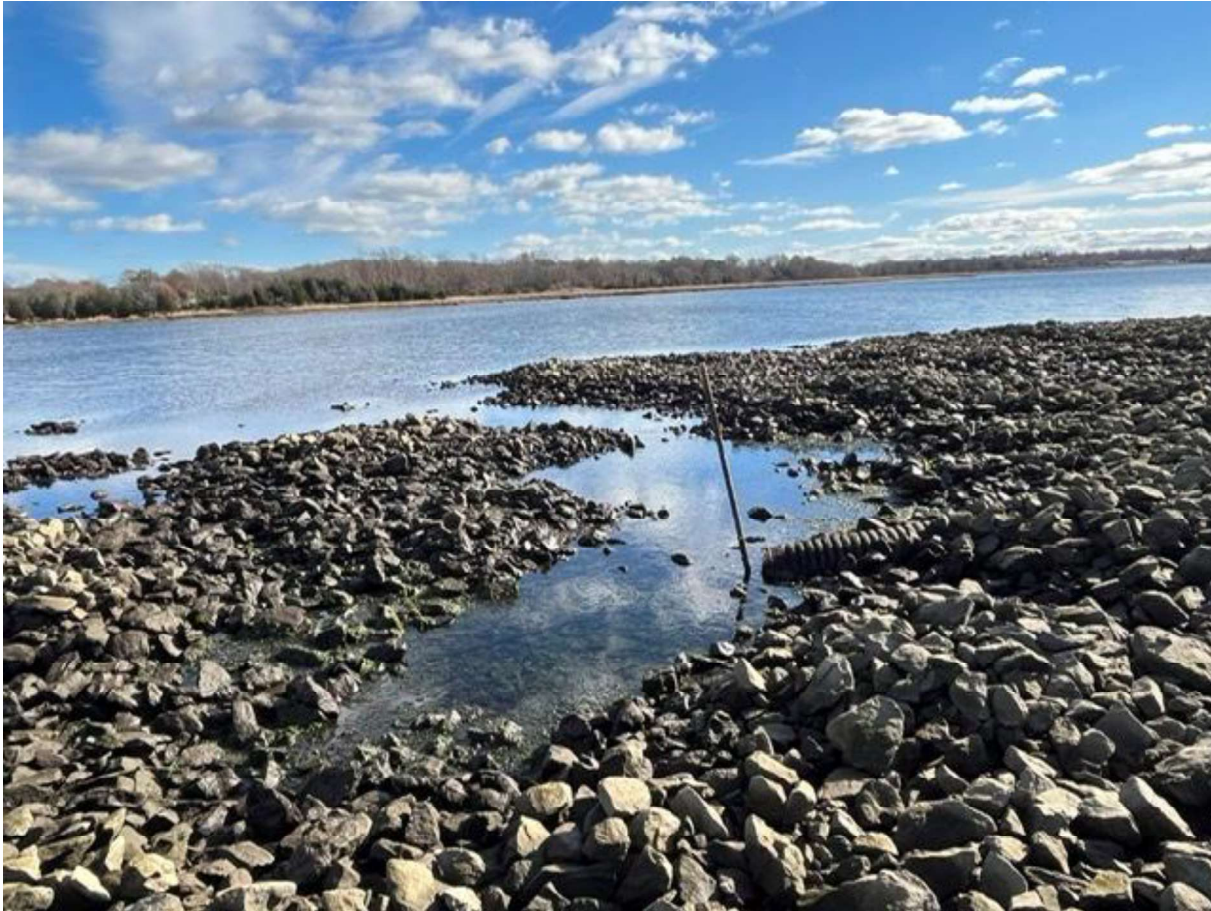
Figure 12: **Crib cap**  
looking SE  
showing storm  
drain outfall.

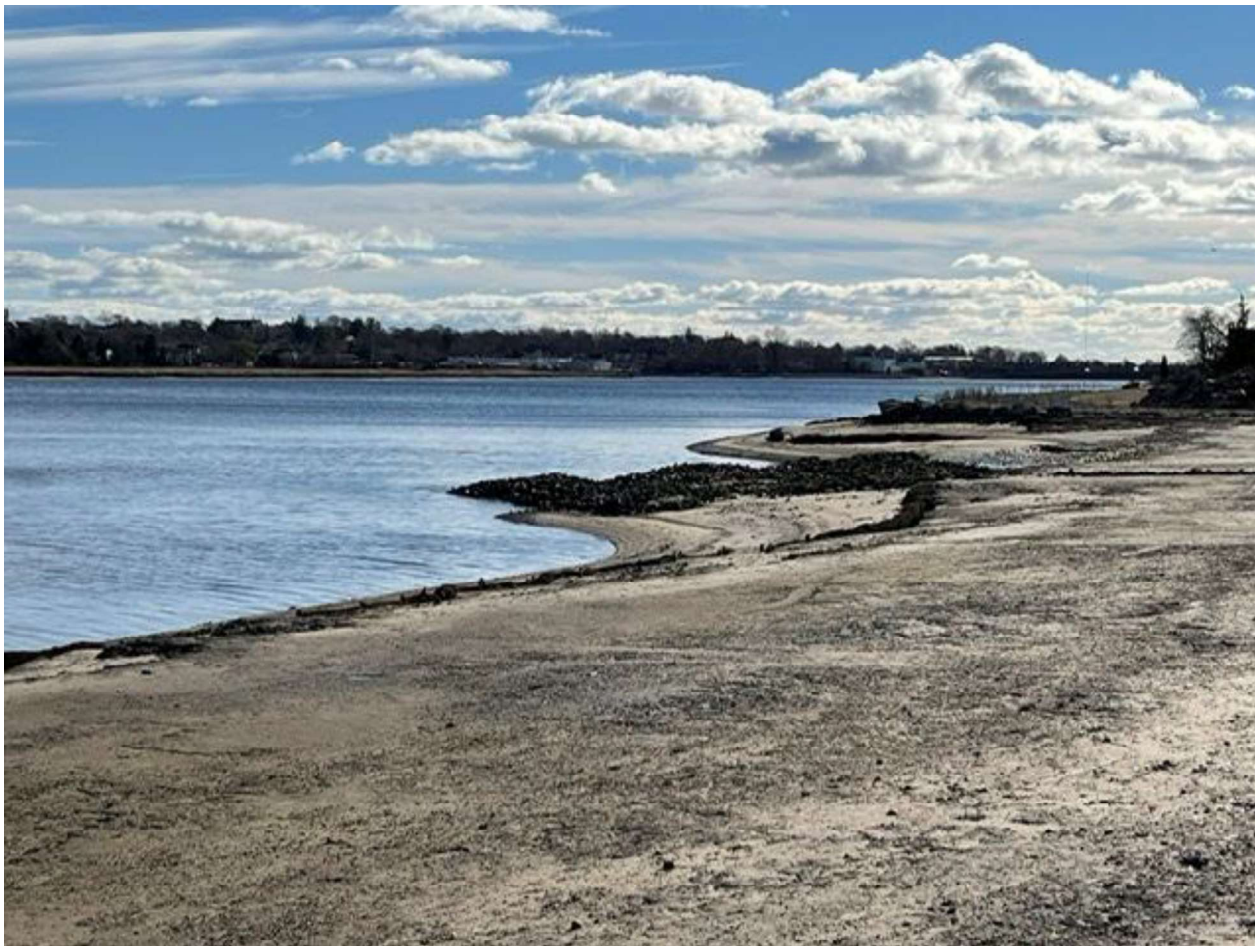
Figure 14: **L-014 cap** looking south. Bare soil is WZ-4 backfill waiting to be planted as saltmarsh in spring 2022 (after replacement of topsoil lost in October 2021 nor'easter).

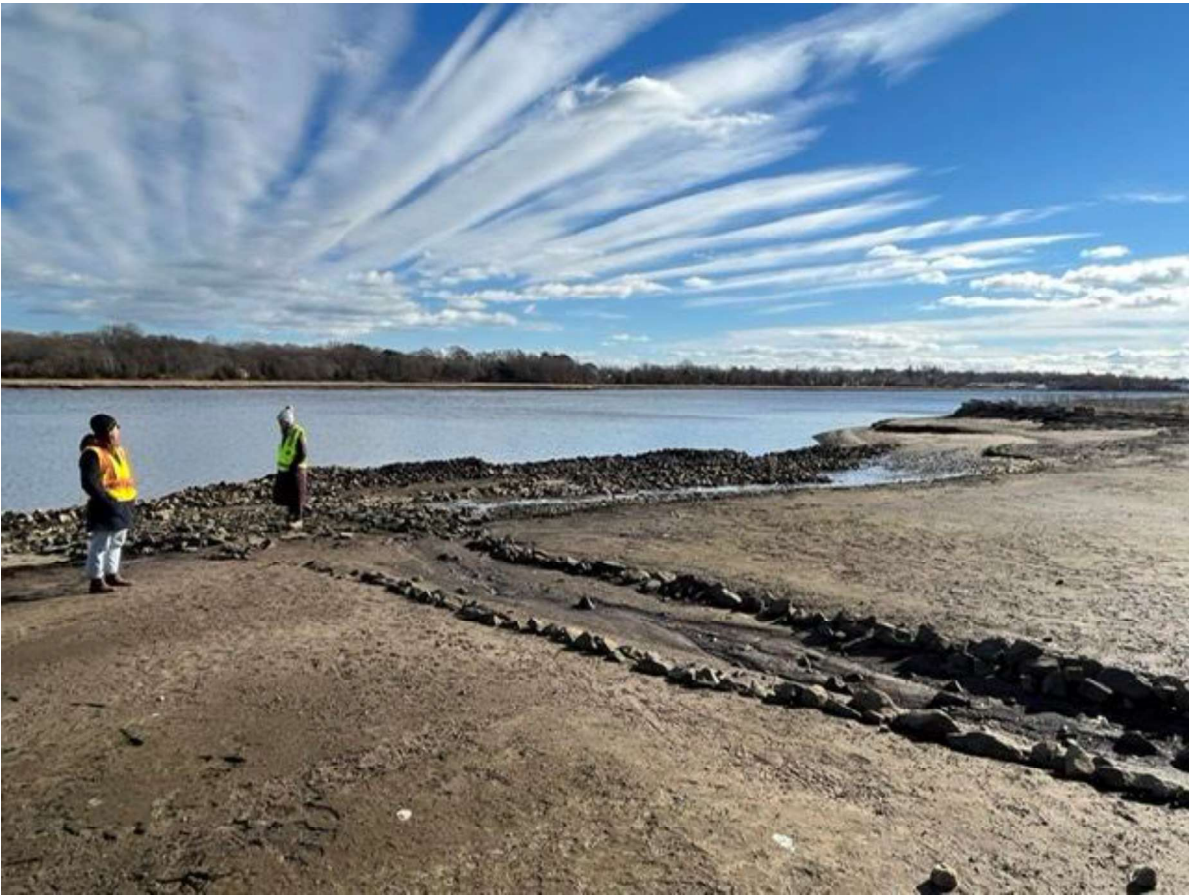
Figure 15:  
**L-014 cap**  
looking SE.  
Swale in  
foreground was  
installed as part  
of WZ-4  
restoration.

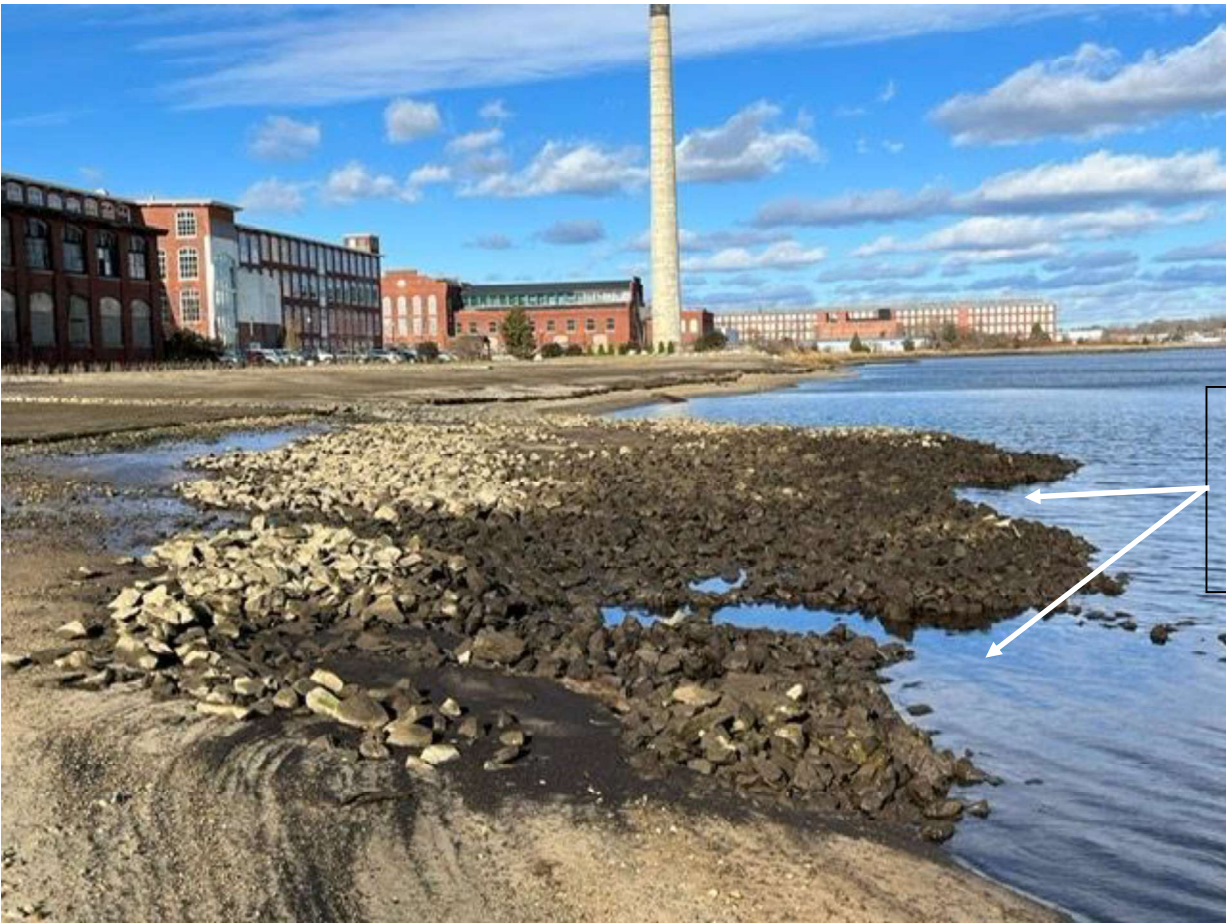
Figure 16:  
**L-014 cap**,  
looking north.

Potential  
displacement  
areas from  
October 2021  
nor'easter.

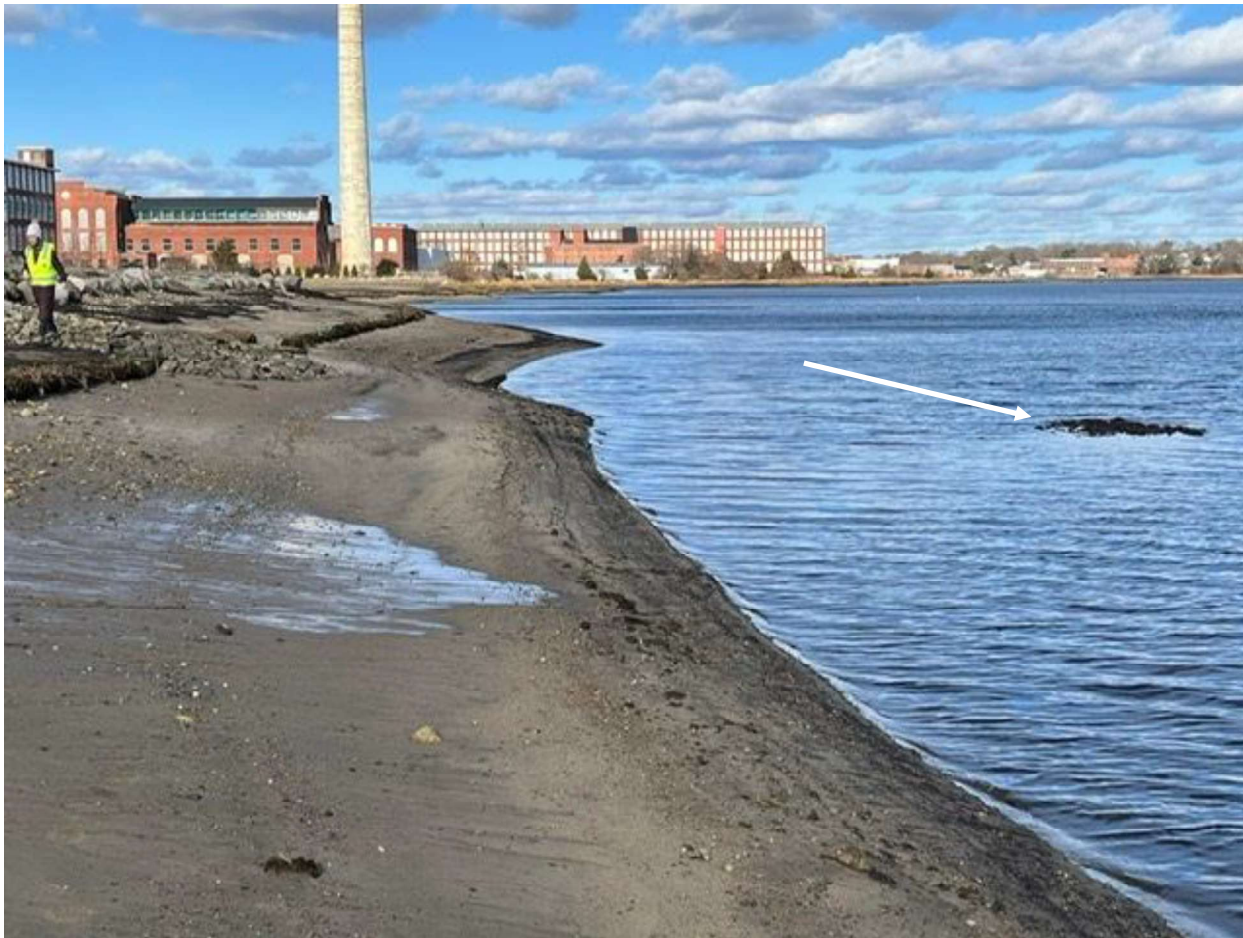
Figure 17:  
**L-114 cap**,  
looking north.  
Only a small  
area of  
emerging armor  
stone can be  
seen at extreme  
low tide.

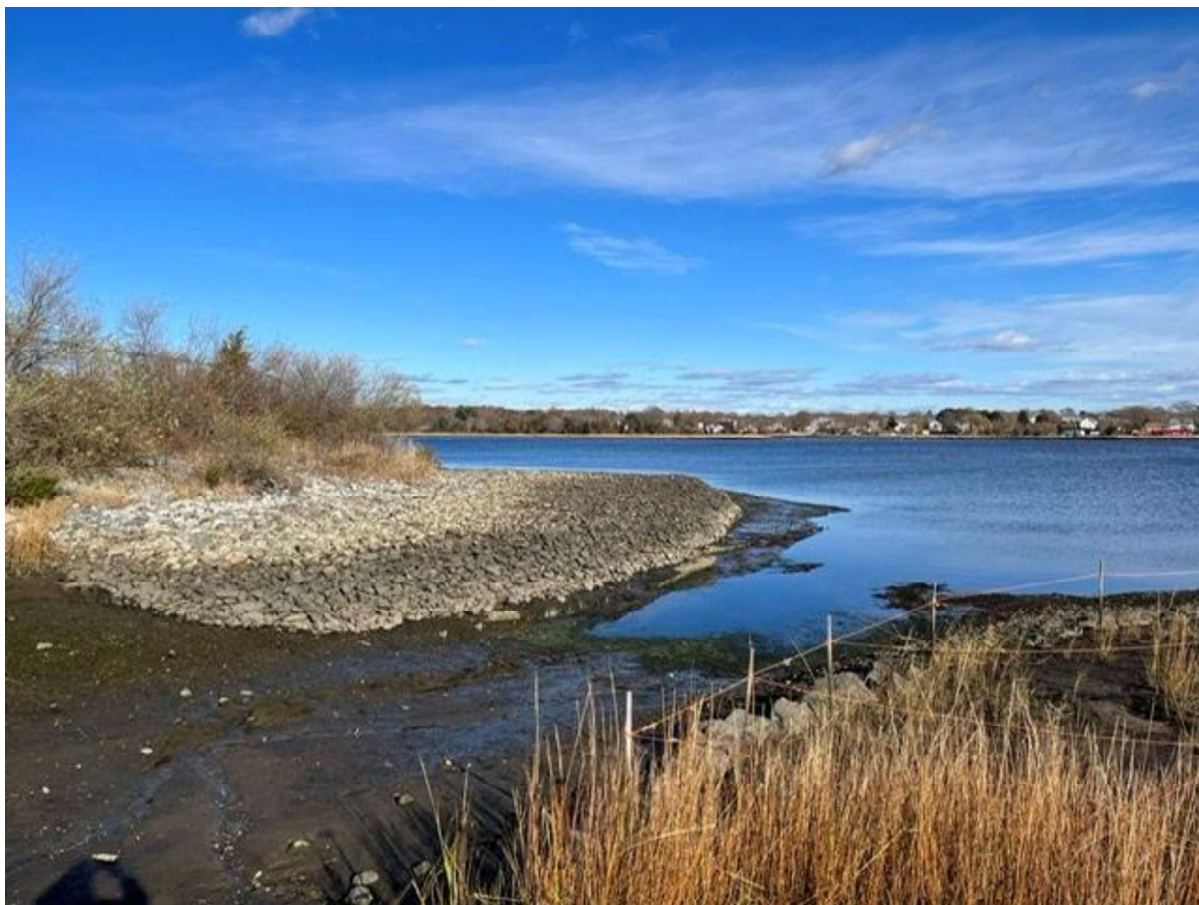
Figure 18:  
**Pilot CDF  
shoreline cap**,  
southern end,  
looking north.  
Parcel 265  
saltmarsh  
replanting in  
fore-ground.
