UNITED STATES ENVIRONMENTAL PROTECTION AGENCY

Memorandum

SUBJ: 5/17/2022 inspection of Upper Harbor sediment caps, NBHSS

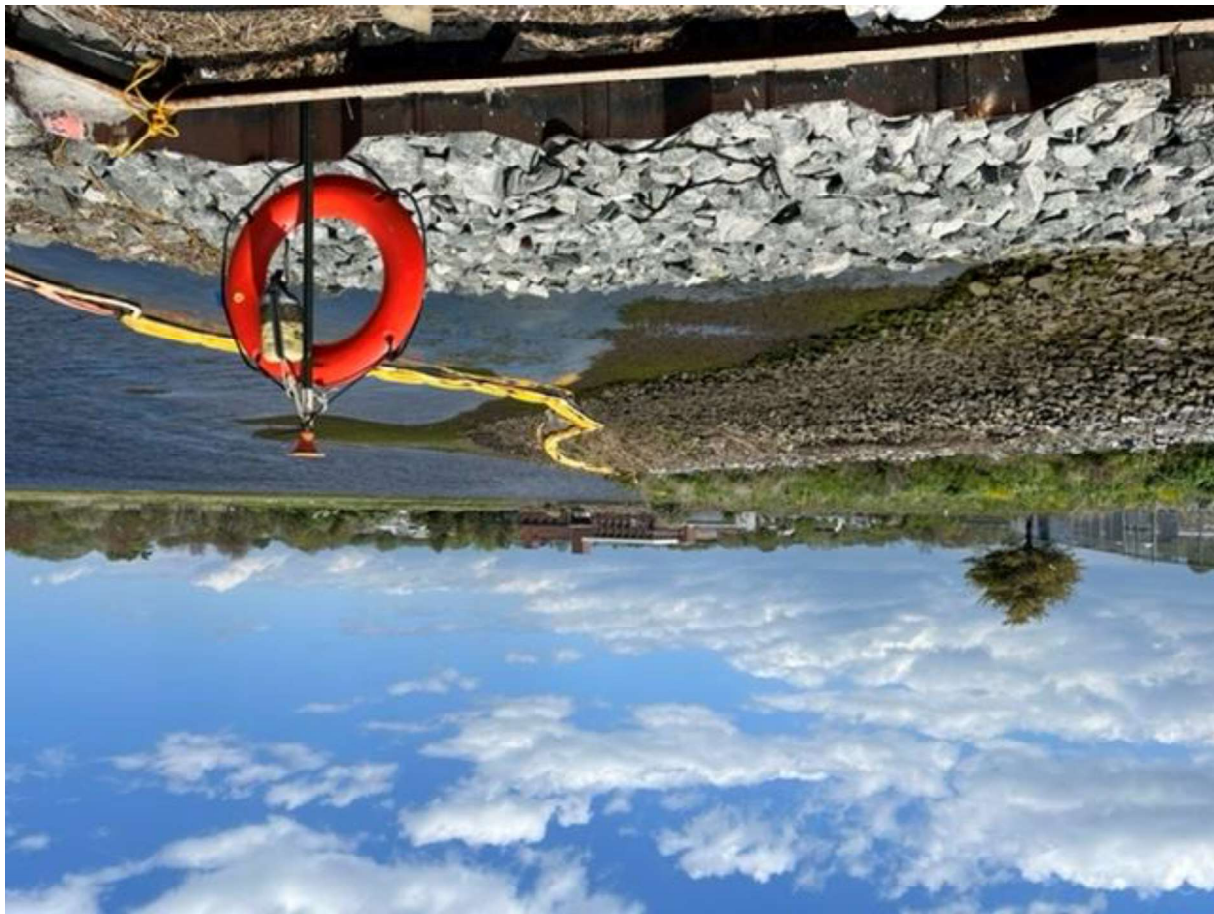
**Figure 2:**  
 Aerox cap looking north from the northeastern edge of the Aerox site. The oil boom is from the ongoing Aerox 21E work. Note that both the N and S drainage trenches remain plugged during the 2022 21E work.

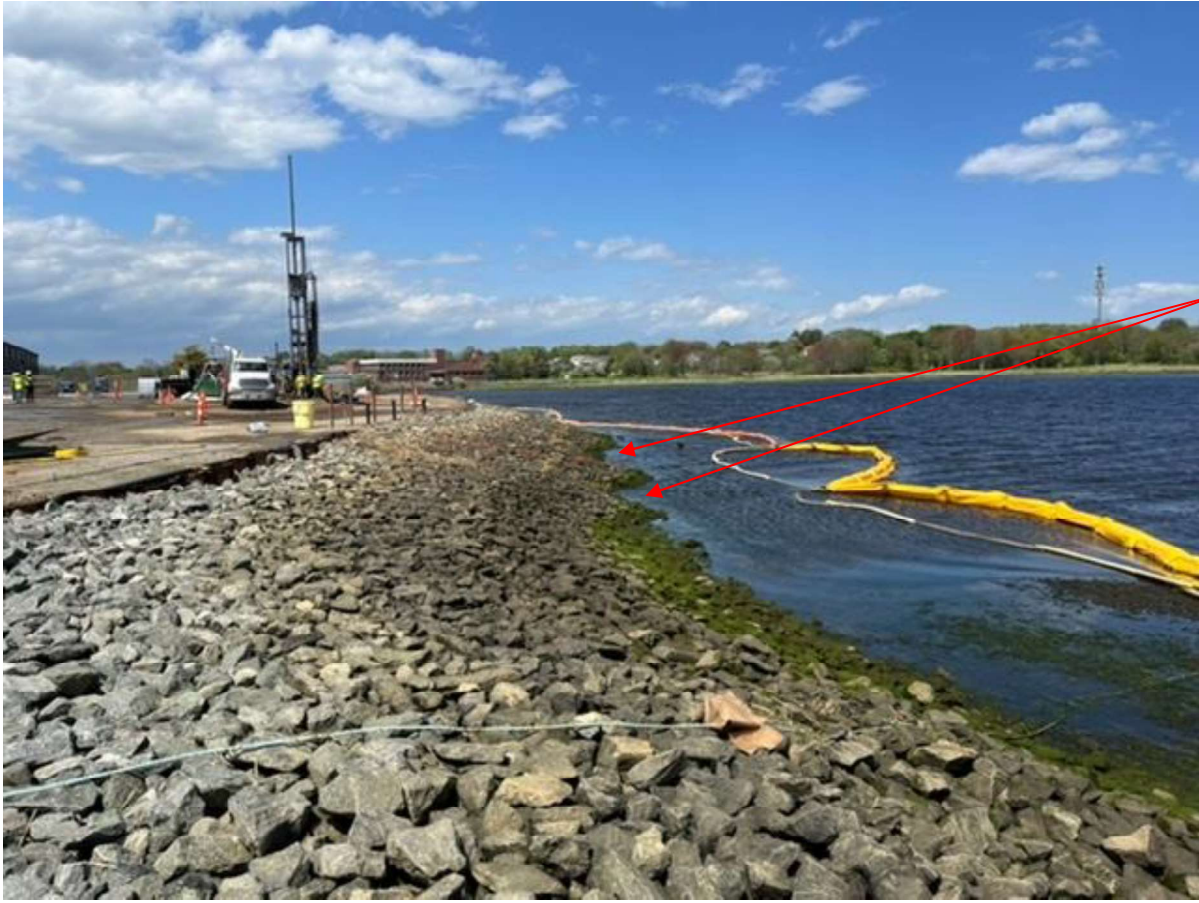
Figure 3:  
**Aerovox cap**  
looking north  
along the  
landward/western  
edge of the cap.  
Note the serrated  
pattern  
developing at the  
toe of slope.

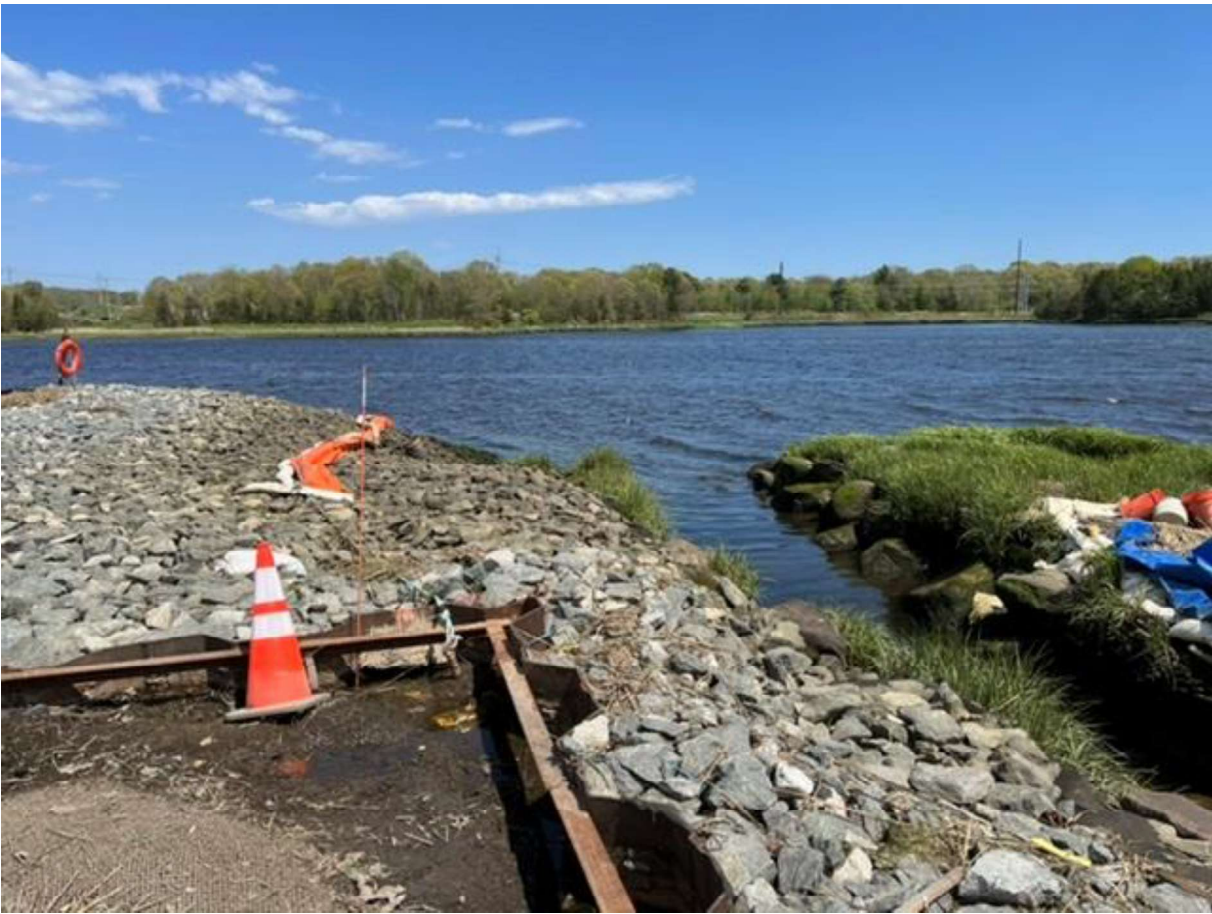
Figure 4:  
**Aerovox cap**  
looking east  
along the  
southern edge of  
the cap. City  
storm drain is on  
the right.

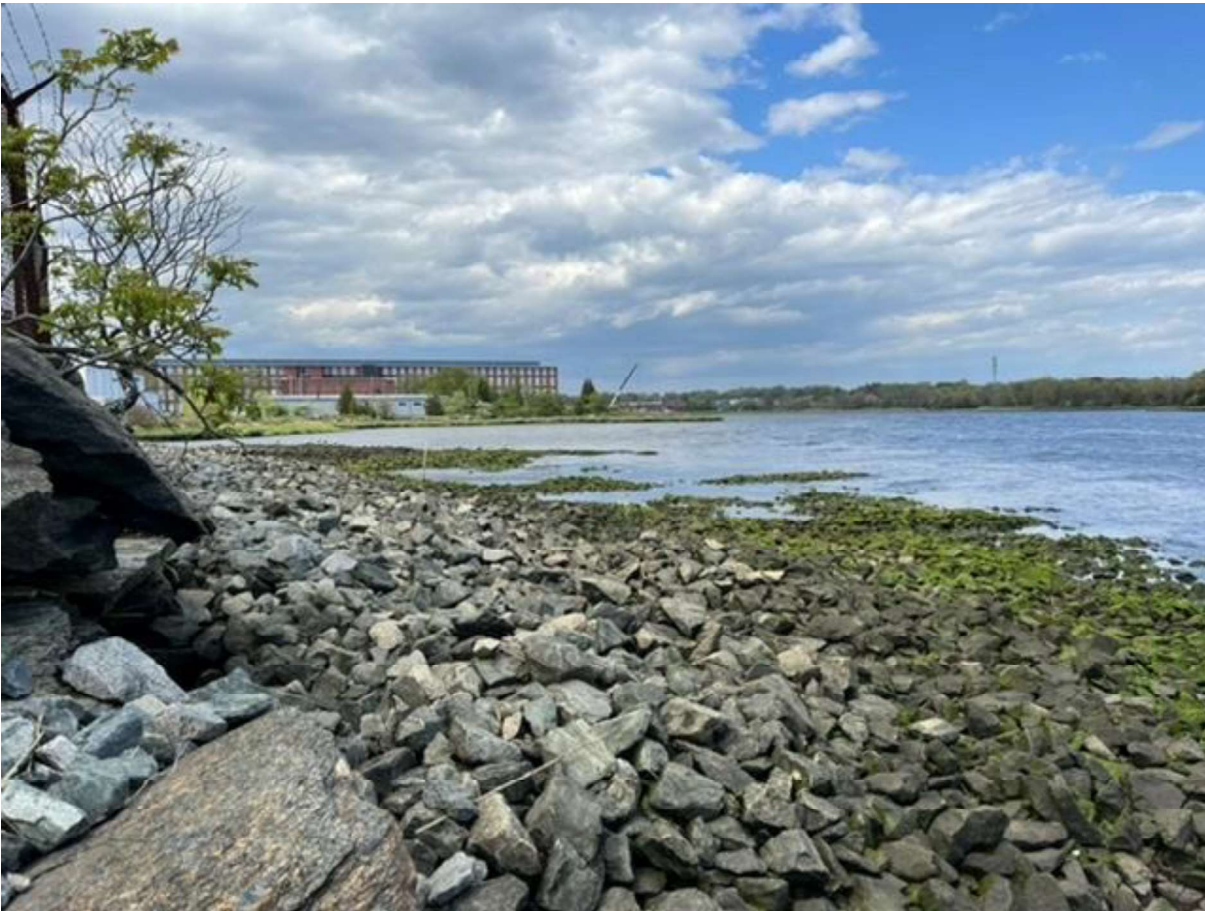
Figure 5:  
**Crib cap**  
looking  
north from  
the southern  
area of the  
cap.

2 – Recommend that additional stone be added at the **Crib cap** during West Zone 2/3 operations to create a more uniform (less undulating) stone surface that will aid in visually detecting potential stone displacement moving forward (similar to repairs/smoothing being performed during this inspection at the L-014 cap).

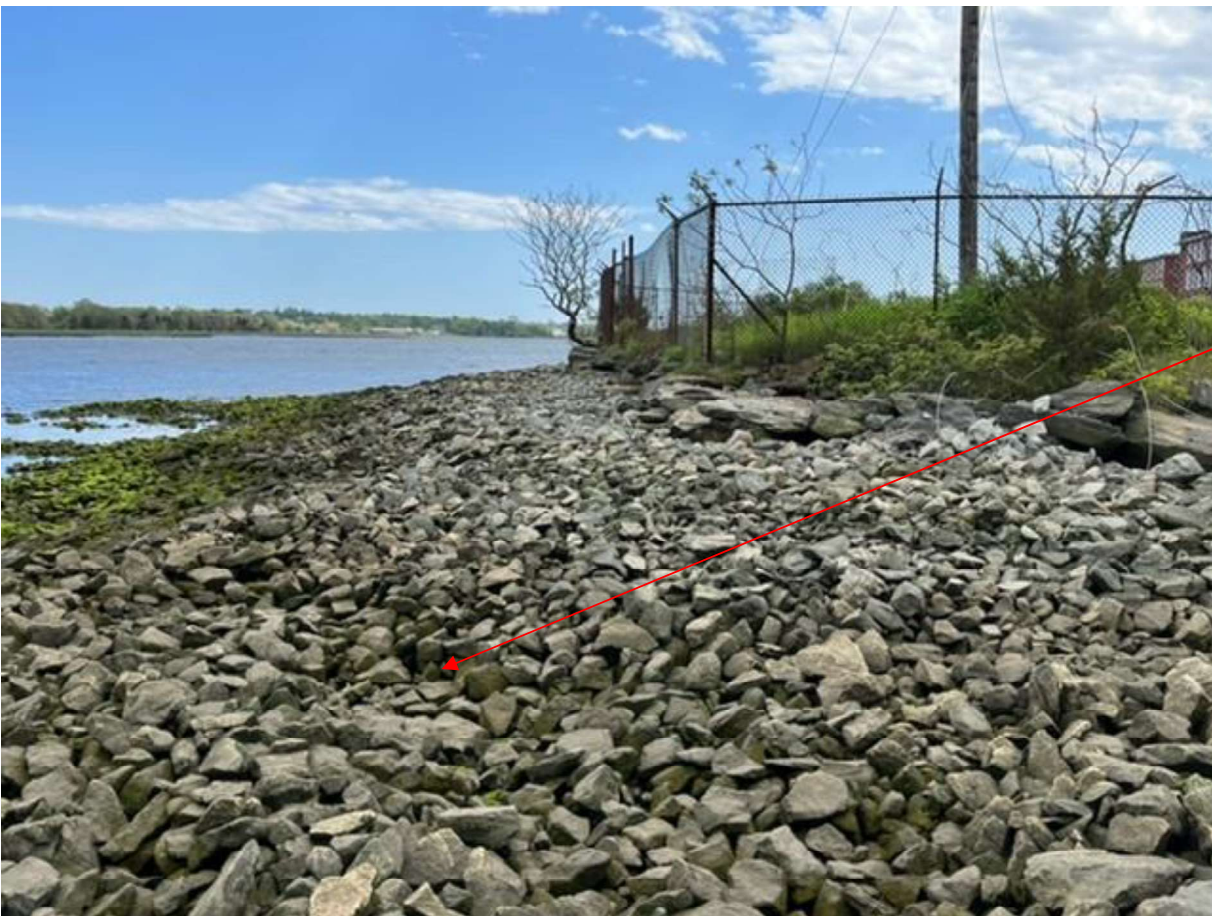
1 - At one small (~3 sf) area at the **Crib cap**, small areas of the sand cap could be seen within the voids of the armor stone (Figures 6 and 7). Armor stone needs to be placed within this area (different than the area noted from the December 2021 inspection).

Figure 6:  
**Crib cap**  
looking south  
showing the  
small area  
needing  
addition of  
armor stone  
(see Figure 7  
for closeup).

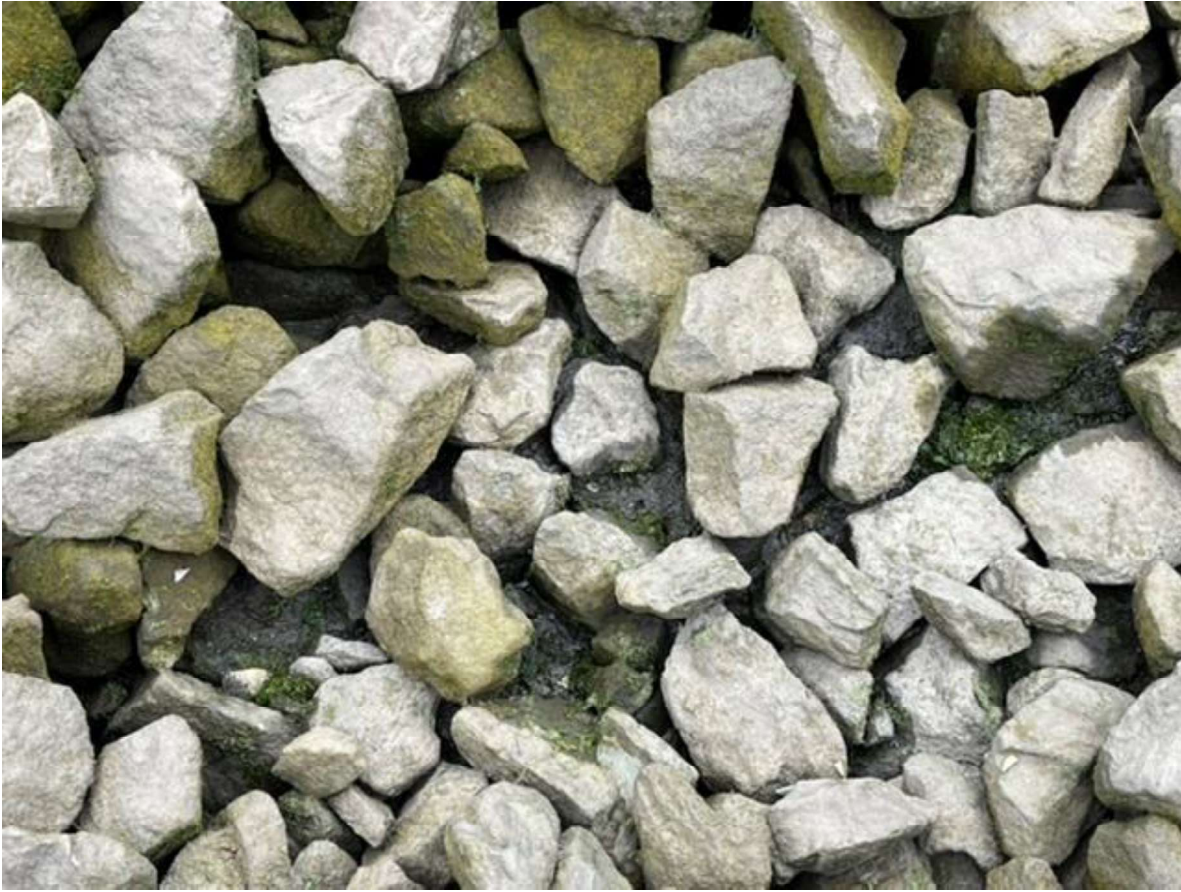
Figure 7: **Crib cap** showing the small areas of exposed sand needing addition of armor stone.

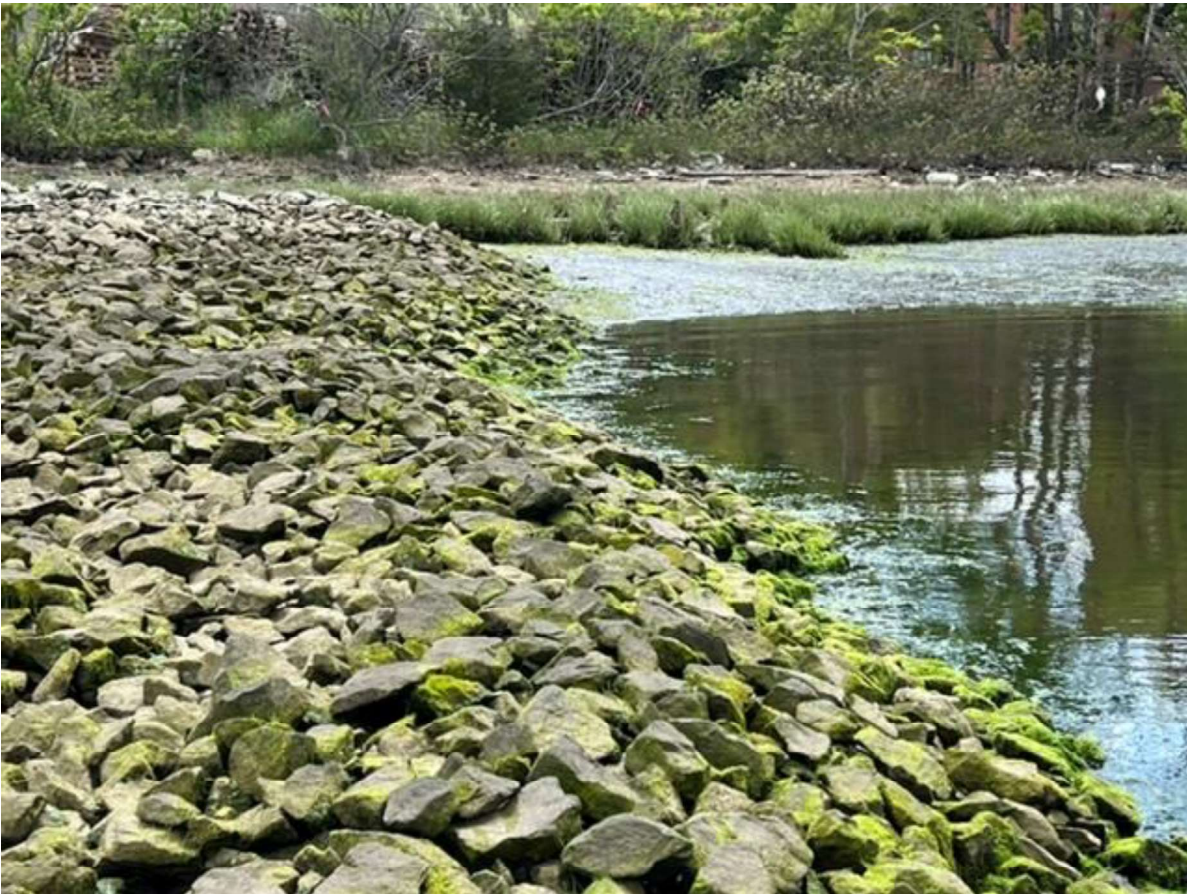
Figure 8: **Crib cap** looking west showing the northern E/W-trending edge of the cap.

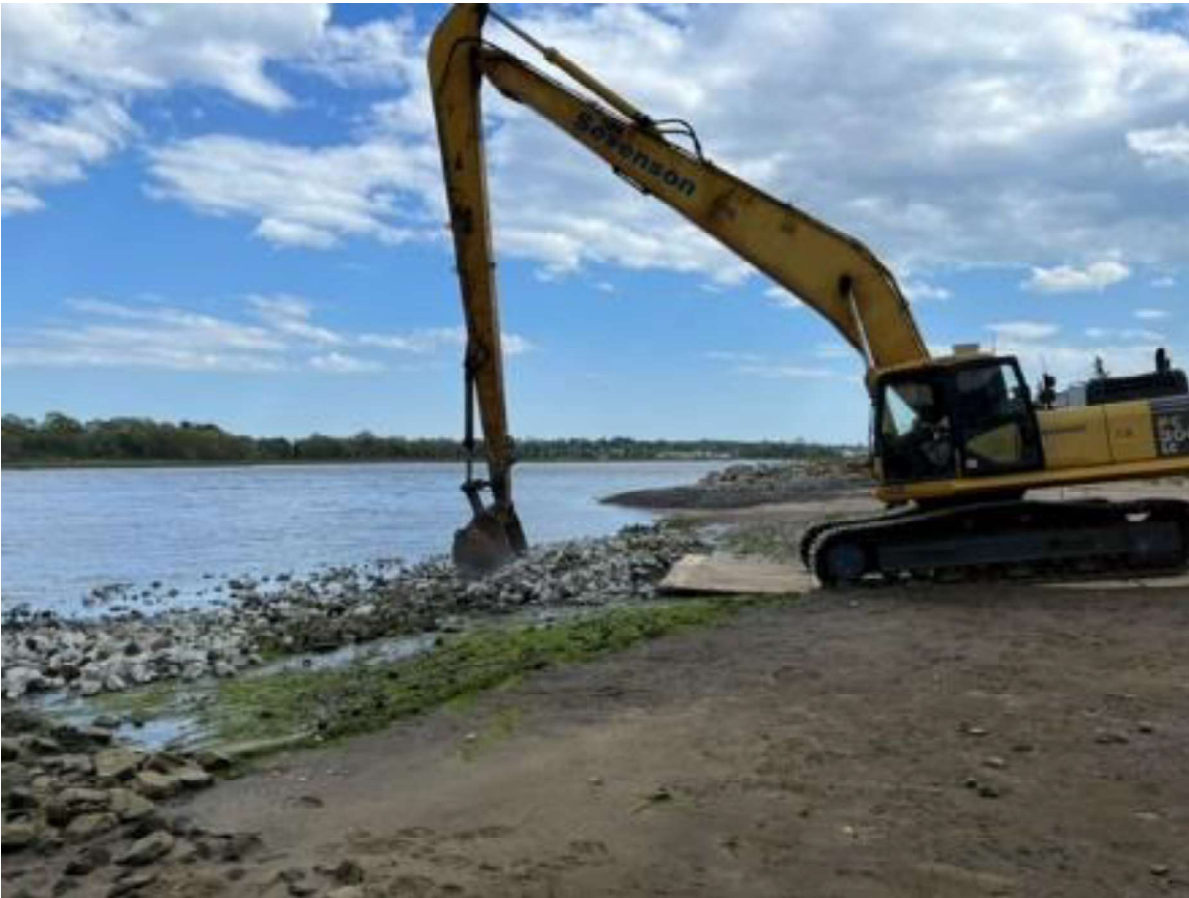
3 – At the **L-014 cap**, the water level did not drop sufficiently to allow visual inspection of the seaward edge of the cap (again, likely due to the strong southerly wind). This seaward edge will have to be viewed again to determine if the cap repairs being performed during the inspection (and the next day) were successful in filling the potentially-damaged areas noted in the December 2021 inspection (Figures 9 and 10).

Figure 9: **L-014 cap** looking south. Additional armor stone being added by the WZ 4 intertidal crew to create a more uniform surface to aid in visual inspections moving forward.

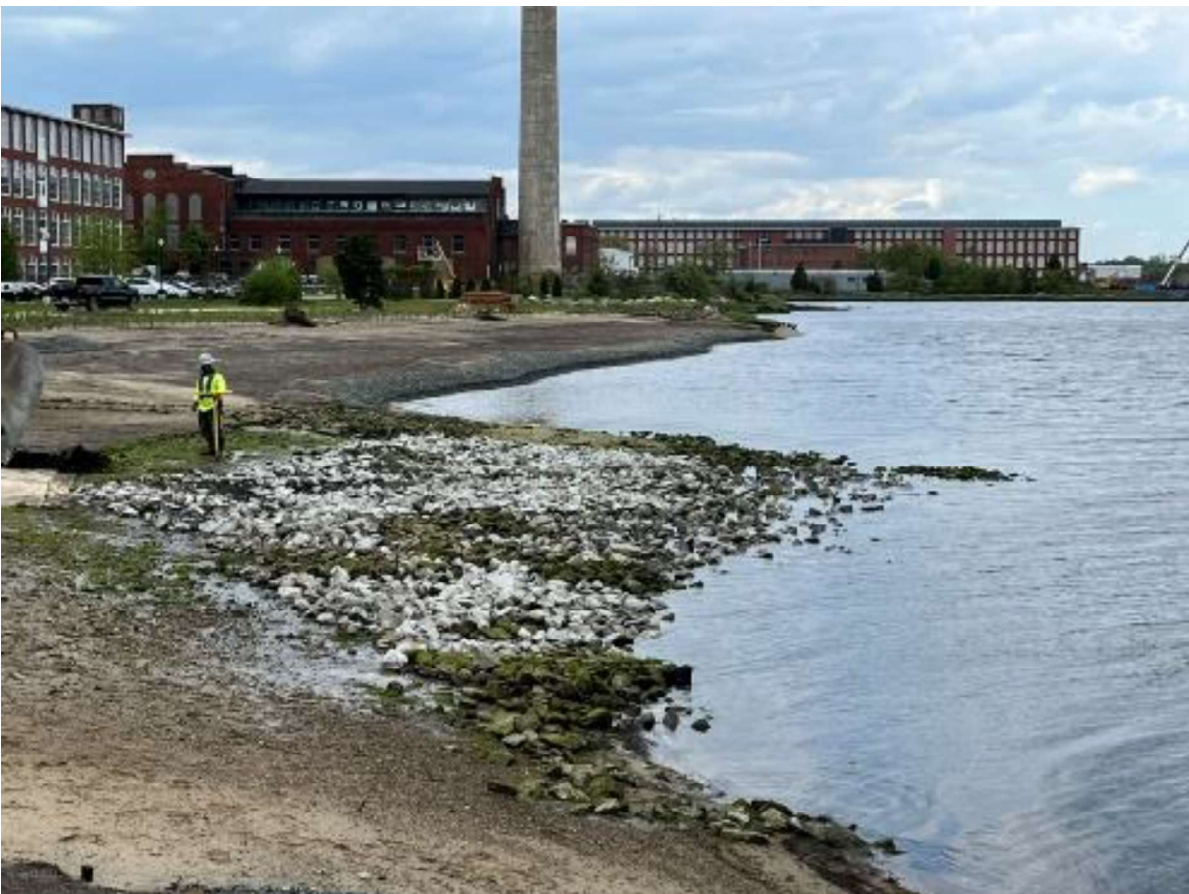
Figure 10: **L-014 cap** looking north. Additional armor stone being added by the WZ 4 intertidal crew.

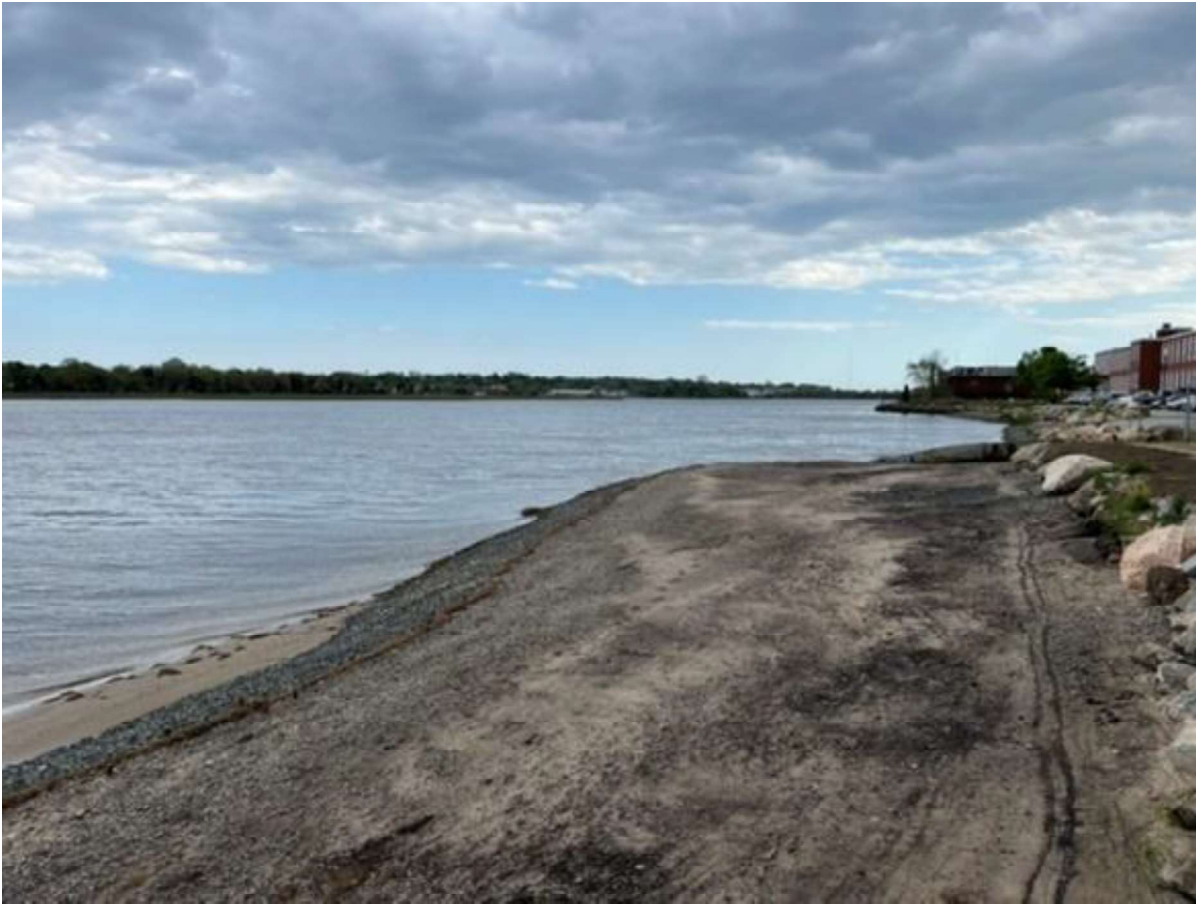
Figure 11: **L-114 cap** (fully submerged, not visible). This photo shows the recently repaired WZ4 intertidal area, ready for saltmarsh plantings. Note coir log and gravel wedge at the seaward face of the low marsh planting area.

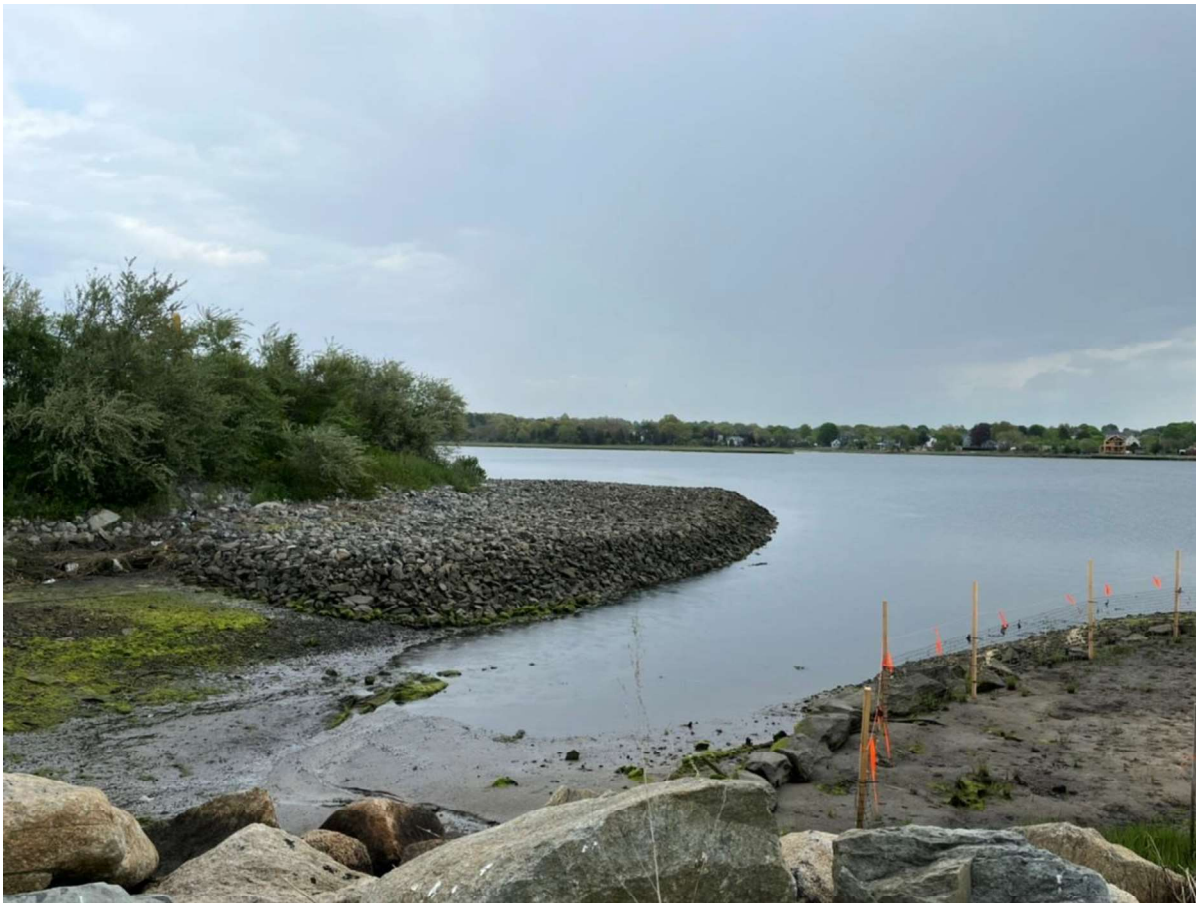
Figure 12: **Pilot CDF shoreline cap** looking northeast showing the southern edge of the cap.

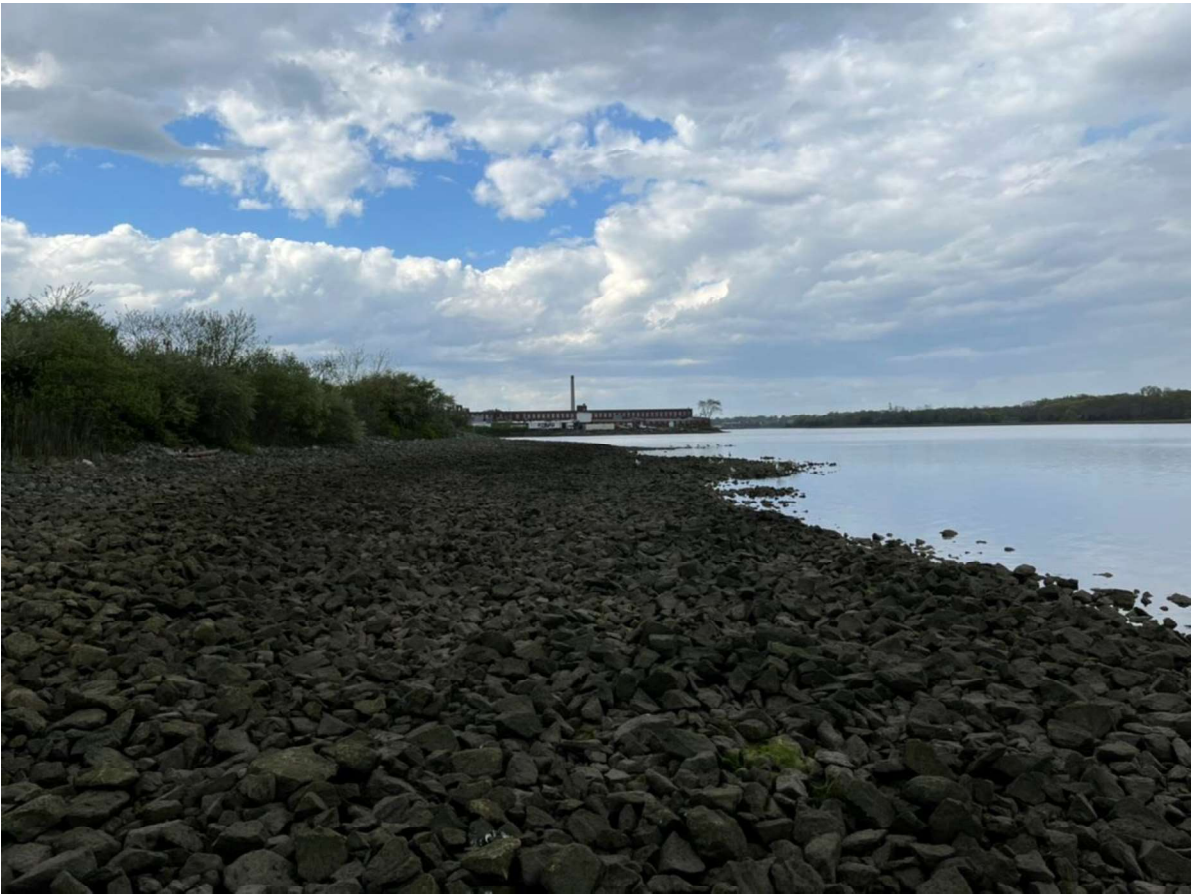
Figure 13: **Pilot CDF shoreline cap** looking north.

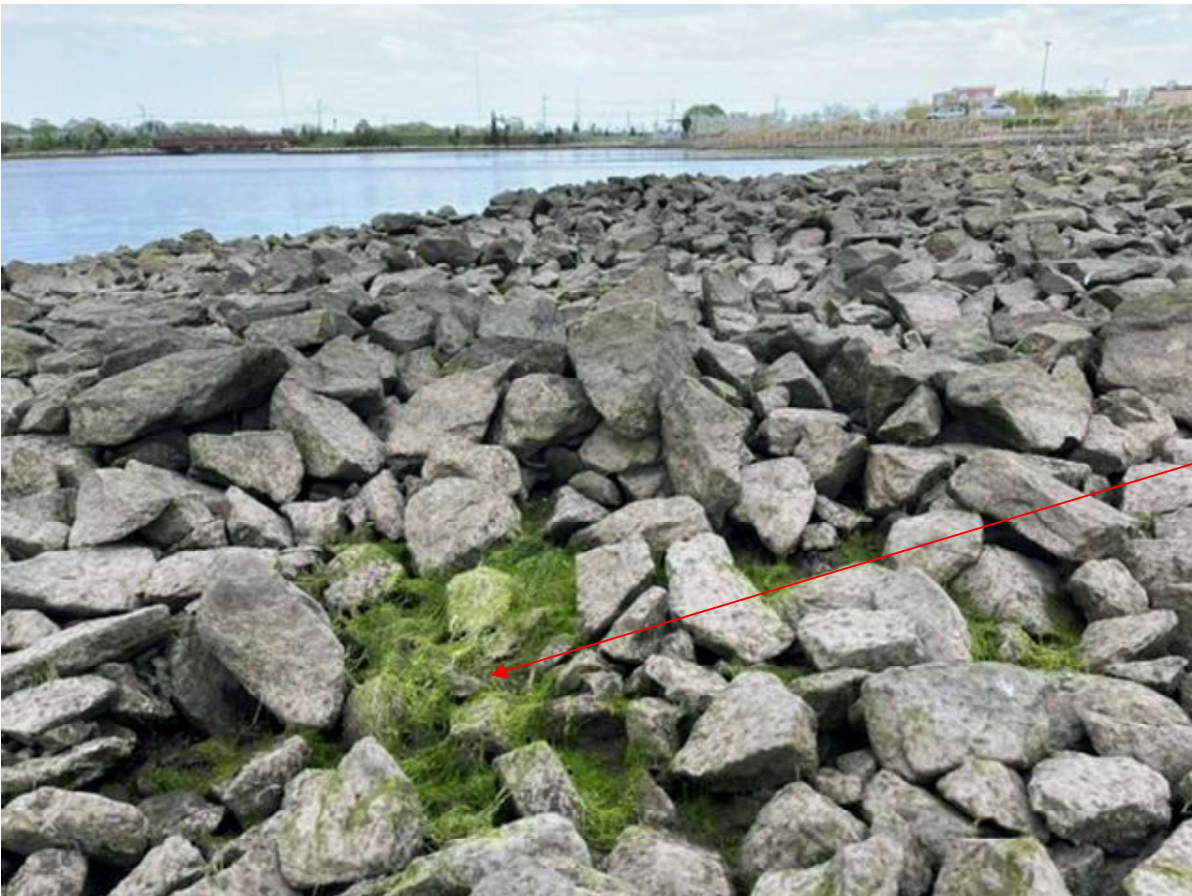
4 – At the **pilot CDF shoreline cap**, one small area (~3 sf) of the sand cap could be seen within the voids of the overlying armor stone (Figure 14). Armor stone needs to be placed within this area.

Figure 14: **Pilot CDF shoreline cap** looking south showing small area needing additional armor stone (area covered with green algae).

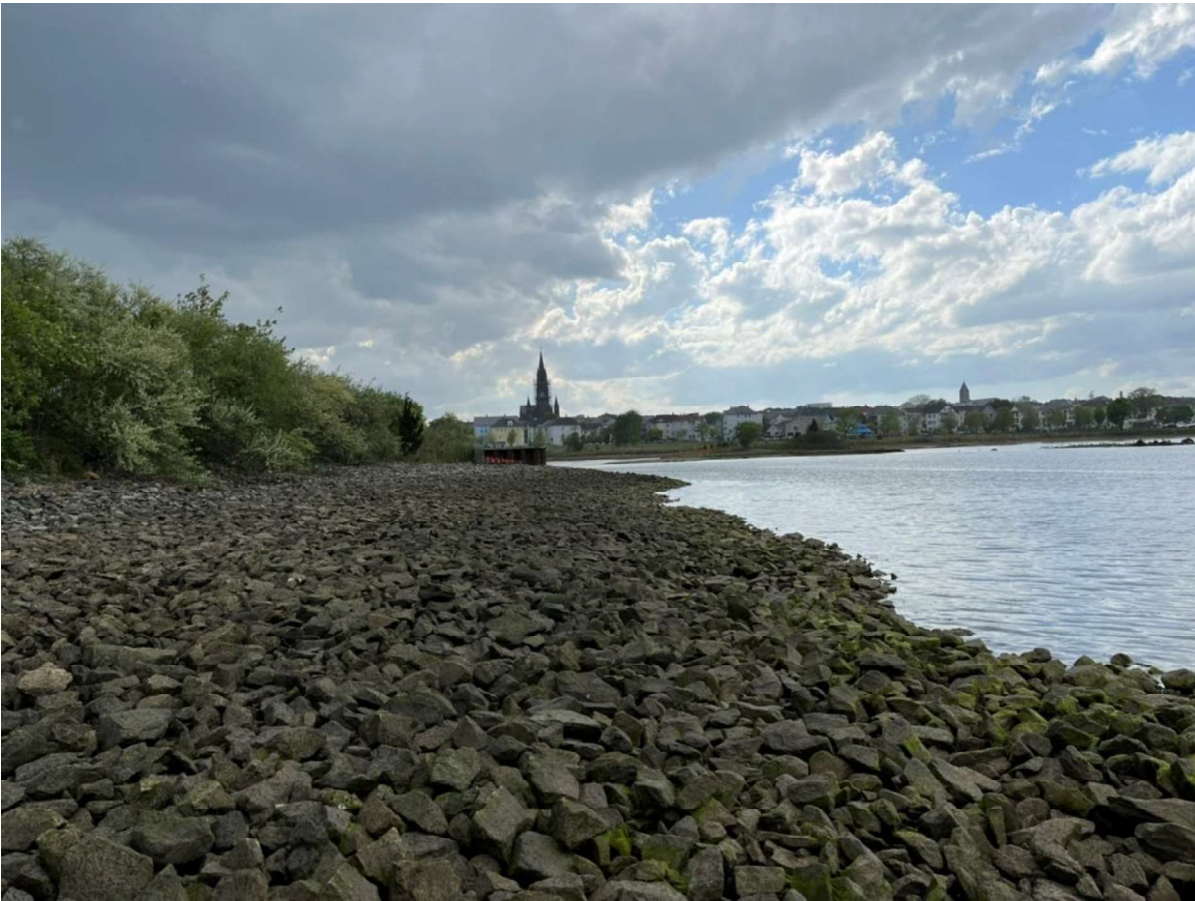
Figure 15:  
**Pilot CDF shoreline cap** looking west showing the northern E/W-trending portion of the cap.

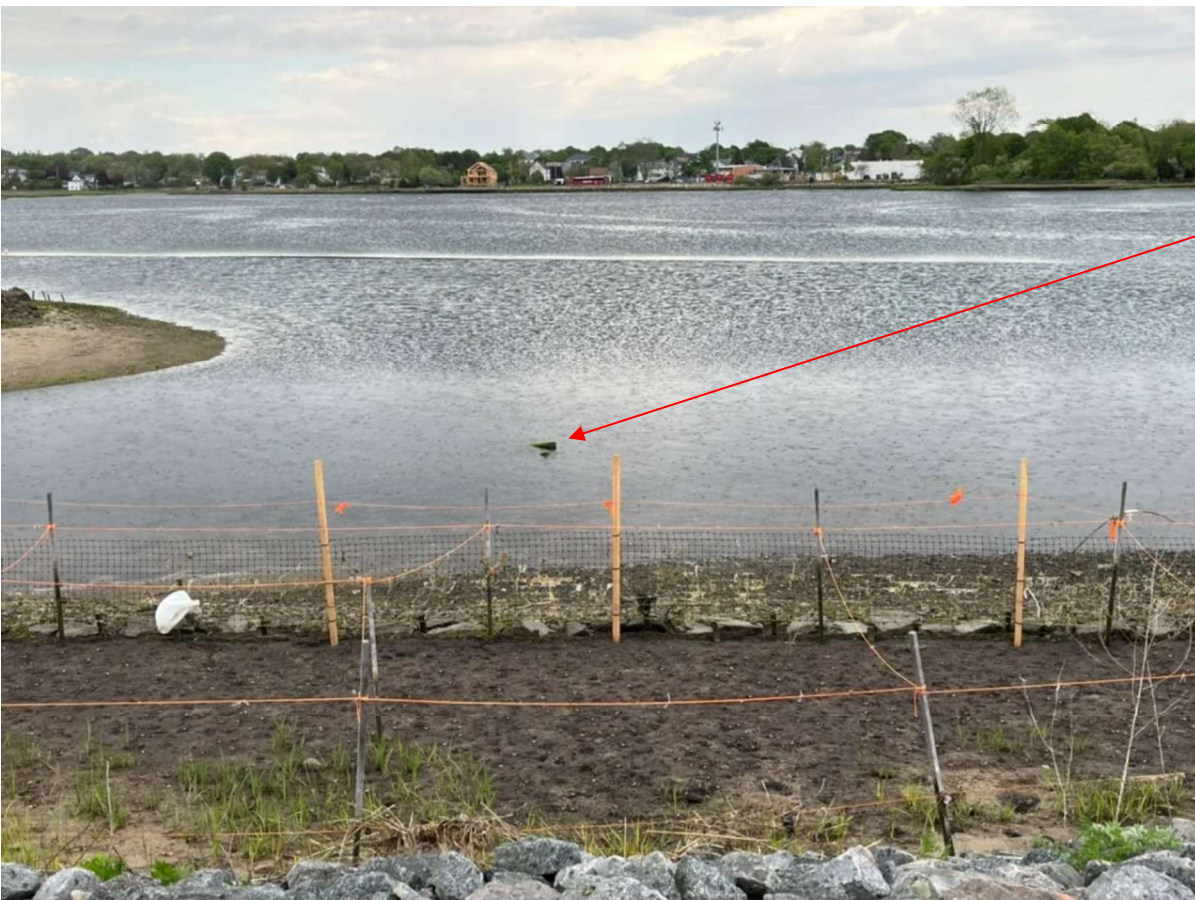
Figure 16:  
**Parcel 265 cap** looking east. Only the very top of the stone cap can be seen. The repaired parcel 265 herbivory fence can be seen in the foreground.

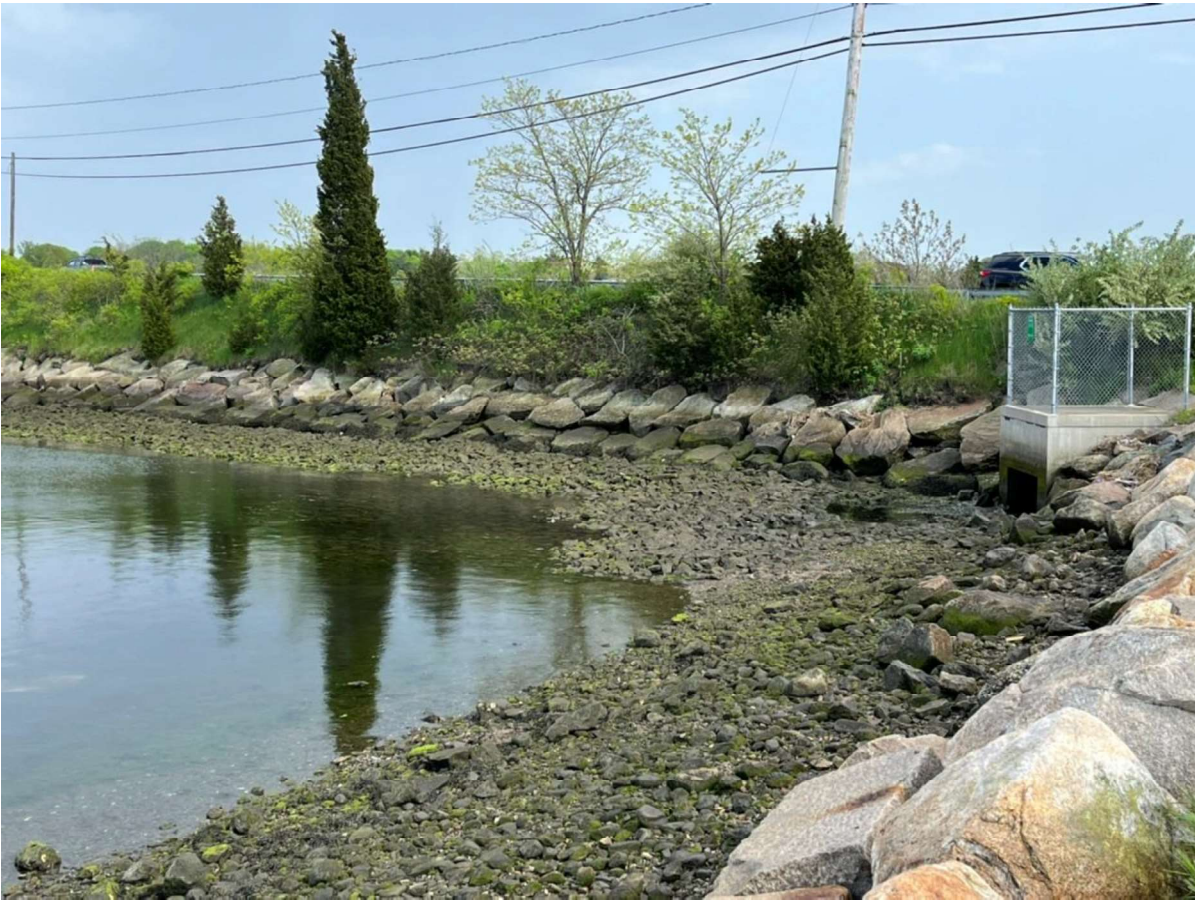
Figure 17:  
**Cogg-West cap** looking south showing the city storm drain.

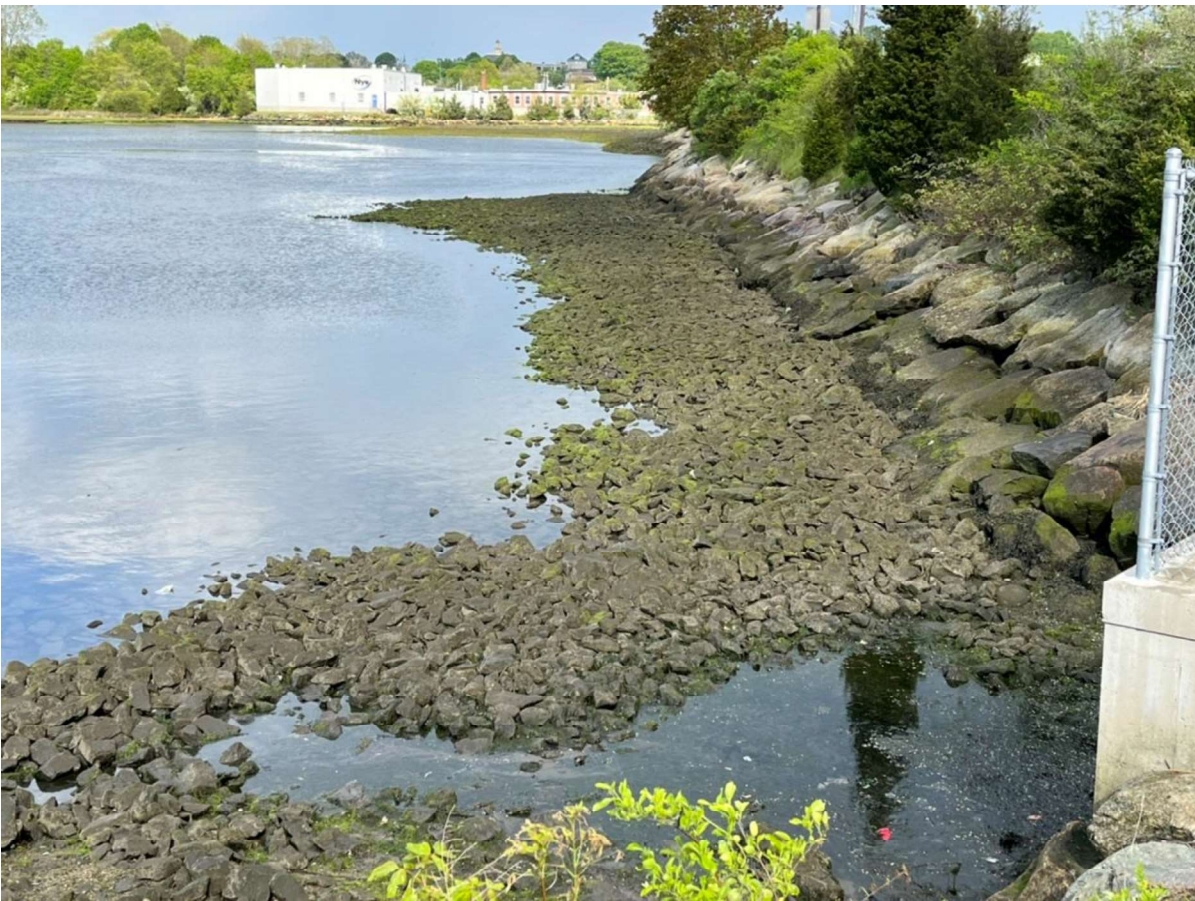
Figure 18:  
**Cogg-West cap** looking east showing the Coggeshall Street bridge embankment.

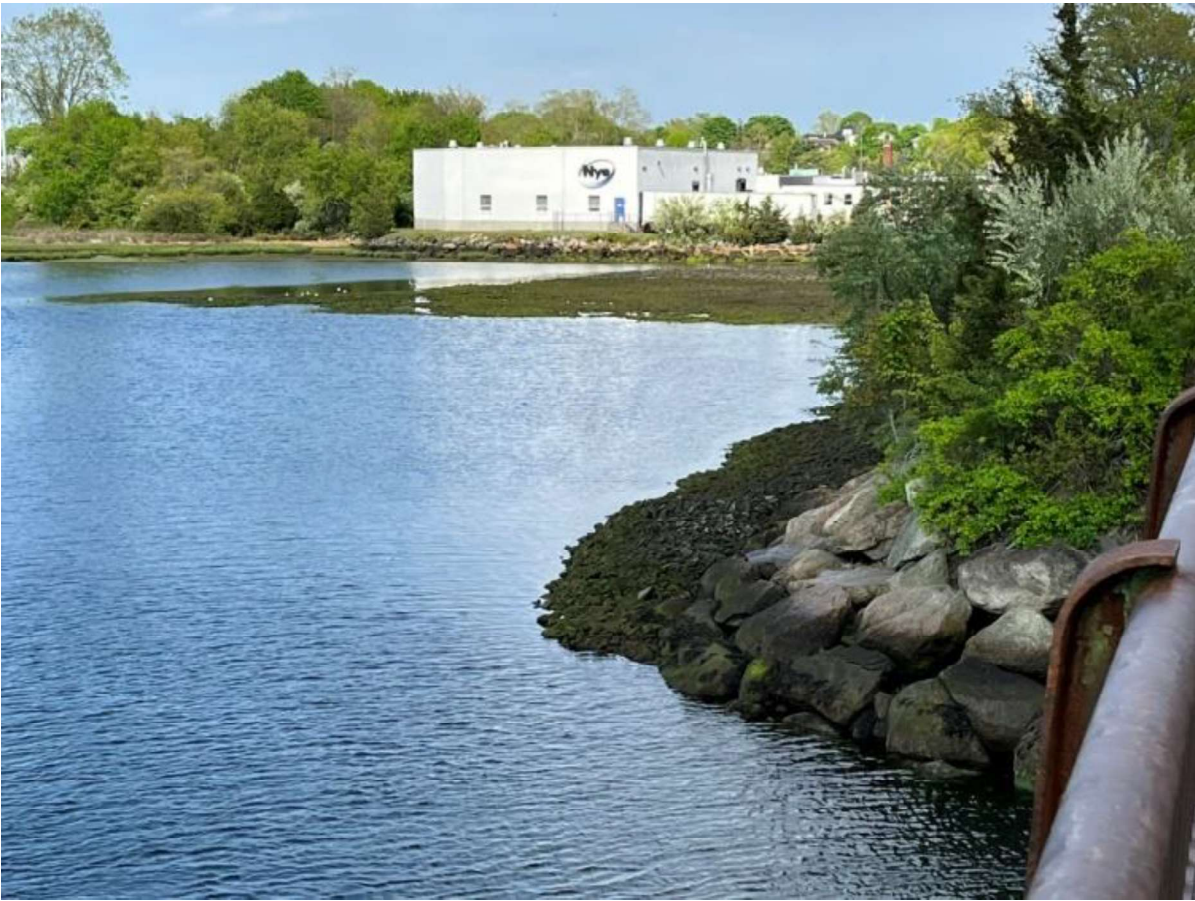
Figure 19:  
**Cogg-West cap** looking east showing the Coggeshall Street bridge opening.

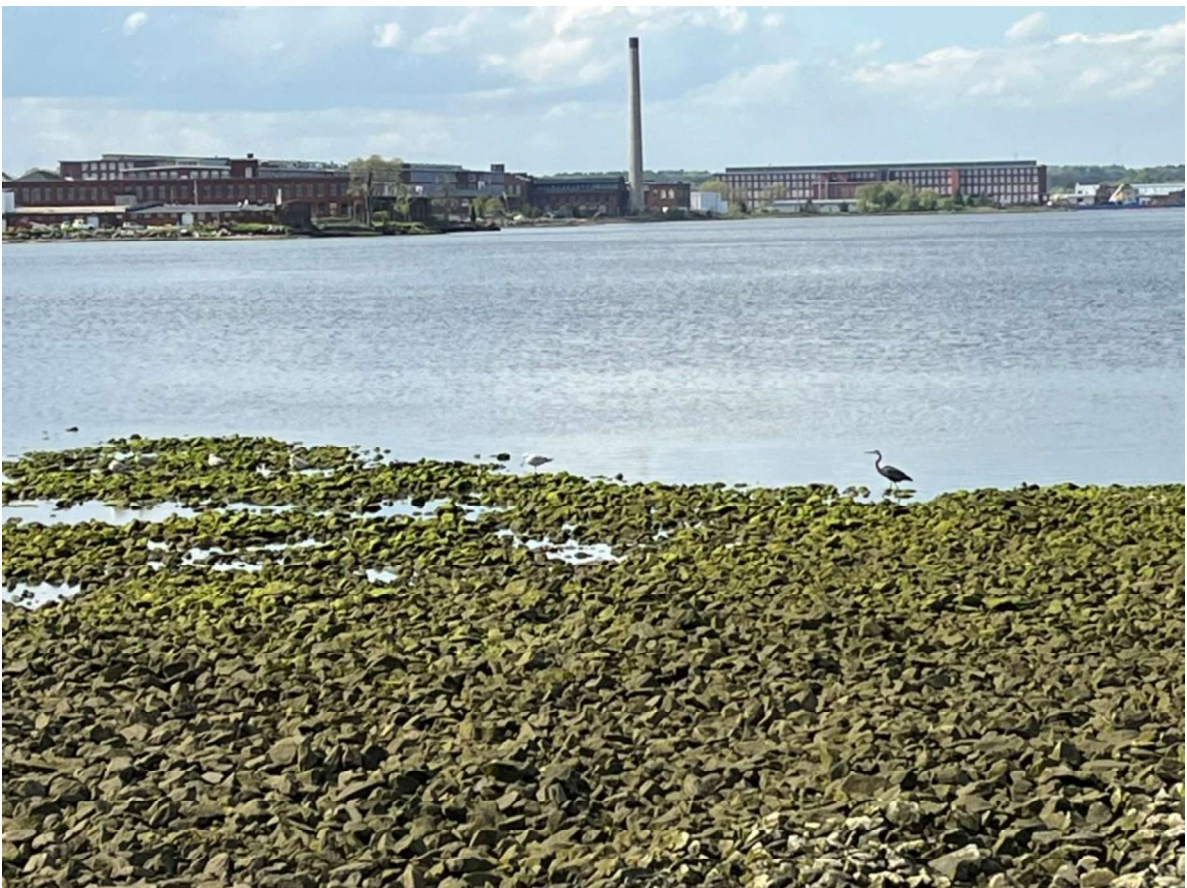
Figure 20:  
**Cogg-West cap** looking north. Note the great blue heron at the cap edge.

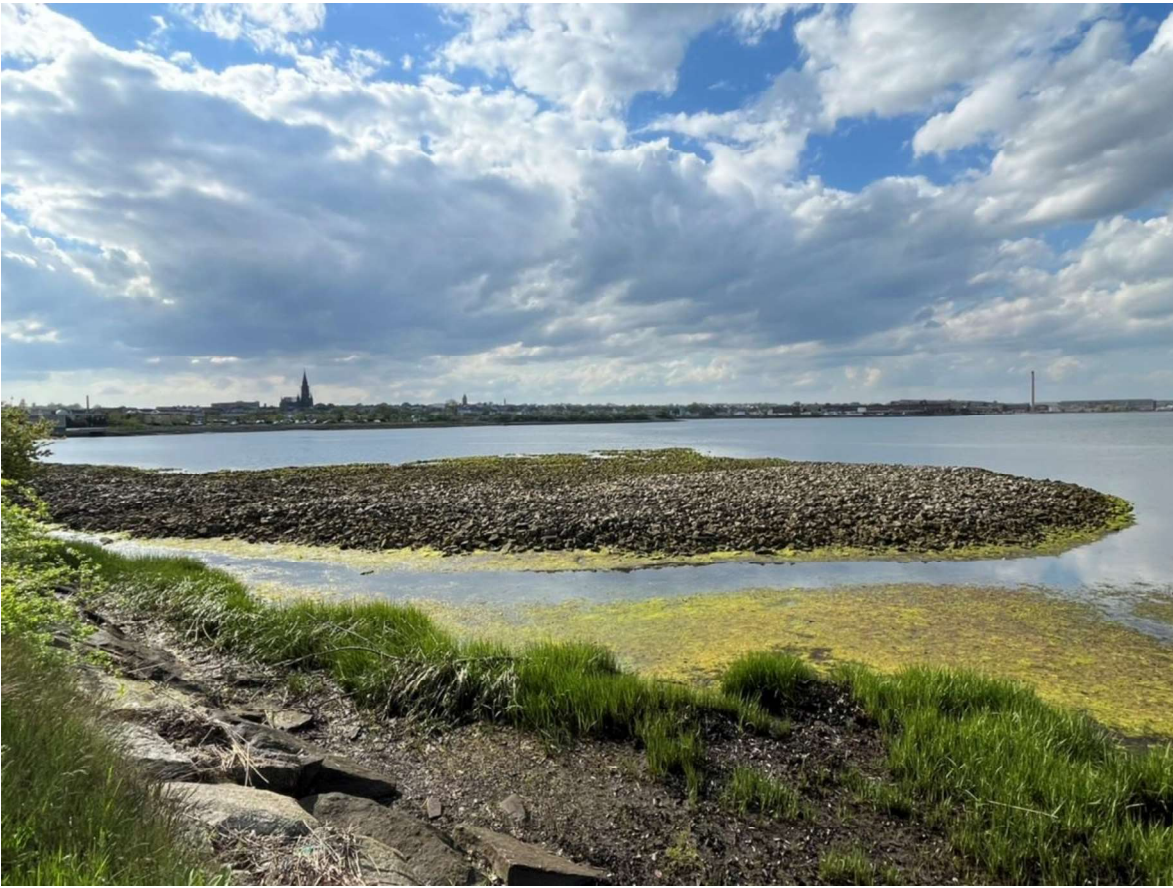
Figure 21: **Coggeshall West cap** looking northwest. Note the *Ulva* seaweed, typically a sign of nutrient/ nitrogen enrichment.
