Kevin Mooney
Senior Project Manager
Global Operations - Environment, Health & Safety

General Electric Company
1 Plastics Ave.
Pittsfield, MA 01201

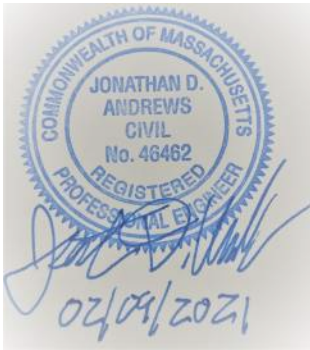
Jonathan D. Andrews, P.E.

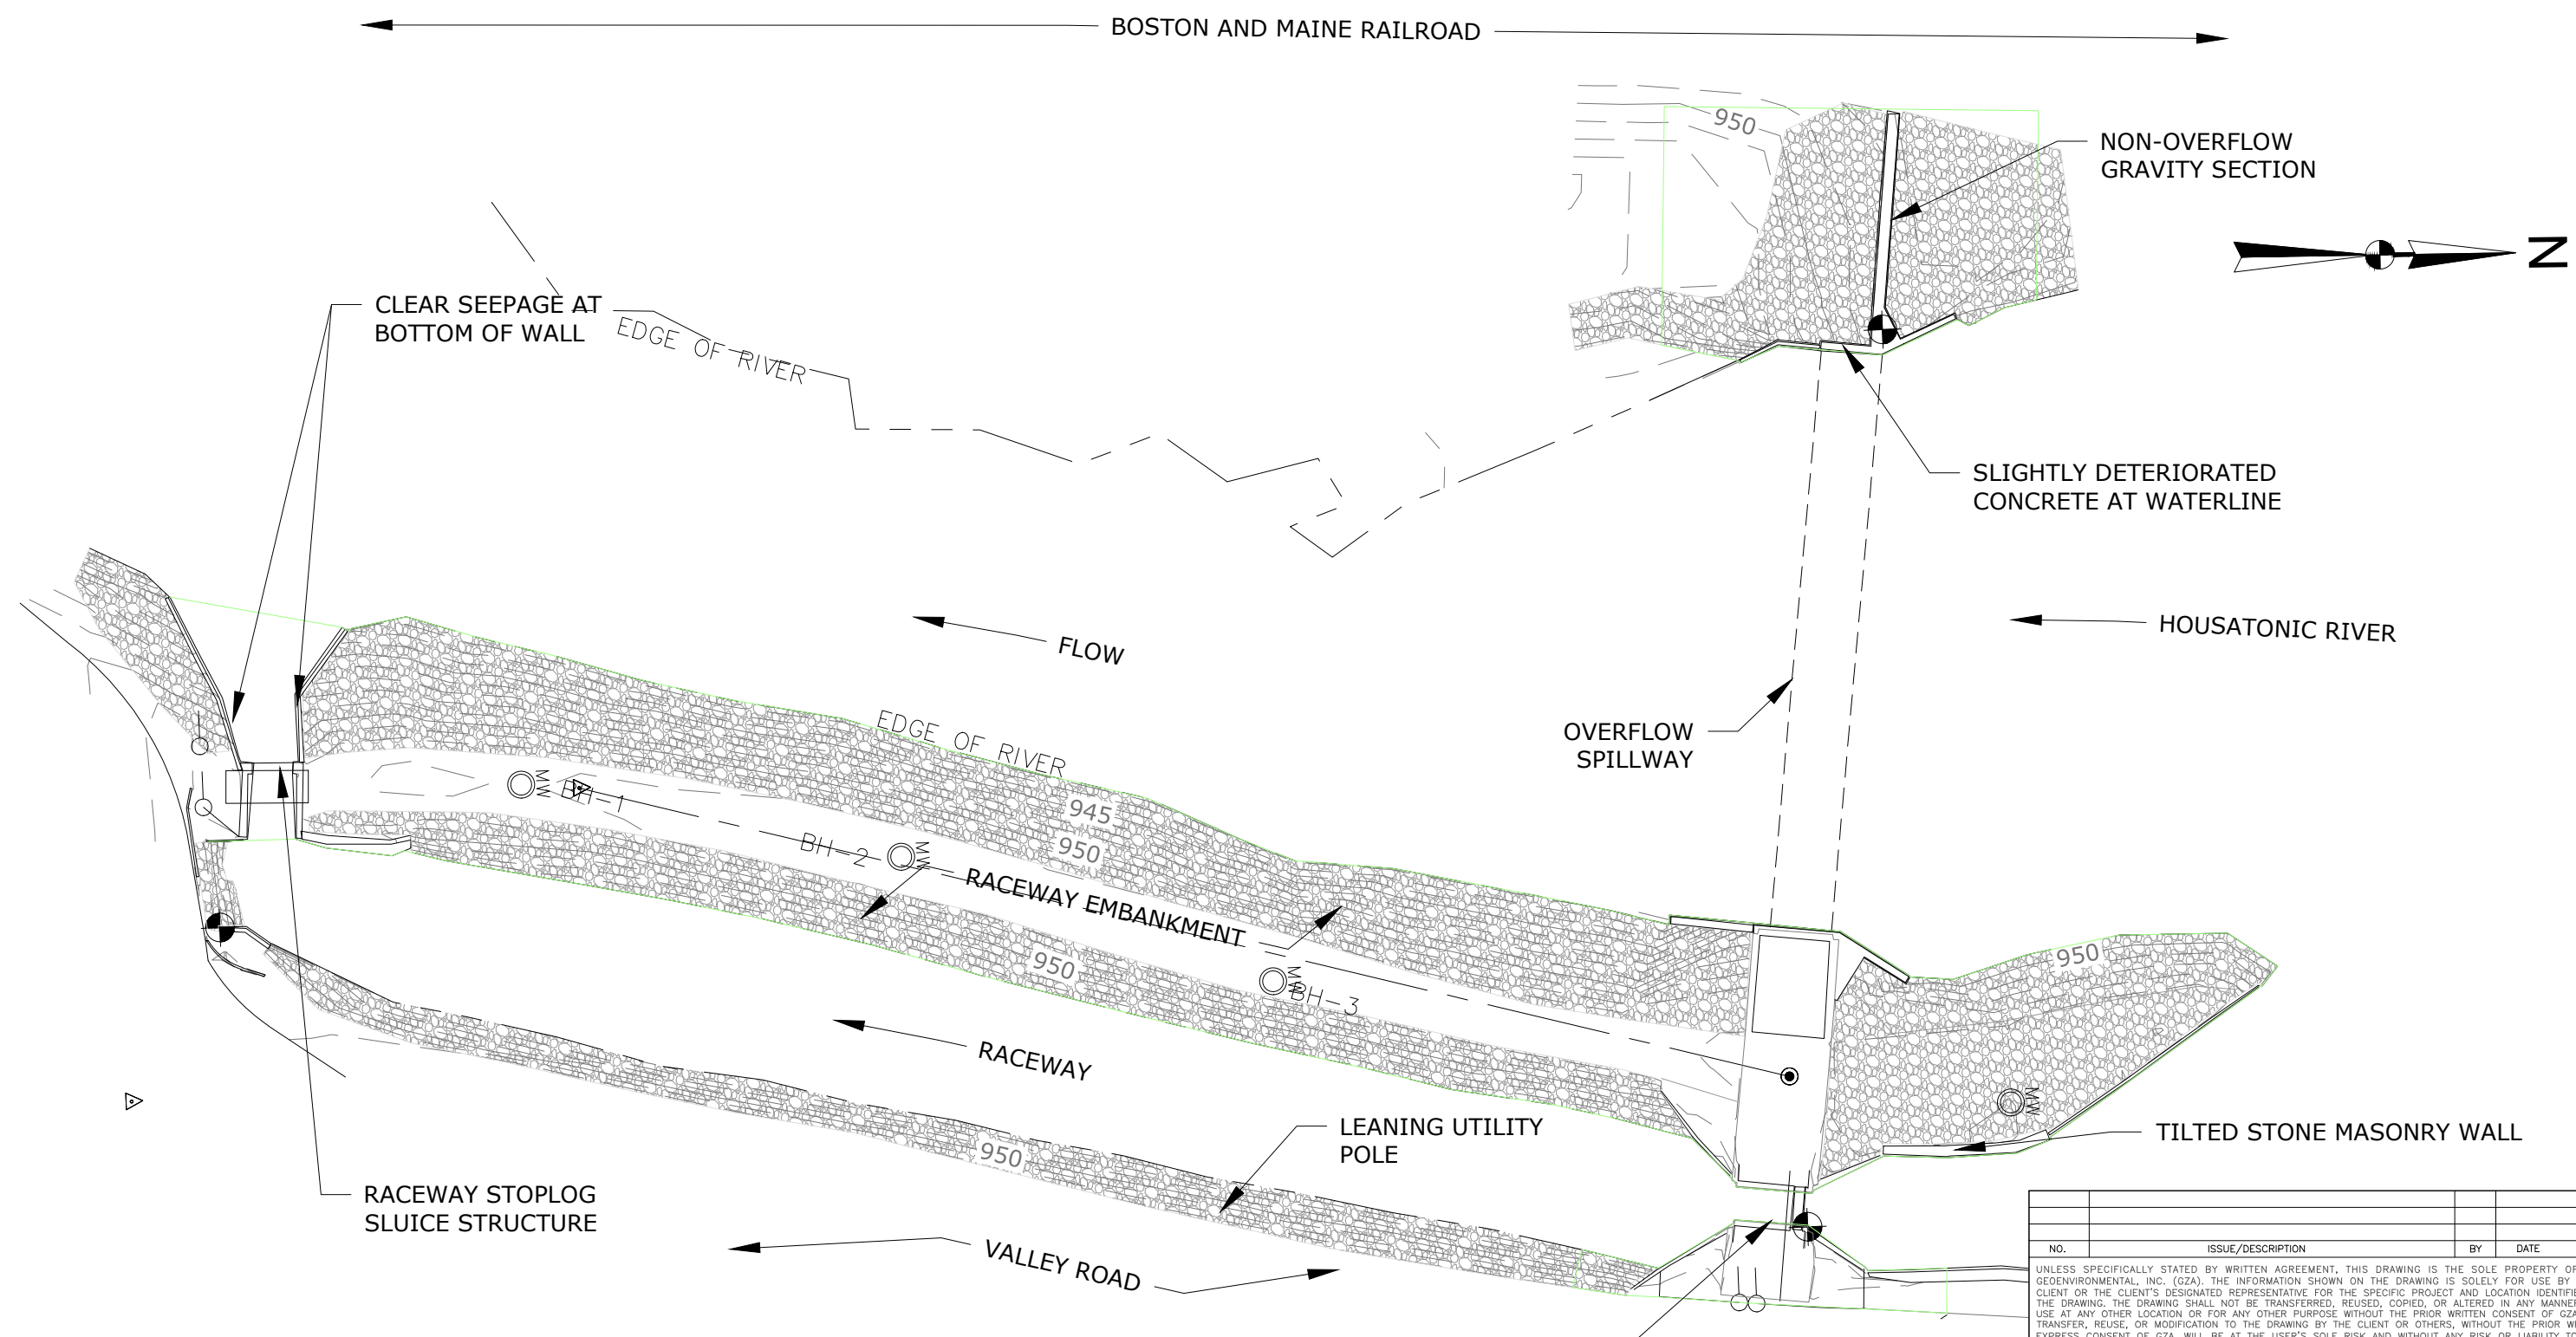
© 2020 - GZA GeoEnvironmental, Inc. GZA-J:\19,000-20,999\19896-50.LAG INSPECTIONS FOR RISING+WOODS\INSPECTIONS\BIENNIAL\PHASE I 2021\FIGURES\WPD BIENNIAL FIGURES 2021.DWG CONDITIONS

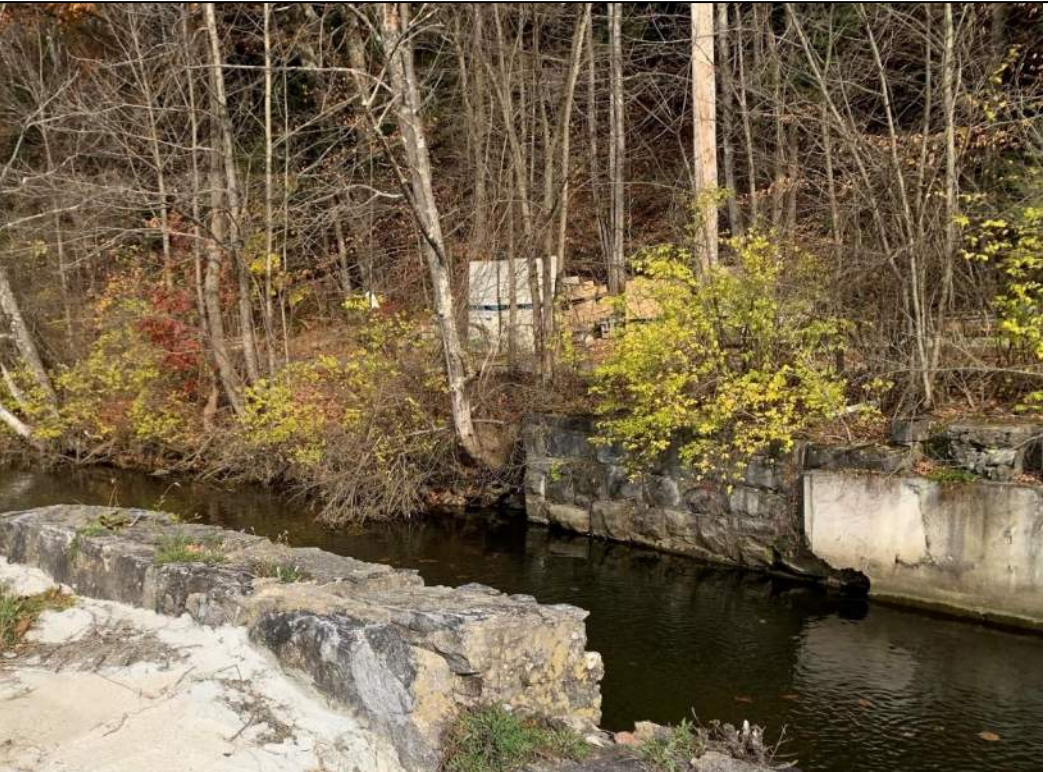
Direction Photo Taken: Right			
Description: Upstream left raceway approach training wall showing area previously repaired.

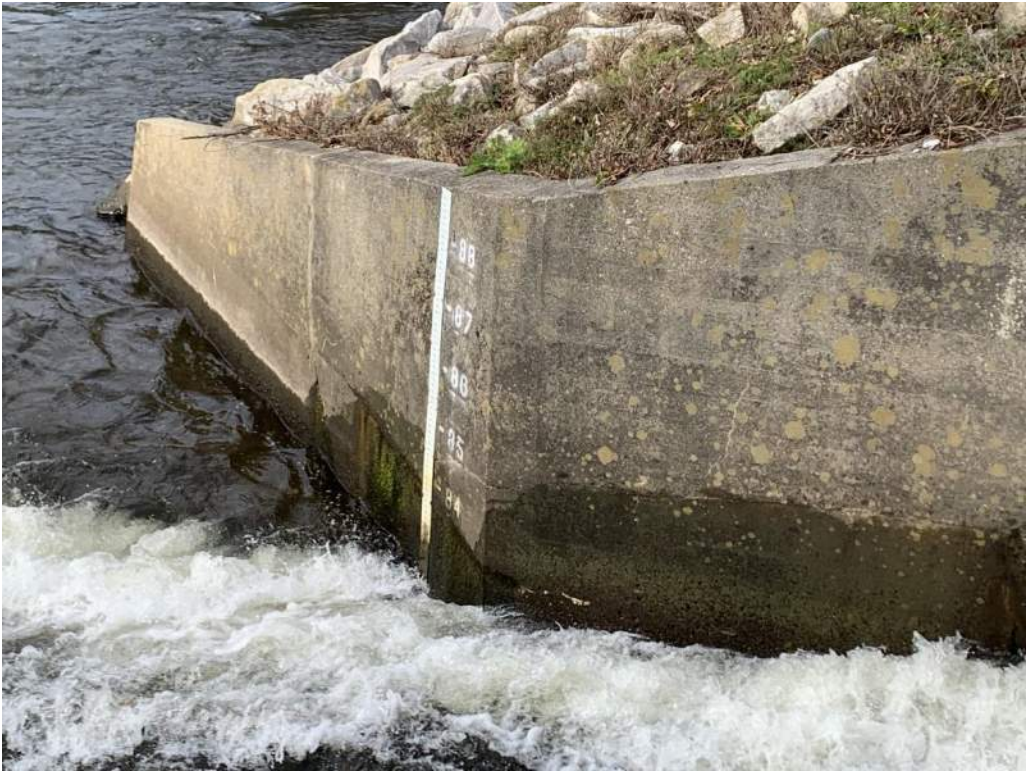
Direction Photo Taken: Upstream			
Description: Downstream raceway outlet left training wall. Note cracking and seepage on left of photo. Note recently painted staff gauge.

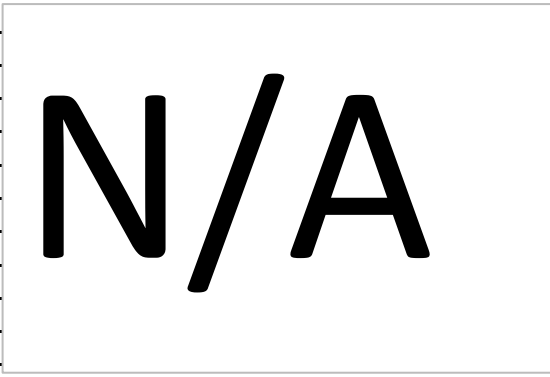
2. WALL ALIGNMENT				
	3. WALL CONDITION				
	4. HEIGHT: TOP OF WALL TO MUDLINE min:				
	5. ABUTMENT CONTACT				
	6. EROSION/SINKHOLES BEHIND WALL				
	7. ANIMAL BURROWS				
	8. UNUSUAL MOVEMENT

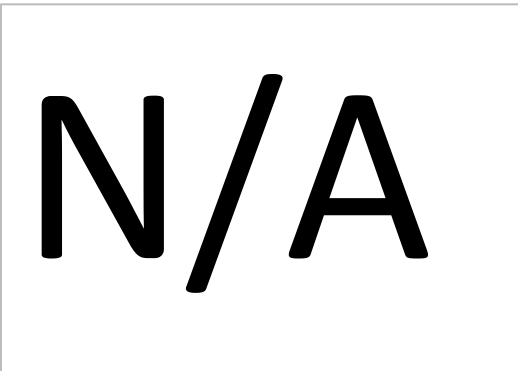
WEIR TYPE				
	SPILLWAY CONDITION				
	TRAINING WALLS				
	SPILLWAY CONTROLS AND CONDITION				
	UNUSUAL MOVEMENT				
	APPROACH AREA				
	DISCHARGE AREA				
	DEBRIS				
	WATER LEVEL AT TIME OF INSPECTION

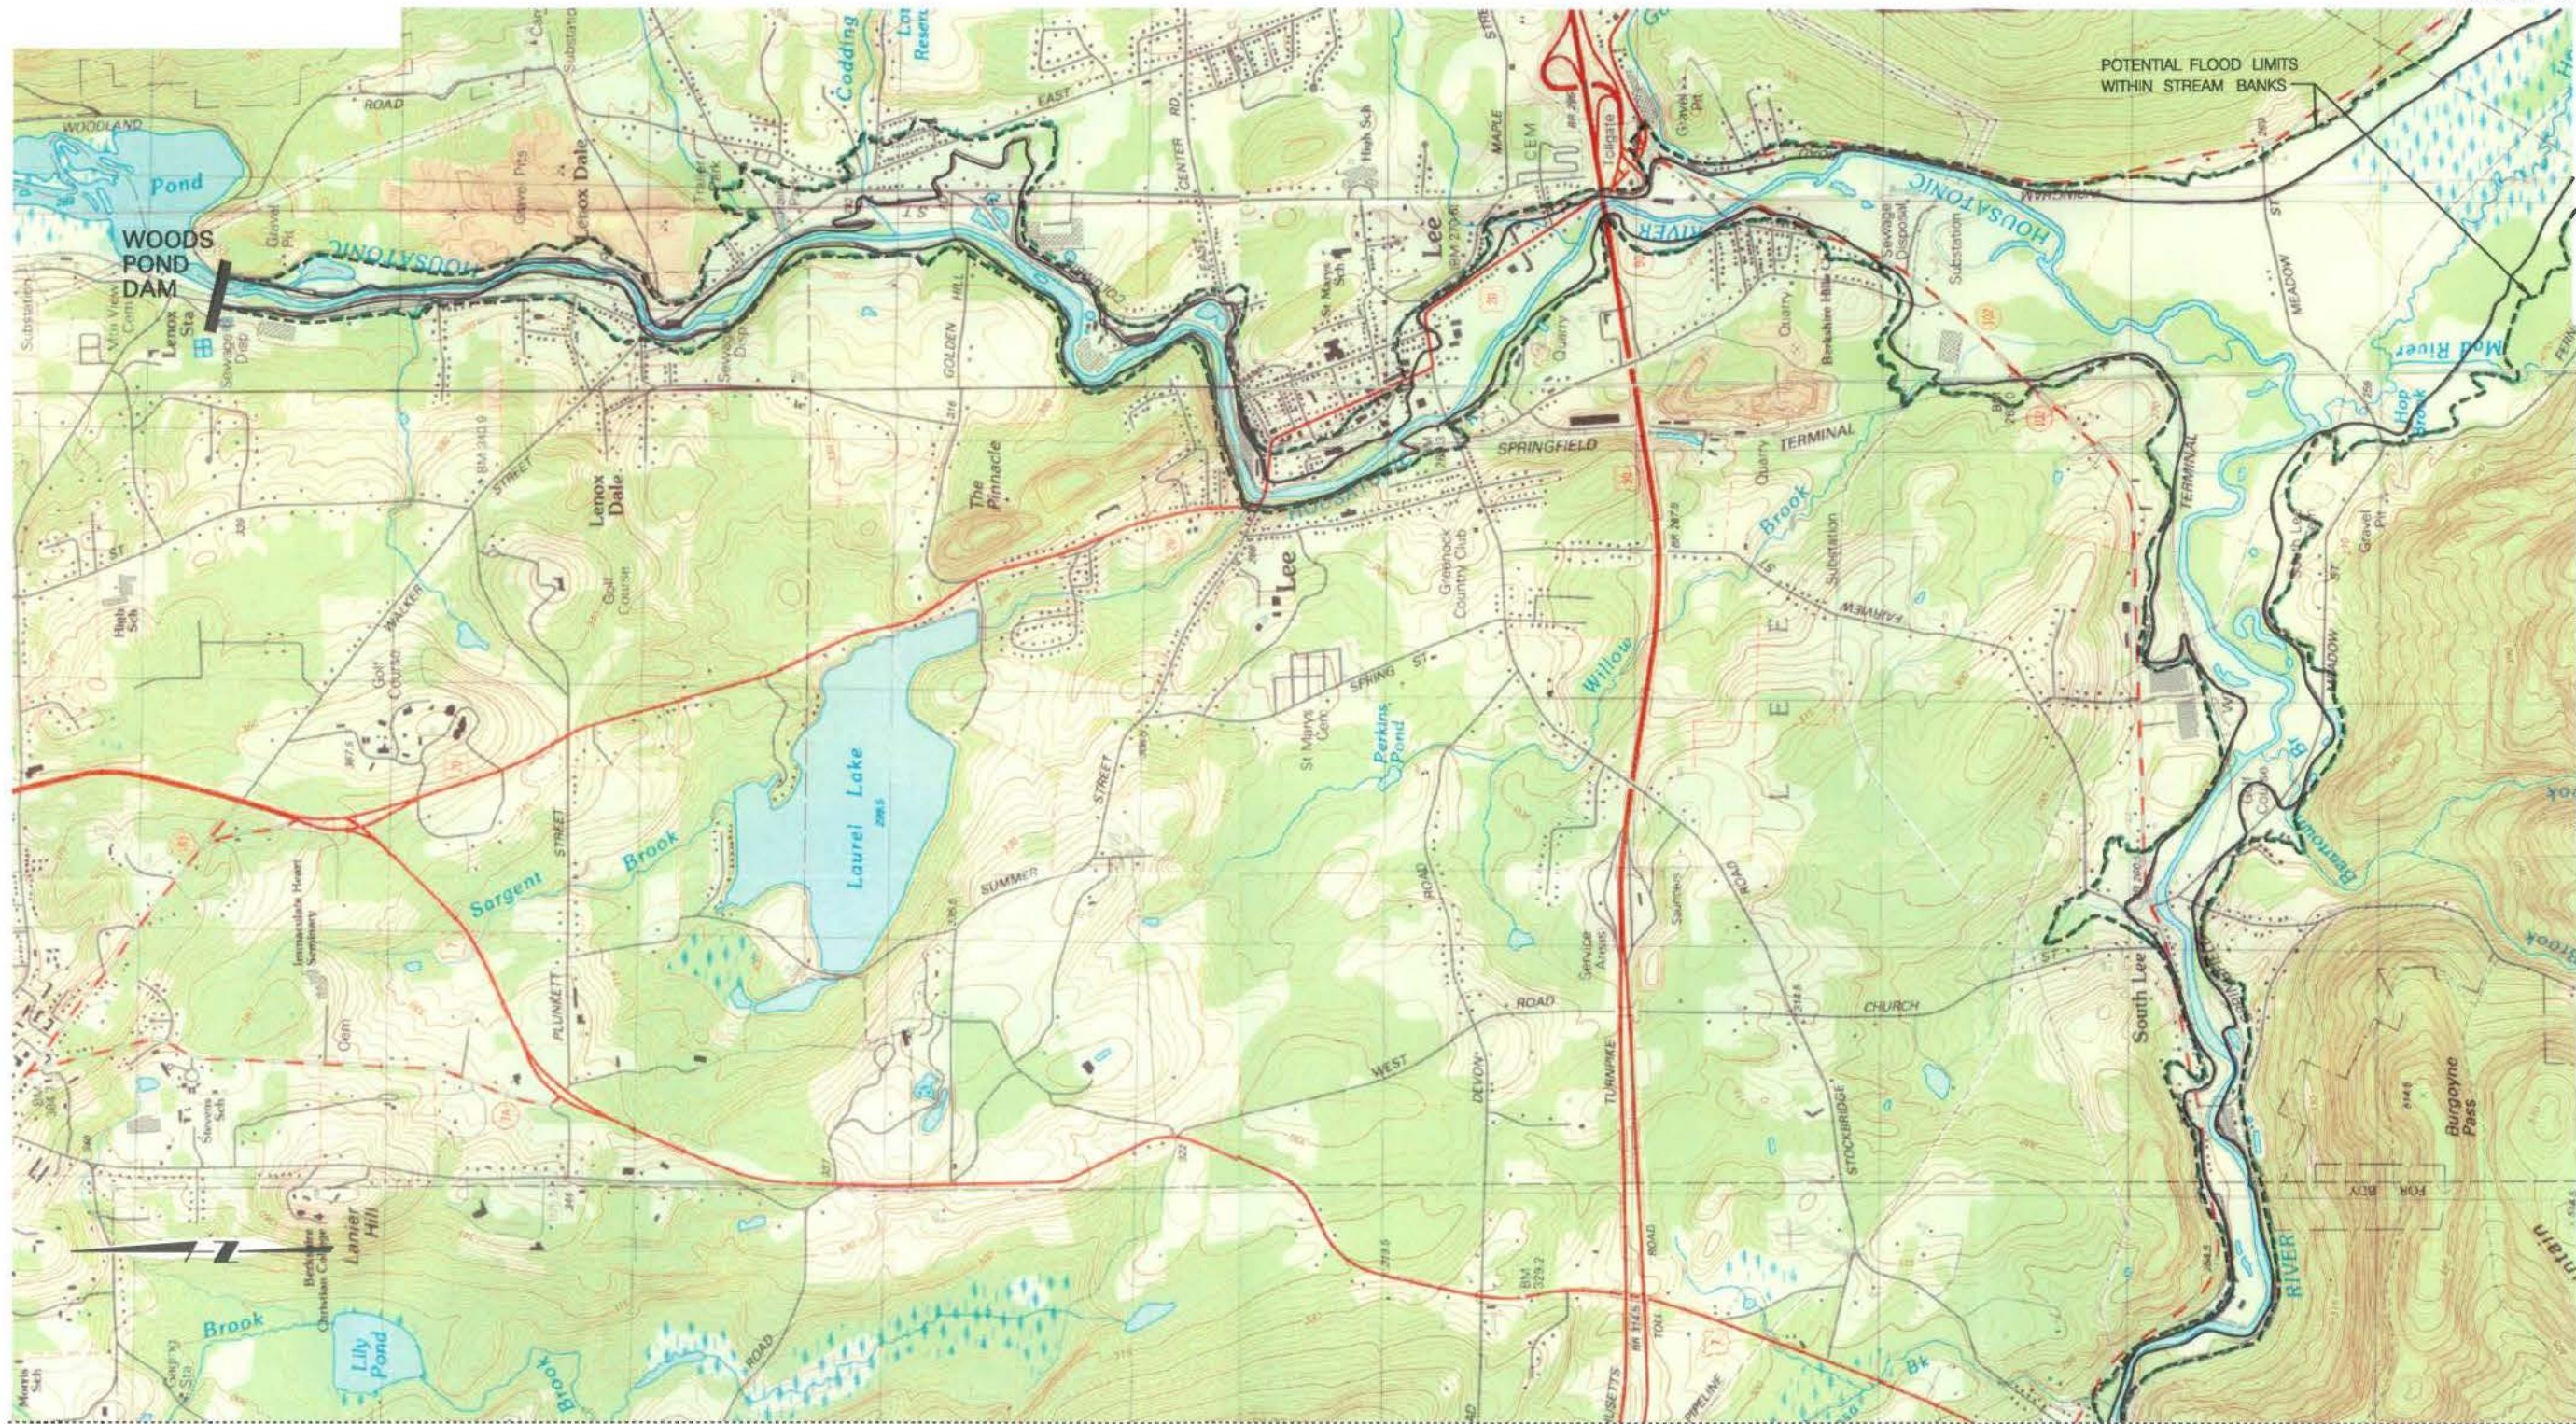
APPENDIX F – MAPPING AND TOPOGRAPHIC AND BATHYMETRIC SURVEY

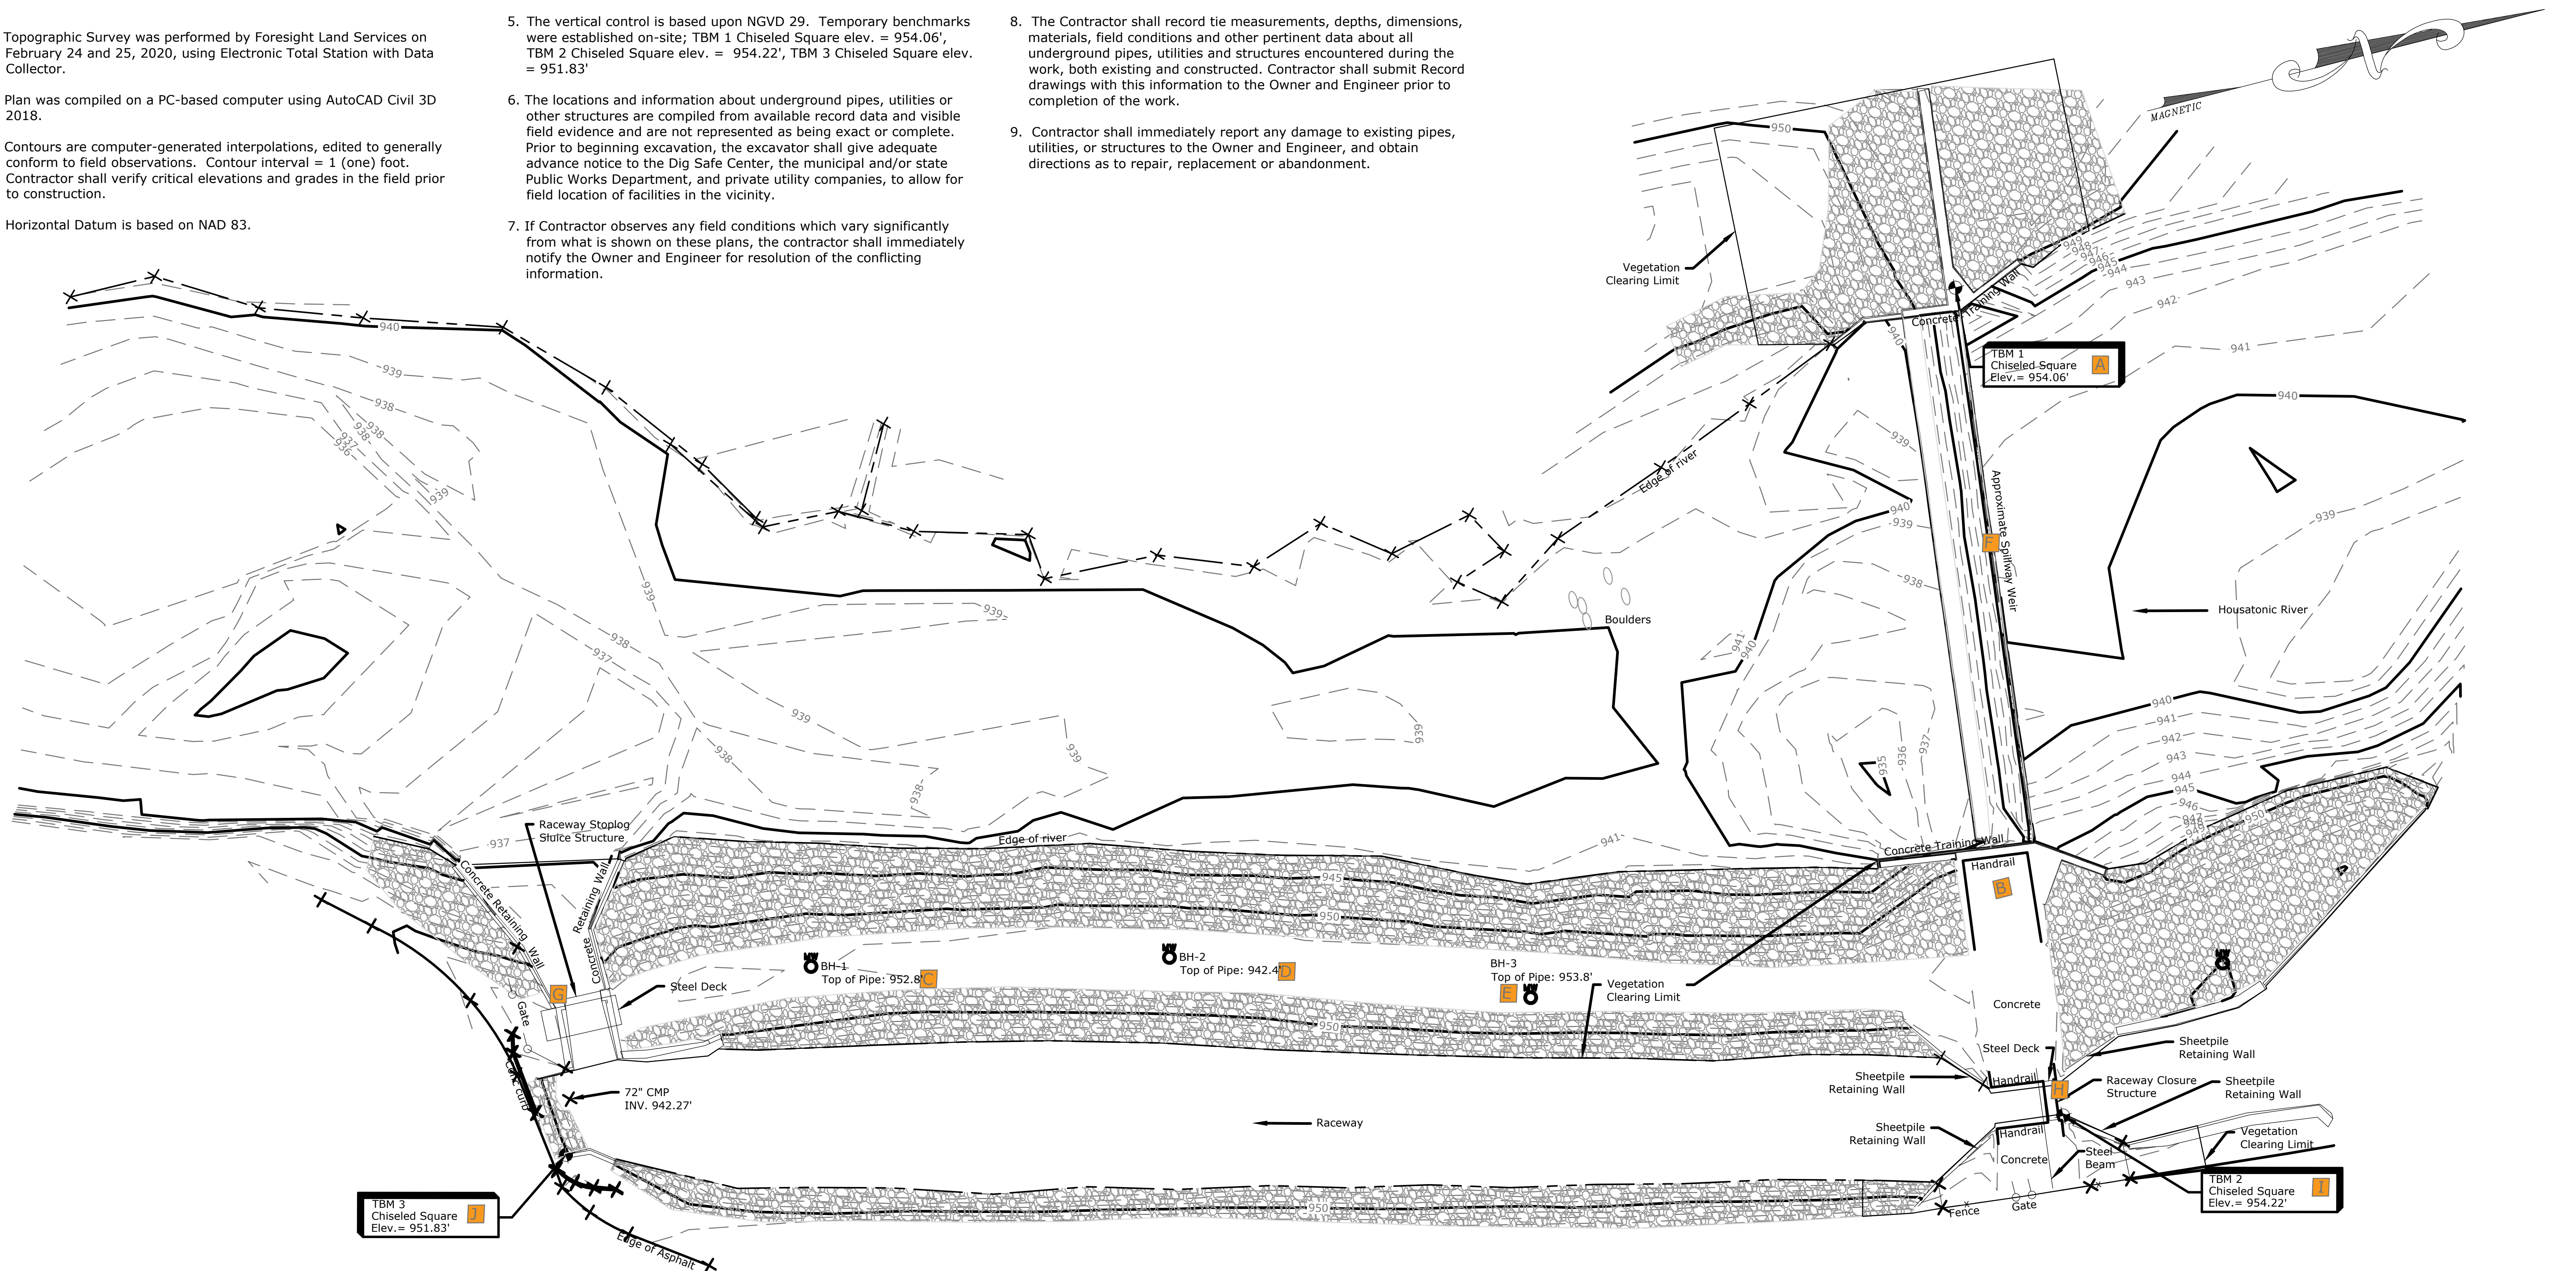
8. The Contractor shall record tie measurements, depths, dimensions, materials, field conditions and other pertinent data about all underground pipes, utilities and structures encountered during the work, both existing and constructed. Contractor shall submit Record drawings with this information to the Owner and Engineer prior to completion of the work.
9. Contractor shall immediately report any damage to existing pipes, utilities, or structures to the Owner and Engineer, and obtain directions as to repair, replacement or abandonment.

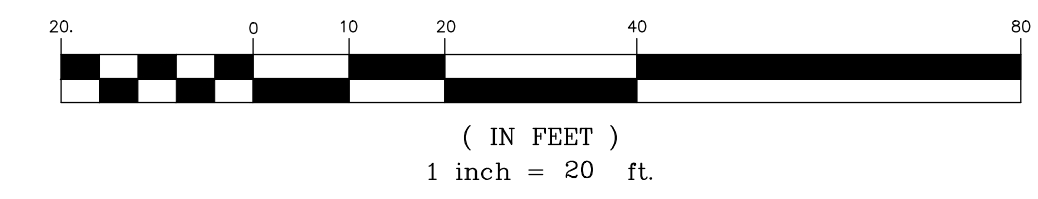
NO.	DATE	REVISION	BY
