Kevin Mooney
Senior Project Manager
Global Operations - Environment, Health & Safety

General Electric Company
1 Plastics Ave.
Pittsfield, MA 01201

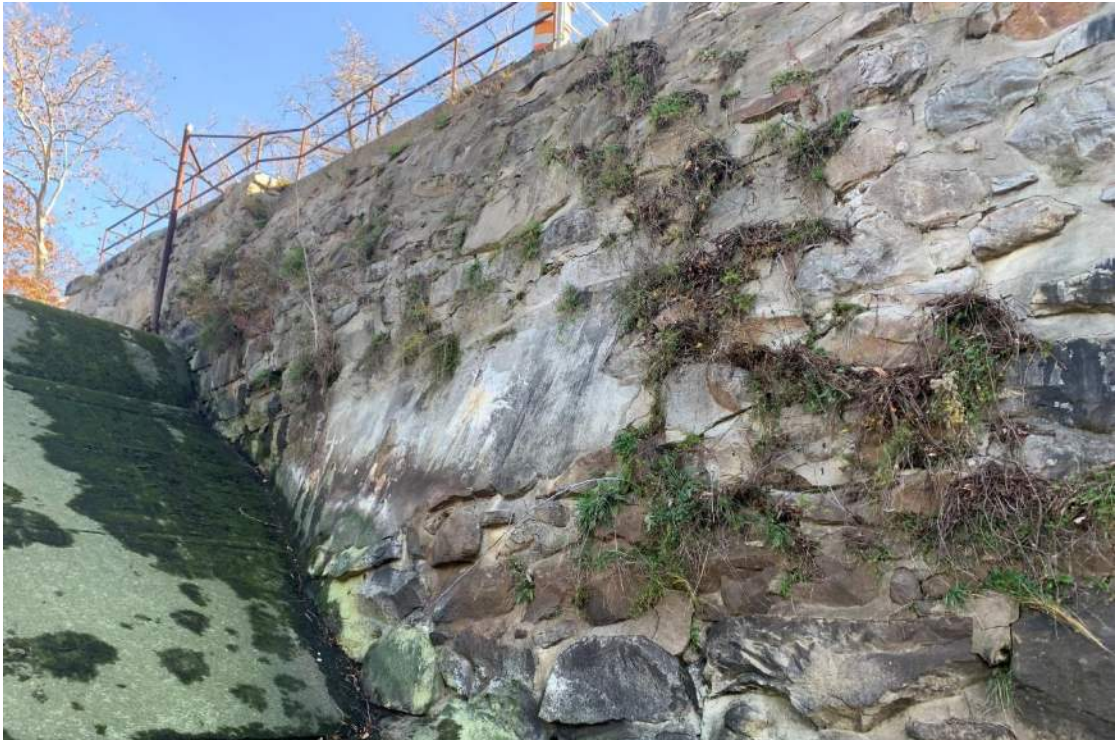
Direction Photo Taken: Upstream/right		
Description: Left training wall. Previously observed seepage from masonry wall was not observed during inspection.

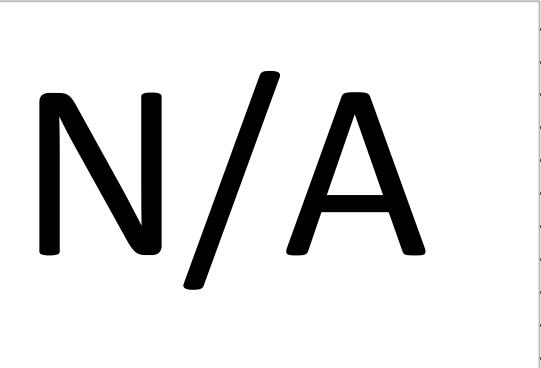
2. WALL ALIGNMENT				
	3. WALL CONDITION				
	4. HEIGHT: TOP OF WALL TO MUDLINE min:				
	5. ABUTMENT CONTACT				
	6. EROSION/SINKHOLES BEHIND WALL				
	7. ANIMAL BURROWS				
	8. UNUSUAL MOVEMENT

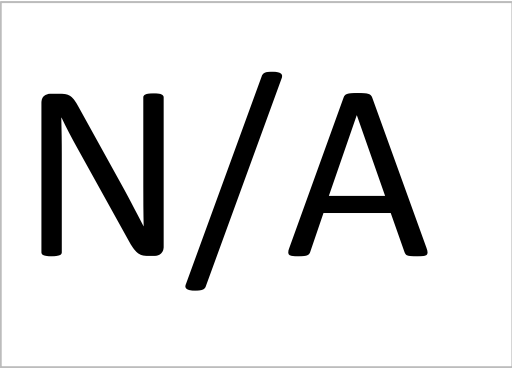
WEIR TYPE				
	SPILLWAY CONDITION				
	TRAINING WALLS				
	SPILLWAY CONTROLS AND CONDITION				
	UNUSUAL MOVEMENT				
	APPROACH AREA				
	DISCHARGE AREA				
	DEBRIS				
	WATER LEVEL AT TIME OF INSPECTION

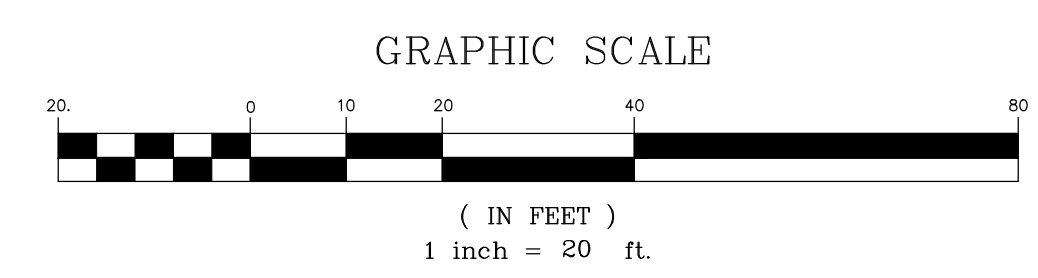
9. Contractor shall immediately report any damage to existing pipes, utilities, or structures to the Owner and Engineer, and obtain directions as to repair, replacement or abandonment.

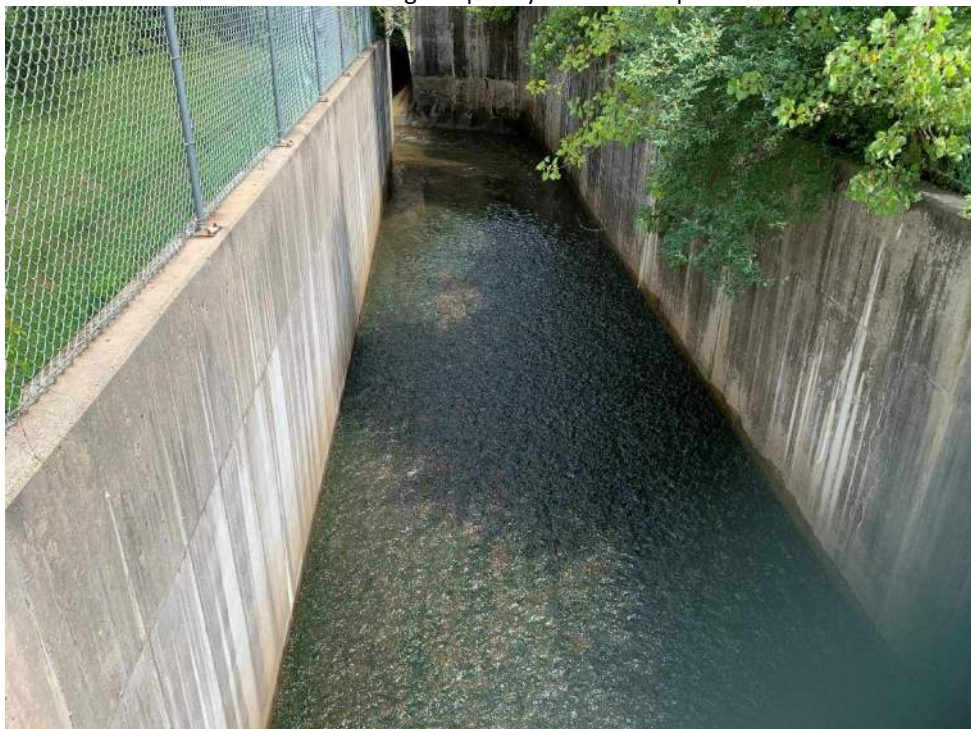
Photo 6: Temporary bulkhead leakage flow at tailrace prior to placing sandbags and plastic sheeting.

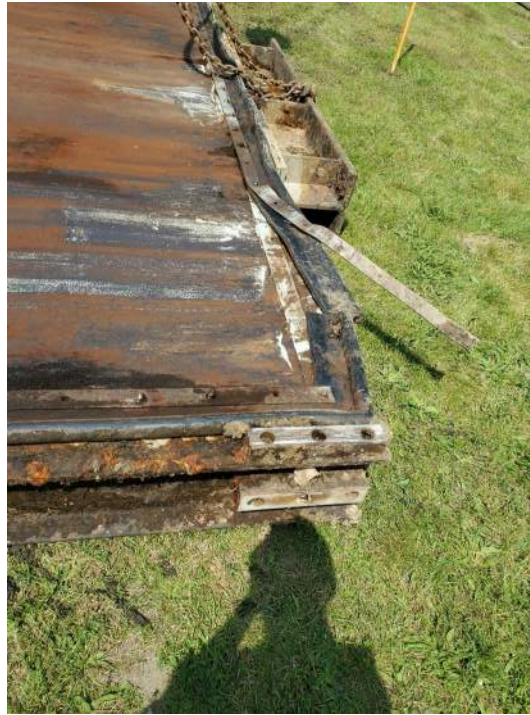
Photo 9: Top seal of gate prior to replacement. Note displaced seal.

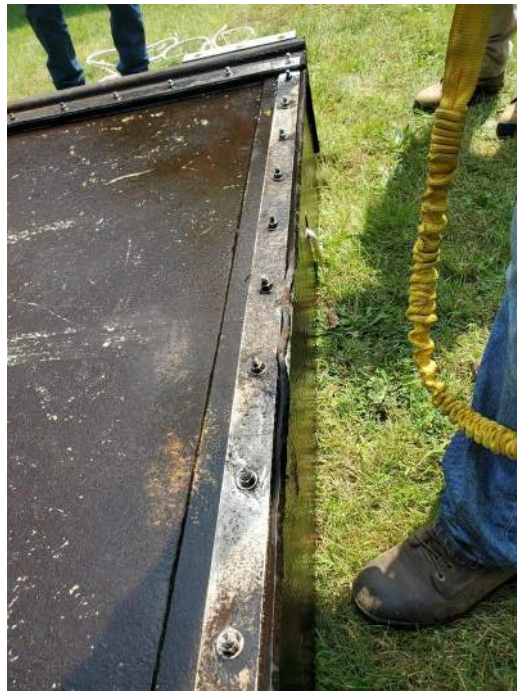
Photo 10: Side seal of gate prior to replacement.

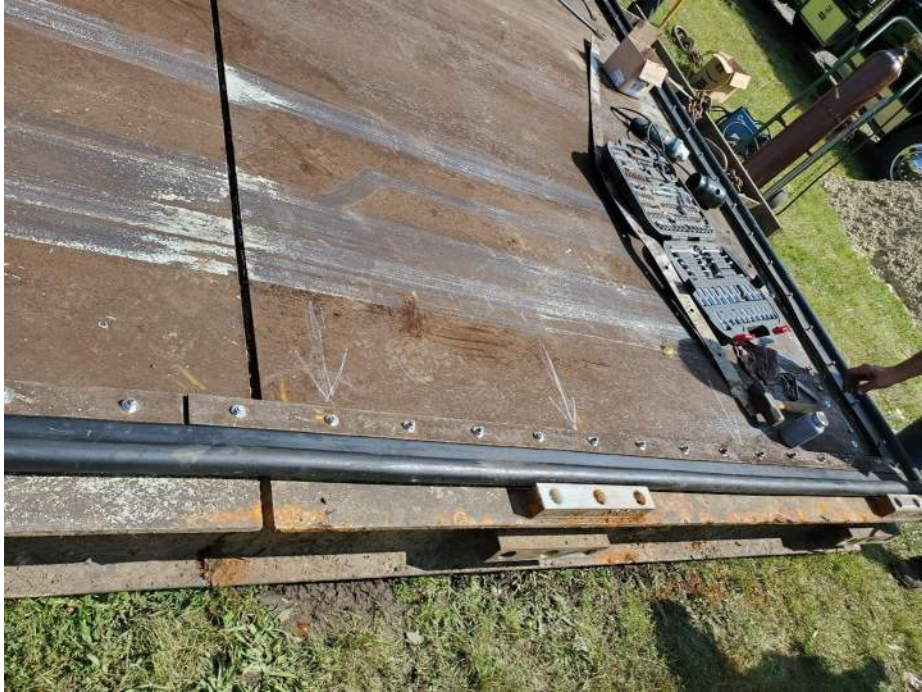
Photo 11: Seal replacement in progress.

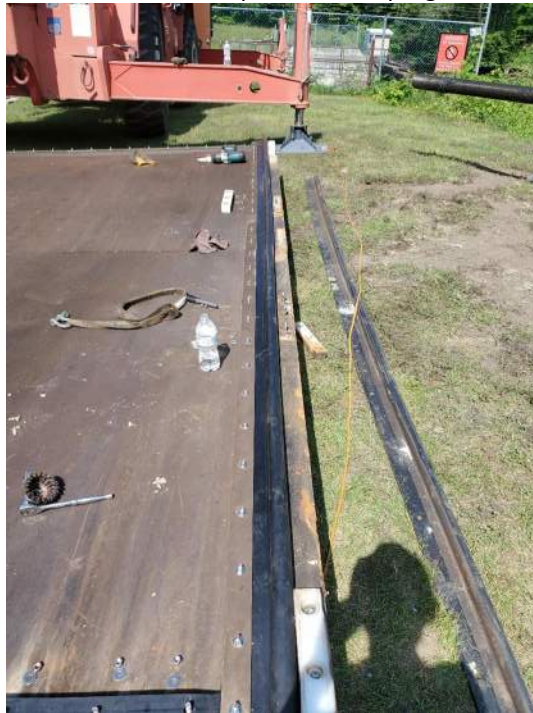
Photo 12: Seal replacement in progress.

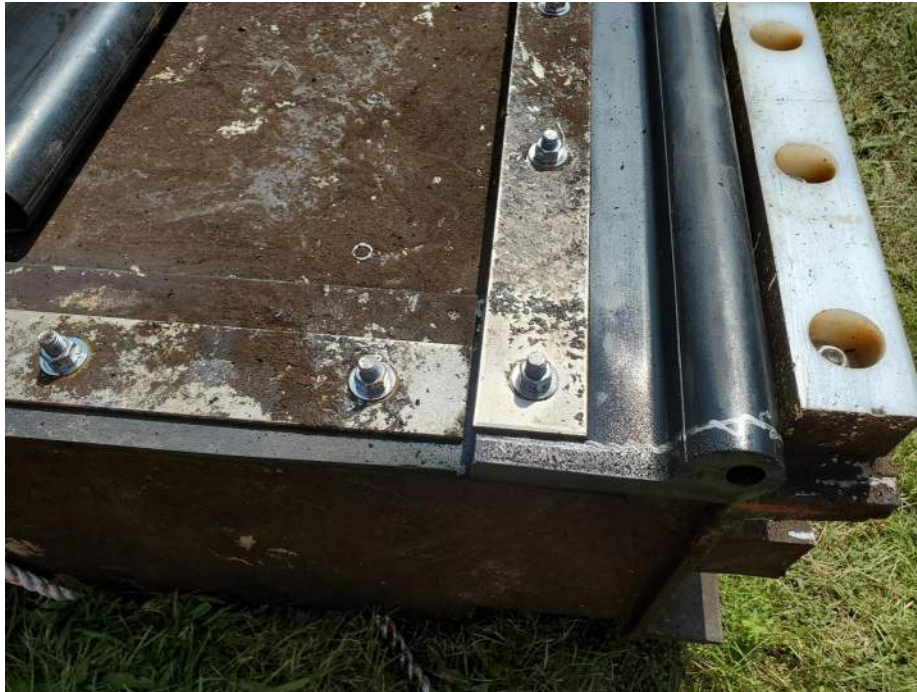
Photo 13: Side seal of gate after replacement.

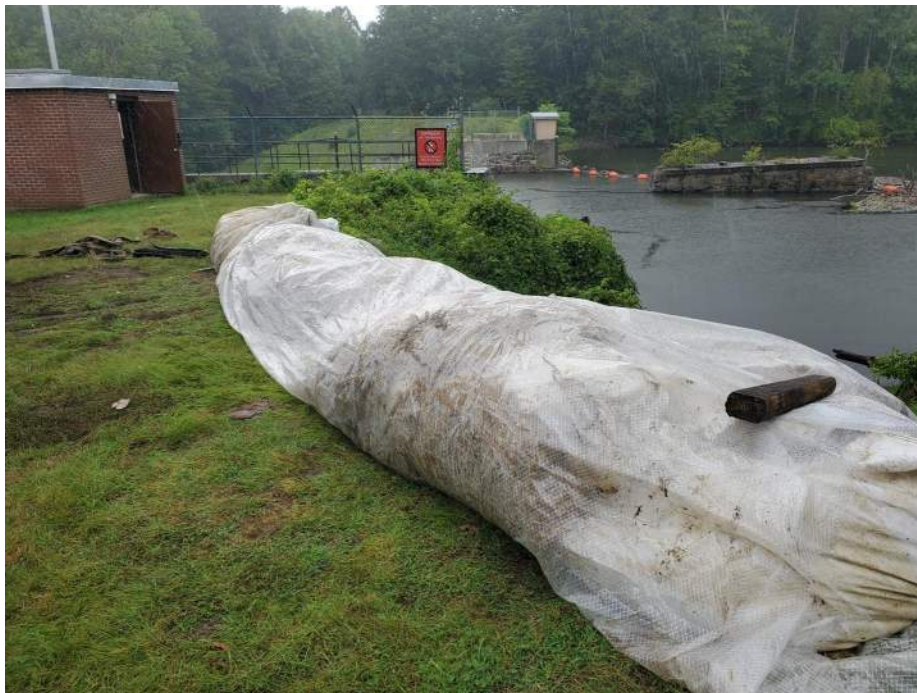
Photo 14: Plastic wrapped sheeting and sandbags pending proper disposal.

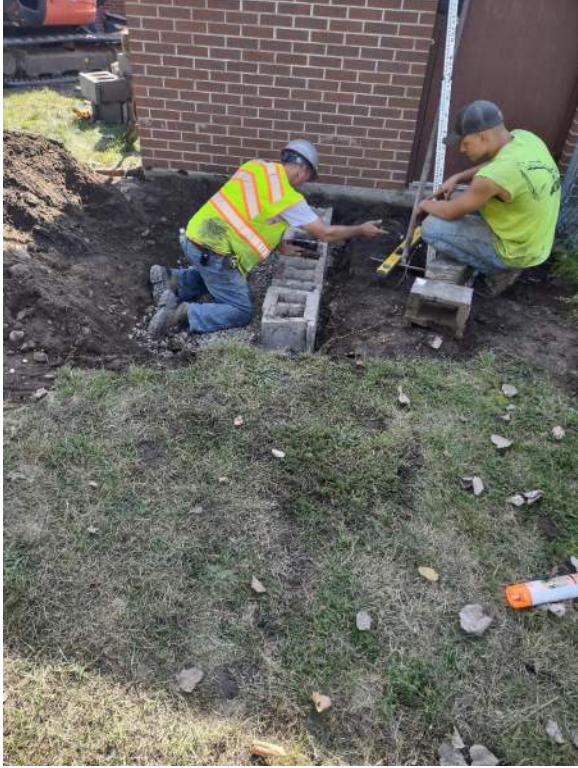
Direction Photo Taken: Downstream			
Description: Installing modular block retaining wall to allow access to pumphouse door (photograph by Richard Gates/GE).
