**Re: GE-Pittsfield/Housatonic River Site  
Rest of River (GECD850)  
Monitoring and Maintenance Plan for Columbia Mill Dam**

# MONITORING AND MAINTENANCE PLAN FOR COLUMBIA MILL DAM – MA 00260

# August 2022 Visual Inspection Report

MA00260 Columbia Mill Dam  
Lee, Massachusetts

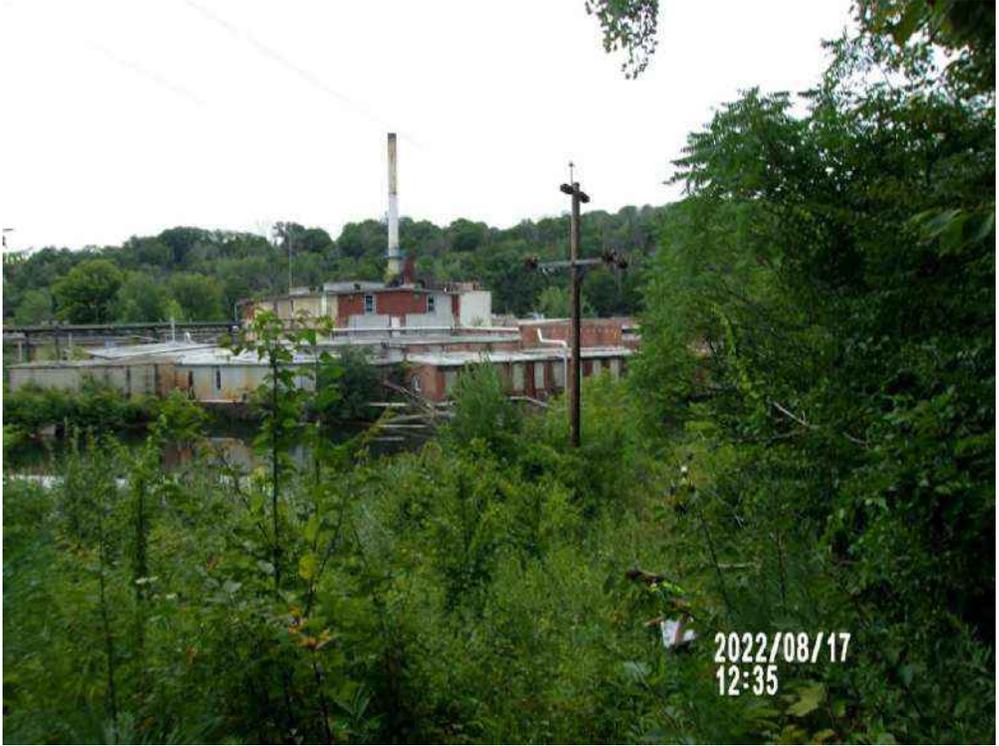
<b>Client Name:</b> General Electric Company		<b>Site Location:</b> Columbia Mill Dam (MA00260) Lee, MA	<b>Project No.</b> 01.0019896.50
<b>Photo No.</b> 1	<b>Date:</b> 8/17/2022

<b>Direction Photo Taken:</b> From right upstream pond shoreline, looking left and downstream.			
<b>Description:</b> Overview of dam from upstream. Dam is obscured by vegetation. Mill complex in background.

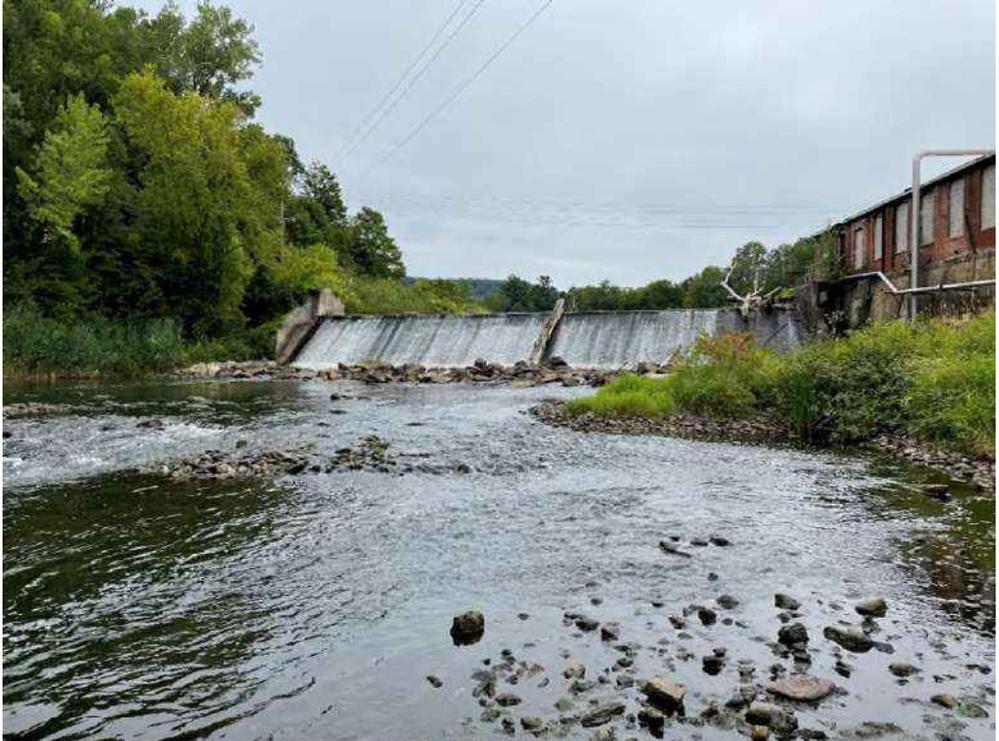
<b>Photo No.</b> 2	<b>Date:</b> 8/17/2022

<b>Direction Photo Taken:</b> From left downstream bank, looking upstream.			
<b>Description:</b> Overview of dam from downstream.

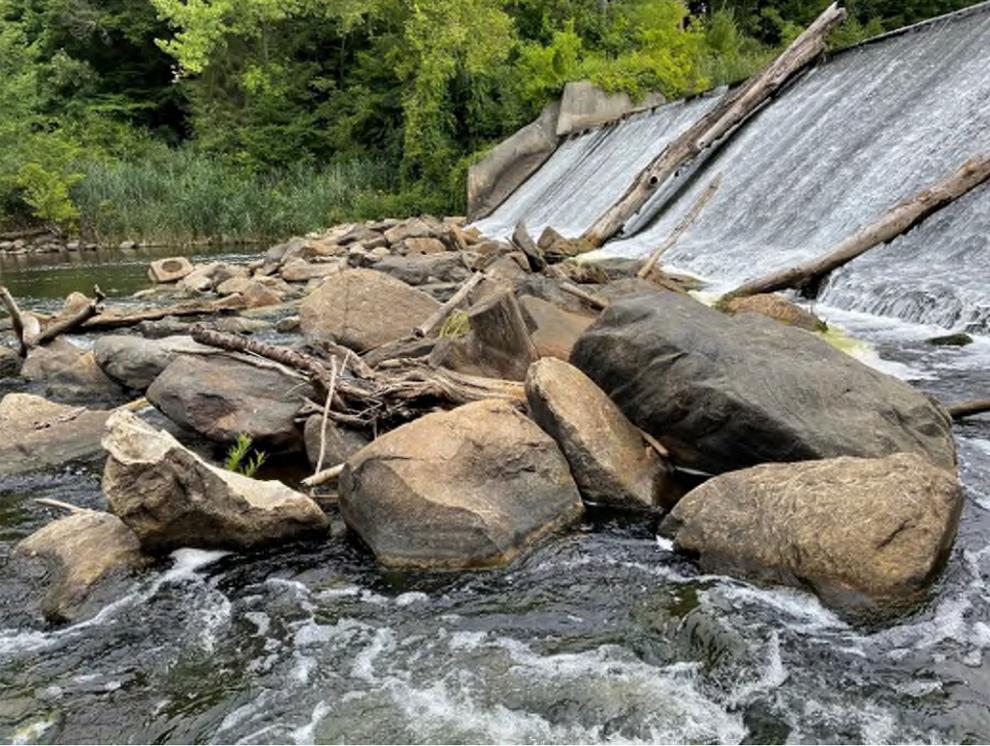
<b>Client Name:</b> General Electric Company		<b>Site Location:</b> Columbia Mill Dam (MA00260) Lee, MA	<b>Project No.</b> 01.0019896.50
<b>Photo No.</b> 5	<b>Date:</b> 8/17/2022

<b>Direction Photo Taken:</b> From left bank downstream, looking right.			
<b>Description:</b> Overview of spillway and downstream riprap field. Note: Right embankment downstream masonry wall obscured by vegetation (photo background)

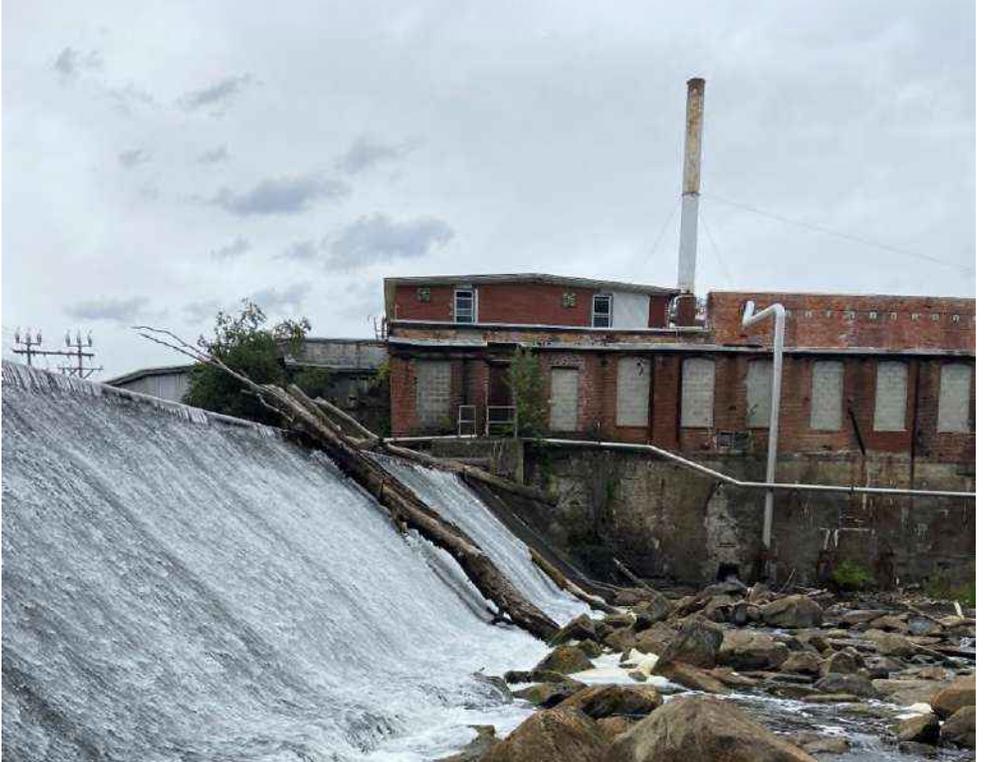
<b>Photo No.</b> 6	<b>Date:</b> 8/17/2022

<b>Direction Photo Taken:</b> From right downstream bank looking left.			
<b>Description:</b> Overview of spillway and downstream riprap field. Mill structure in photo background.

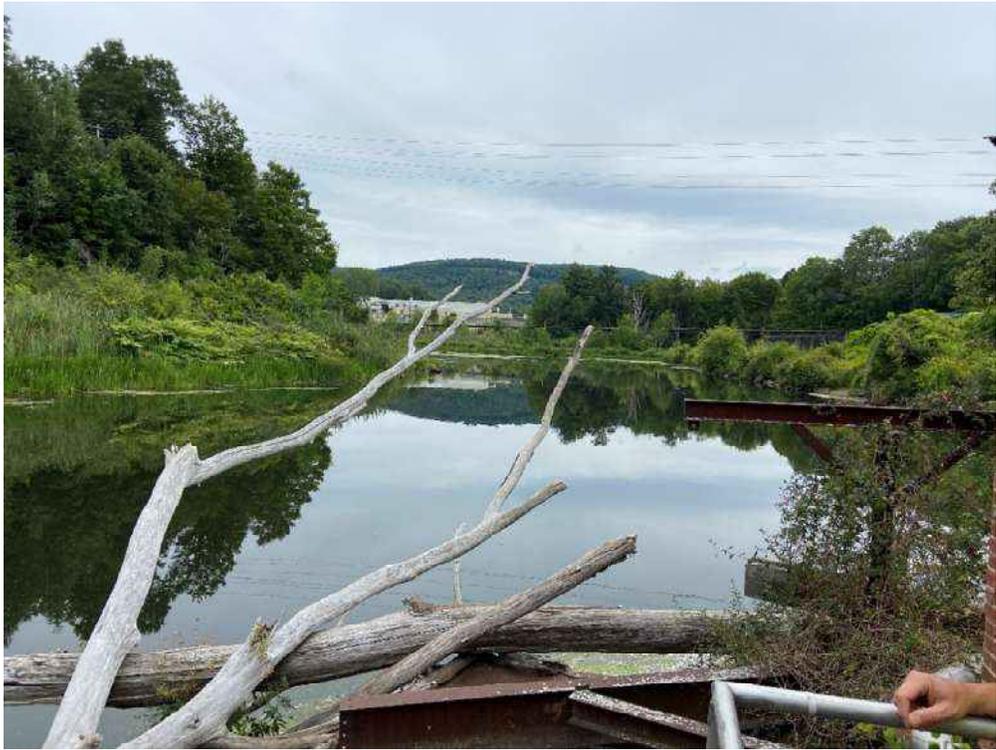
<b>Client Name:</b> General Electric Company		<b>Site Location:</b> Columbia Mill Dam (MA00260) Lee, MA	<b>Project No.</b> 01.0019896.50
<b>Photo No.</b> 7	<b>Date:</b> 8/17/2022

<b>Direction Photo Taken:</b> From left end of spillway looking upstream.			
<b>Description:</b> Overview of impoundment. Note: Logs and debris on spillway crest debris in foreground.

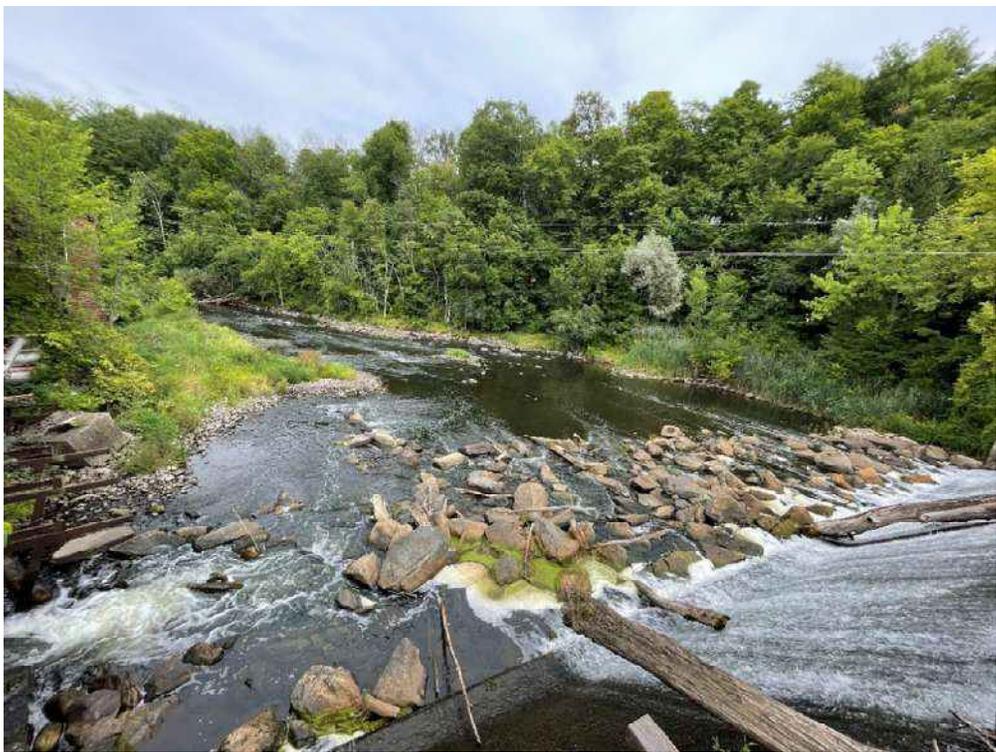
<b>Photo No.</b> 8	<b>Date:</b> 8/17/2022

<b>Direction Photo Taken:</b> From left end of spillway looking downstream.			
<b>Description:</b> Overview of downstream channel.

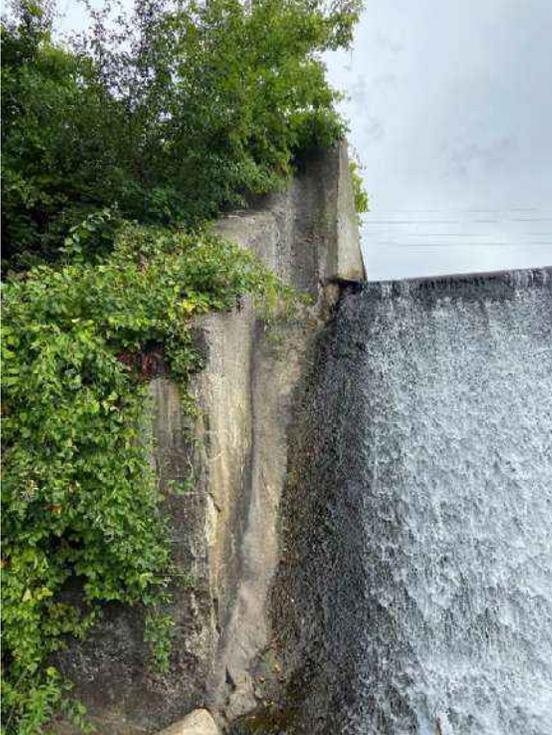
<b>Client Name:</b> General Electric Company		<b>Site Location:</b> Columbia Mill Dam (MA00260) Lee, MA	<b>Project No.</b> 01.0019896.50
<b>Photo No.</b> 9	<b>Date:</b> 8/17/2022

<b>Direction Photo Taken:</b> From right base of spillway looking upstream.			
<b>Description:</b> Right spillway training wall.

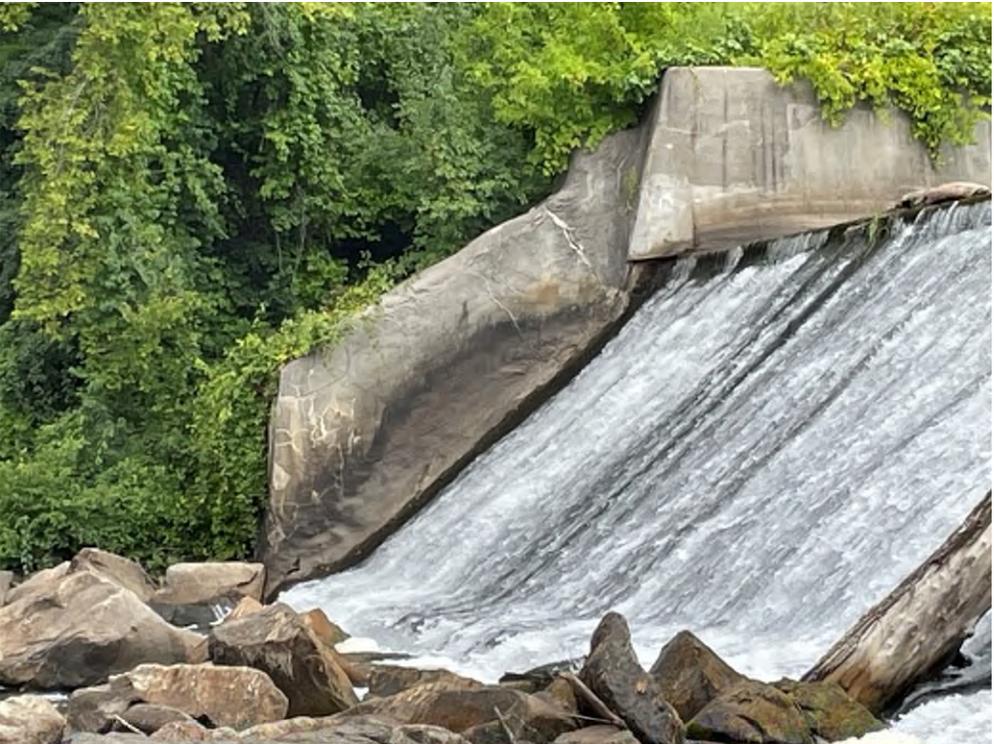
<b>Photo No.</b> 10	<b>Date:</b> 8/17/2022

<b>Direction Photo Taken:</b> From left downstream bank looking right.			
<b>Description:</b> Right spillway training wall. Note: Cracks on wall and vegetation obscuring right embankment downstream masonry wall.

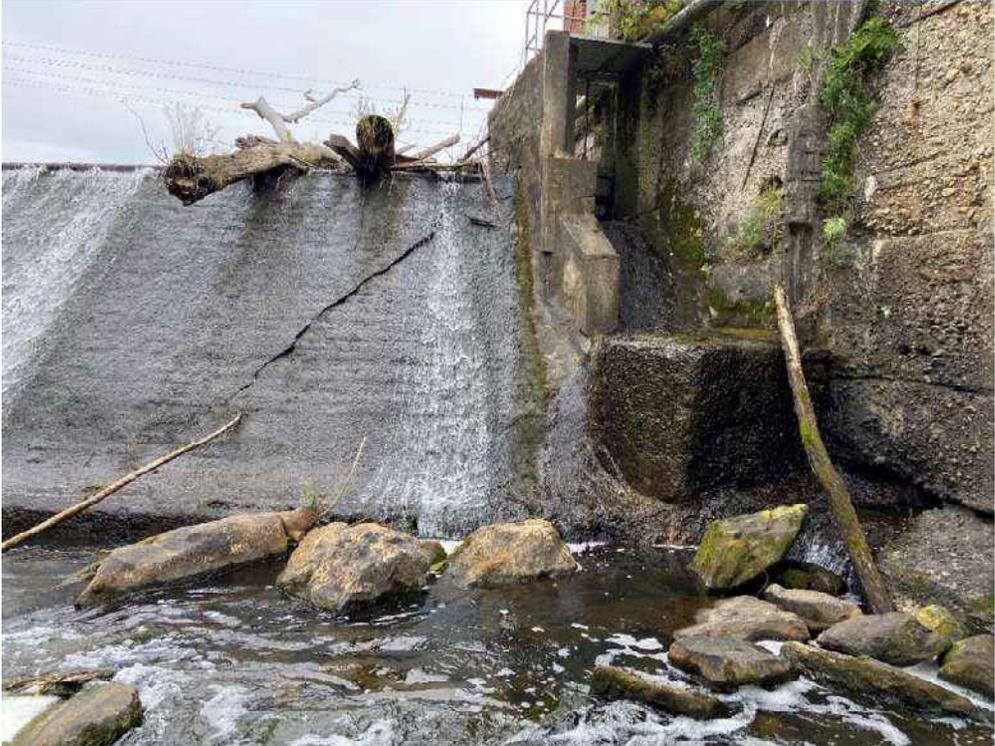
<b>Client Name:</b> General Electric Company		<b>Site Location:</b> Columbia Mill Dam (MA00260) Lee, MA	<b>Project No.</b> 01.0019896.50
<b>Photo No.</b> 11	<b>Date:</b> 8/17/2022

<b>Direction Photo Taken:</b> From left base of spillway looking upstream.			
<b>Description:</b> From photo left to photo right: Left portion of spillway, sluiceway outlet structure, and exterior wall of mill building. Note: Diagonal crack on downstream face of spillway.

1. Fill vortex near left side gate platform;
2. Repair the crack in the downstream face of the spillway on the left side; and
3. Repair the separation of the concrete joint at the weir crest.

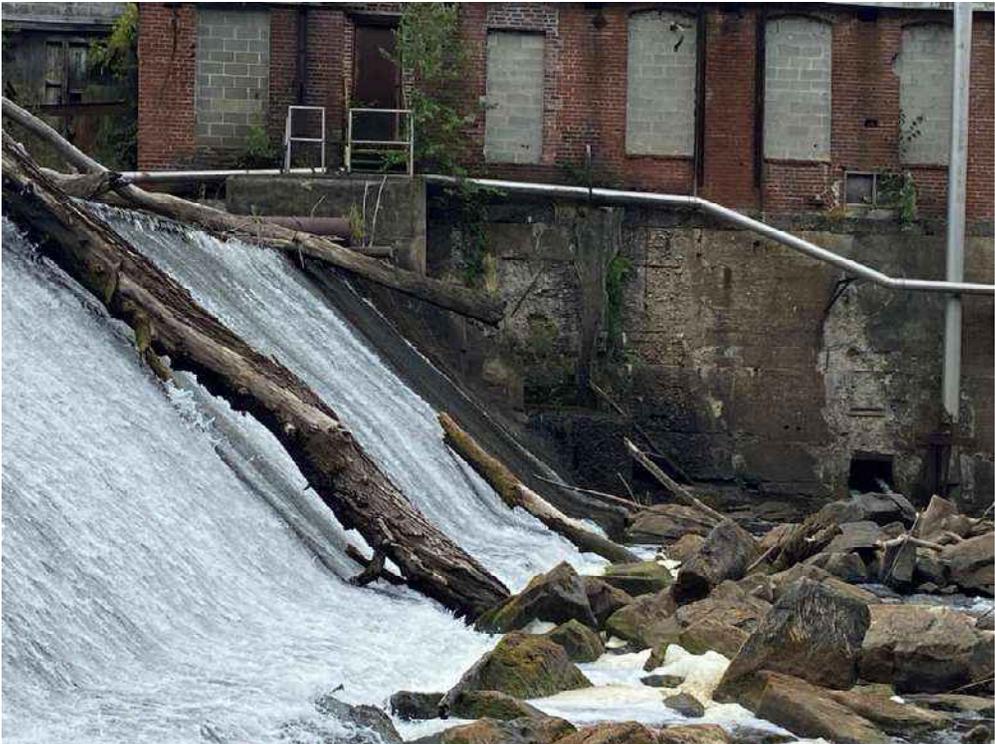
<b>Photo No.</b> 12	<b>Date:</b> 8/17/2022

<b>Direction Photo Taken:</b> From right downstream bank looking left.			
<b>Description:</b> Left spillway training wall / sluiceway wall, outlet structure, and mill building.  Note concrete degradation on mill building foundation with exposed reinforcing steel.

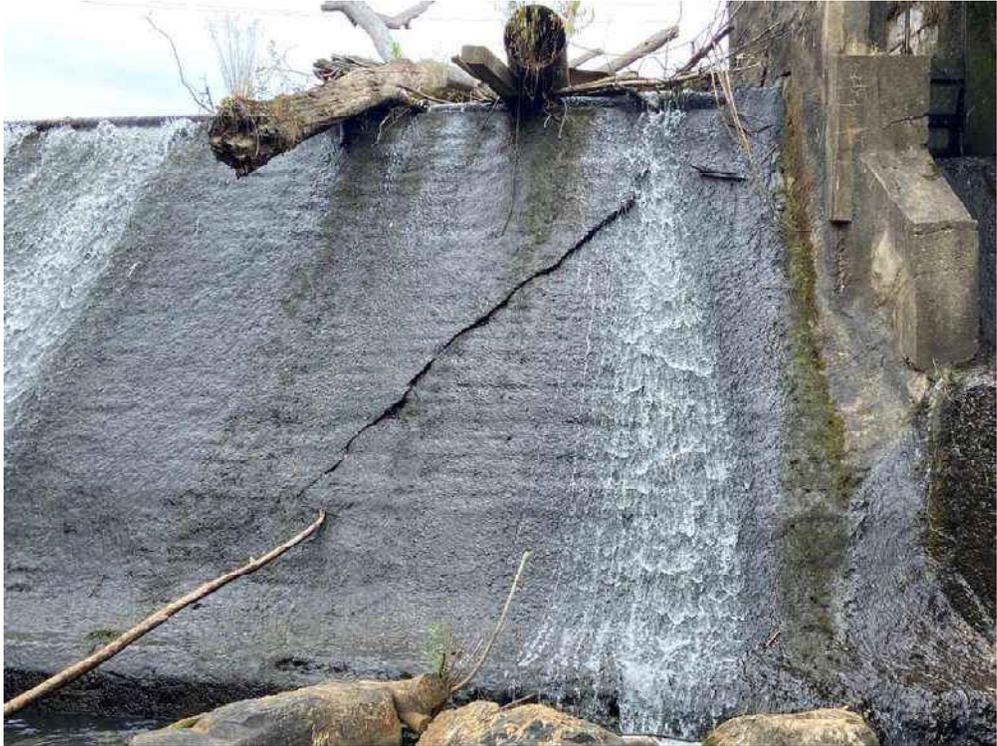
<b>Client Name:</b> General Electric Company		<b>Site Location:</b> Columbia Mill Dam (MA00260) Lee, MA	<b>Project No.</b> 01.0019896.50
<b>Photo No.</b> 13	<b>Date:</b> 8/17/2022

<b>Direction Photo Taken:</b> From left base of spillway looking upstream.			
<b>Description:</b> Large diagonal crack in spillway face, large debris on spillway crest.

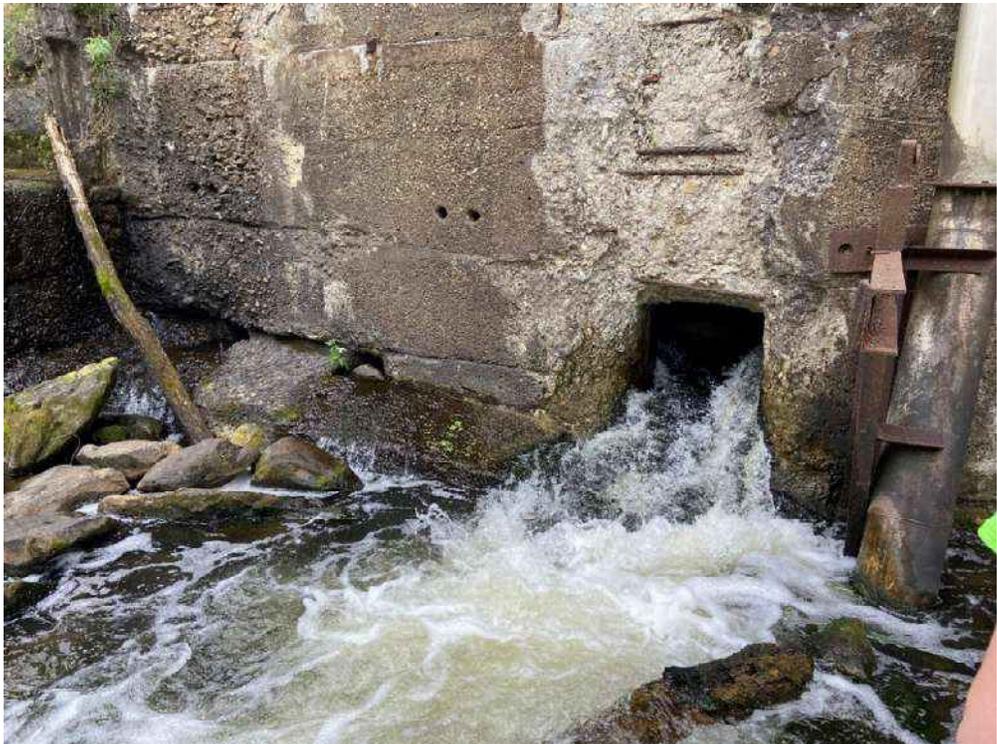
<b>Photo No.</b> 14	<b>Date:</b> 8/17/2022

<b>Direction Photo Taken:</b> From left downstream bank, looking left.			
<b>Description:</b> Internal mill sluiceway outlet through exterior mill building wall.  Note deteriorated mill concrete wall with exposed steel reinforcing and leakage at base of wall (upstream of outlet/photo right).

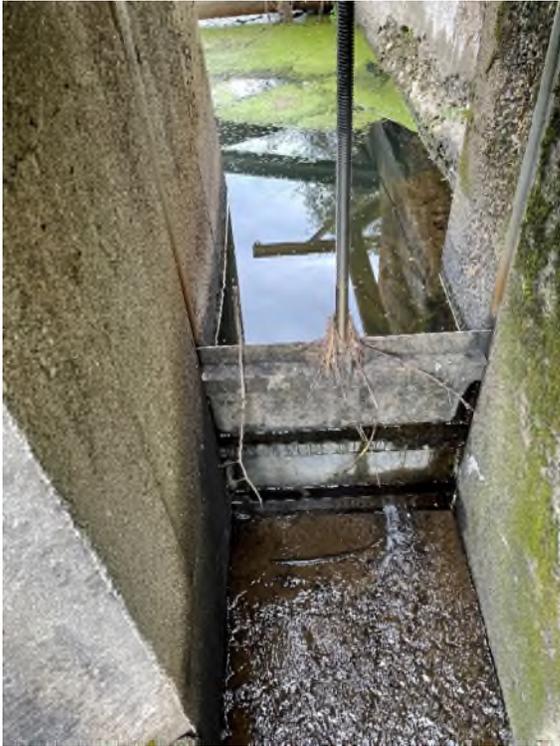
<b>Client Name:</b> General Electric Company		<b>Site Location:</b> Columbia Mill Dam (MA00260) Lee, MA	<b>Project No.</b> 01.0019896.50
<b>Photo No.</b> 15	<b>Date:</b> 8/17/2022

<b>Direction Photo Taken:</b> From left, looking upstream.			
<b>Description:</b> Sluiceway slide gate.

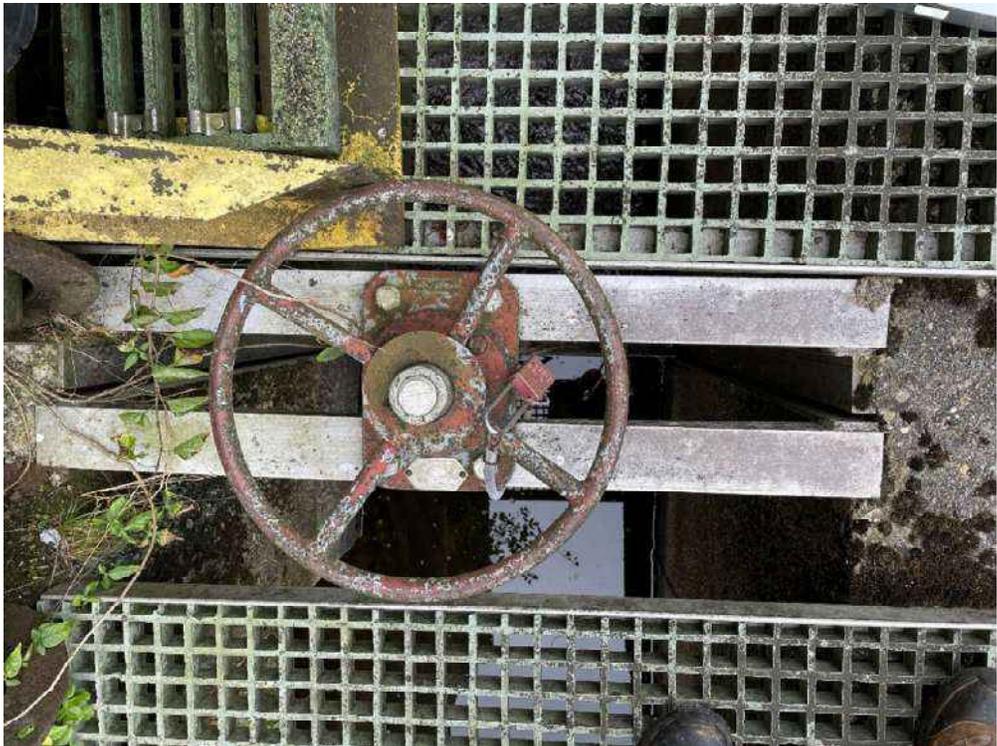
<b>Photo No.</b> 16	<b>Date:</b> 8/17/2022

<b>Direction Photo Taken:</b> From left.			
<b>Description:</b> Sluiceway slide gate operator looking down.

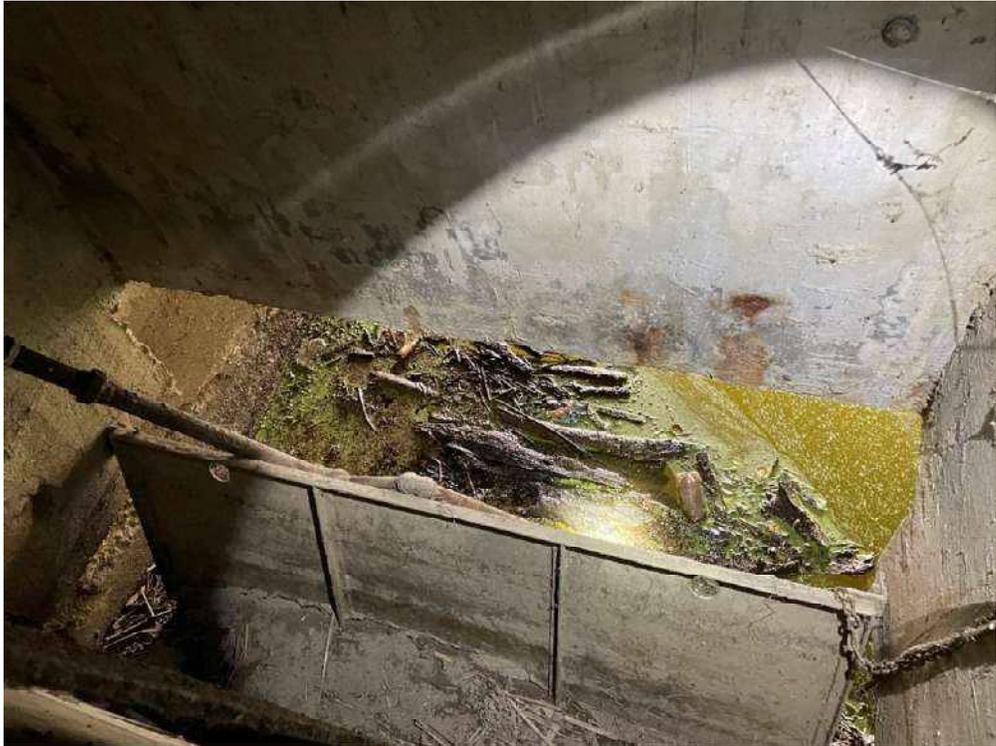
<b>Client Name:</b> General Electric Company		<b>Site Location:</b> Columbia Mill Dam (MA00260) Lee, MA	<b>Project No.</b> 01.0019896.50
<b>Photo No.</b> 17	<b>Date:</b> 8/17/2022

<b>Direction Photo Taken:</b> Inside mill building, looking upstream.			
<b>Description:</b> Internal mill sluiceway inoperable gate. Note debris buildup.

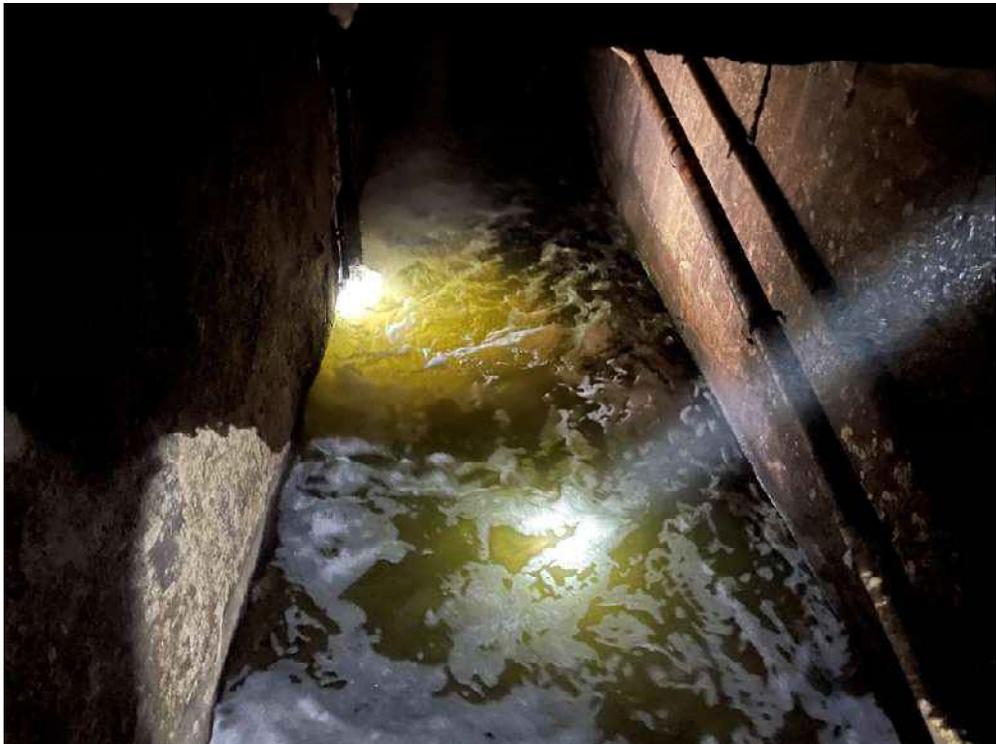
<b>Photo No.</b> 18	<b>Date:</b> 8/17/2022

<b>Direction Photo Taken:</b> Inside building, looking upstream.			
<b>Description:</b> Internal mill sluiceway from inside mill. Outlet to downstream channel can be seen on left.

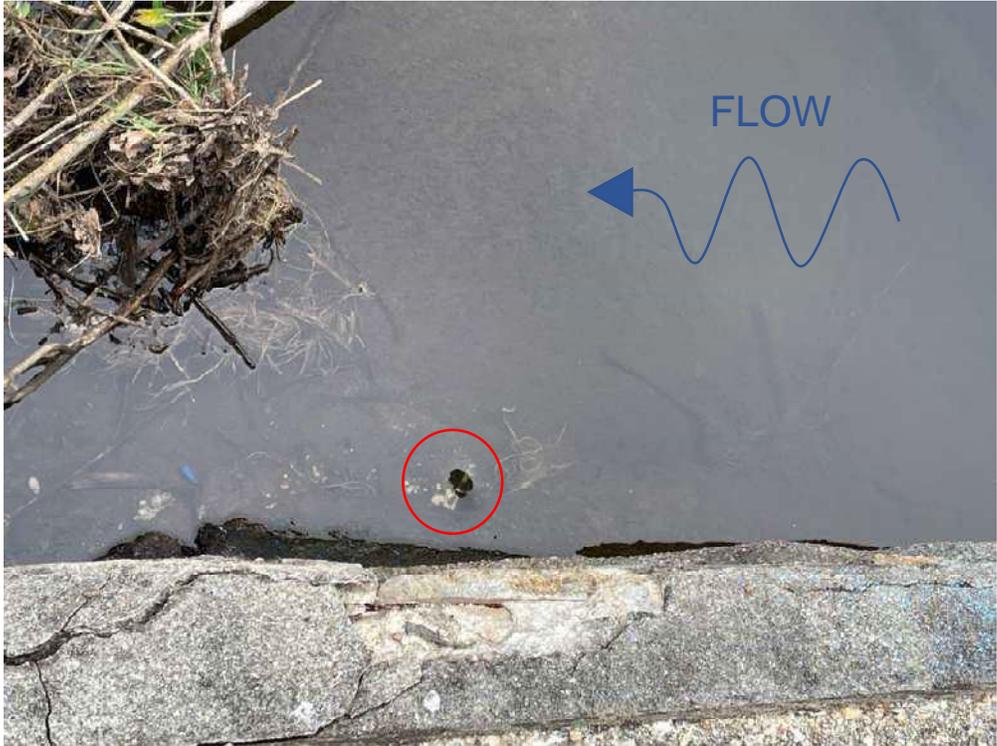
<b>Client Name:</b> General Electric Company		<b>Site Location:</b> Columbia Mill Dam (MA00260) Lee, MA	<b>Project No.</b> 01.0019896.50
<b>Photo No.</b> 19	<b>Date:</b> 8/17/2022

<b>Direction Photo Taken:</b> Down			
<b>Description:</b> Small 1-inch± diameter vortex adjacent to left upstream training wall/sluciceway wall, circled in red.

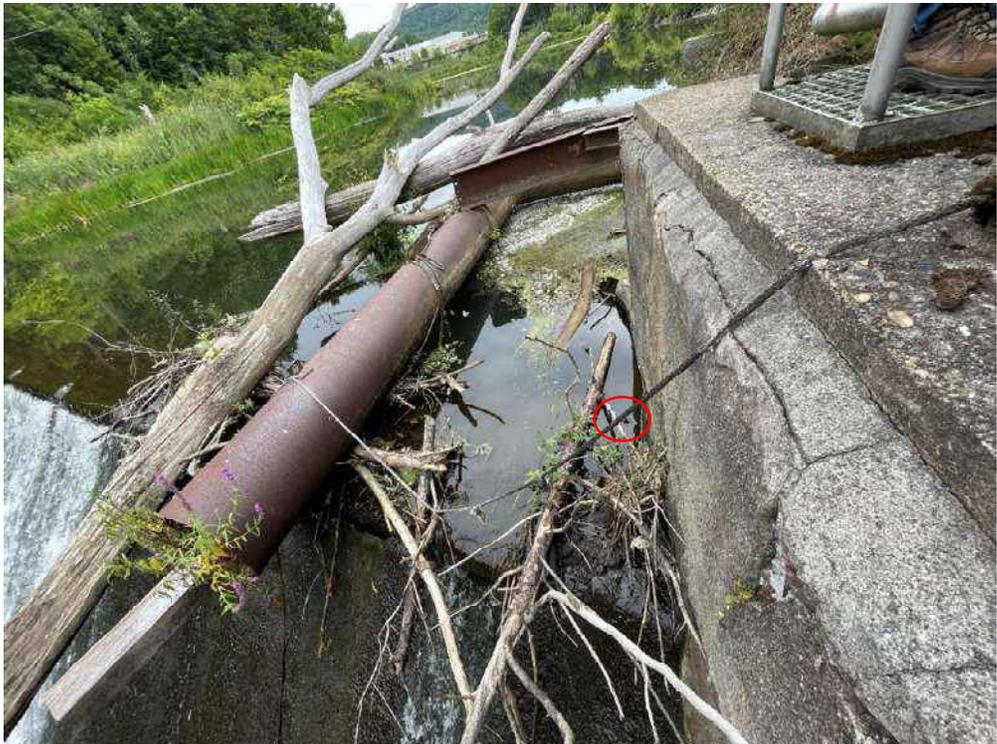
<b>Photo No.</b> 20	<b>Date:</b> 8/17/2022

<b>Direction Photo Taken:</b> From left edge of spillway, looking upstream.			
<b>Description:</b> Vortex area looking upstream. Vortex circled in red.  Note log, debris and reported wastewater treatment plant effluent pipe on spillway crest.
