UNITED STATES ENVIRONMENTAL PROTECTION AGENCY

Memorandum

DATE: November 17, 2022

SUBJ: 10/25/2022 inspection of Upper Harbor sediment caps, NBHSS

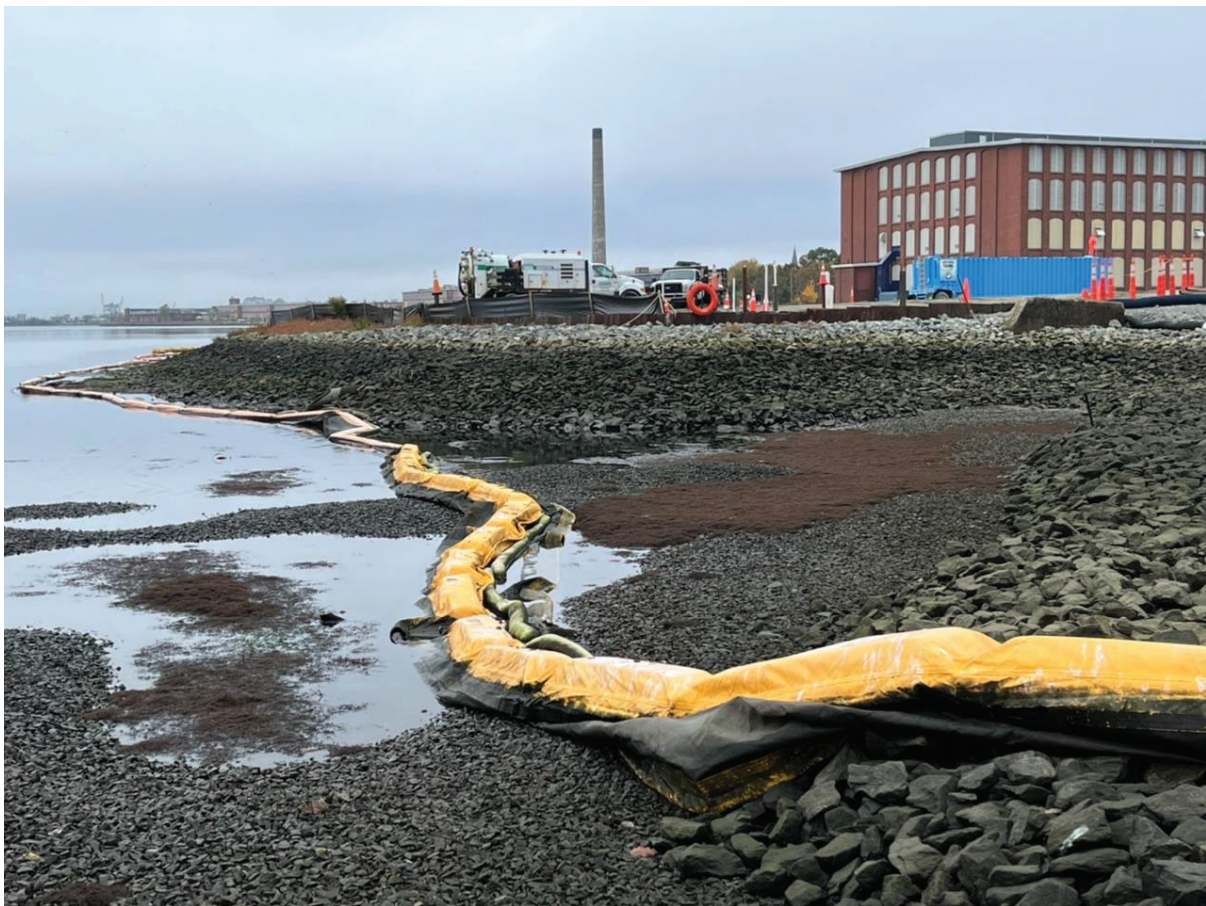
Figure 2:  
**Aerovox cap**  
 looking south  
 from the  
 northern area of  
 the cap. The oil  
 boom is from  
 the ongoing  
 Aerovox 21E  
 work. The  
 brown color is a  
 seaweed mat.

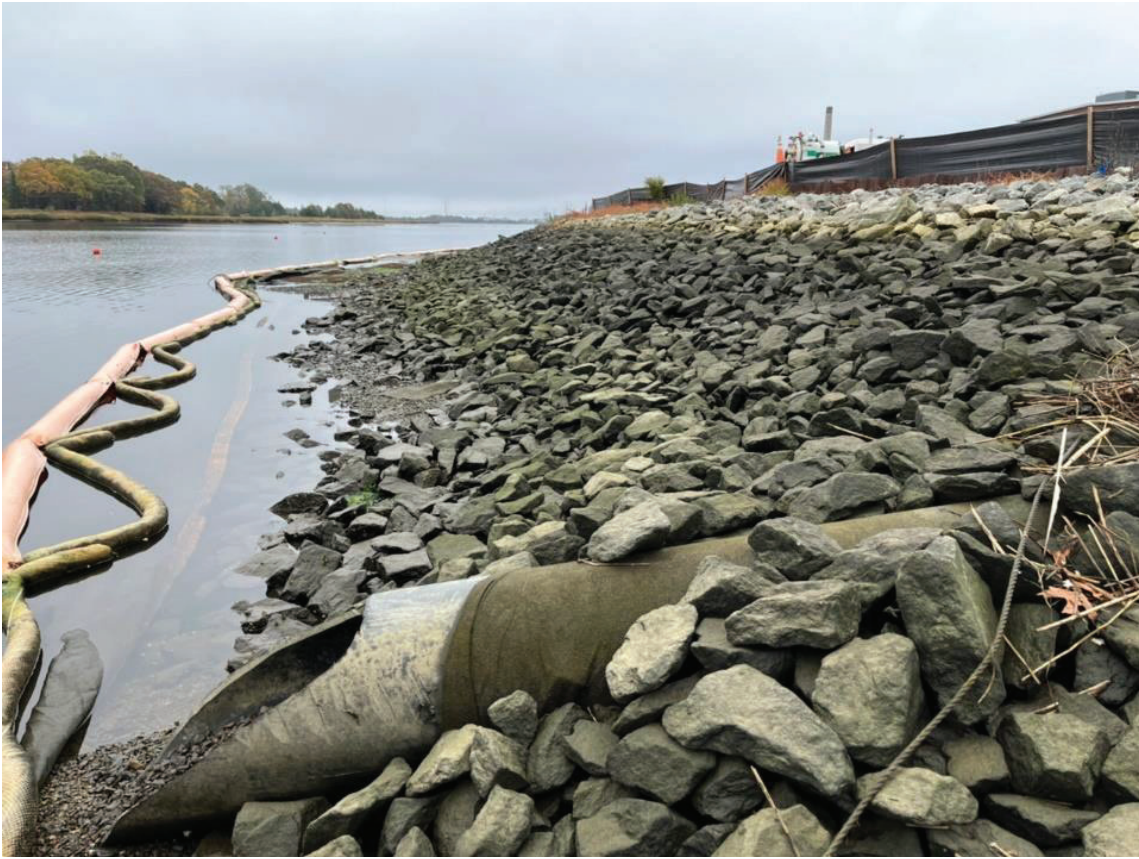
Figure 3:  
**Aerovox cap** looking south along the toe of slope. Note the north trench outfall in foreground (still plugged per the 21E cleanup).

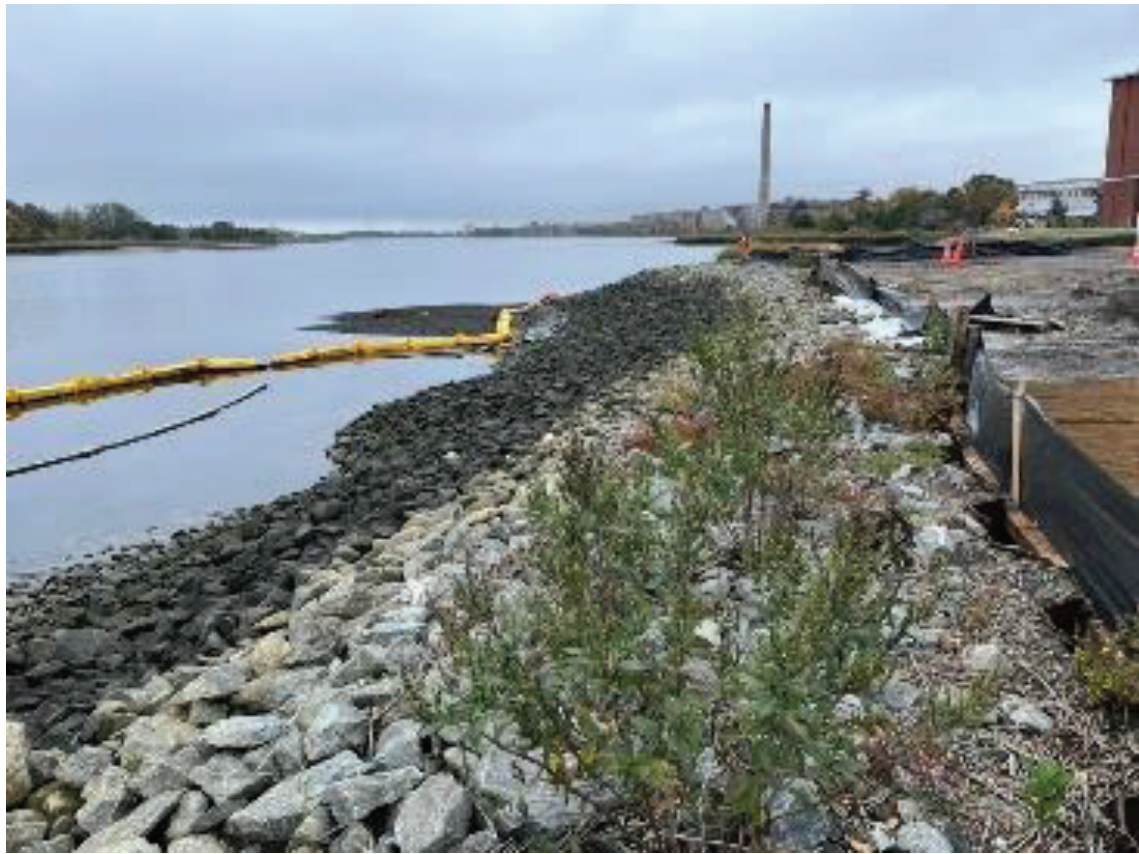
Figure 4: **Aerovox cap** looking south. Note native high tide bush (*Iva frutescens*) emerging at top of slope. Underlying this part of the armor stone is the original, large-stone-size seawall, thus non-woody vegetation such as this is fine (and may help stabilize the surface).

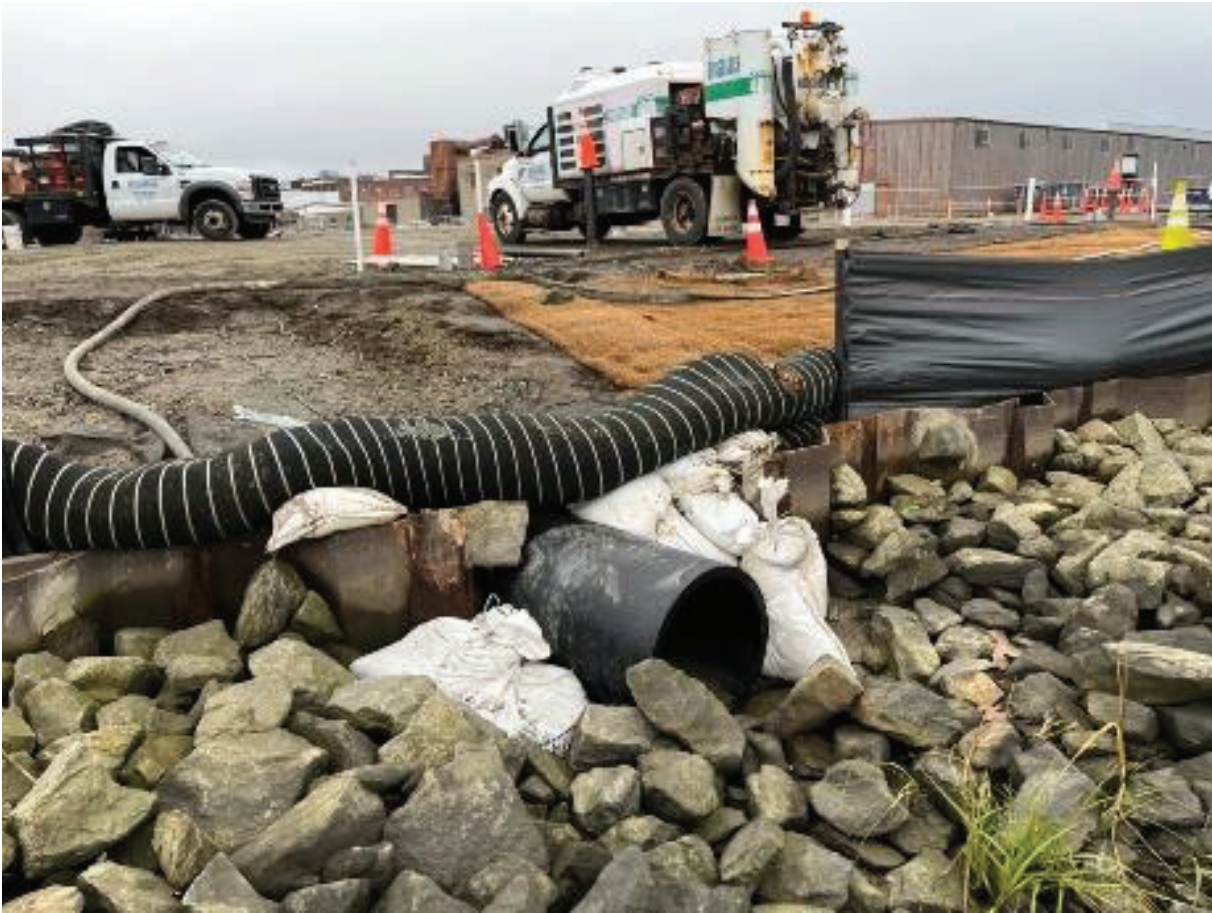
Figure 5:  
**Aerovox cap**  
looking northwest  
showing the new  
south trench  
outfall. This  
former trench will  
now be an HDPE  
pipe covered with  
concrete (with  
similar invert  
elevation). Note  
marsh grass  
(*Spartina  
alterniflora?*)  
emerging in  
foreground.

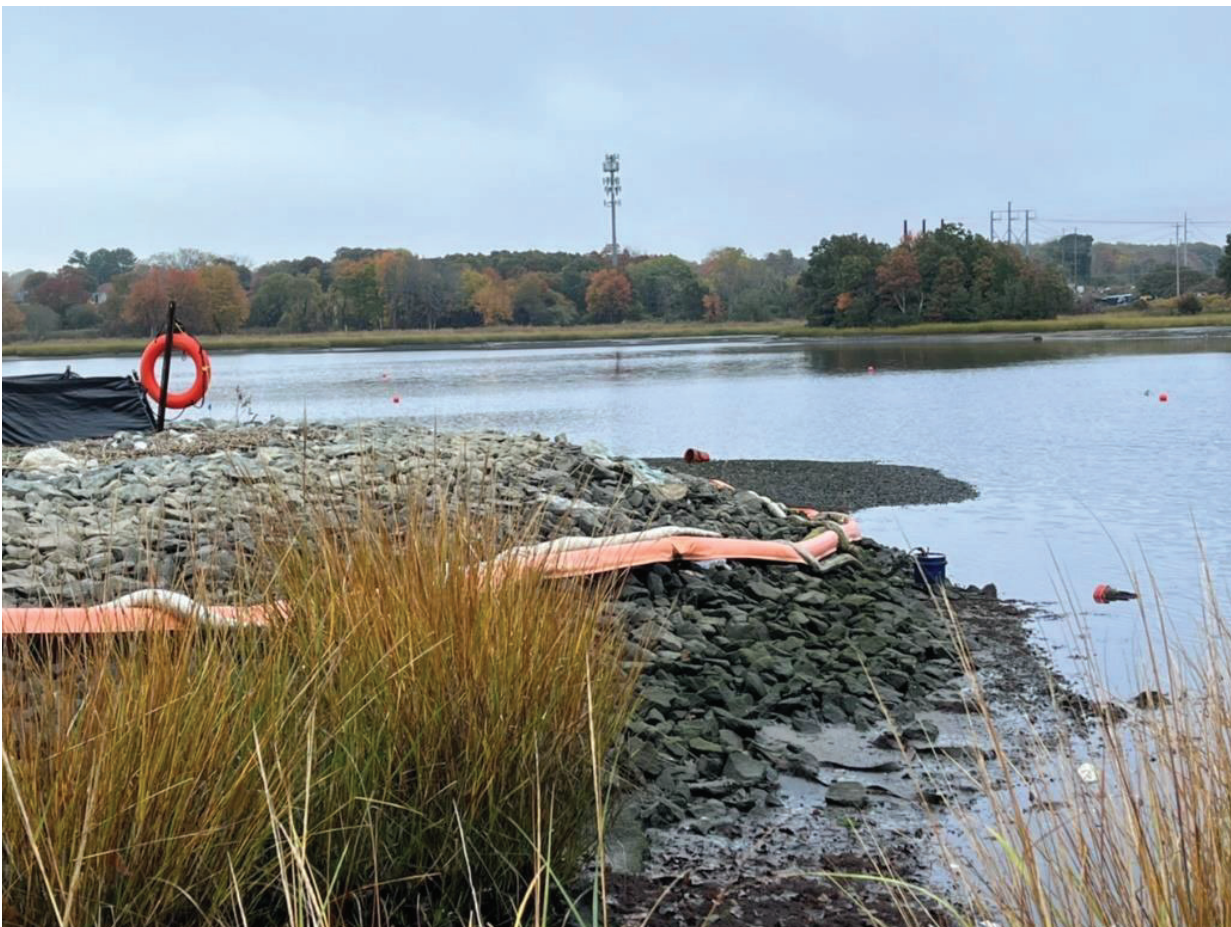
Figure 6:  
**Aerovox cap**  
looking east  
from the  
southern edge  
of the cap.  
Foreground is  
the east end  
of the large  
Hadley Street  
storm drain.

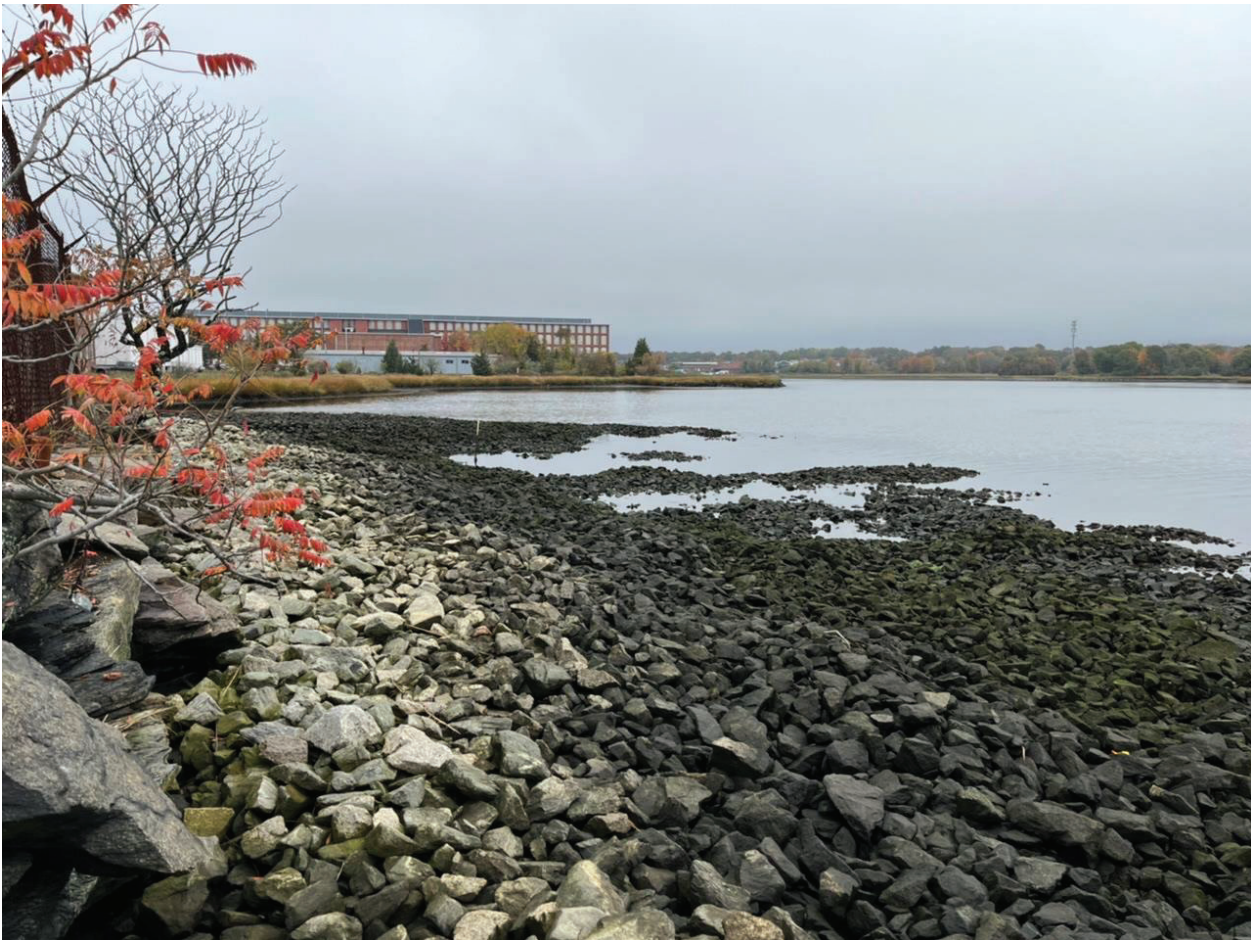
Figure 7:  
**Crib cap**  
looking north  
from the  
south end of  
the cap. White  
pole is the  
location of an  
outfall pipe  
(extended  
through cap  
during cap  
construction).

- At the Crib cap, when implementing the upcoming West Zone 2/3 remedial action in 2023/2024, consider using the excavator bucket to create a more uniform, smoother (less undulating) stone surface within the reach of the excavator from shore. This would aid in visually detecting potential stone displacement moving forward during O&M to minimize the need for topographic/bathymetric surveys during O&M. Additional stone could be added if necessary to help create this uniform, smoother surface.

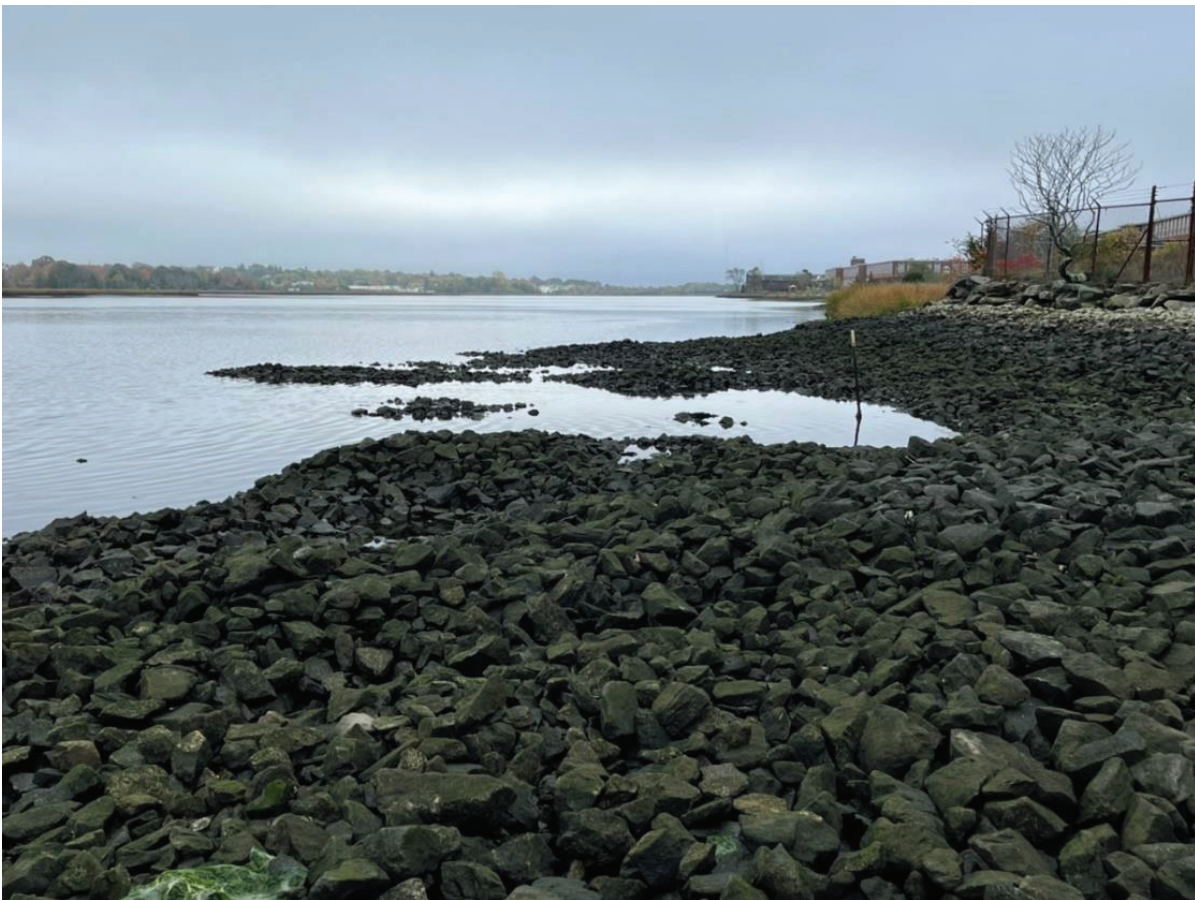
Figure 8:  
**Crib cap**  
looking  
south. White  
pole is the  
location of  
the outfall  
pipe.

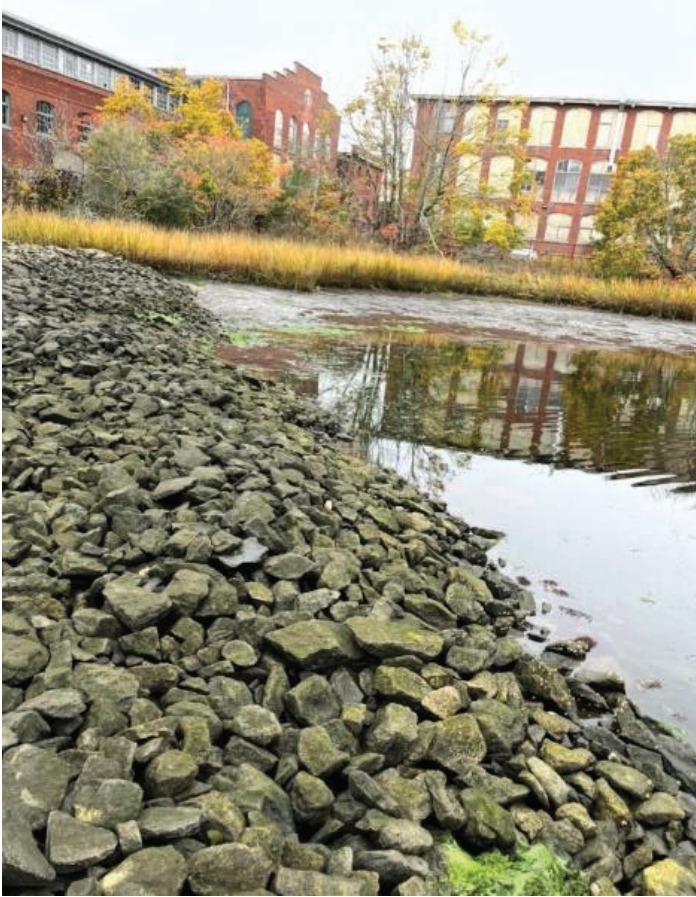
Figure 9: **Crib cap** looking west from the NE corner of the cap.

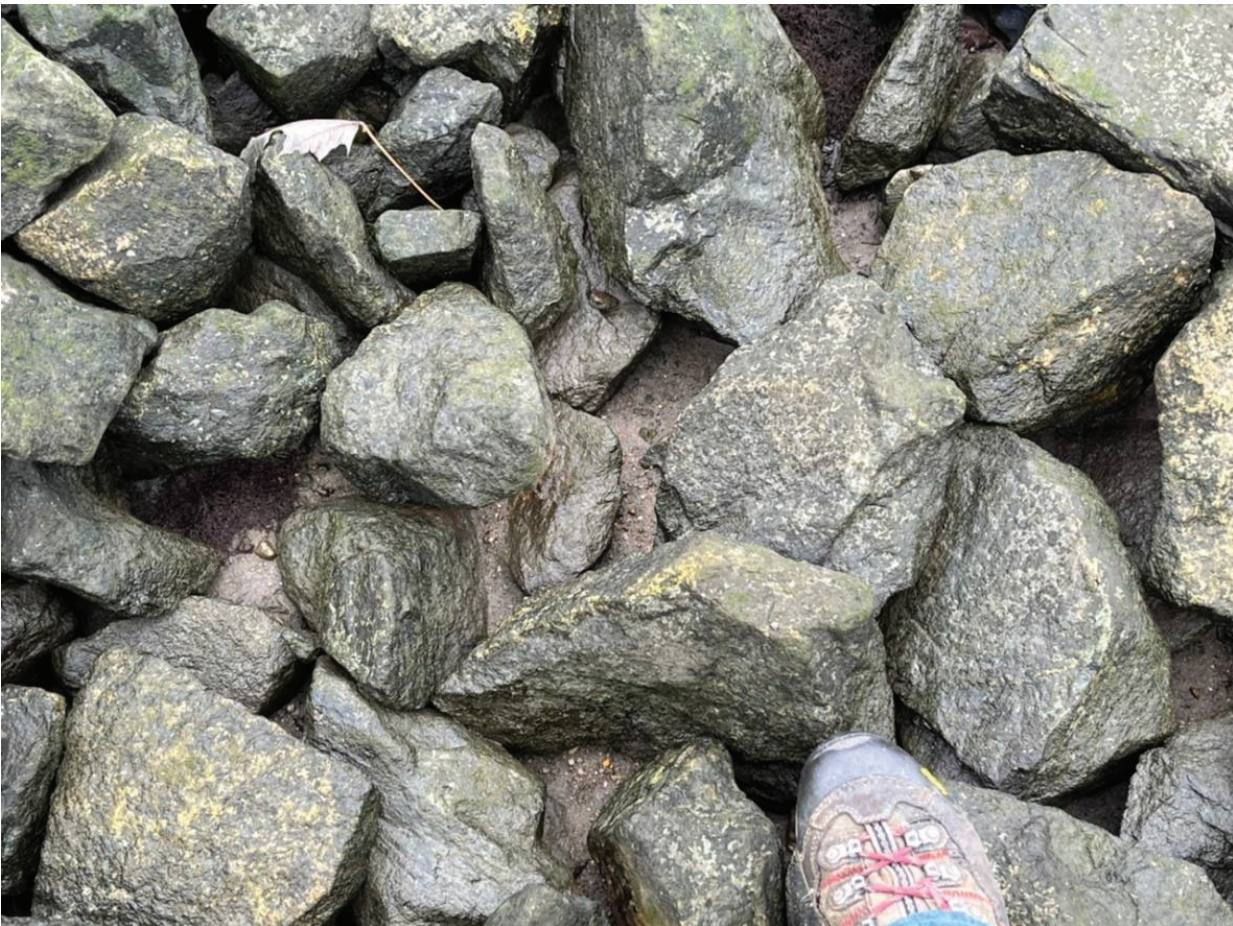
Figure 10: **Crib cap** showing very small area of exposed sand (app. 2 sq ft) 20-25' south of the white pole noted in Figures 7 and 8 above.

Armor stone from obvious nearby high spots were used to fill in this small area during the inspection.

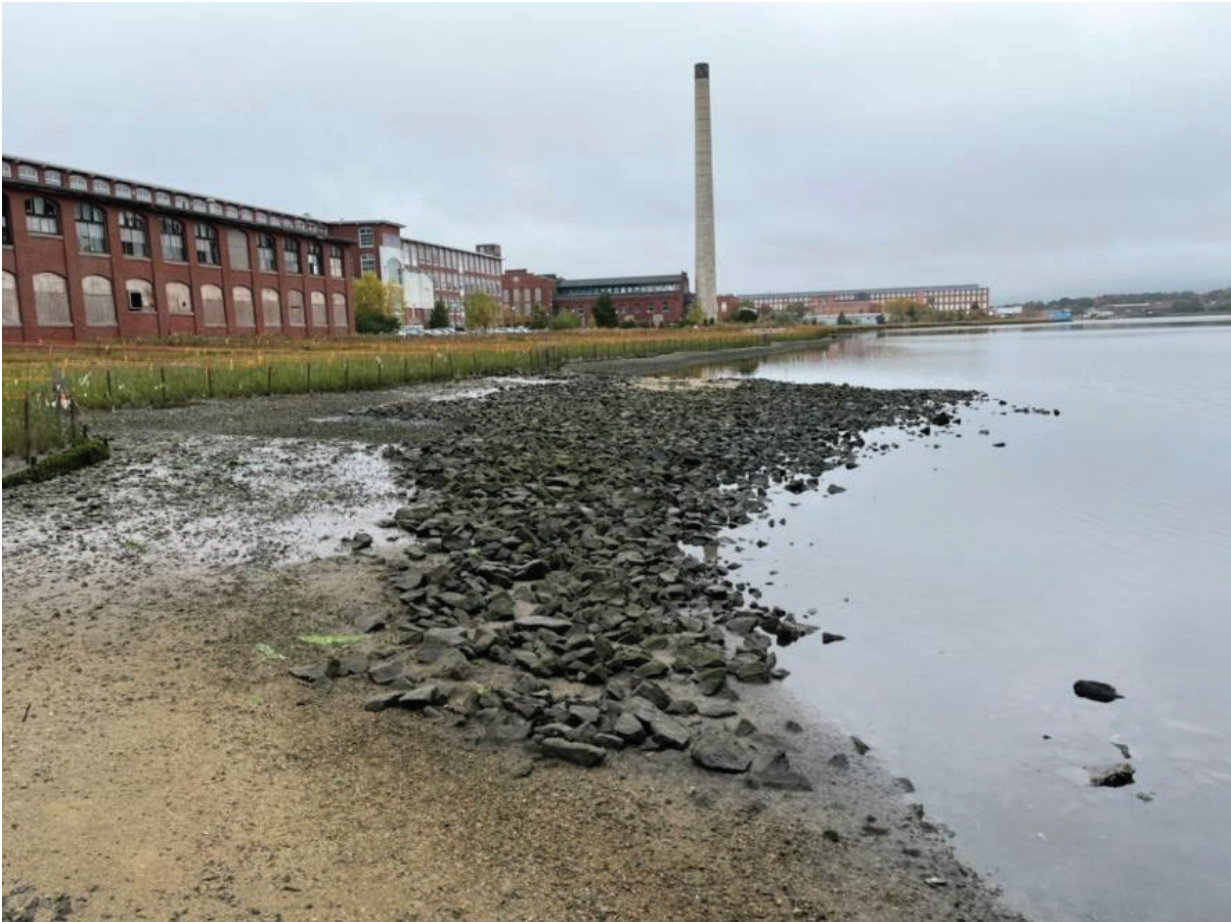
Figure 11:  
**L-014 cap**  
looking north,  
after  
“smoothing”  
operations  
during WZ4  
Remedial  
Action (RA) in  
May 2022.  
Restored WZ4  
saltmarsh is in  
the background.

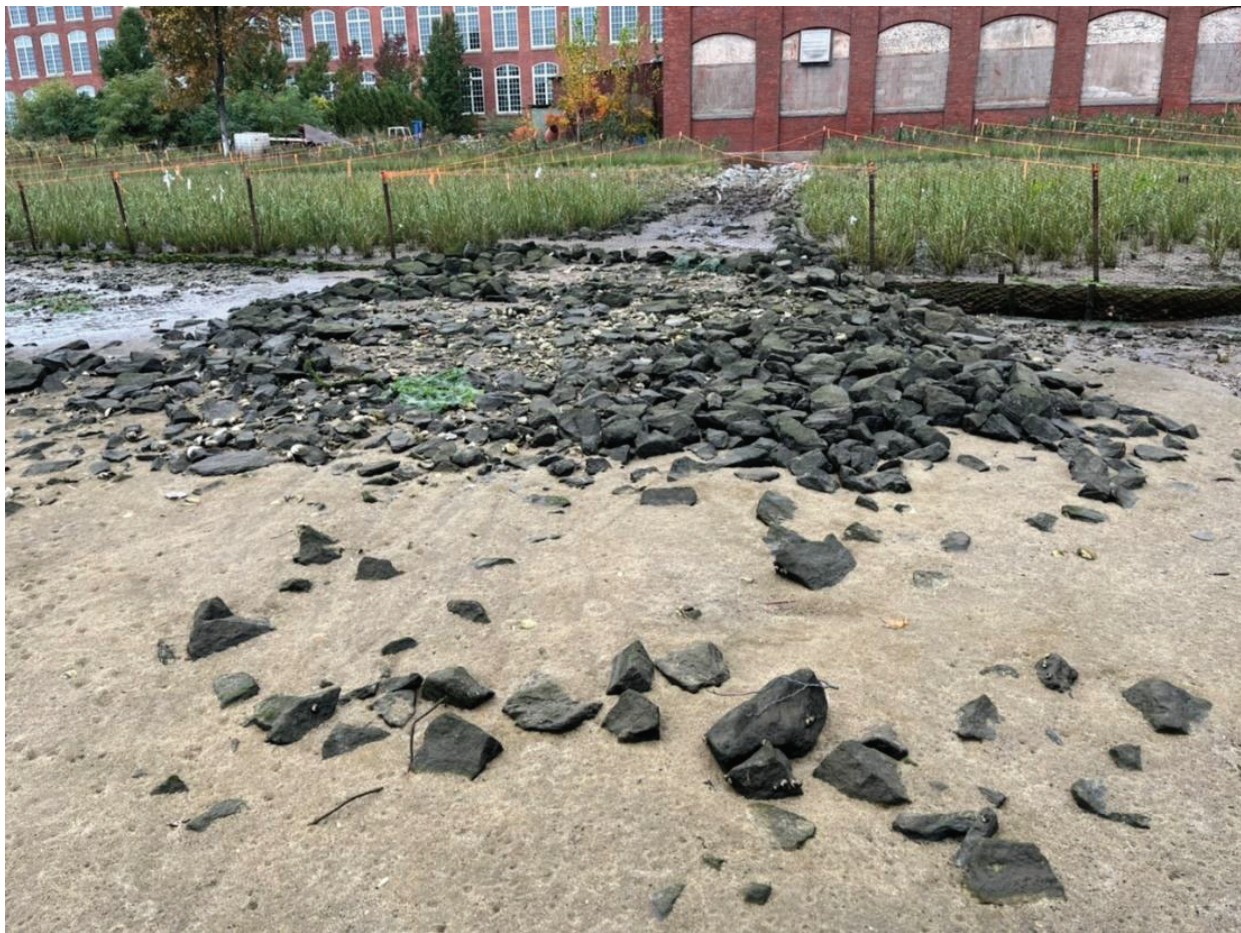
Figure 12:  
**L-014 cap**  
looking west,  
showing  
drainage swale  
and topsoil  
washed onto  
cap surface.  
Restored WZ4  
saltmarsh in  
background.

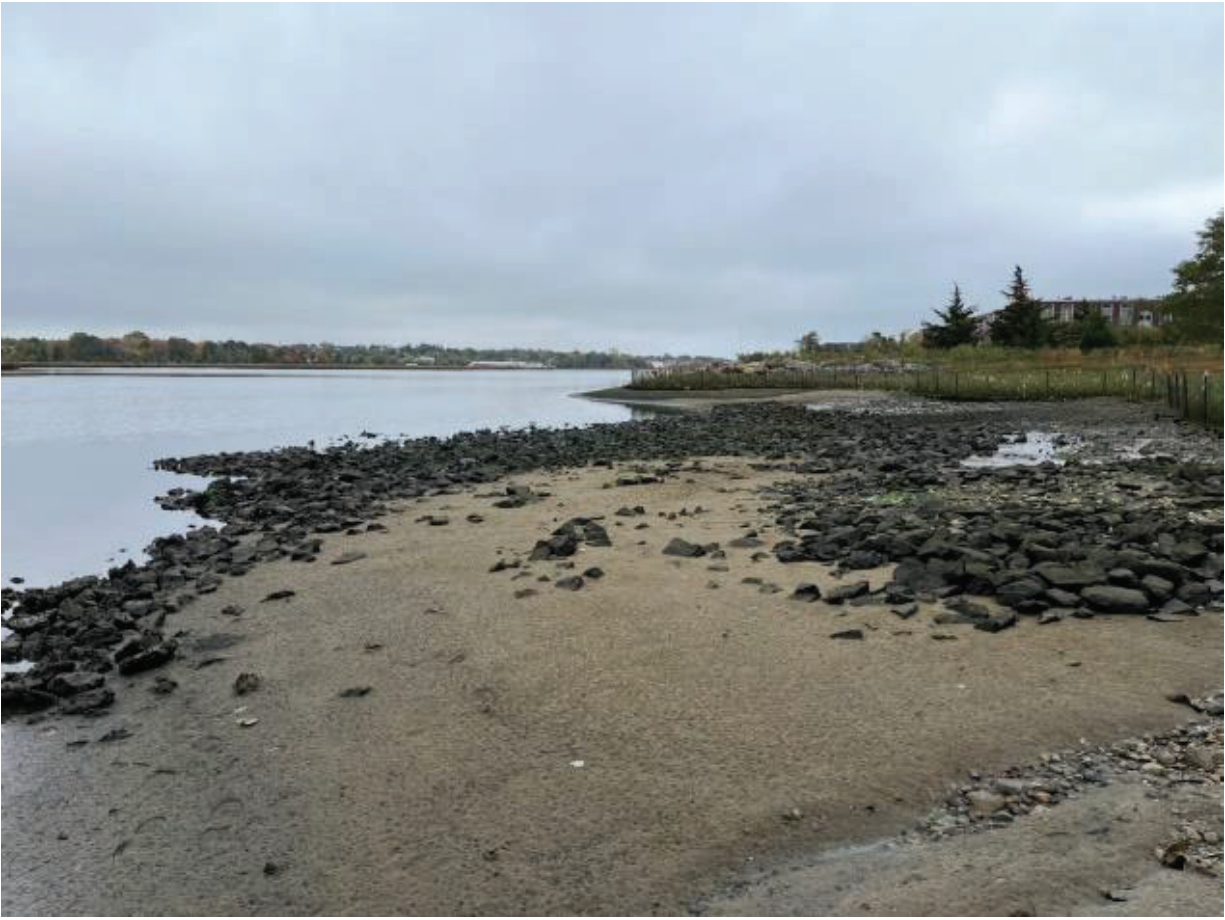
Figure 13:  
**L-014 cap**  
looking south  
from north end  
of the cap.

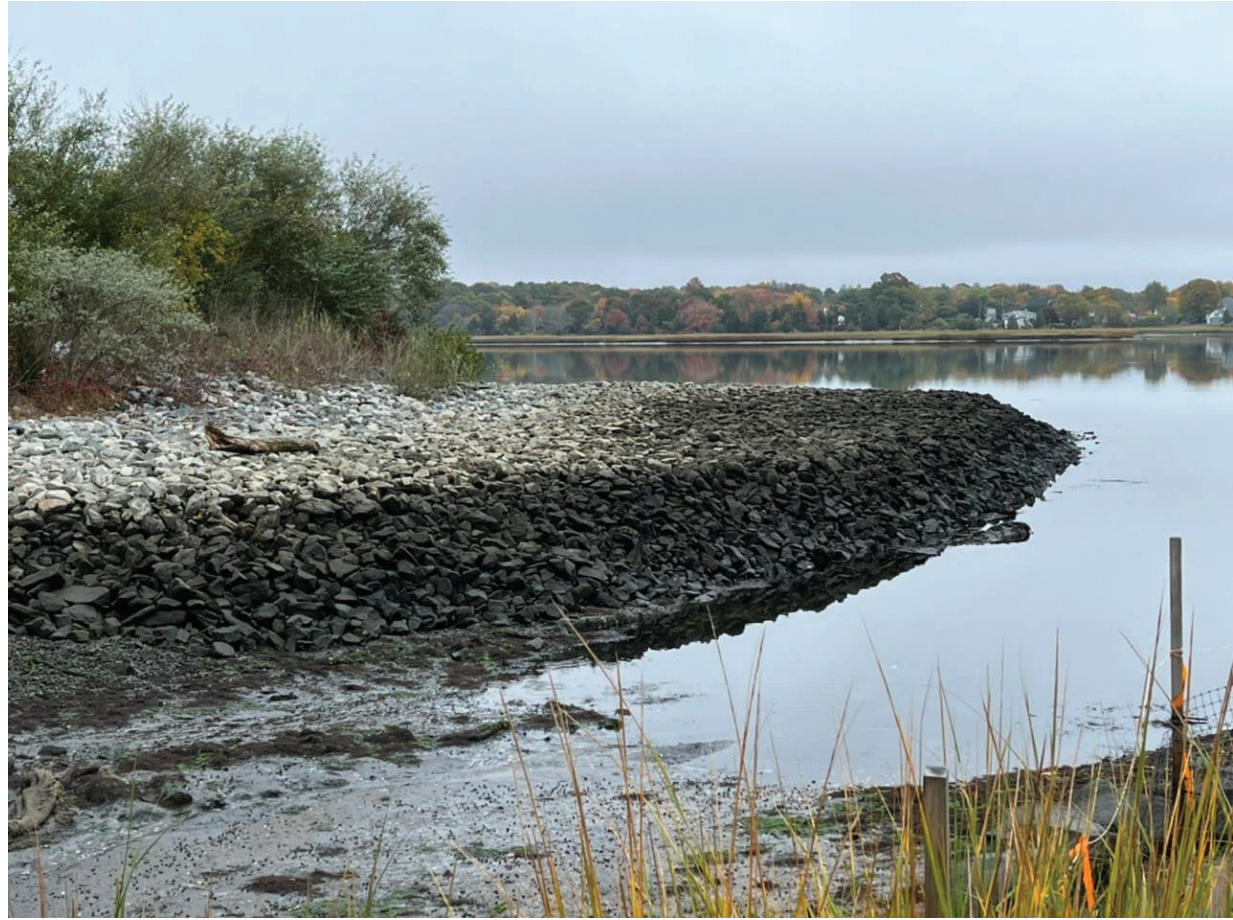
Figure 14: **Pilot  
CDF Shoreline  
Cap** looking  
north from south  
end of the cap.  
Boat ramp and  
Parcel 265  
plantings in fore-  
ground.

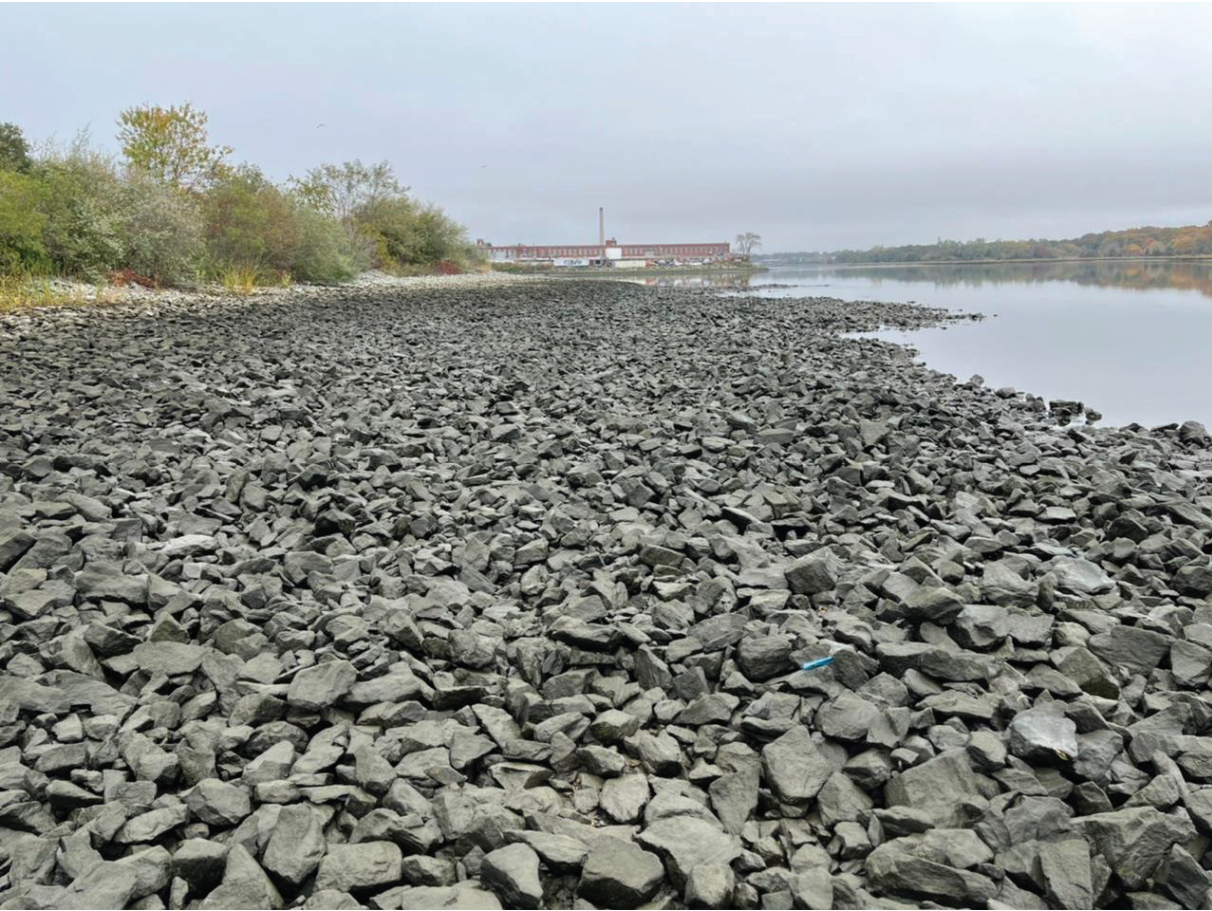
**Figure 15: Pilot CDF Shoreline Cap looking north.**

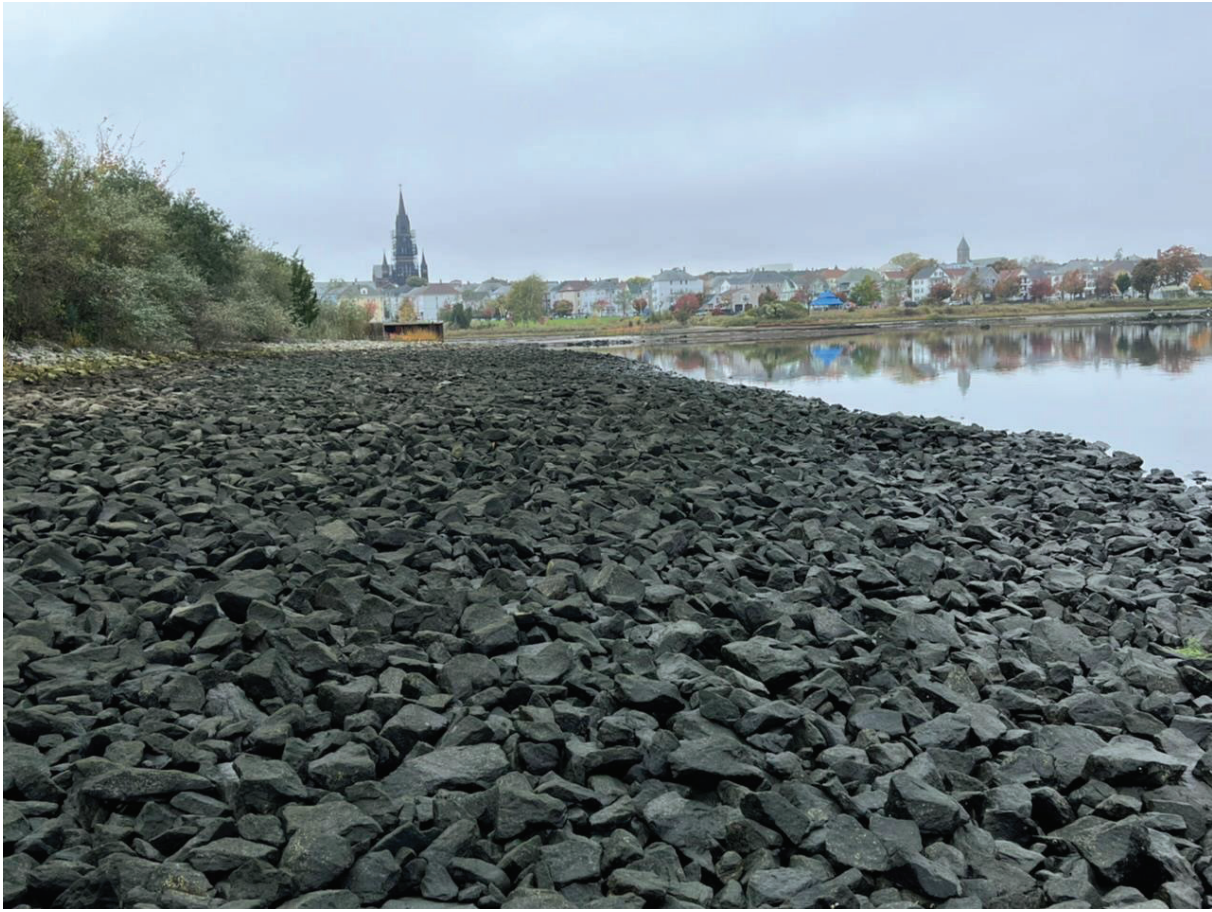
**Figure 16: Pilot CDF Shoreline Cap looking west from the NE corner of the cap.**

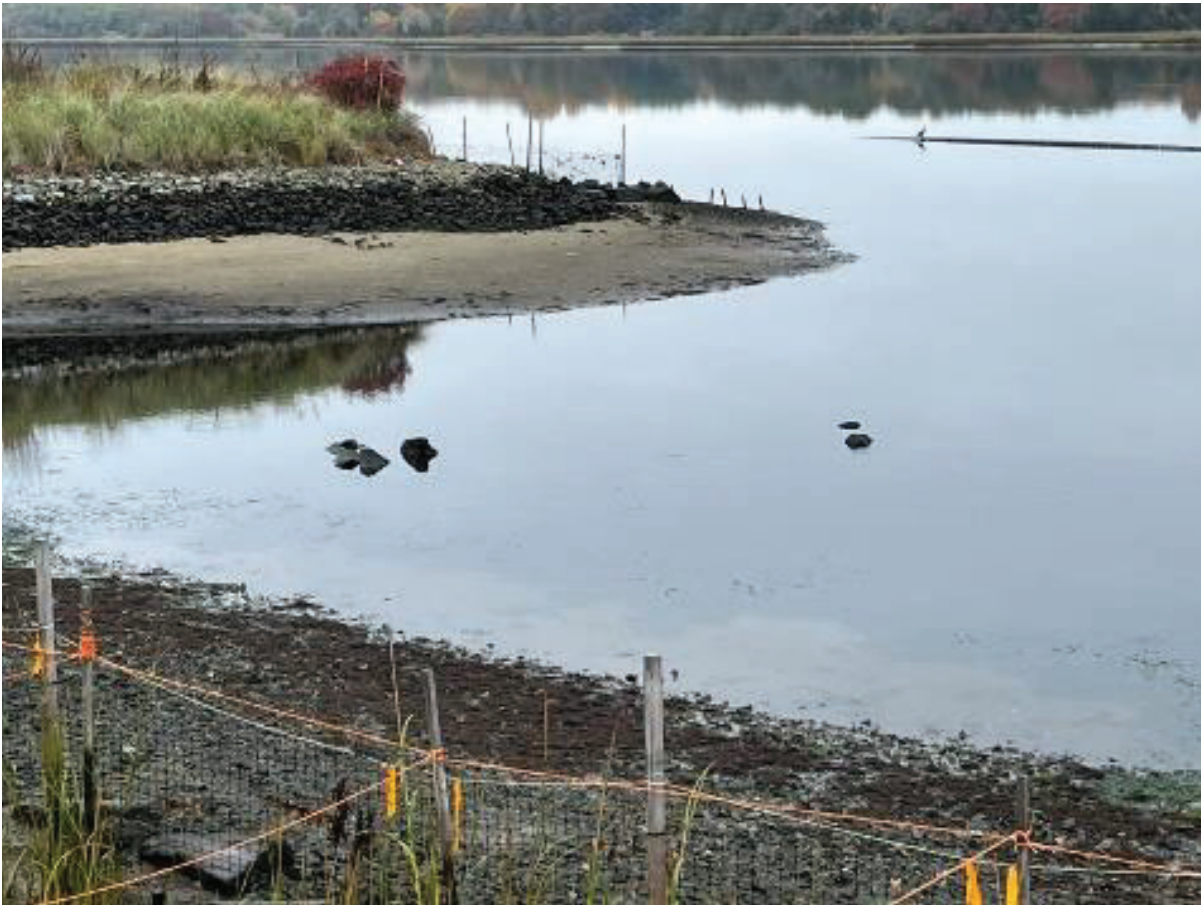
Figure 17: **Parcel 265 stone cap** looking northeast (only a few emergent stones cap be seen at low tide). Parcel 265 restoration plantings in foreground and background.

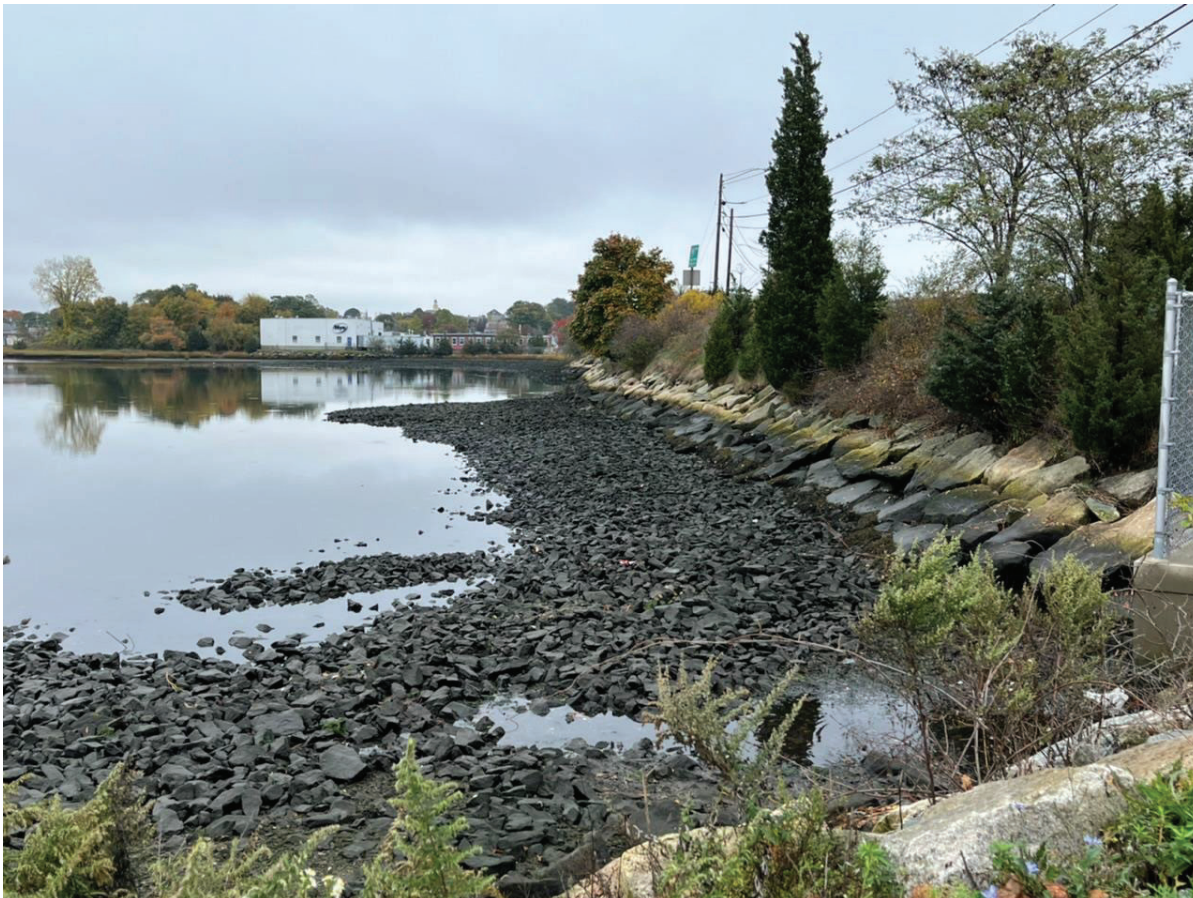
Figure 18: **Cogg-West Cap** looking east.

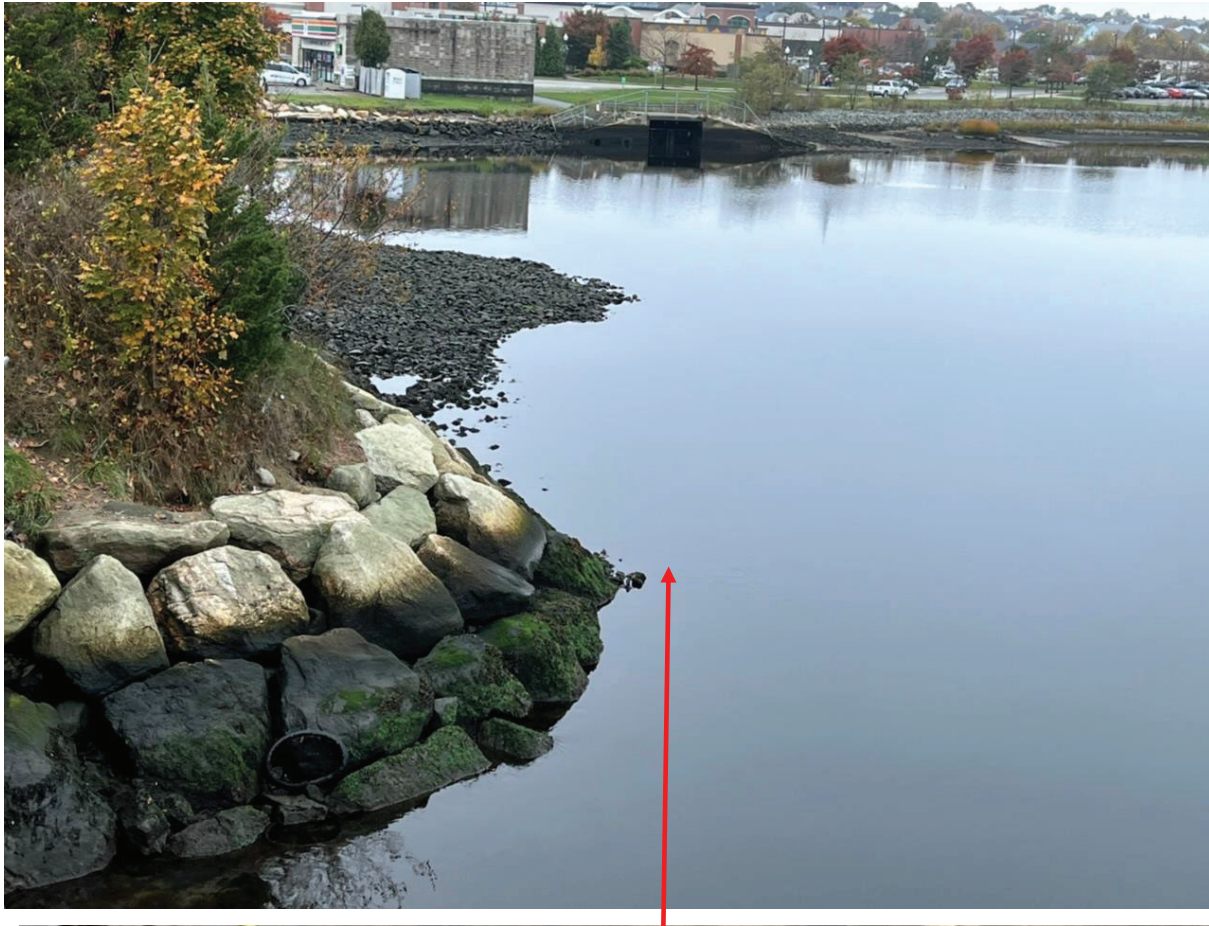
Figure 19: **Cogg-West Cap** looking west from the bridge opening. Shoreline outfall structure in the background (with chain link fence) is the relocated Sawyer Steet CSO.

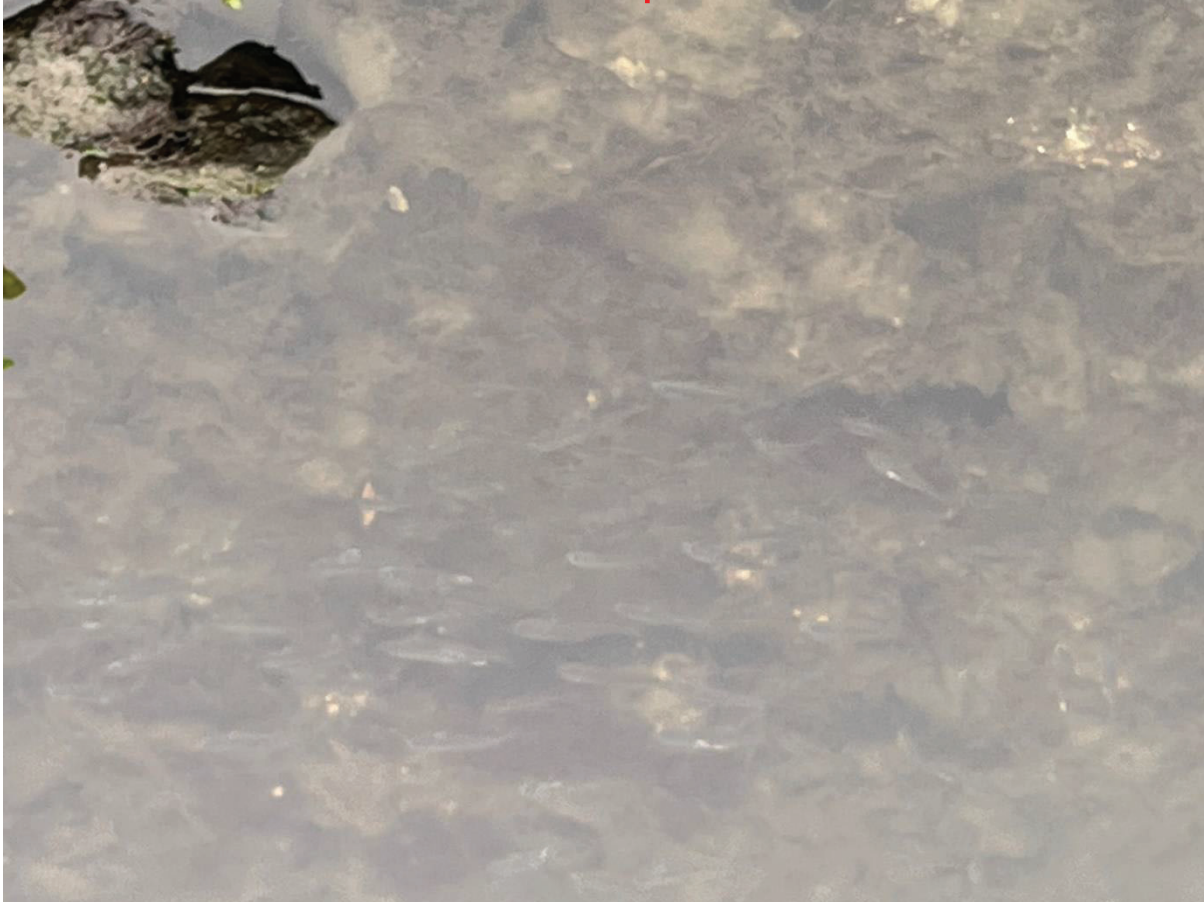
Figure 20: **Cogg-West Cap**. Small school of 3-4” minnows observed facing into the outgoing current on the shallow shelf provided by the cap at this tide (approximate location noted above in Figure 19 by the red arrow).

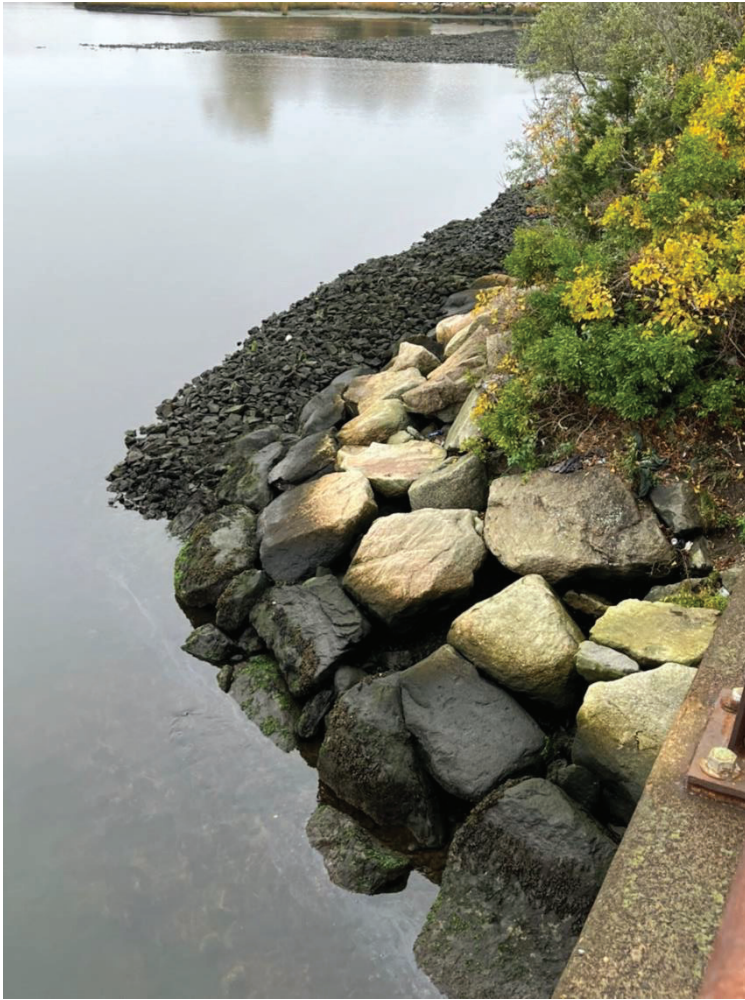
Figure 21: **Cogg-East Cap** looking east from bridge opening.

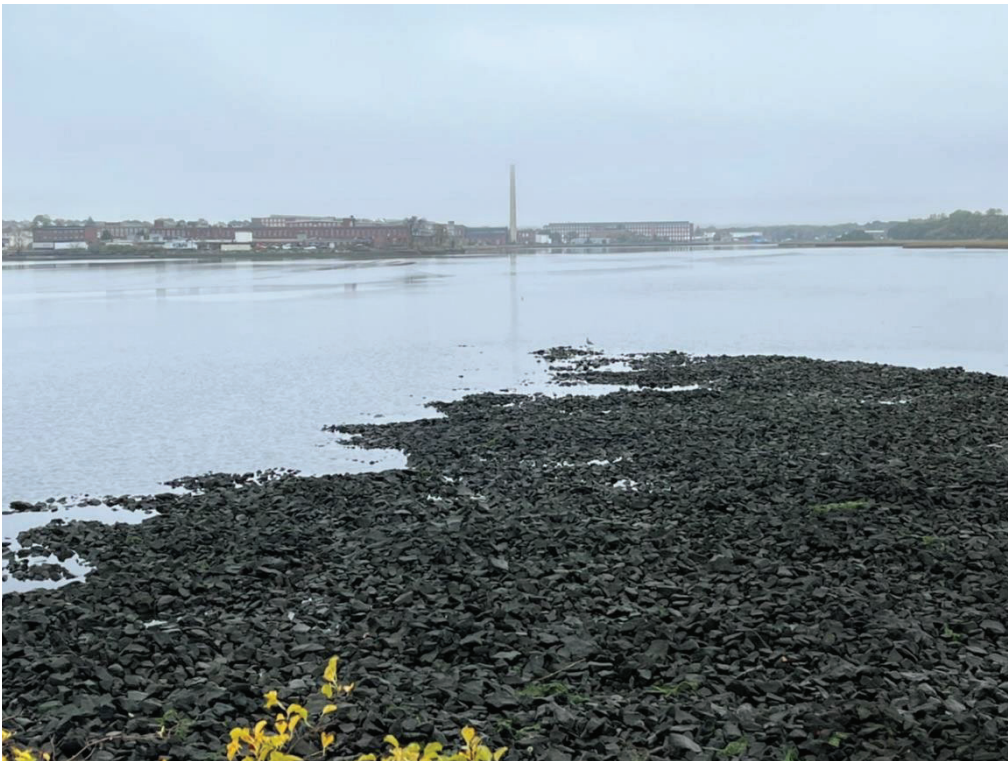
Figure 22: **Cogg-East Cap** looking north. Photo taken from road level.
