UNITED STATES ENVIRONMENTAL PROTECTION AGENCY

Memorandum

DATE: November 17, 2022

SUBJ: 10/25/2022 inspection of Upper Harbor sediment caps, NBHSS

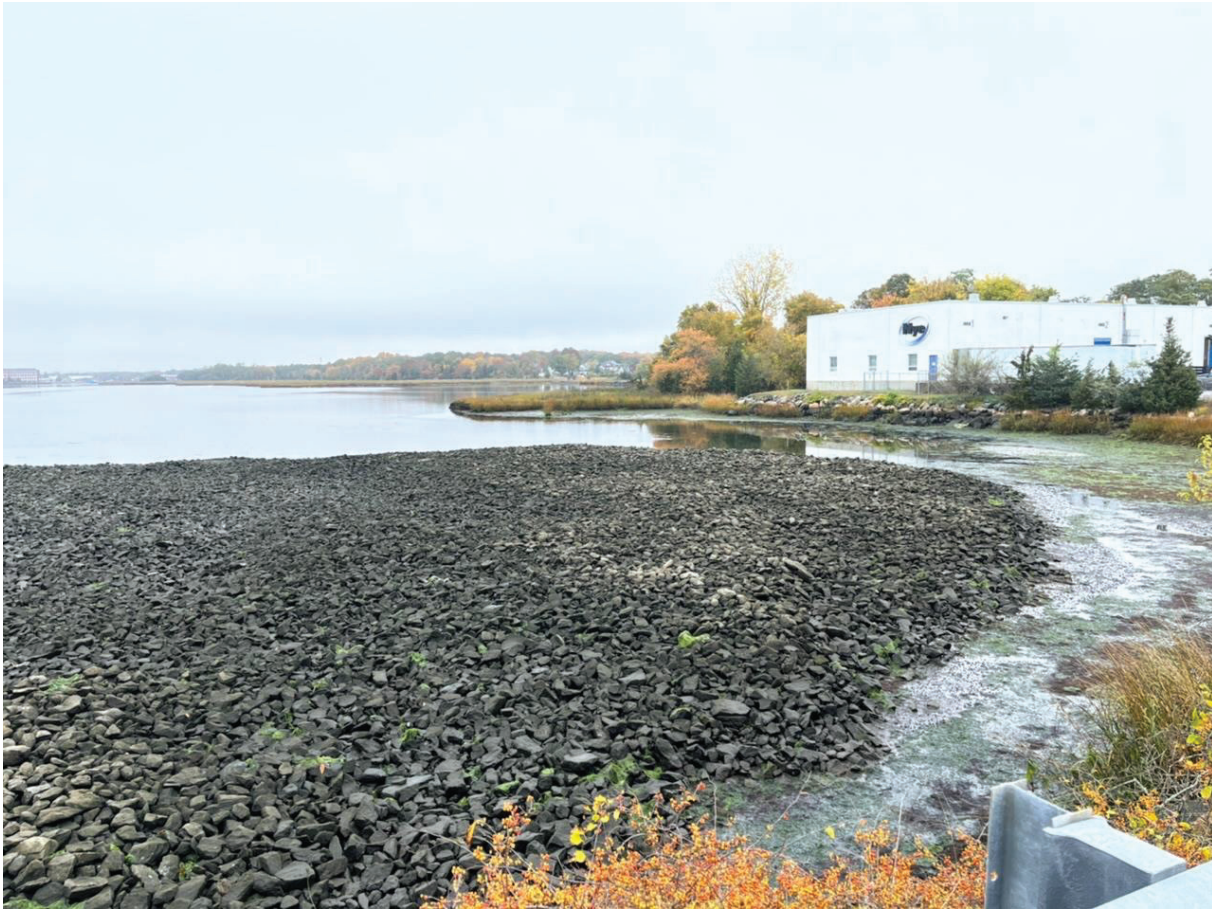
Figure 23:  
**Cogg-East Cap**  
looking north  
from the eastern  
edge of the cap.

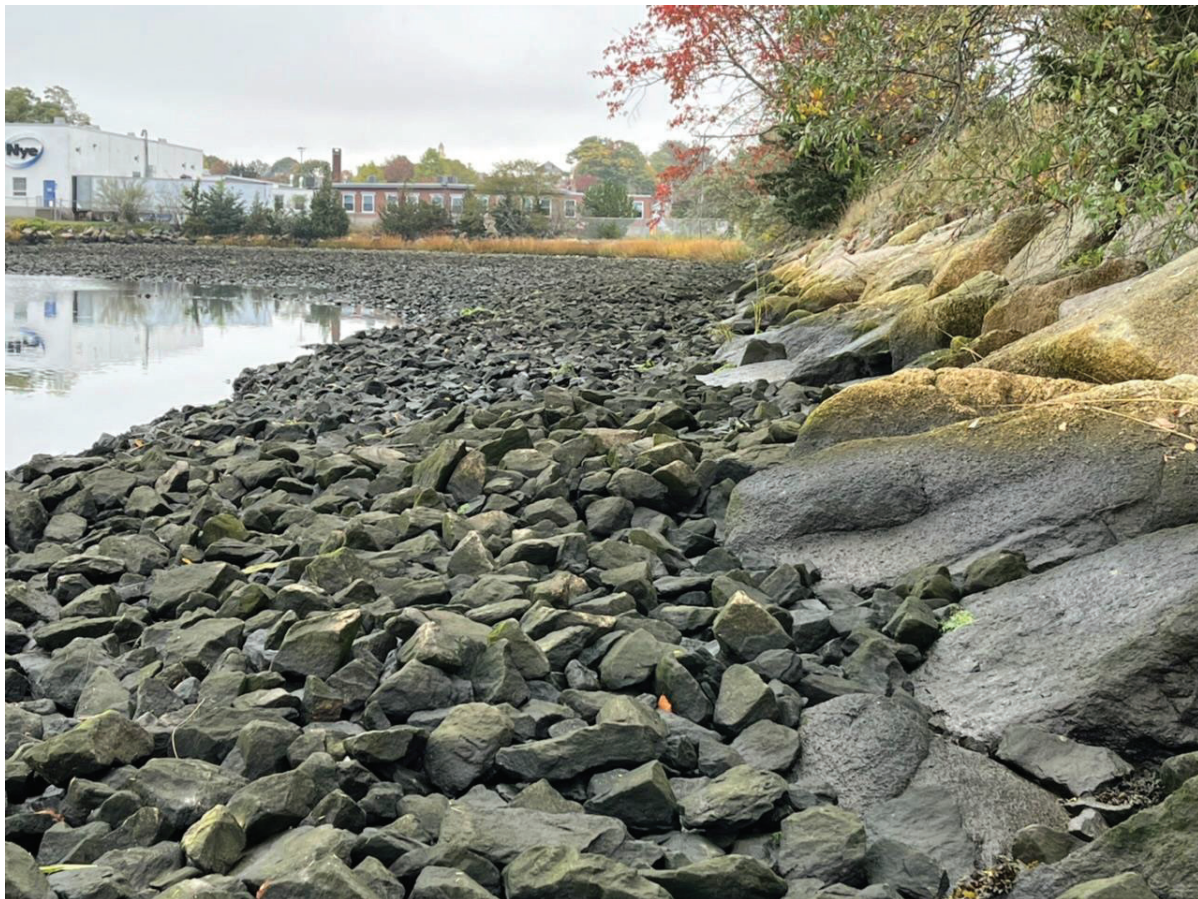
Figure 24:  
**Cogg-East Cap**  
looking east  
from near the  
bridge opening.
