UNITED STATES ENVIRONMENTAL PROTECTION AGENCY

Memorandum

SUBJ: 5/5/2023 inspection of Upper Harbor sediment caps, NBHSS

FROM: David Dickerson, Remedial Project Manager

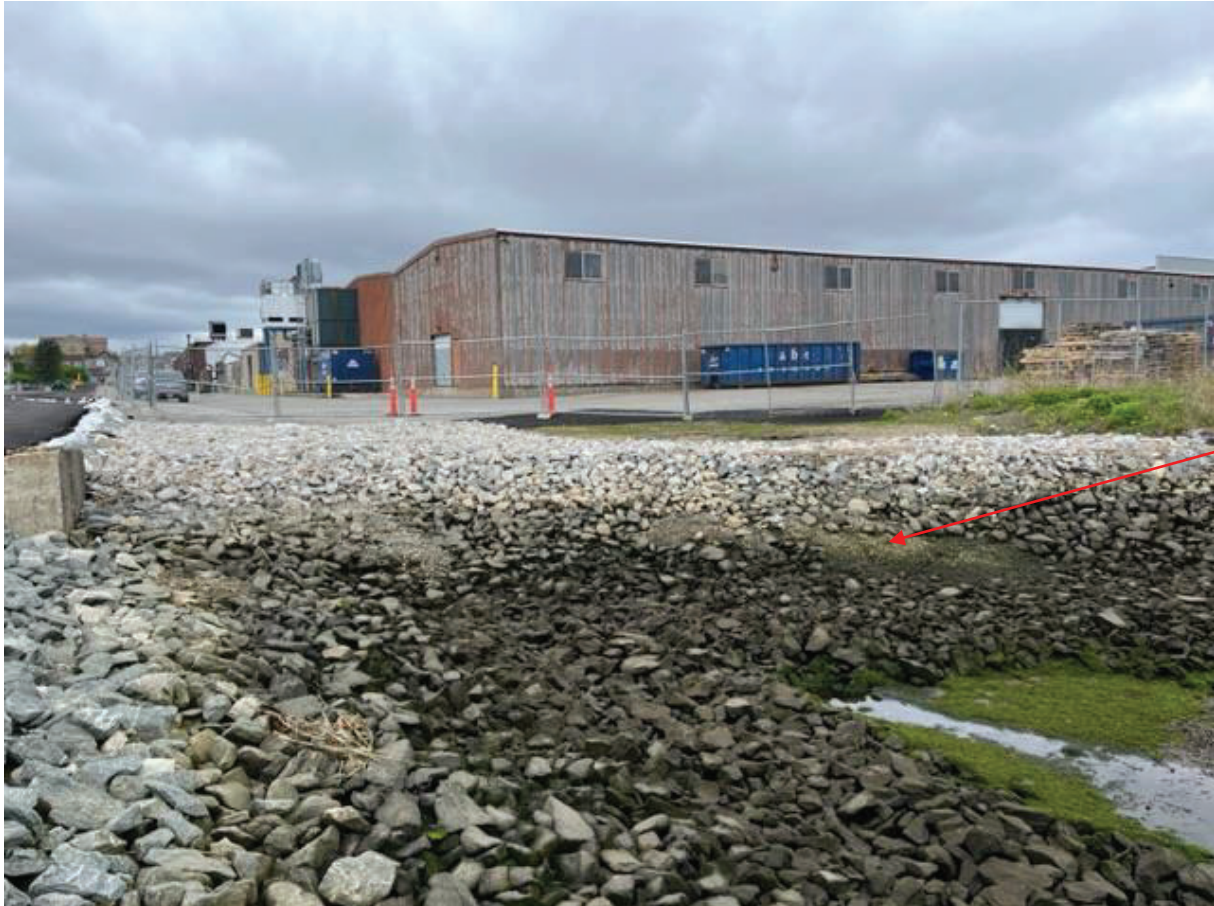
Figure 2:
Aerovox Cap:
Looking west showing the improved east end of the Graham Street drainage swale, with larger stone added. Remnants of the original smaller stone that washed out can be seen.

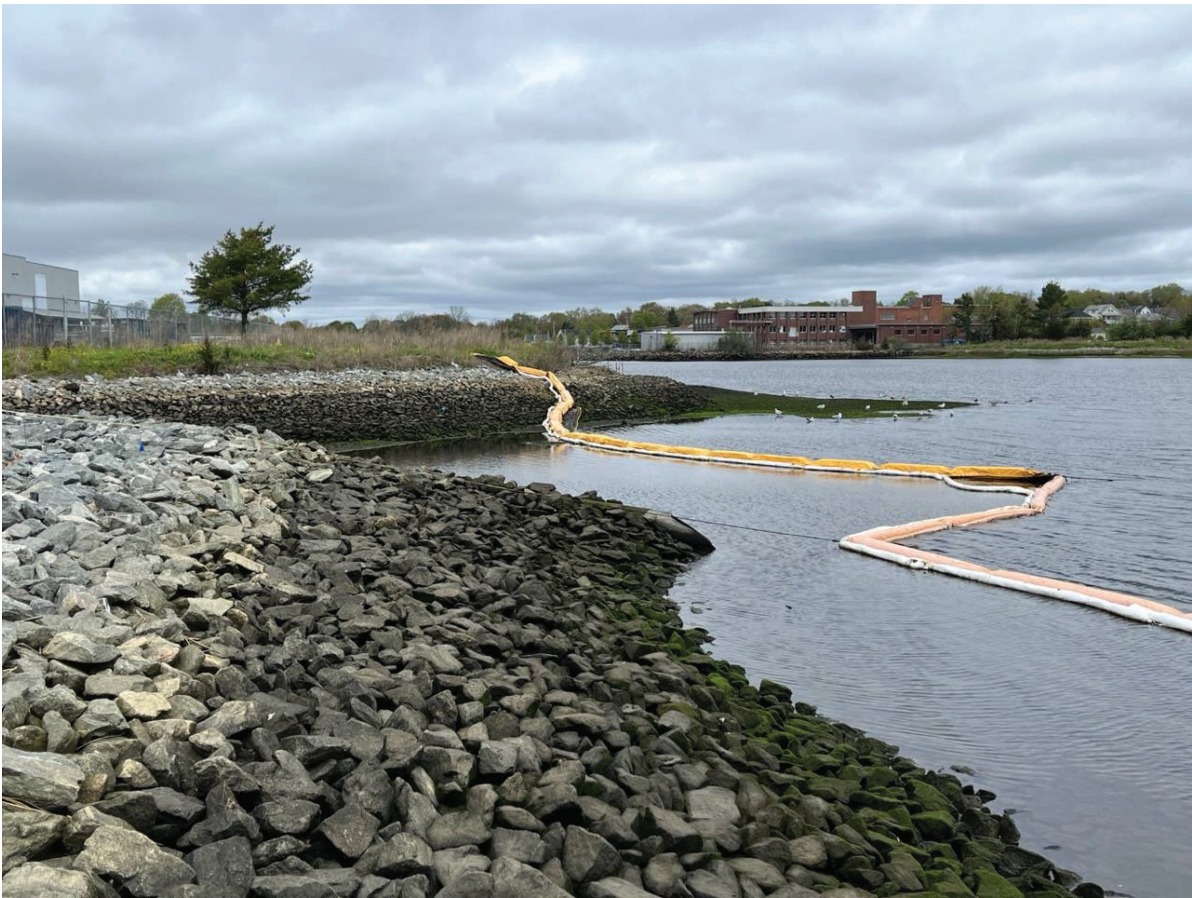
Figure 3:
Aerovox Cap:
Looking north
showing the
northern portions
of the cap. The
silt curtain and oil
boom are from on-
going 21E
operations.

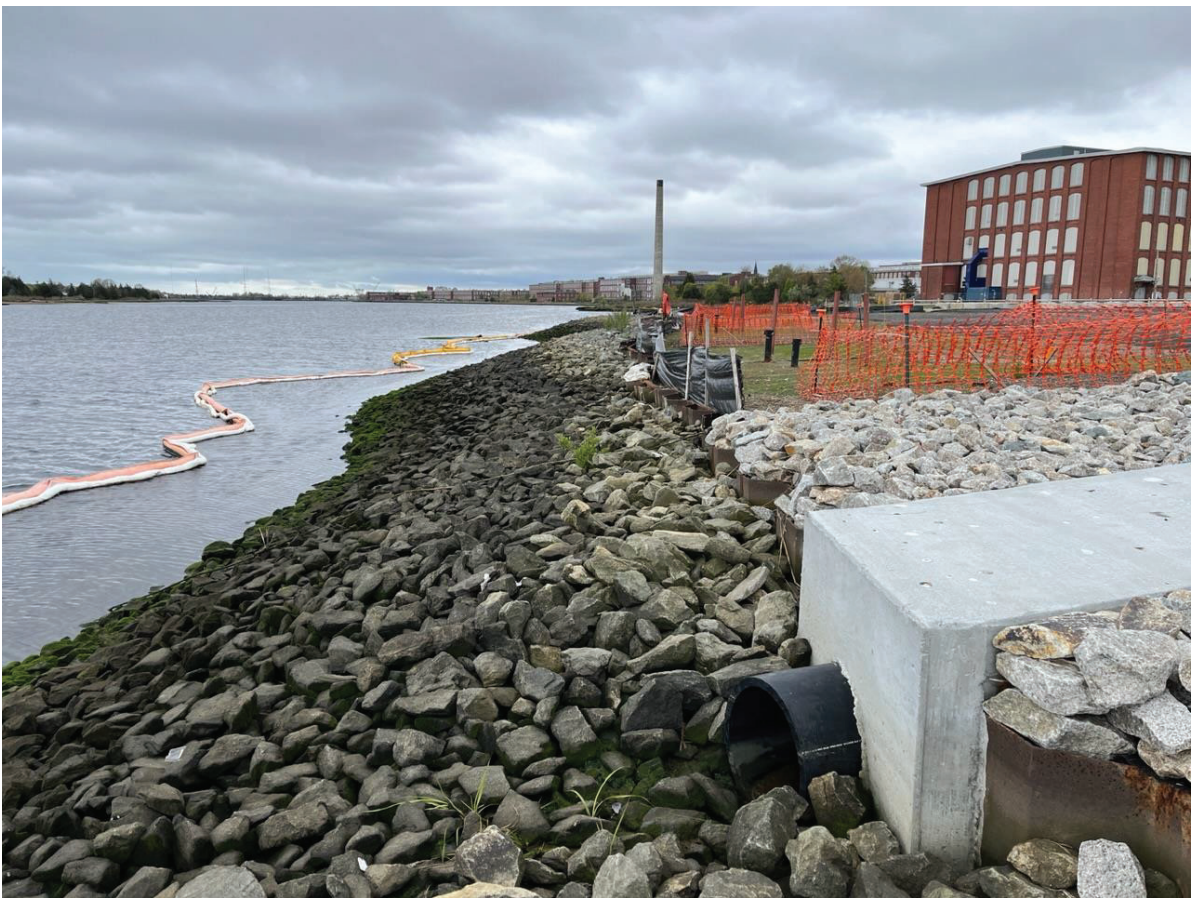
Figure 4:
Aerovox Cap:
Looking south
showing the new
South Trench
discharge structure
in foreground.
Emergent salt grass
noted in previous
inspection remains
near outfall.

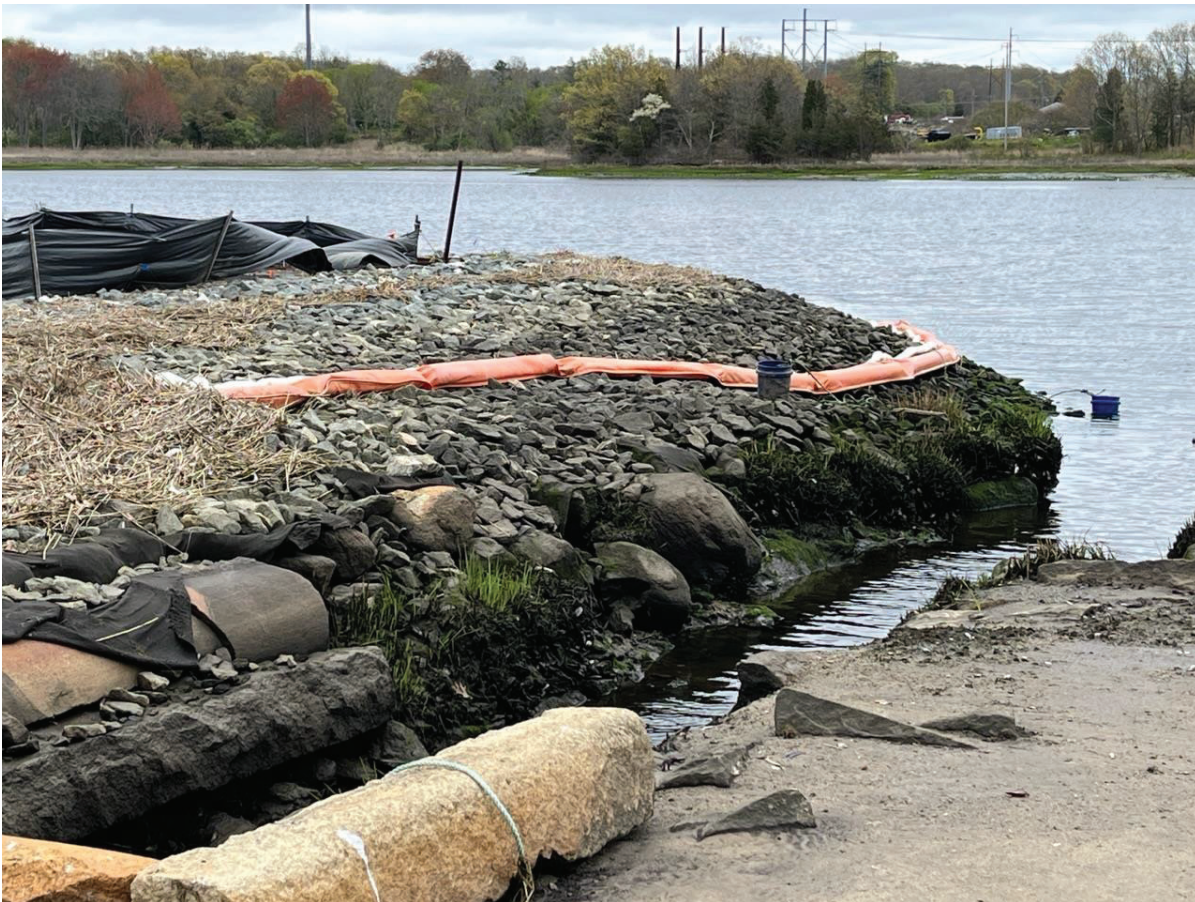
Figure 5:
Aerovox Cap:
Looking NE
showing the
Hadley Street
storm drain
outfall which
abuts the
southern end of
this cap.

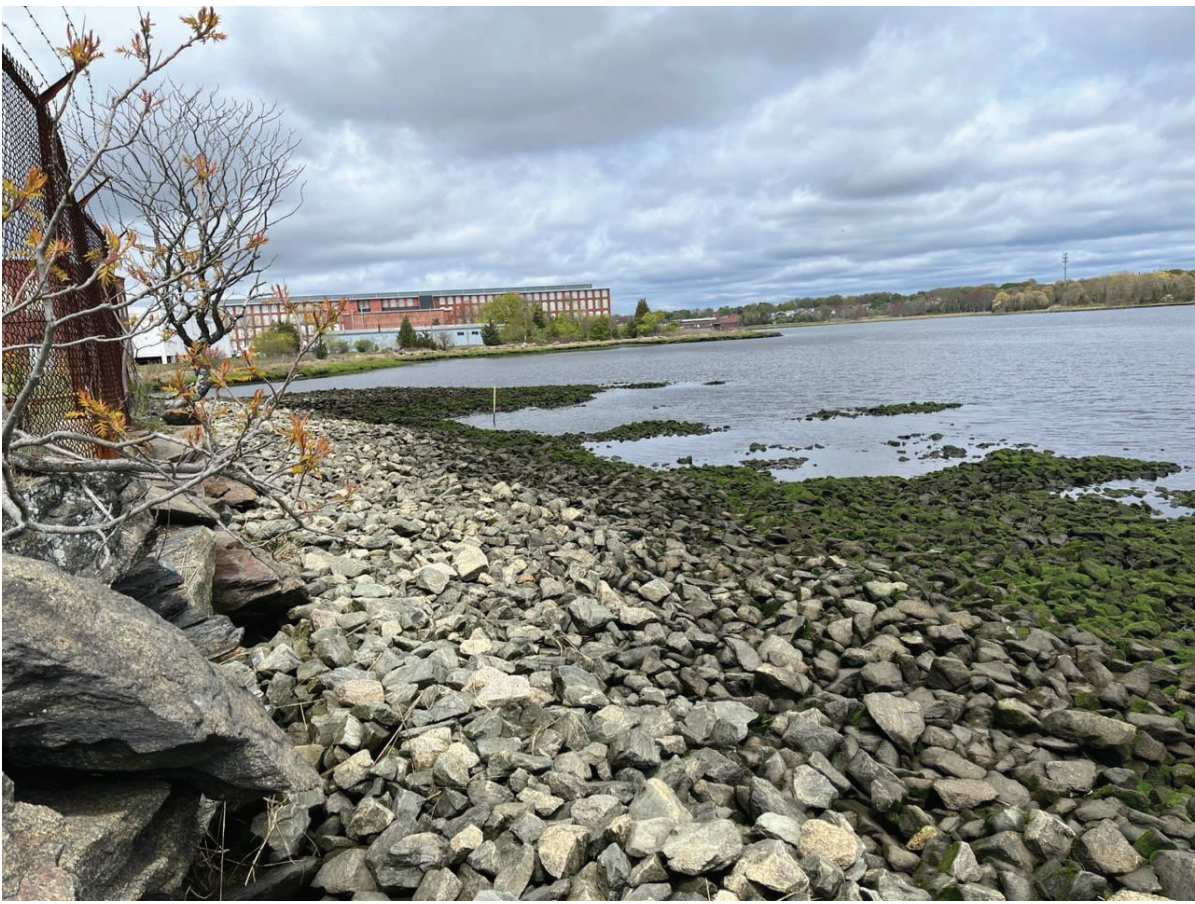
Figure 6:
Crib Cap looking
north. The white
stake is the
location of an old
storm drain.

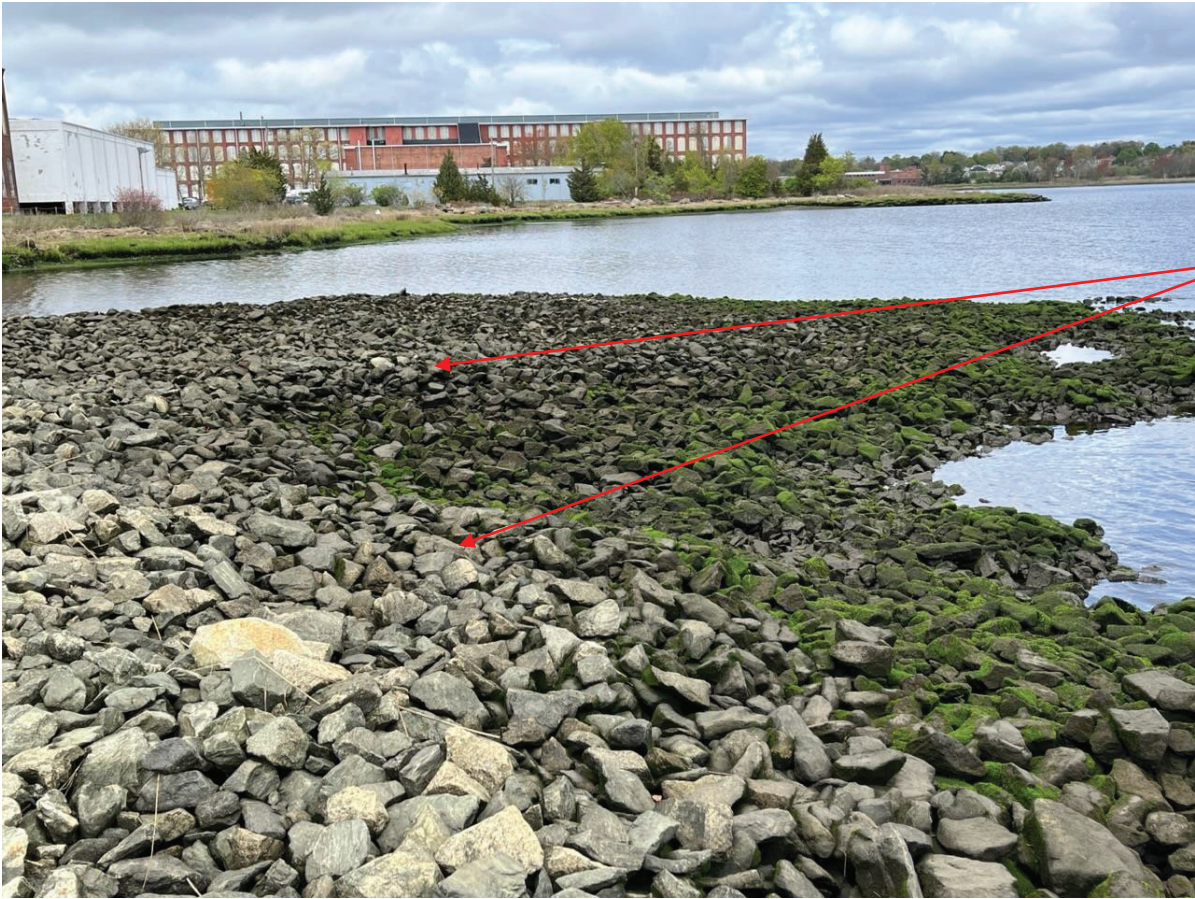
Figure 7:
Crib Cap
looking north,
showing
examples of
high spots to be
smoothed per
the one action
item discussed
above on p.1.

- At the Crib cap, when implementing the upcoming West Zone 2/3 remedial action in 2023/2024, consider use of a low-ground-pressure small excavator to create a more uniform, smoother (less undulating) stone surface. This would aid in visually detecting potential stone displacement moving forward during O&M to minimize the need for topographic/bathymetric surveys during O&M. Additional stone could be added if necessary to help create this uniform, smoother surface.

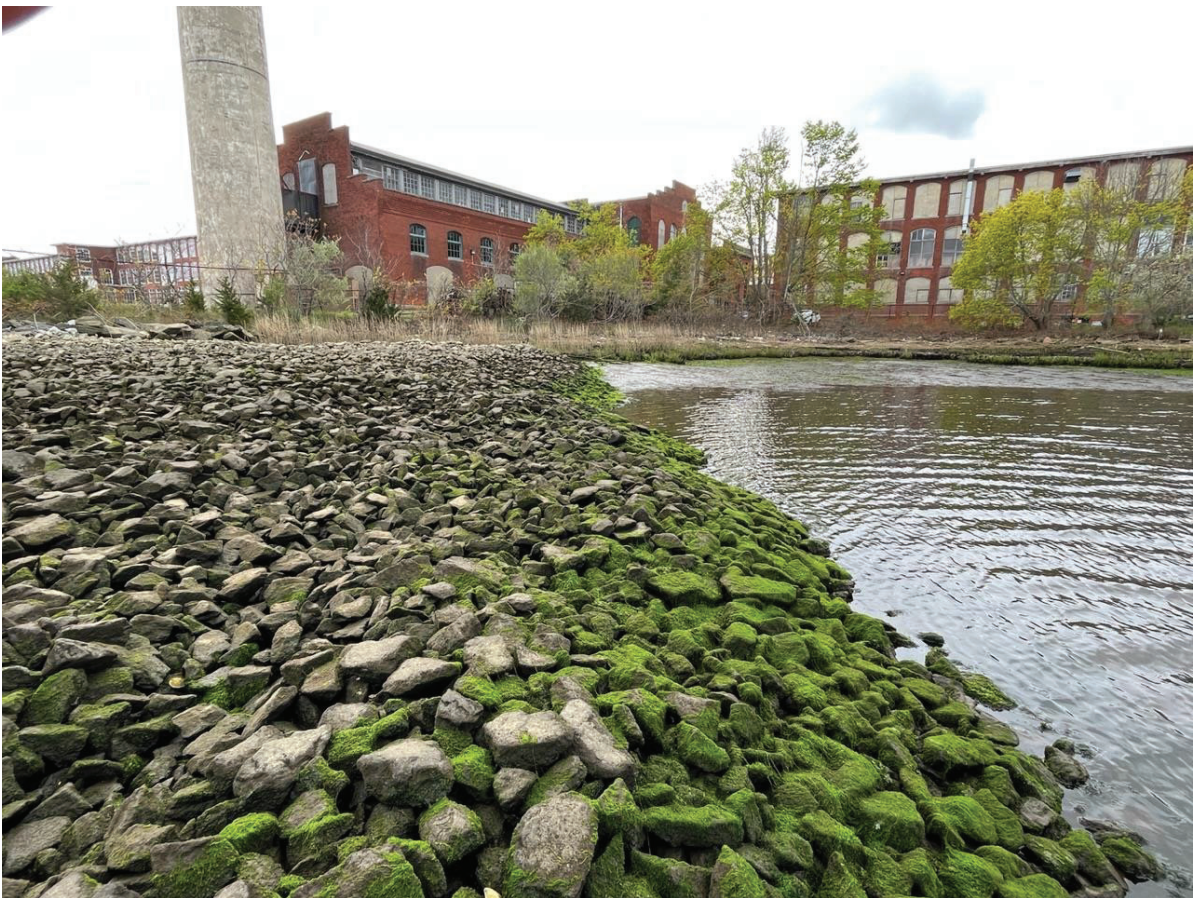
Figure 8:
Crib Cap
looking west,
showing the
northern edge of
this cap.

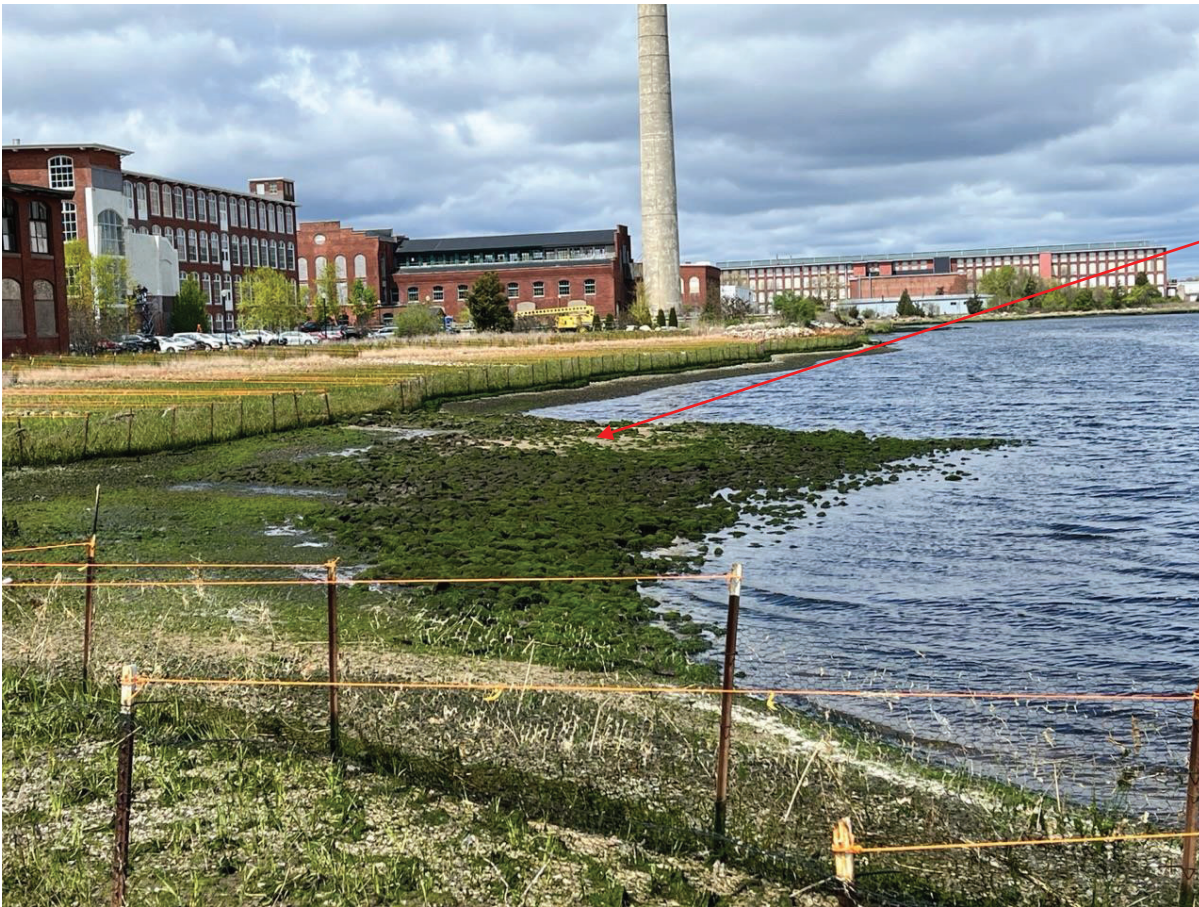
Figure 9:
L-014 Cap
looking north.
Light brown
color is
silt/topsoil
deposition from a
WZ-4 drainage
swale.

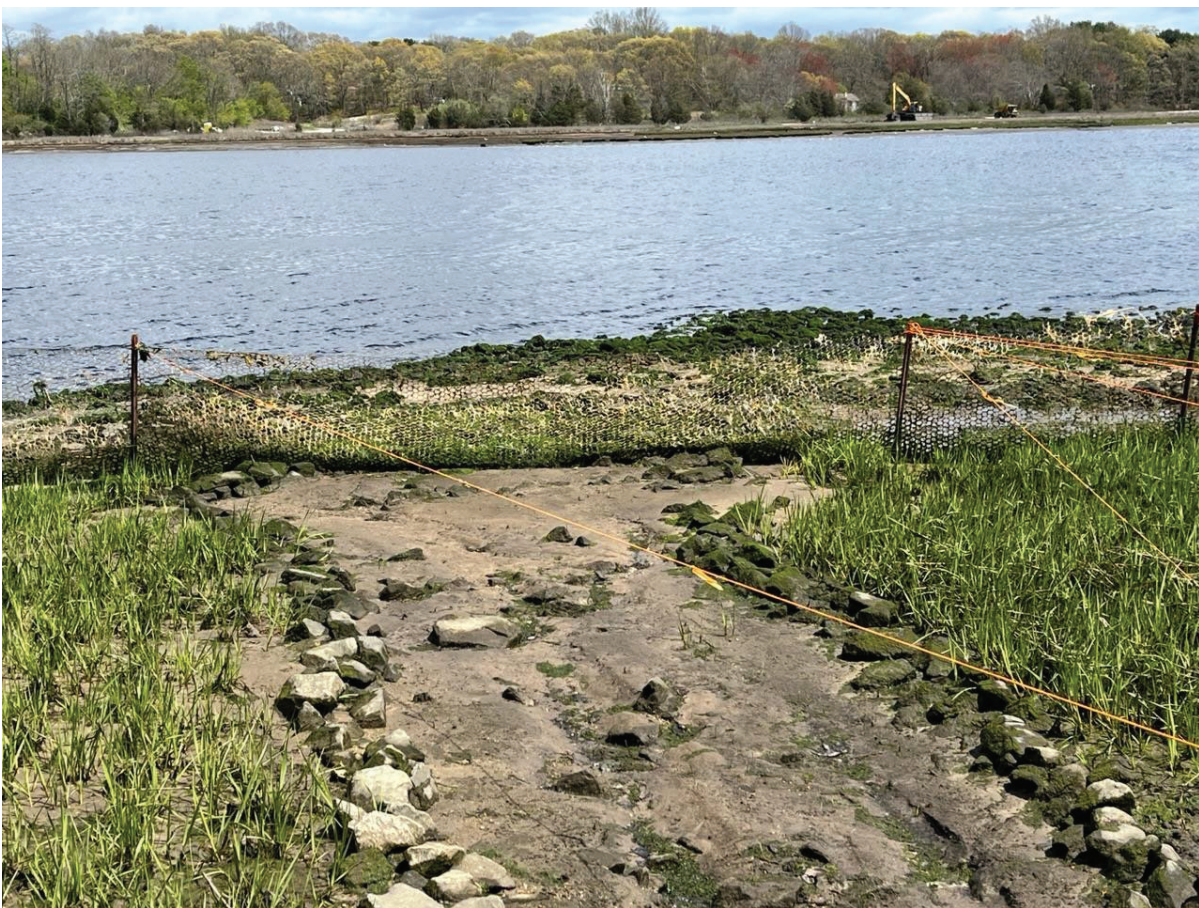
Figure 10:
L-014 Cap
looking east,
showing the
WZ-4 drainage
swale and
related silt and
topsoil
deposition.

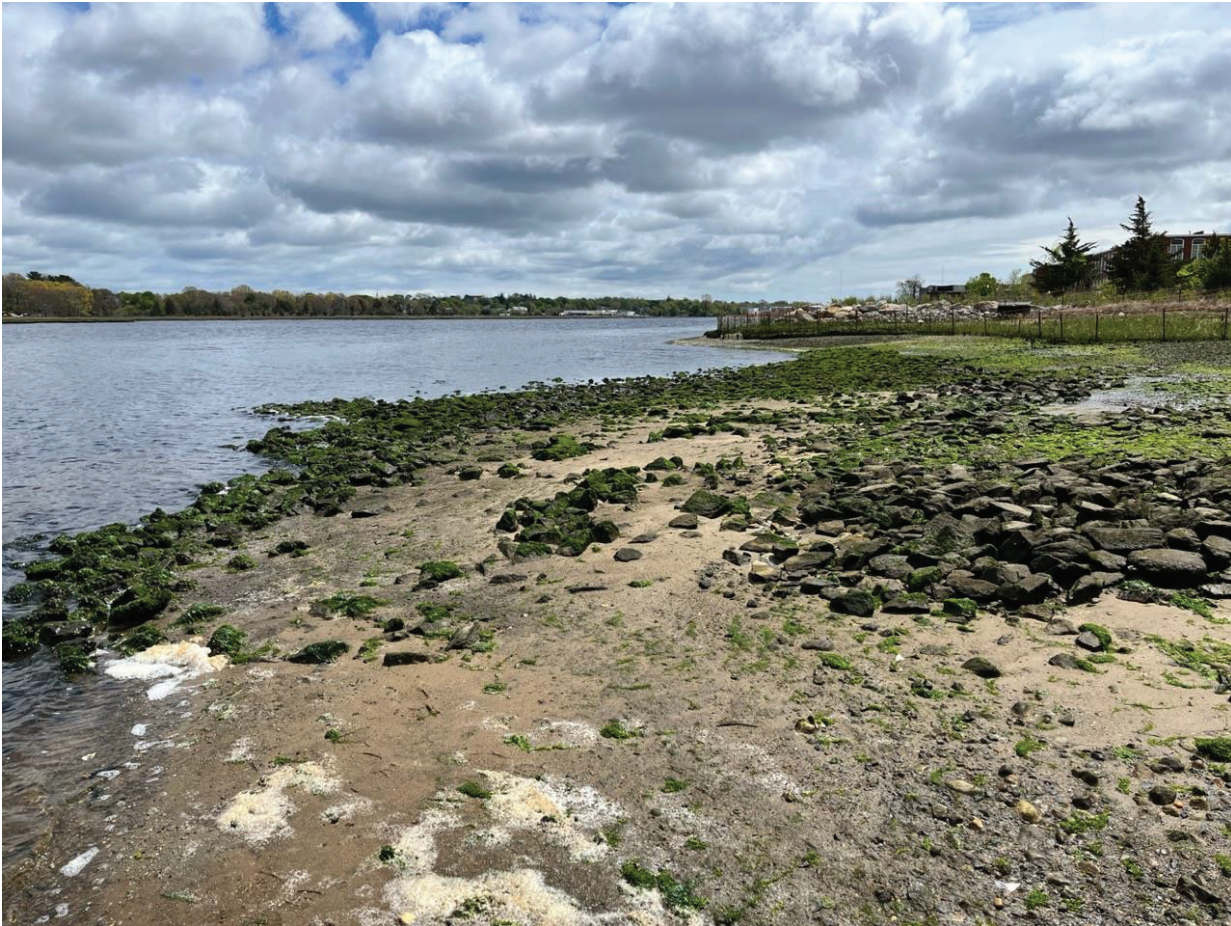
Figure 11:
L-014 Cap
looking south,
showing silt
deposition
within the stone
cap surface.

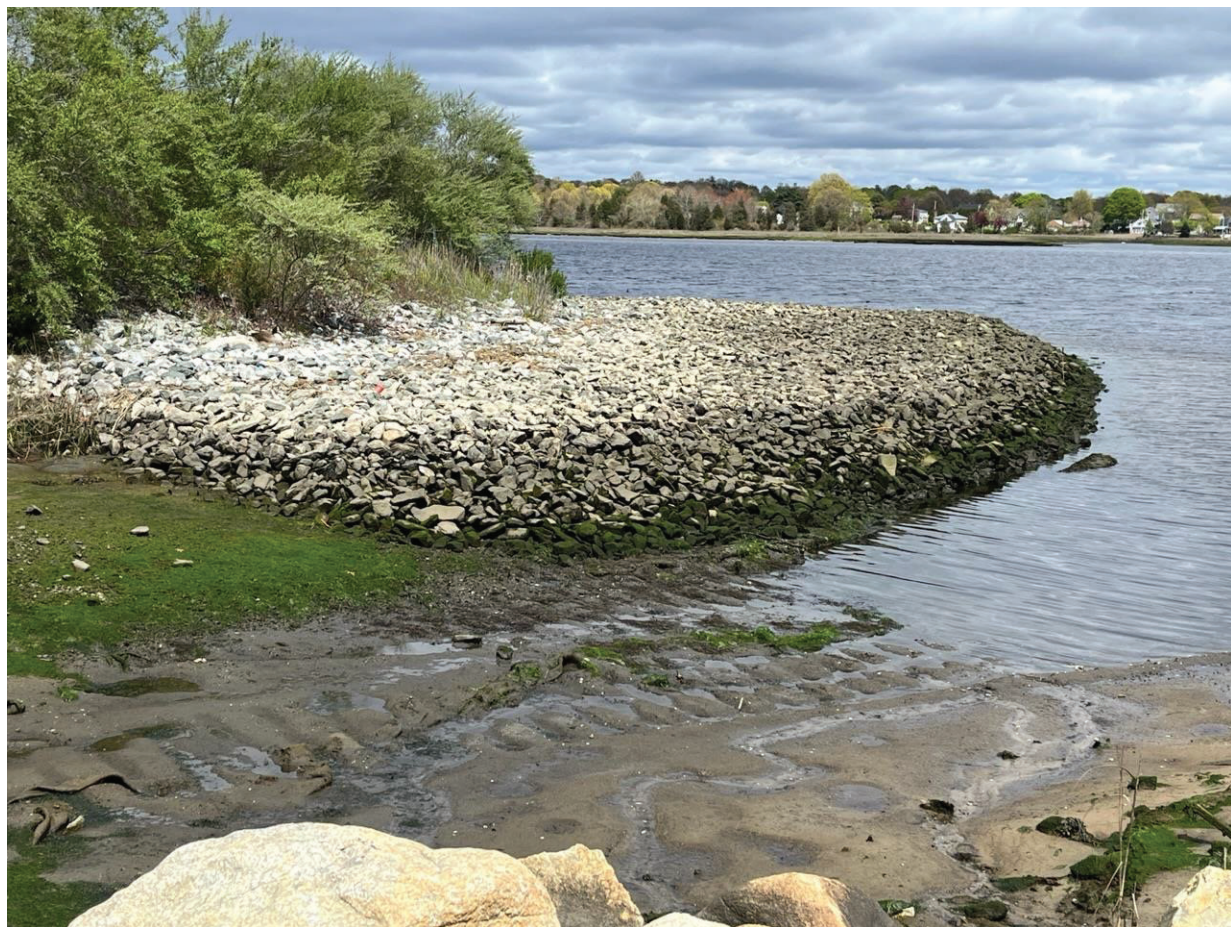
Figure 12:
**Pilot CDF
Cap** looking
NE, showing
the southern
portion of this
cap.

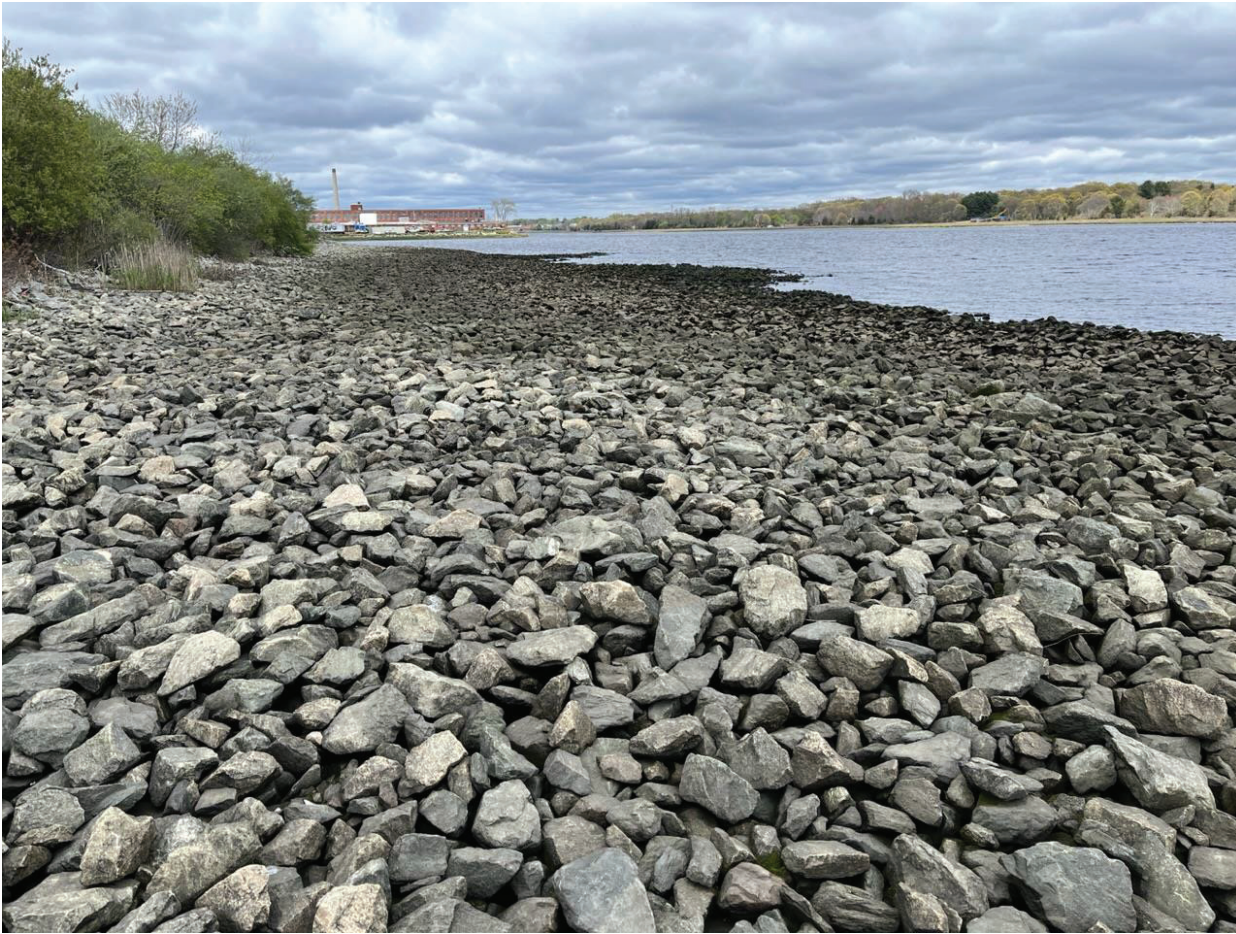
Figure 13:
**Pilot CDF
Cap** looking
north,
showing the
eastern edge
of this cap.

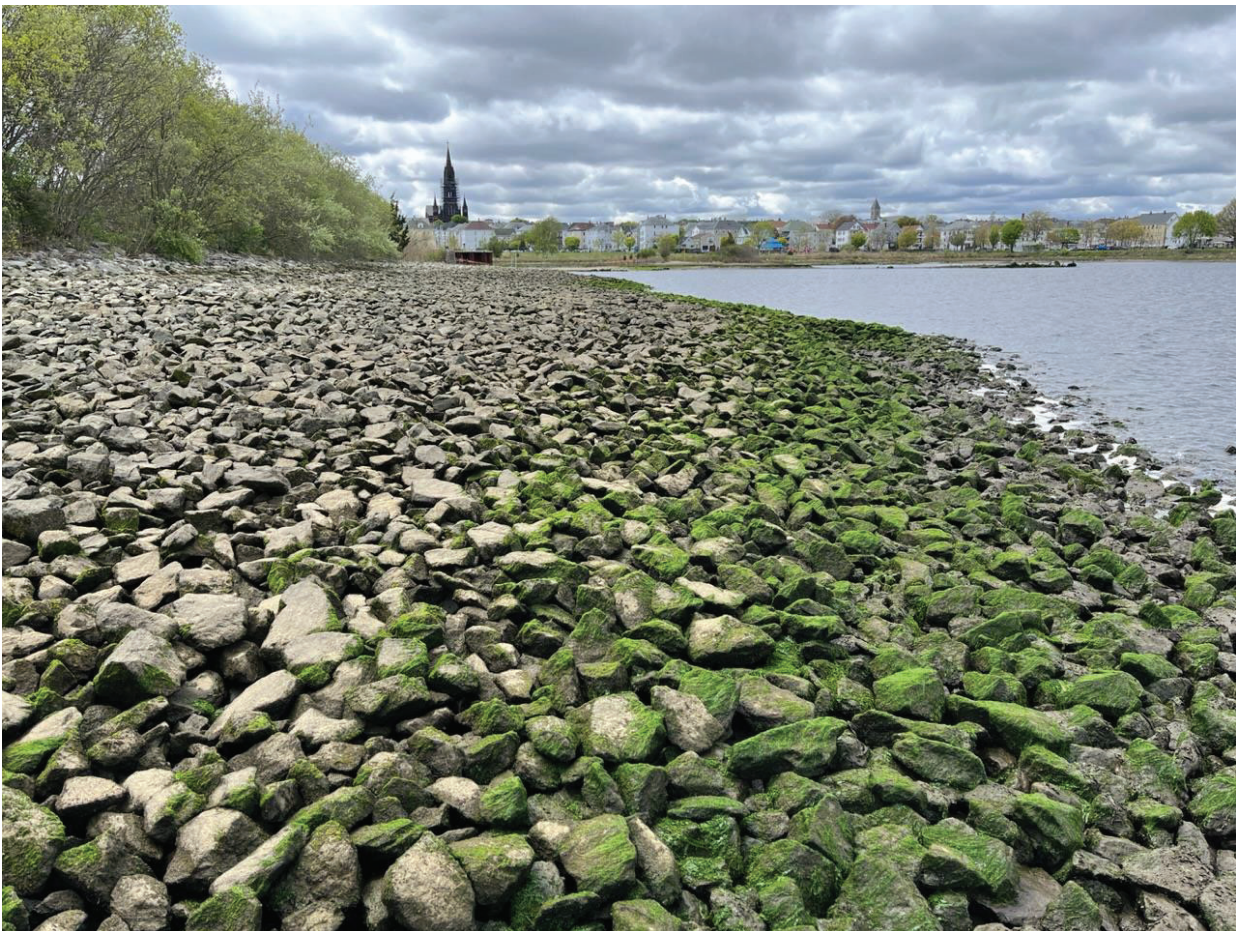
Figure 14:
**Pilot CDF
Cap** looking
west, showing
the northern
edge of this
cap.

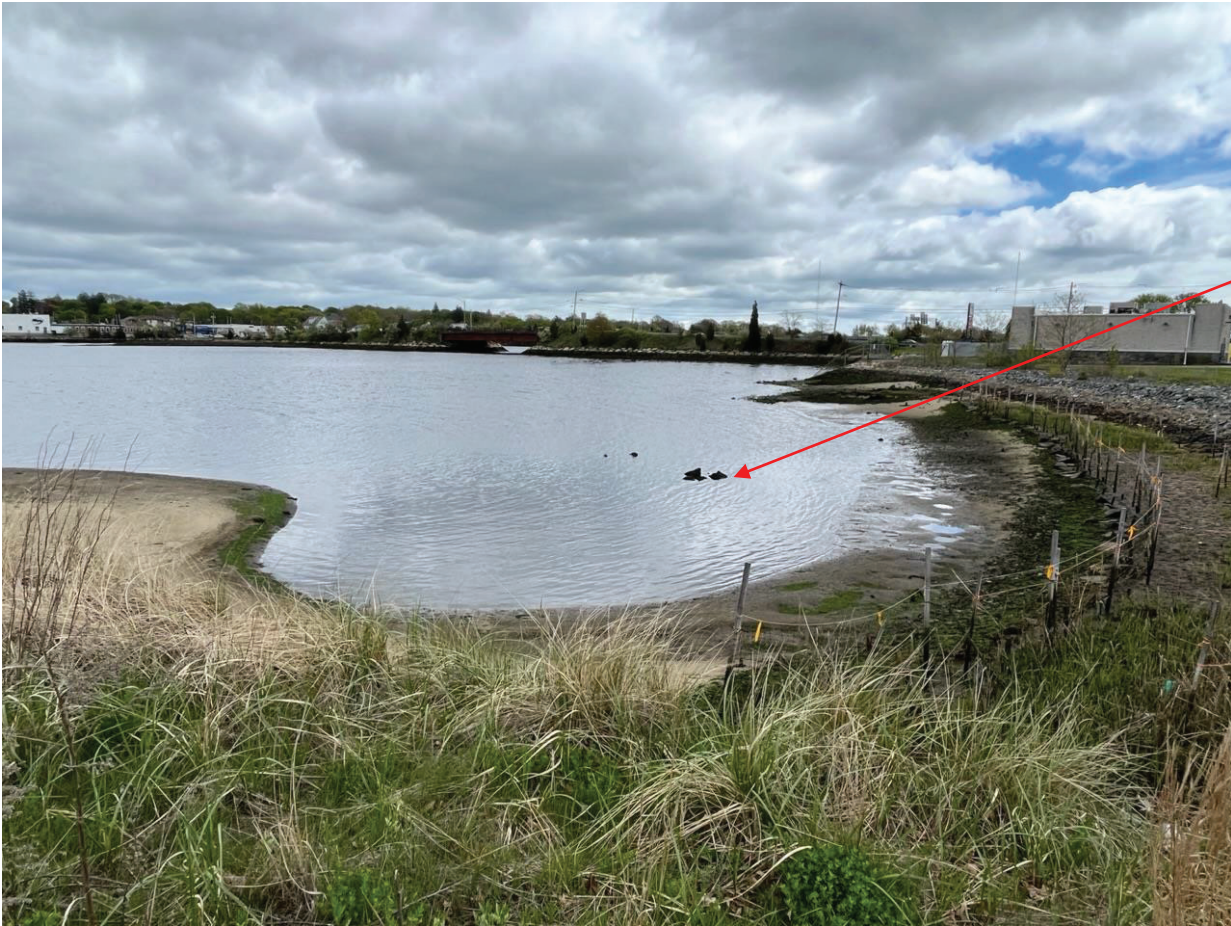
Figure 15:
Parcel 265
Cap looking east. Only a few cap stones are visible at low tide at this cap.

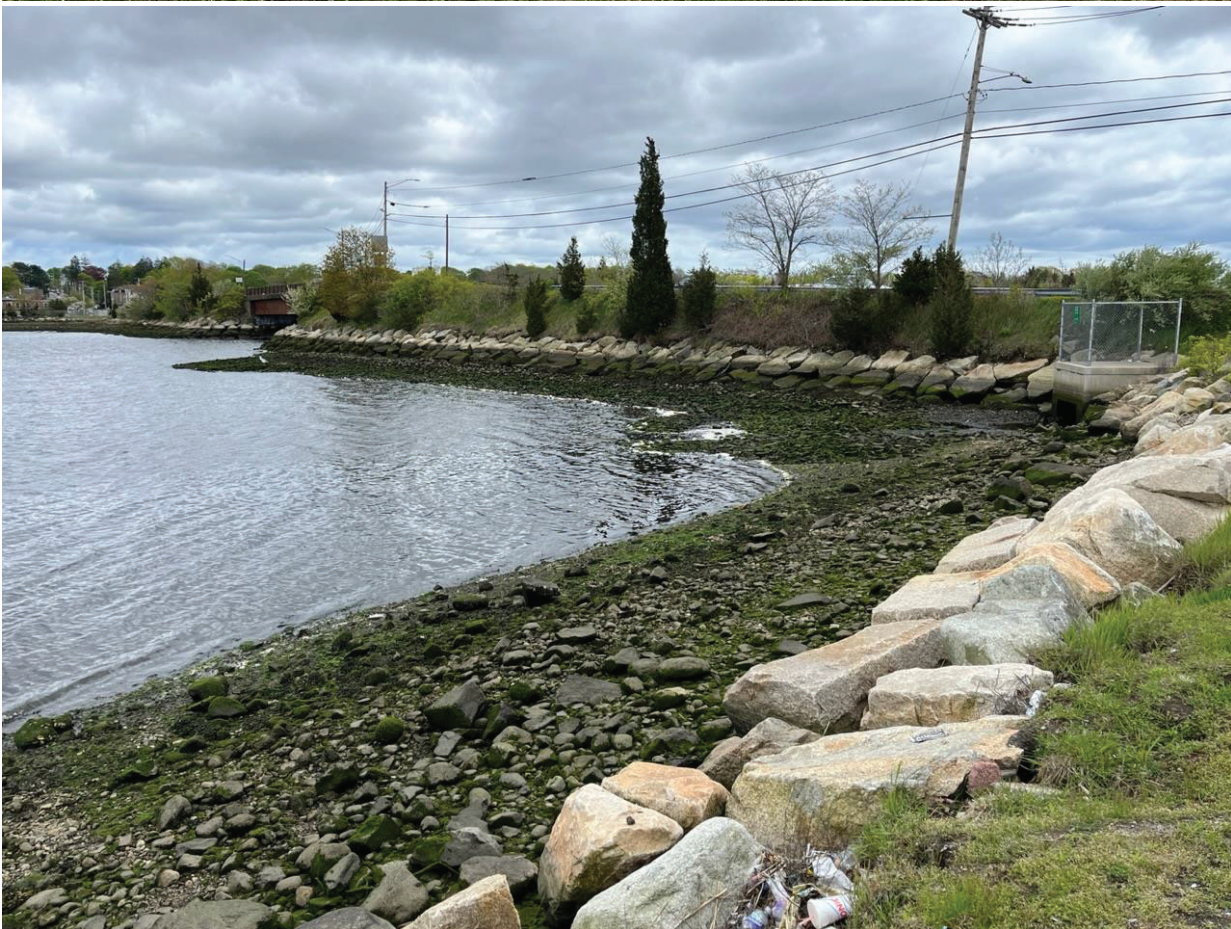
Figure 16:
Coggeshall-
West Cap
looking SE. City storm drain structure is located at the 90 degree turn of the shoreline.

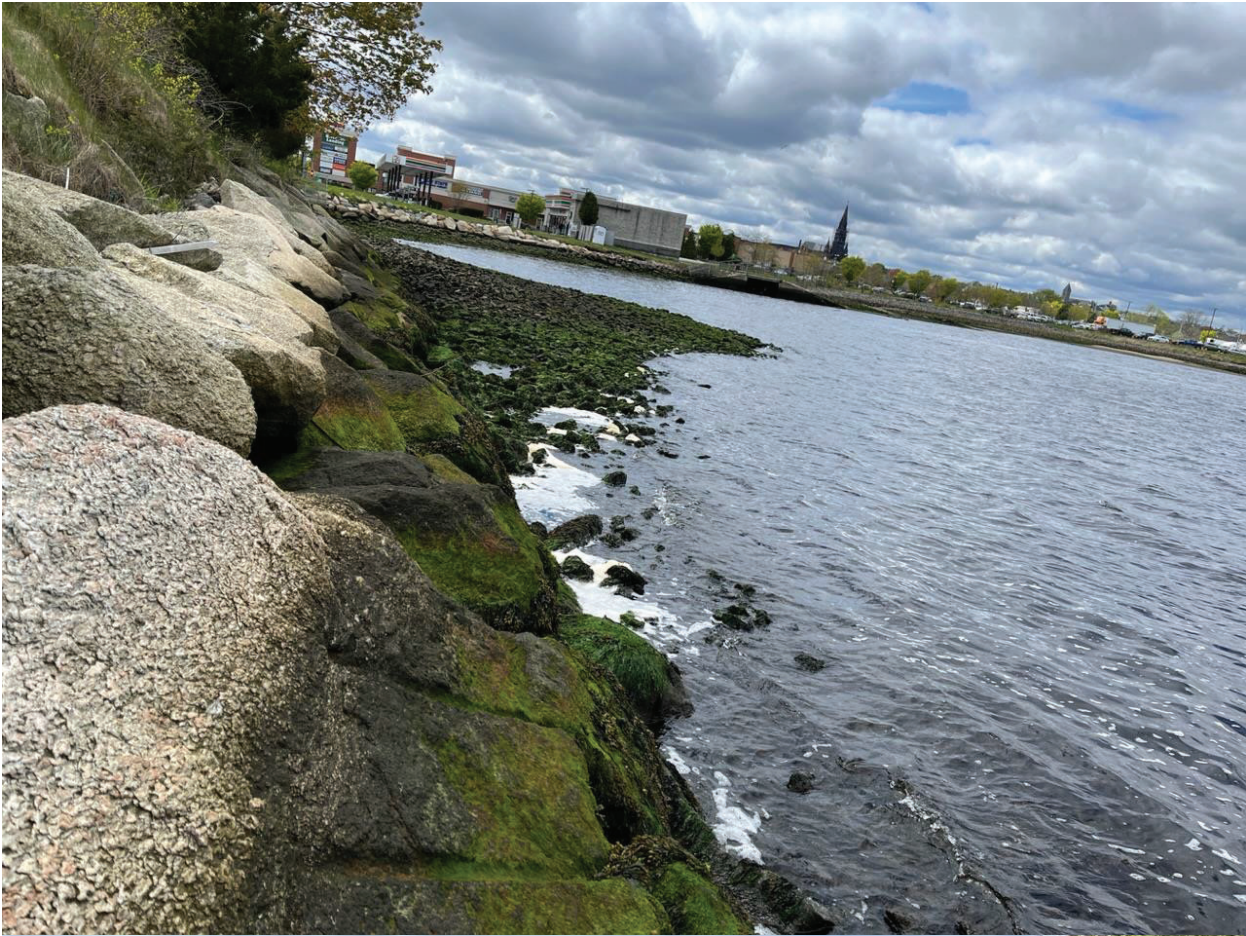
Figure 17:
**Coggeshall-
West Cap**
looking west.
Photo taken
from near the
bridge
opening.

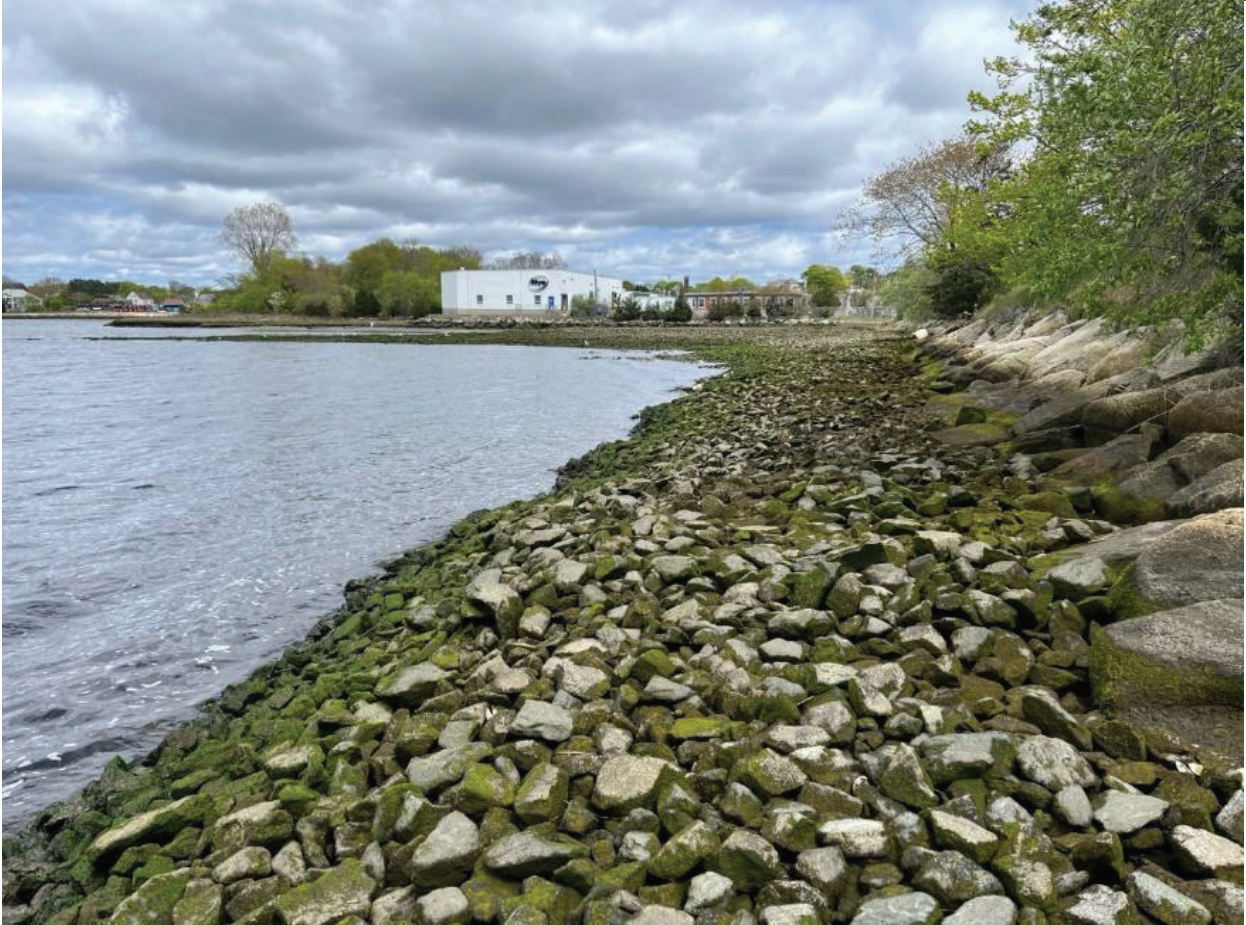
Figure 18:
**Coggeshall-
East Cap**
looking east.
Photo taken
from near the
bridge
opening.

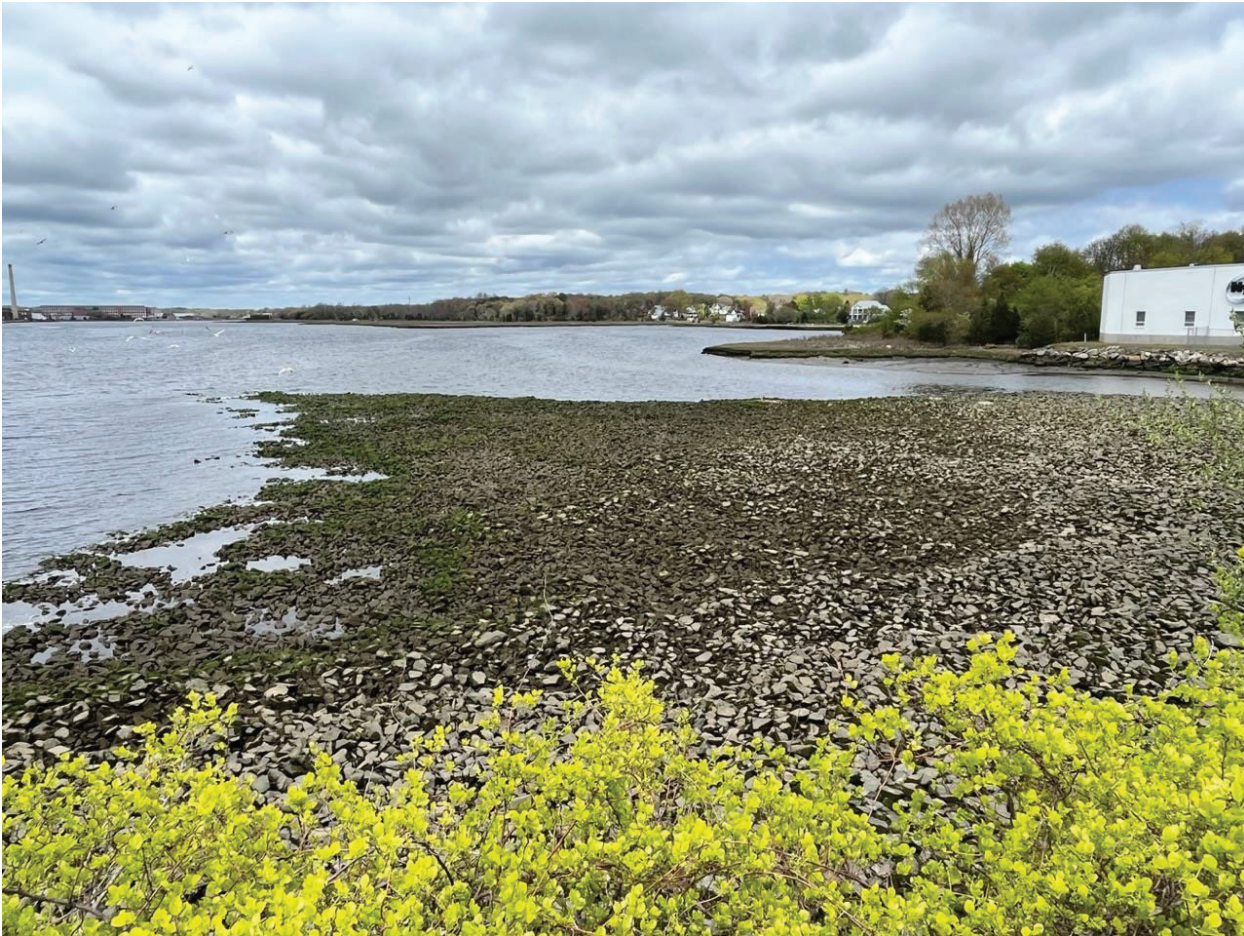
Figure 19:
**Coggeshall-
East Cap**
looking north.
Photo taken
from the
Coggeshall
Street
sidewalk.

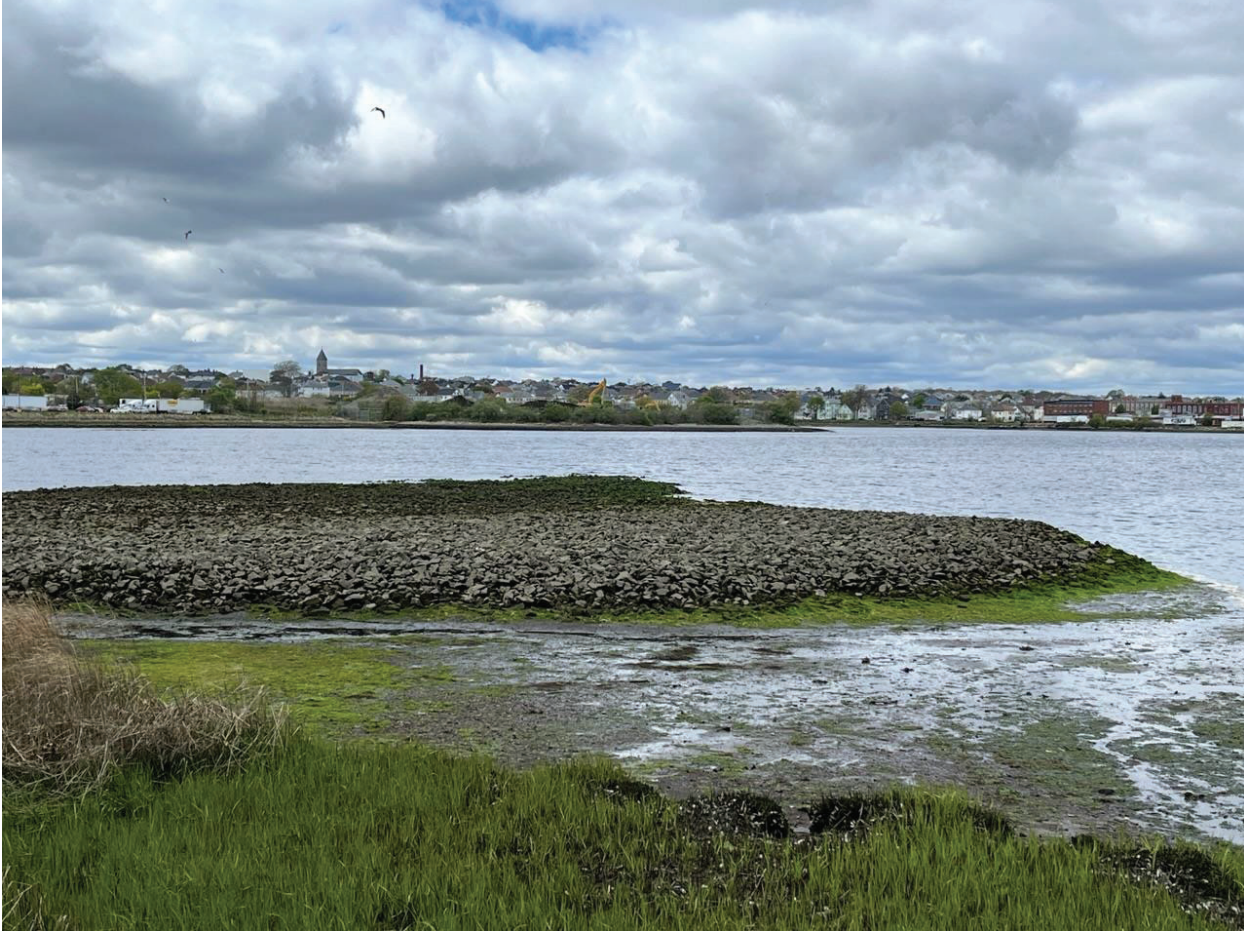
Figure 20:
**Coggeshall-
East Cap**
looking NW
showing the
eastern end of
this cap.
Photo taken
from the
Coggeshall
Street
sidewalk.
