UNITED STATES ENVIRONMENTAL PROTECTION AGENCY

SUBJ: 11/13/2023 inspection of Upper Harbor sediment caps, NBHSS

This memo documents the visual shoreline inspection of all Upper Harbor (UH) sediment caps performed by D. Dickerson and N. Burgo on 11/13/2023. The inspections took place between approximately one hour before and one hour after a 0.1 ft low tide at 1:15 pm that day, since only the intertidal portions of the caps can be seen visually. Two caps, 0-711 and L-114, were completely subtidal and thus could not be seen. At the Parcel 265 cap, only the very top of one stone of the cap could be seen (Figure 21). Bathymetric and topographic surveys performed earlier in fall 2023 will augment this visual feature inspection.

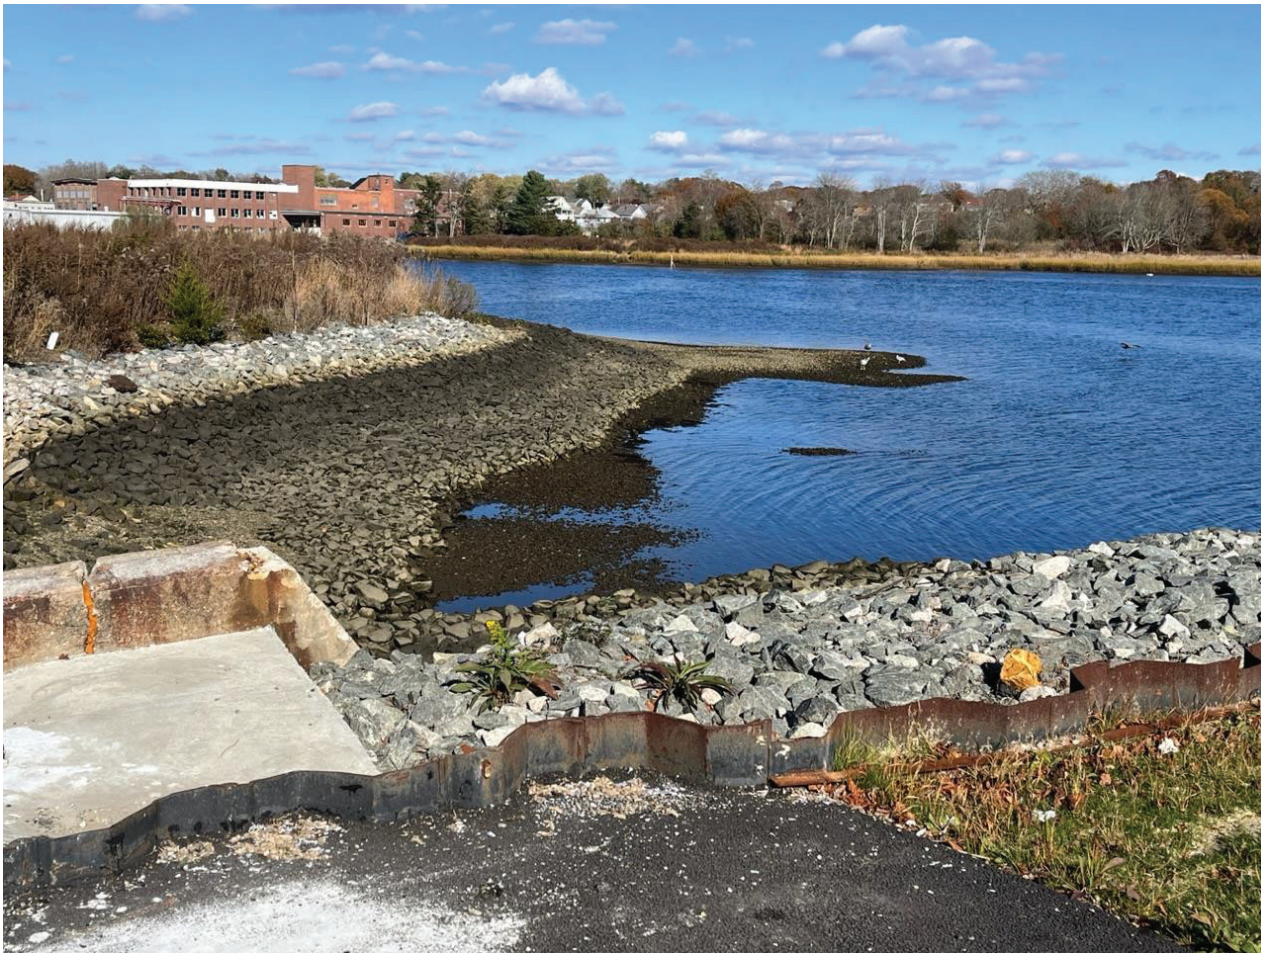
Figure 2:
Aerovox Cap:
 Looking NE showing “capacitor cove.” The lower edge of the larger armor stone on the river bank can be seen where it meets the smaller armor stone of the flatter portions of the cap.

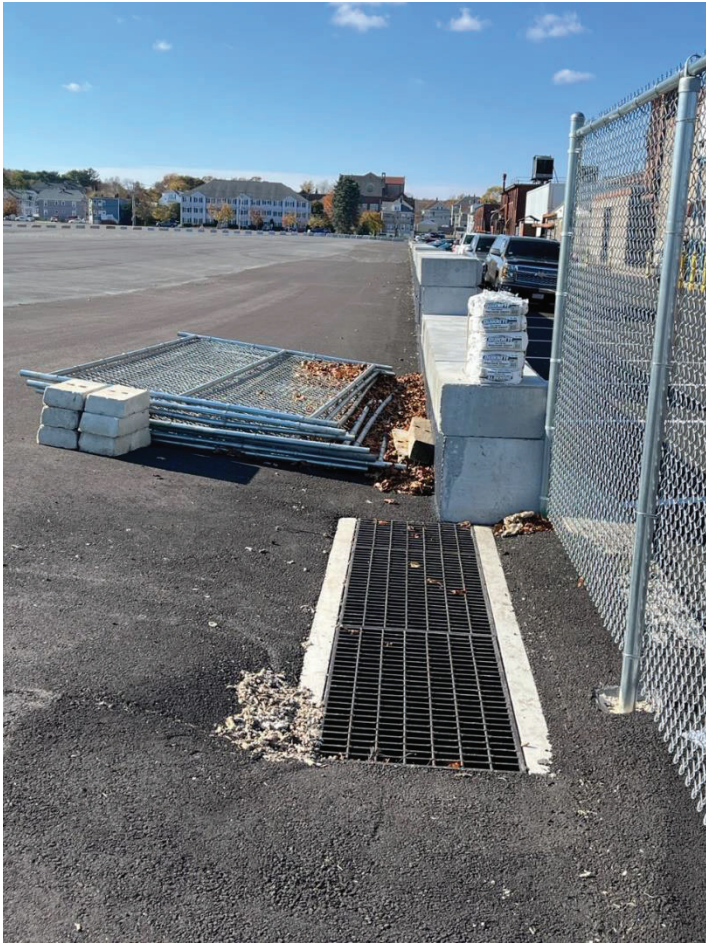
Figure 3:
Aerovox Cap:
Looking west
showing the as-
built condition of
the recently
completed
(summer 2023)
North Trench
drainage grating.

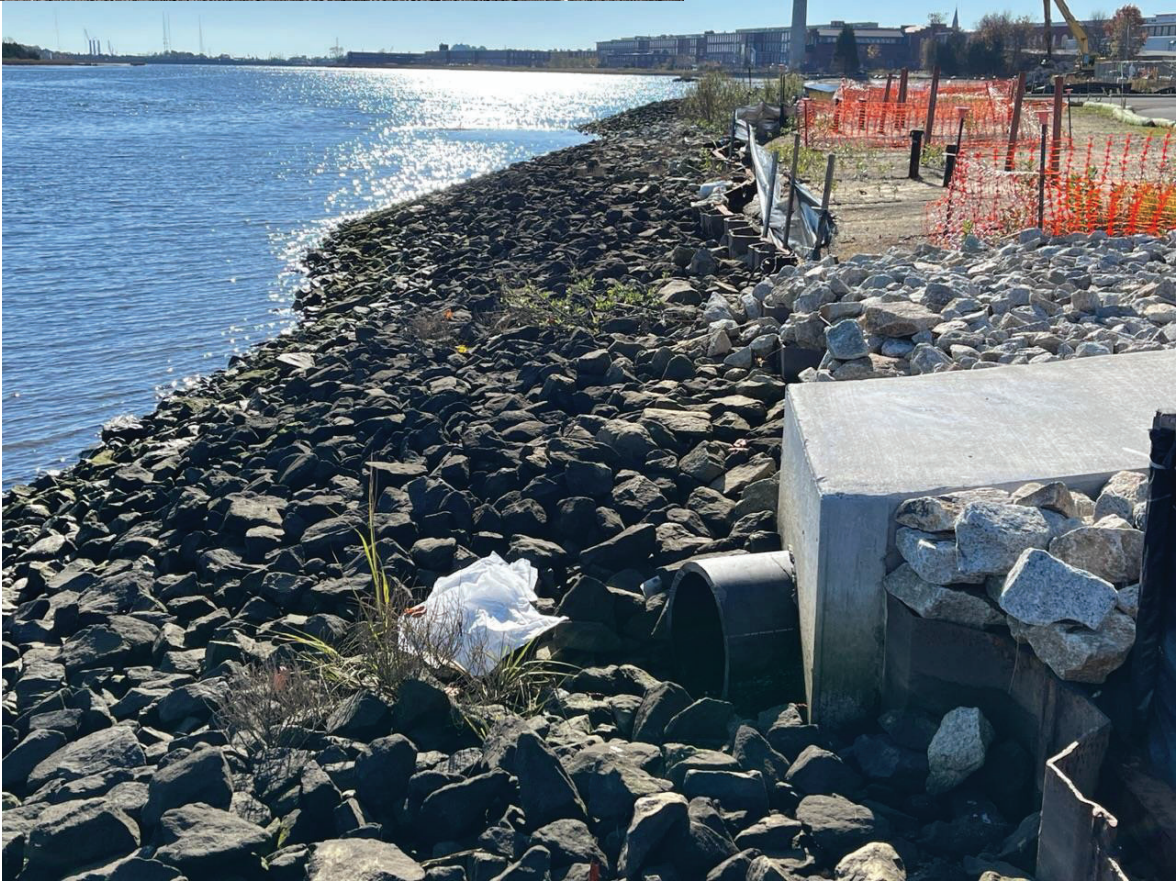
Figure 4:
Aerovox Cap:
Looking south
showing the
South Trench
discharge
structure in
foreground.
Emergent salt
grass noted in
previous
inspections
remains near the
outfall (the void
spaces in the
armor stone are
likely filling in
with silt from the
drainage
discharge).

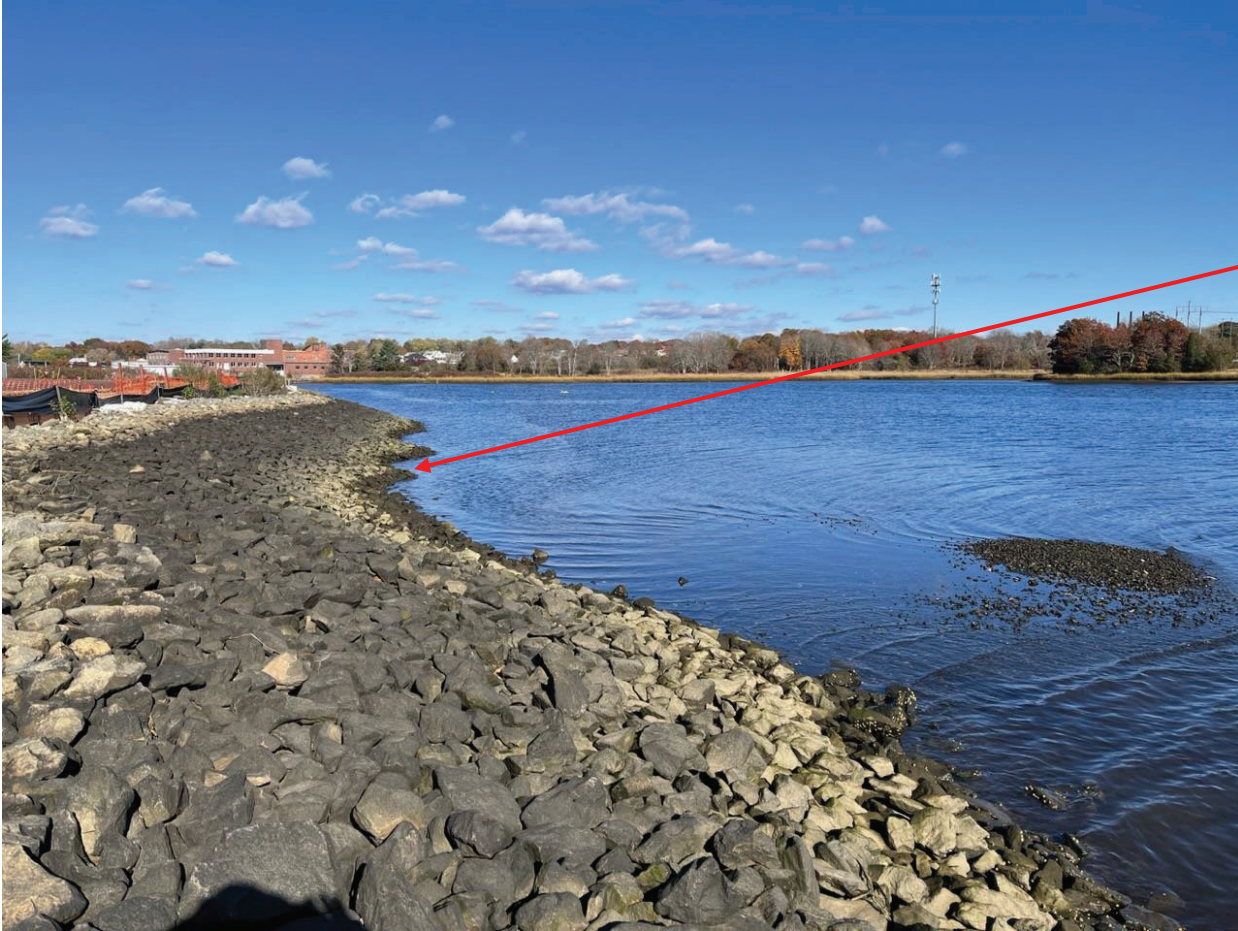
Figure 6:
**Aerovox
Cap:** looking
north
showing a
serrated
pattern at the
waterline in
some areas.

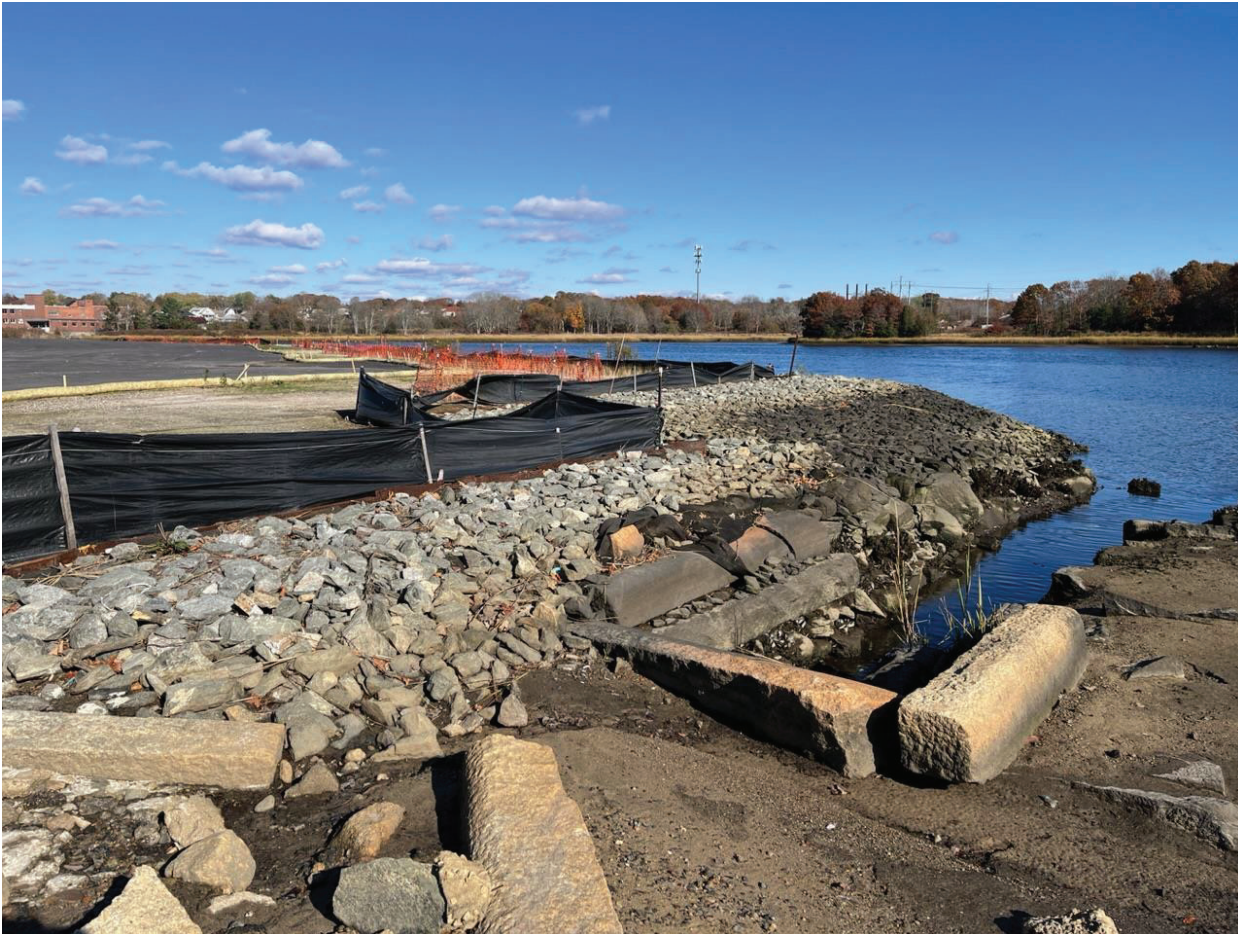
Figure 7:
**Aerovox
Cap:**
Looking
northeast
showing the
southern
section of the
cap and the
abutting
Hadley Street
storm drain

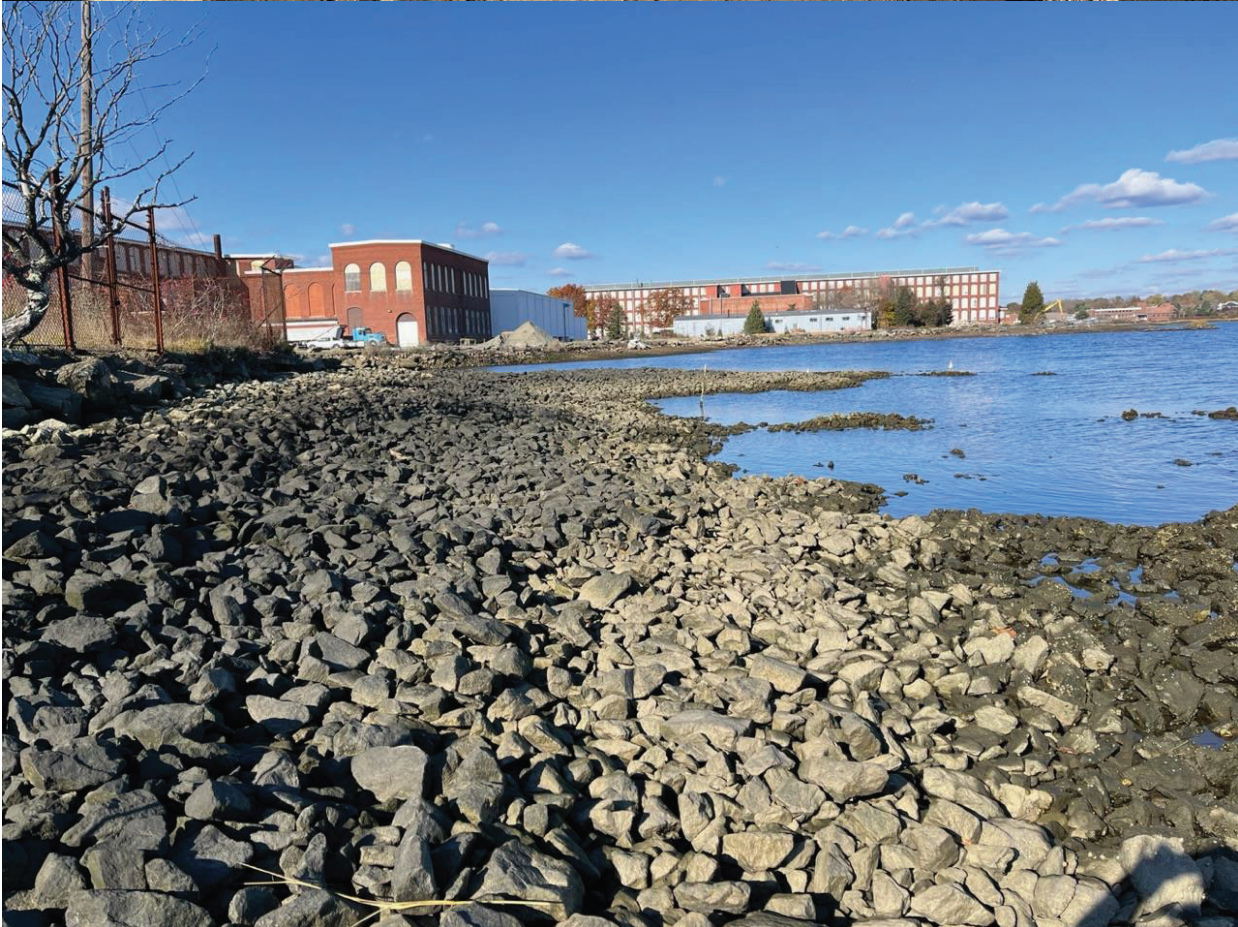
Figure 8:
Crib Cap:
Looking
north.

- At the crib cap, when implementing the ongoing West Zone 2/3 remedial action, a low-ground-pressure small excavator or similar machine will be used to create a more uniform, smoother (less undulating) stone surface. This will aid in visually detecting potential stone displacement moving forward during O&M to minimize the need for topographic/bathymetric surveys during O&M. Additional stone may be added if necessary to help create this uniform, smoother surface.

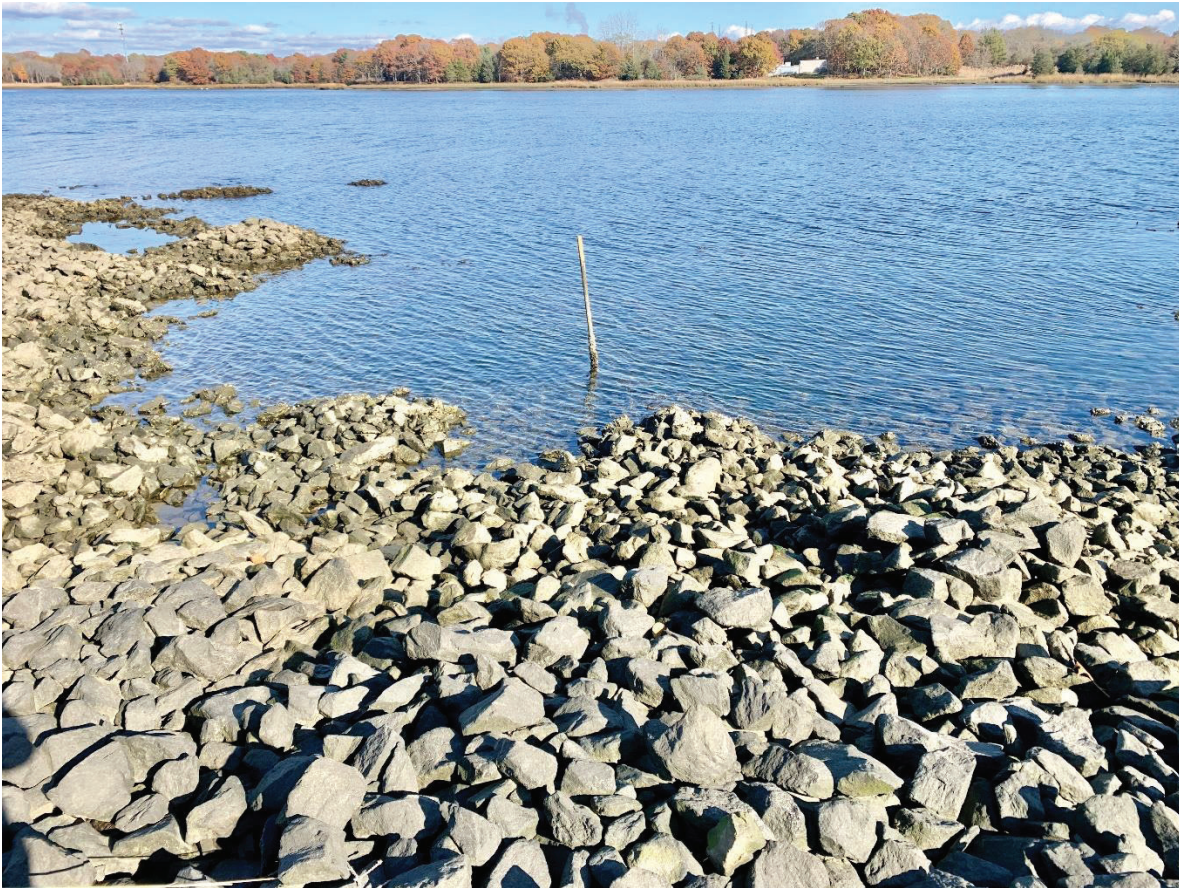
Figure 9:
Crib Cap:
Looking
northeast
showing area
near a drainage
outfall
(possibly
defunct).

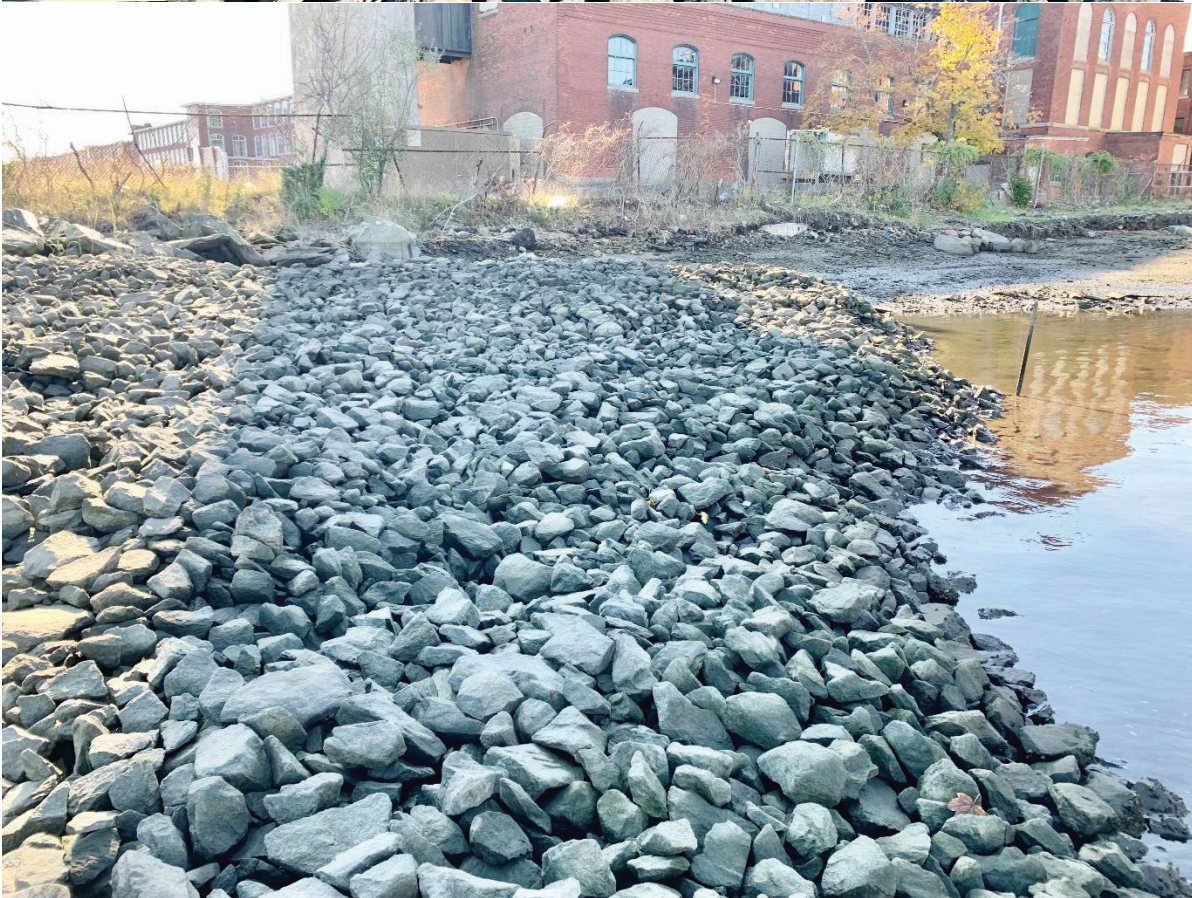
Figure 10:
Crib Cap:
Looking
southwest
showing the
northern edge of
the cap.
The southern
edge of the
ongoing WZ2/3
shoreline
excavation can
be seen in the
background.

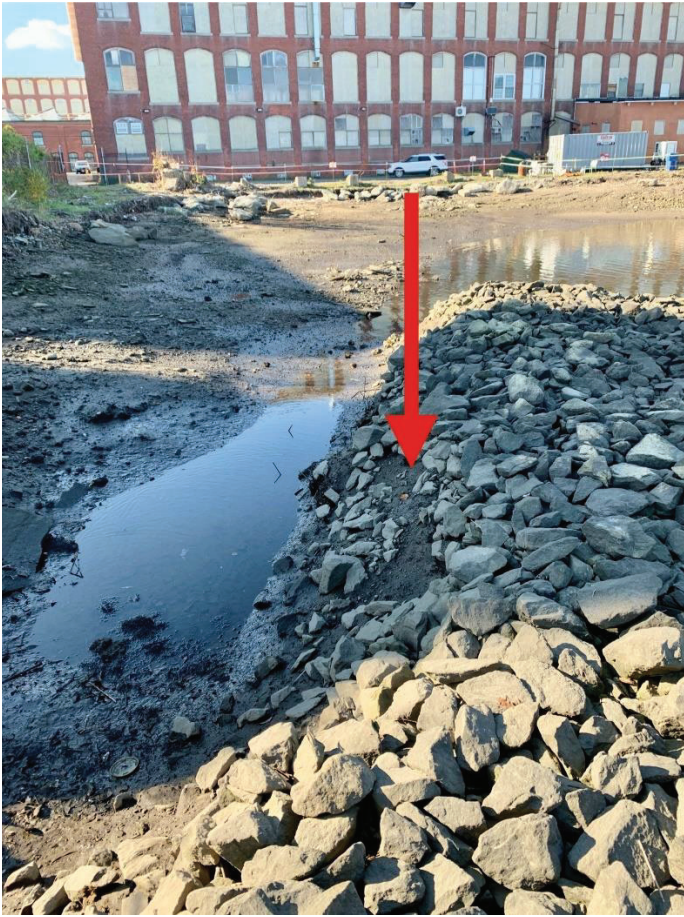
Figure 11:
Crib Cap:
Looking west
showing an area
needing
additional armor
stone at the
northwestern
end of the cap.

- At the crib cap and pilot CDF shoreline cap, a few very small areas (most <1 ft² each) were observed where the sand layer of the cap was not completely covered with armor stone (see Figures 11, 12 and 18). At these areas armor stone will need to be placed (or relocated from visible high spots) to ensure the underlying sand cap is well protected against wave-based erosional forces. The action item above for crib cap smoothing is expected to address these areas for that cap, such that only limited stone placement will be required at the pilot CDF shoreline cap. The few areas at the pilot CDF shoreline cap requiring this minor stone placement are along the east-facing portion of that cap.

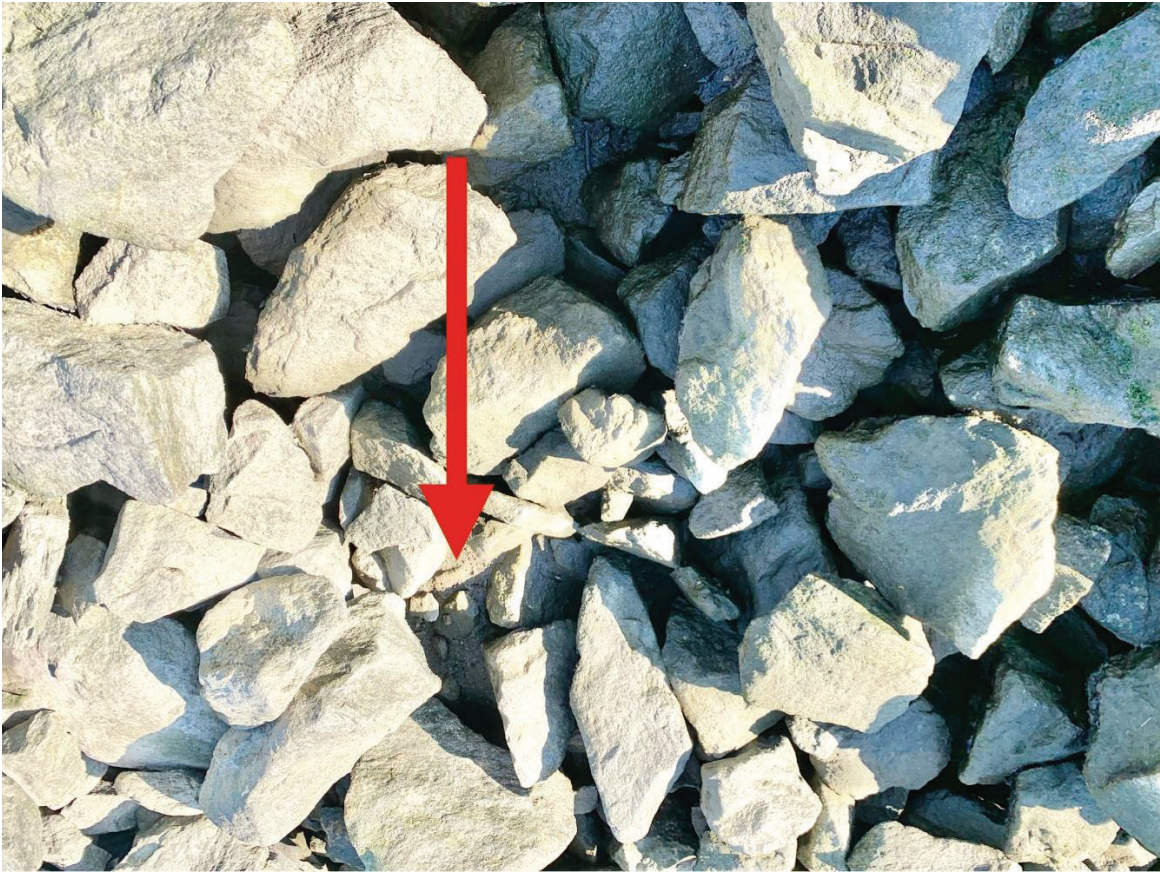
Figure 12:
Crib Cap:
showing a very
small area
needing
additional armor
stone.

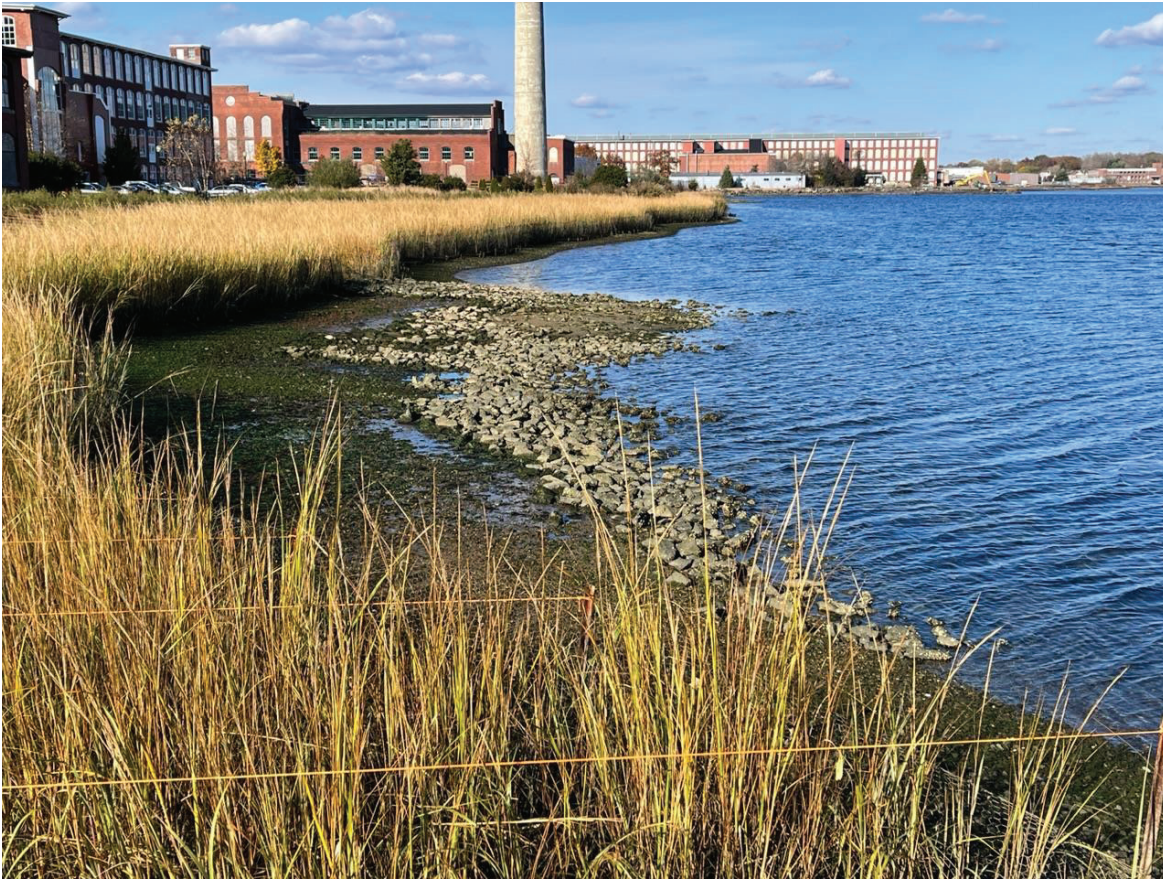
Figure 13:
L-014 Cap:
Looking north.

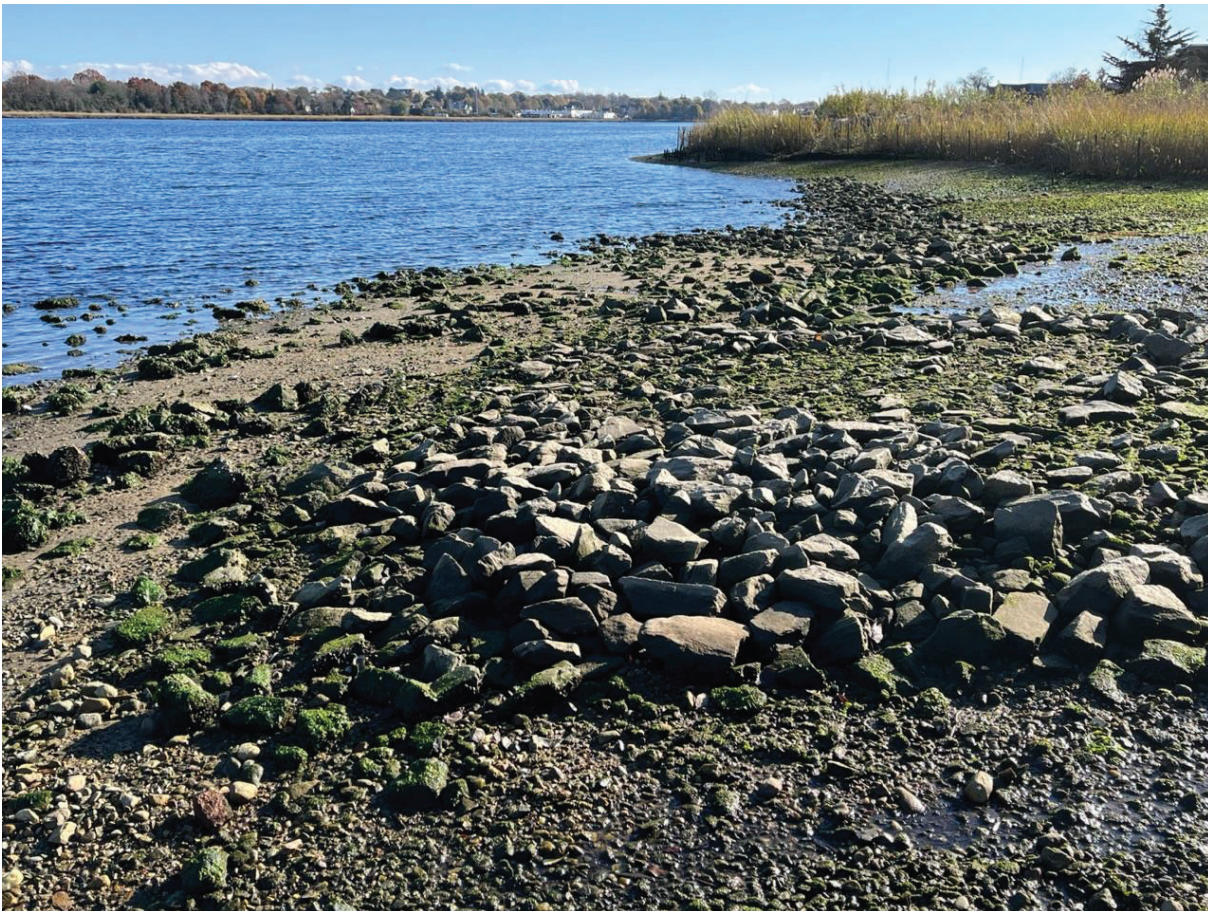
Figure 14:
L-014 Cap:
Looking south showing area where original topsoil from the abutting WZ4 restoration washed into the armor stone (WZ4 topsoil was subsequently replaced).

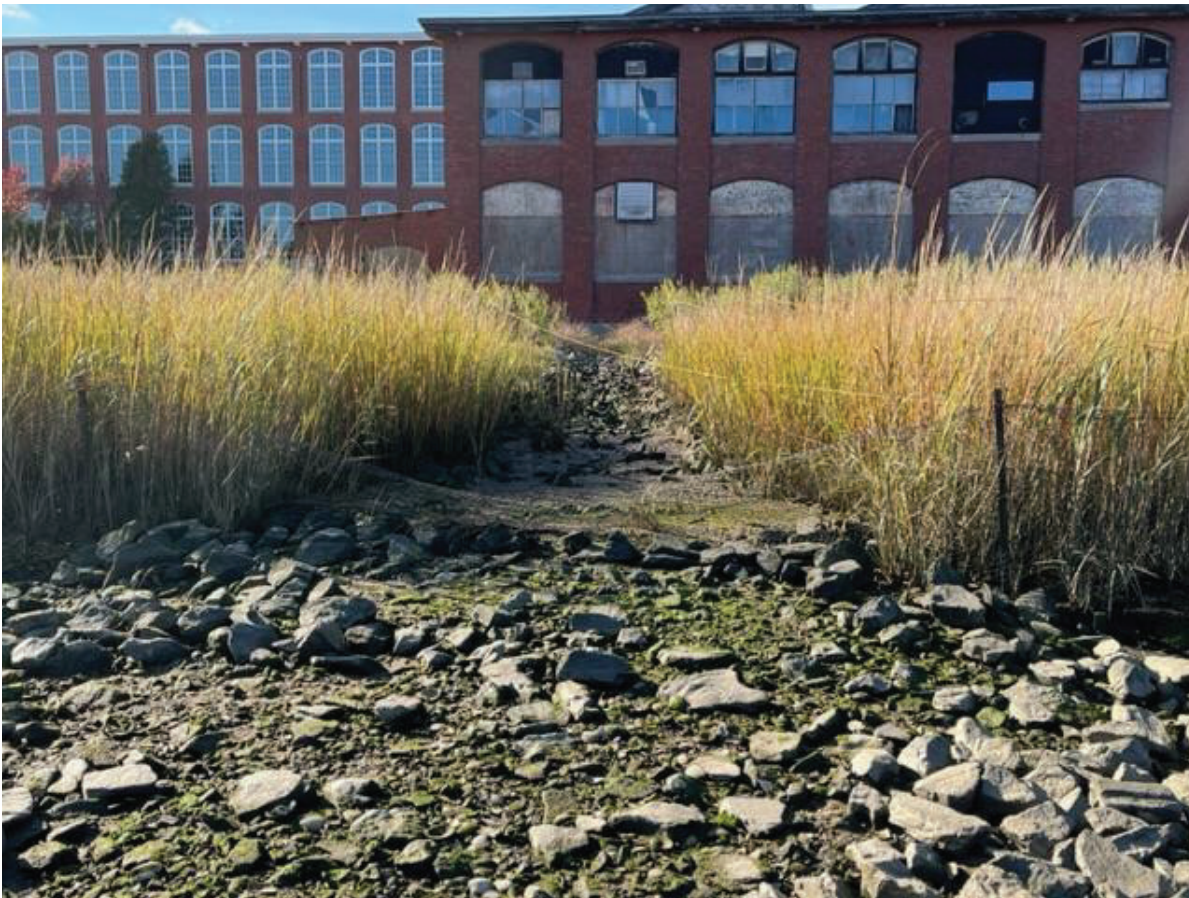
Figure 15:
L-014 Cap:
Looking west
showing the
drainage swale
where original
WZ4 topsoil was
likely discharged
onto the cap.

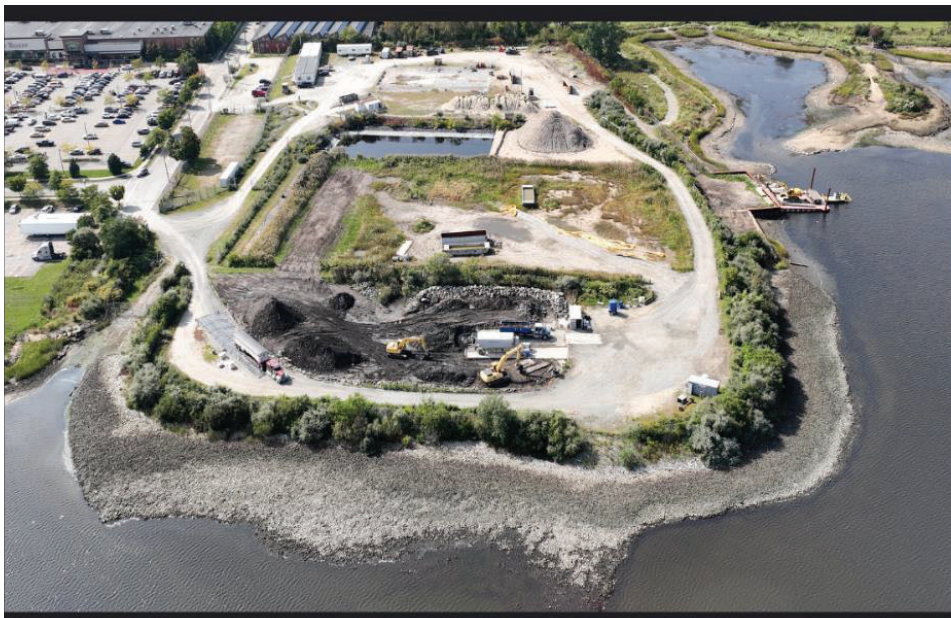
Figure 16:
**Pilot CDF Shore-
line Cap** (the
rocky surface
seaward of the
Sawyer Street
facility). Aerial
view looking west
at low tide.

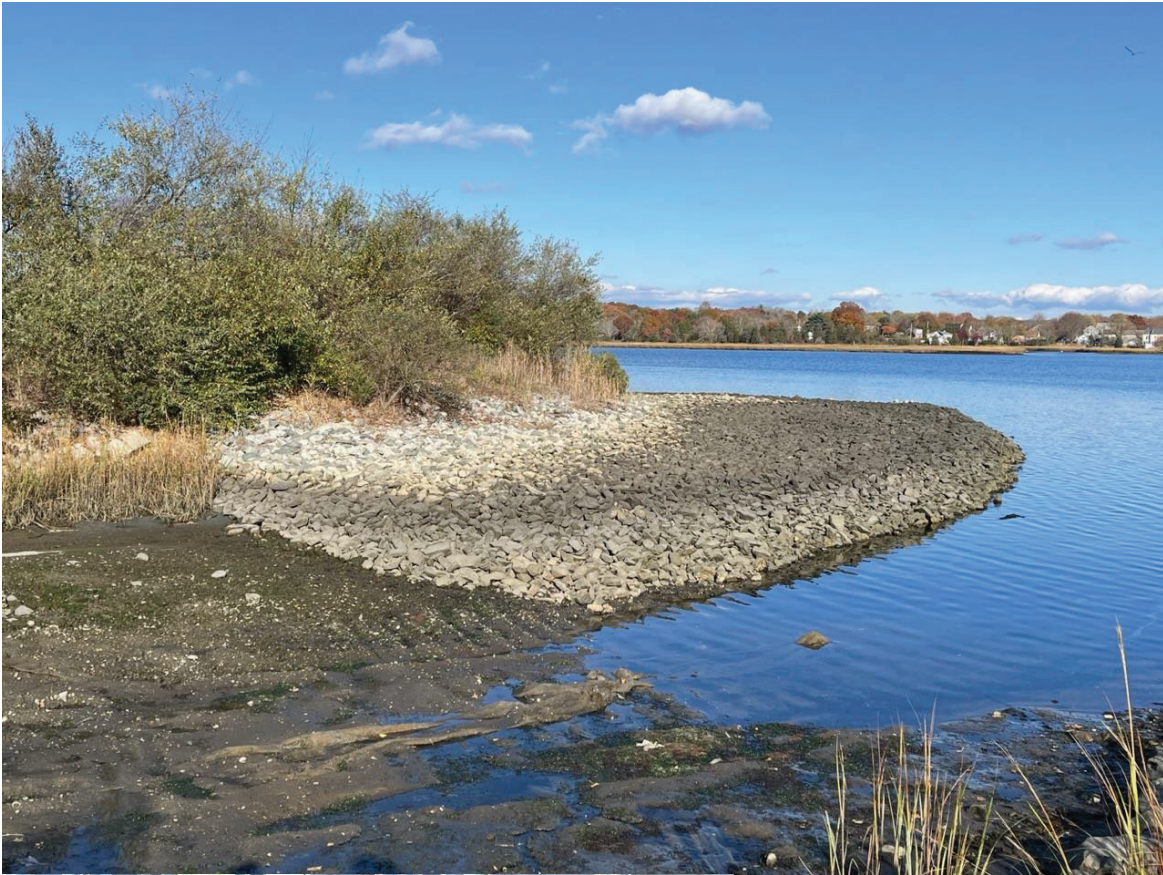
Figure 17:
**Pilot CDF Shore-
line Cap:** looking
northeast showing
the southern edge
of the cap. Toe of
slope remains
well defined.

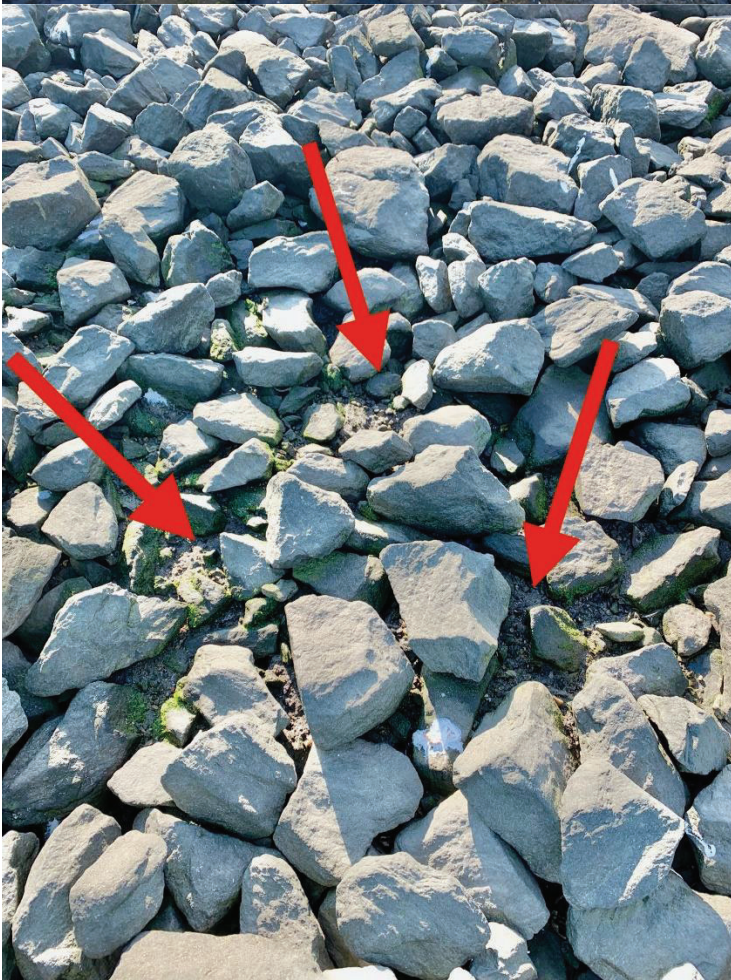
Figure 18:
**Pilot CDF Shore-
line Cap:** showing
area with thin armor
stone layer and
some exposed sand
isolation layer.

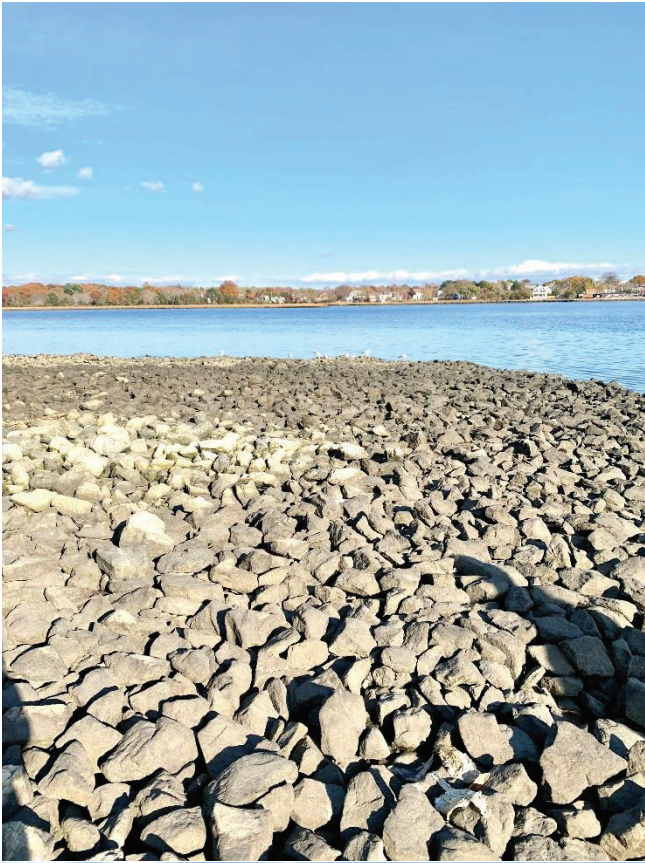
Figure 19:
**Pilot CDF Shore-
line Cap:** looking
east.

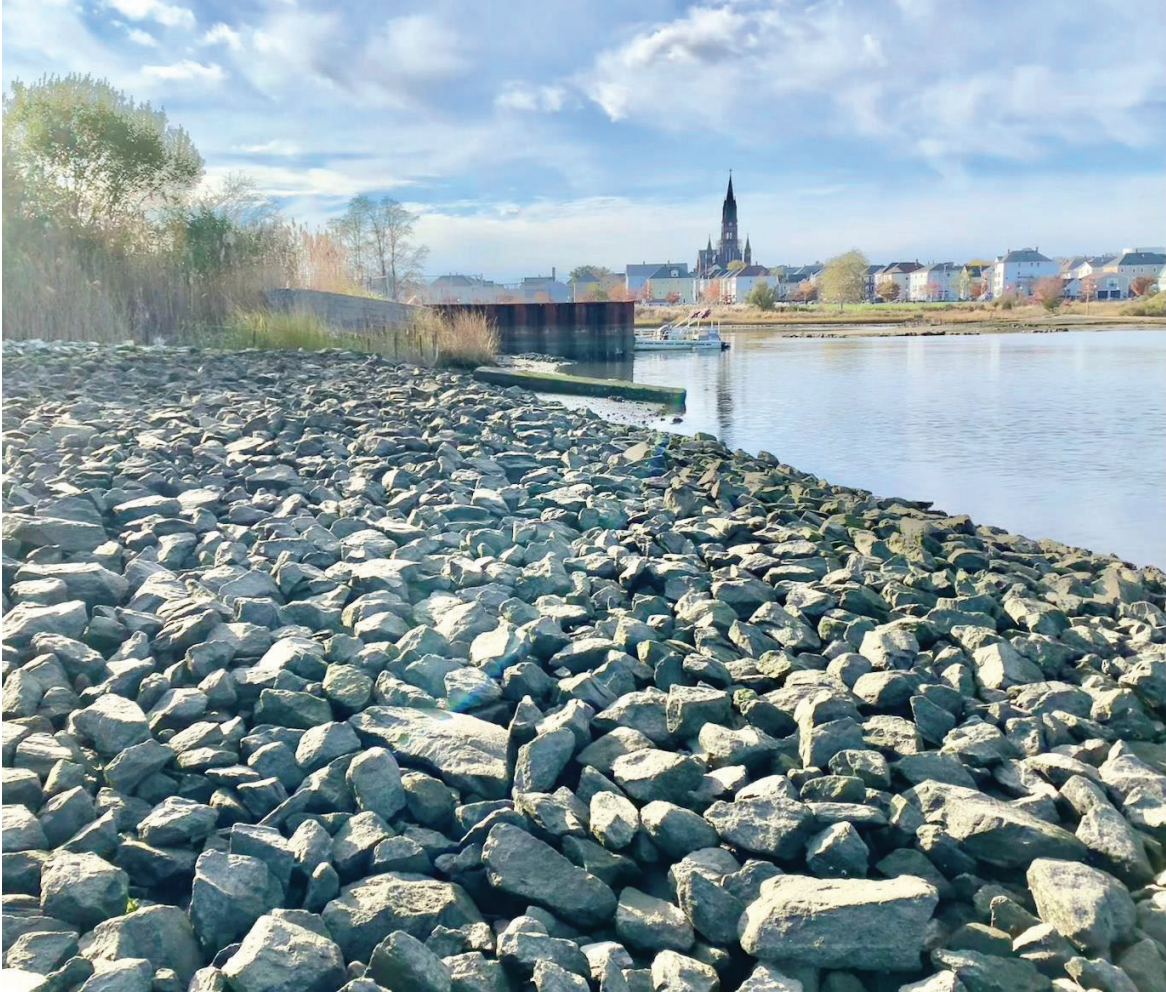
Figure 20:
**Pilot CDF Shore-
line Cap:** looking
west showing the
northern edge of
the cap.

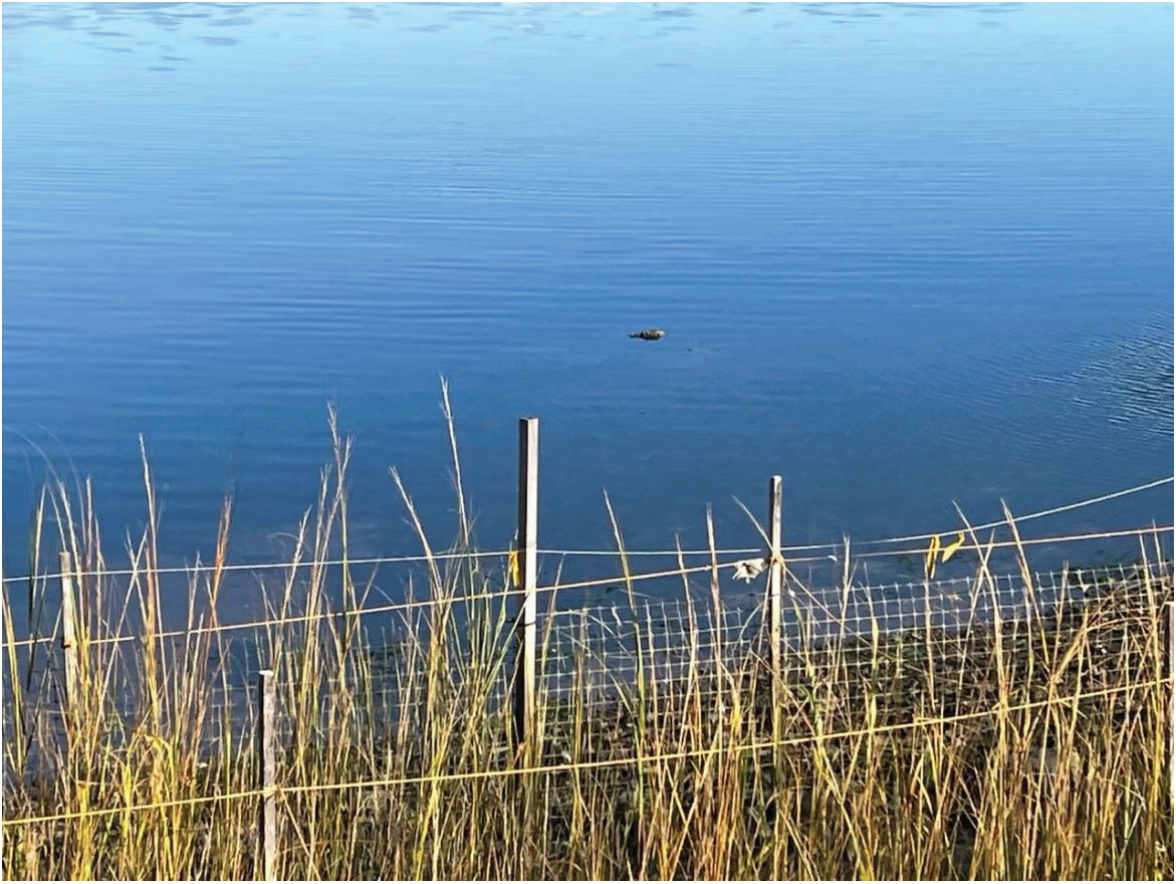
Figure 21:
Parcel 265 Cap:
looking east. Only
the very top of one
stone was showing
at the time of the
inspection.

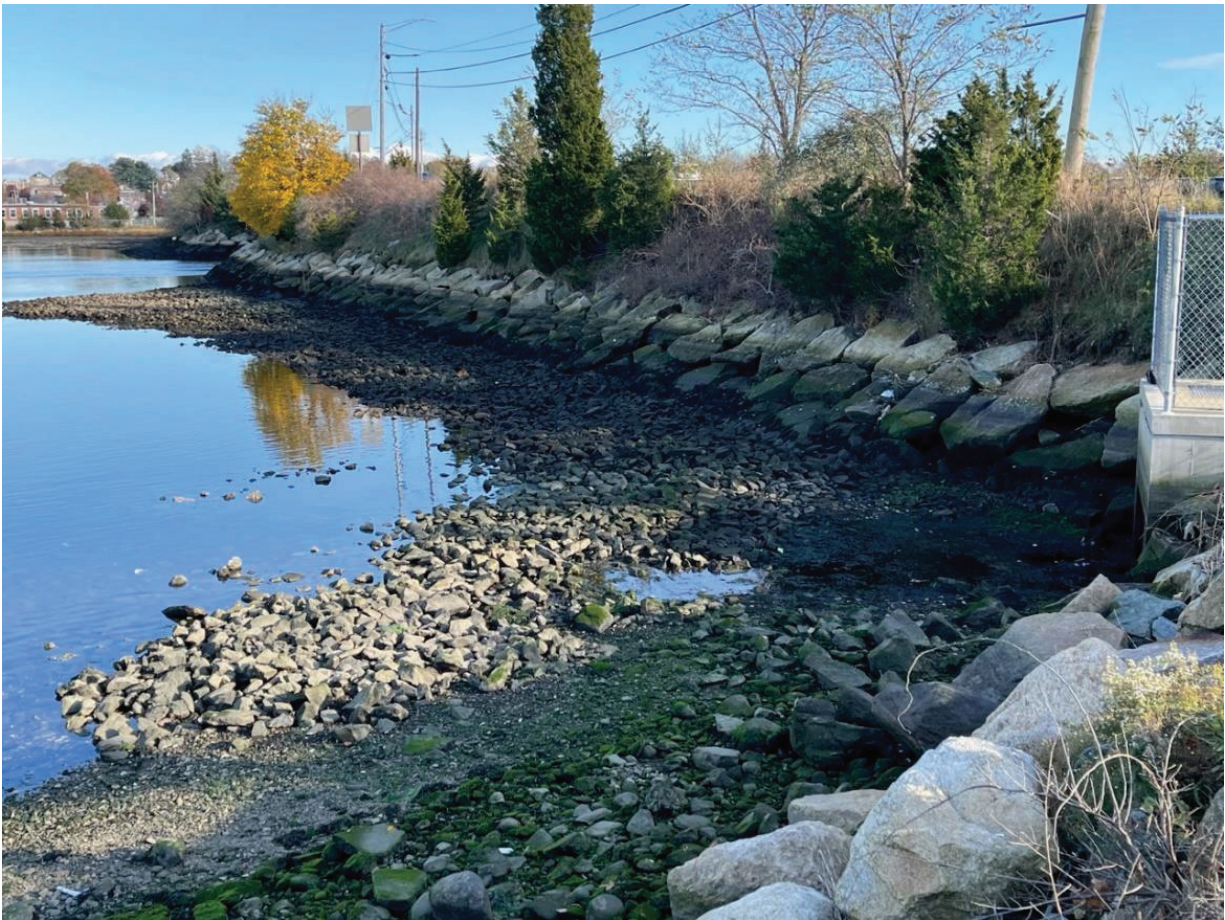
Figure 22:
**Cogg-West
Cap:** looking
southeast.

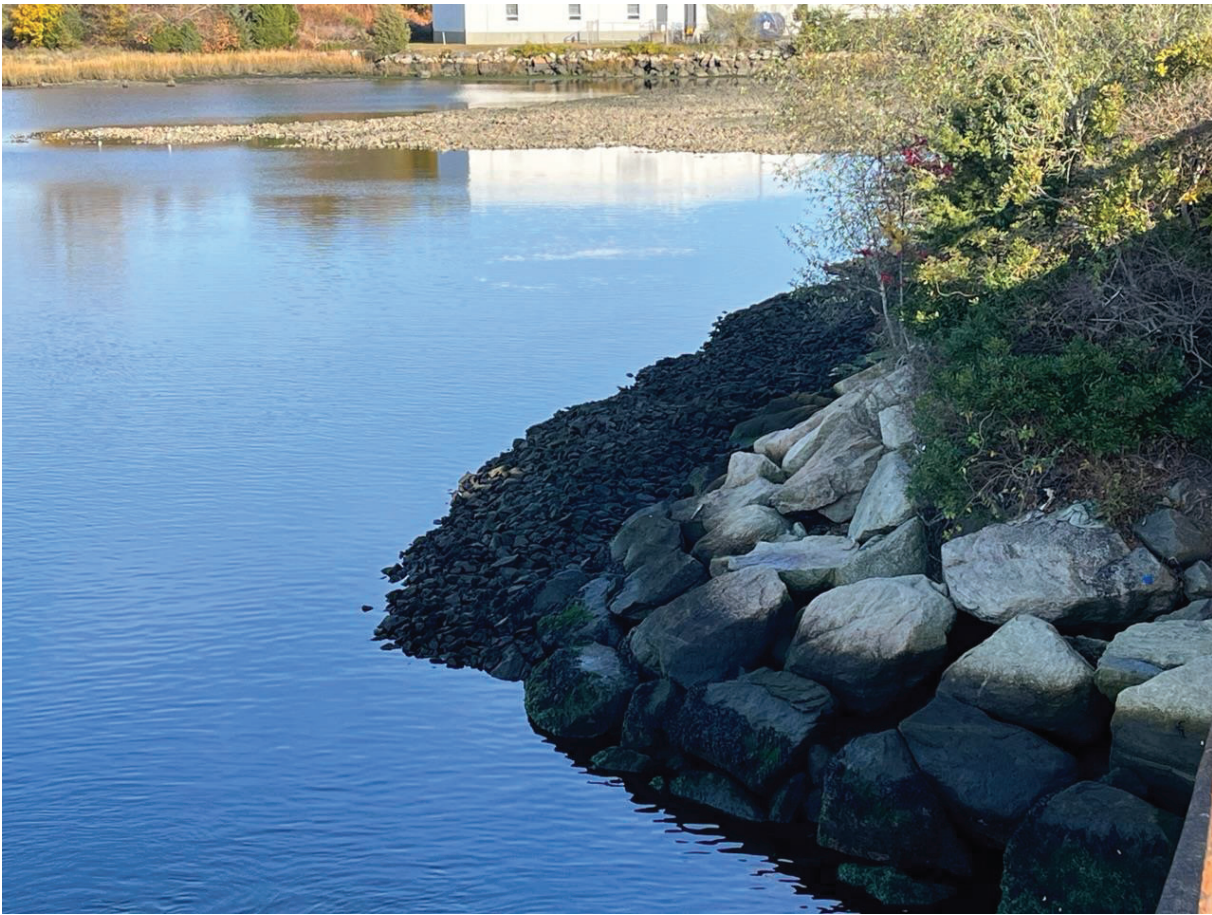
Figure 23:
**Cogg-East
Cap:** looking
east showing
the western
edge of the cap
at the
Coggeshall St
bridge opening.
Cap armor
stone also
shown in
background.

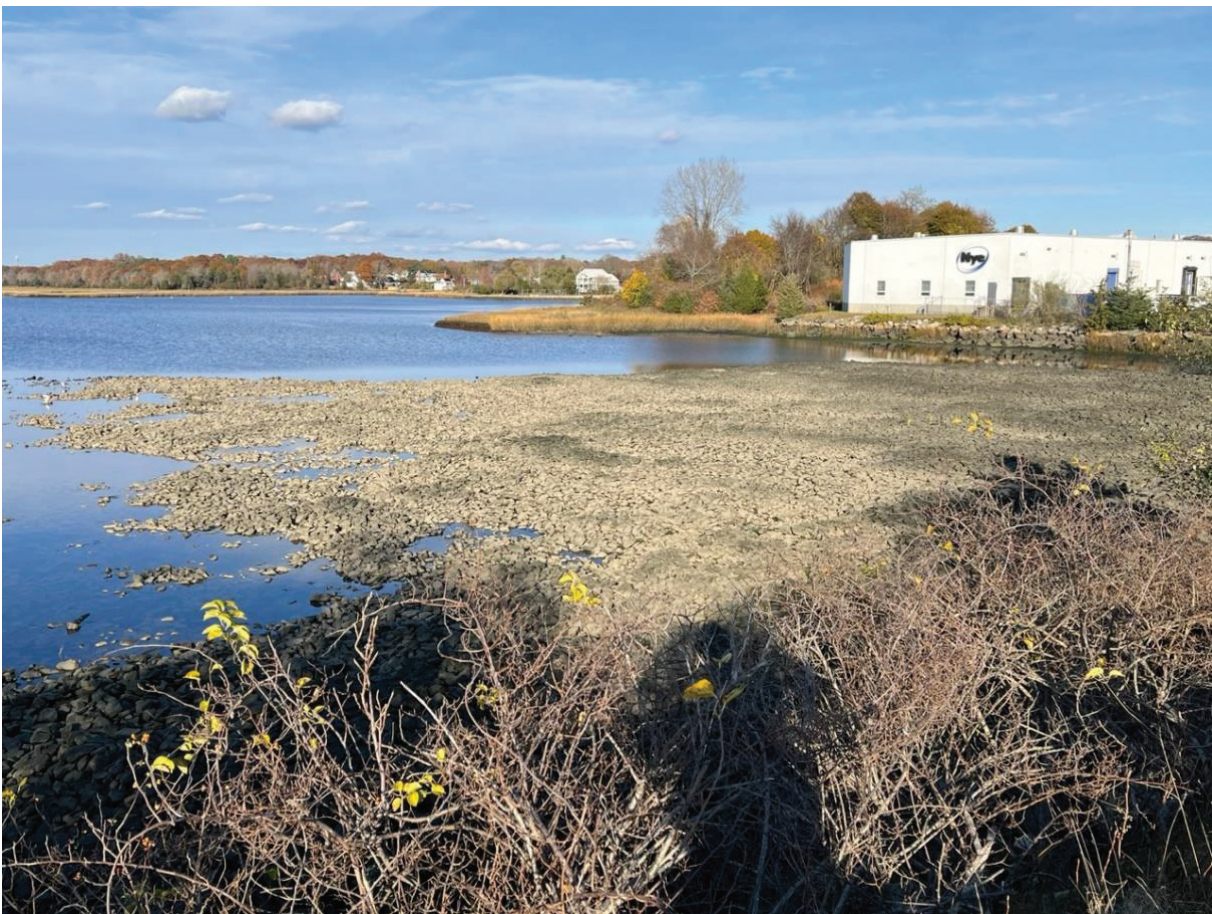
Figure 24:
**Cogg-East
Cap:** looking
northeast.
