UNITED STATES ENVIRONMENTAL PROTECTION AGENCY

SUBJ: 11/13/2023 inspection of Upper Harbor sediment caps, NBHSS

This memo documents the visual shoreline inspection of all Upper Harbor (UH) sediment caps performed by D. Dickerson and N. Burgo on 11/13/2023. The inspections took place between approximately one hour before and one hour after a 0.1 ft low tide at 1:15 pm that day, since only the intertidal portions of the caps can be seen visually. Two caps, 0-711 and L-114, were completely subtidal and thus could not be seen. At the Parcel 265 cap, only the very top of one stone of the cap could be seen (Figure 21). Bathymetric and topographic surveys performed earlier in fall 2023 will augment this visual feature inspection.

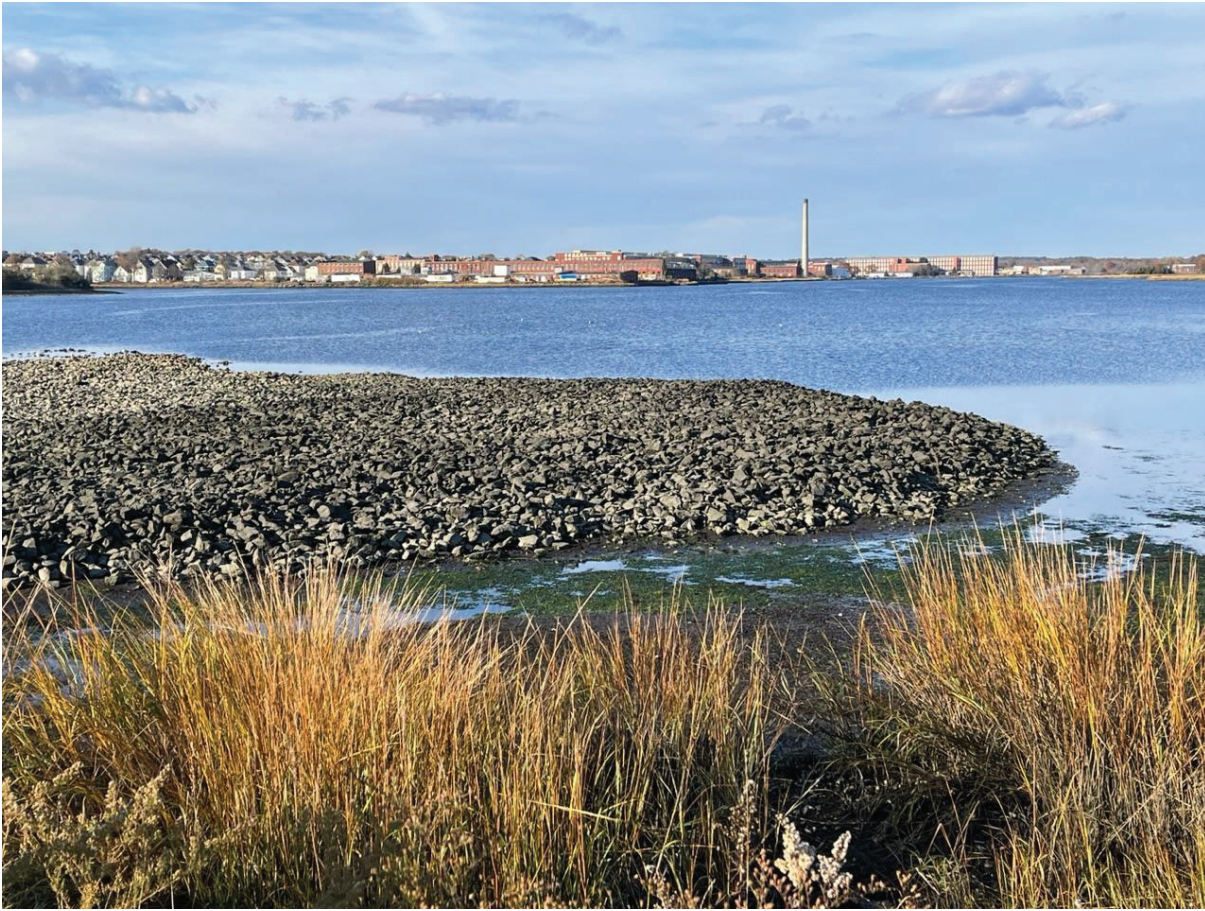
Figure 25:
**Cogg-East
Cap:** looking
north showing
the eastern end
of the cap.
