**Re: GE-Pittsfield/Housatonic River Site  
Rest of River (GECD850)  
2023 Annual Visual Inspection Report for Willow Mill Dam**

# 2023 Annual Visual Inspection Report Willow Mill Dam (MA00262) South Lee, Massachusetts

Date of Inspection: November 14, 2023

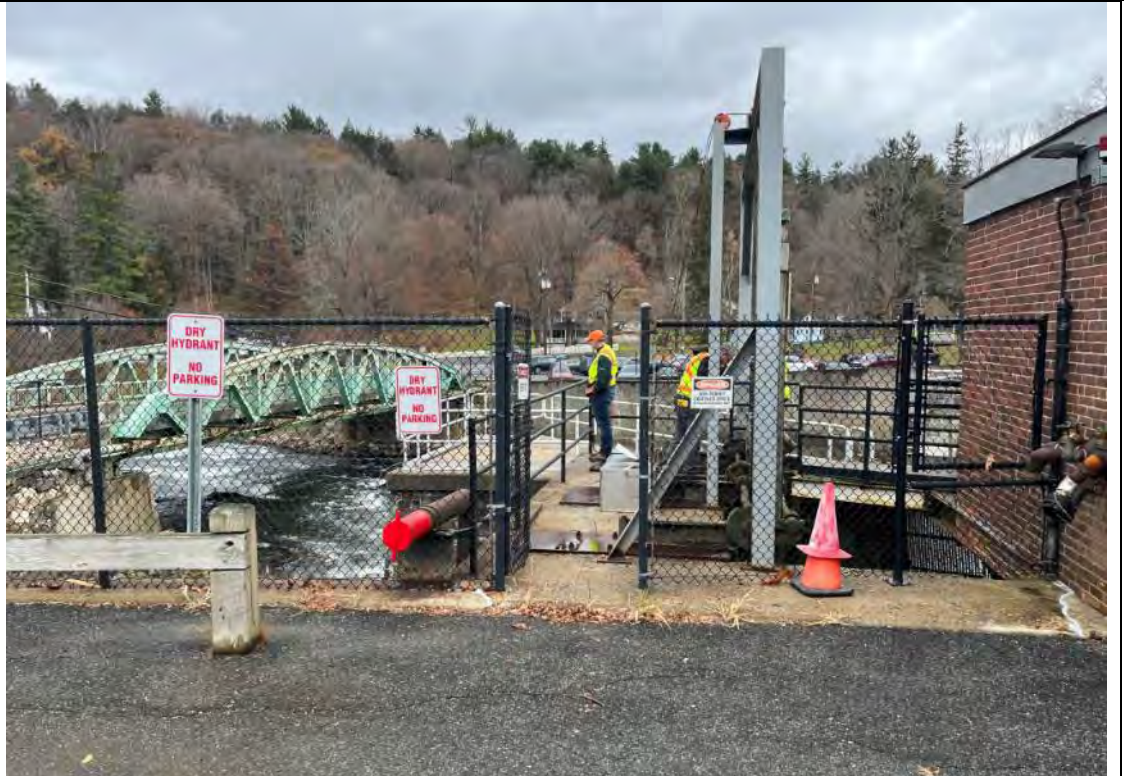
**Description:**  
Canal sluice gates and intake structure from left abutment parking lot.

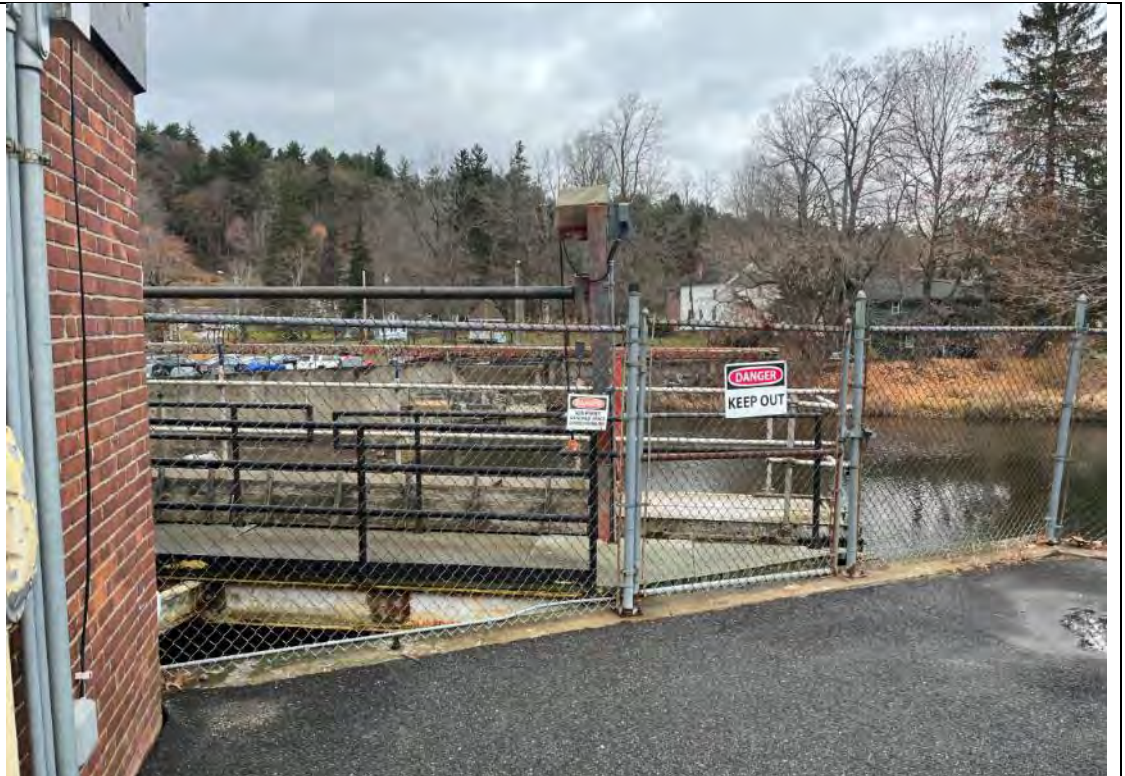
<b>Photo No.</b> 2	<b>Date:</b> 11/14/2023
-----------------------	----------------------------

**Description:**  
Fish screen (trash rack) platform from left abutment parking lot.

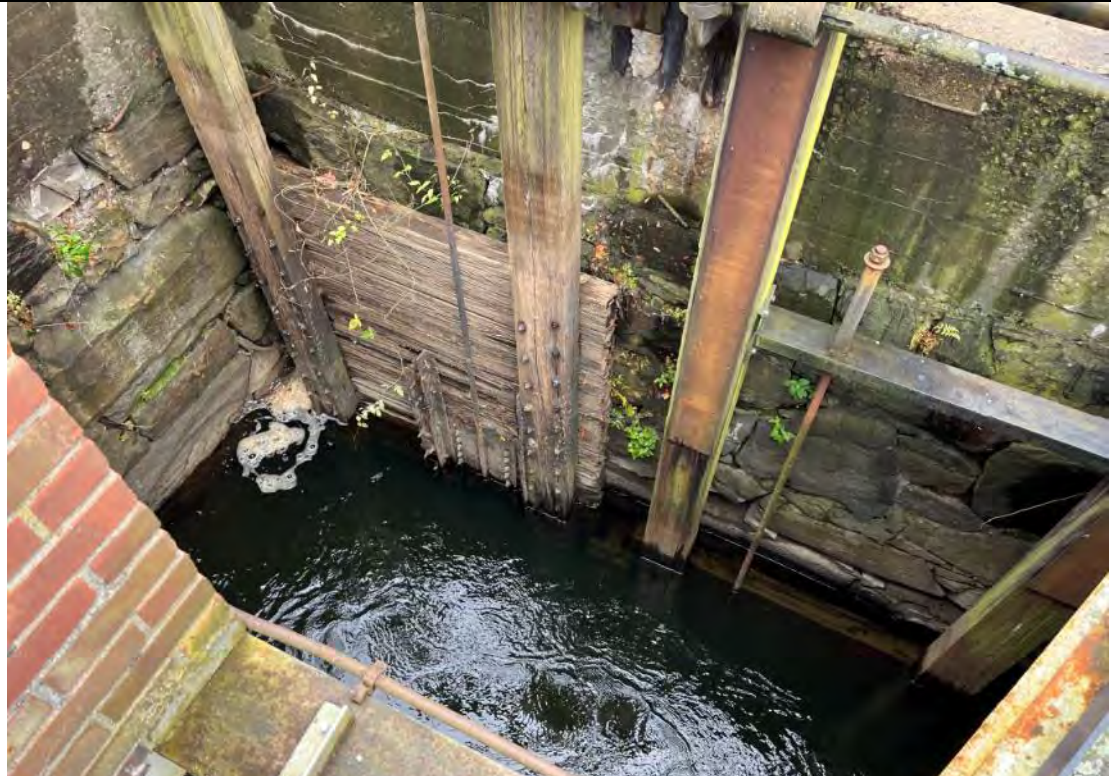
<b>Client Name:</b> General Electric Company		<b>Site Location:</b> Willow Mill Dam (MA00262) South Lee, MA	<b>Project No.</b> 01.0019896.70
<b>Photo No.</b> 7	<b>Date:</b> 11/14/2023

<b>Direction Photo Taken:</b> Downstream facing down.			
<b>Description:</b> Upstream side of the canal sluice gates.  Note missing mortar between the stone masonry blocks.  Based on probing, about 1-to-3-inches of sediment was measured upstream of the gates.

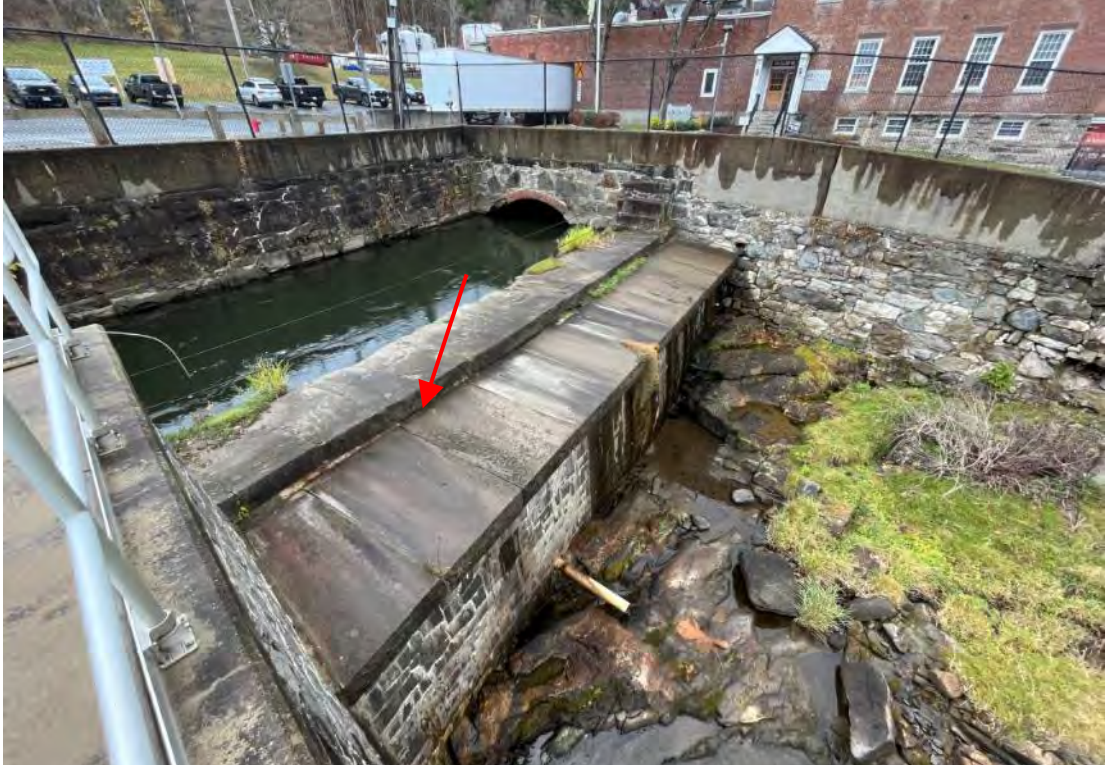
<b>Client Name:</b> General Electric Company		<b>Site Location:</b> Willow Mill Dam (MA00262) South Lee, MA	<b>Project No.</b> 01.0019896.70
<b>Photo No.</b> 9	<b>Date:</b> 11/14/2023

A six-inch diameter PVC canal drainpipe was observed at the right-side toe of the auxiliary spillway. Little to no flow through the drainpipe was observed. Onyx indicated that the drainpipe usually flows freely but has to be periodically cleared of debris to re-establish flow.

<b>Direction Photo Taken:</b> Downstream to the left.			
<b>Description:</b> Overview of the auxiliary spillway (waste weir) from the canal sluice gate platform. Missing mortar observed along the horizontal joint of the concrete cap (red arrow). Also note vegetation growth in the joint. Minor flow from PVC drainpipe at downstream toe (also see photo 30).

2. Since little to no flow was observed from the six-inch auxiliary spillway canal drainpipe, flow should be reestablished through the drainpipe during planned maintenance activities when there is safe access to the drainpipe, typically during the summer low flow conditions. [Checklist Item 75]

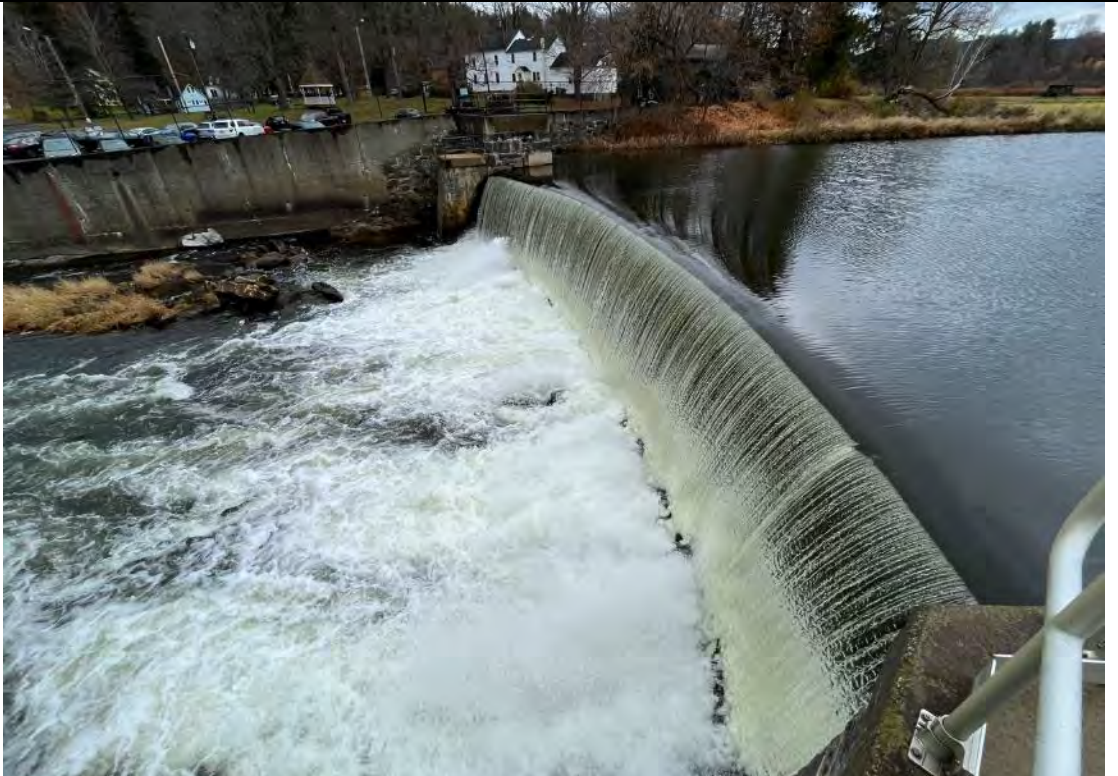
<b>Client Name:</b> General Electric Company		<b>Site Location:</b> Willow Mill Dam (MA00262) South Lee, MA	<b>Project No.</b> 01.0019896.70
<b>Photo No.</b> 11	<b>Date:</b> 11/14/2023

The spillway was overtopping during the inspection; therefore, the downstream face of the spillway, spillway toe, and other areas downstream of the spillway were partially obstructed by water and difficult to observe. Based on discussions with Onyx, low-flow conditions when the upstream water levels drop below the spillway crest occur periodically throughout the year, allowing opportunity to observe the spillway's features.

<b>Direction Photo Taken:</b> Right.			
<b>Description:</b> Spillway and right side of the dam from the sluice gate platform.  About 14-inches of water flow over the spillway at the time of the inspection.

1. Visually observe typically submerged structures during low-flow conditions, including looking for signs of scour at the spillway toe and the missing piece of stone masonry in the downstream spillway face noted in the 2022 Phase I Inspection Report. These observations could be made during the routine quarterly inspections, subject to flow conditions. Photographs should be taken to help document conditions during low-flow periods. [Checklist Items 1 to 4, 7 to 12, 15, 18, 19, 29, 31, 33, 34, 44, 49, 65 to 68, 93, 97, 99]

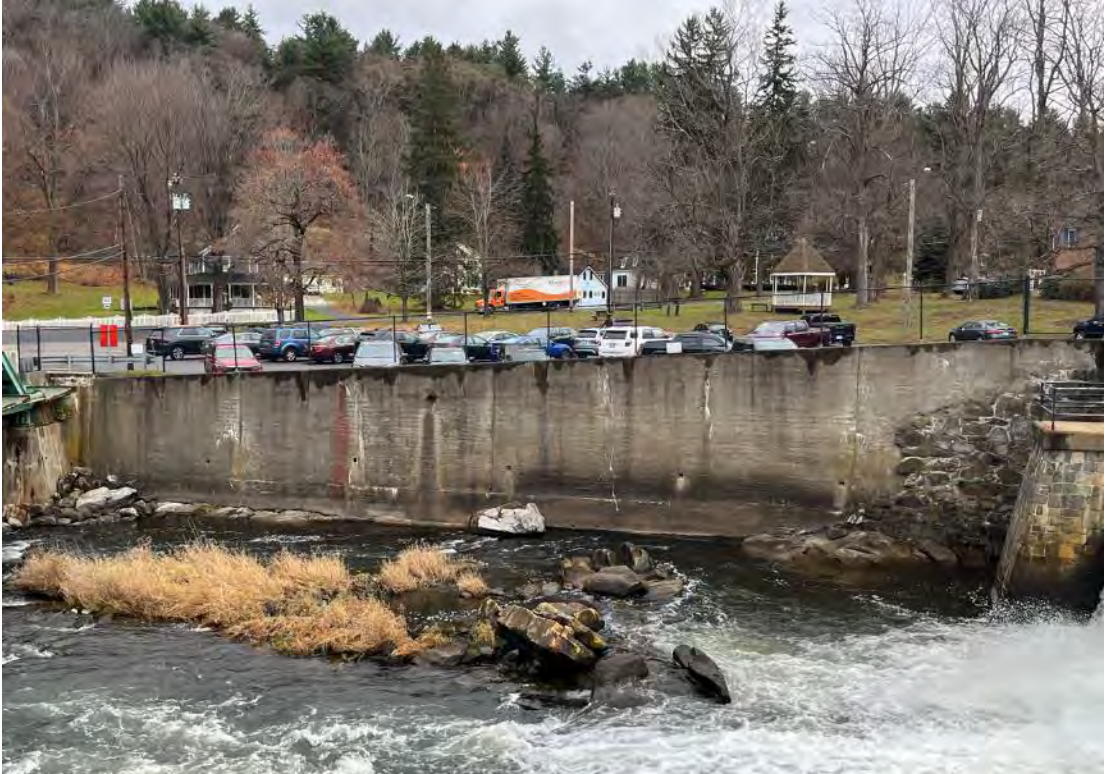
<b>Client Name:</b> General Electric Company		<b>Site Location:</b> Willow Mill Dam (MA00262) South Lee, MA	<b>Project No.</b> 01.0019896.70
<b>Photo No.</b> 13	<b>Date:</b> 11/14/2023

Minor cracking and efflorescence were observed in the right-side training wall downstream of the river outlet control structure.

<b>Direction Photo Taken:</b> Downstream and right.			
<b>Description:</b> Right downstream concrete training wall.  Minor cracking and efflorescence of the concrete observed.

8. Monitor the cracking and efflorescence in the downstream right-side concrete training wall. [Checklist Item 111]

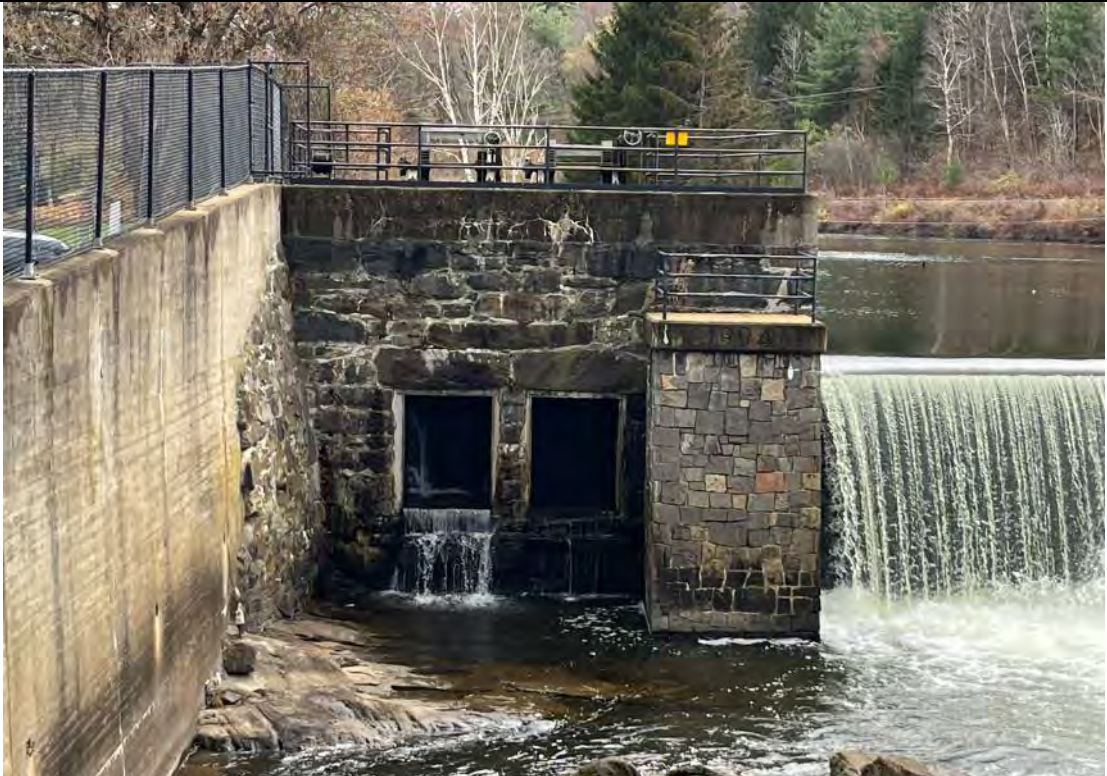
<b>Client Name:</b> General Electric Company		<b>Site Location:</b> Willow Mill Dam (MA00262) South Lee, MA	<b>Project No.</b> 01.0019896.70
<b>Photo No.</b> 15	<b>Date:</b> 11/14/2023

Only minor leakage through the right gate (Gate #1) was observed during the inspection. Significantly greater leakage through both gates had been observed on July 29, 2022 based on the photographs contained in the above-referenced 2022 Phase I Inspection Report.

<b>Direction Photo Taken:</b> Upstream.			
<b>Description:</b> Downstream of the outlet control structure.  Note minor leakage through the right (photo left) gate.

2. Monitor the left upstream training wall for missing masonry, as noted in the 2022 Phase I Inspection Report. [Checklist Item 27]
3. Monitor the leakage observed through the river outlet control structure gates. [Checklist Item 48]

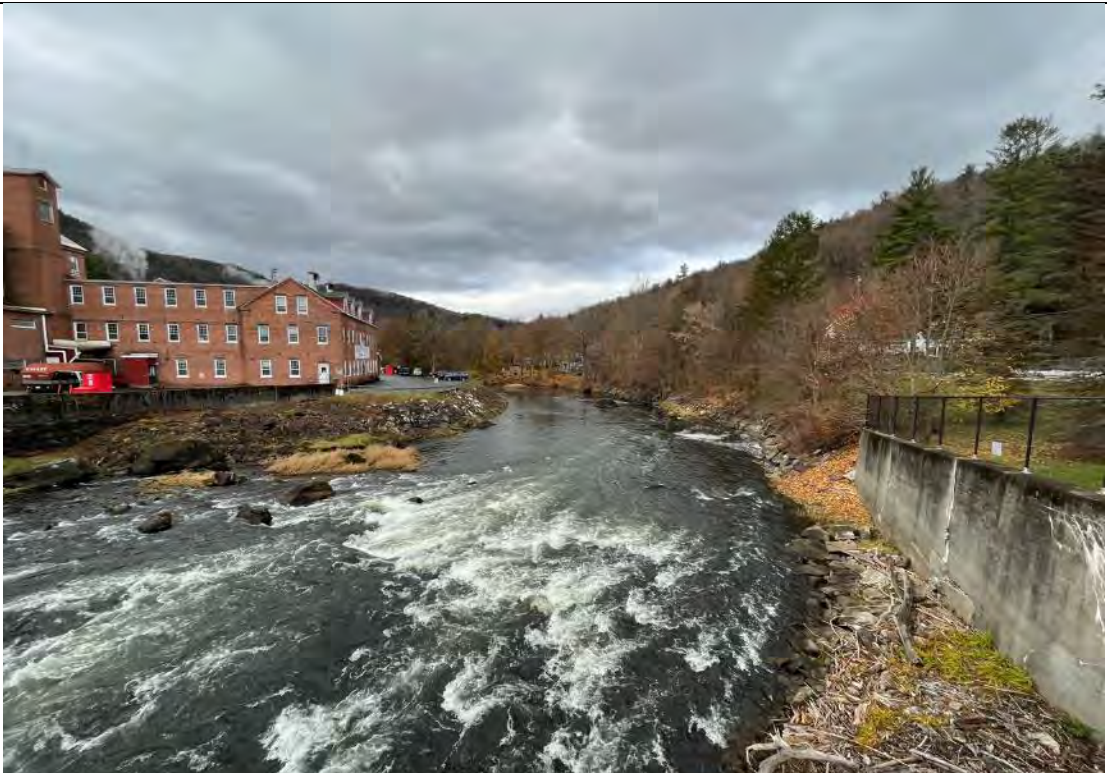
<b>Photo No.</b> 16	<b>Date:</b> 11/14/2023

<b>Direction Photo Taken:</b> Downstream.			
<b>Description:</b> Channel downstream of the Willow Street Bridge.

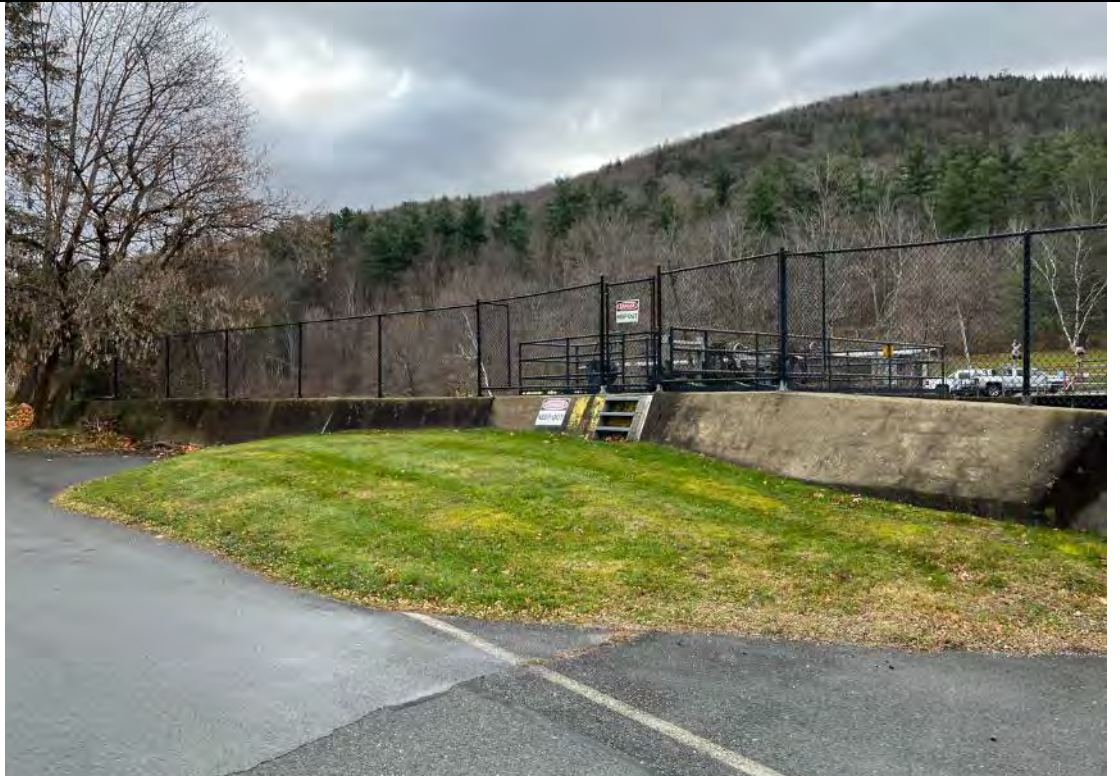
**Description:**  
Right side of right concrete training wall adjacent to the outlet control structure.

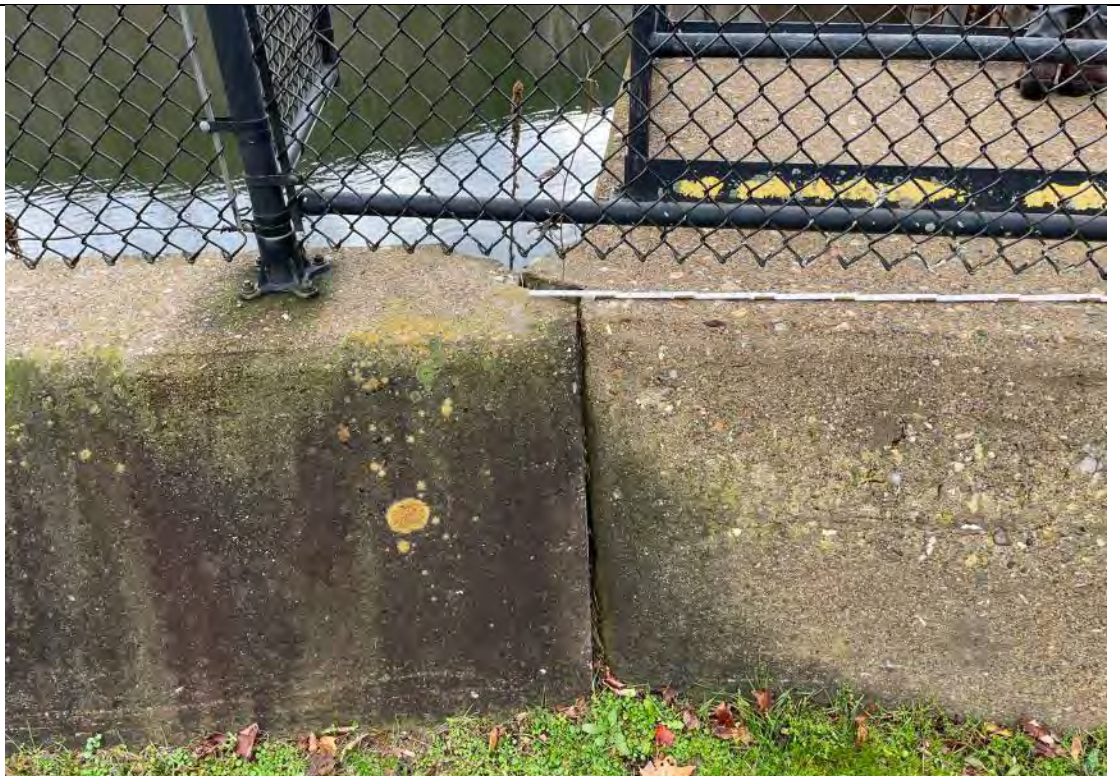
<b>Photo No.</b> 20	<b>Date:</b> 11/14/2023
------------------------	----------------------------

An offset vertical joint in the right concrete training wall was observed just upstream of the river outlet control structure. The offset was measured to be about two inches longitudinally (perpendicular to the flow of the river). A small vertical crack in the right training wall was observed just downstream of the river outlet control structure. Both features appeared similar to those in photographs included in the 2022 Phase I Inspection Report.

**Description:**  
Offset of a vertical joint in the right concrete training wall at upstream end of the outlet control structure (also see photo 21).

4. Monitor the deteriorated mortar joints, minor cracking, and efflorescence at the outlet control structure. [Checklist Items 56, 57, 58]
5. Monitor the offset vertical joint in the right upstream concrete training wall adjacent to the outlet control structure. [Checklist Item 63]

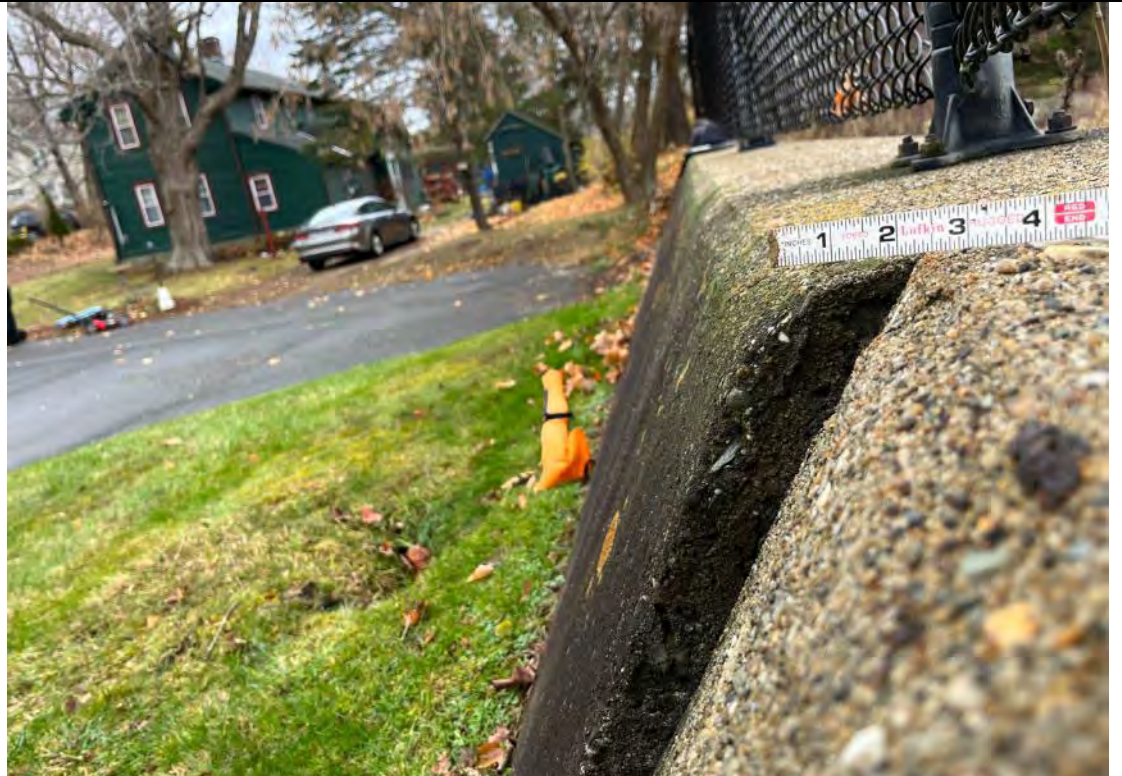
<b>Client Name:</b> General Electric Company		<b>Site Location:</b> Willow Mill Dam (MA00262) South Lee, MA	<b>Project No.</b> 01.0019896.70
<b>Photo No.</b> 21	<b>Date:</b> 11/14/2023

<b>Direction Photo Taken:</b> Upstream.			
<b>Description:</b> Closeup of the offset of the vertical joint in the right concrete training wall upstream of the outlet control structure (also see photo 20).

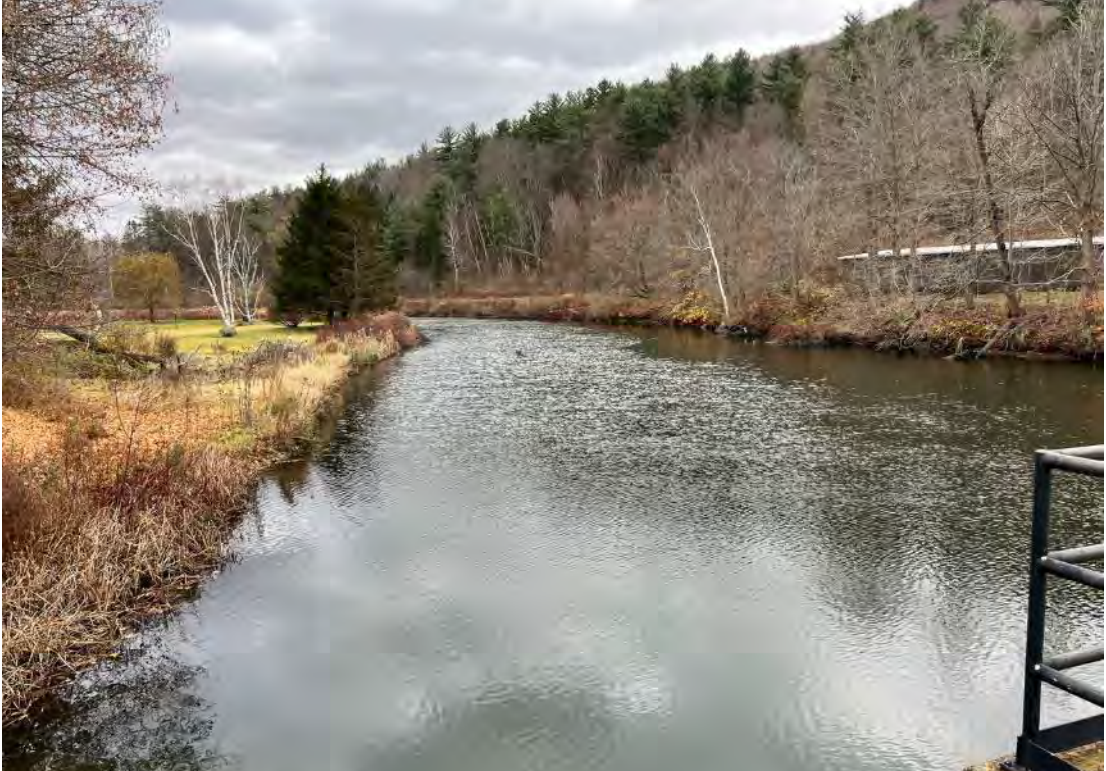
<b>Client Name:</b> General Electric Company		<b>Site Location:</b> Willow Mill Dam (MA00262) South Lee, MA	<b>Project No.</b> 01.0019896.70
<b>Photo No.</b> 23	<b>Date:</b> 11/14/2023

<b>Direction Photo Taken:</b> Upstream.			
<b>Description:</b> Overview of the impoundment from the outlet control structure.

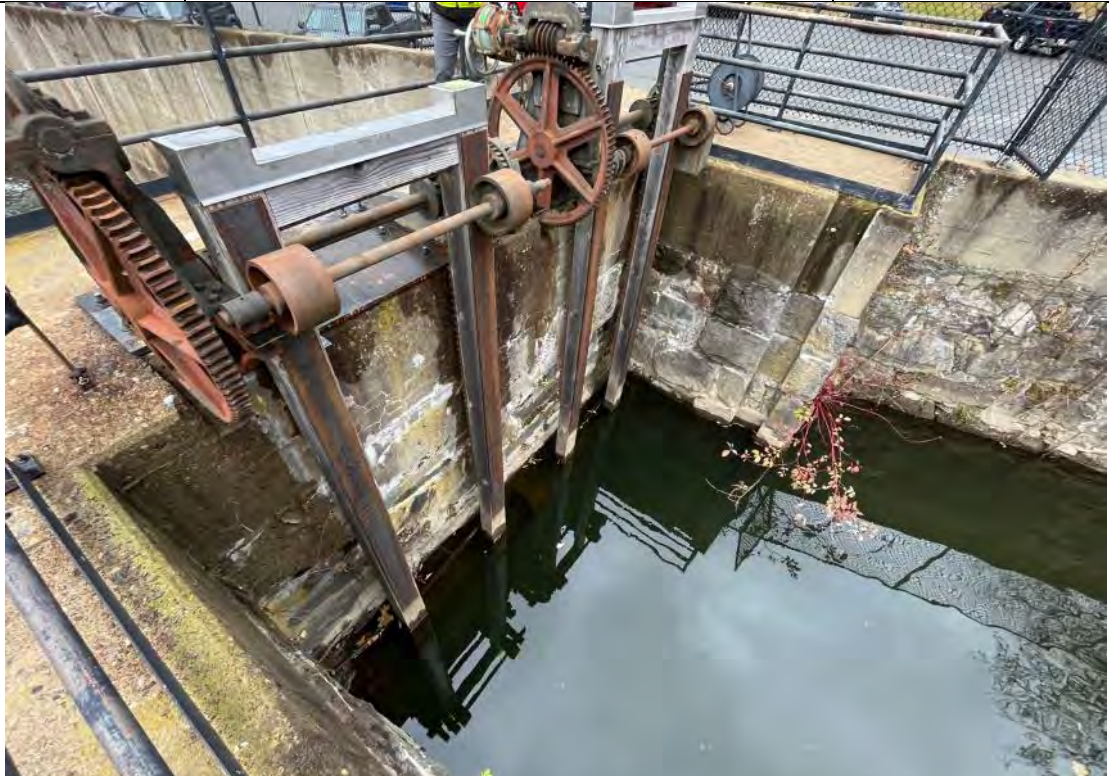
<b>Client Name:</b> General Electric Company		<b>Site Location:</b> Willow Mill Dam (MA00262) South Lee, MA	<b>Project No.</b> 01.0019896.70
<b>Photo No.</b> 25	<b>Date:</b> 11/14/2023

<b>Direction Photo Taken:</b> Downstream and right.			
<b>Description:</b> Upstream side of the outlet control structure gate operators (Gate 1 on the right and Gate 2 on the left).  Based on probing, no sediment was measured upstream of the gates.

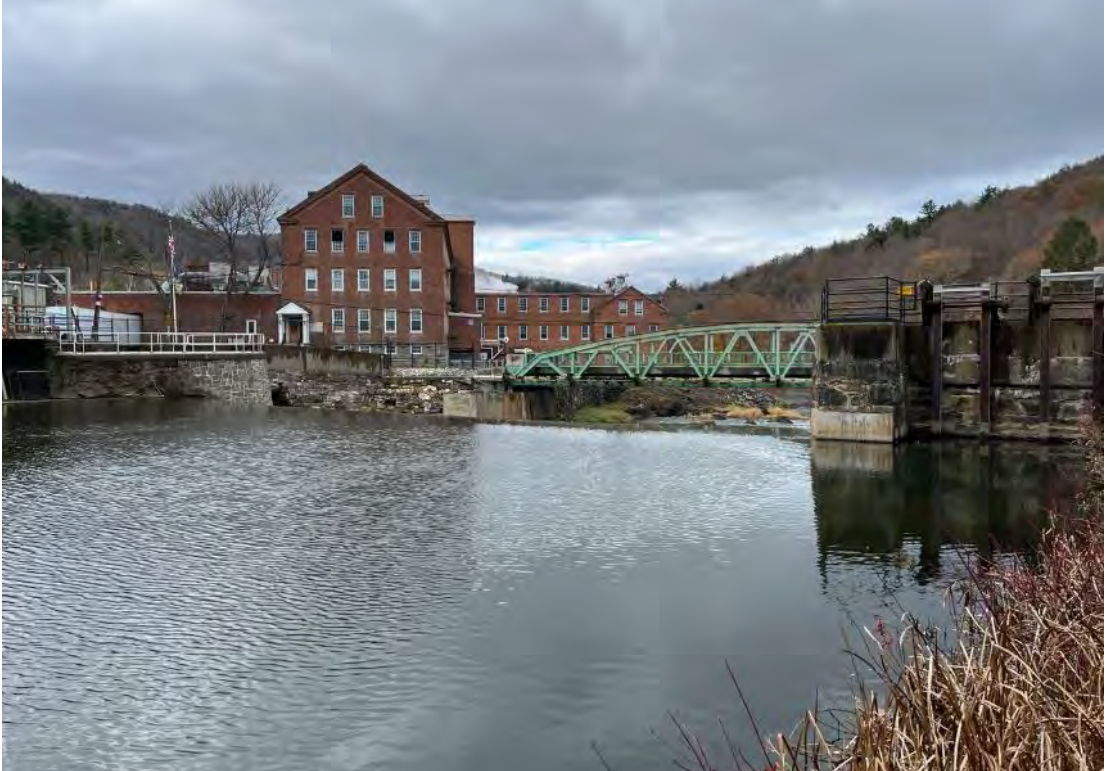
<b>Client Name:</b> General Electric Company		<b>Site Location:</b> Willow Mill Dam (MA00262) South Lee, MA	<b>Project No.</b> 01.0019896.70
<b>Photo No.</b> 27	<b>Date:</b> 11/14/2023

<b>Direction Photo Taken:</b> Downstream.			
<b>Description:</b> Area upstream of the spillway from the right upstream side of the dam.

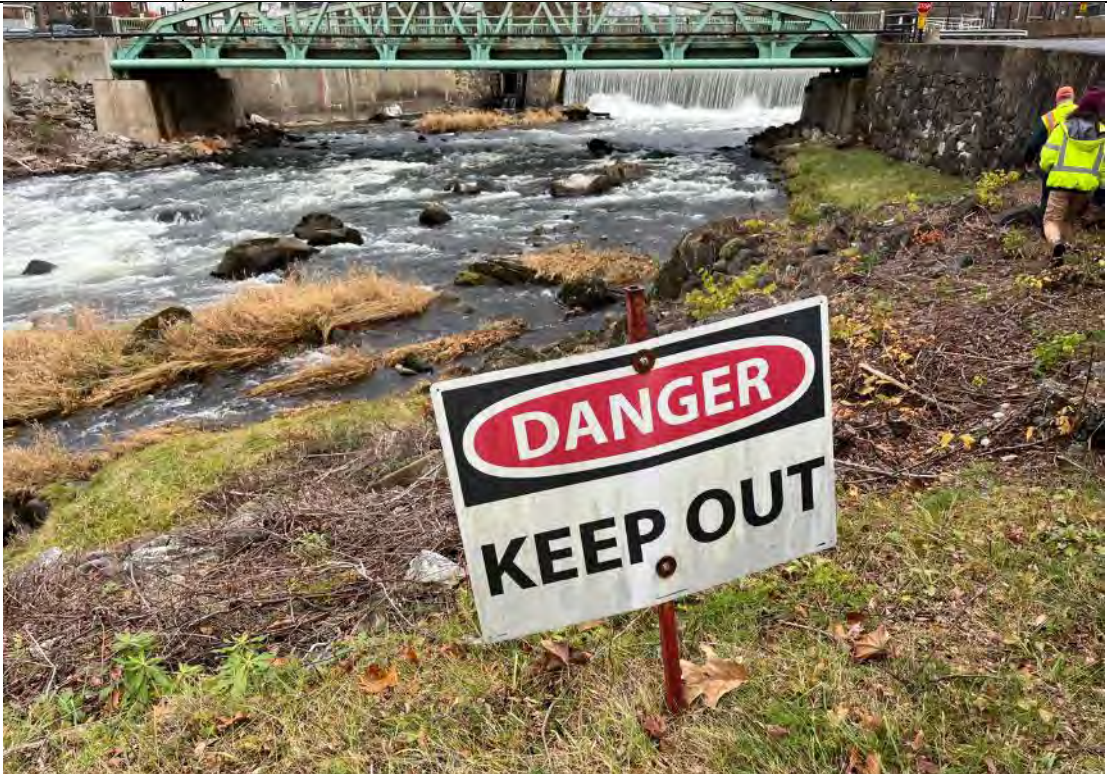
<b>Client Name:</b> General Electric Company		<b>Site Location:</b> Willow Mill Dam (MA00262) South Lee, MA	<b>Project No.</b> 01.0019896.70
<b>Photo No.</b> 29	<b>Date:</b> 11/14/2023

<b>Direction Photo Taken:</b> Upstream.			
<b>Description:</b> Downstream access to the toe of the dam.

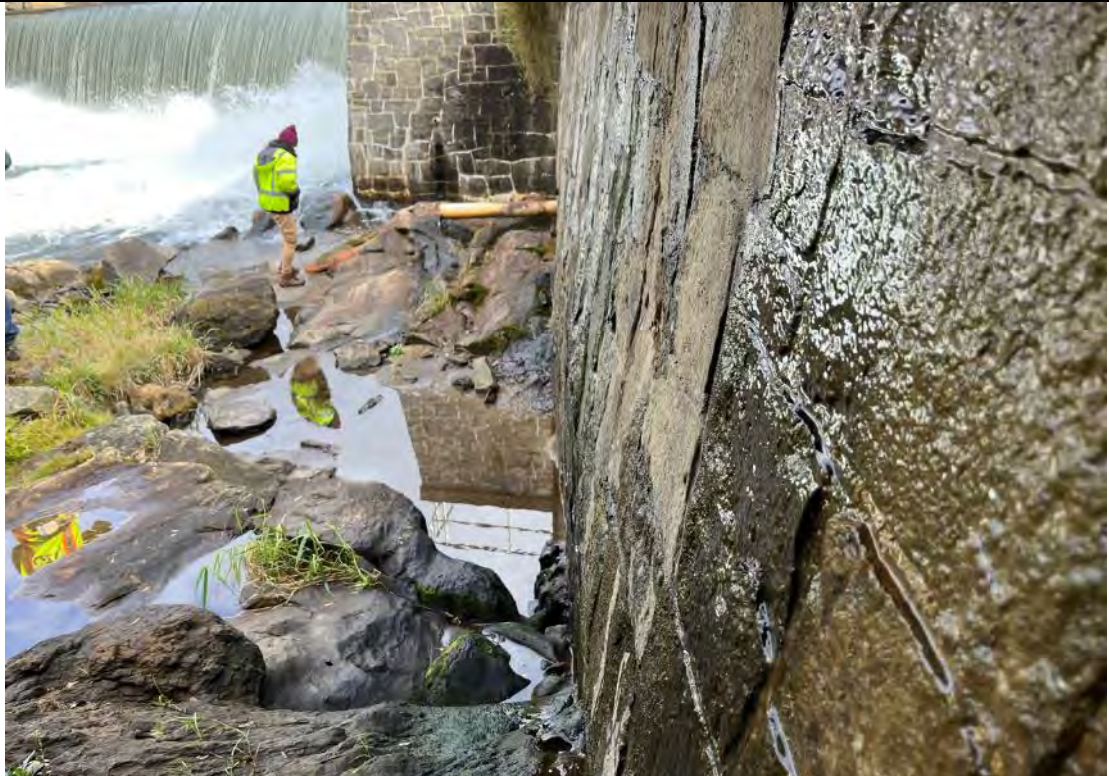
<b>Client Name:</b> General Electric Company		<b>Site Location:</b> Willow Mill Dam (MA00262) South Lee, MA	<b>Project No.</b> 01.0019896.70
<b>Photo No.</b> 31	<b>Date:</b> 11/14/2023

A slight angle or bulge was observed in the downstream direction in the masonry façade of the auxiliary spillway. A review of the project's record drawings<sup>1</sup> indicates that the auxiliary spillway façade was constructed with this angle/bulge. No distress, cracking, offsets, or signs of displacement or continuous movement of the auxiliary spillway were observed.

<b>Direction Photo Taken:</b> Upstream.			
<b>Description:</b> View parallel to the downstream face of the auxiliary spillway. Slight bulge observed in the center of the structure. No cracking of the façade was observed, indicating little to no displacement since the 2004 repairs.

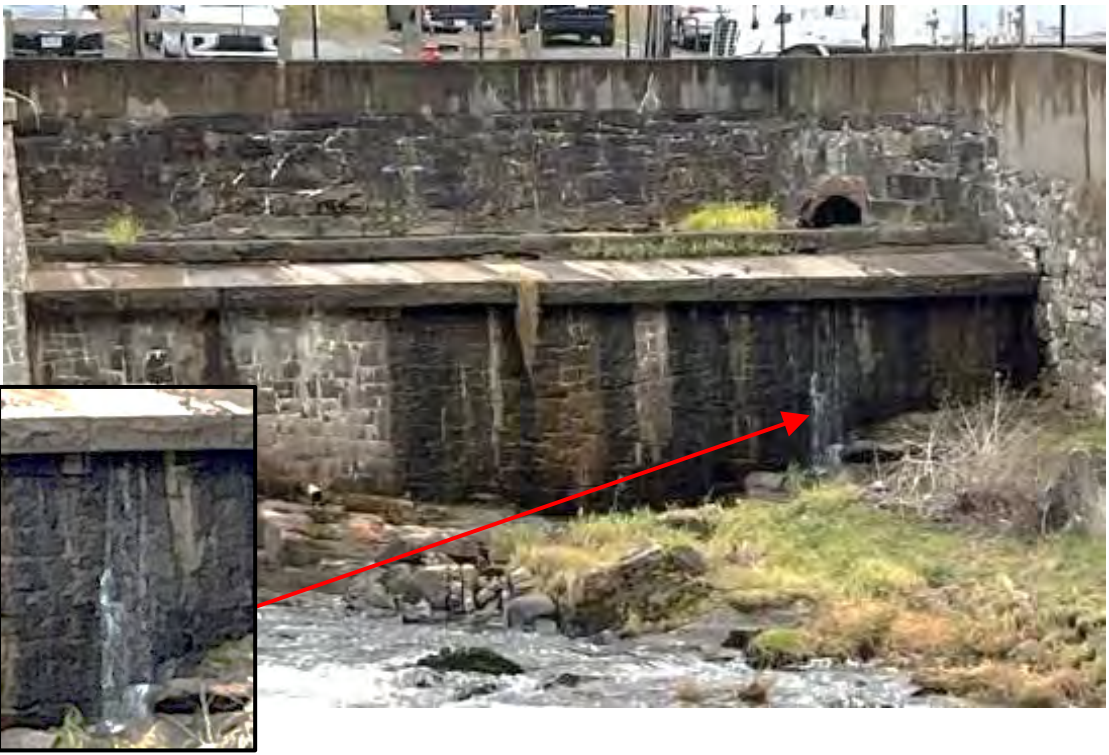
<b>Photo No.</b> 32	<b>Date:</b> 11/14/2023

During the inspection, GZA observed the beginning of minor leakage under the left side auxiliary spillway cap stone. This condition was not present during the first half of the inspection and started towards the end of the inspection. It is likely that the water level inside the canal slightly increased, causing minor leakage through a deteriorated mortar joint. Although the canal water level was similar during the 2022 Phase I Inspection, this minor leakage was not reported at that time.

<b>Direction Photo Taken:</b> Left.			
<b>Description:</b> Auxiliary spillway.  Minor leakage through the cap stone of the auxiliary spillway began during the inspection (inset and red arrow). Leakage observed approximately 30 minutes after Photo 30 was taken with little to no leakage observed.

6. Continue to monitor the flow from the six-inch canal drainpipe at the auxiliary spillway. [Checklist Item 75]
7. Monitor the leakage through the auxiliary spillway stone masonry. [Checklist Items 76, 77, 78]
