**Kevin Mooney**  
Senior Project Manager  
Global Operations - Environment, Health & Safety

General Electric Company  
1 Plastics Ave.  
Pittsfield, MA 01201

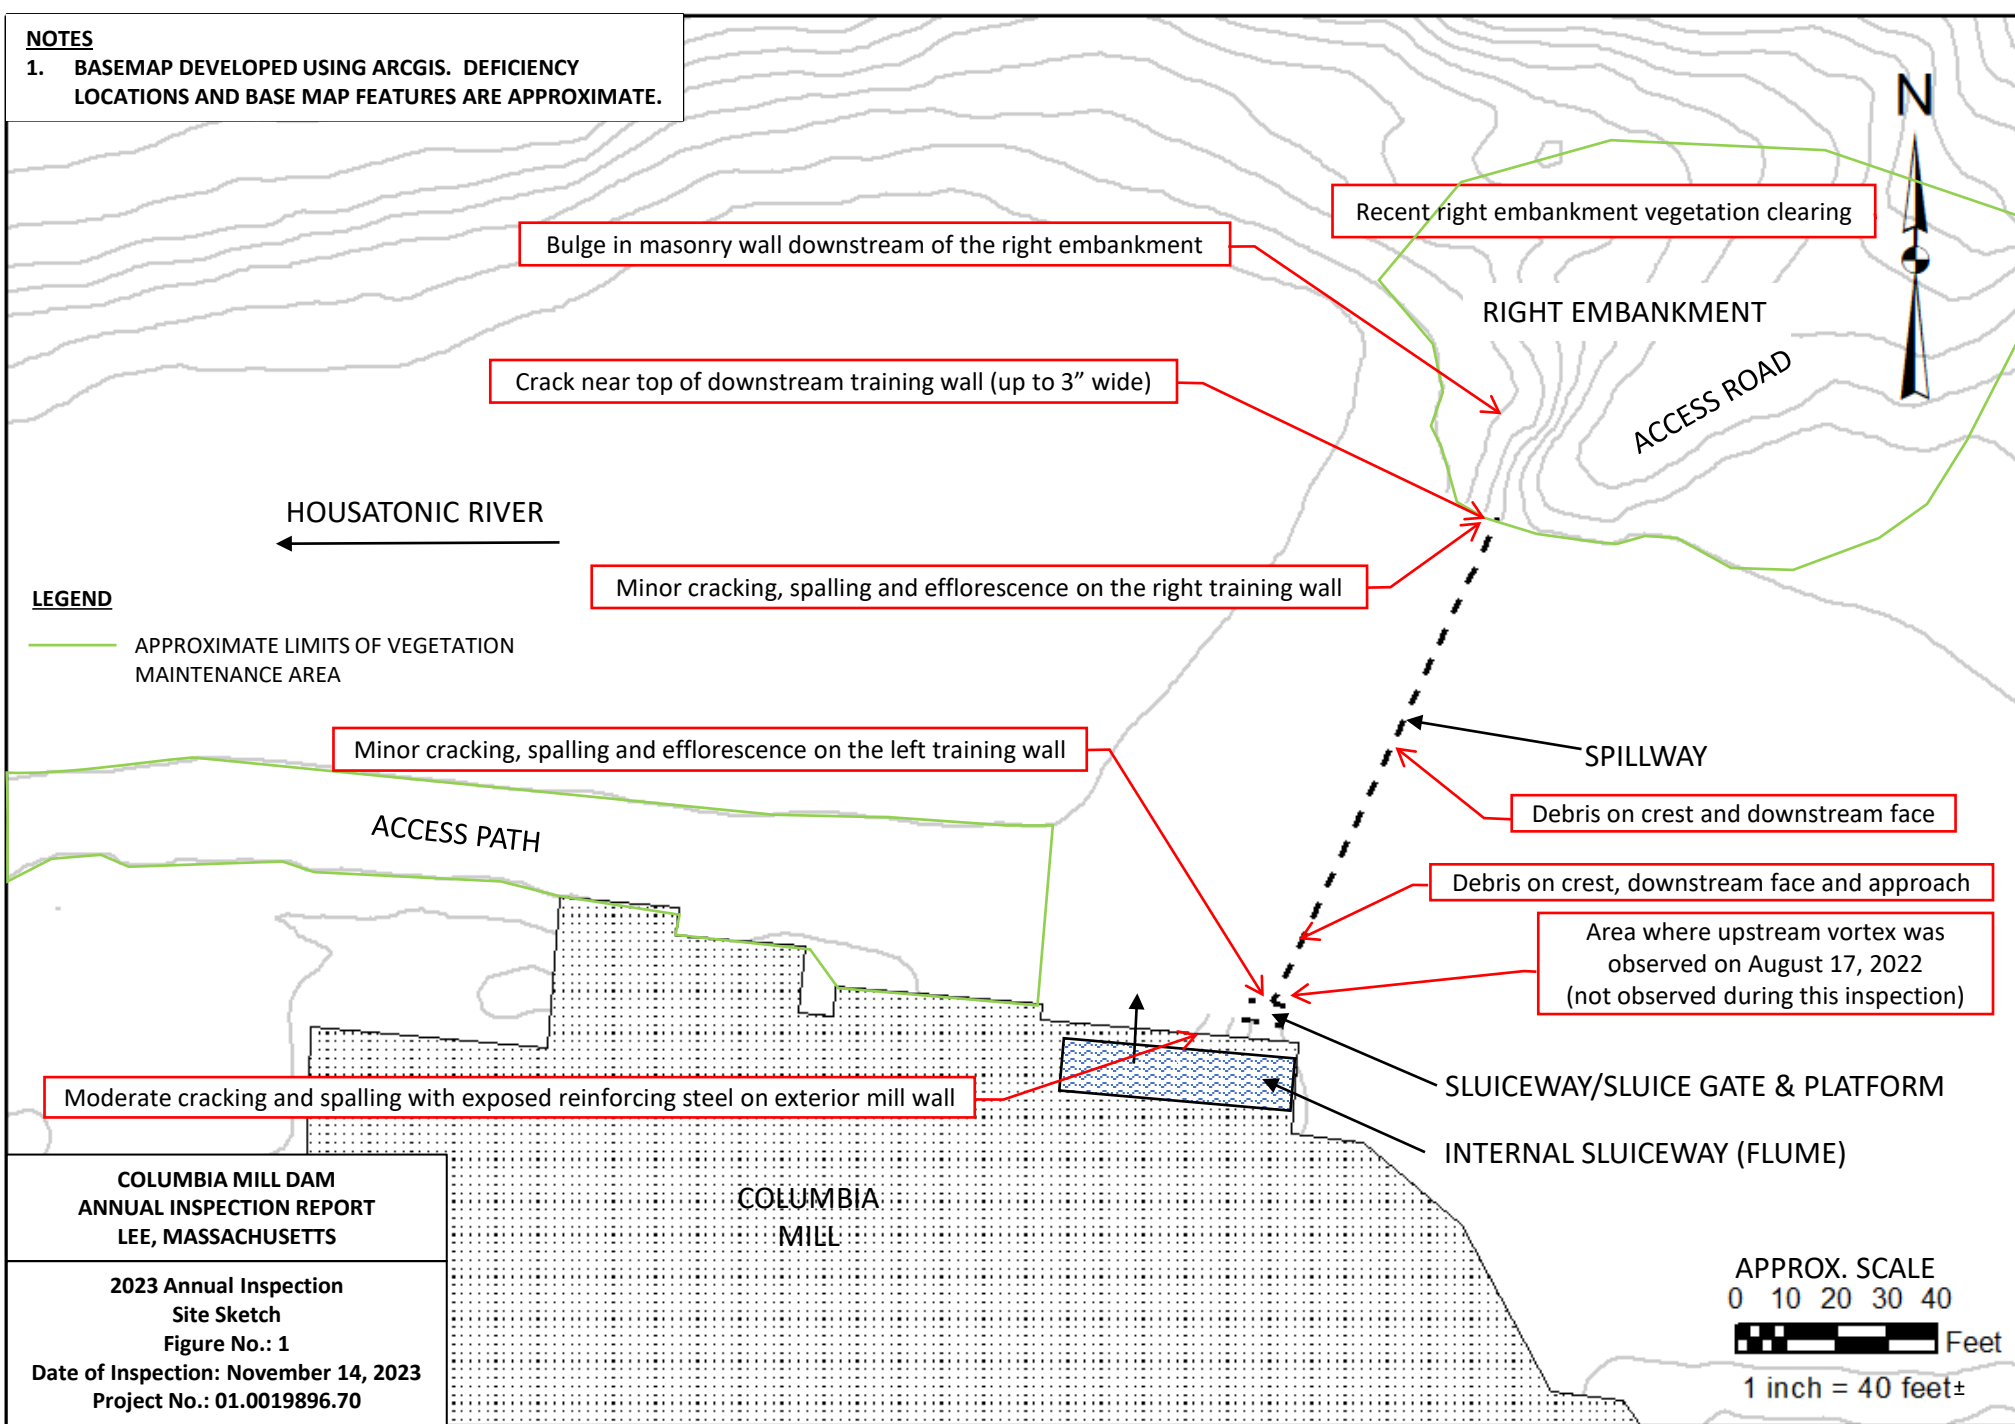
**COLUMBIA MILL DAM  
ANNUAL INSPECTION REPORT  
LEE, MASSACHUSETTS**

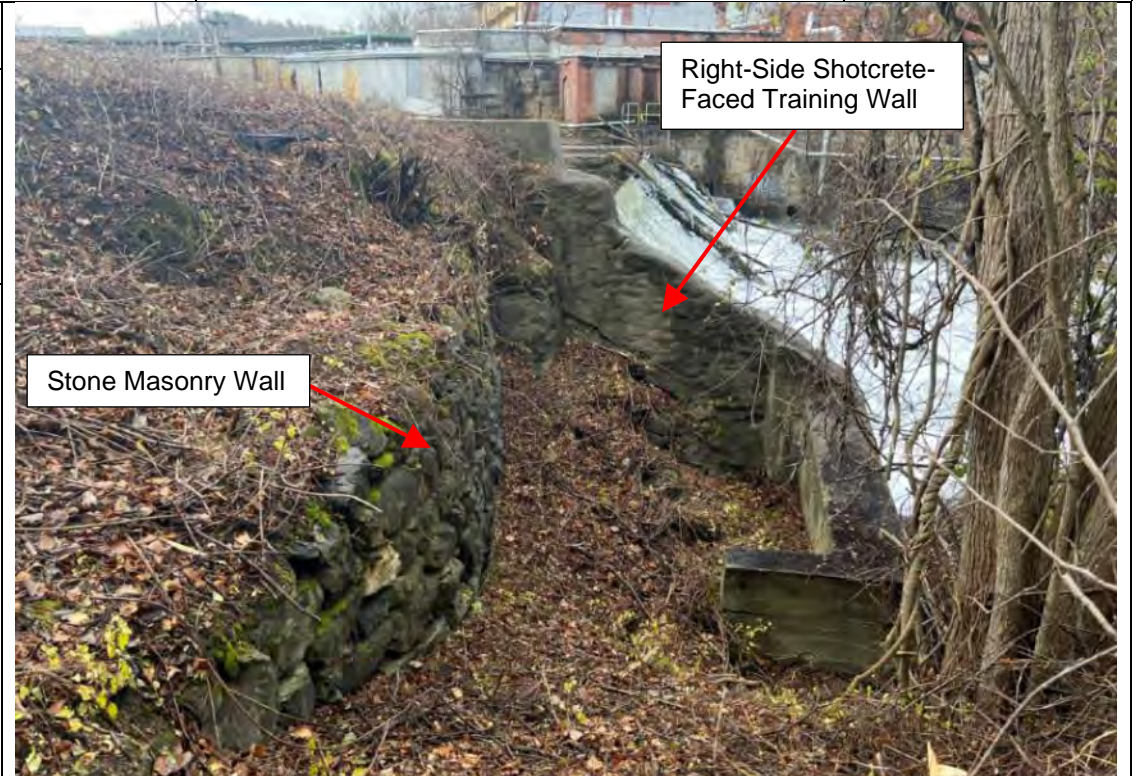
<b>Photo No.</b> 24	<b>Date:</b> 11/14/2023
------------------------	----------------------------

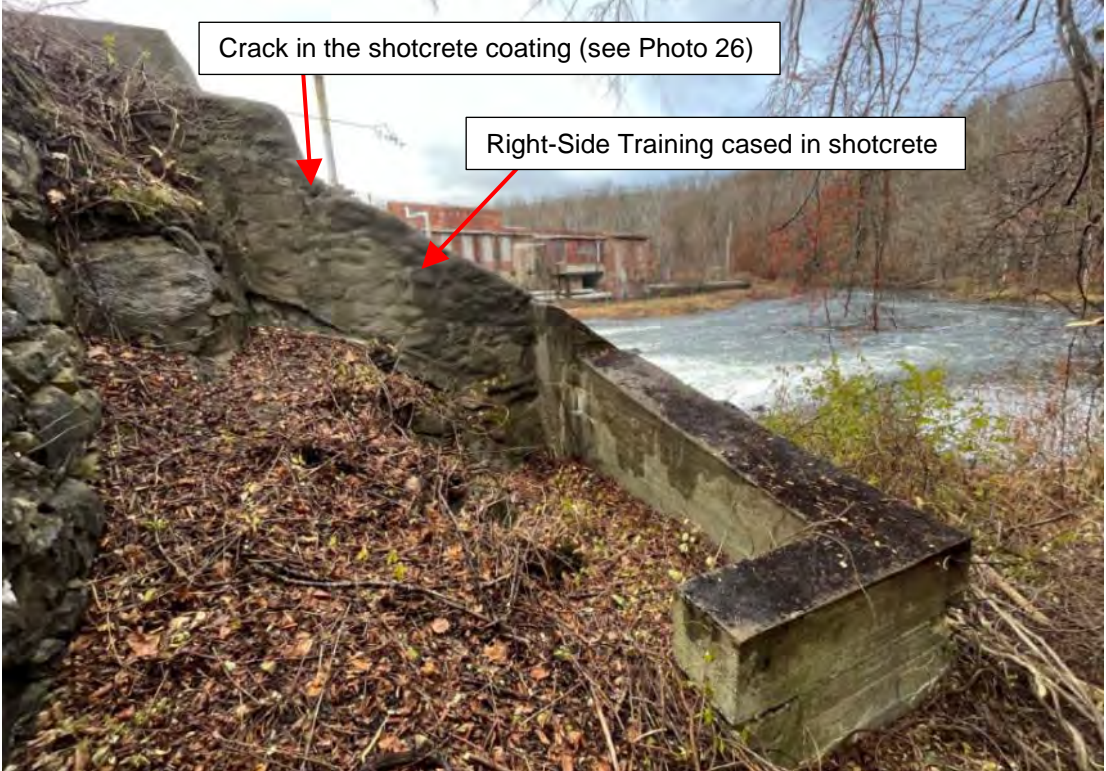
<p>Crack in the shotcrete coating (see Photo 26)</p> <p>Right-Side Training cased in shotcrete</p>	
<b>Direction Photo Taken:</b> Left.			
<b>Description:</b> Right-side downstream training wall.  The wall appears to have been constructed of stone masonry and then faced with shotcrete.

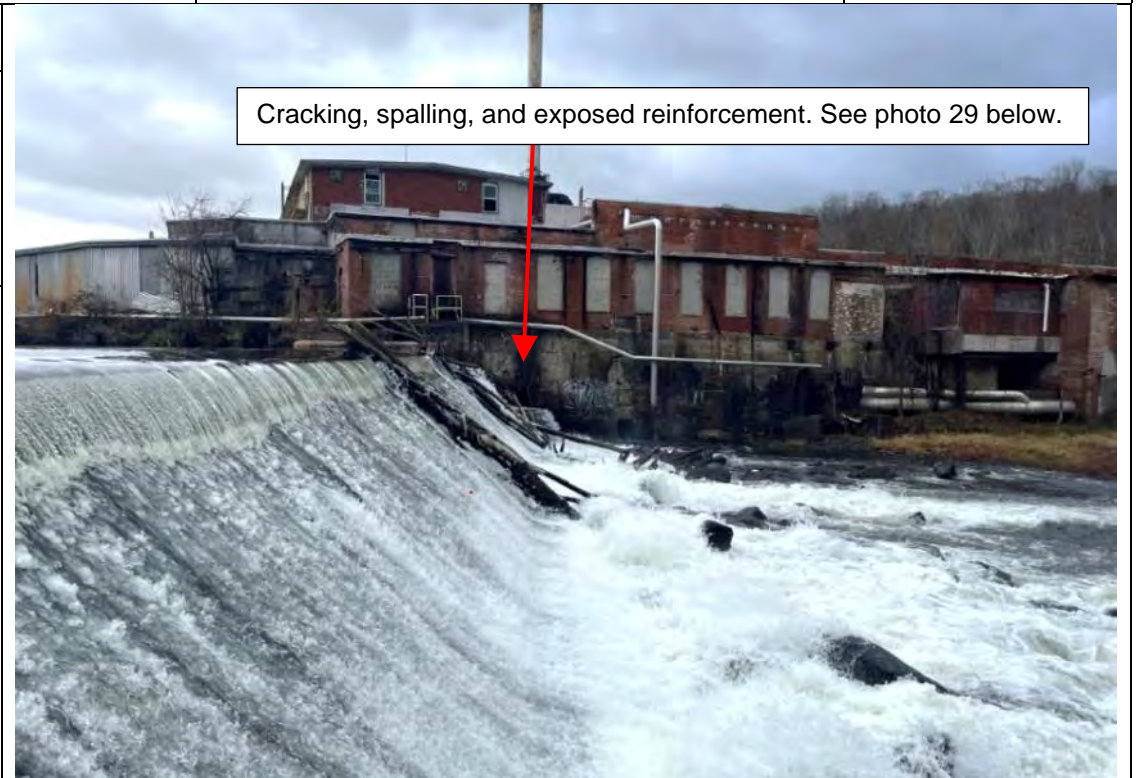
<b>Photo No.</b> 30	<b>Date:</b> 11/14/2023
------------------------	----------------------------

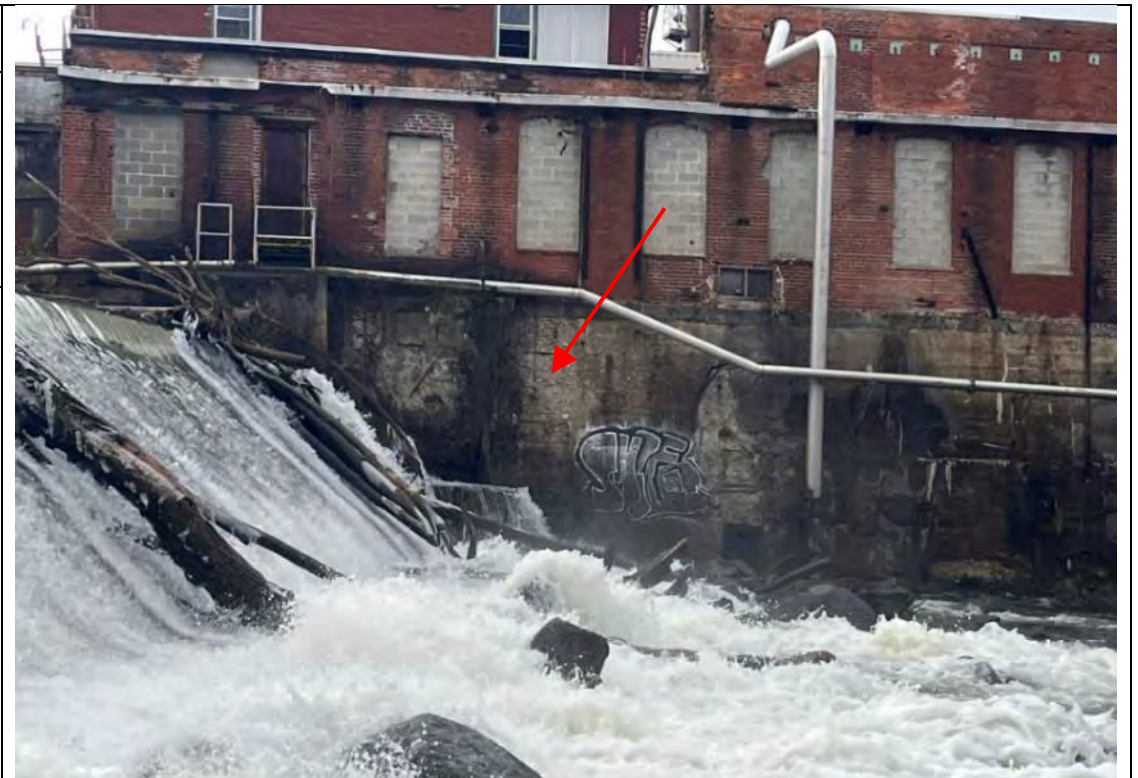
Note moderate cracking, spalling, and exposed reinforcement of the mill building wall concrete.

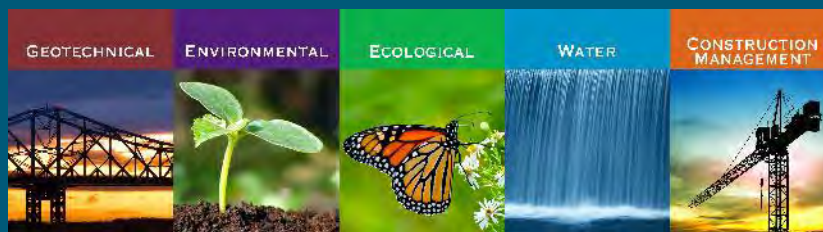
GZA GeoEnvironmental, Inc.
