Kevin Mooney
Senior Project Manager
Global Operations - Environment, Health & Safety

General Electric Company
1 Plastics Ave.
Pittsfield, MA 01201

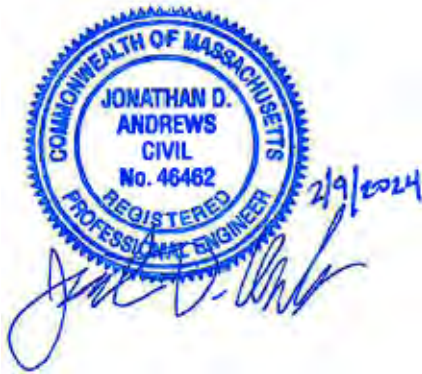
Jonathan D. Andrews, P.E.

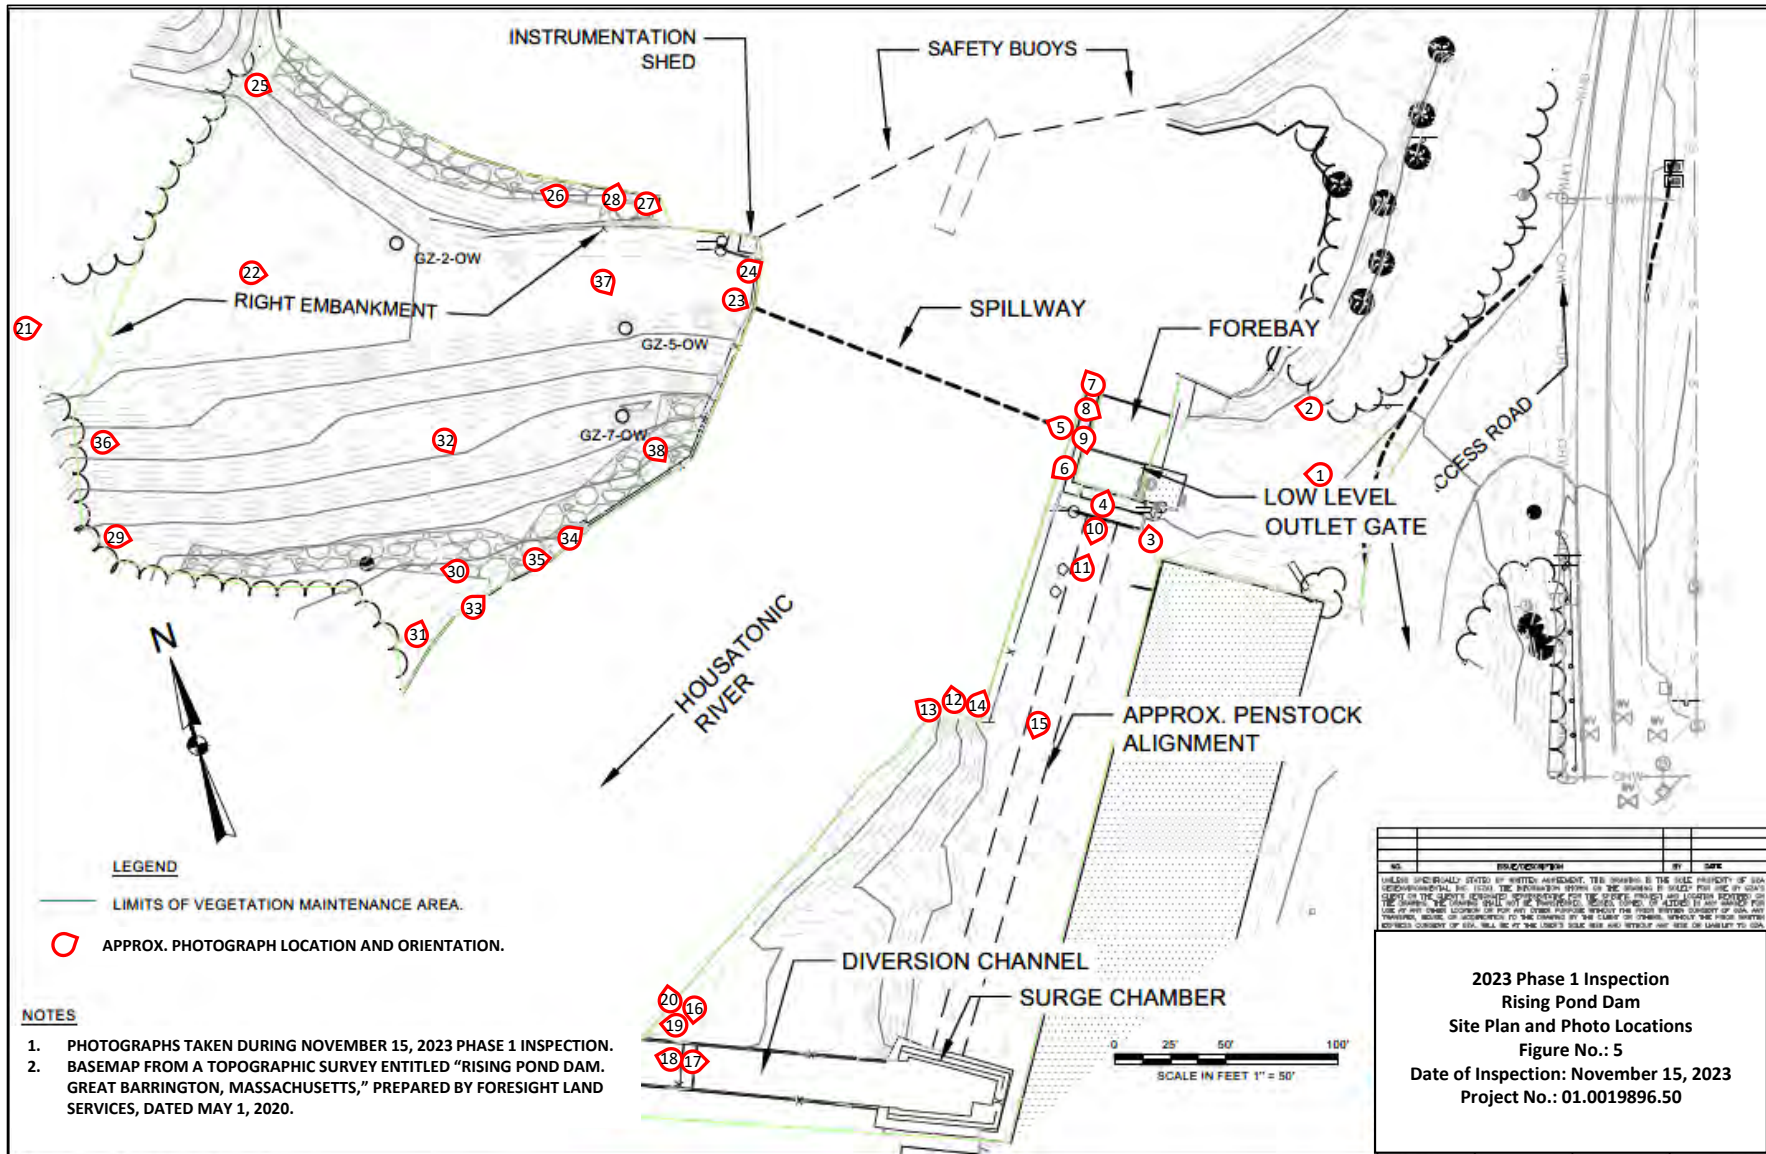
NO.	DESCRIPTION	BY	DATE

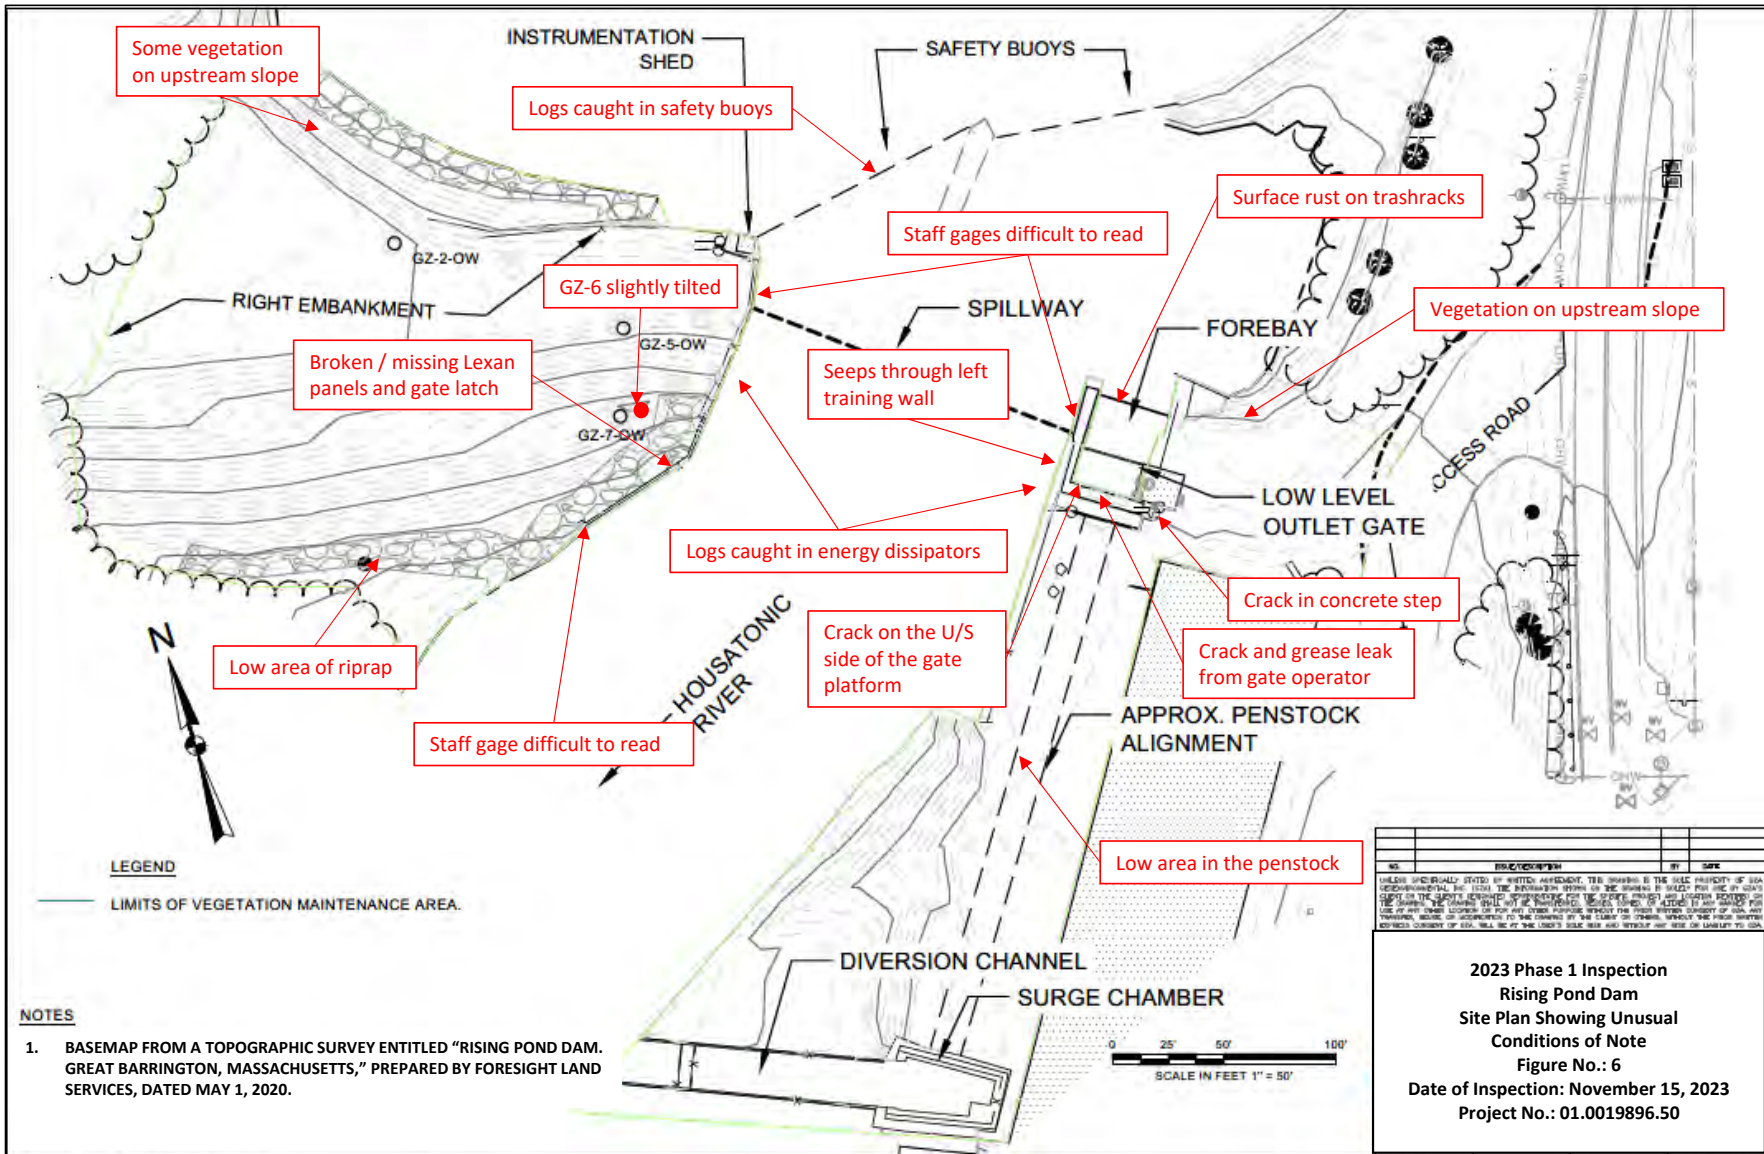
UNLESS OTHERWISE NOTED BY WRITTEN AGREEMENT, THE DRAWING IS THE SOLE PROPERTY OF SOA INCORPORATED AND FROM THE INFORMATION HEREON NO WARRANTY IS MADE FOR USE BY OTHERS. THE USER SHALL BE RESPONSIBLE FOR THE SAFETY, DESIGN AND CONSTRUCTION OF THE WORK. THE USER SHALL NOT BE HELD RESPONSIBLE FOR DAMAGES OF ANY KIND FOR USE OF ANY OTHER LOCATION OR FOR ANY OTHER PURPOSES UNLESS THE USER HAS BEEN ADVISED OTHERWISE. SOA, INC. OR THE USER'S SOLE AGENT SHALL BE RESPONSIBLE FOR THE SAFETY OF THE USER'S SOLE AGENT AND SHALL BE RESPONSIBLE FOR THE SAFETY OF THE USER'S SOLE AGENT.

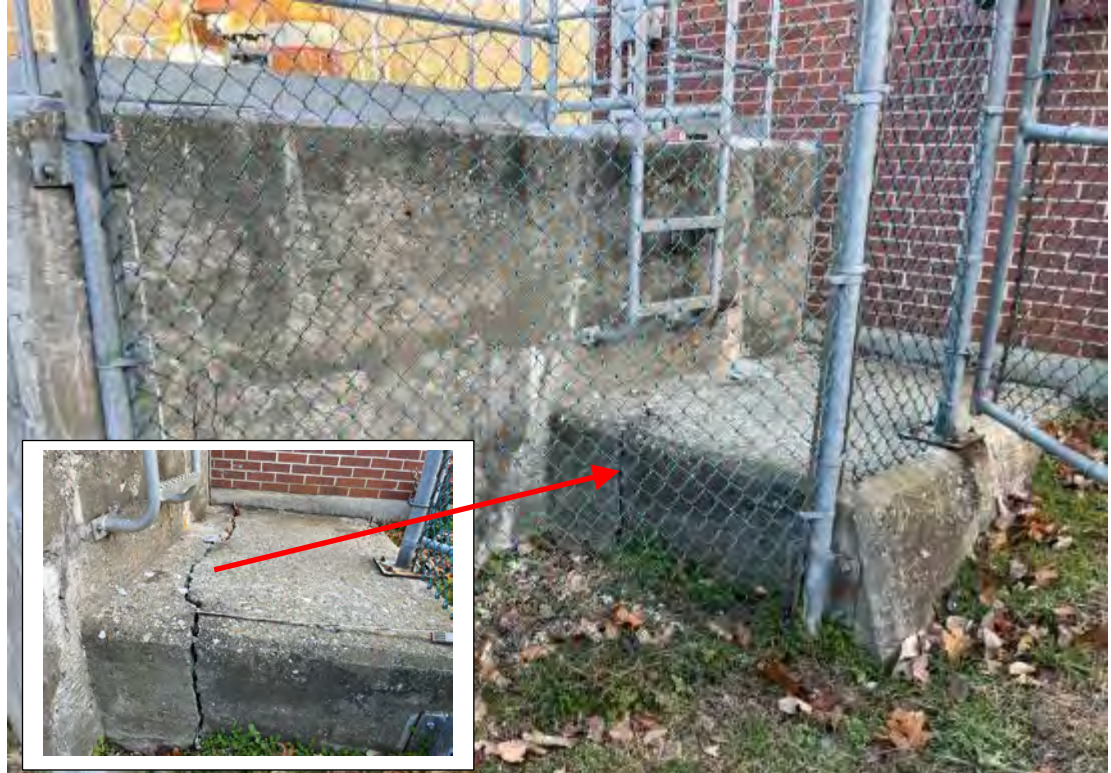
Direction Photo Taken: Upstream and right.			
Description: Crack in step leading to gate platform.

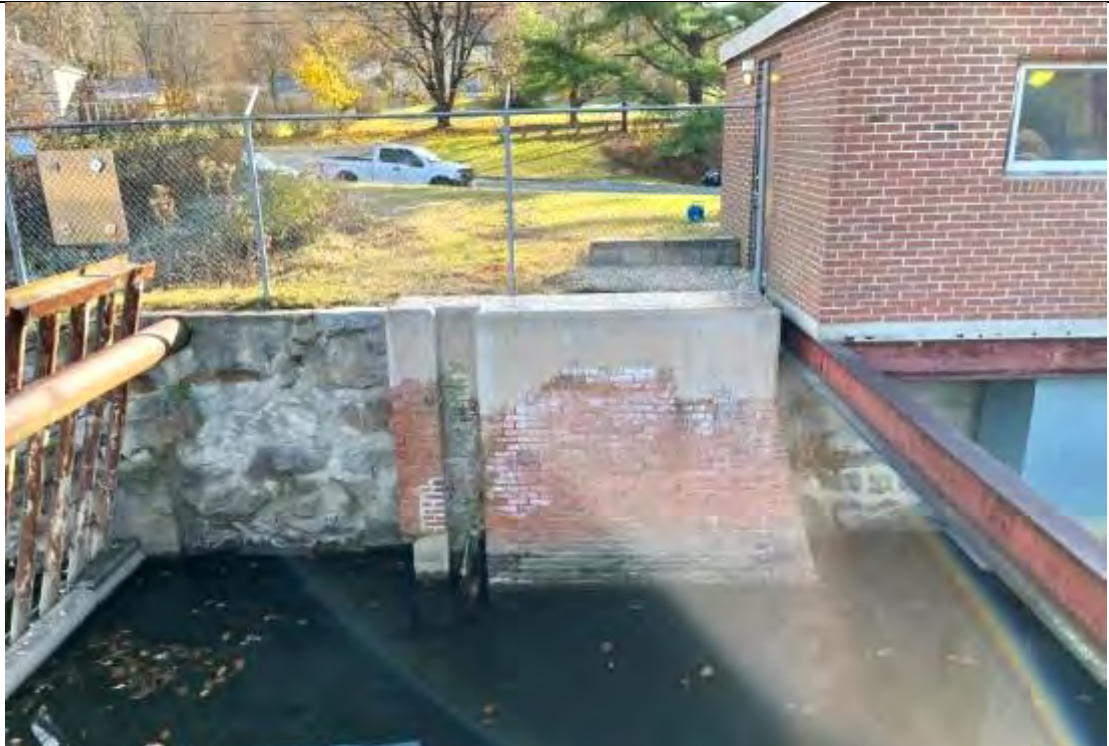
Direction Photo Taken: Left.			
Description: Left forebay training wall. Note recent concrete repair at previously deteriorated area of brick masonry. Repair observed to be in good condition.

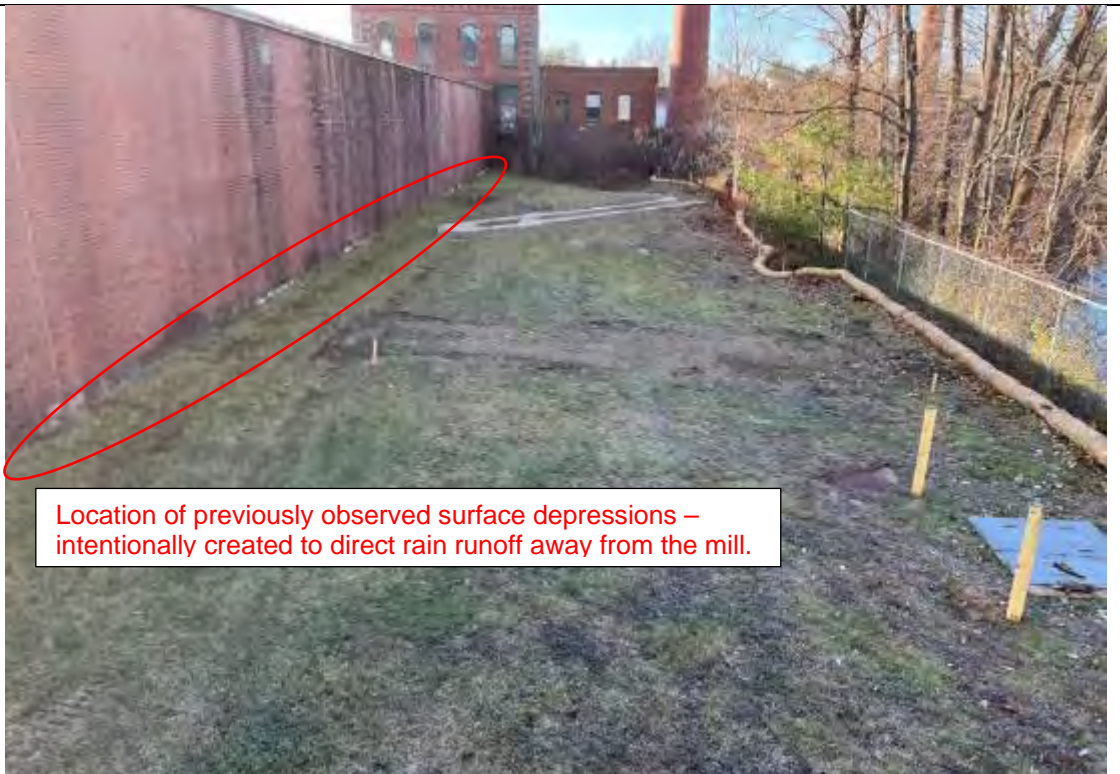
Direction Photo Taken: Downstream.		
Description: Grassy area above the buried penstock. Note areas of surficial disturbance due to ongoing penstock investigations. The previously observed surficial depressions along the mill building wall (to the left of the photo) were intentionally created by the mill owners to direct rain runoff away from the mill.

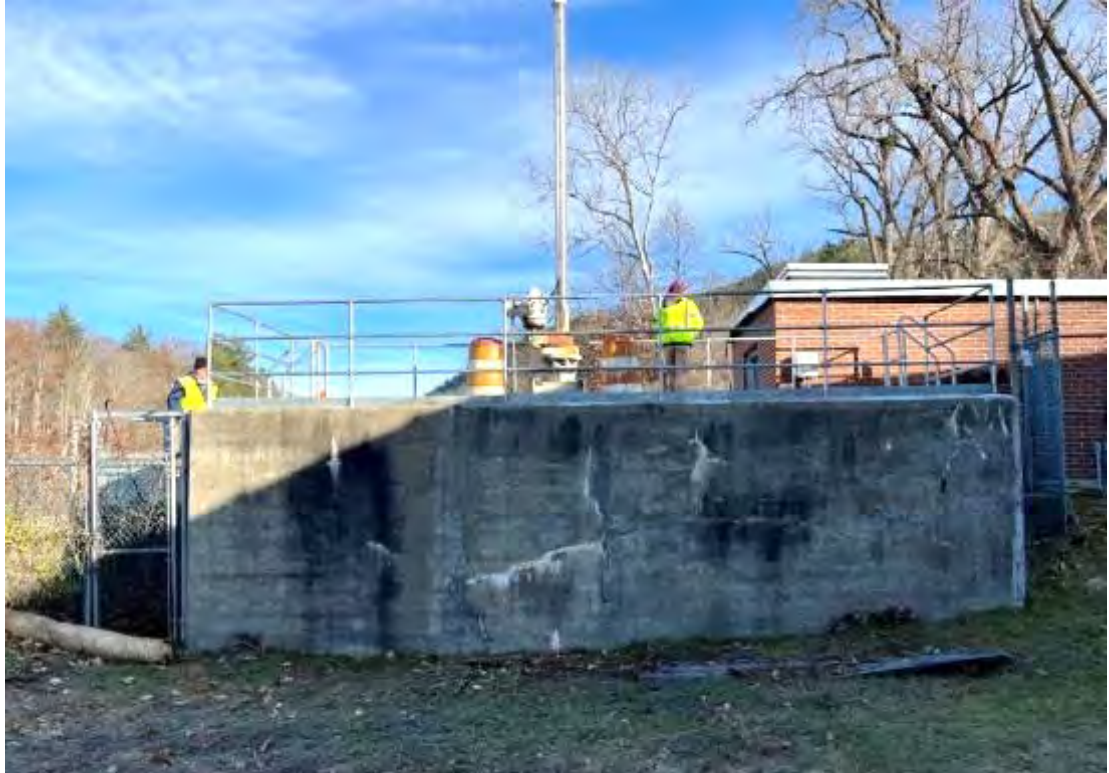
Direction Photo Taken: Upstream.			
Description: Downstream face of the gate platform structure. Note minor cracking and efflorescence.

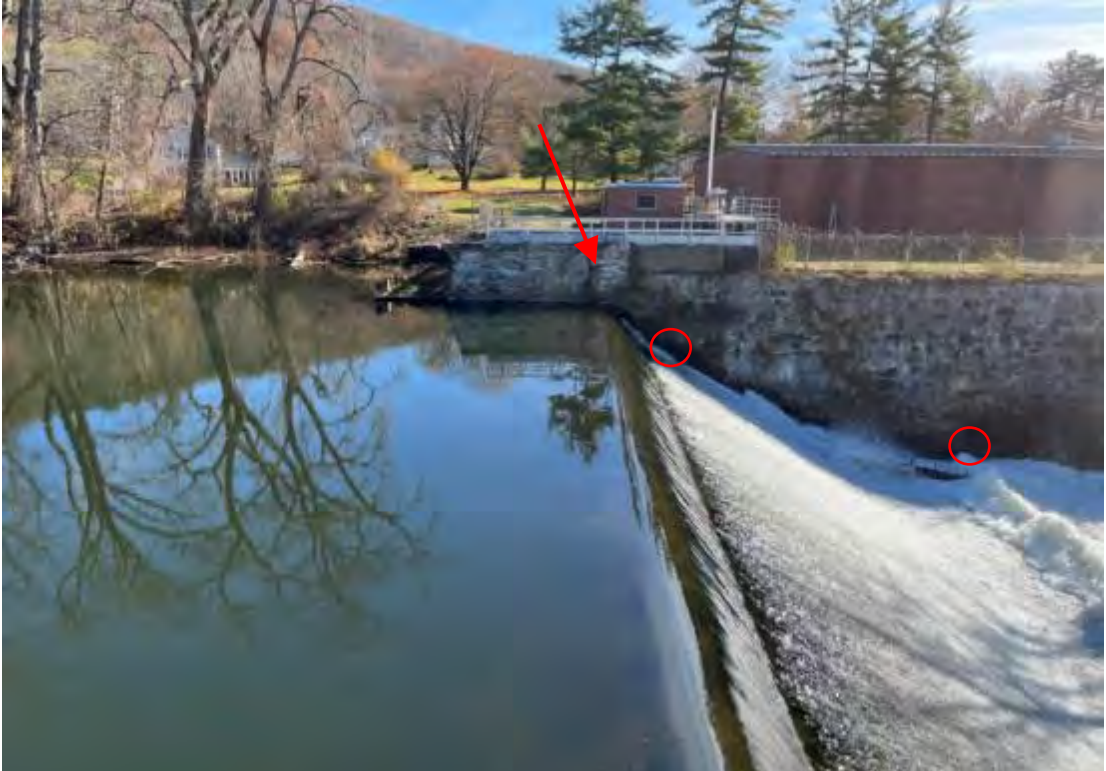
Direction Photo Taken: Left.			
Description: Overview of the spillway and left side of the Dam. Areas of apparent seepage through left training wall joints / weep holes noted with red circles. Seepage areas appeared similar to previous observations. Also note painted staff gage on the left training wall at the crest of the spillway. Staff gage numbering was faded.

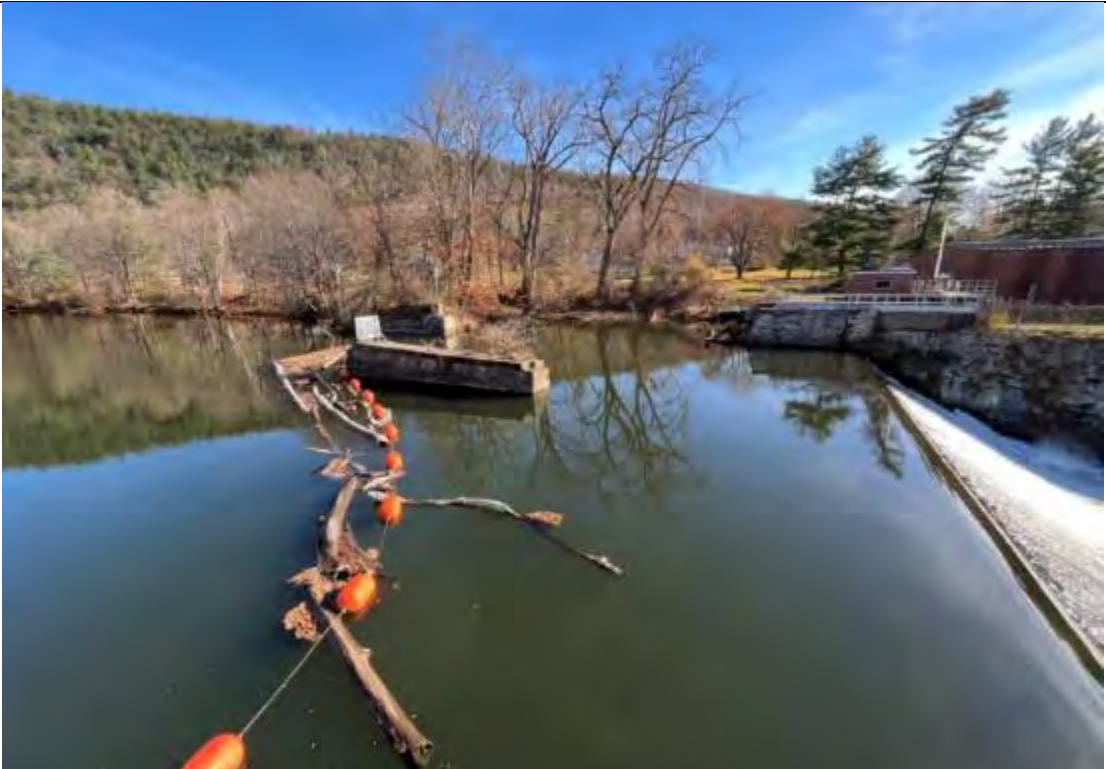
Direction Photo Taken: Left.			
Description: Safety buoys upstream of the Dam. Note debris caught in the buoy line.

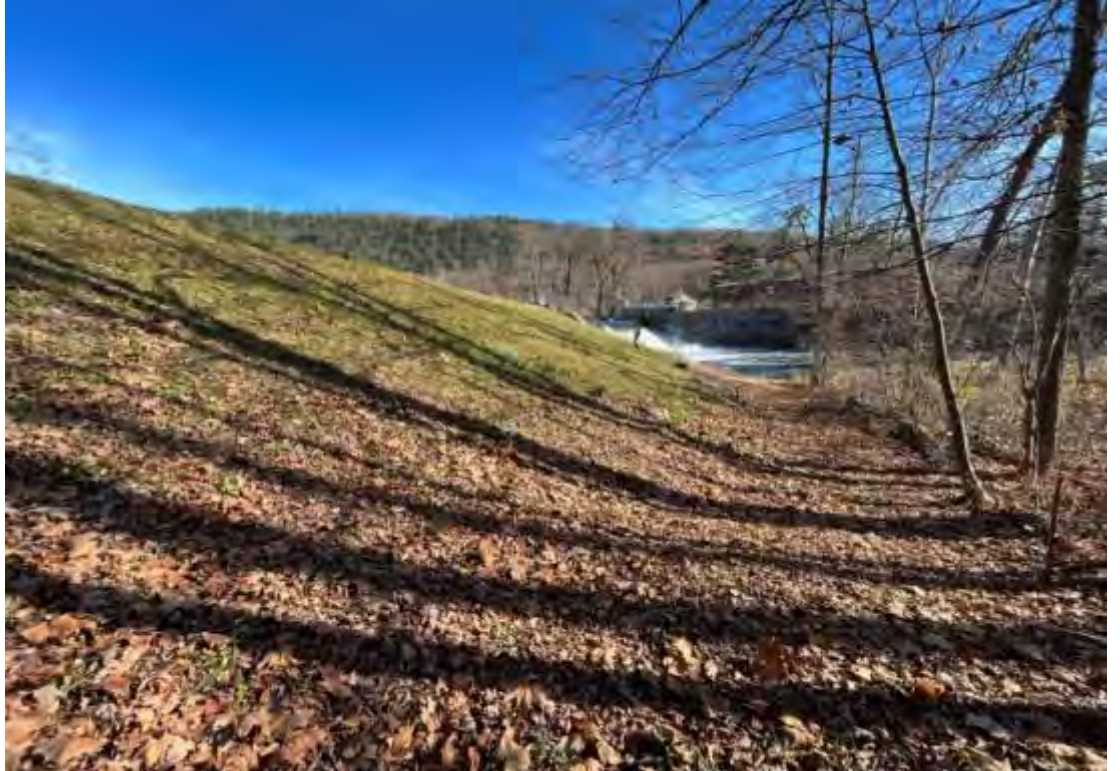
Direction Photo Taken: Left.			
Description: Downstream slope and toe of the right embankment.

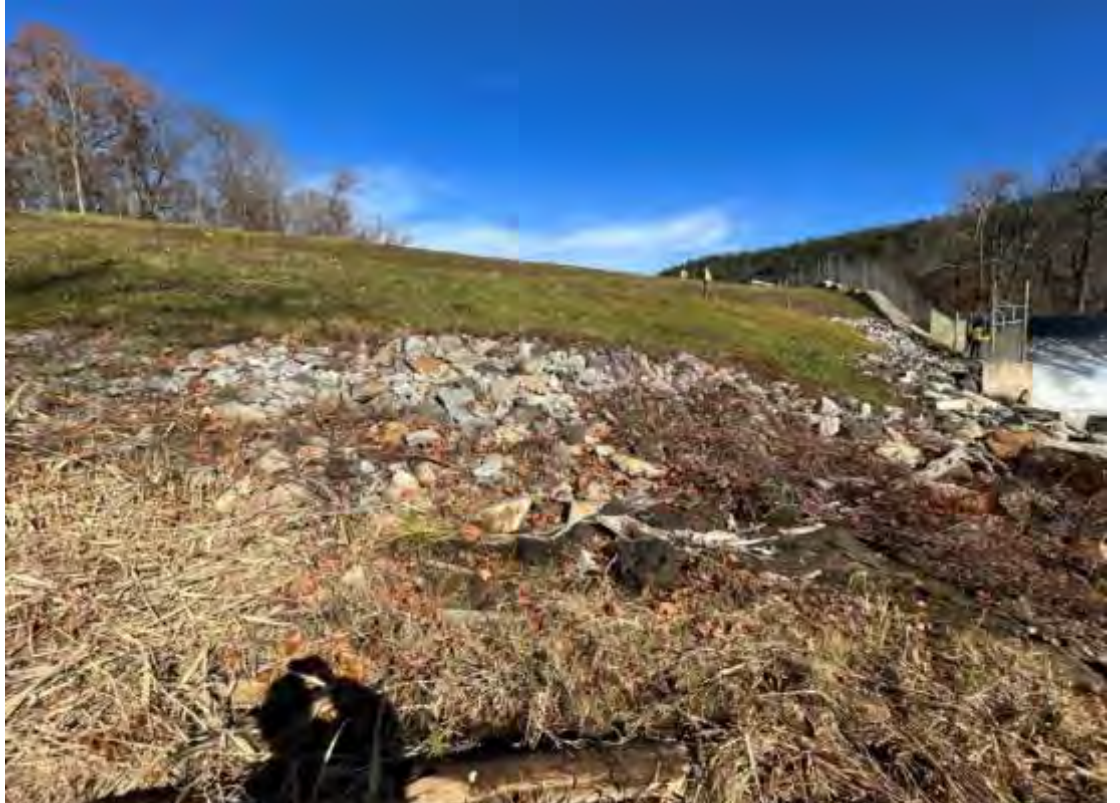
Direction Photo Taken: Upstream.			
Description: Previously identified (Q2 2020) and staked area of standing water and apparent erosion channel. Residual iron staining was not present at the time of this inspection. Standing water was observed downstream of the Dam. Standing water likely tied to fluctuations in tailwater (see Photo 32). Note recently cut vegetation on lower portion of riprap.

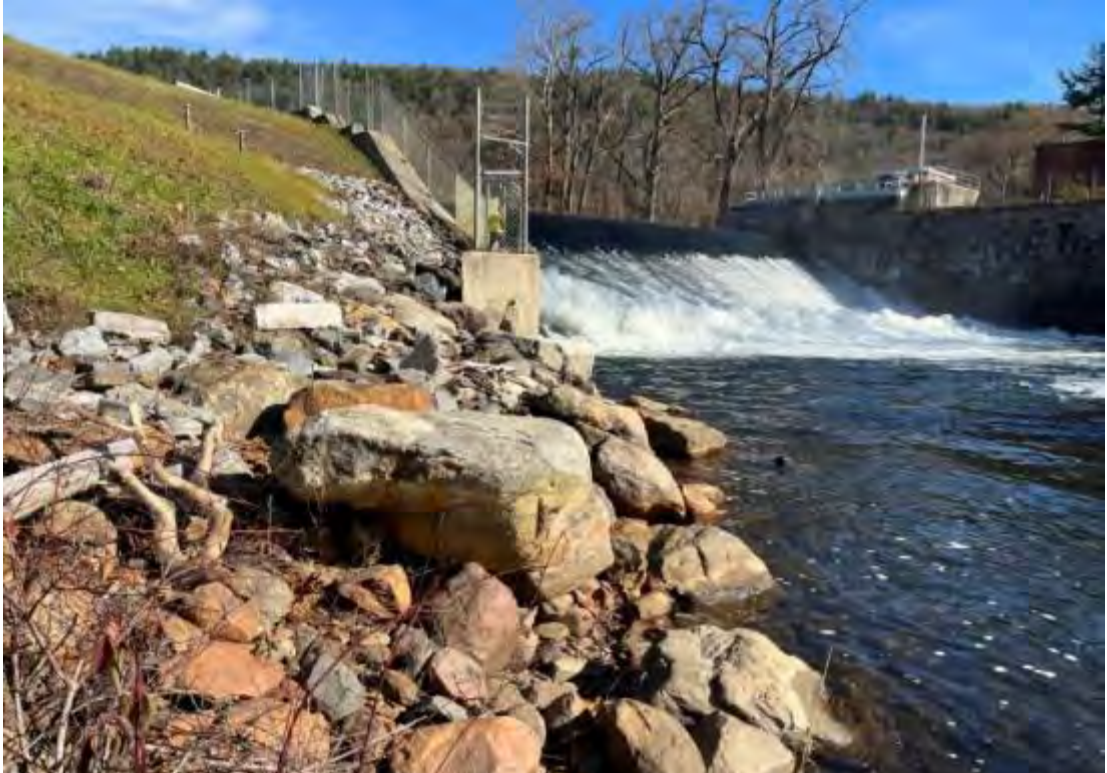
Direction Photo Taken: Upstream.			
Description: Downstream slope of the right embankment at the waterline. Riprap armoring appeared to be in good condition.

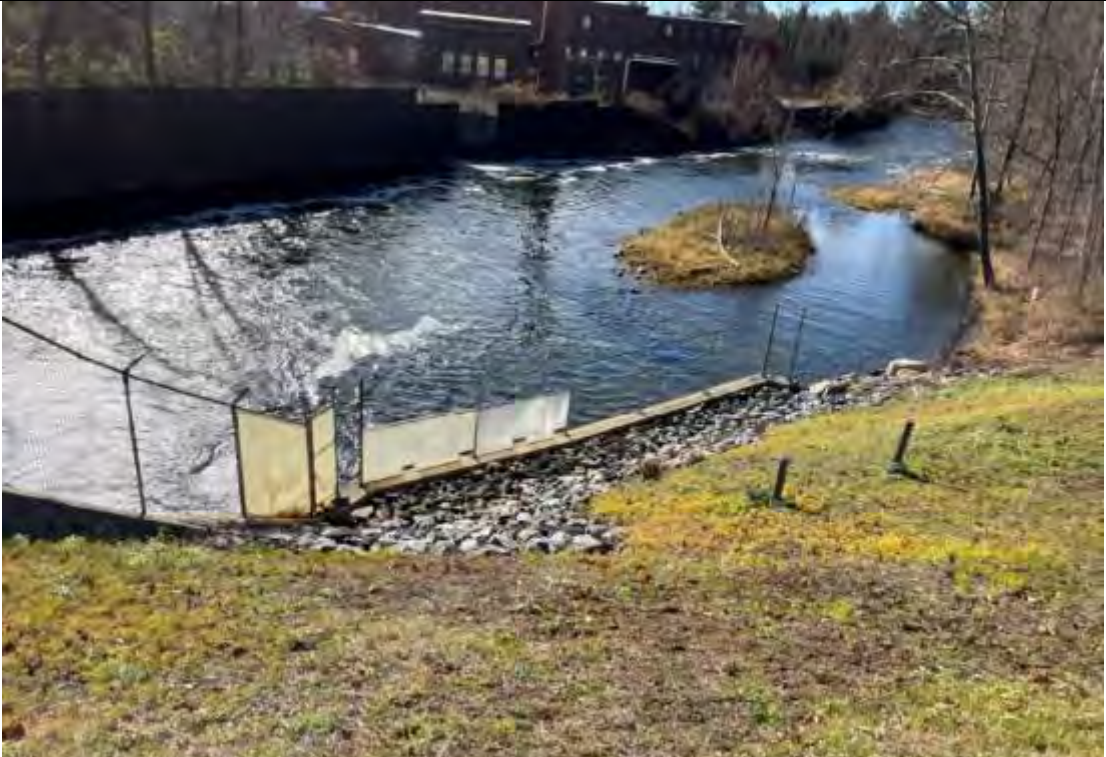
Direction Photo Taken: Downstream and left.			
Description: Embankment slope upstream of the right spillway training wall. riprap.

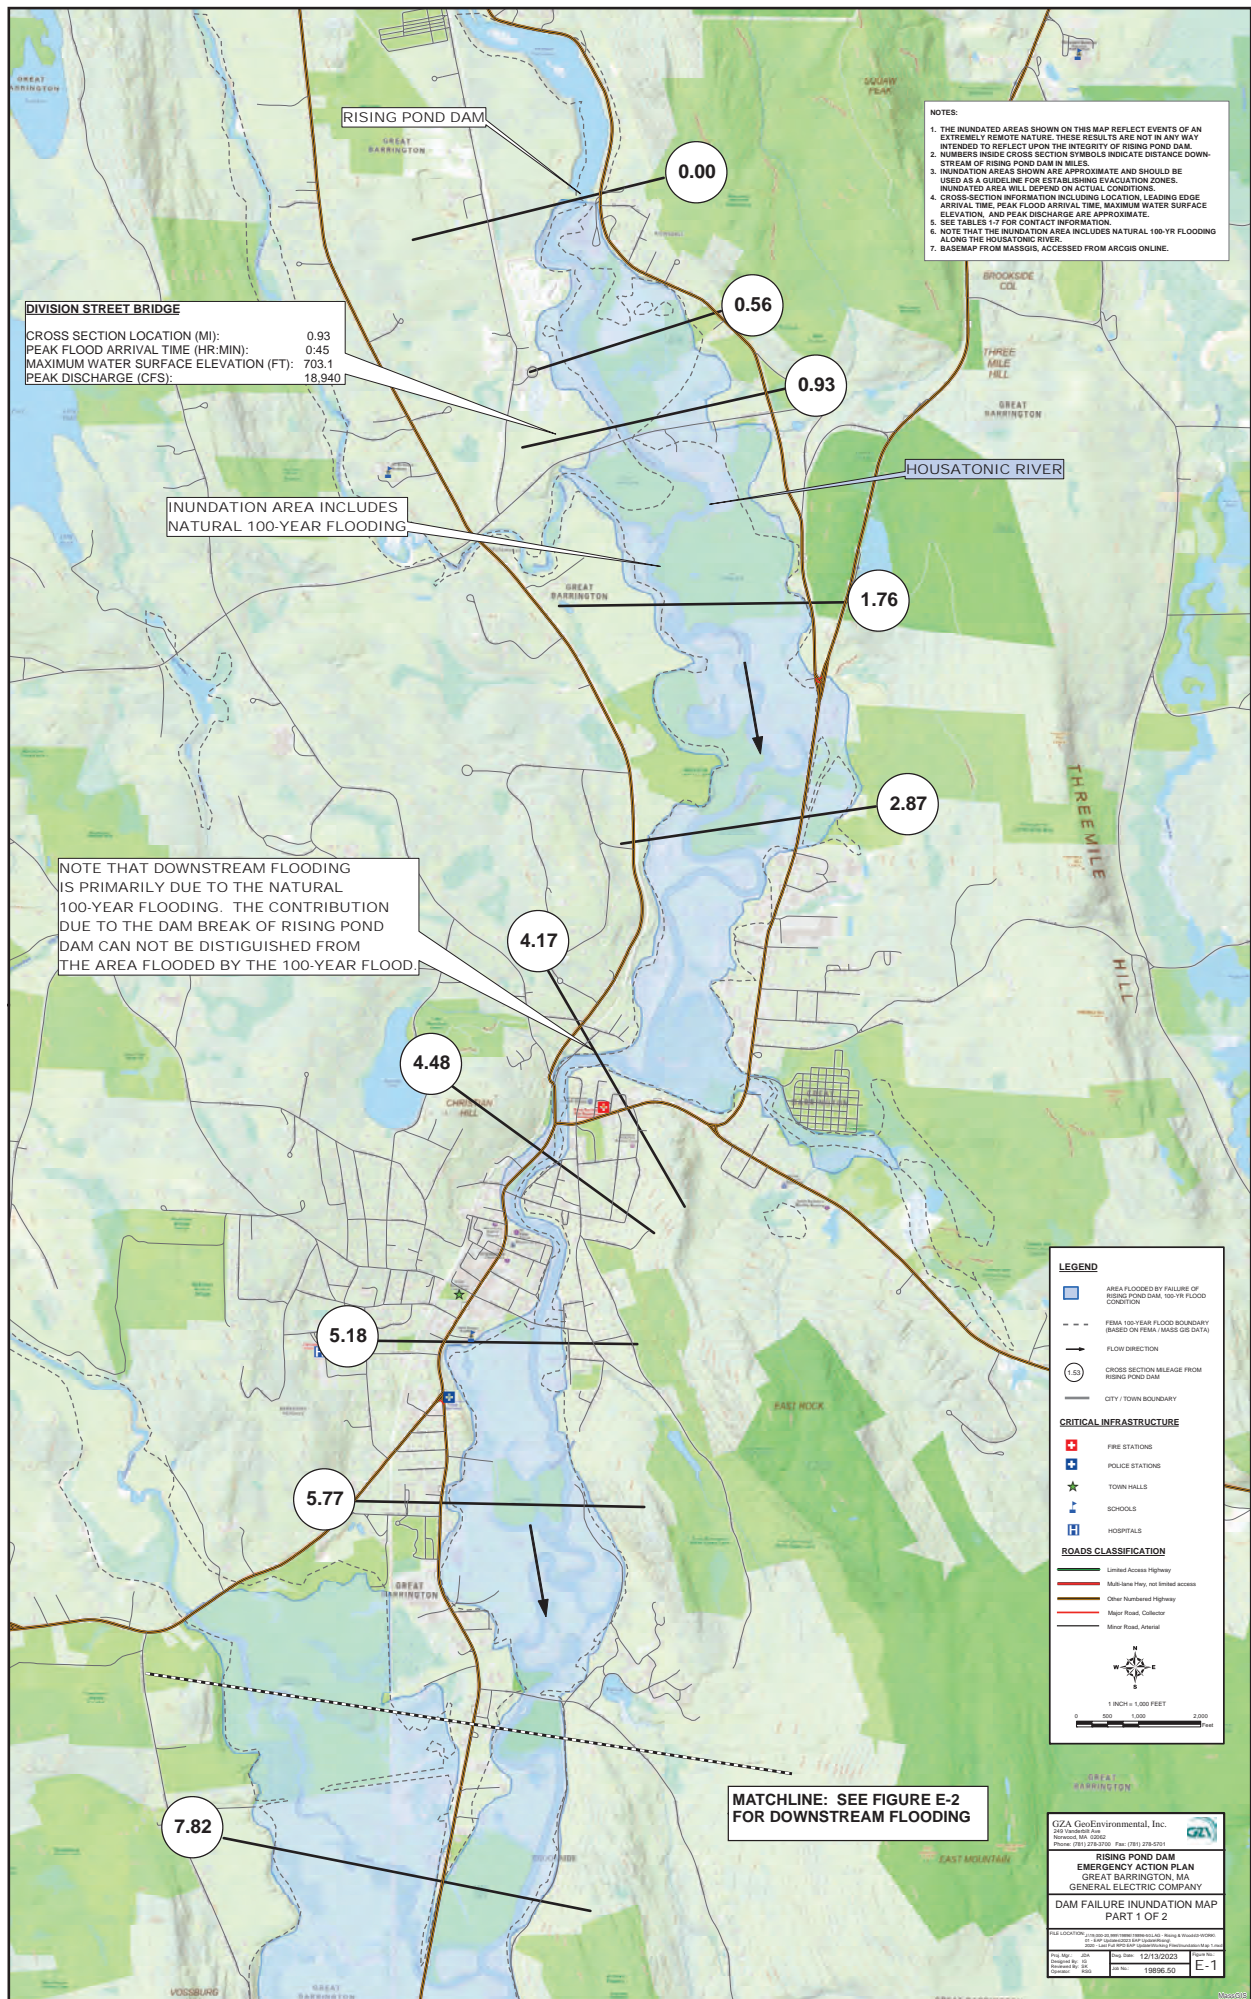
SCALE: 1" = 20'	DWN. BY: DAW	CHK. BY: SAM
DATE: October 7, 2020	DWG. NO. RPD SURVEY WITH	MONITORING POINTS
JOB NO. S3013A	Layout Tab:	W01

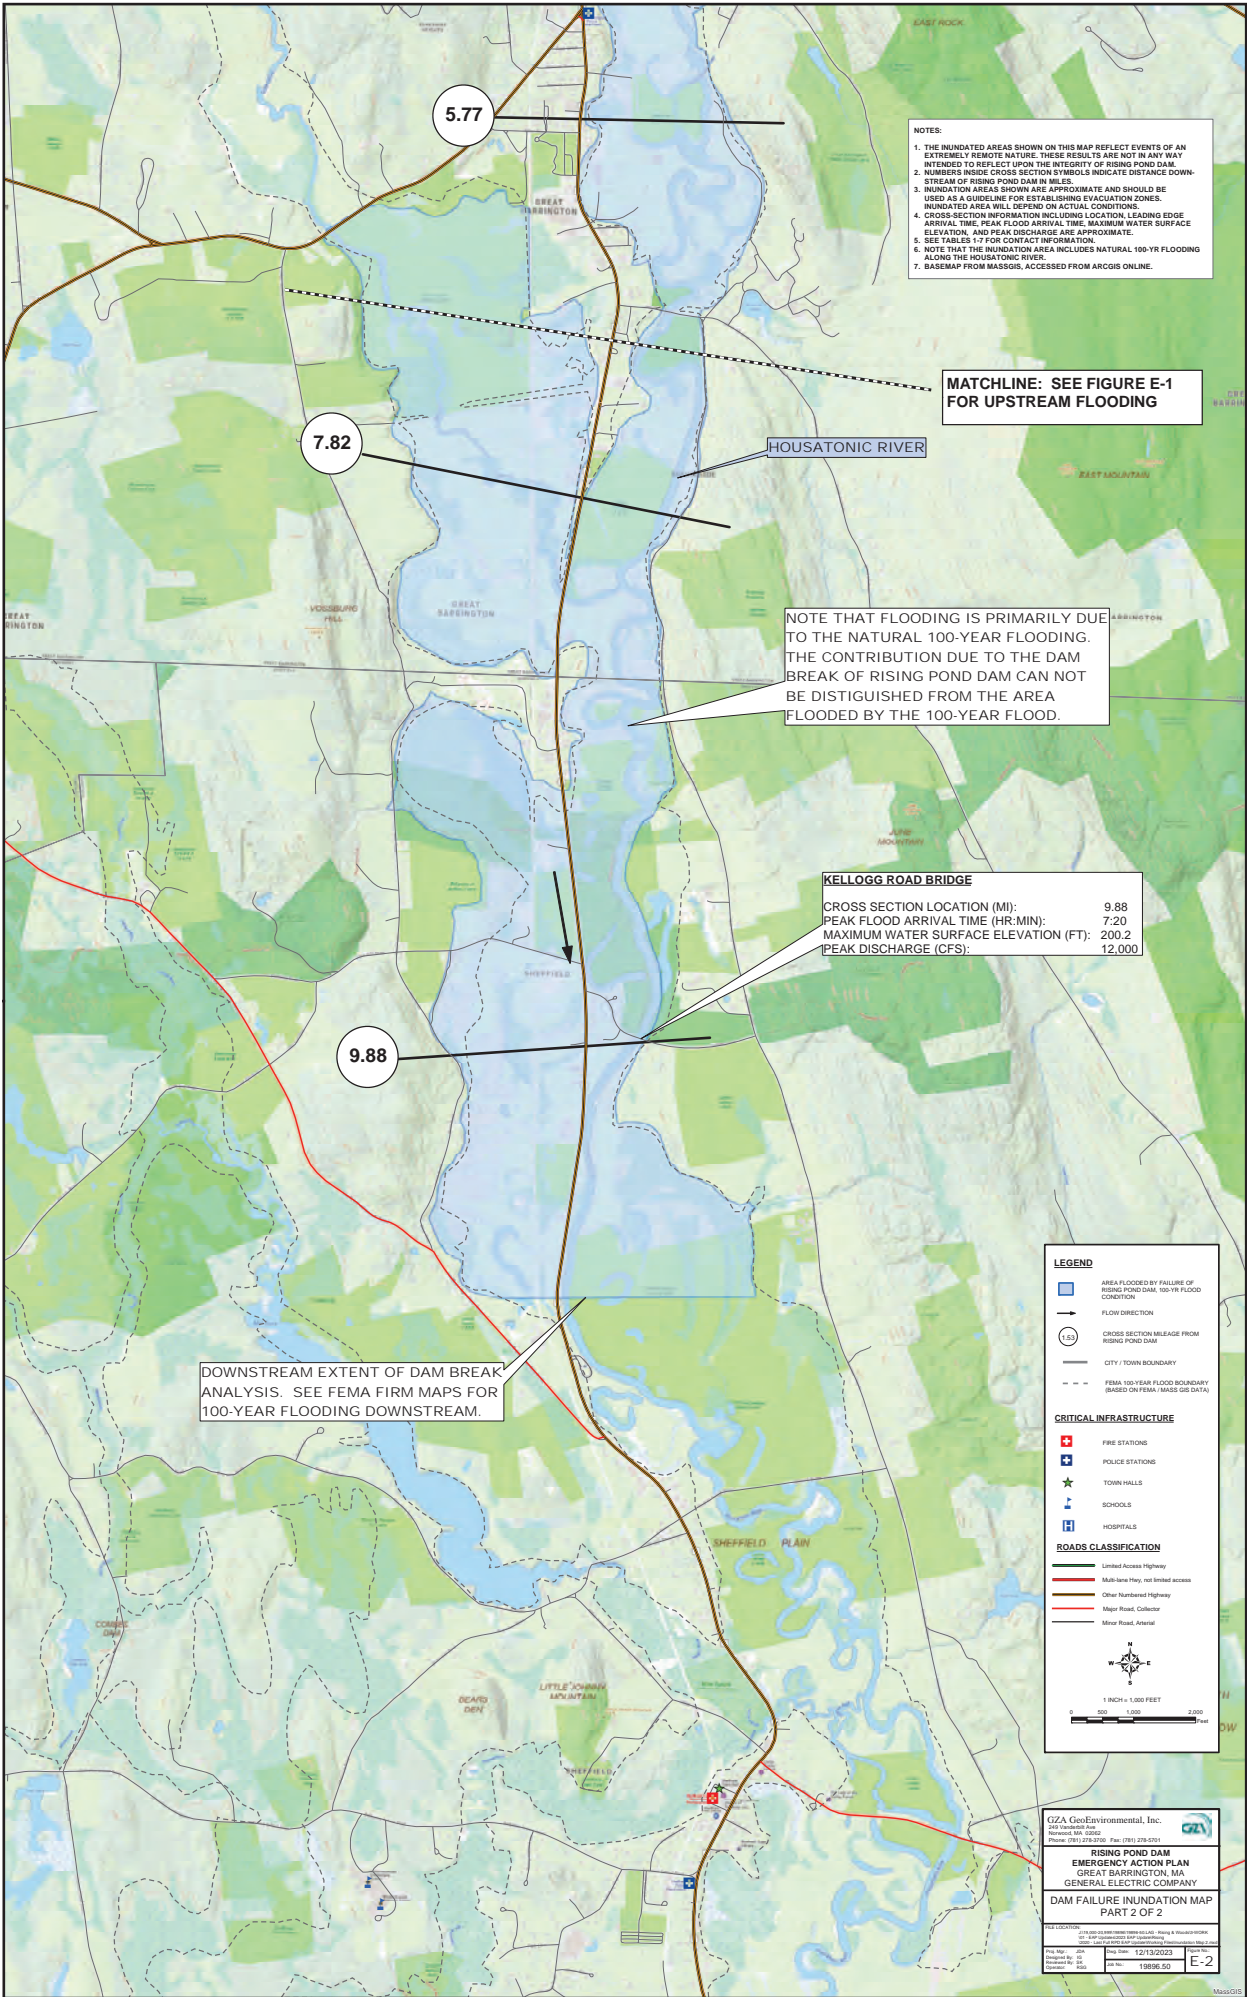
FIG. NO. 100-01 Date: 12/13/2023
 Project No. 19886-50 E-1
