Kevin Mooney
Senior Project Manager
Global Operations - Environment, Health & Safety

General Electric Company
1 Plastics Ave.
Pittsfield, MA 01201

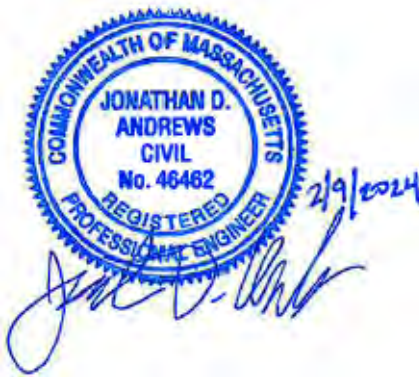
Jonathan D. Andrews, P.E.

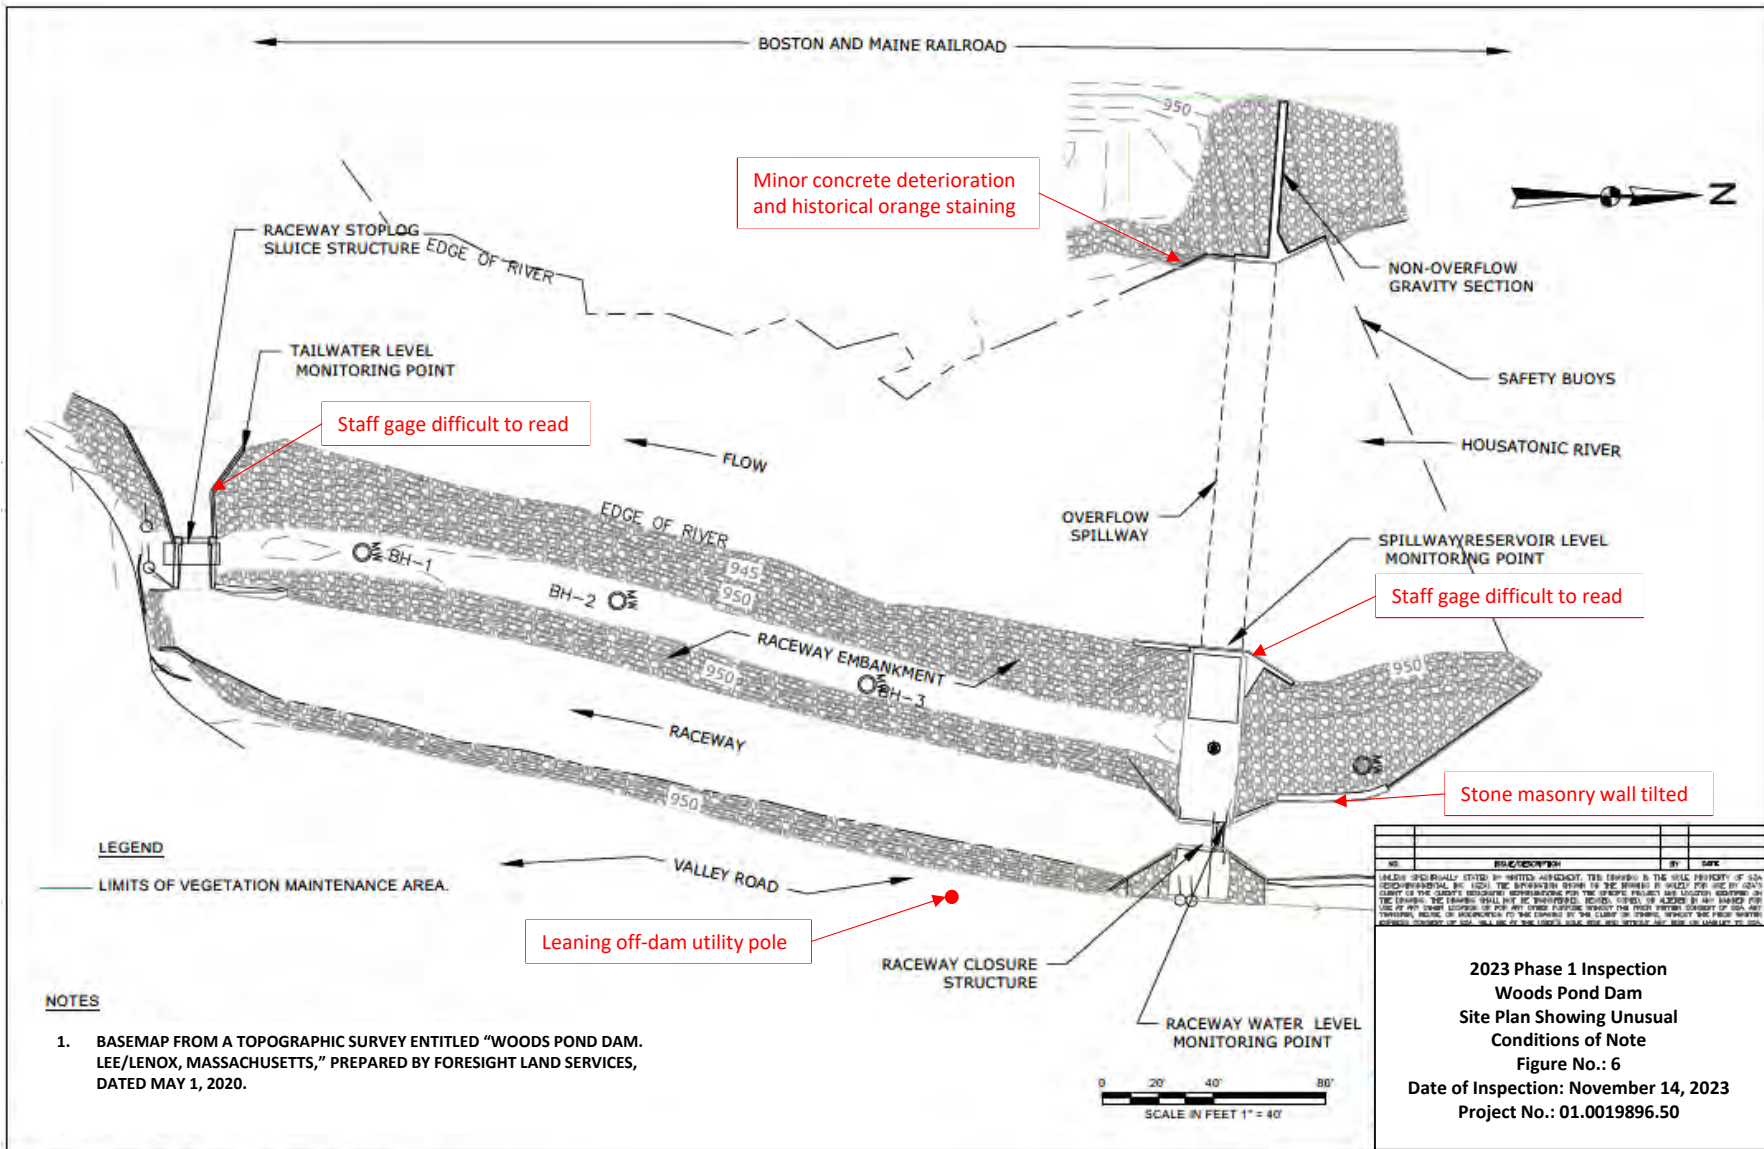
Minor concrete deterioration and historical orange staining

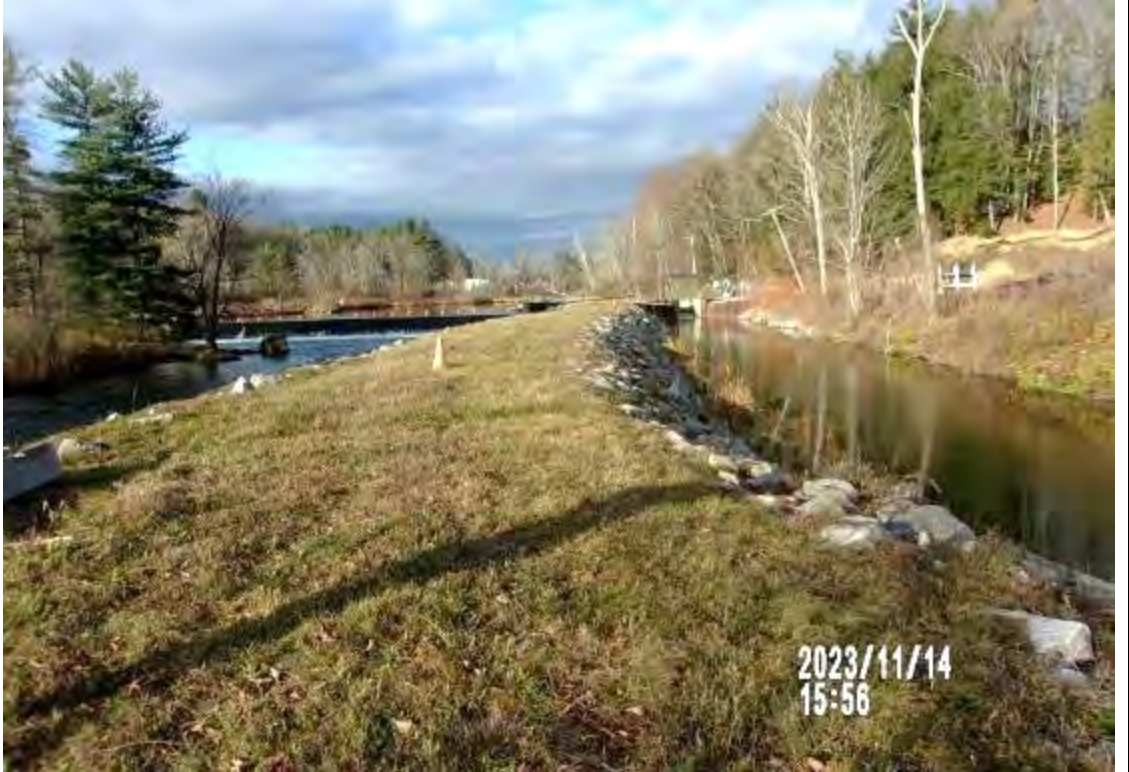
<p>2023/11/14 15:56</p>	
Direction Photo Taken: Upstream			
Description: Overview of Woods Pond Dam and raceway embankment from near downstream stoplog sluice structure. Slight unevenness of the top of embankment (crest) was observed.

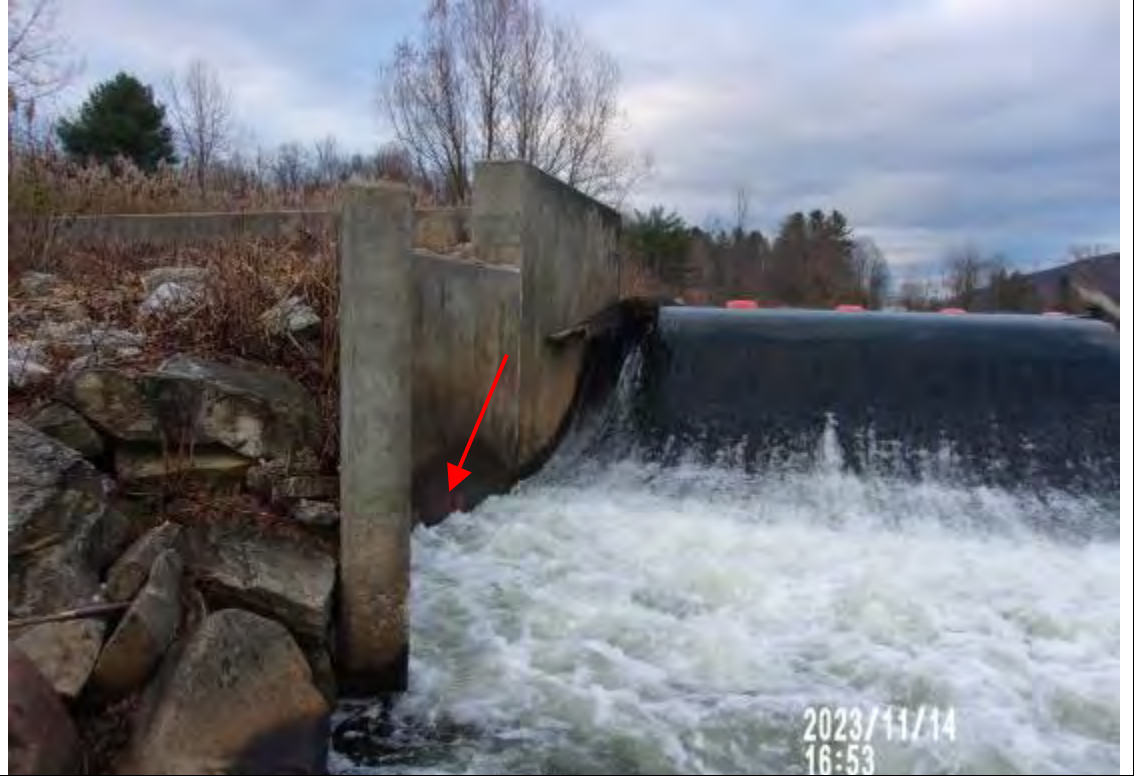
Photo No. 14	Date: 11/14/2023
------------------------	----------------------------

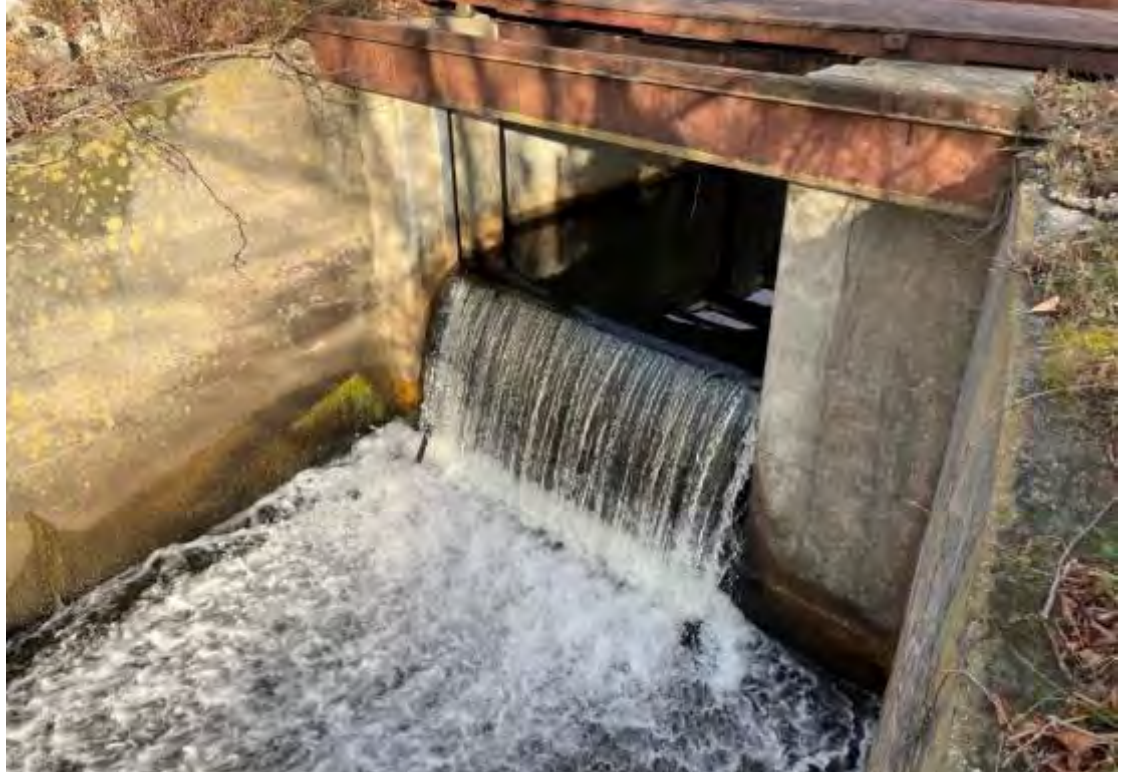
Direction Photo Taken: Upstream and Left			
Description: Downstream raceway stoplog sluice structure (downstream control).

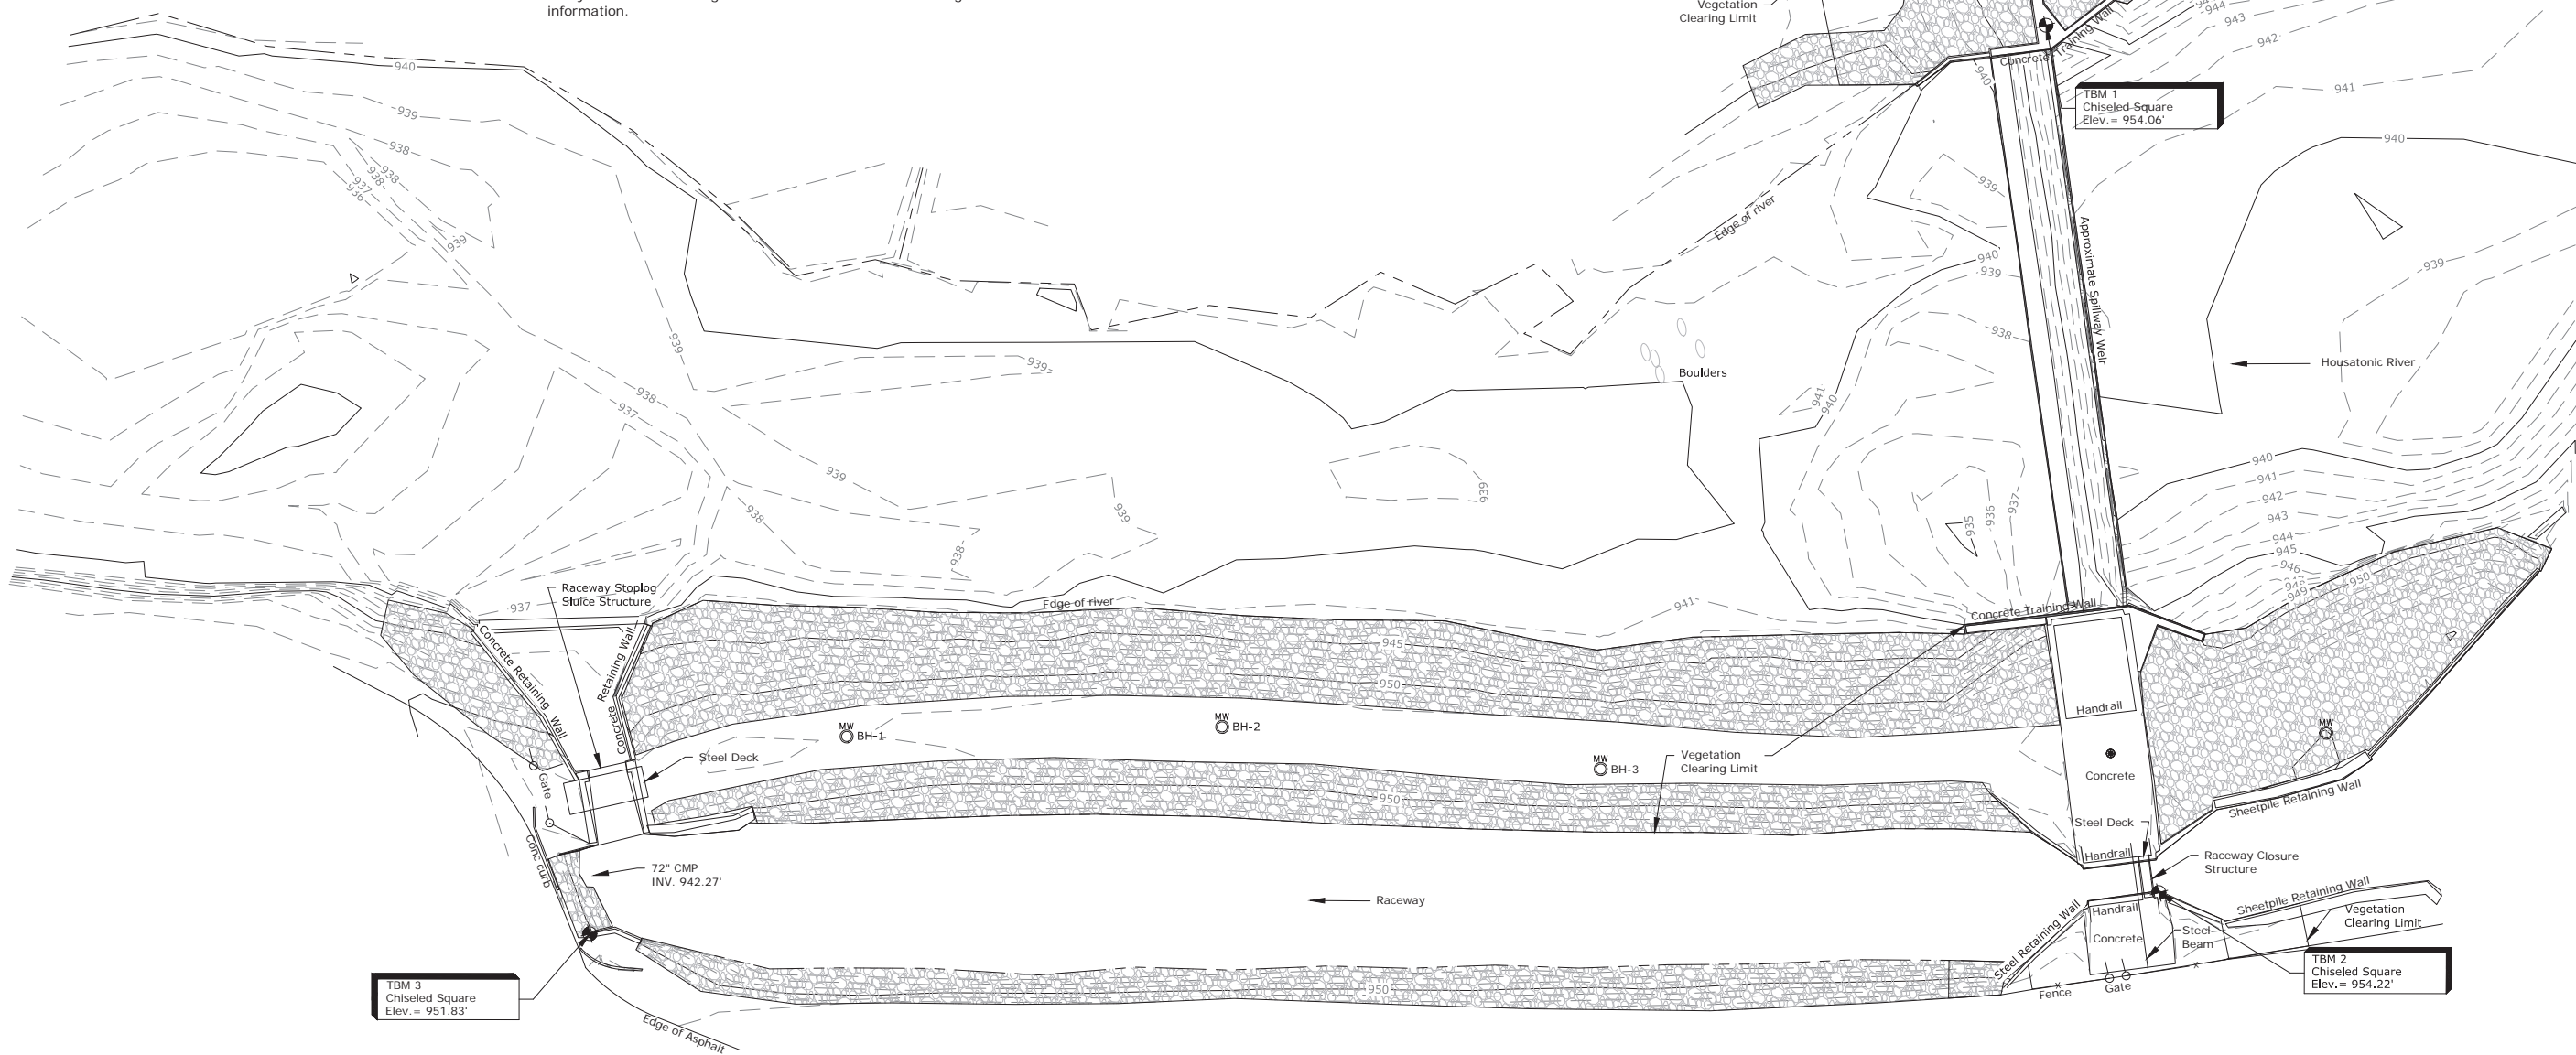
VICINITY MAP APPROXIMATE SCALE 1"=500'

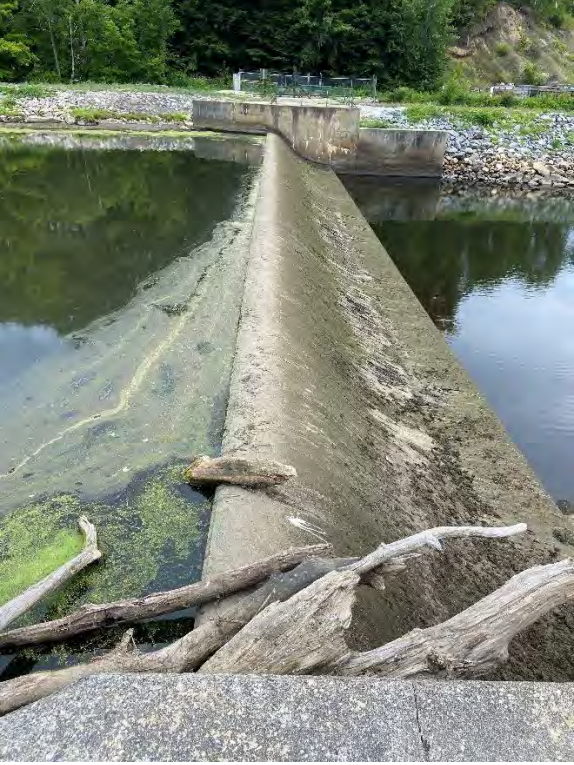
Direction Photo Taken: From right abutment of spillway, looking left.				
Description: Overview of spillway crest. Note logs on spillway crest are monitored during quarterly and biennial inspections.

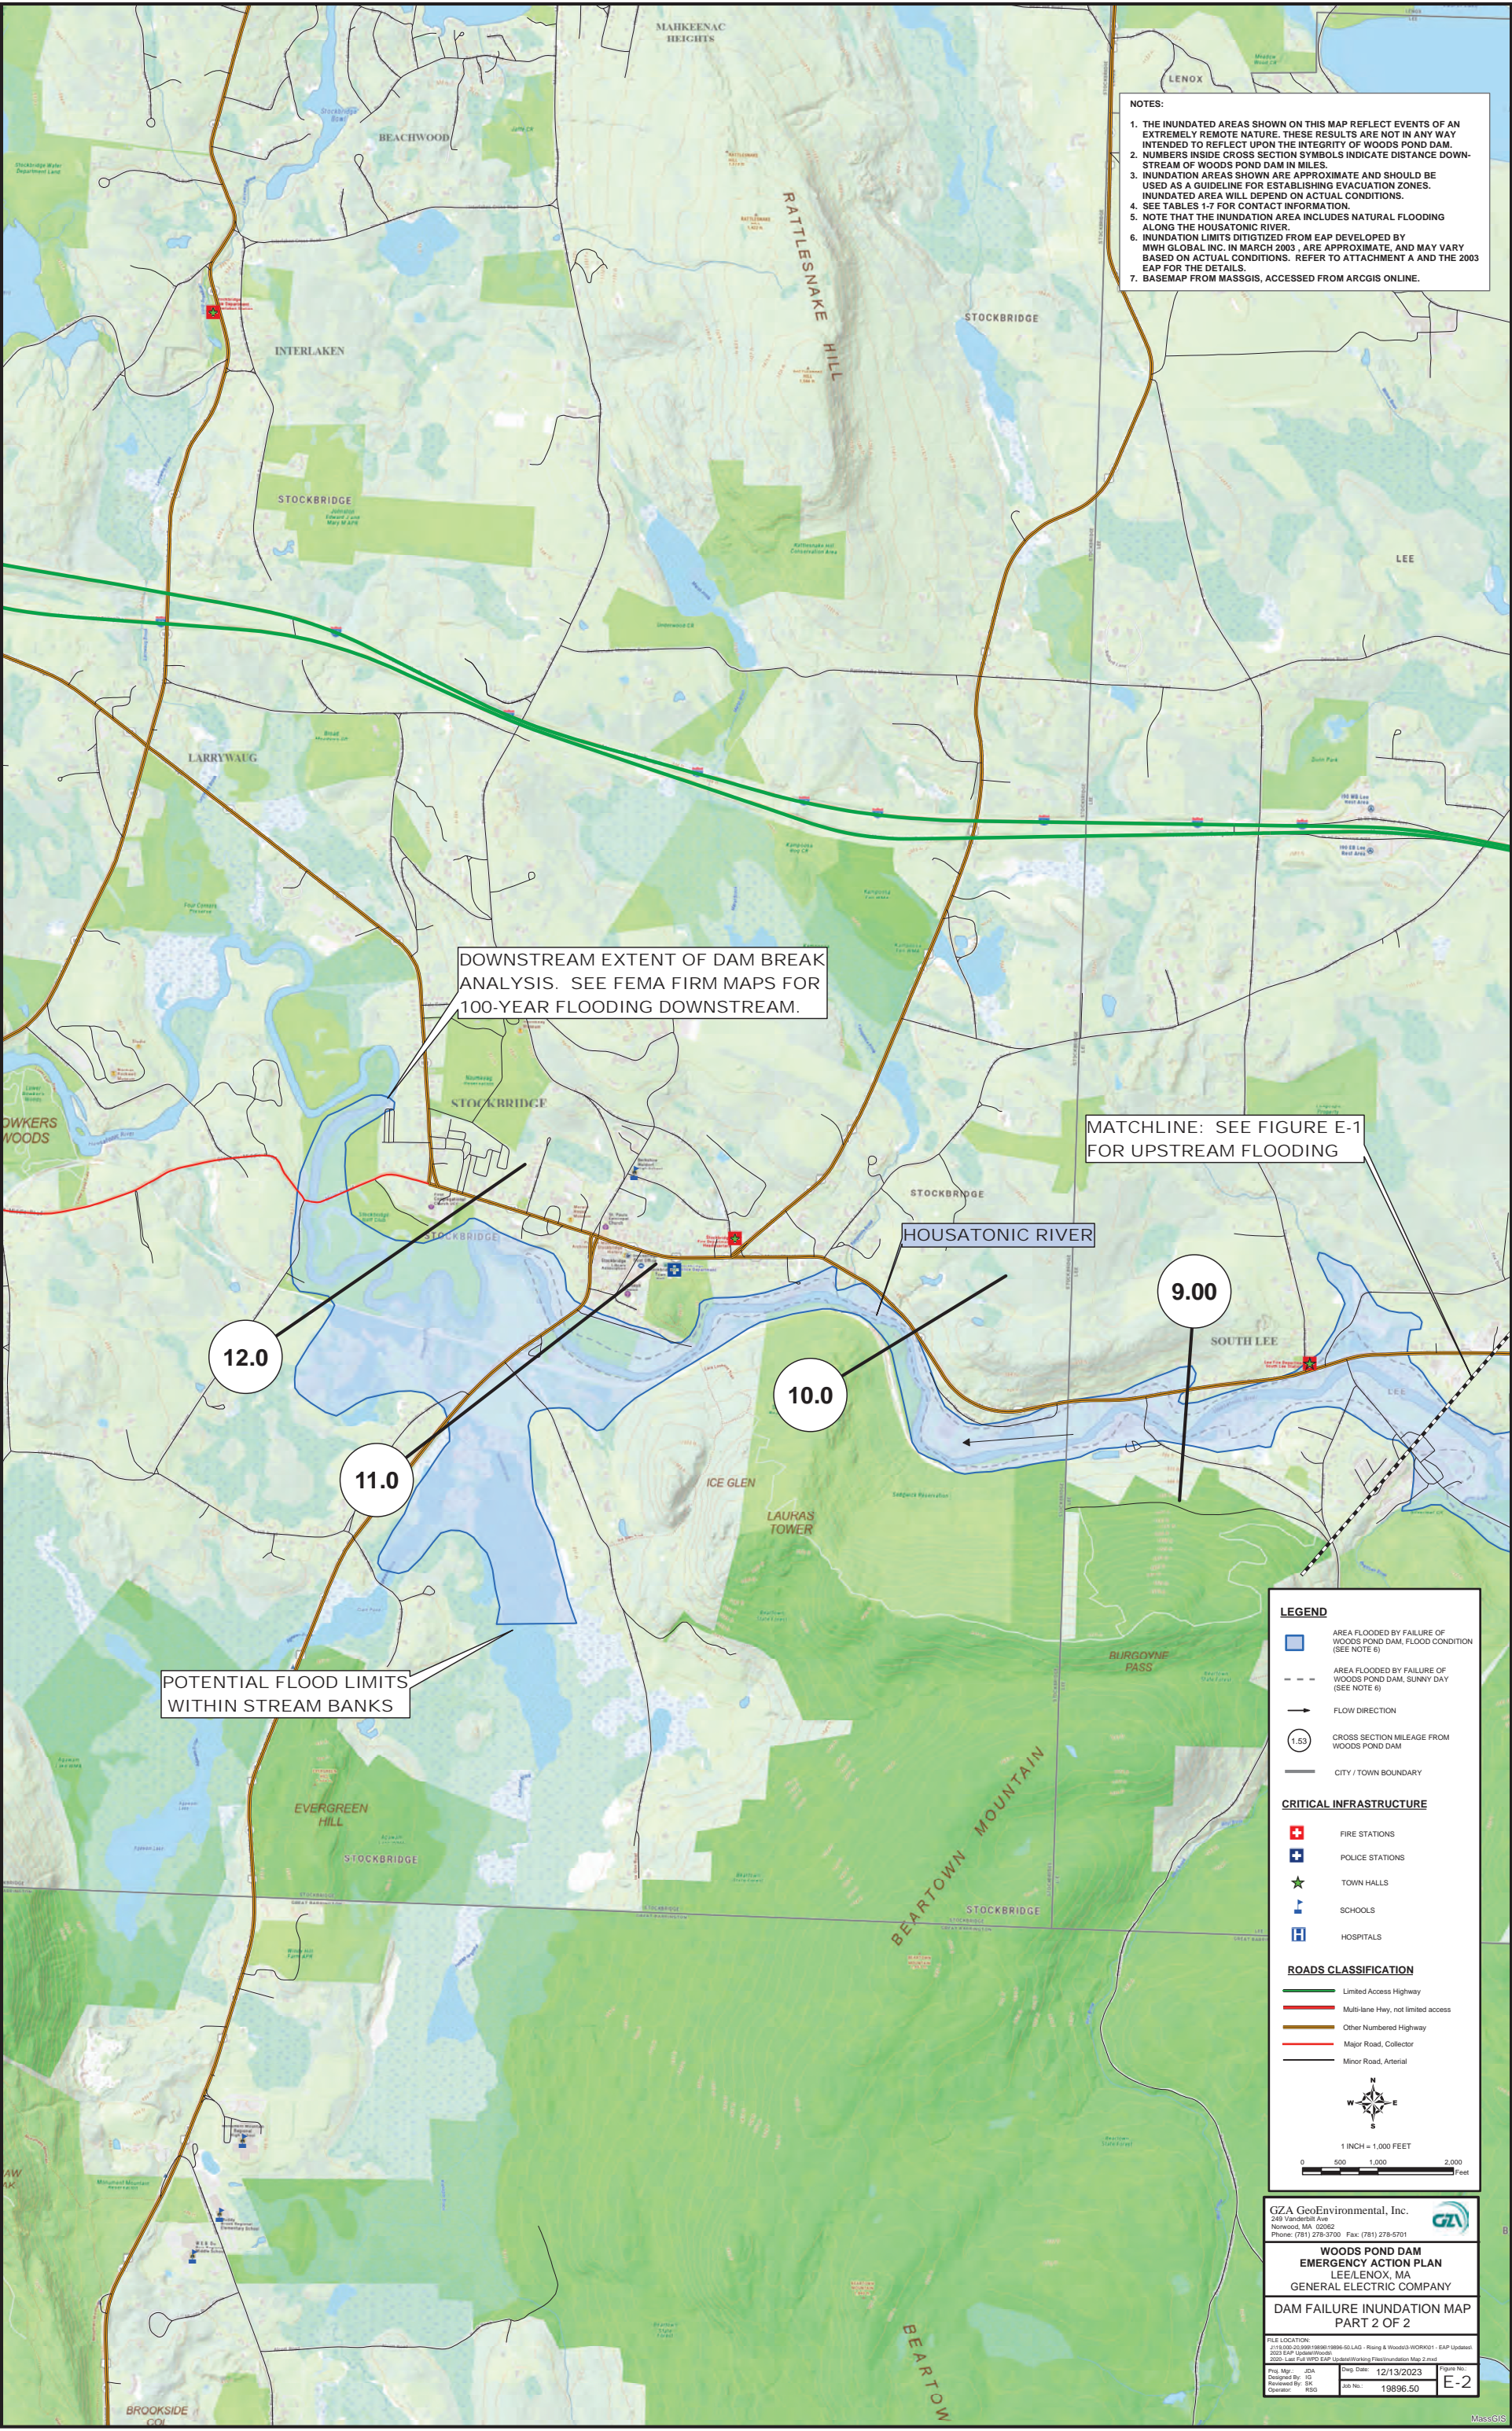
- NOTES:**
1. THE INUNDATED AREAS SHOWN ON THIS MAP REFLECT EVENTS OF AN EXTREMELY REMOTE NATURE. THESE RESULTS ARE NOT IN ANY WAY INTENDED TO REFLECT UPON THE INTEGRITY OF WOODS POND DAM.
 2. NUMBERS INSIDE CROSS SECTION SYMBOLS INDICATE DISTANCE DOWNSTREAM OF WOODS POND DAM IN MILES.
 3. INUNDATION AREAS SHOWN ARE APPROXIMATE AND SHOULD BE USED AS A GUIDELINE FOR ESTABLISHING EVACUATION ZONES. INUNDATED AREA WILL DEPEND ON ACTUAL CONDITIONS.
 4. SEE TABLES 1-7 FOR CONTACT INFORMATION.
 5. NOTE THAT THE INUNDATION AREA INCLUDES NATURAL FLOODING ALONG THE HOUSATONIC RIVER.
 6. INUNDATION LIMITS DIGITIZED FROM EAP DEVELOPED BY MWH GLOBAL INC. IN MARCH 2003, ARE APPROXIMATE, AND MAY VARY BASED ON ACTUAL CONDITIONS. REFER TO ATTACHMENT A AND THE 2003 EAP FOR THE DETAILS.
 7. BASEMAP FROM MASSGIS, ACCESSED FROM ARCGIS ONLINE.
