UNITED STATES ENVIRONMENTAL PROTECTION AGENCY

Memorandum

SUBJ: 10/16/2024 inspection of Upper Harbor sediment caps, NBHSS

FROM: David Dickerson, Remedial Project Manager

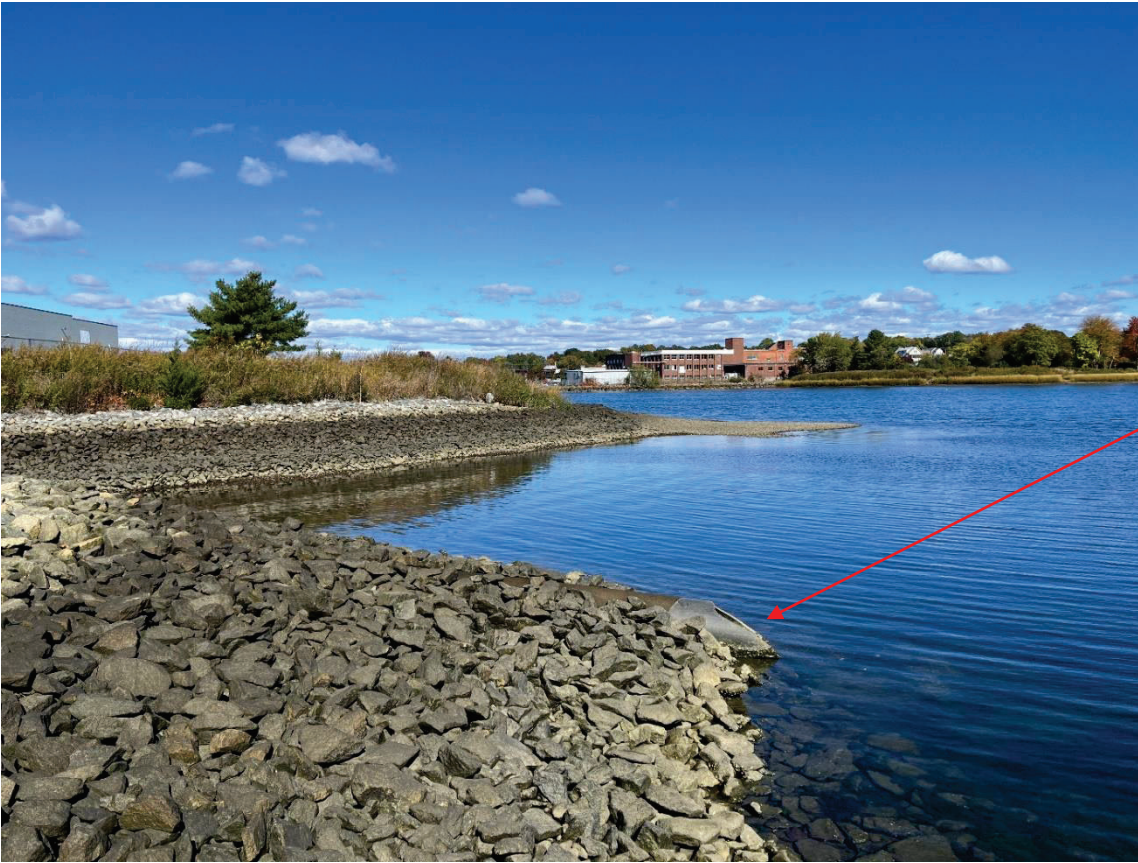
Figure 2:
Aerovox Cap:
Looking north
showing the
northern area of
the cap. In the
foreground is the
North Trench
storm drain outlet
at the toe of
slope.

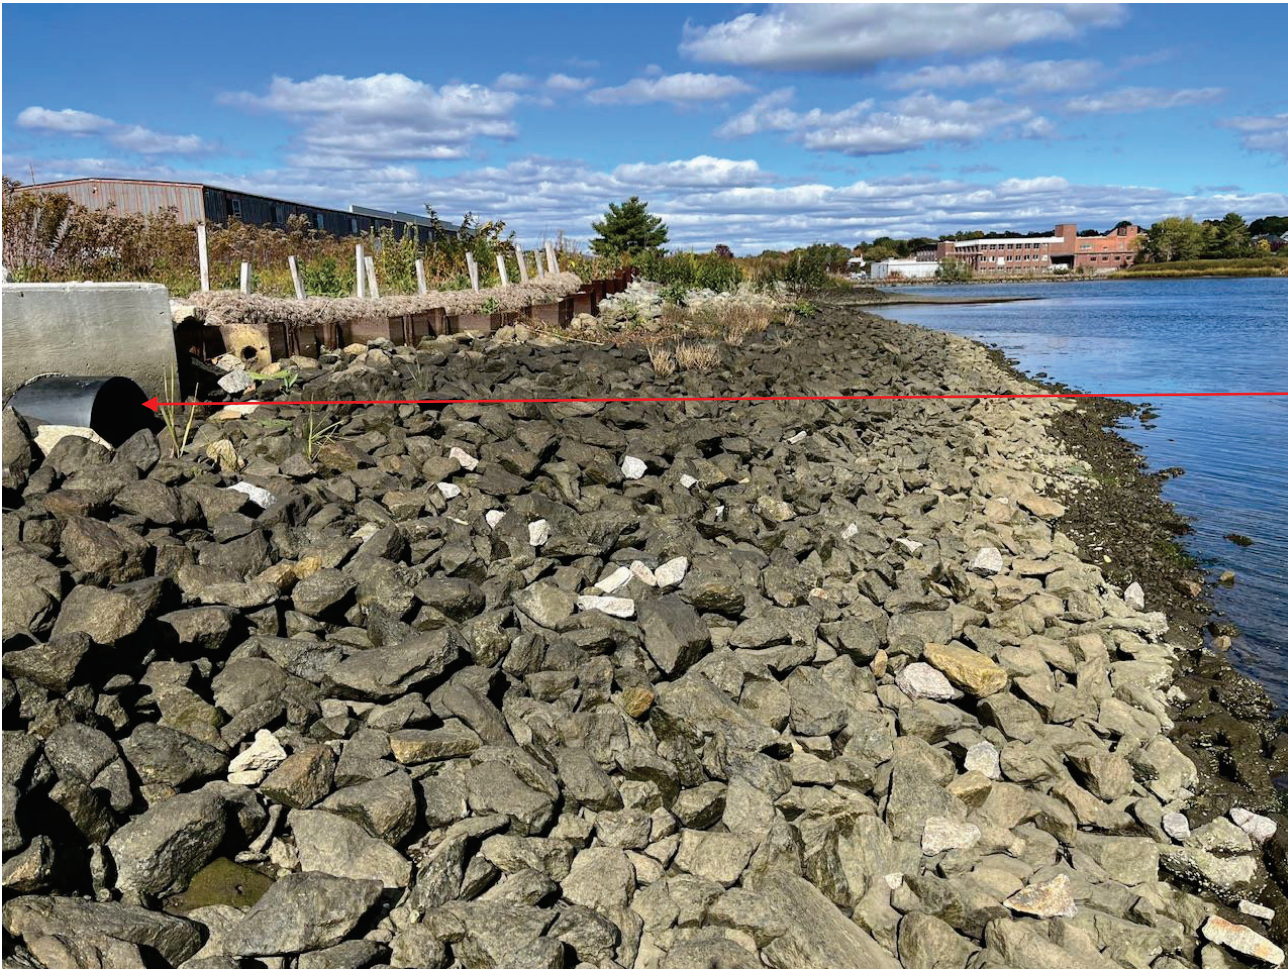
Figure 3:
**Aerovox
Cap:**
Looking
north
showing
the South
Trench
storm drain
outlet.

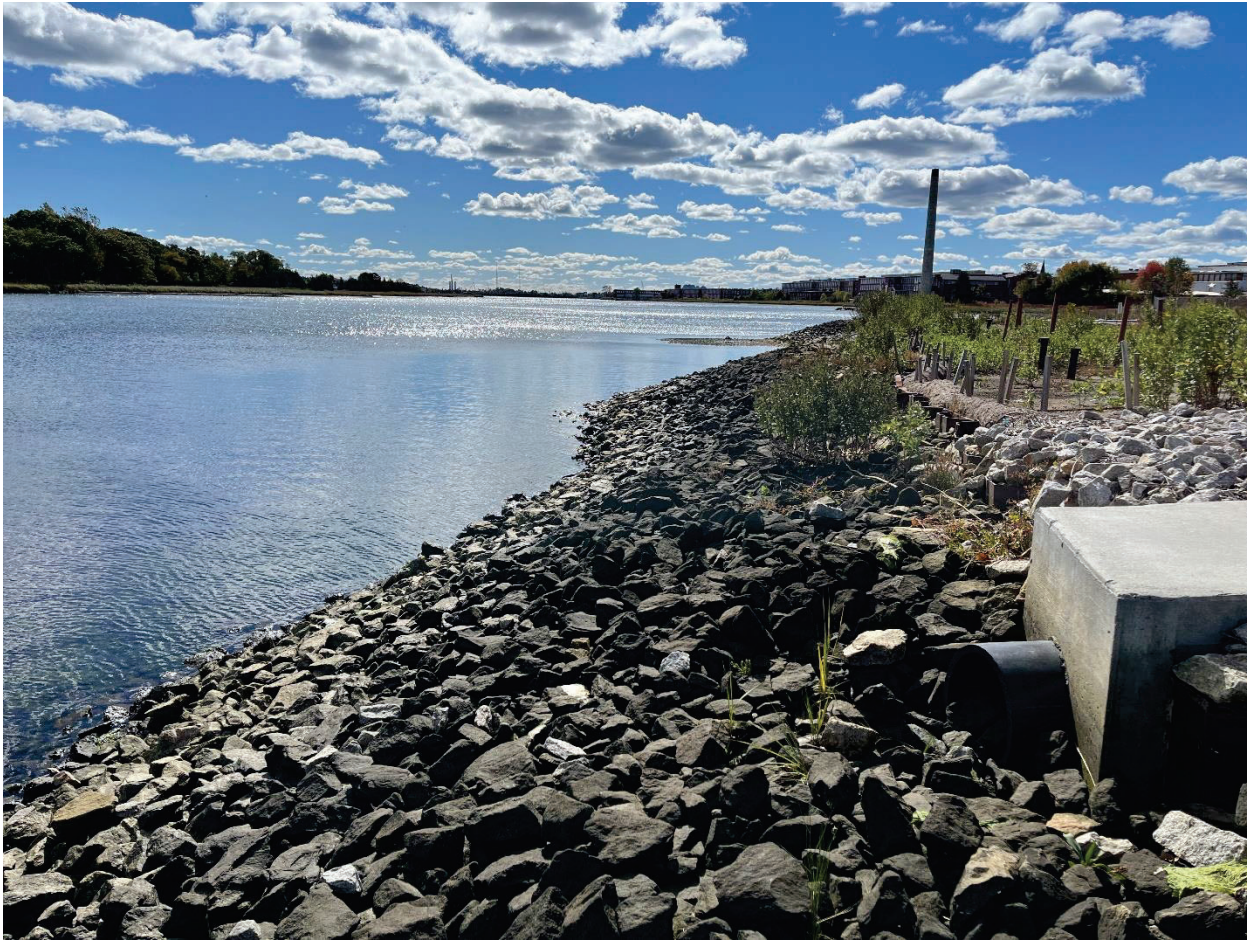
Figure 4:
Aerovox Cap:
Looking south
showing the
South Trench
storm drain
outlet in the
foreground.

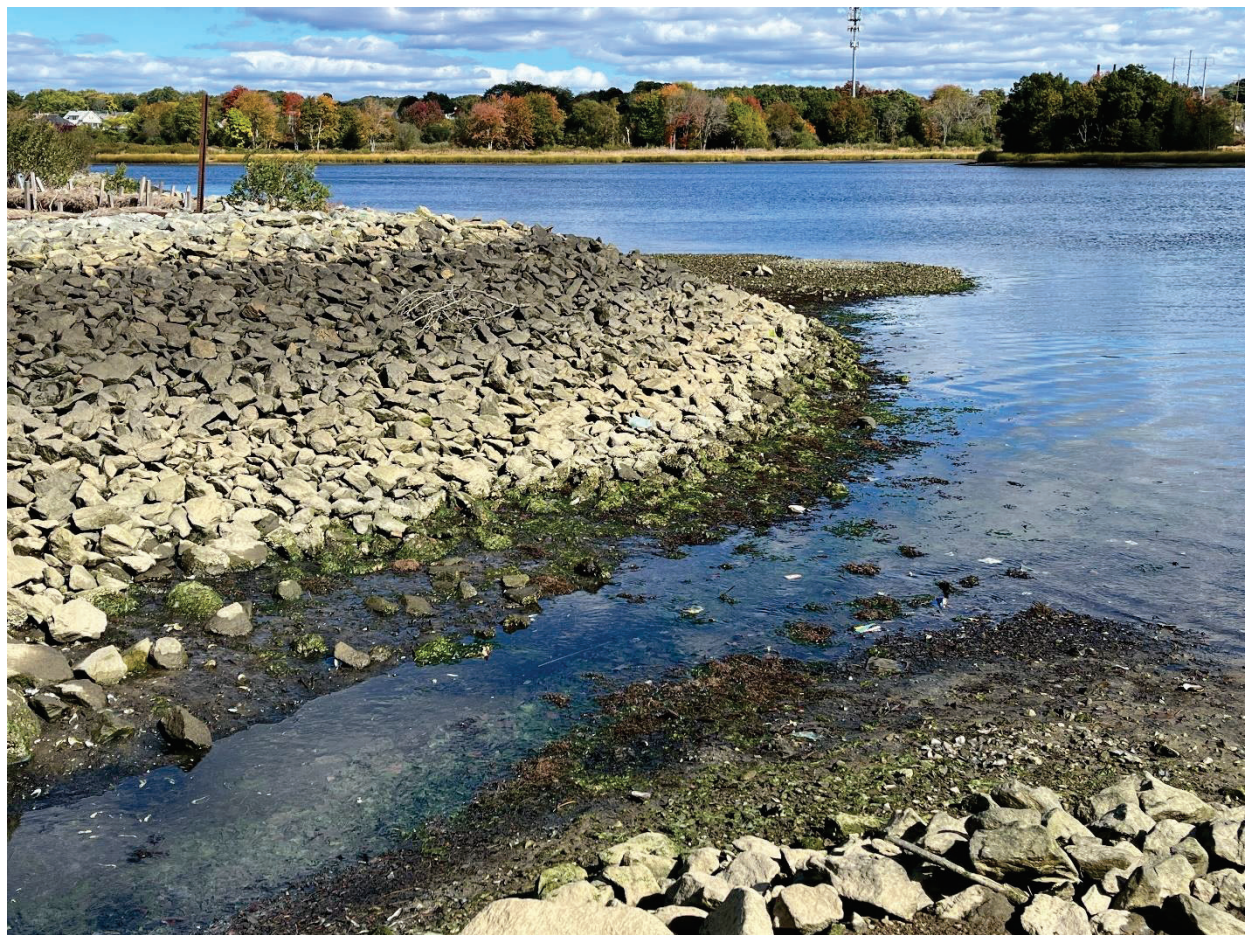
Figure 5:
Aerovox Cap:
Looking
northeast
showing the
southern area of
the cap and the
abutting Hadley
Street storm drain
swale in the
foreground.

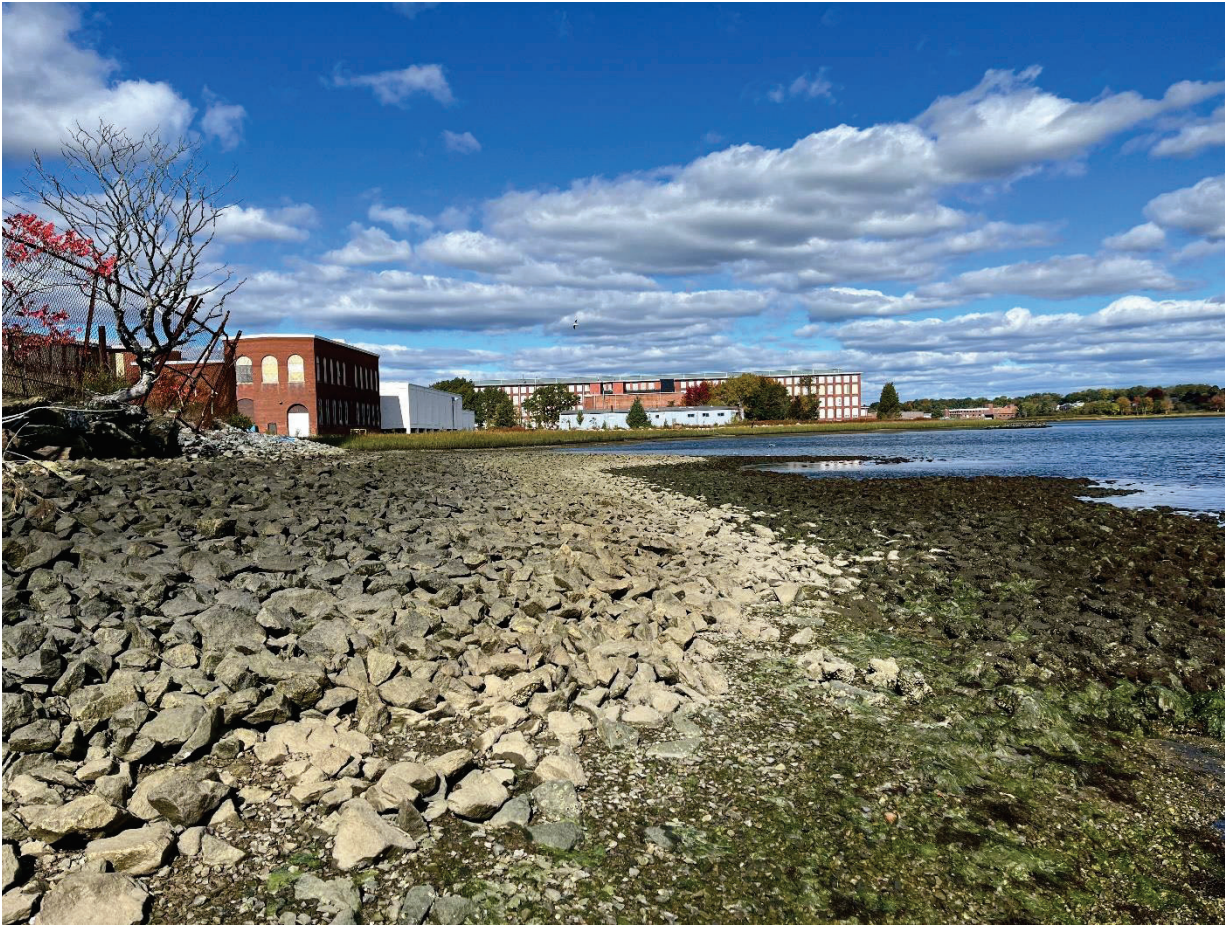
Figure 6: **Crib Cap:** Looking north showing the southern area of the cap and the abutting stone seawall with chain link fence along the left/western side of the cap.

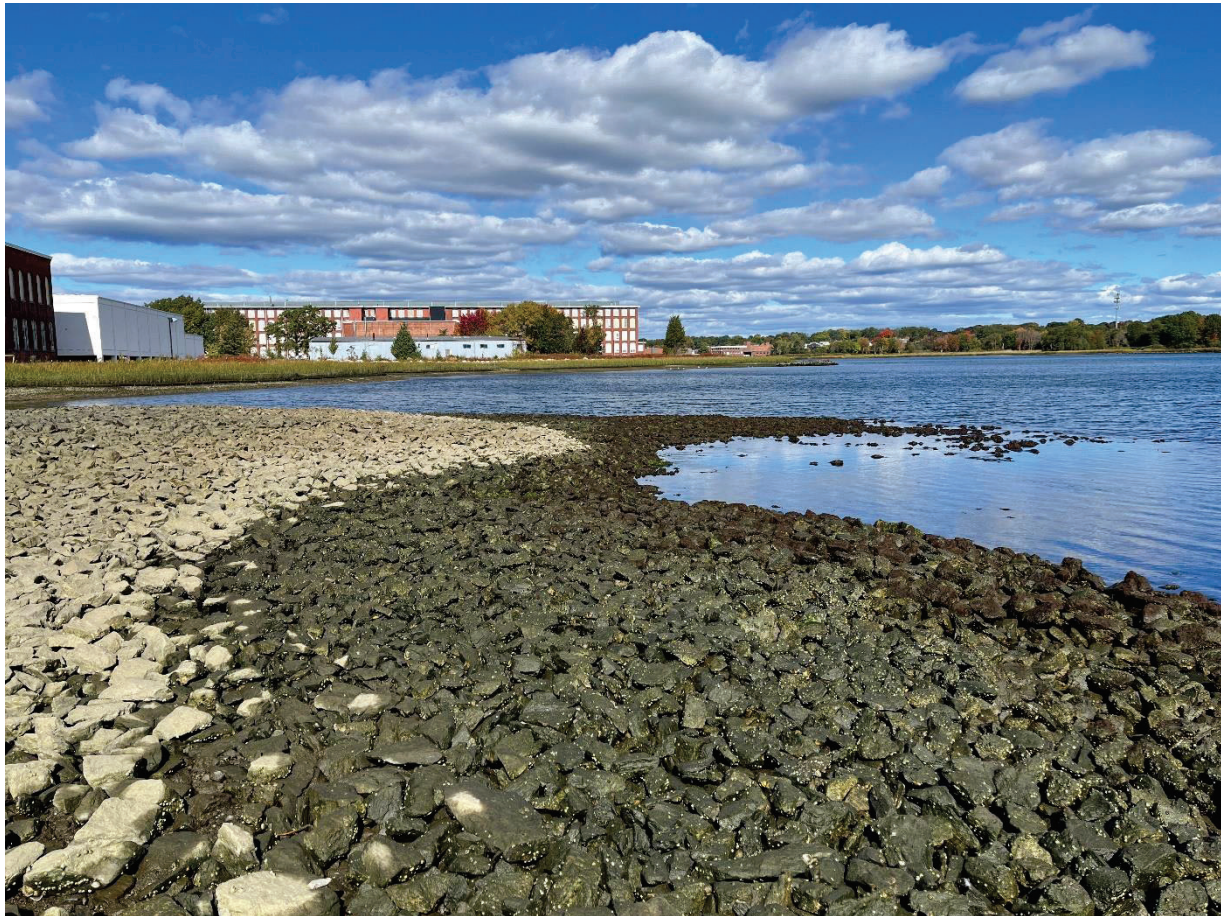
Figure 7: **Crib Cap:** Looking north.

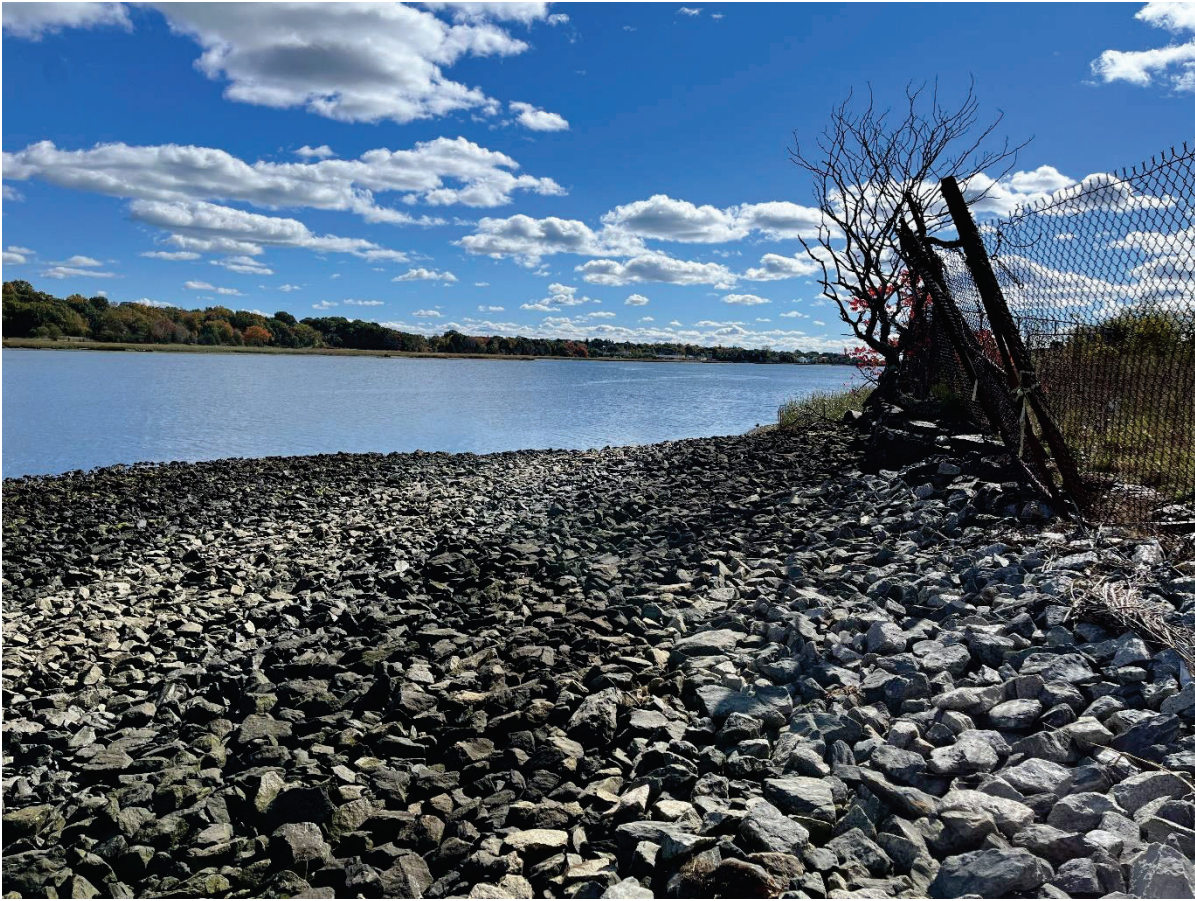
Figure 8: **Crib Cap:** Looking south showing the top of the abutting seawall with chain link fence along the western side of the cap.

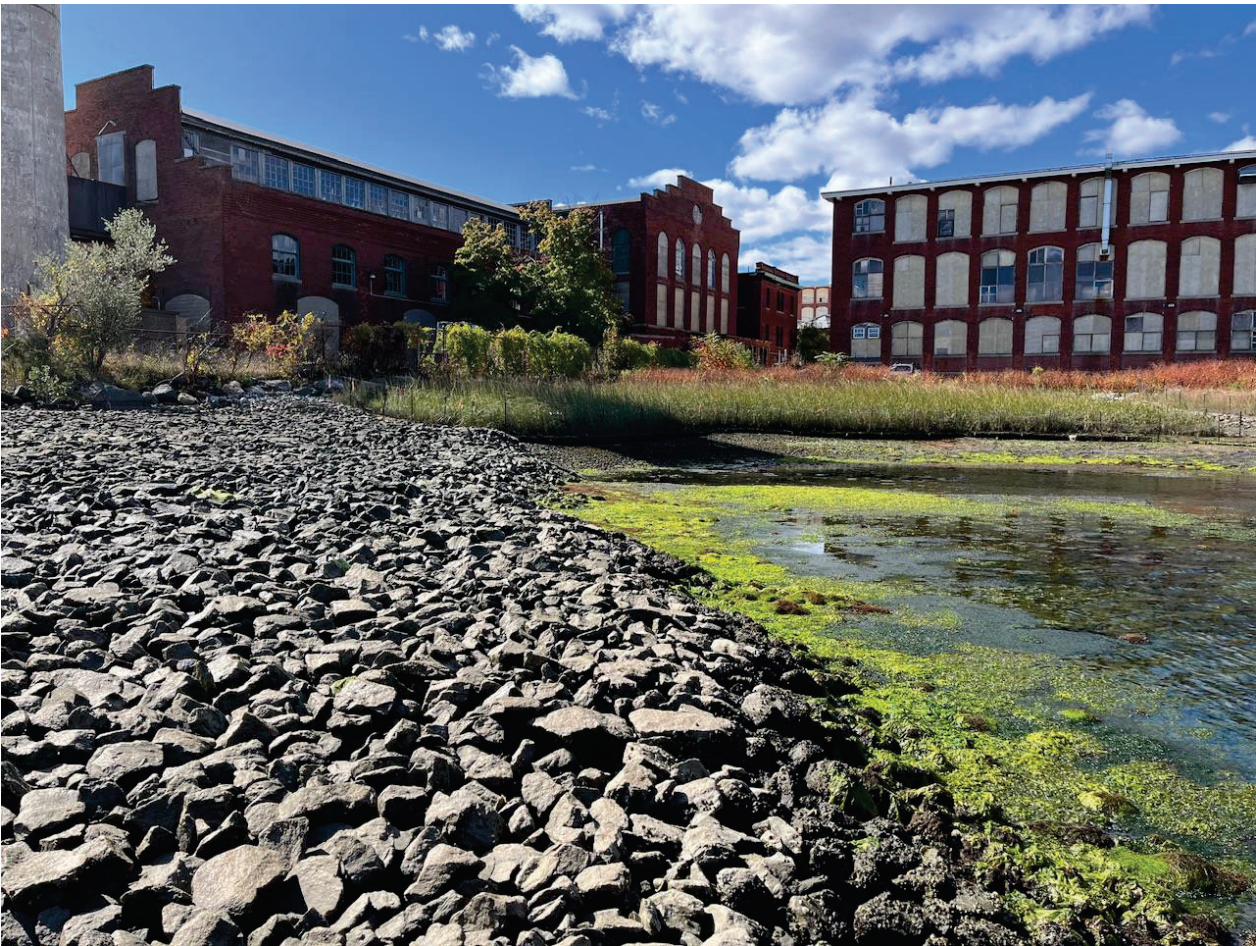
Figure 9: **Crib Cap:** Looking west showing the northern east-west trending edge of the cap. The restored WZ2/3 saltmarsh plantings are in the background beyond the cap armor stone.

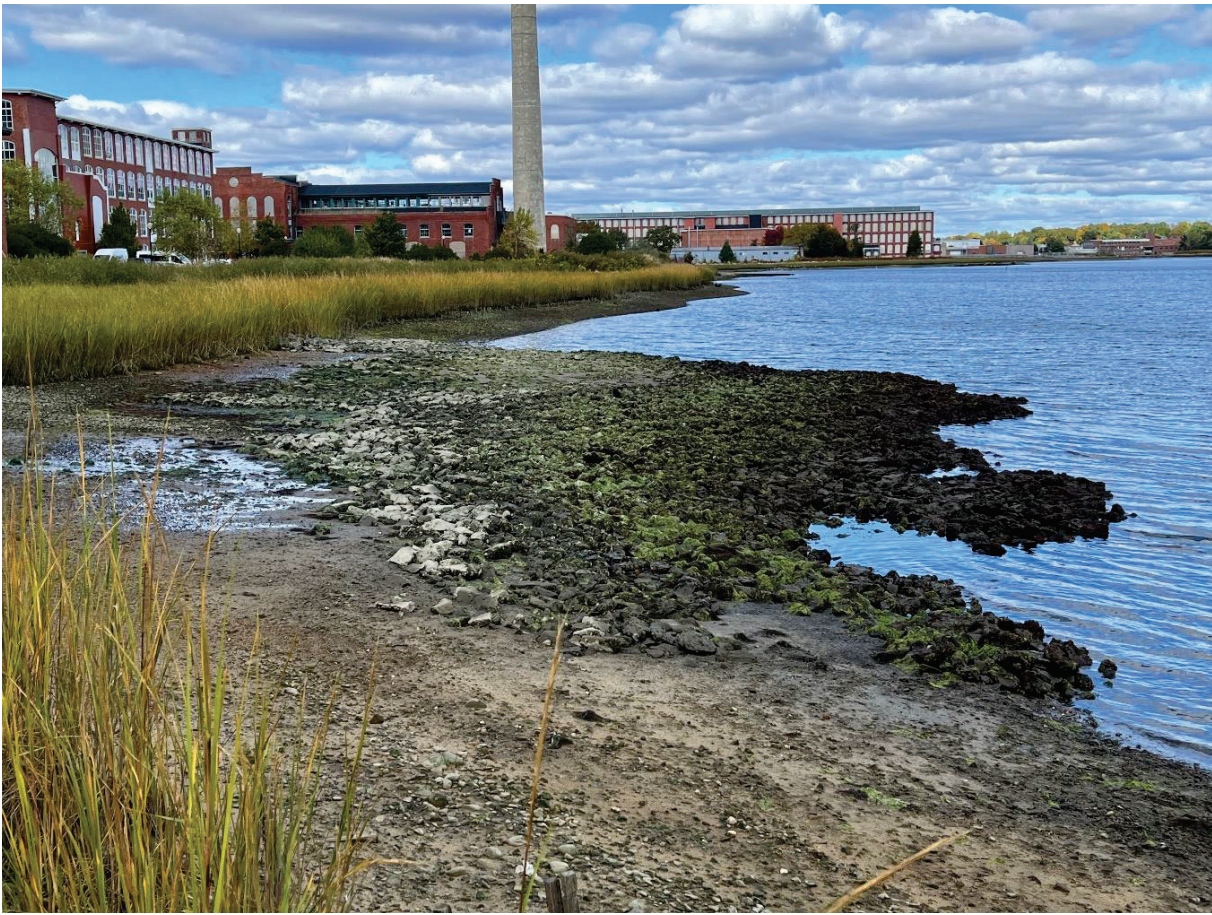
Figure 10: L-014 Cap: Looking north. Saltmarsh grasses in the photo are the WZ-4 restoration.

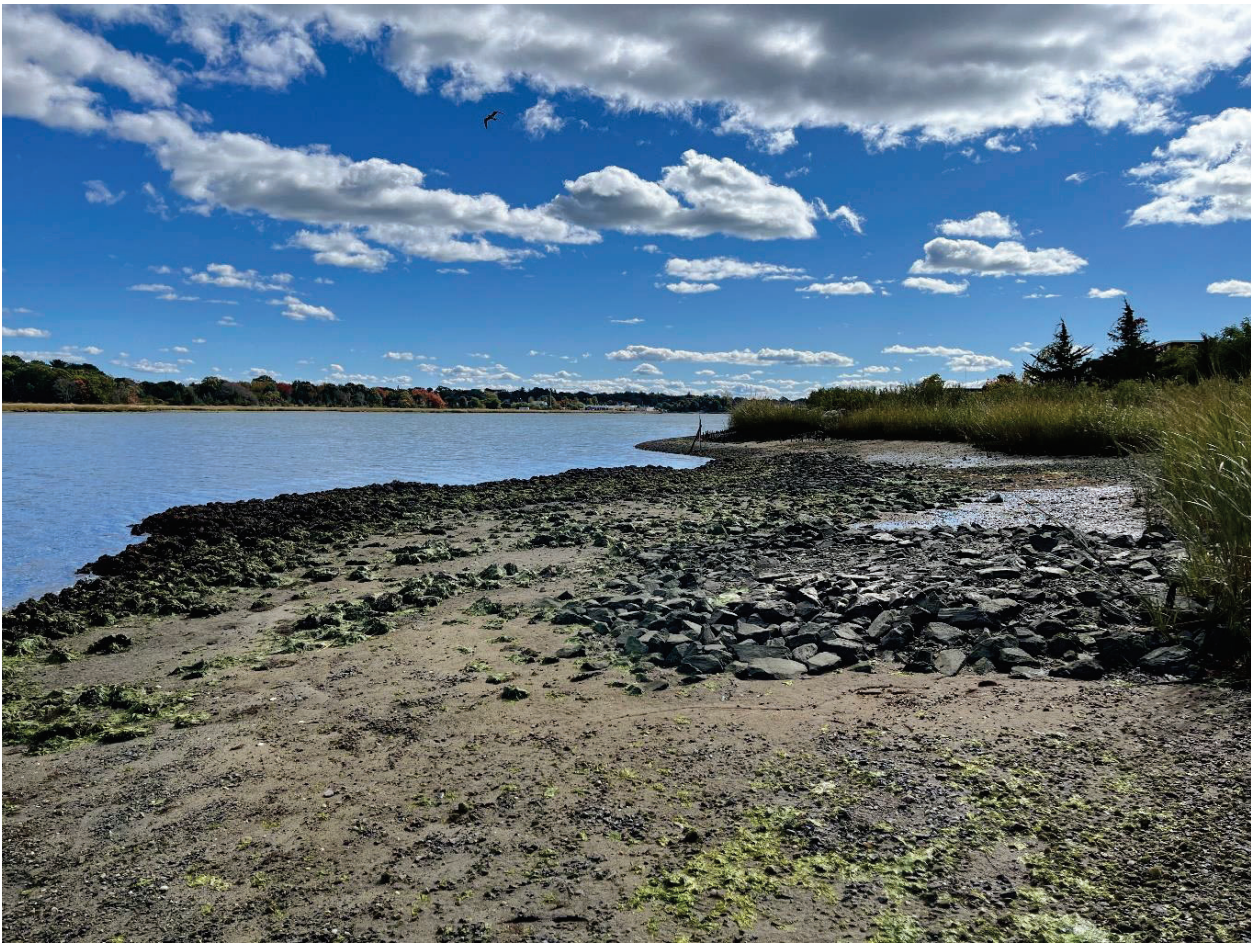
Figure 11: L-014 Cap: Looking south. The sandy topsoil in the foreground is topsoil that eroded from the abutting WZ-4 saltmarsh restoration, and NOT the underlying sediment cap isolation layer.

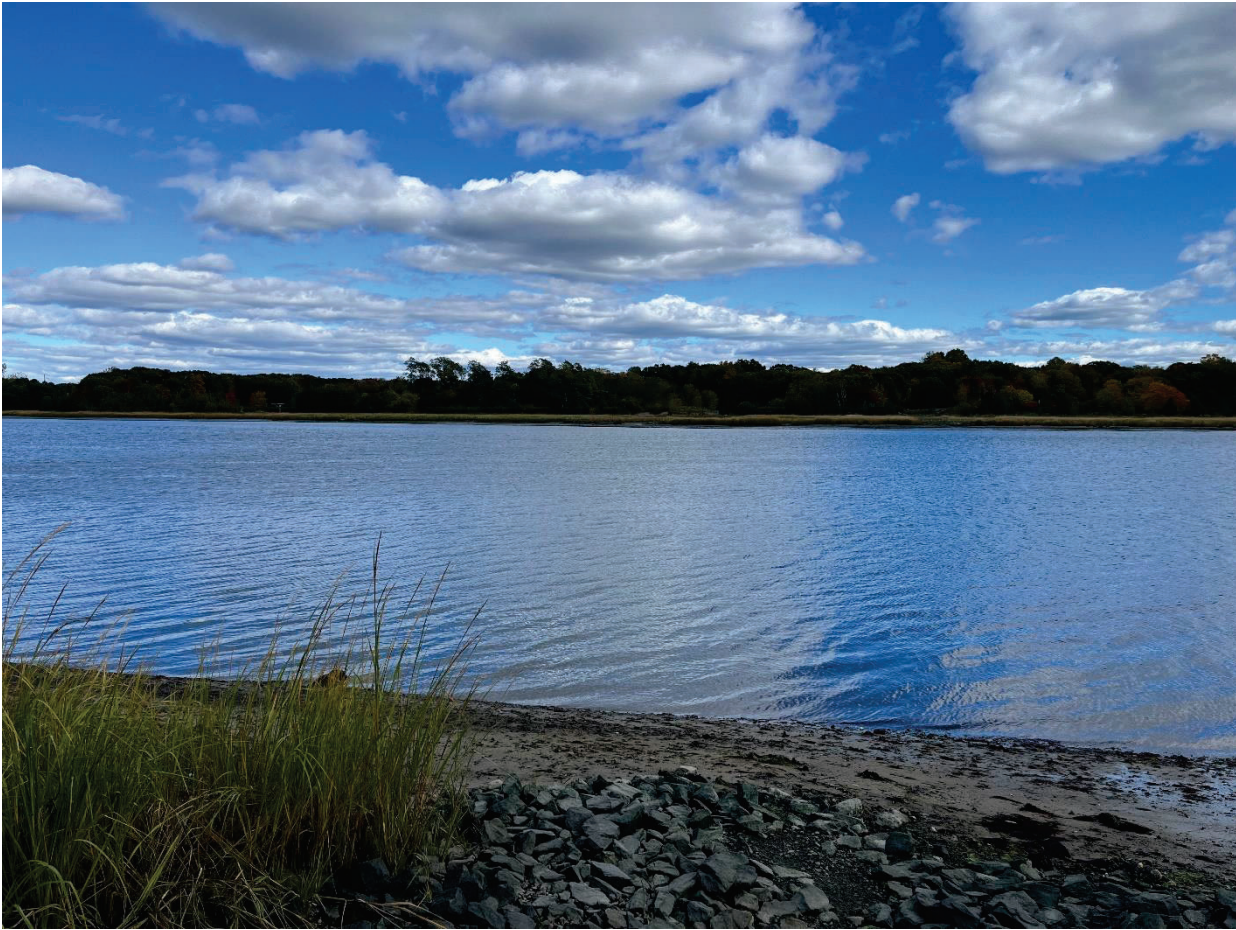
Figure 12: Photo taken looking east at exactly low tide (1:26pm) in the vicinity of the **L-114 cap**. No cap visible even at these extreme low tide conditions. Winds were 8-10 mph from the north which can help keep water levels even lower (*i.e.*, this would have been the best time to see any emergent parts of this cap).

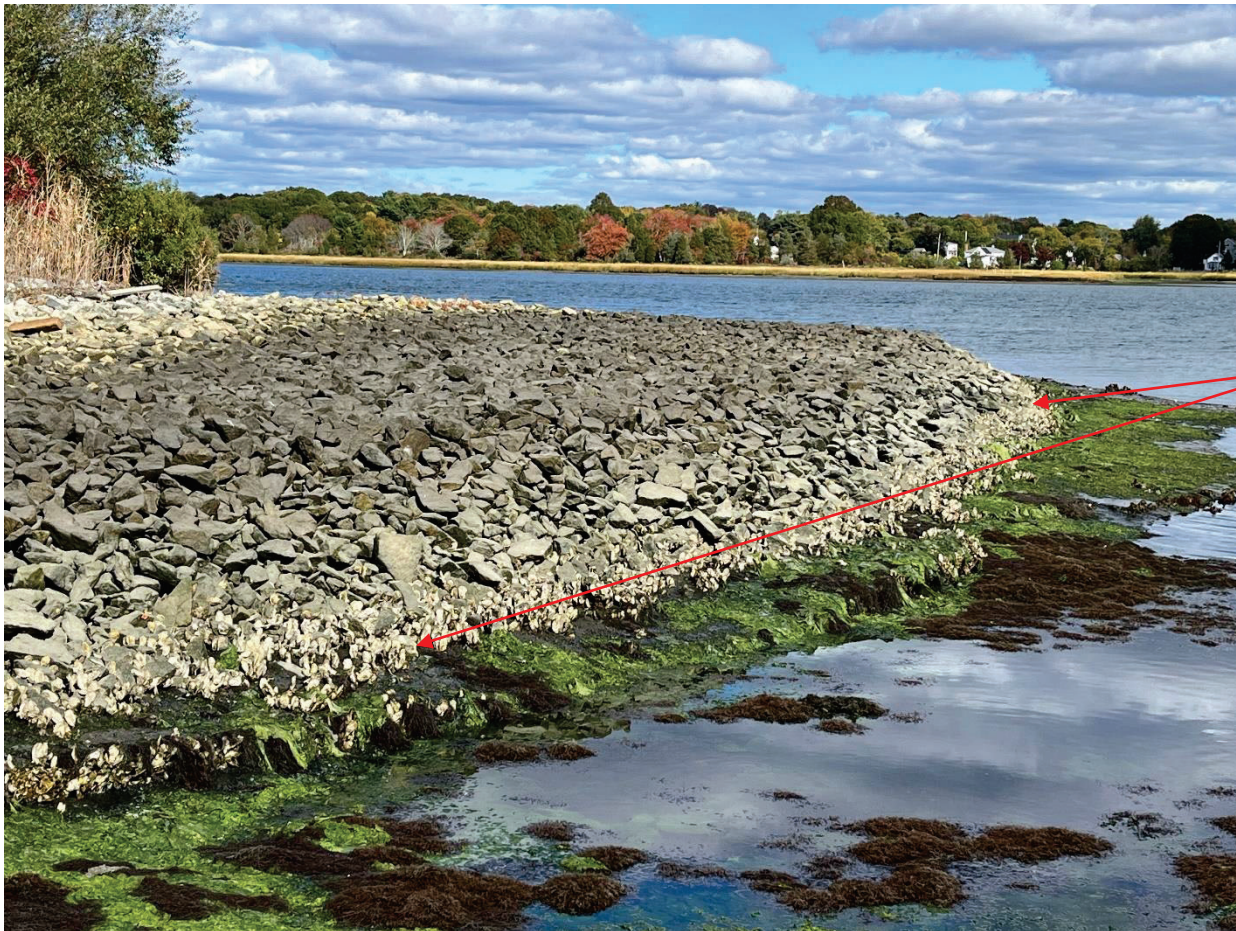
Figure 13: **Pilot CDF Shoreline Cap** looking east showing the southern part of the cap. Note the many oysters that have self-colonized along the toe-of-slope.

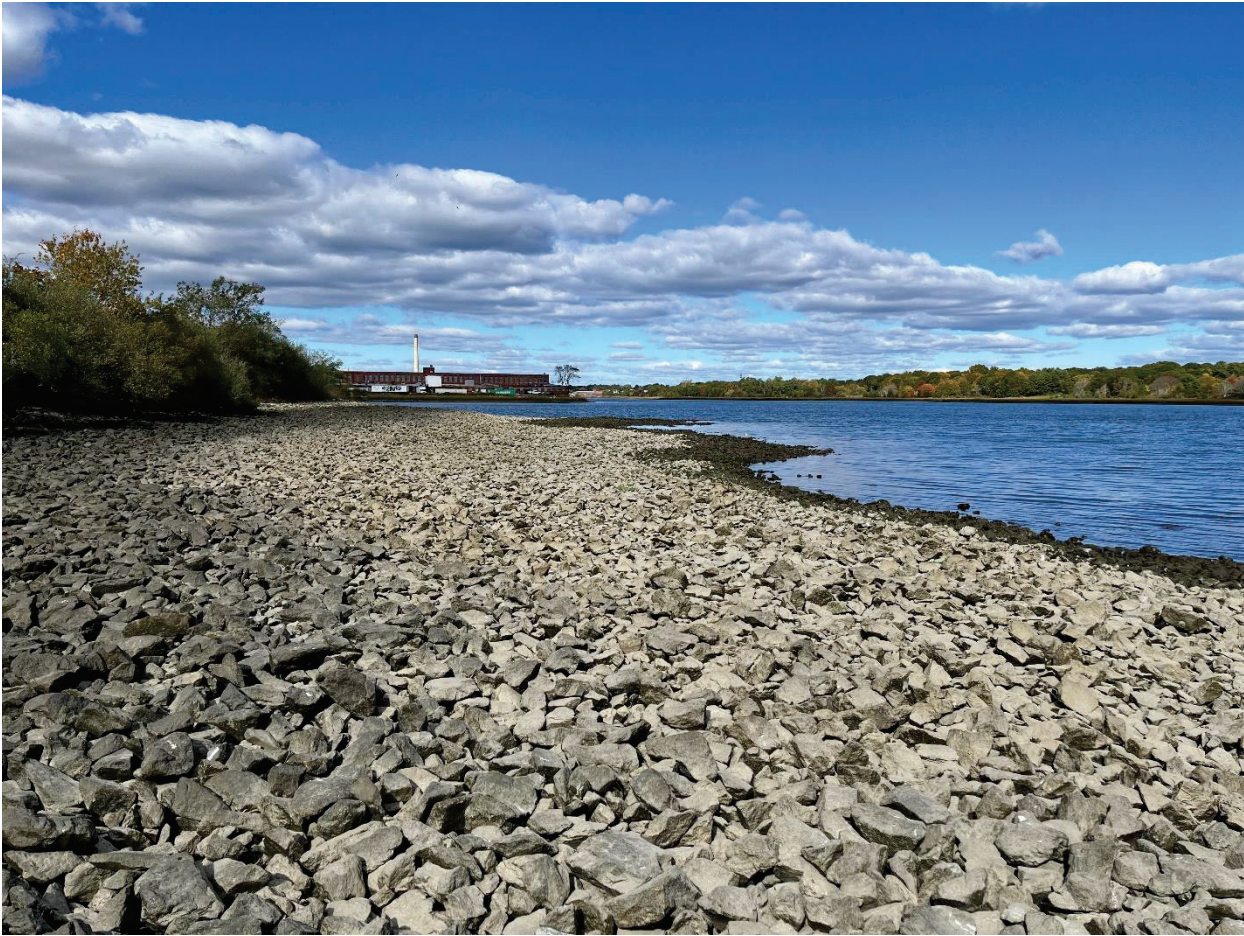
Figure 14: **Pilot CDF Shoreline Cap** looking north showing the N/S trending/eastern part of the cap.

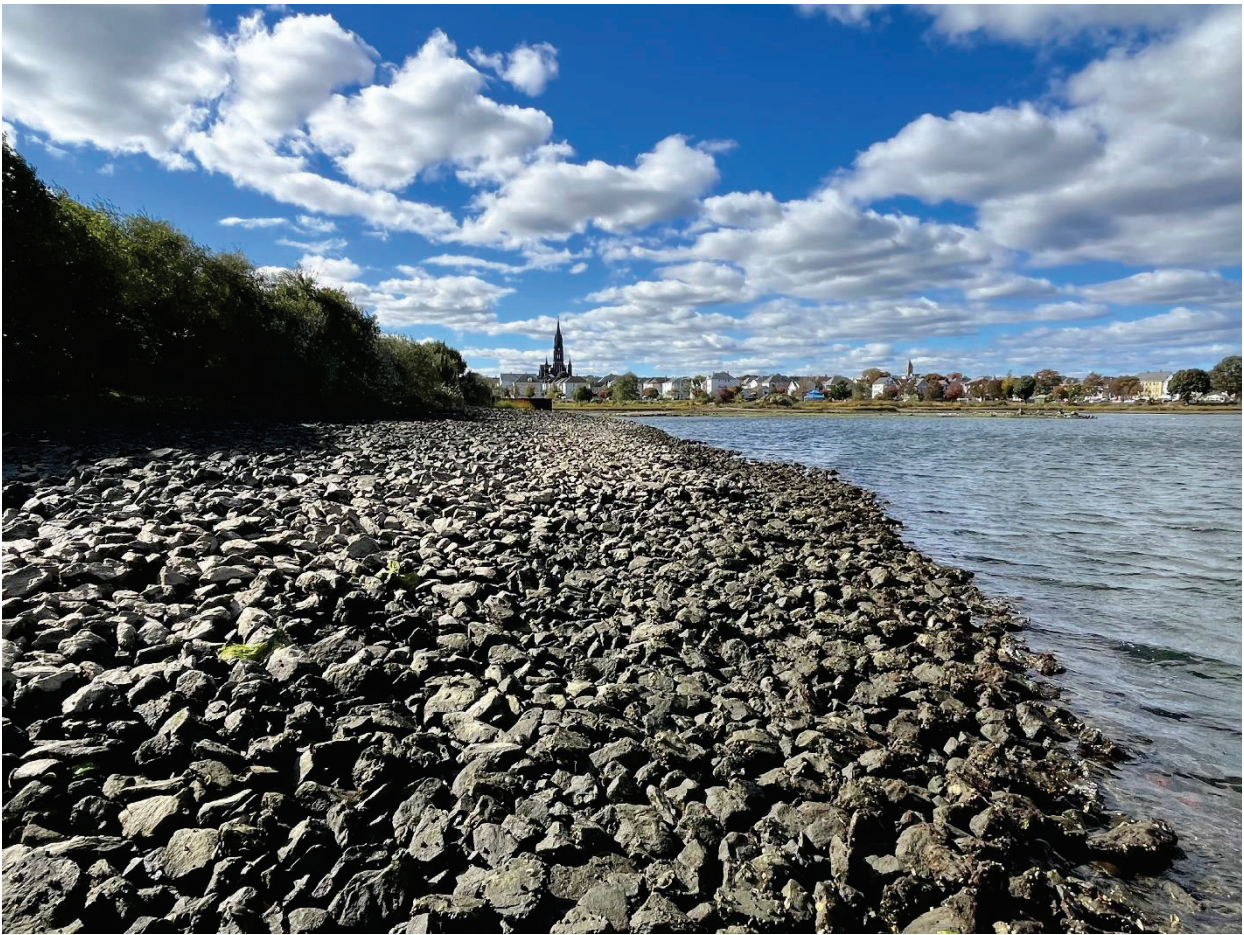
Figure 15: **Pilot CDF Shoreline Cap** looking west showing the northern portion of the cap.

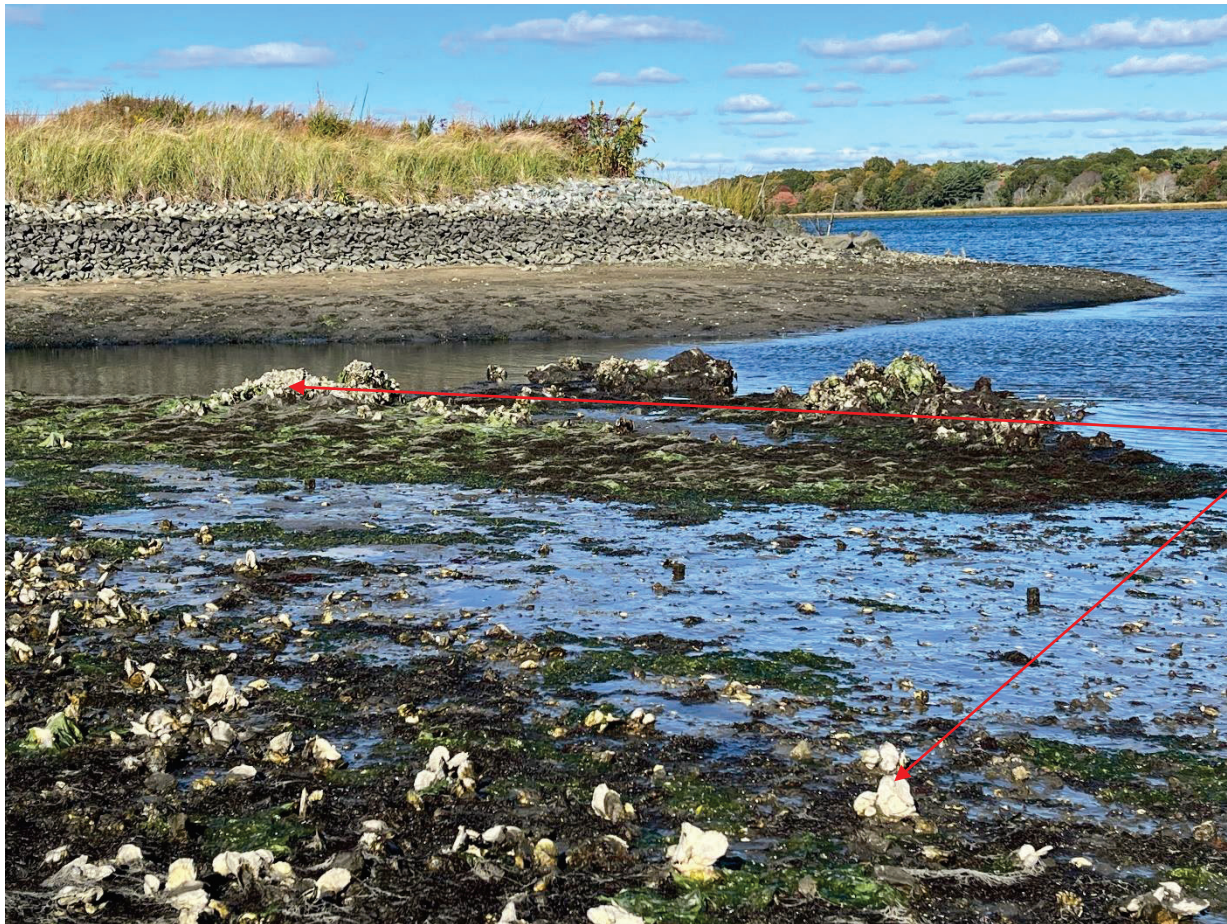
Figure 16: **Parcel 265 Cap** looking north. Note that due to the extreme low tide this is by far the most of this cap that has been visible during these shoreline visual inspections.

Also note the many oysters that, as also shown in Figure 13, have colonized this cap and the surrounding area.

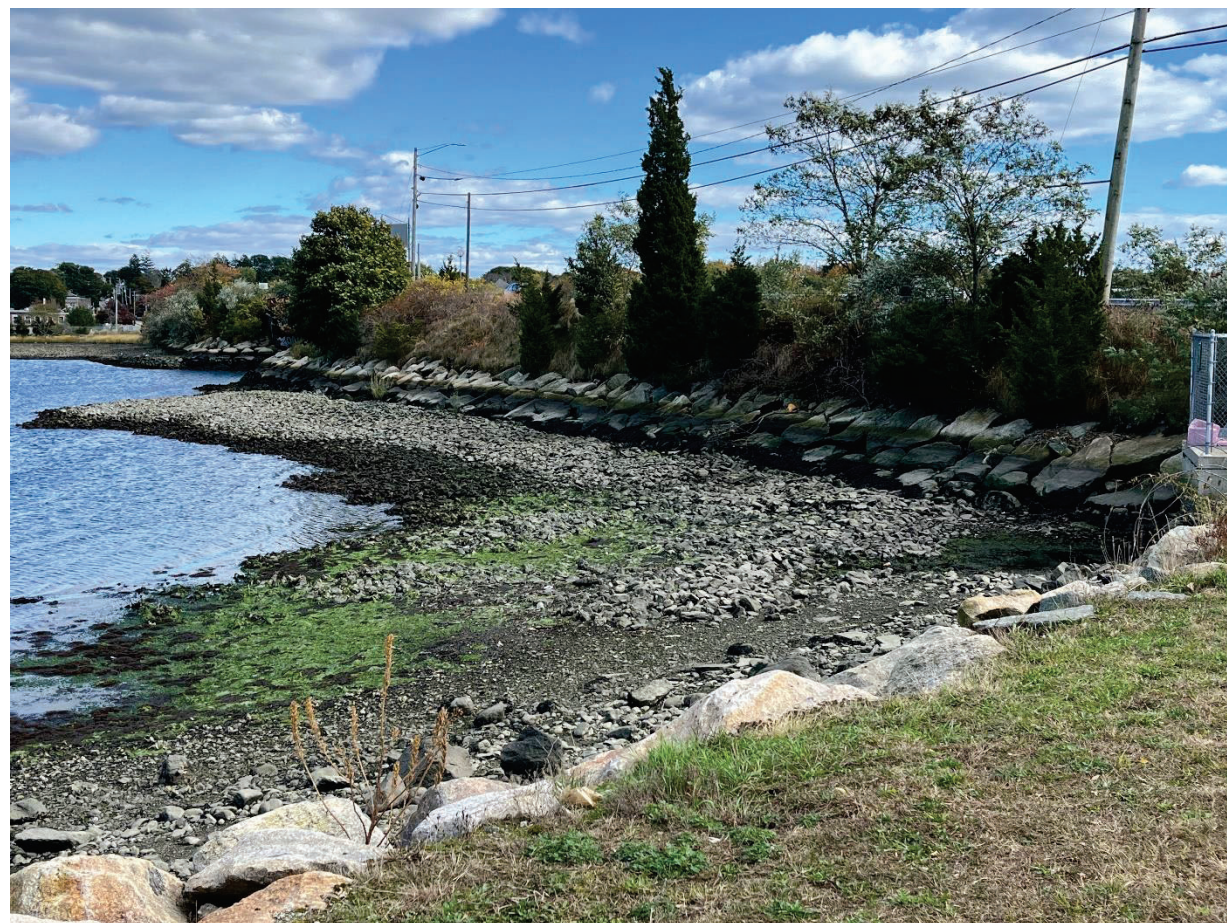
Figure 17: **Cogg-West Cap** looking southeast. The City CSO outfall structure can be seen on the right side of the photo.

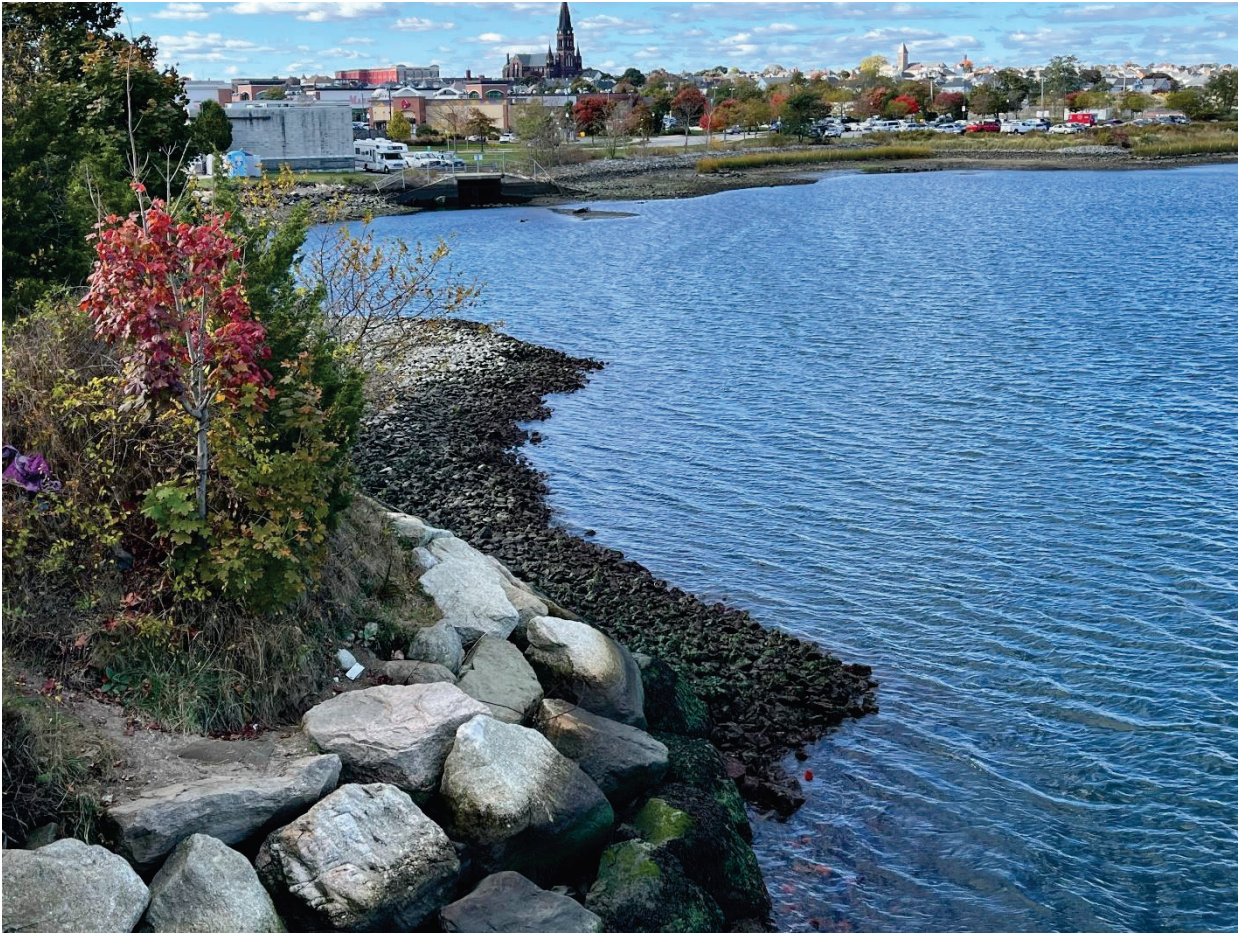
Figure 18:
**Cogg-West
Cap** looking
west from the
opening of the
Coggeshall
Street bridge.

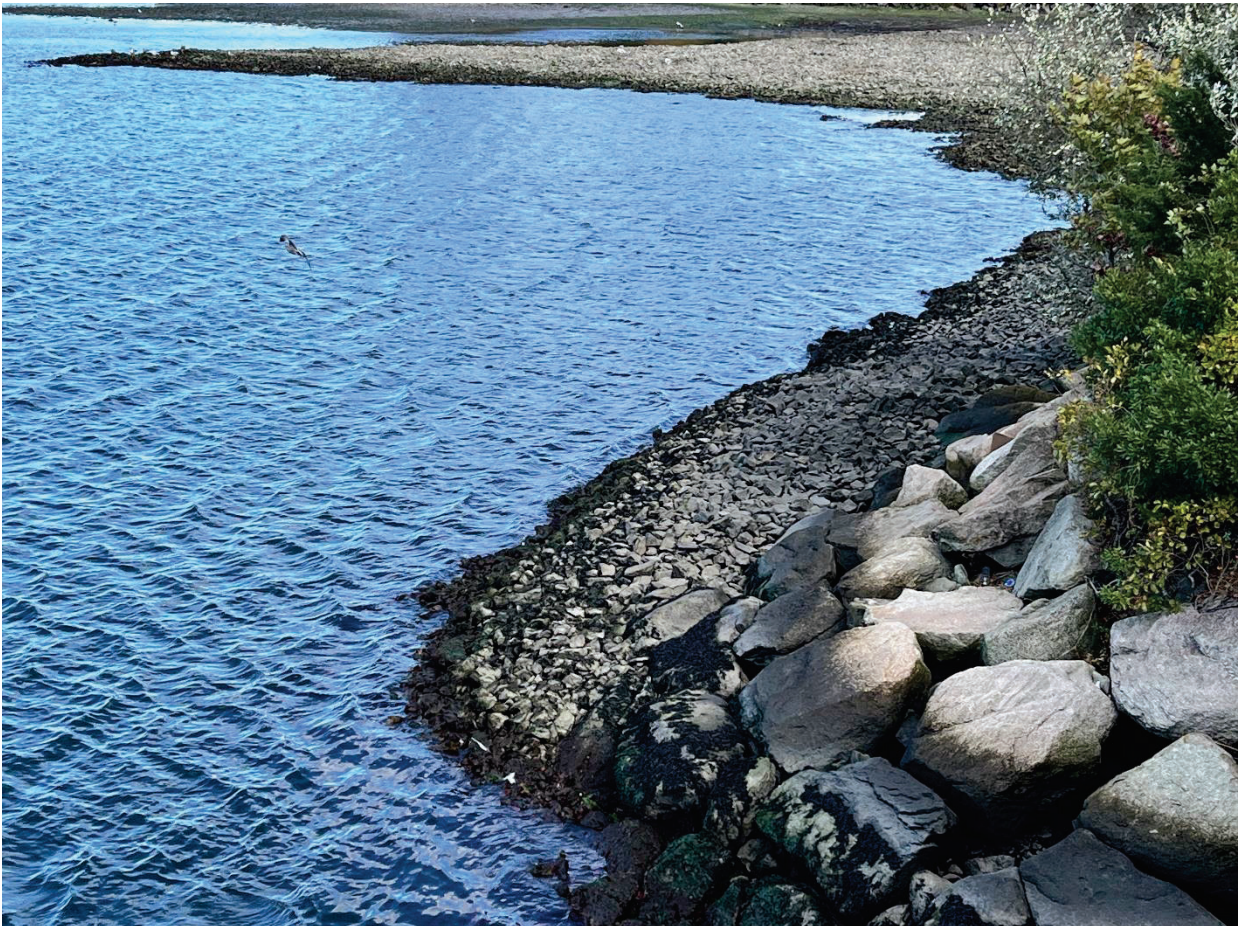
Figure 19:
**Cogg-East
Cap** looking
east from the
opening of the
Coggeshall
Street bridge.

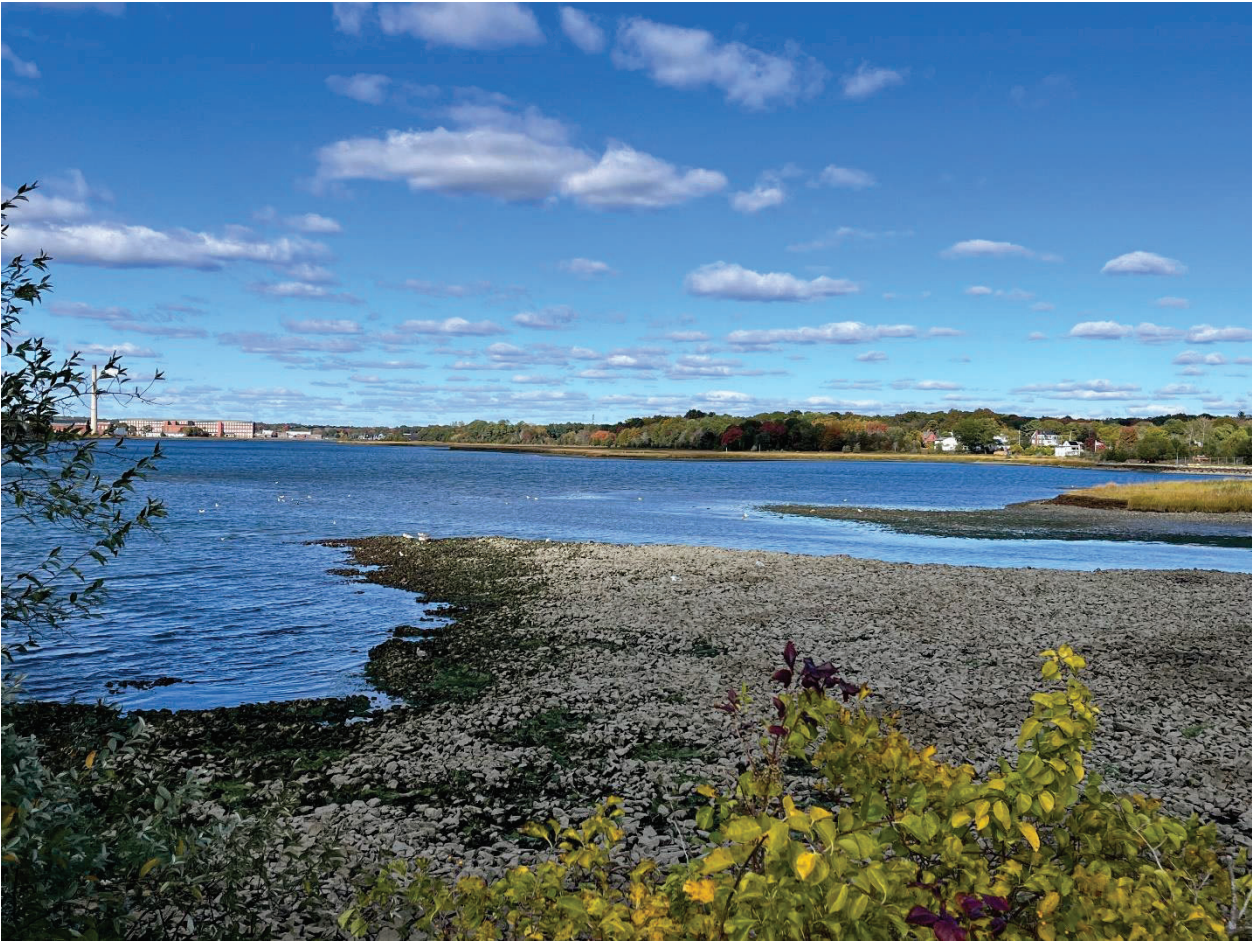
Figure 20: **Cogg-East Cap** looking north from the Coggeshall Street bridge.
