UNITED STATES ENVIRONMENTAL PROTECTION AGENCY

Memorandum

SUBJ: 10/16/2024 inspection of Upper Harbor sediment caps, NBHSS

FROM: David Dickerson, Remedial Project Manager

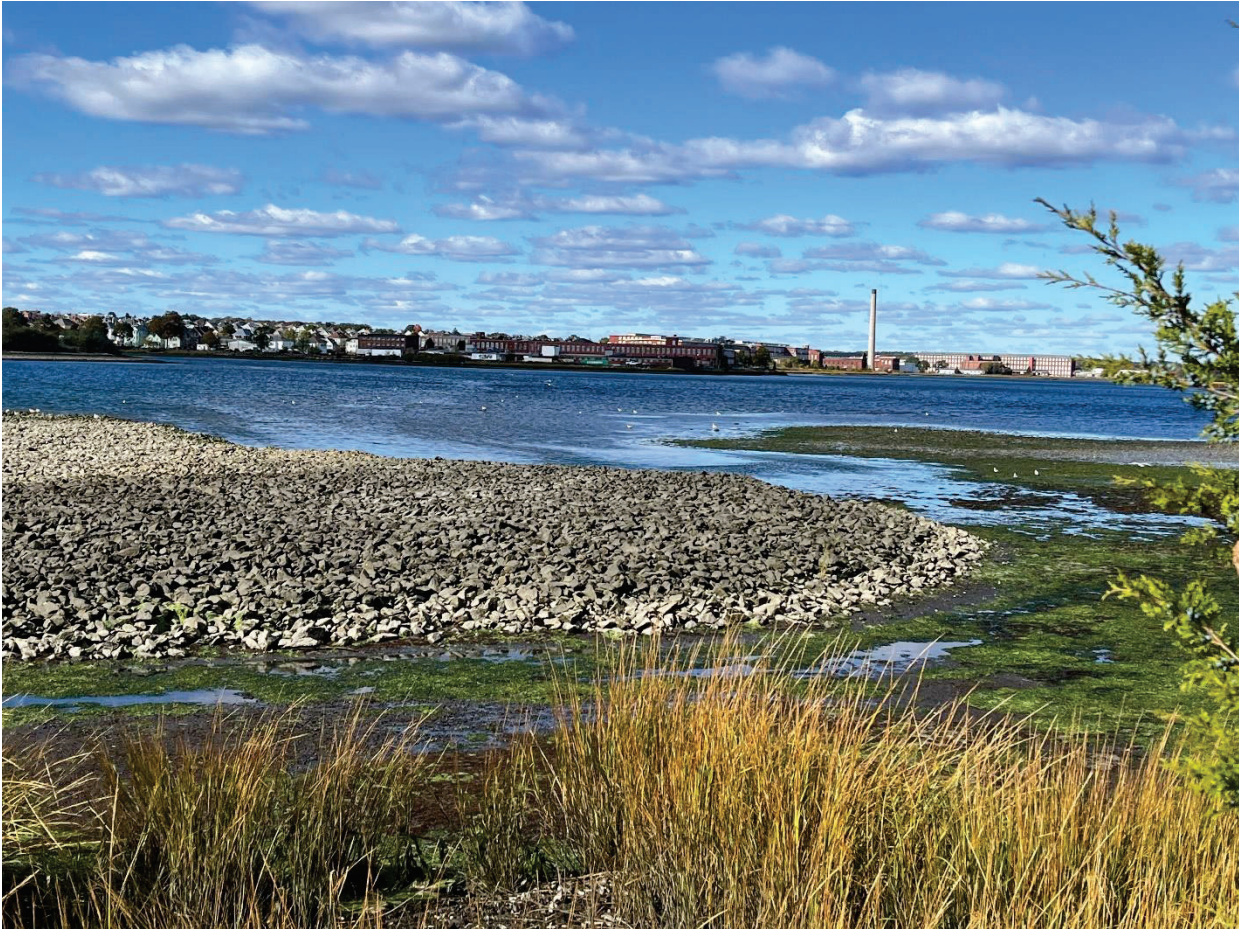
Figure 21: **Cogg-East Cap** looking northwest showing the eastern portion of the cap.
