**Re: GE-Pittsfield/Housatonic River Site
Rest of River (GECD850)
Revised Operation, Monitoring, and Maintenance Plan for Rising Pond Dam**

OPERATION, MONITORING, AND MAINTENANCE PLAN RISING POND DAM – MA00250

Great Barrington, MA

Revised December 2024
GZA File No.: 01.0019896.80

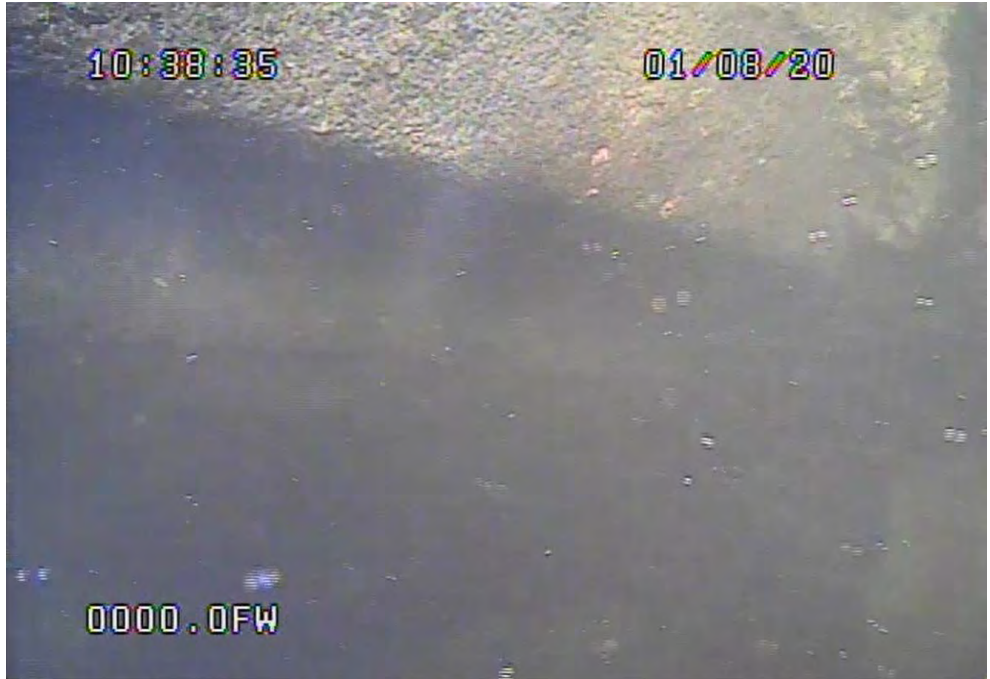
Photo 4	Date: 1/8/2020
-------------------	--------------------------

Description:
Sheet pile downstream
of spillway.

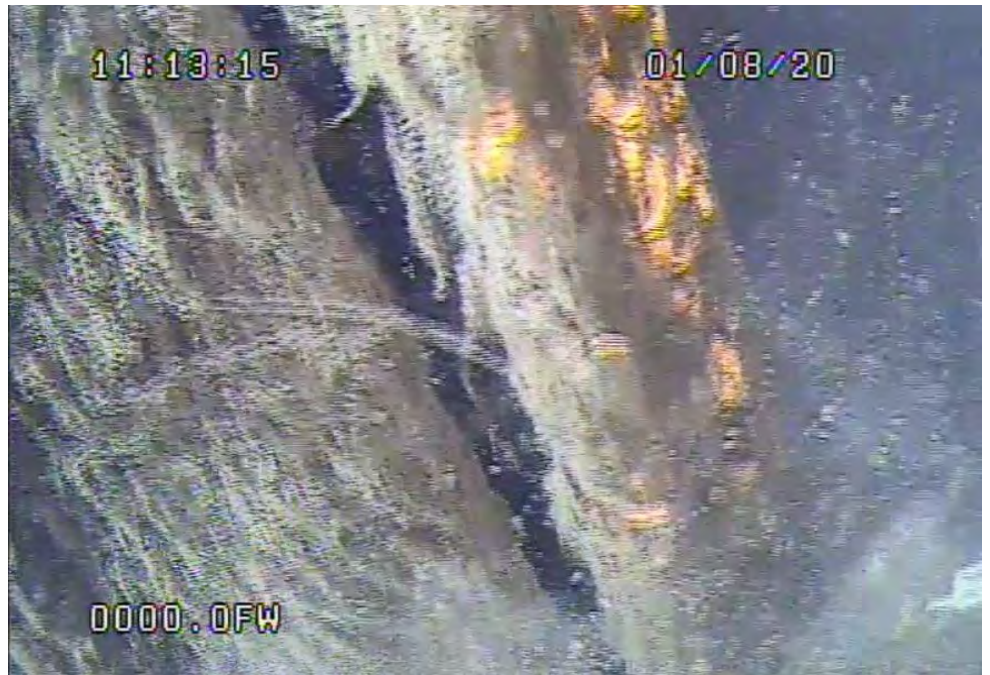
Description:
Corner of upstream
sheet pile below
instrumentation shed.

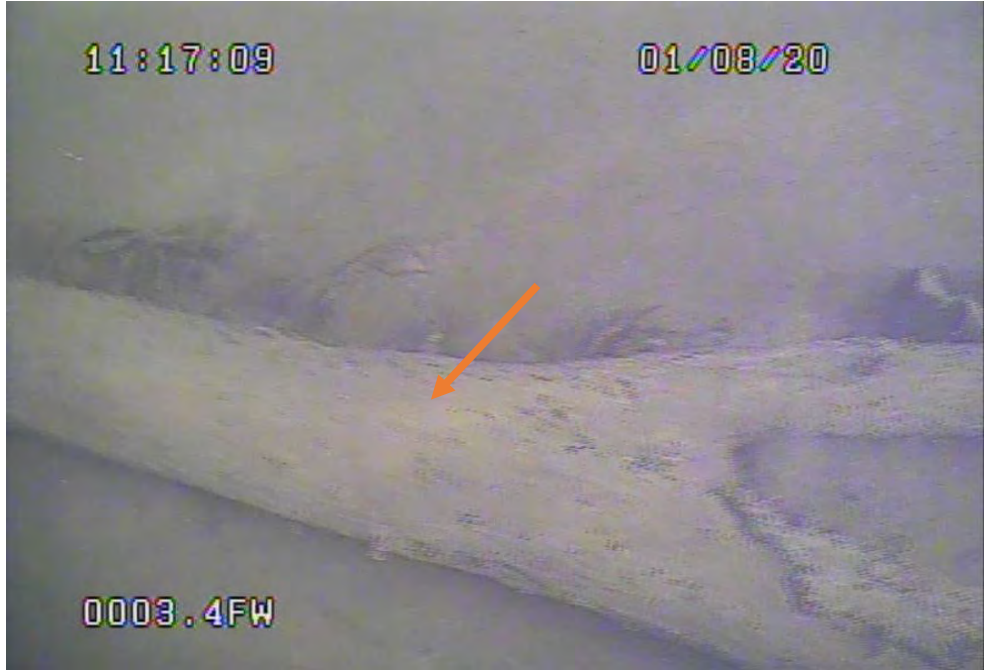
Photo 6	Date: 1/8/2020
-------------------	--------------------------

Description:
At upstream edge of spillway. Wood debris at sheetpile/concrete apron interface.

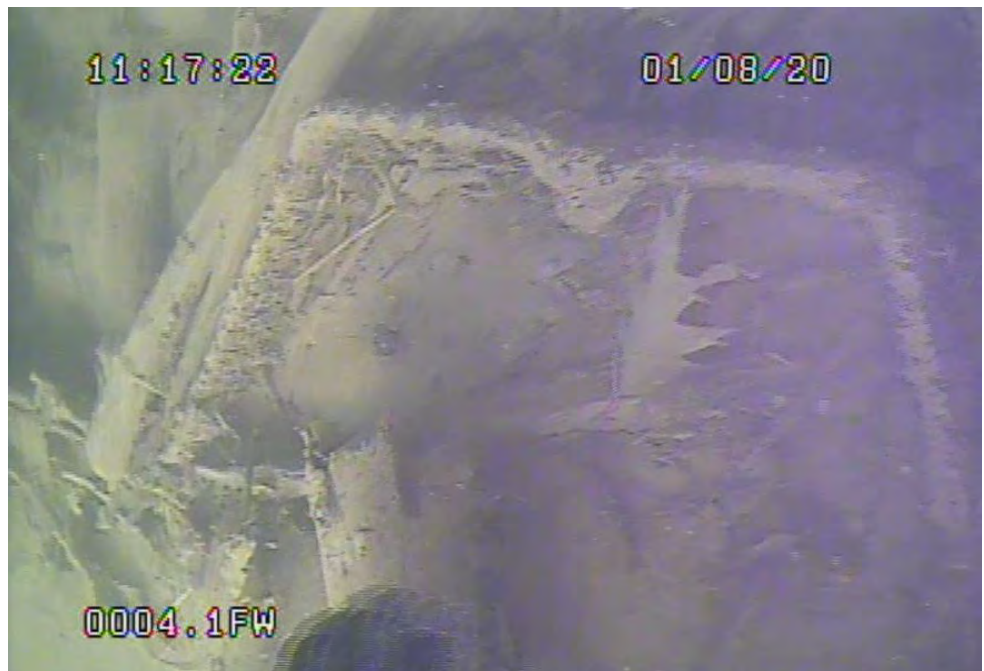
Description:
Spillway apron/sheetpile interface. Sheetpiling is exposed 6 inch above the river bottom. Muddy river bottom, logs and leaves are shown.

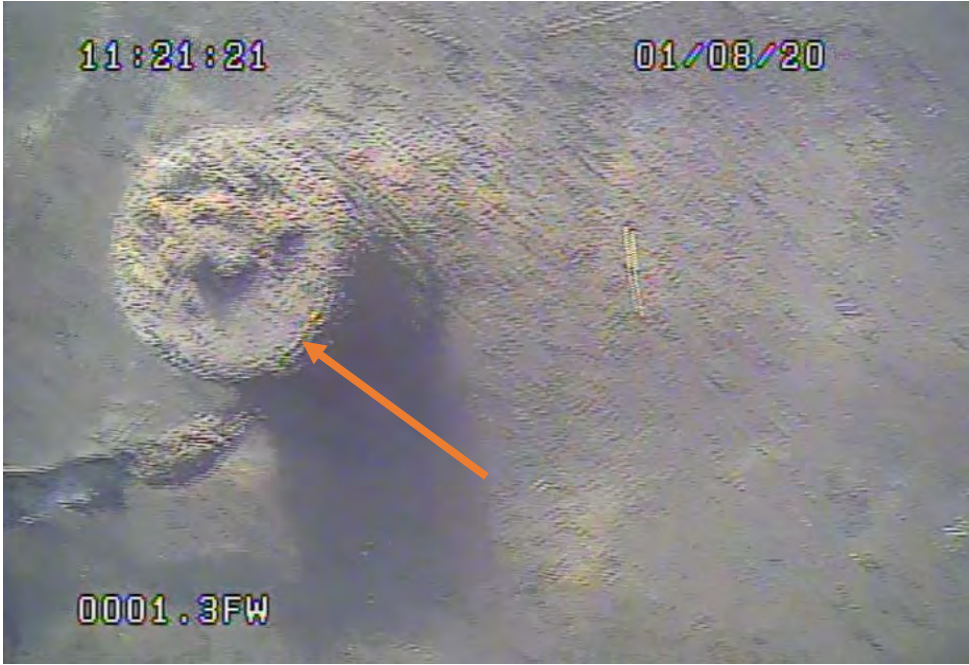
Client Name: General Electric Company		Site Location: Rising Pond Dam Great Barrington, MA	Project No.: 01.0019896.50
Photo 7	Date: 1/8/2020

Direction Photo Taken: Downstream			
Description: Top of spillway; abandoned instrument casing.

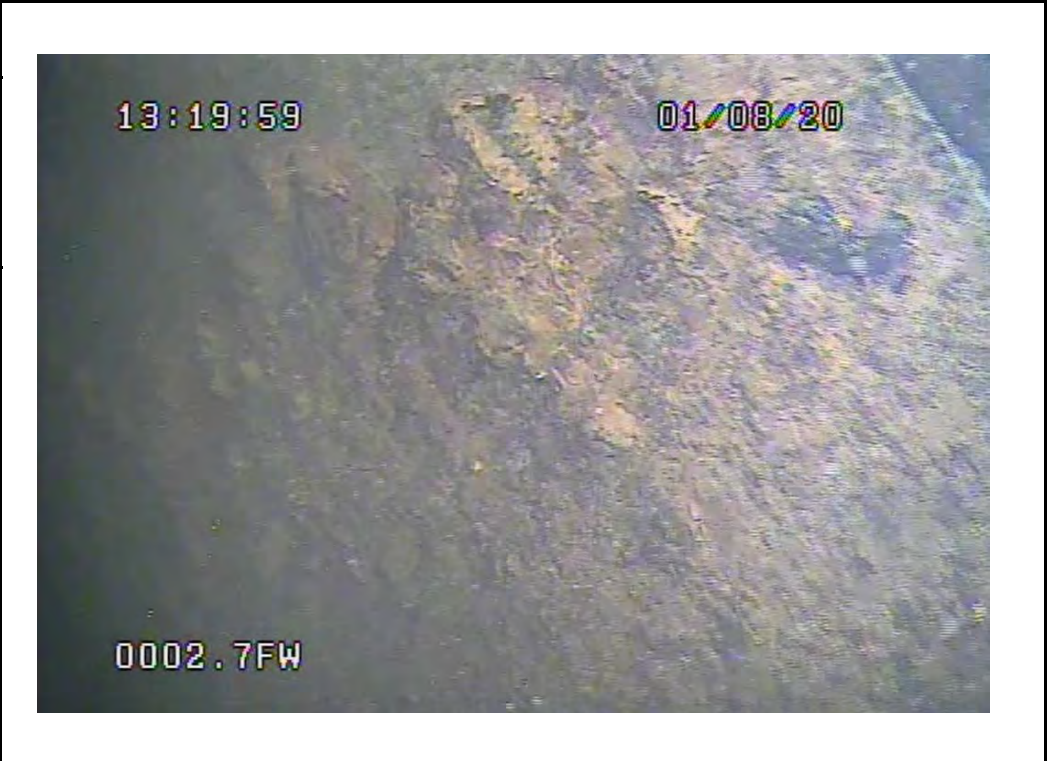
Photo 10	Date: 1/8/2020
--------------------	--------------------------

Description:
Upstream side of the trash rack.

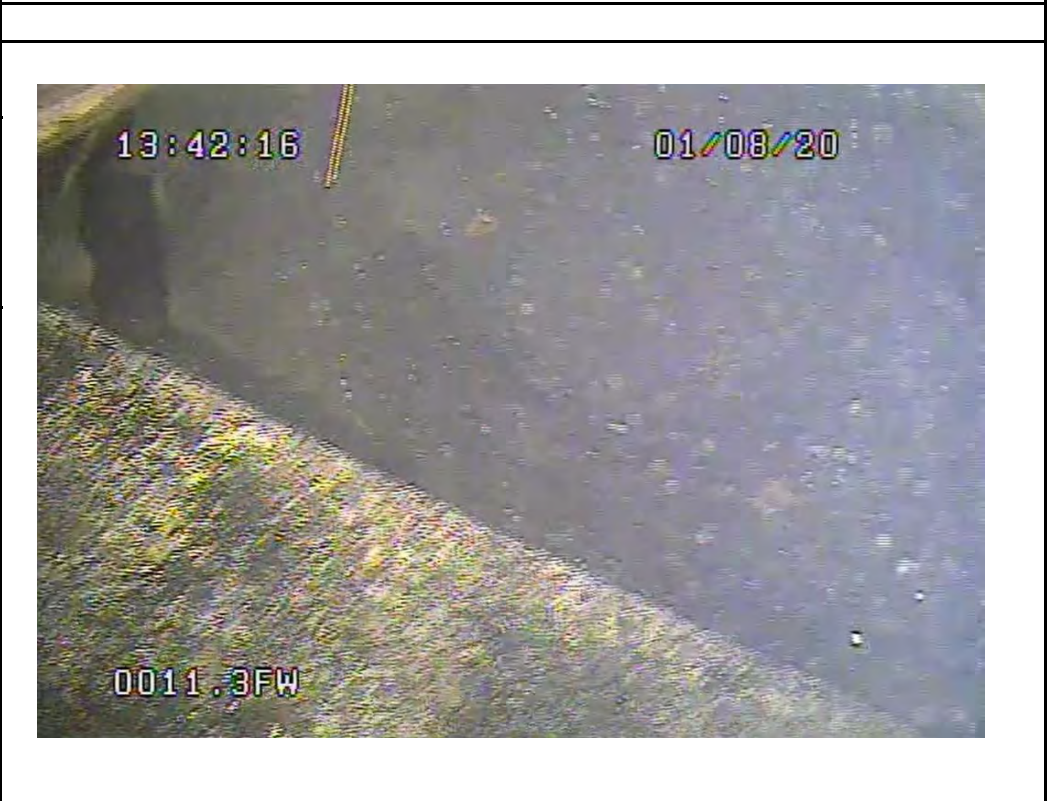
Description:
Downstream side of the trash rack.

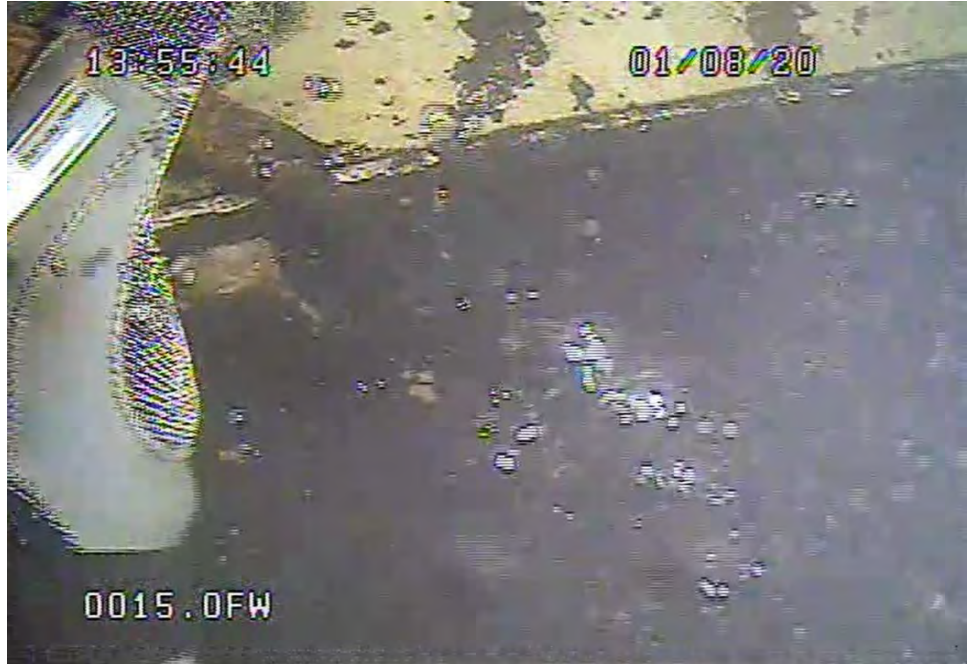
Photo 12	Date: 1/8/2020
--------------------	--------------------------

Description:
Left side of low level outlet gate.

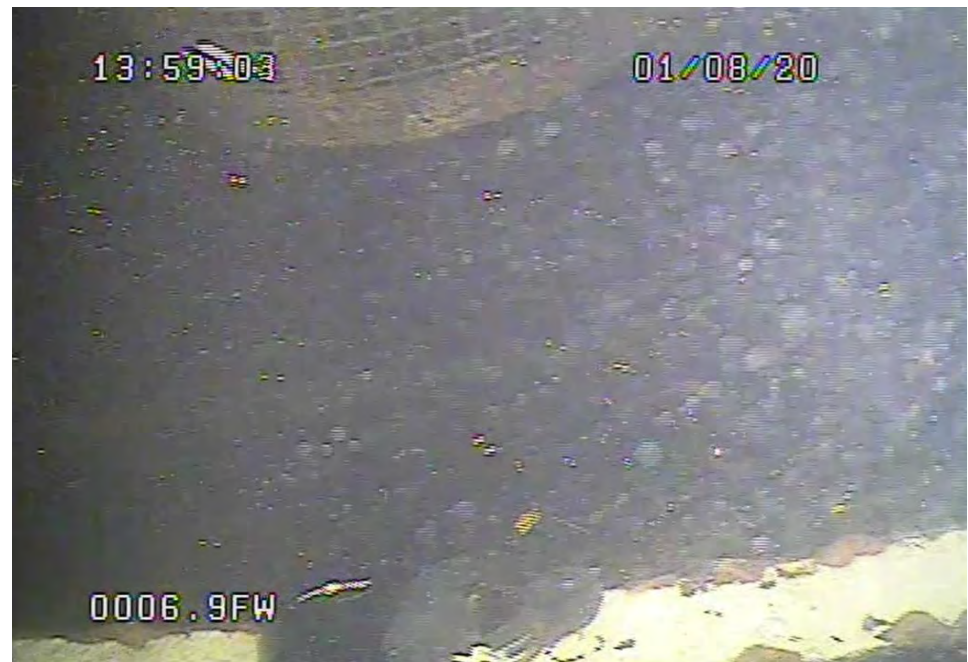
Description:
Former fire pump intake at left wall of forebay.

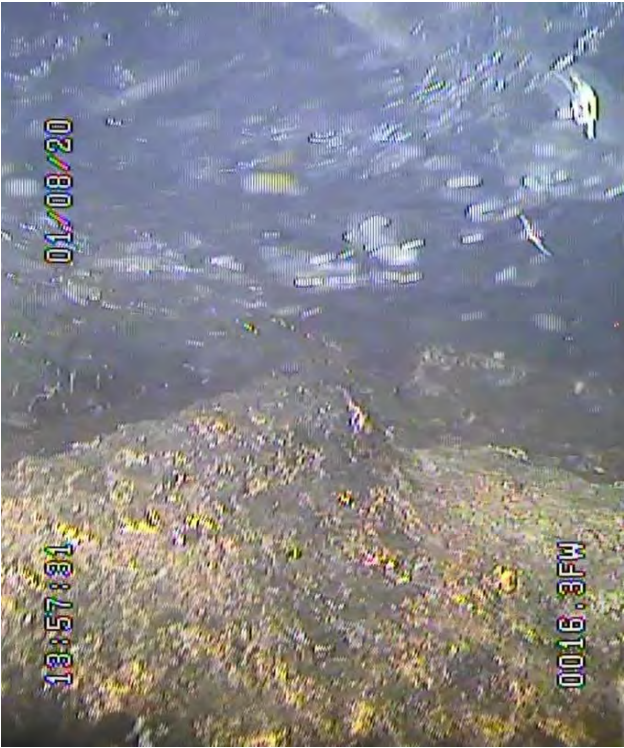
Client Name: General Electric Company		Site Location: Rising Pond Dam Great Barrington, MA	Project No.: 01.0019896.50
Photo 13	Date: 1/8/2020

Direction Photo Taken: Downstream/Right			
Description: Bottom of the low level gate, which was not fully closed possibly due to debris at bottom.
