Public Input on General Electric's Road Assessment Work Plan, dated June 26, 2025

Re: Housatonic Rest of River (GECD850) Road Assessment Work Plan

STRUCTURES INSPECTION FIELD REPORT ROUTINE INSPECTION

BR. DEPT. NO. **P-10-023**

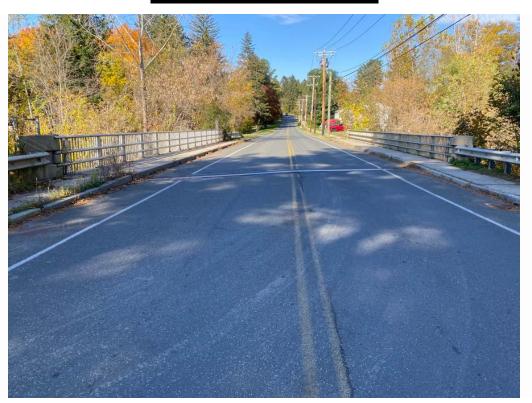
Photo 1: General topside, looking west.

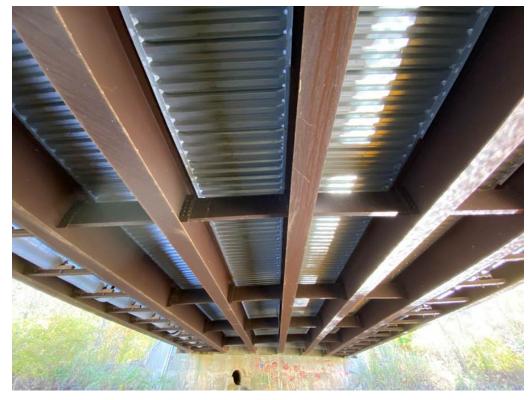
All bays have stay in place forms. See photo 2.

Photo 2: Typical underside, looking east.

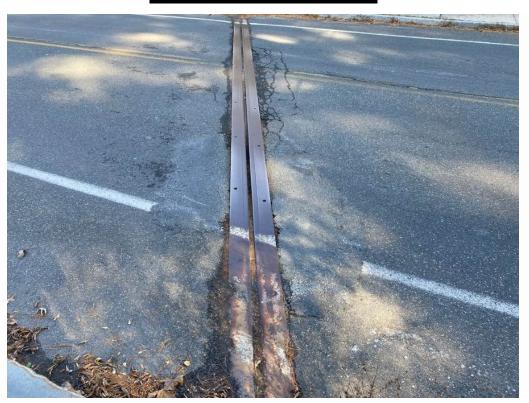
At the east deck joint, the wearing surface is pulling away from the armor, with cracking and patches. See photo 3.

The east deck joint is filled with sand and debris. See photo 3.

At the east deck joint, the approach pavement is pulling away from the armor, with cracking and patches. See photo 3.

Photo 3: East deck joint filled with sand and debris. Note the approach pavement pulling away from the armor and patches.

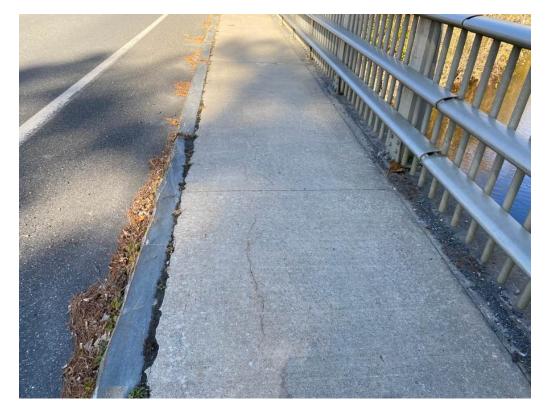
In the north curb, between the curb and sidewalk, there is a moderate amount of vegetation. See photo 4.

The north sidewalk, adjacent to the curb, has scaled areas, full length x up to 2" wide x 1" deep, with light vegetation growth. See photo 4.

Photo 4: Vegetation growing between the north sidewalk and curb.

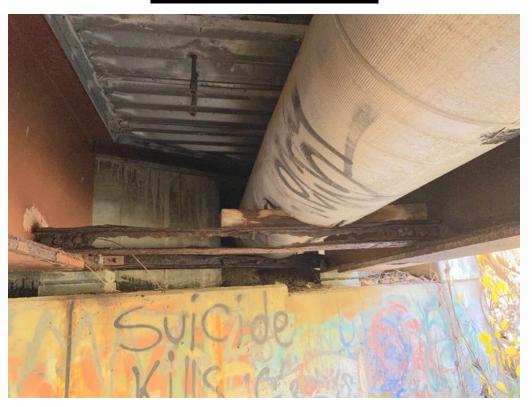
In bay 1, the second bracket from the west is severely rusted with holes throughout the web. The utility is located directly under a set of deck weeps. See photo 5.

At both backwalls, in bay 1 around the utility pipe, the bricks and mortar are deteriorated. Fill from below the approach sidewalks is spilling through in these areas. See photo 5.

Photo 5: Rusted utility support at the west end of bay 1. Also, note the fill spilling through the utility bay in the backwall.

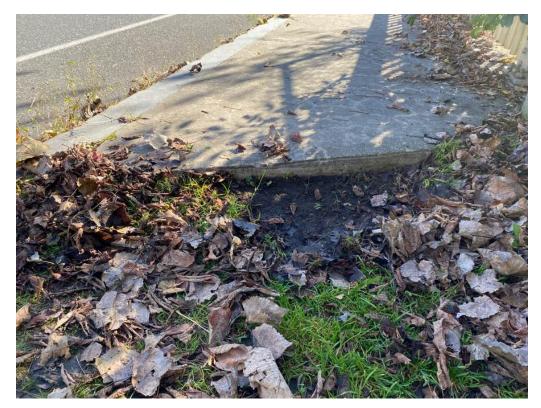
The southwest corner is settled, 2". The approach walkway in this area is dirt / grass. See photo 6.

Photo 6: Approach sidewalk settlement at the west end of the south sidewalk.

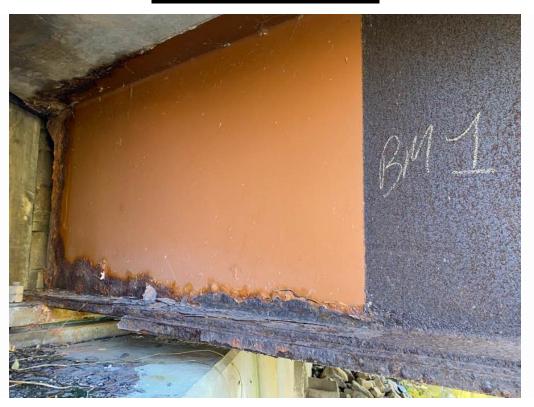
Beam 1, at the east end, has minor laminating rust in the painted section near the bottom flange, 6' long. See photo 7.

At the east end of beam 1, the cover plate welds have rust with delamination. See photo 7.

Beam 1, at the east end, mostly along the bottom of the web, has peeling in the paint and patina failure, 6' long. See photo 7.

Photo 7: Rusting with delamination at the east end of beam 1. Also, note the delamination in the cover plate and the associated welds.

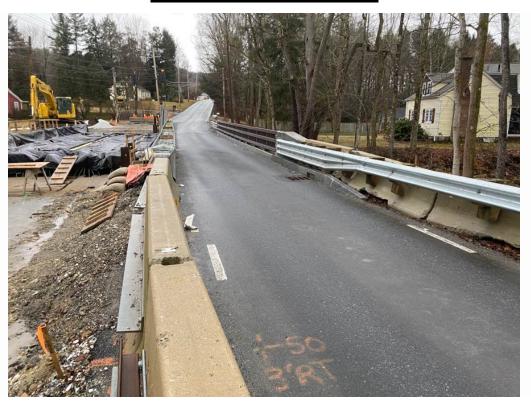
Photo 1: General topside, looking south.

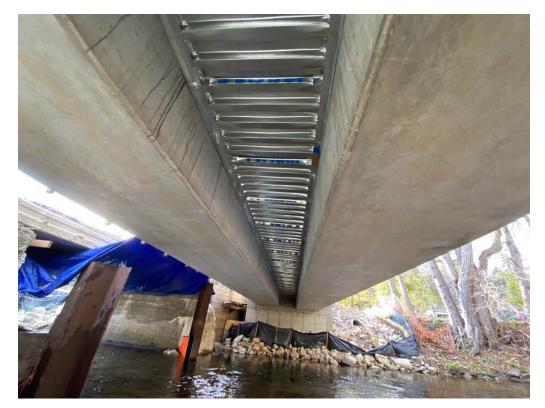
Photo 2: General underside, looking south.
