**Re: GE-Pittsfield/Housatonic River Site  
Rest of River (GECD850)  
2025 Annual Visual Inspection Report for Willow Mill Dam**

# 2025 Annual Visual Inspection Report Willow Mill Dam (MA00262) South Lee, Massachusetts

Date of Inspection: August 12, 2025

Date of Report: October 10, 2025

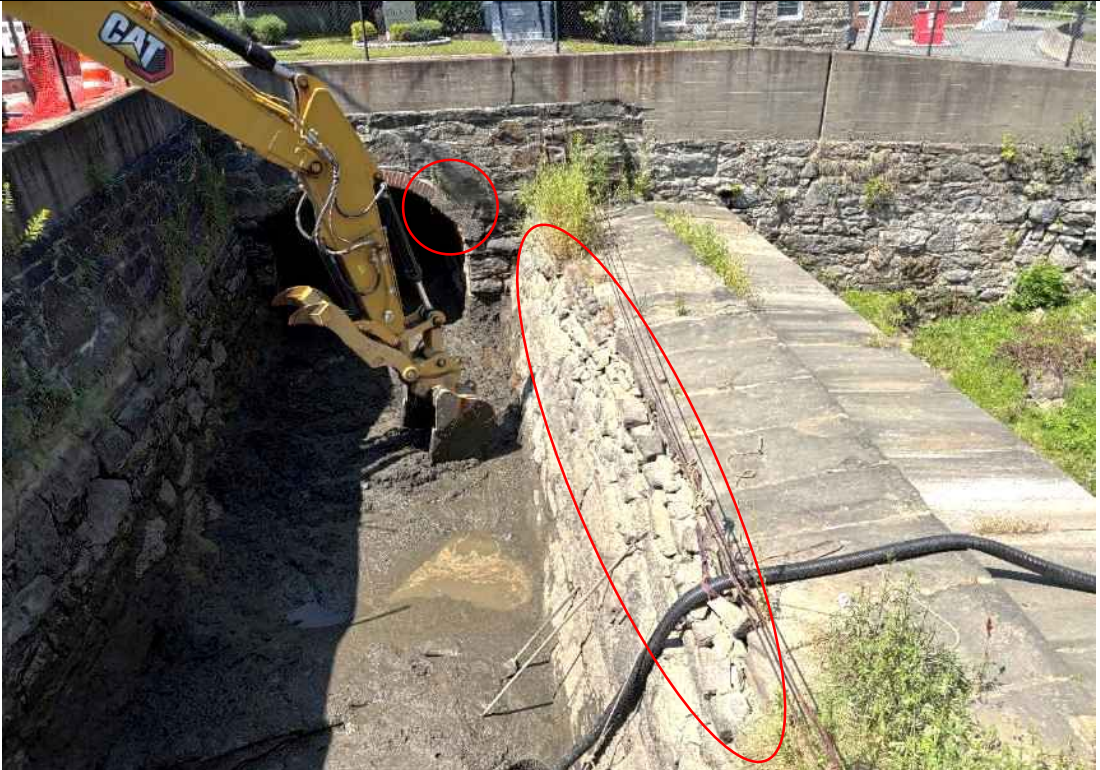
<b>Client Name:</b> General Electric Company		<b>Site Location:</b> Willow Mill Dam (MA00262) South Lee, MA	<b>Project No.</b> 01.0019896.72
<b>Photo No.</b> 5	<b>Date:</b> 8/12/2025

<b>Direction Photo Taken:</b> Downstream.			
<b>Description:</b> Canal and auxiliary spillway (waste weir) structure.  Note sediment removal operations were being performed during inspection and repairs to the canal and auxiliary spillway structure were performed in August and September of 2025.

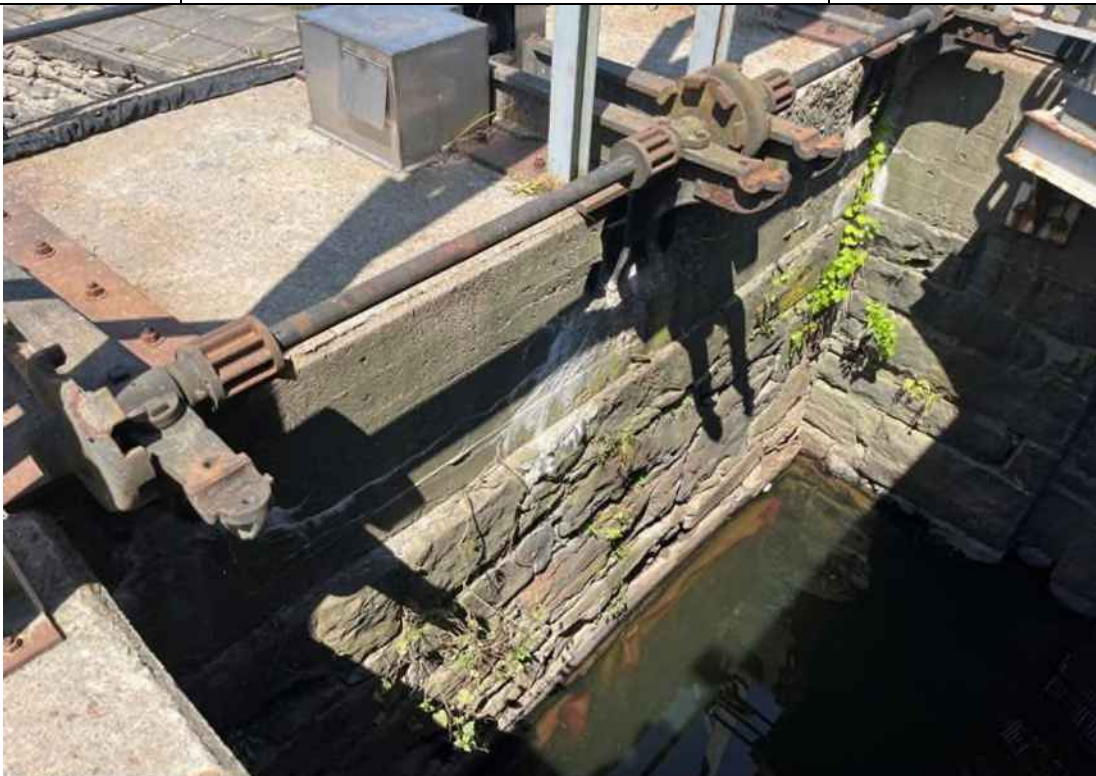
<b>Client Name:</b> General Electric Company		<b>Site Location:</b> Willow Mill Dam (MA00262) South Lee, MA	<b>Project No.</b> 01.0019896.72
<b>Photo No.</b> 7	<b>Date:</b> 8/12/2025

<b>Direction Photo Taken:</b> Downstream facing down.			
<b>Description:</b> Upstream side of the canal sluice gates.  Note missing mortar between the stone masonry blocks. Both gates had been removed to prepare for in-kind replacement.

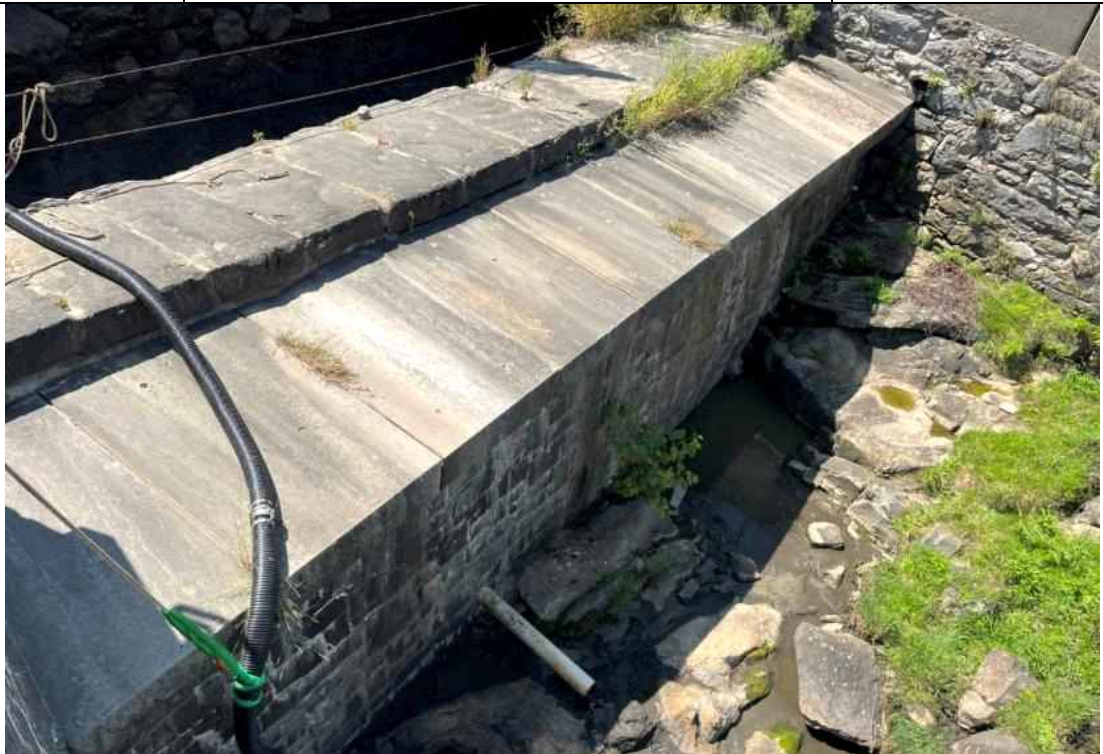
<b>Client Name:</b> General Electric Company		<b>Site Location:</b> Willow Mill Dam (MA00262) South Lee, MA	<b>Project No.</b> 01.0019896.72
<b>Photo No.</b> 11	<b>Date:</b> 8/12/2025

<b>Direction Photo Taken:</b> Downstream and left.			
<b>Description:</b> Overview of the auxiliary spillway (waste weir) from the canal sluice gate platform.  Note areas of missing mortar, particularly on sloping masonry downstream of weir. Vegetation growth in joints. Black corrugated pipe is for temporary canal dewatering. No flow from PVC canal drainpipe (at base of auxiliary spillway) due to temporary canal dewatering.

1. Complete the masonry joint repairs in the headrace canal walls by repointing the downstream auxiliary spillway masonry joints during the next scheduled planned maintenance activities [Checklist Item 72]. In the interim, this condition should be monitored, and if observed to worsen, expedited repairs should be made.

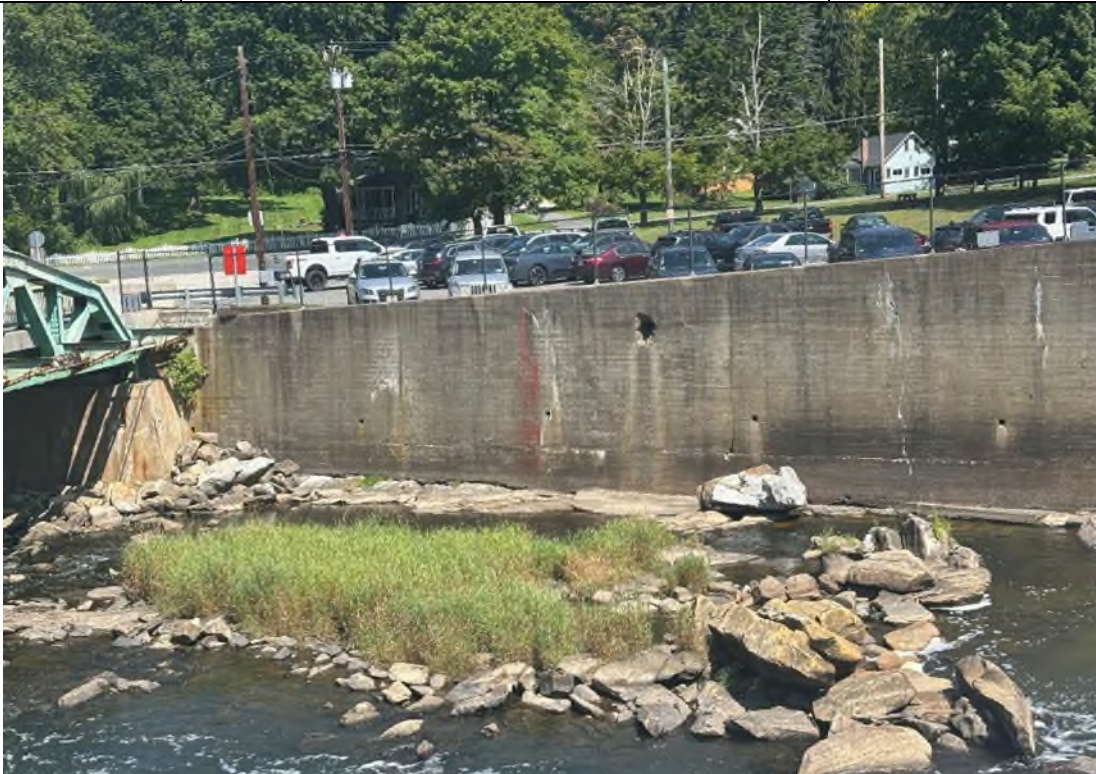
<b>Client Name:</b> General Electric Company		<b>Site Location:</b> Willow Mill Dam (MA00262) South Lee, MA	<b>Project No.</b> 01.0019896.72
<b>Photo No.</b> 15	<b>Date:</b> 8/12/2025

Minor cracking and efflorescence were observed in the right-side training wall downstream of the river outlet control structure.

<b>Direction Photo Taken:</b> Right.			
<b>Description:</b> Right downstream concrete training wall.  Minor cracking and efflorescence of the concrete observed.

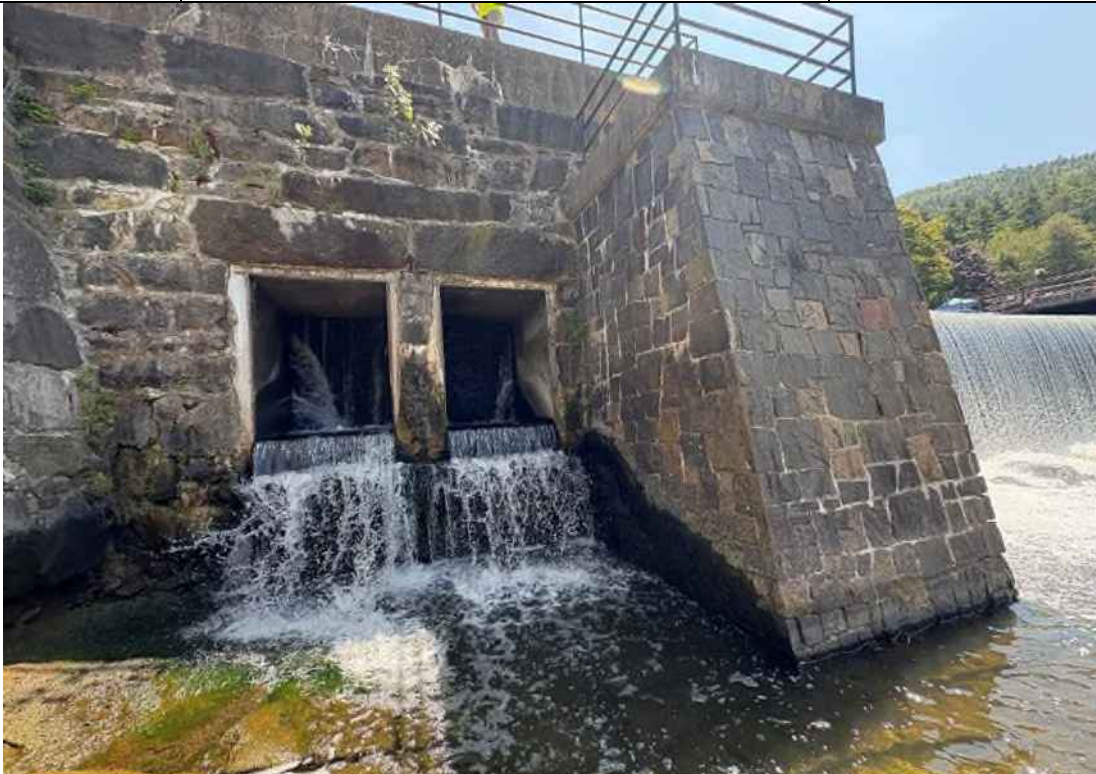
<b>Client Name:</b> General Electric Company		<b>Site Location:</b> Willow Mill Dam (MA00262) South Lee, MA	<b>Project No.</b> 01.0019896.72
<b>Photo No.</b> 17	<b>Date:</b> 8/12/2025

Minor leakage through Gate #1 and Gate #2 was observed during the inspection. The leakage appeared similar to that observed during the 2024 annual inspection.

<b>Direction Photo Taken:</b> Upstream.			
<b>Description:</b> Downstream side of the river outlet control structure.  Note minor leakage through both gates.

2. Continue to monitor the leakage observed through the river outlet works (control structure) gates [Checklist Items 48 and 53].
3. Continue to monitor the deteriorated mortar joints, minor cracking, and efflorescence at the river outlet works (control structure) [Checklist Items 56, 57, 58].

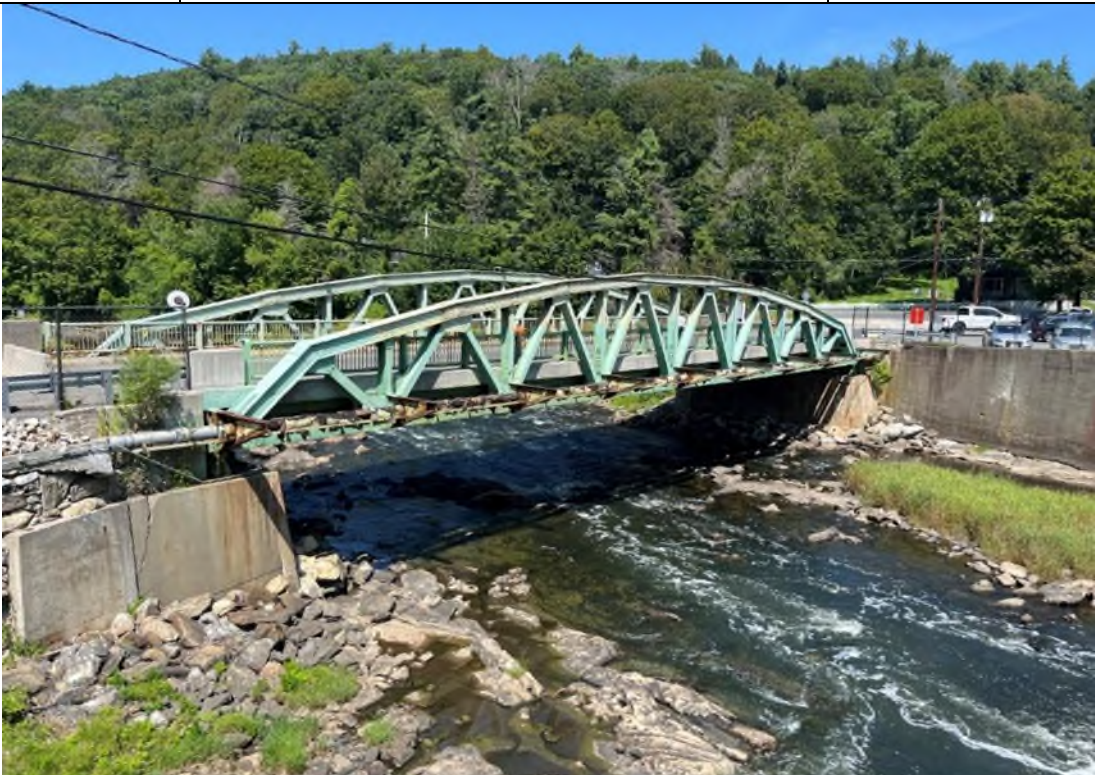
<b>Client Name:</b> General Electric Company		<b>Site Location:</b> Willow Mill Dam (MA00262) South Lee, MA	<b>Project No.</b> 01.0019896.72
<b>Photo No.</b> 19	<b>Date:</b> 8/12/2025

<b>Direction Photo Taken:</b> Downstream.			
<b>Description:</b> Downstream of dam and bridge from power canal sluiceway platform.

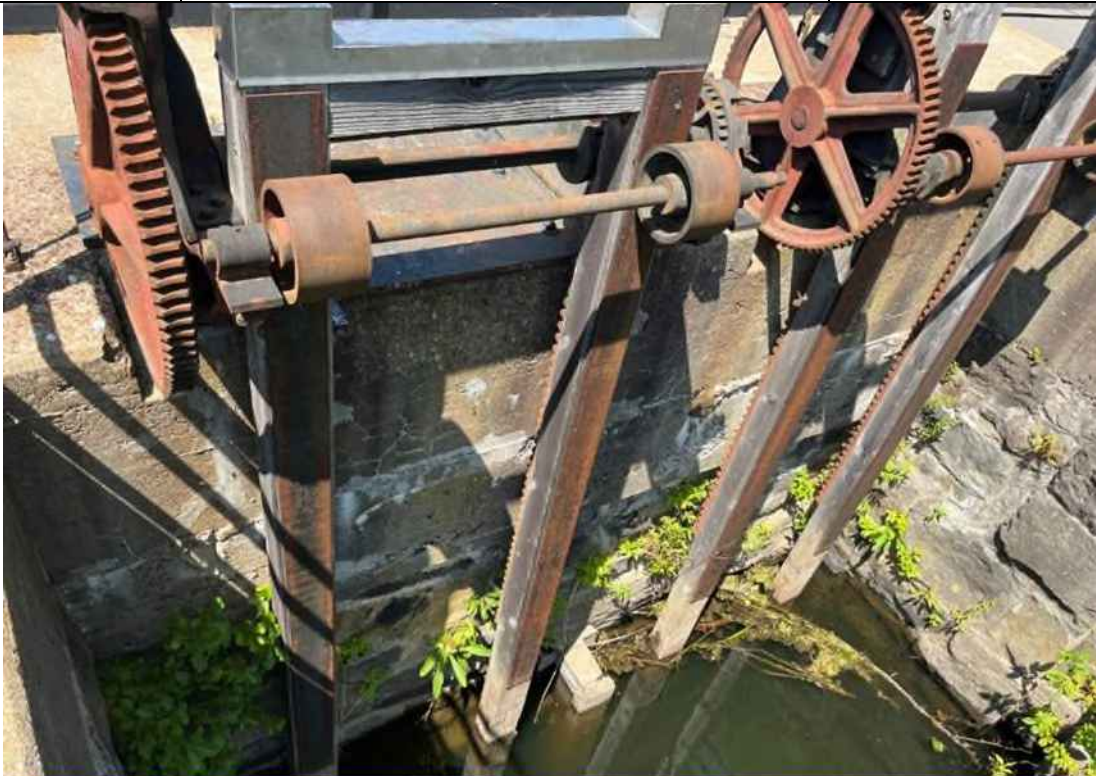
<b>Client Name:</b> General Electric Company		<b>Site Location:</b> Willow Mill Dam (MA00262) South Lee, MA	<b>Project No.</b> 01.0019896.72
<b>Photo No.</b> 23	<b>Date:</b> 8/12/2025

<b>Direction Photo Taken:</b> Downstream.			
<b>Description:</b> Upstream side of the river outlet control structure gate operators (Gate 1 on the right and Gate 2 on the left).

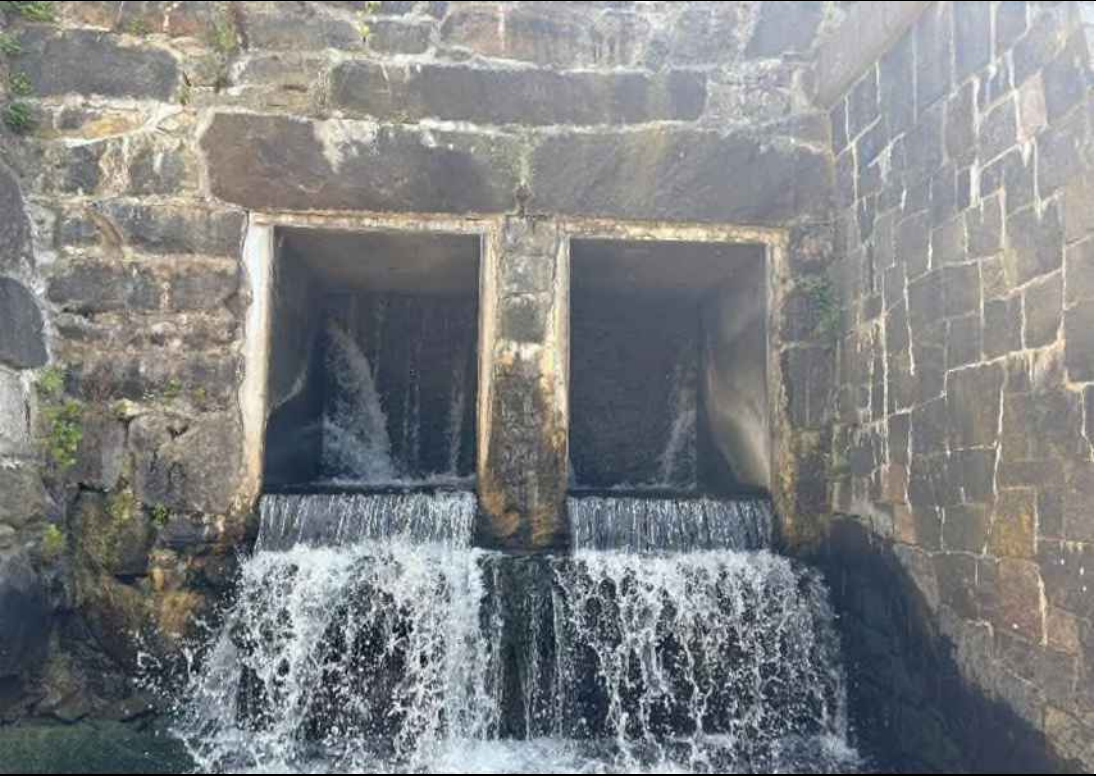
<b>Client Name:</b> General Electric Company		<b>Site Location:</b> Willow Mill Dam (MA00262) South Lee, MA	<b>Project No.</b> 01.0019896.72
<b>Photo No.</b> 29	<b>Date:</b> 8/12/2025

<b>Direction Photo Taken:</b> Upstream.			
<b>Description:</b> Closeup of river outlet control structure gates.  Note: Minor leakage through the gates.

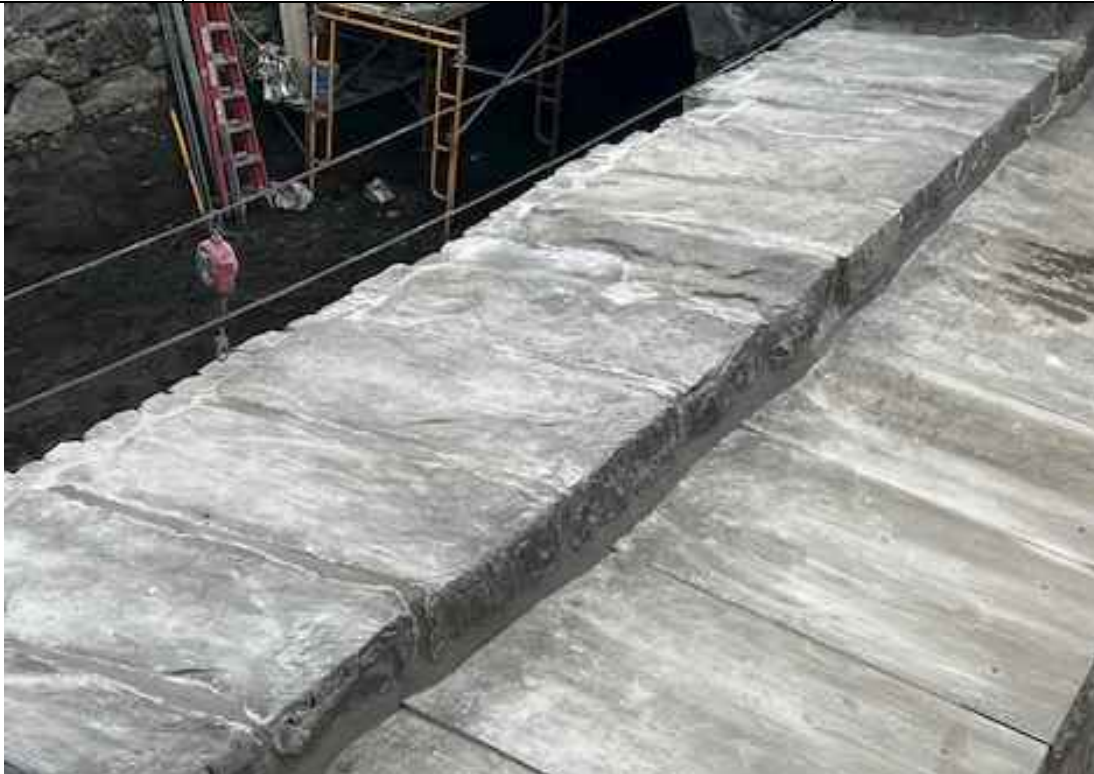
<b>Client Name:</b> General Electric Company		<b>Site Location:</b> Willow Mill Dam (MA00262) South Lee, MA	<b>Project No.</b> 01.0019896.72
<b>Photo No.</b> 3

<b>Direction Photo Taken:</b> Downstream			
<b>Description:</b> Crest of the repaired auxiliary spillway. Note repointed mortar joints.
