**Re: GE-Pittsfield/Housatonic River Site
Silver Lake Area (GECD600)
2025 Cap Maintenance Summary Report**

**GE-Pittsfield/Housatonic River Site
Silver Lake Area (GECD600)
2025 Cap Maintenance Summary Report**

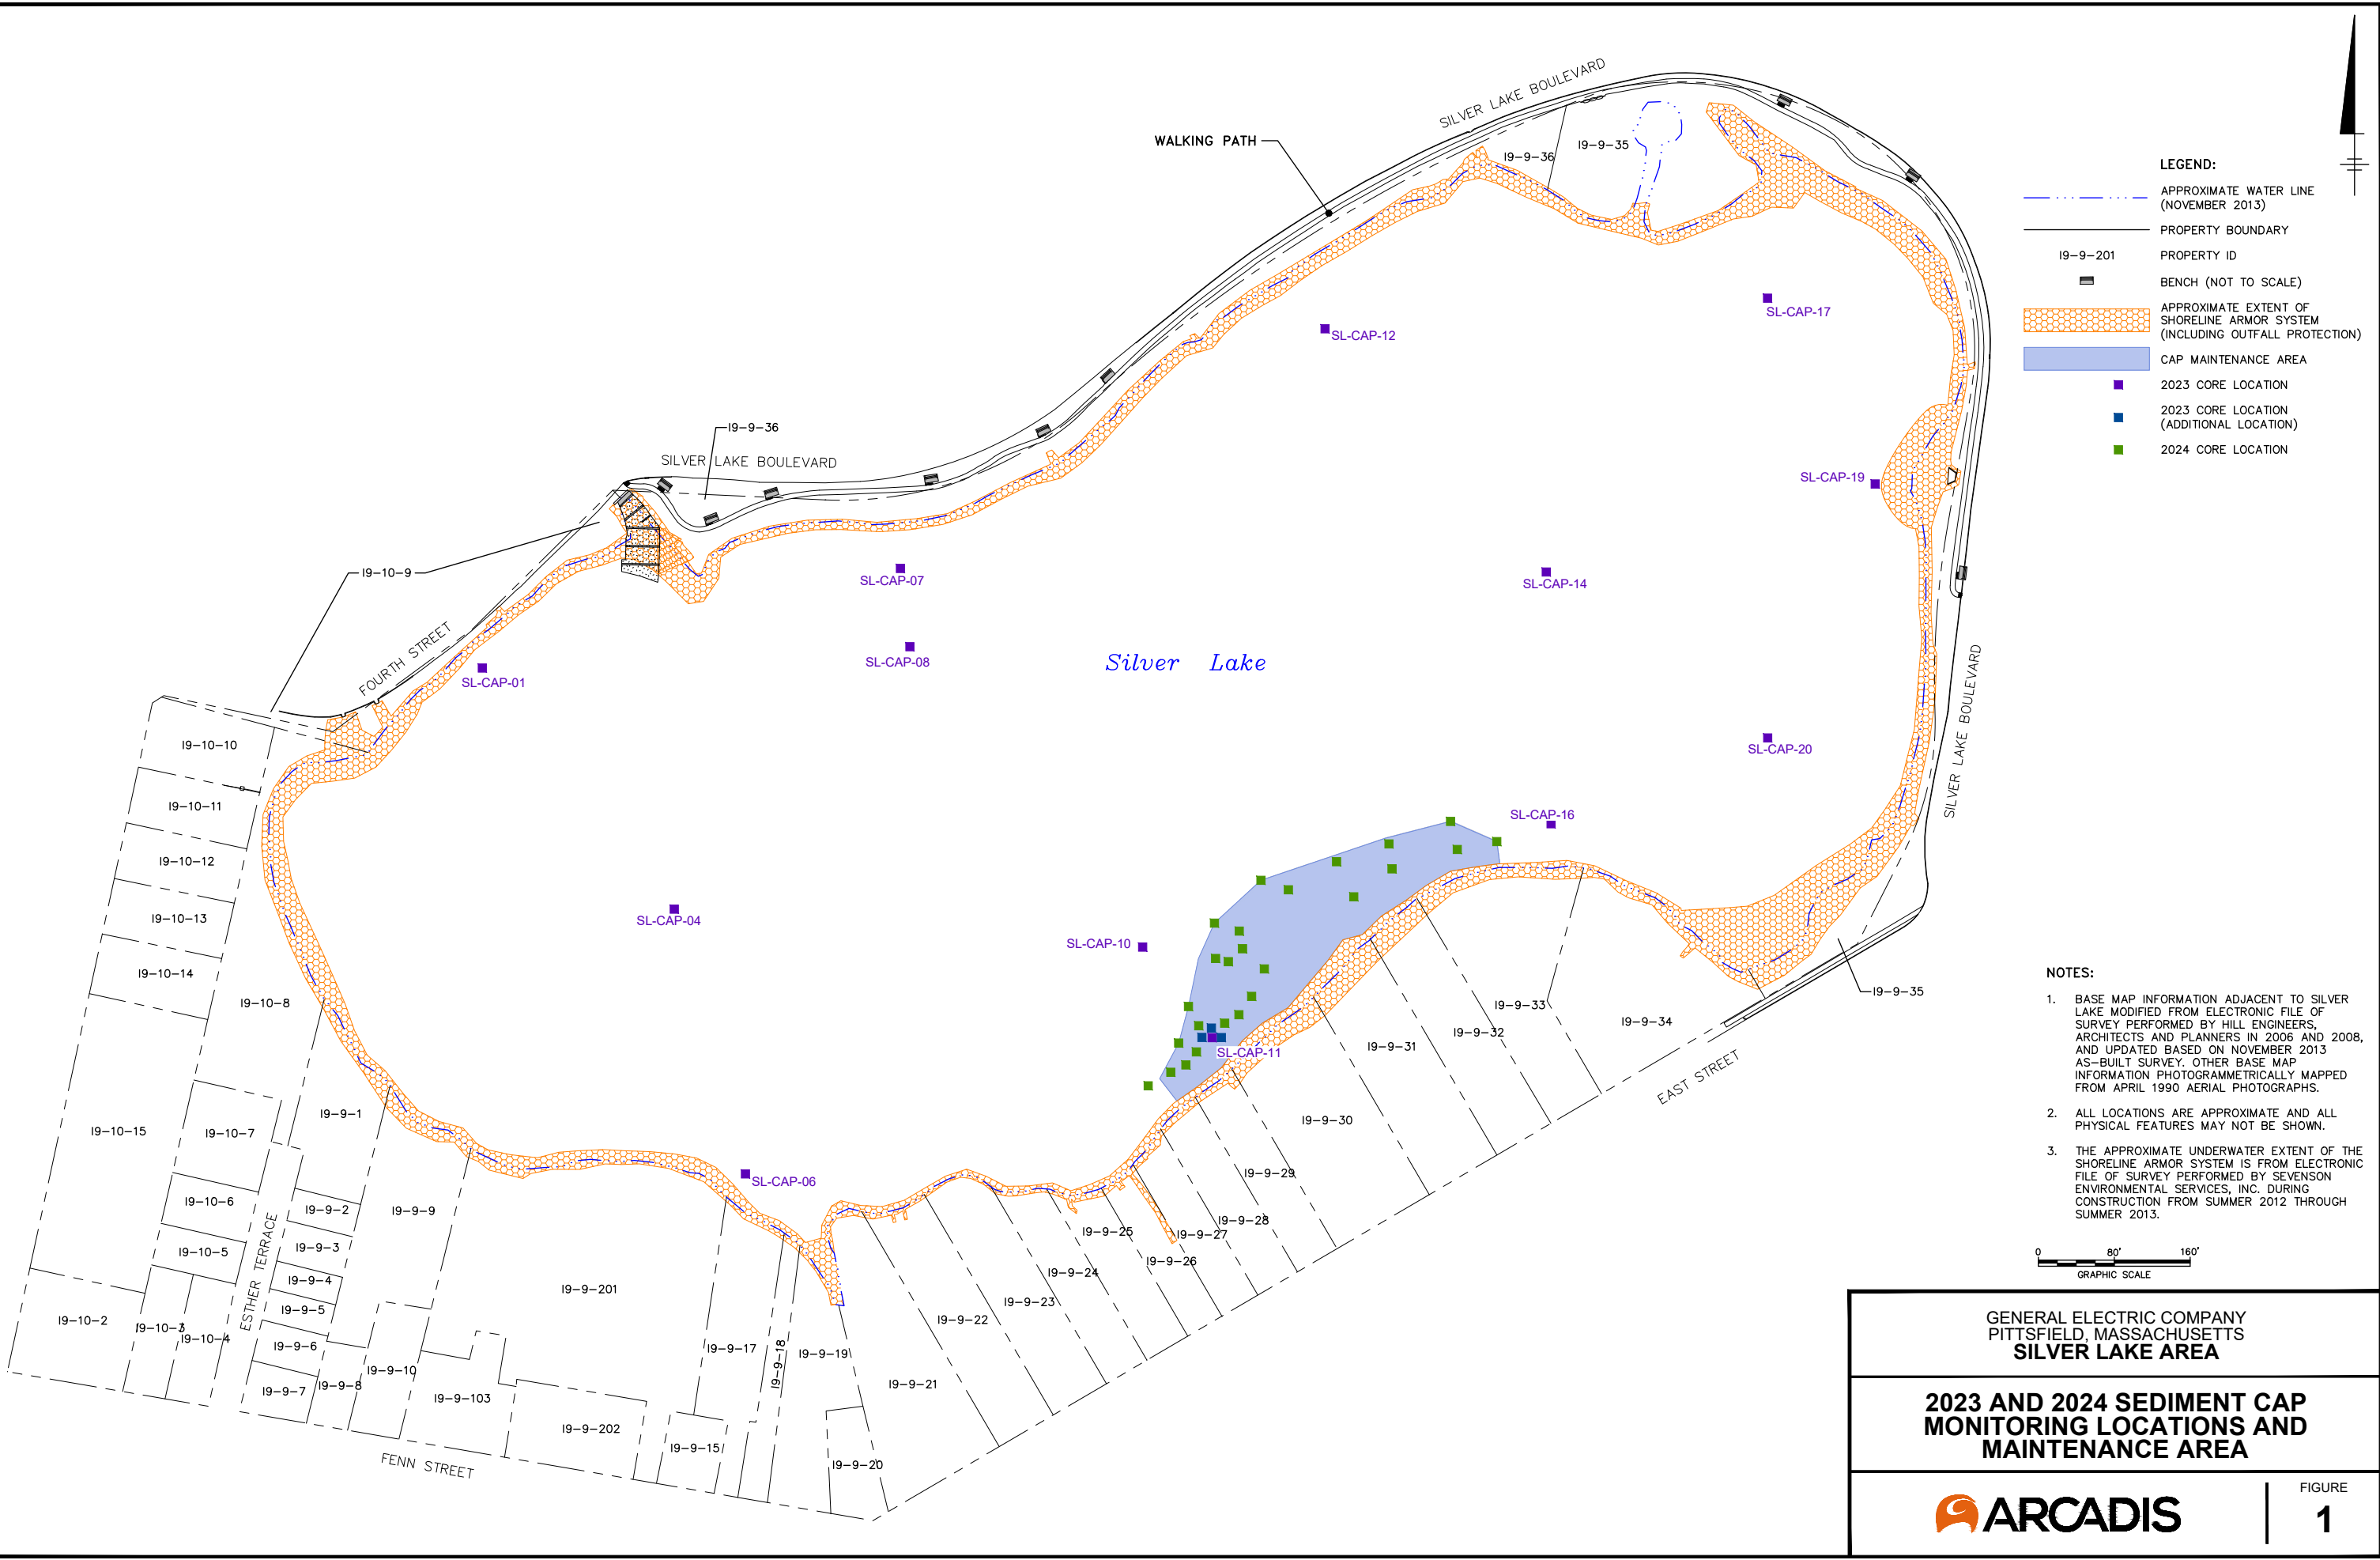
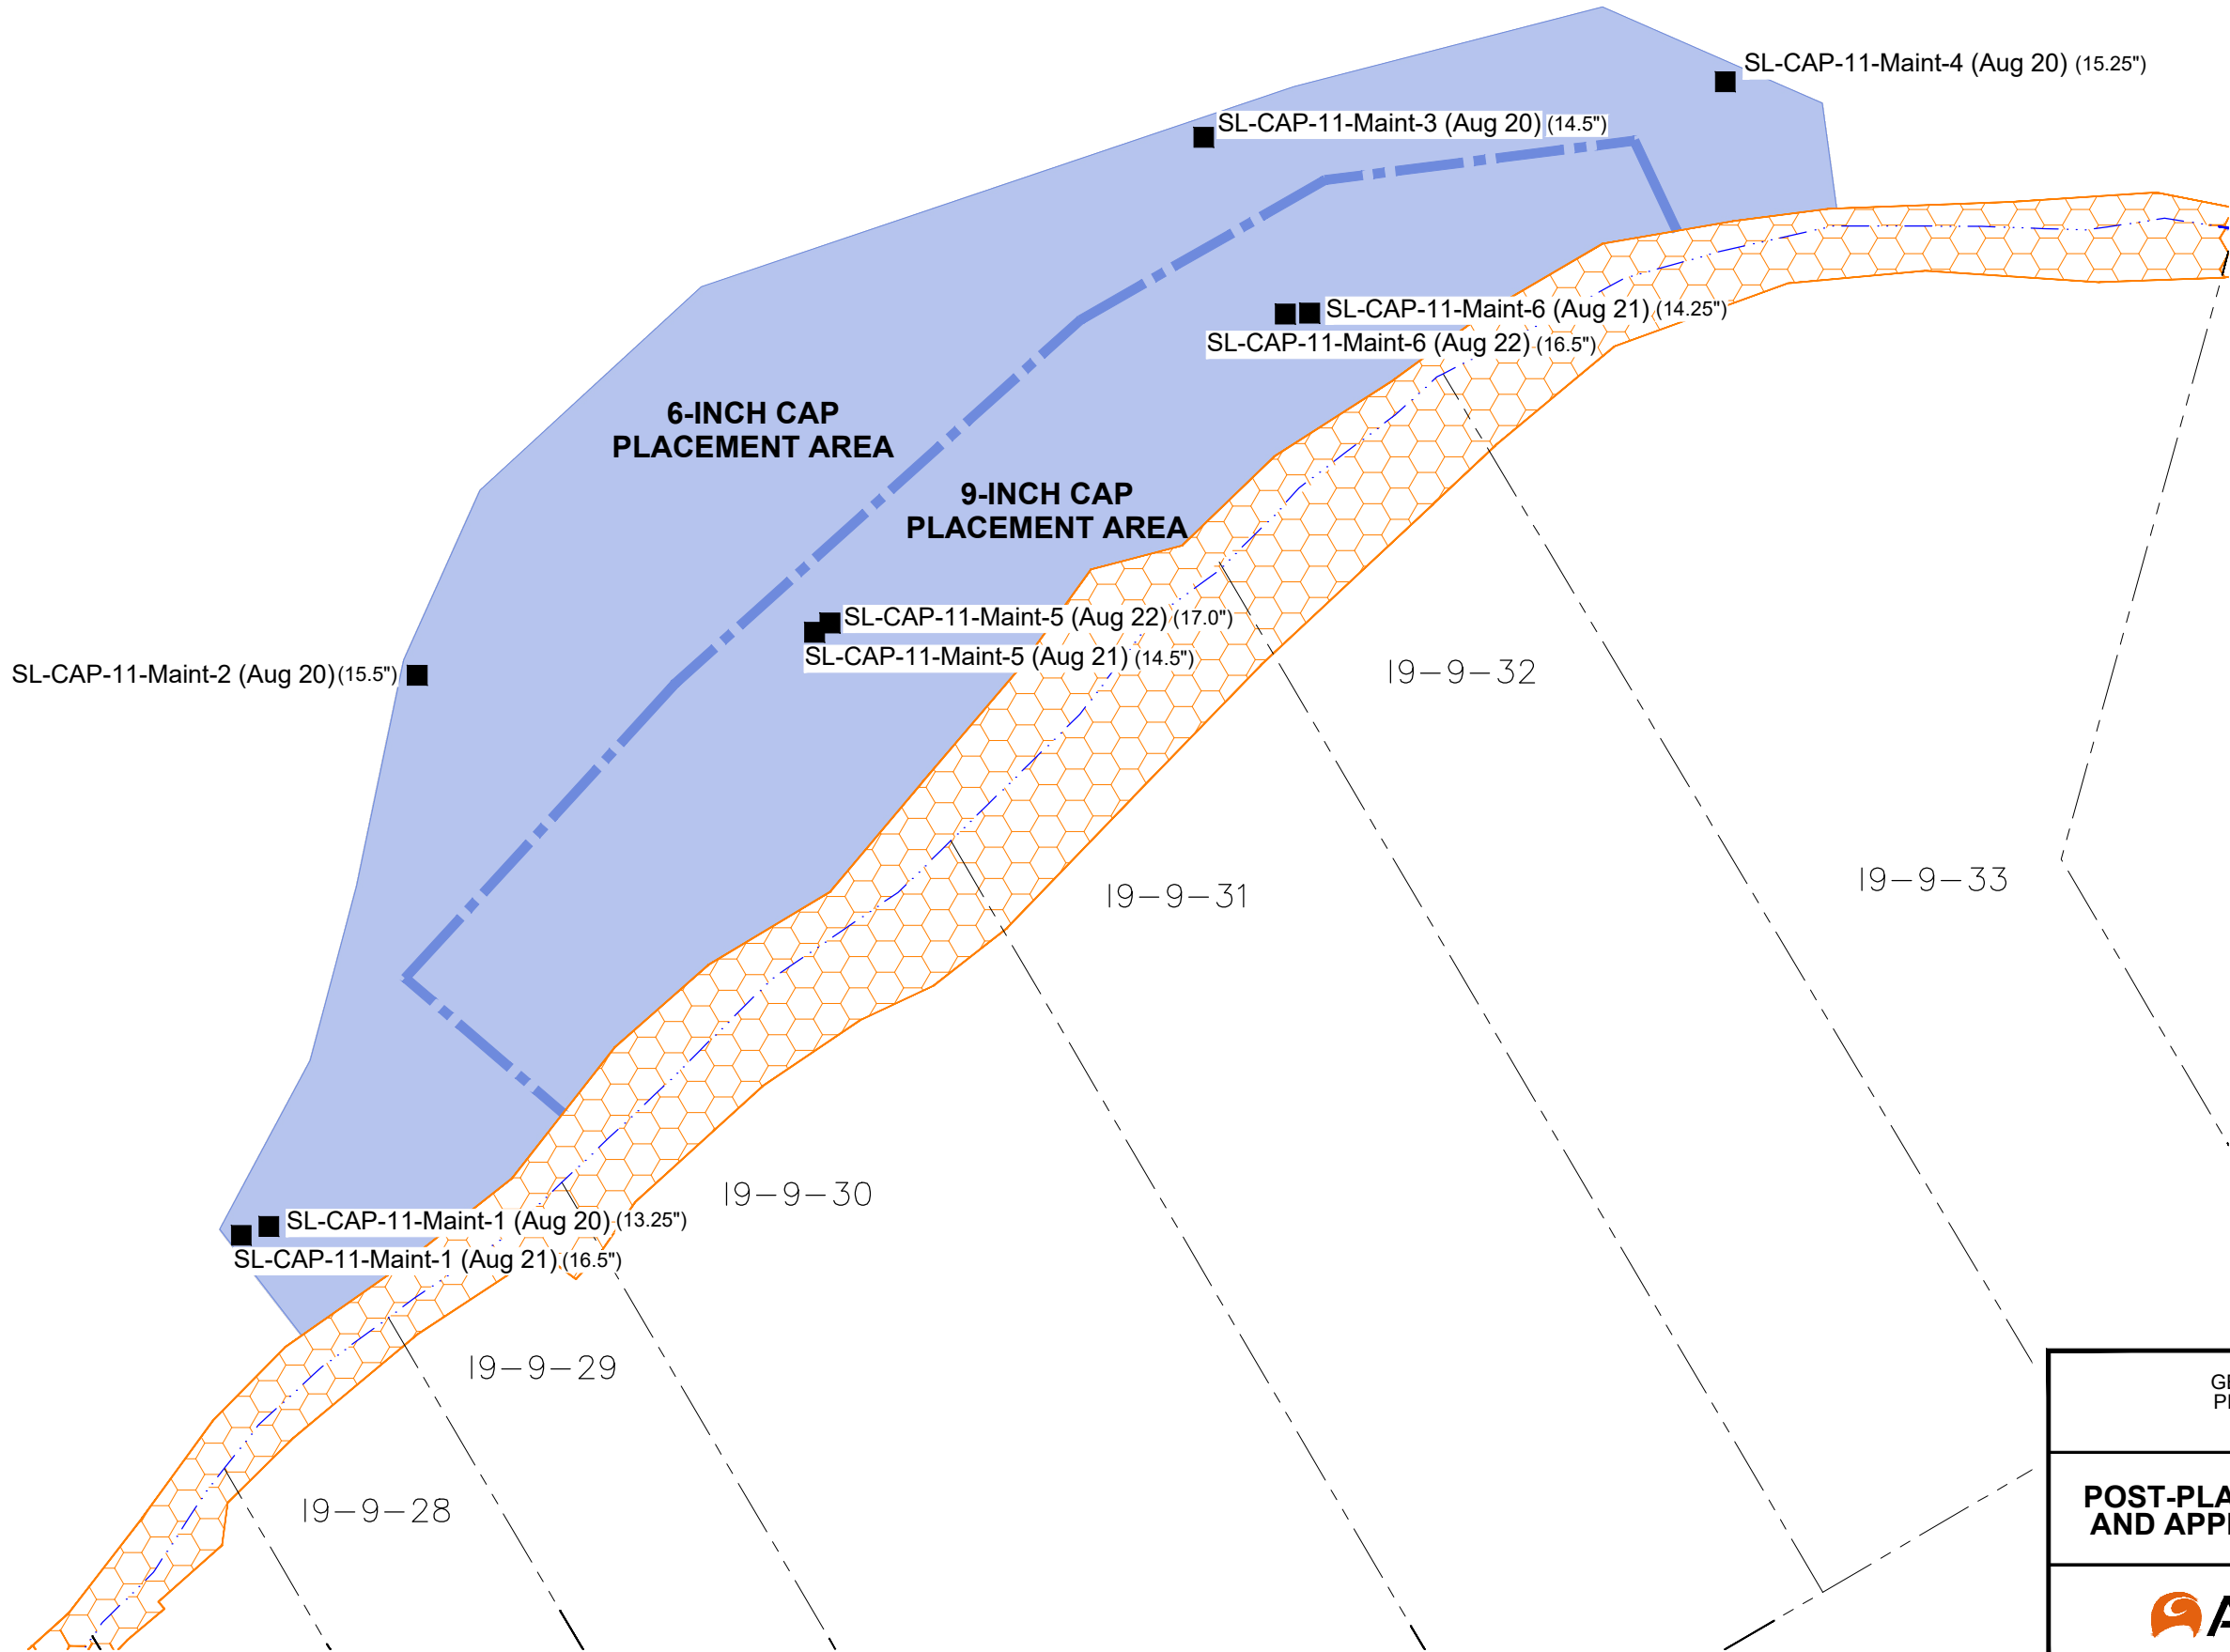
FIGURE
2

Between August 14 and 22, 2025, GE placed an additional six to nine inches of cap material, respectively, in the six-inch and nine-inch cap placement areas illustrated on Figure 2, covering an area of approximately 34,000 square feet. A total of nearly 1,500 cy of material was placed. Work was performed in accordance with the approved work plan by mechanically placing thin lifts of cap materials through the water column from a floating platform. Each lift was placed across the entire area proposed for maintenance before starting the next lift. Throughout cap placement activities, the area to be capped was monitored routinely to provide interim information to the contractor on cap thickness. Such monitoring consisted of use of standard geolocation technology (e.g., RTK-GPS) on the mechanical placement equipment and routine surveys.

GE continued to place material across the nine-inch cap placement area, and then placed an extra lift of material in the area around one of the previously sampled locations in that area (SL-CAP-11-5th-NE), as required by the November 2024 letter. After all of the required cap maintenance activities were completed, on August 21, 2025, GE collected the post-placement thickness monitoring cores at the two locations designated in the November 2024 letter within the nine-inch cap placement area (i.e., locations SL-CAP-11-Maint-5 and -6 illustrated on Figure 2). The core measurements indicated that placement achieved the performance standard thickness of 14 inches at all locations. However, as a conservative measure, GE placed additional cap material, up to the 1,500 cy total volume approved by EPA, across all of the nine-inch cap placement area and a portion of the six-inch cap placement area. Following installation of the additional cap material, GE re-collected post-placement thickness monitoring cores at SL-CAP-11-Maint-5 and -6 on August 22, 2025, which confirmed the total thickness of the installed cap. The final thickness results are included in Table 1 and illustrated on Figure 2.

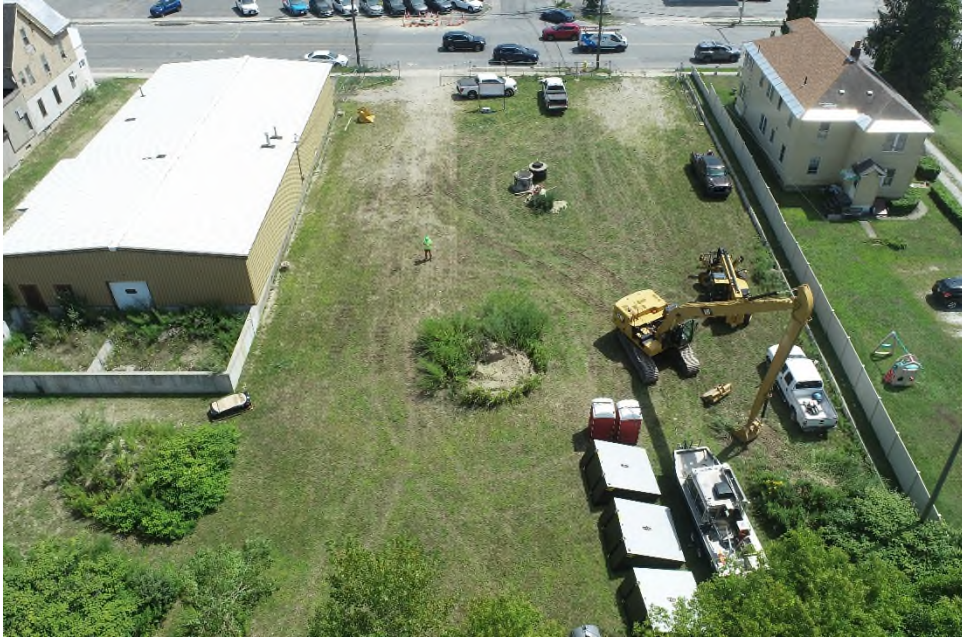
Photograph: 1

Description:
Mobilization of
equipment

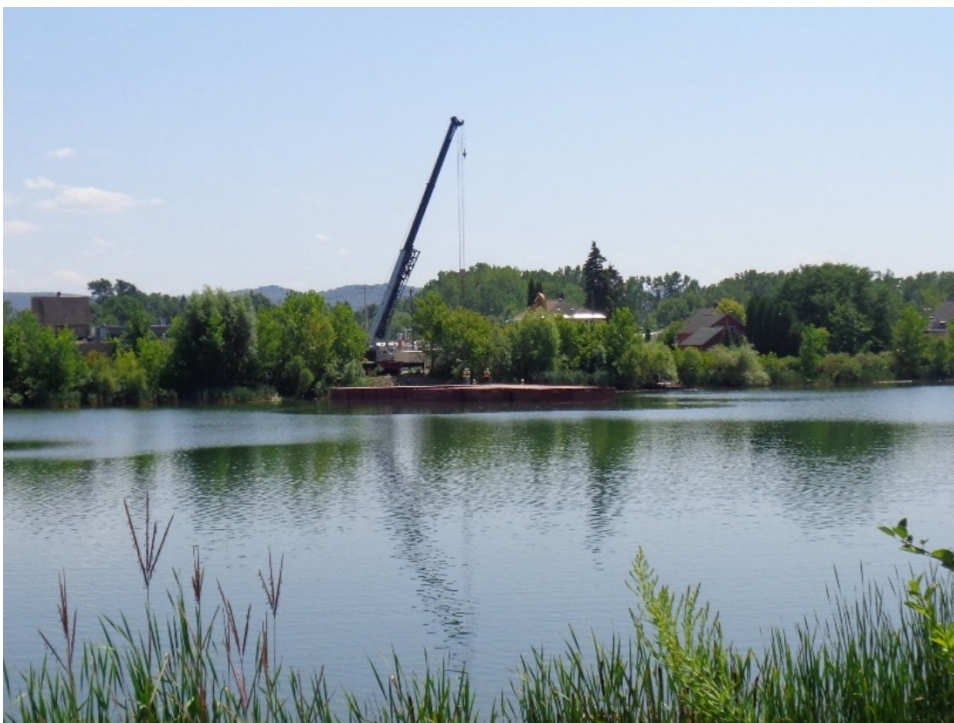
Photograph: 2

Description:
Mobilization of
equipment

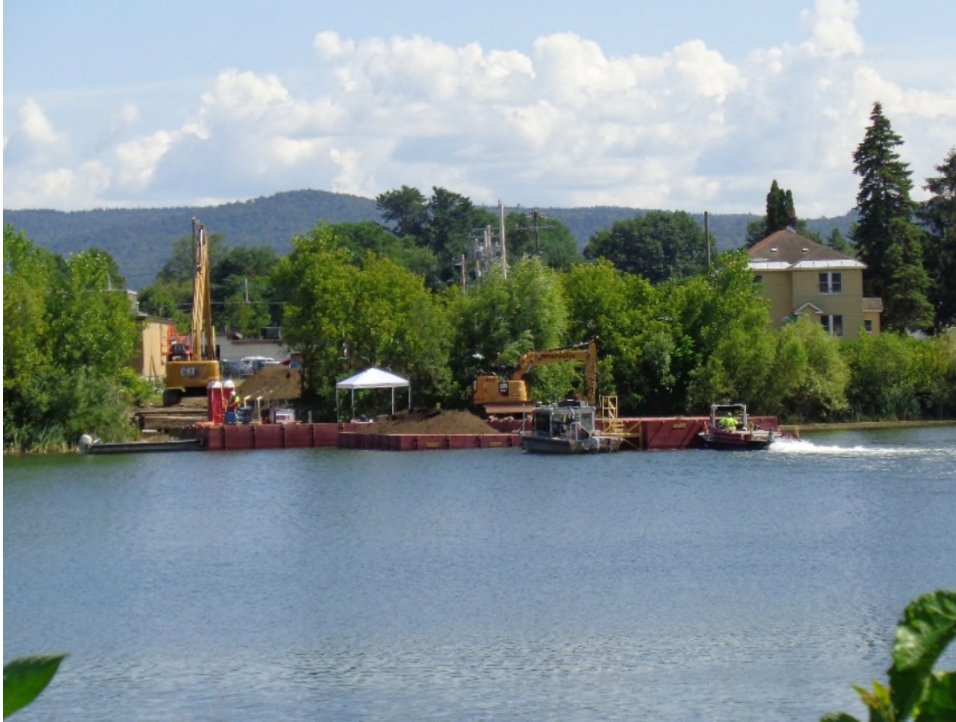
Photograph: 3

Description: Cap placement activities

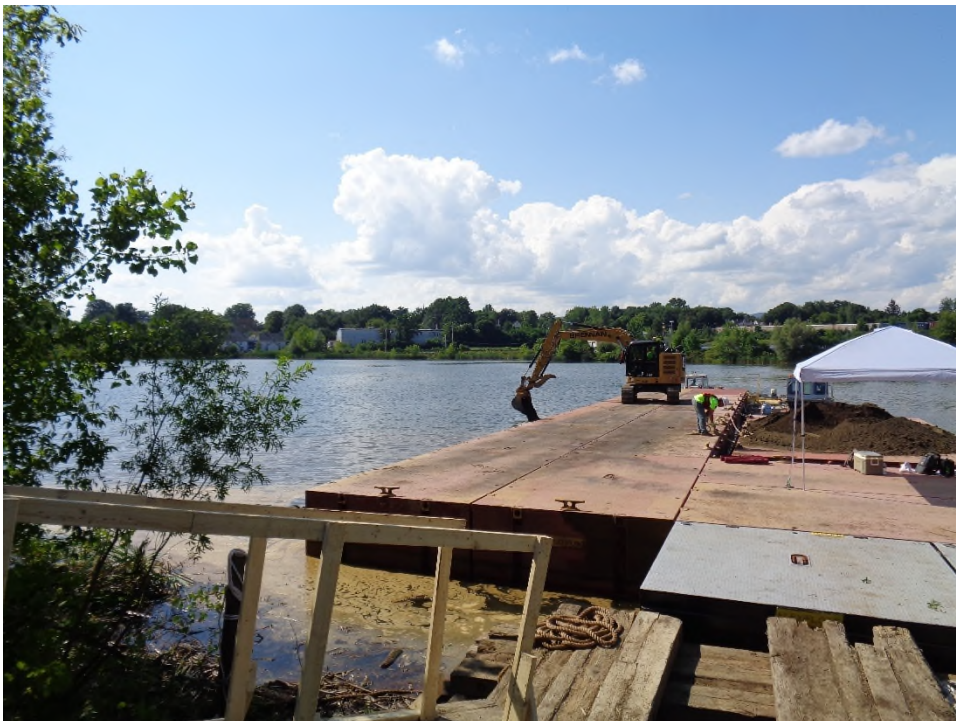
Photograph: 4

Description: Cap placement activities

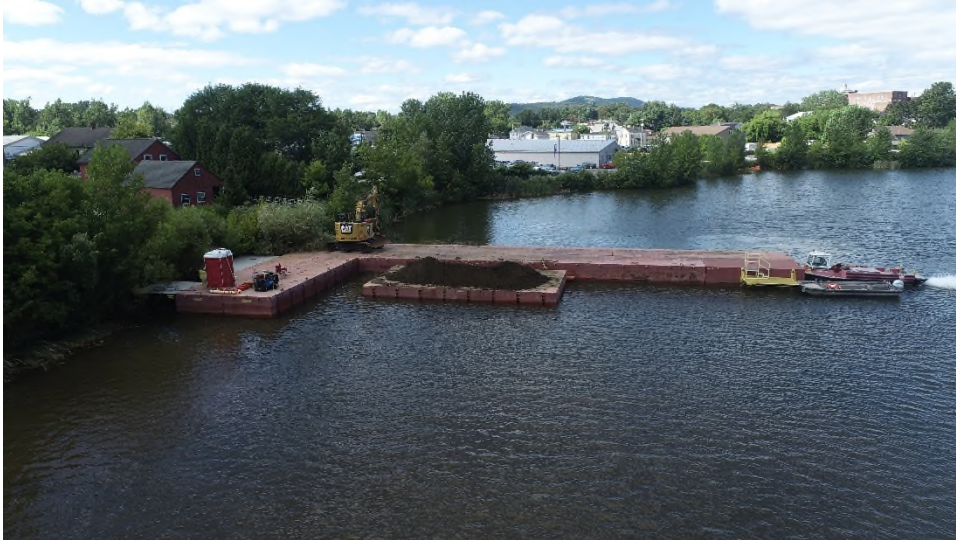
Photograph: 5

Description: Aerial view of cap placement activities

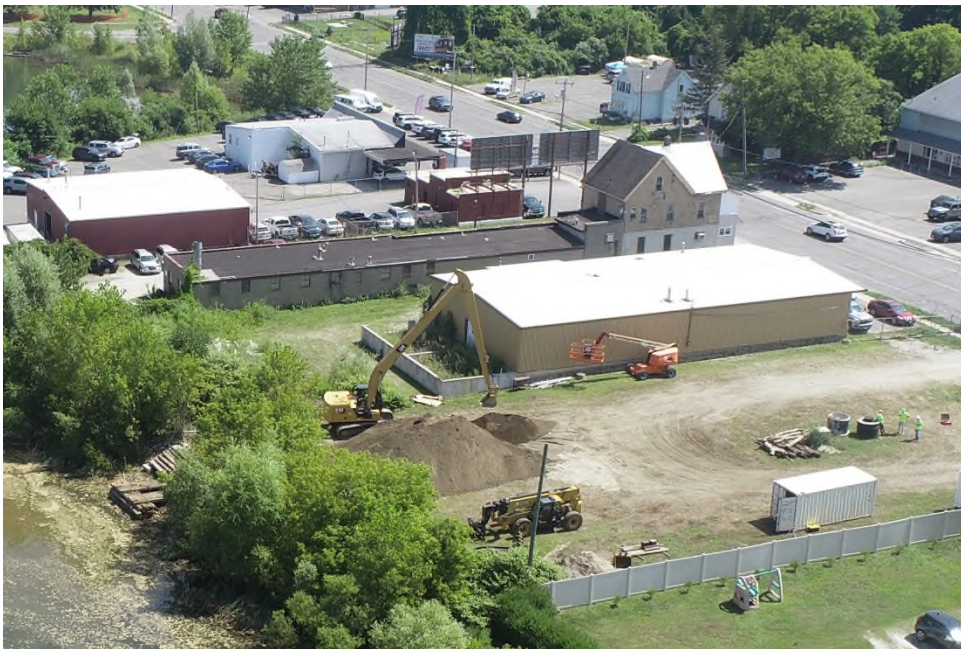
Photograph: 6

Description: View of staging area during cap placement activities

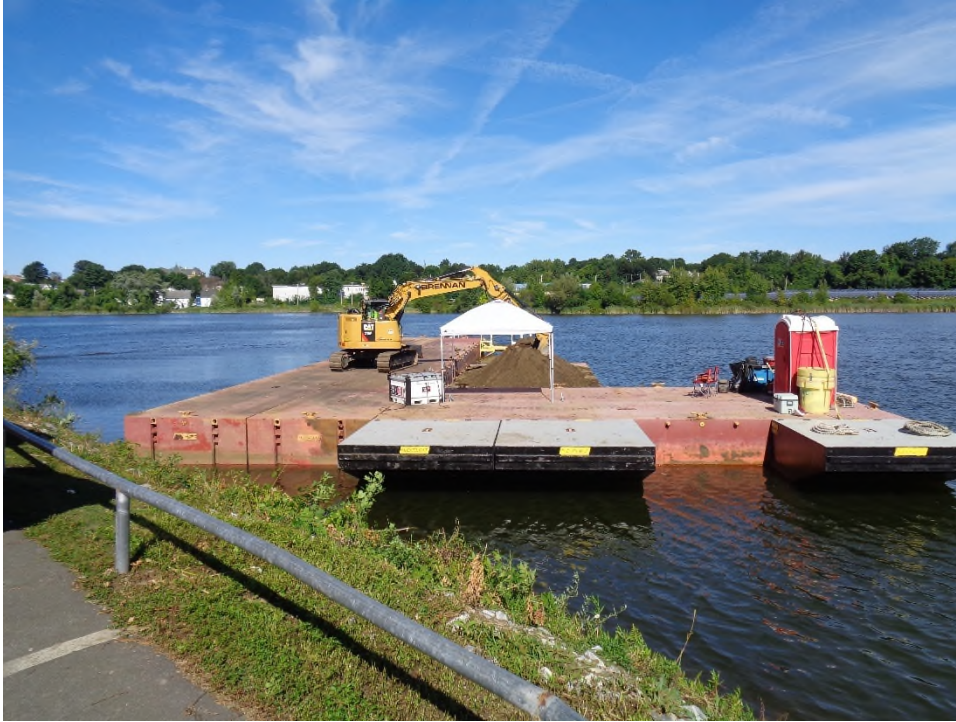
Photograph: 7

Description: Cap placement activities

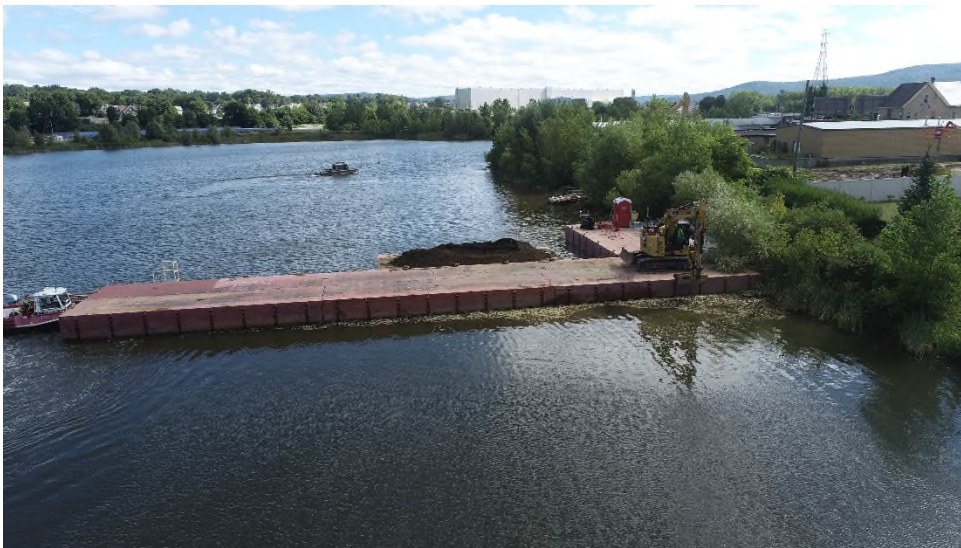
Photograph: 8

Description: Aerial view of cap placement activities

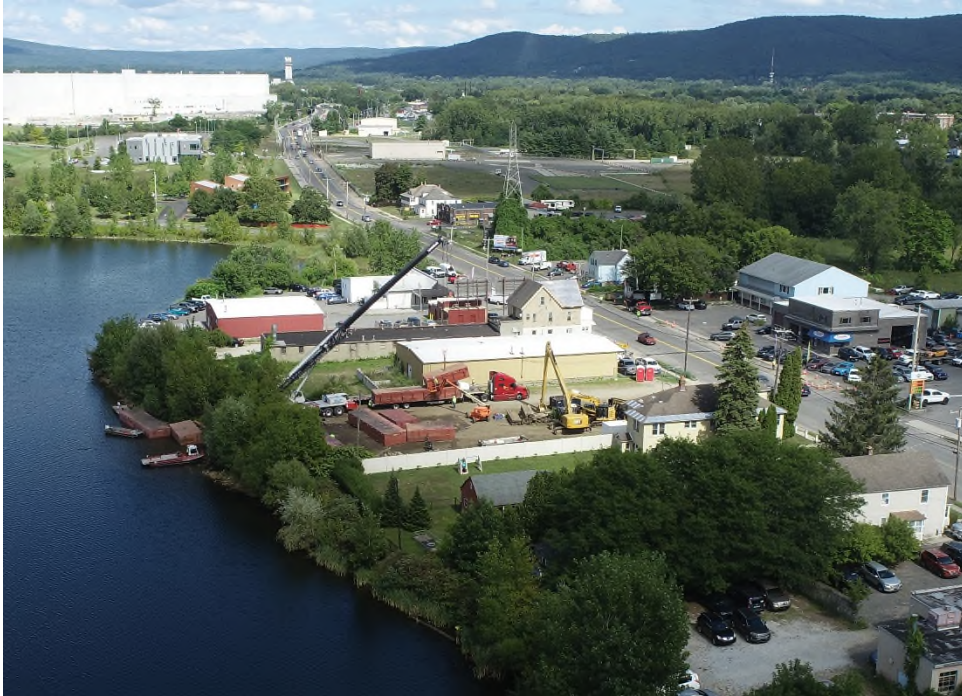
Photograph: 9

Description:
Demobilization of
equipment/materials

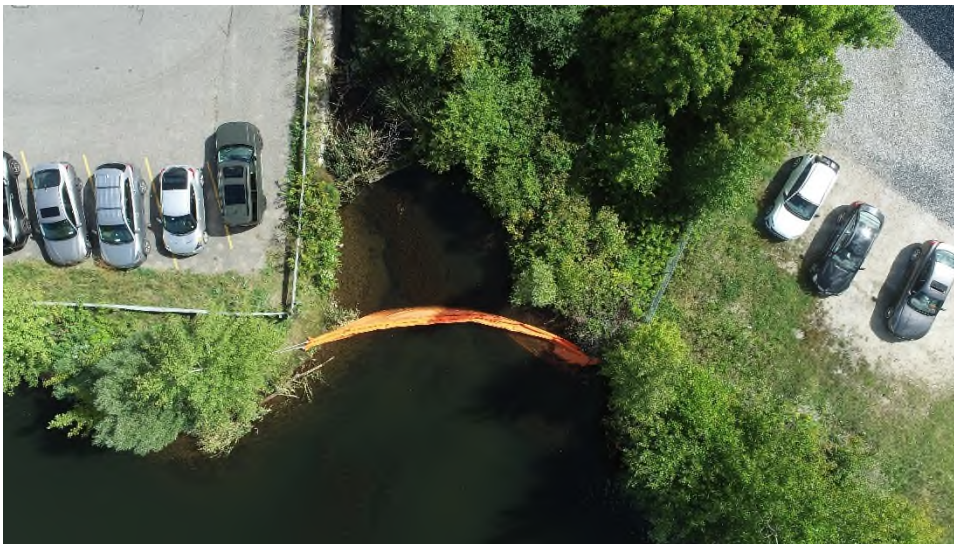
Photograph: 10

Description: View of
similar water clarity on
both sides of turbidity
curtain, after
completion of cap
placement activities
and before removal of
turbidity curtain

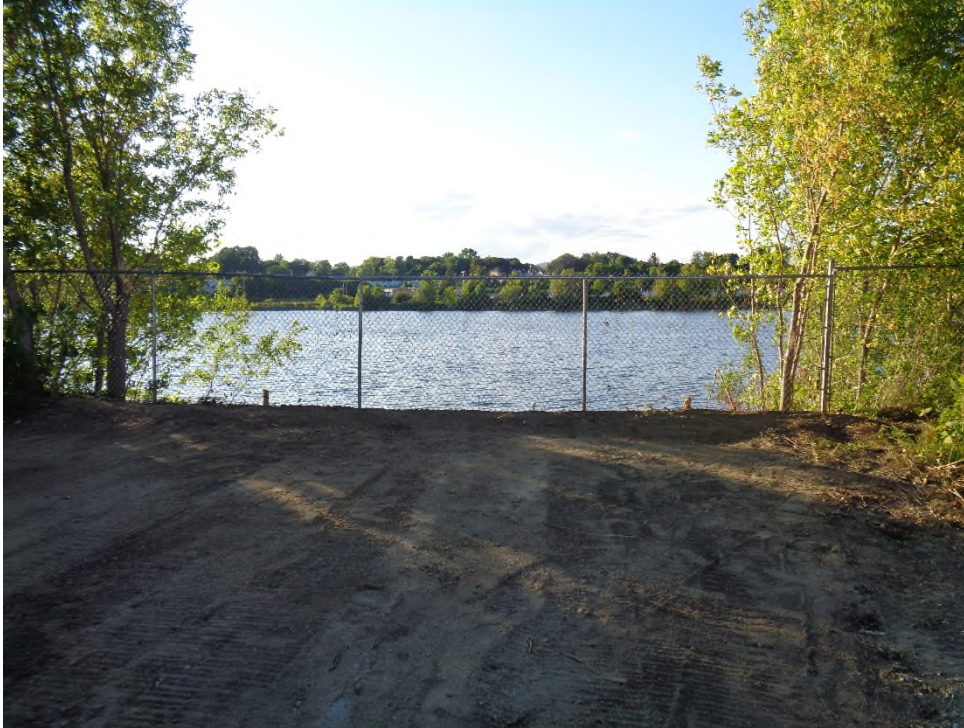
Photograph: 11

Description: Restored
bank access area

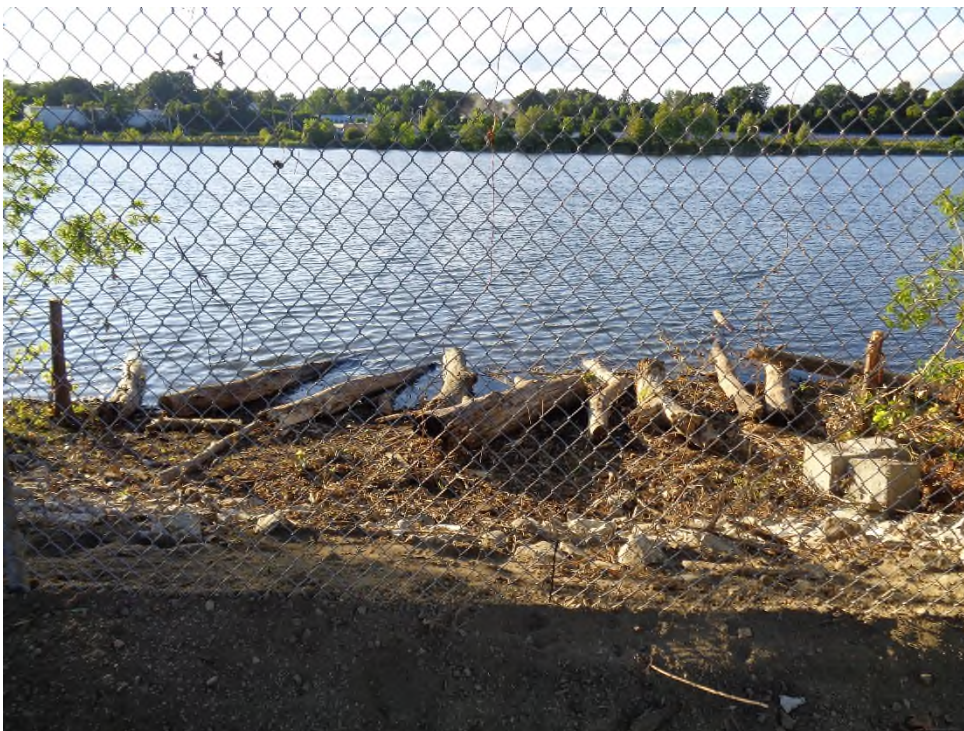
Photograph: 12

Description: Replaced
large woody debris

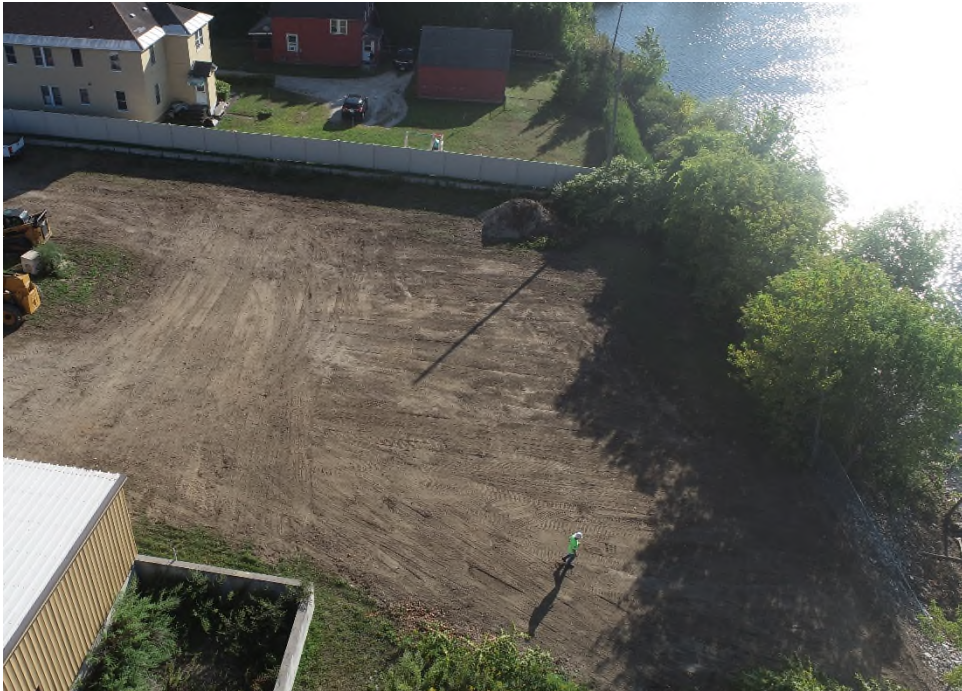
Photograph: 13

Demobilization of
equipment/materials
and restoration of
access area
