**Kevin Mooney**

Senior Project Manager  
GE Aerospace

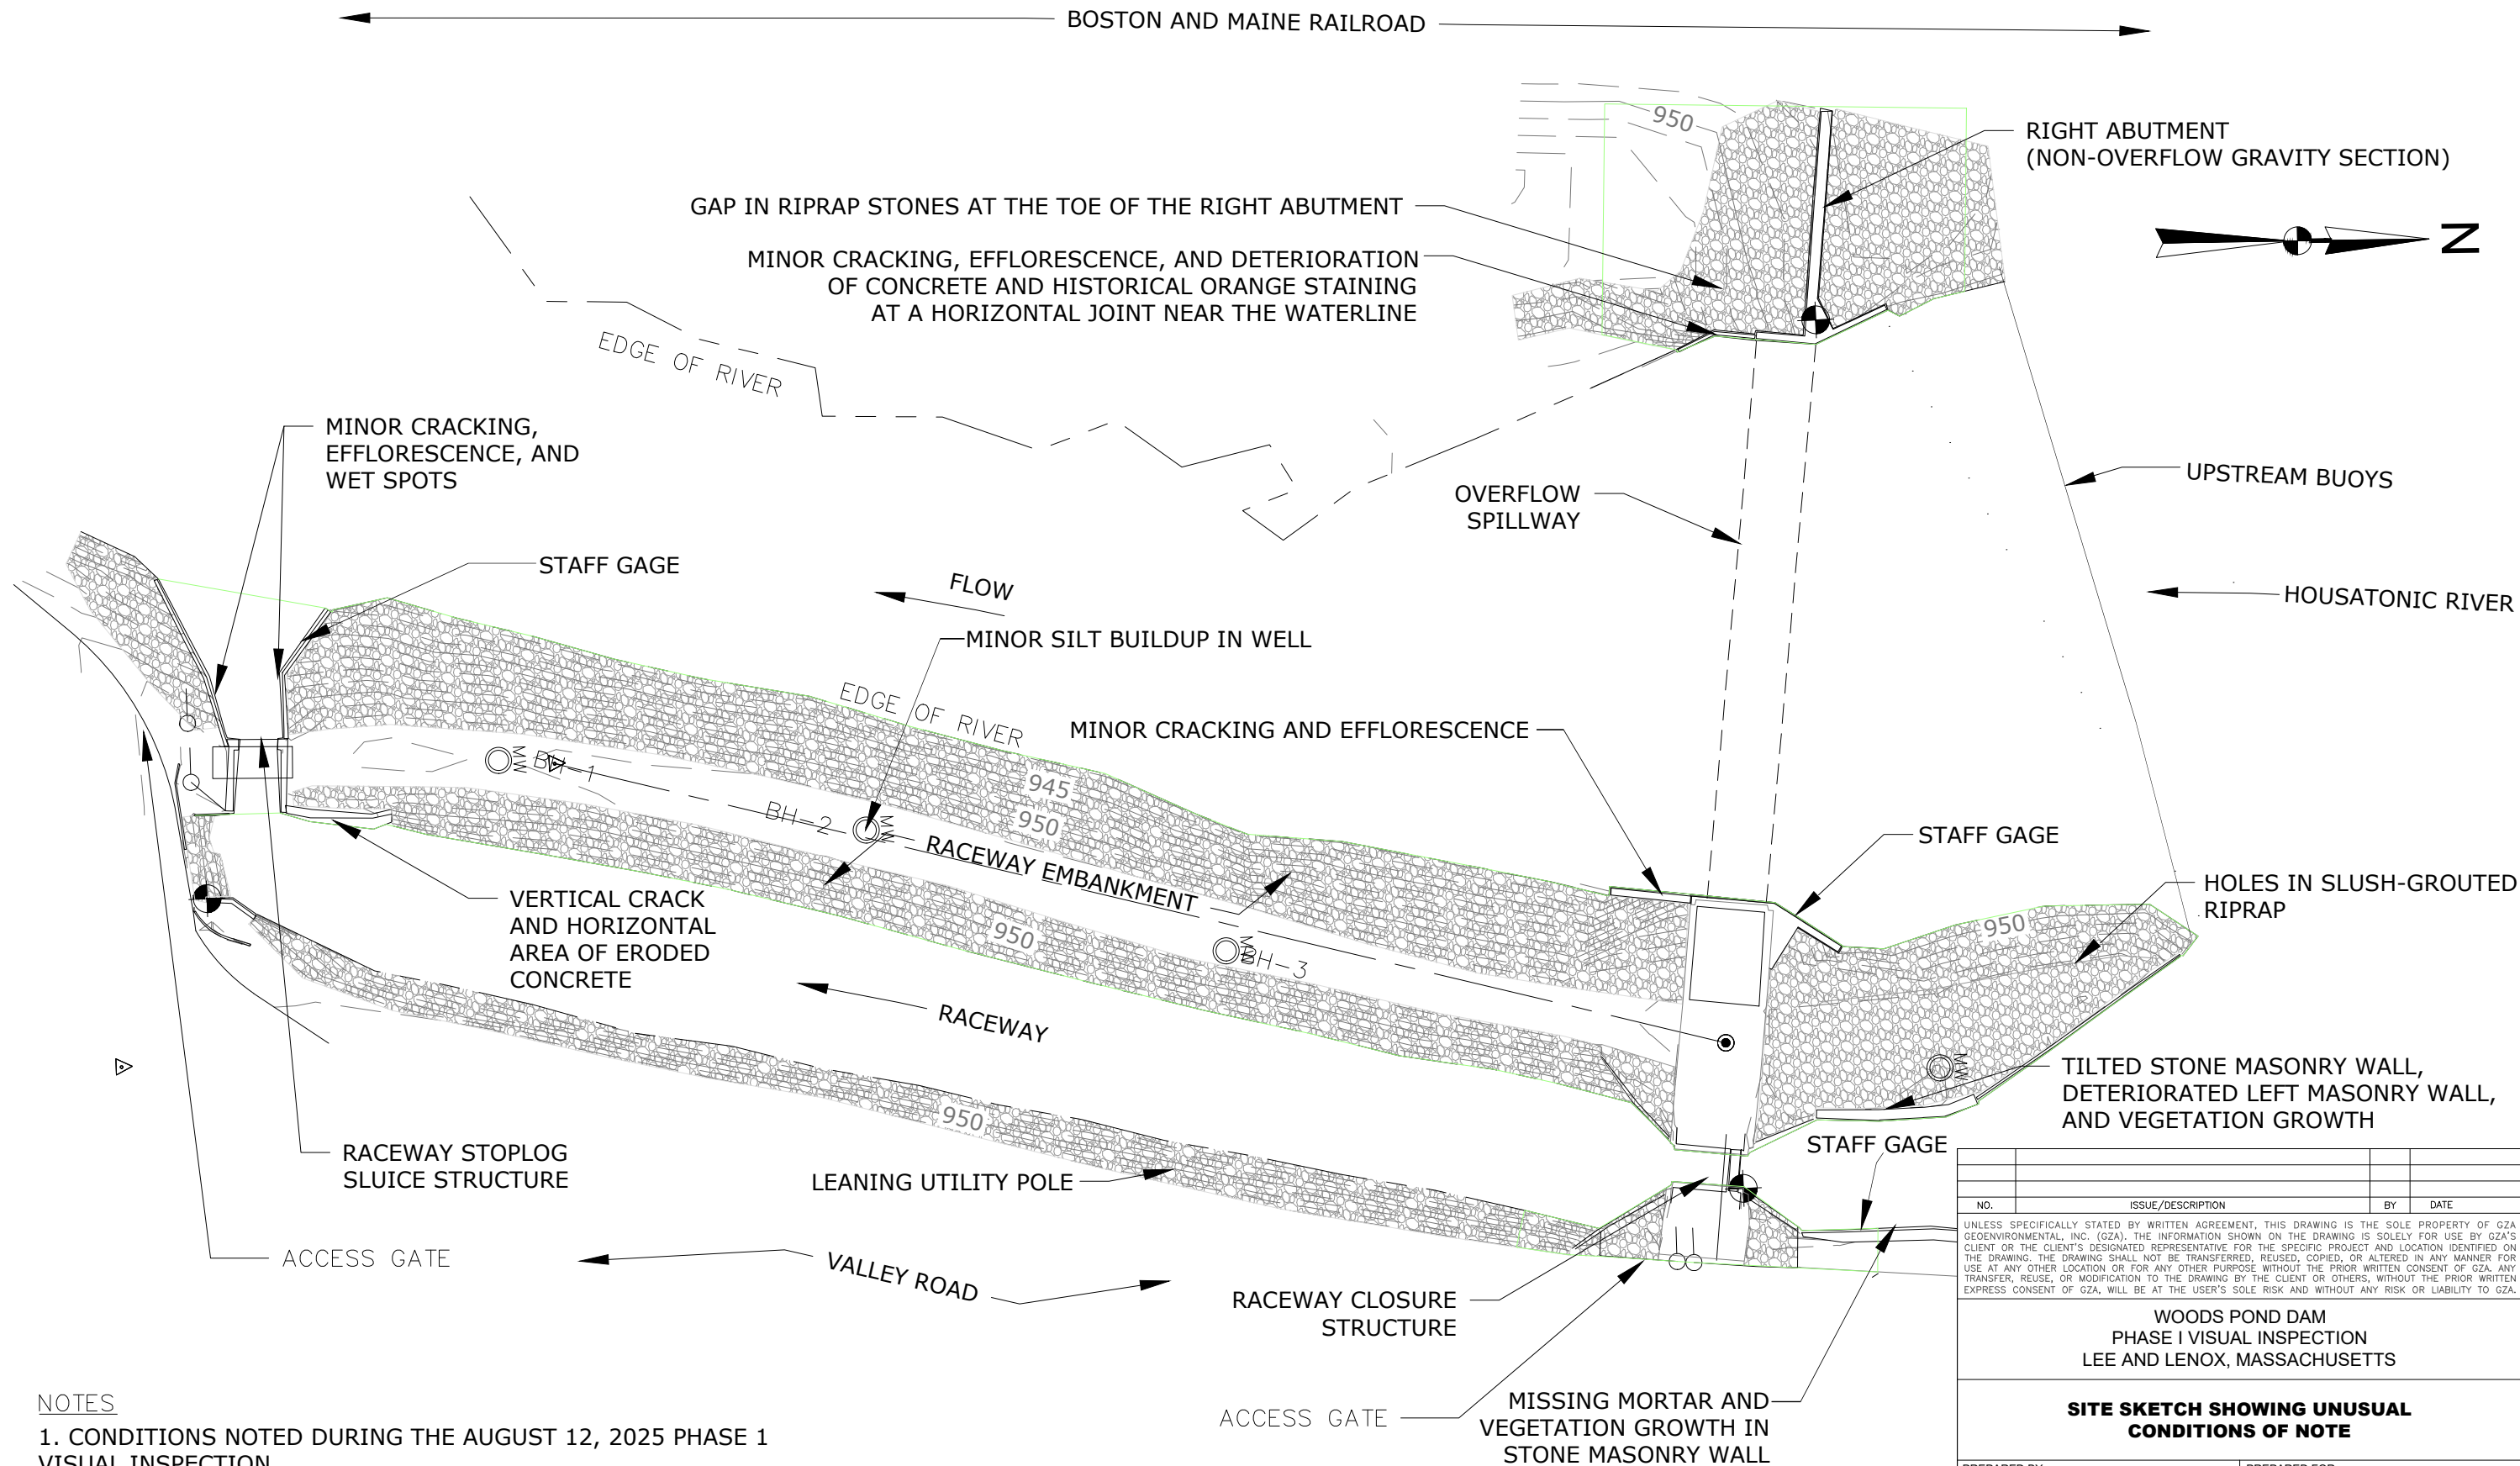
©2025 - GZA GeoEnvironmental, Inc. GZA-\\GZANOR\JOBS\19,000-20,999\19896-81\3-WORK\05 - PHASE 1 INSPECTIONS\2025 08 12 - WOODS POND DAM PHASE I INSPECTION\FIGURES\CAD\WPD BIENNIAL FIG

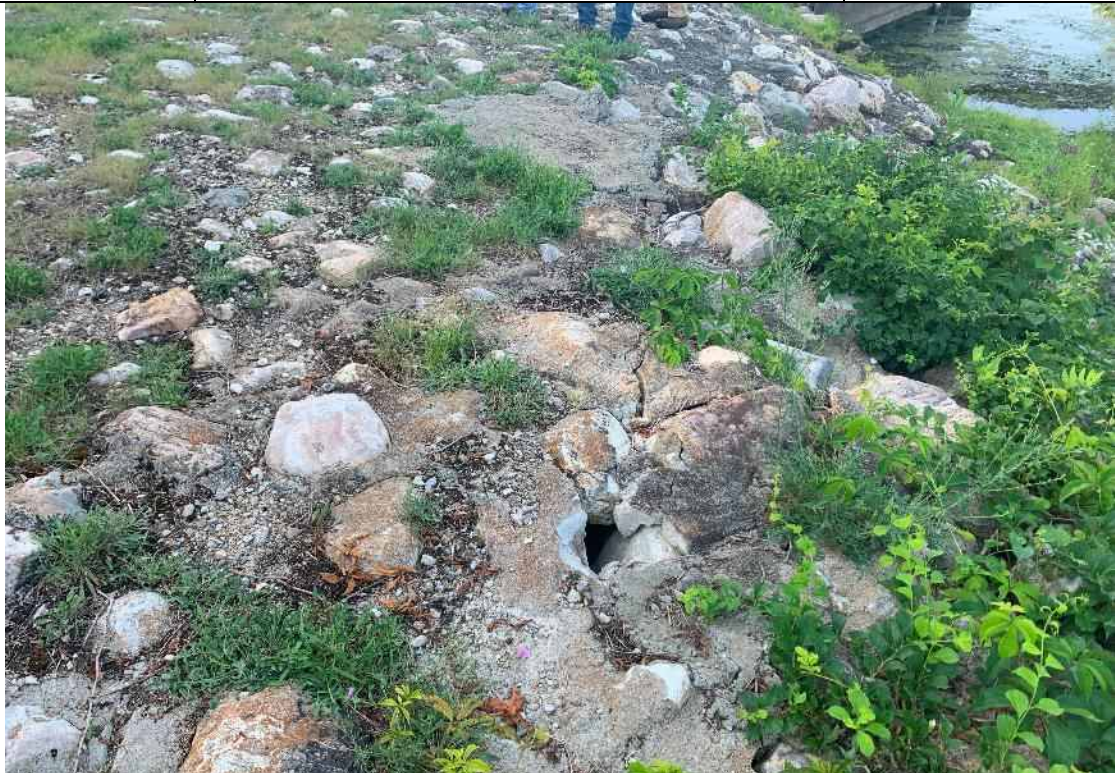
<b>Direction Photo Taken:</b> Downstream			
<b>Description:</b> Close-up of previously observed holes and cracks within the slush-grouted riprap on the raceway embankment upstream of the dam.

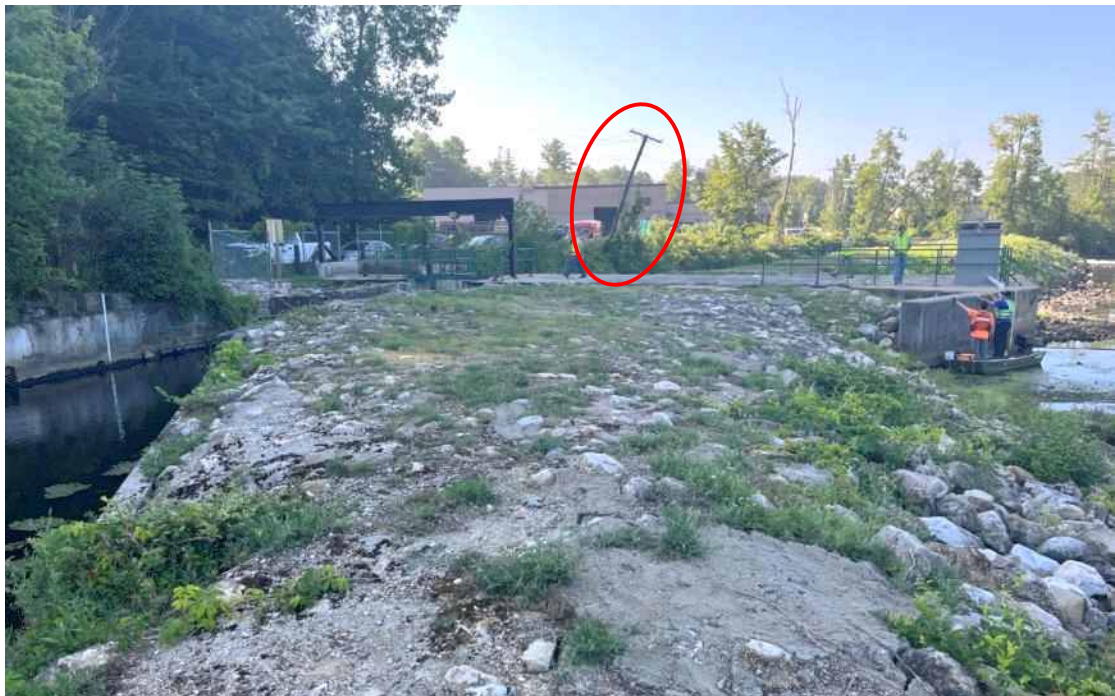
<b>Direction Photo Taken:</b> Downstream		
<b>Description:</b> Overview of the raceway embankment upstream of the dam. Note the utility pole leaning towards the raceway channel (red circle; also see Photo 9).

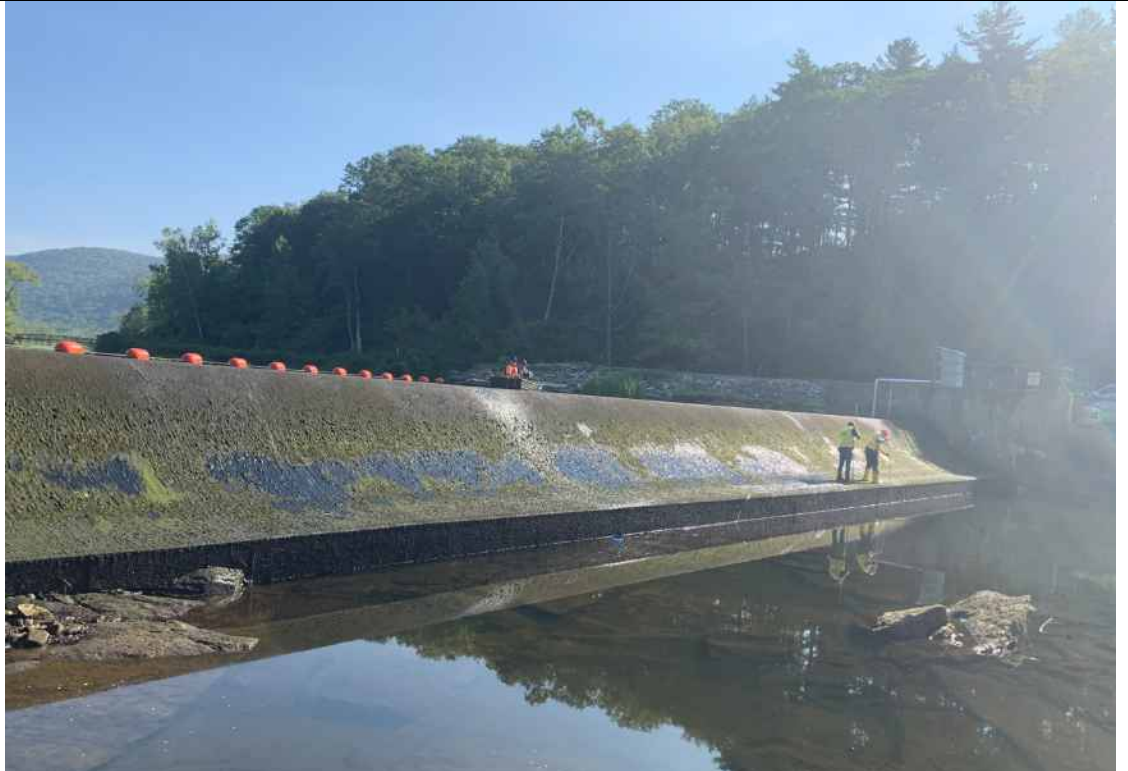
<b>Direction Photo Taken:</b> Left			
<b>Description:</b> Overview of dewatered spillway downstream face. Note the mossy growth along the downstream face.

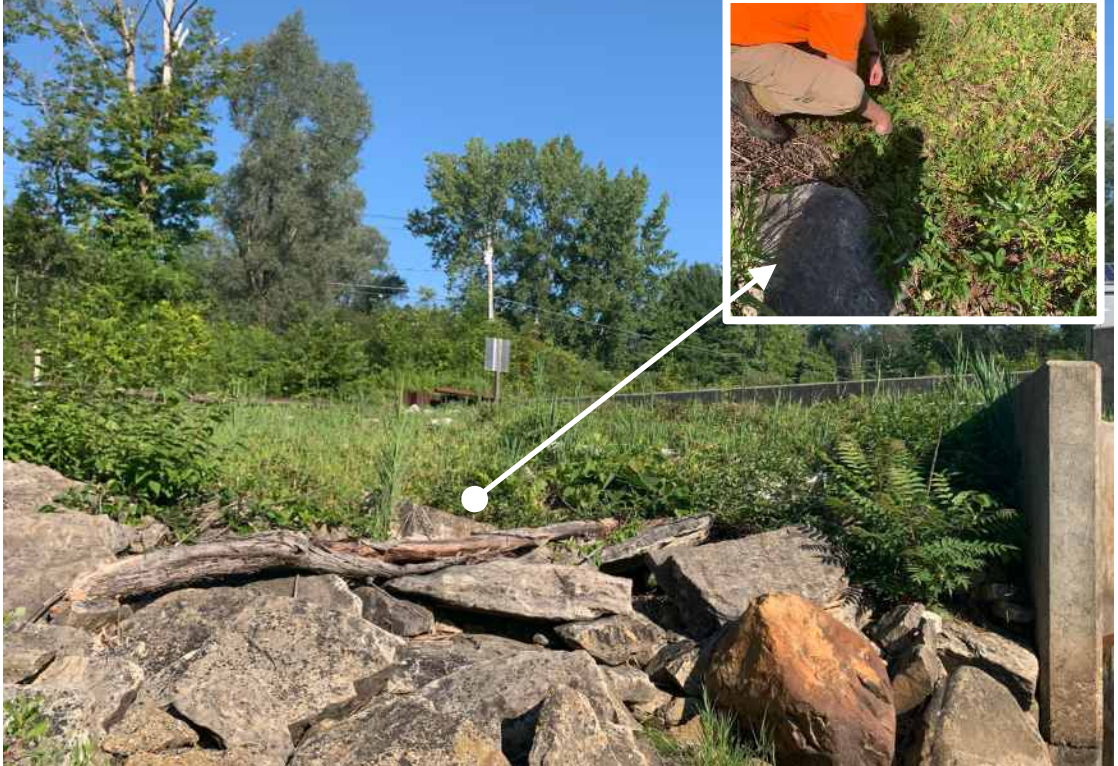
<b>Direction Photo Taken:</b> Left			
<b>Description:</b> Gap between riprap stones at the downstream toe of the right abutment non-overflow gravity section. The gap measured approximately 2.5 feet in diameter, 2 feet deep, and was probed upstream (towards the gravity section) to about 1-foot deep, which is similar to previous inspections.

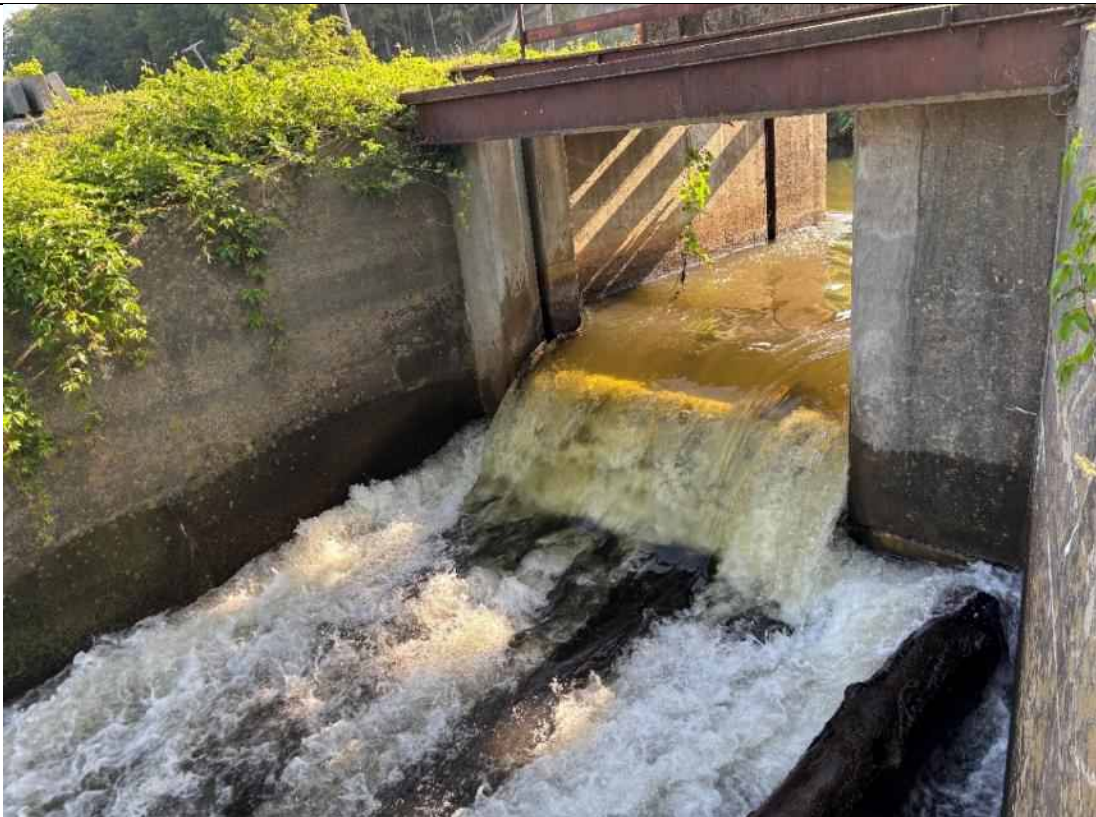
<b>Direction Photo Taken:</b> Left		
<b>Description:</b> Downstream side of the raceway stoplog sluice structure (downstream control structure). More flow than usual was observed flowing through the downstream control structure, as the spillway was bypassed to allow for a dewatered inspection.

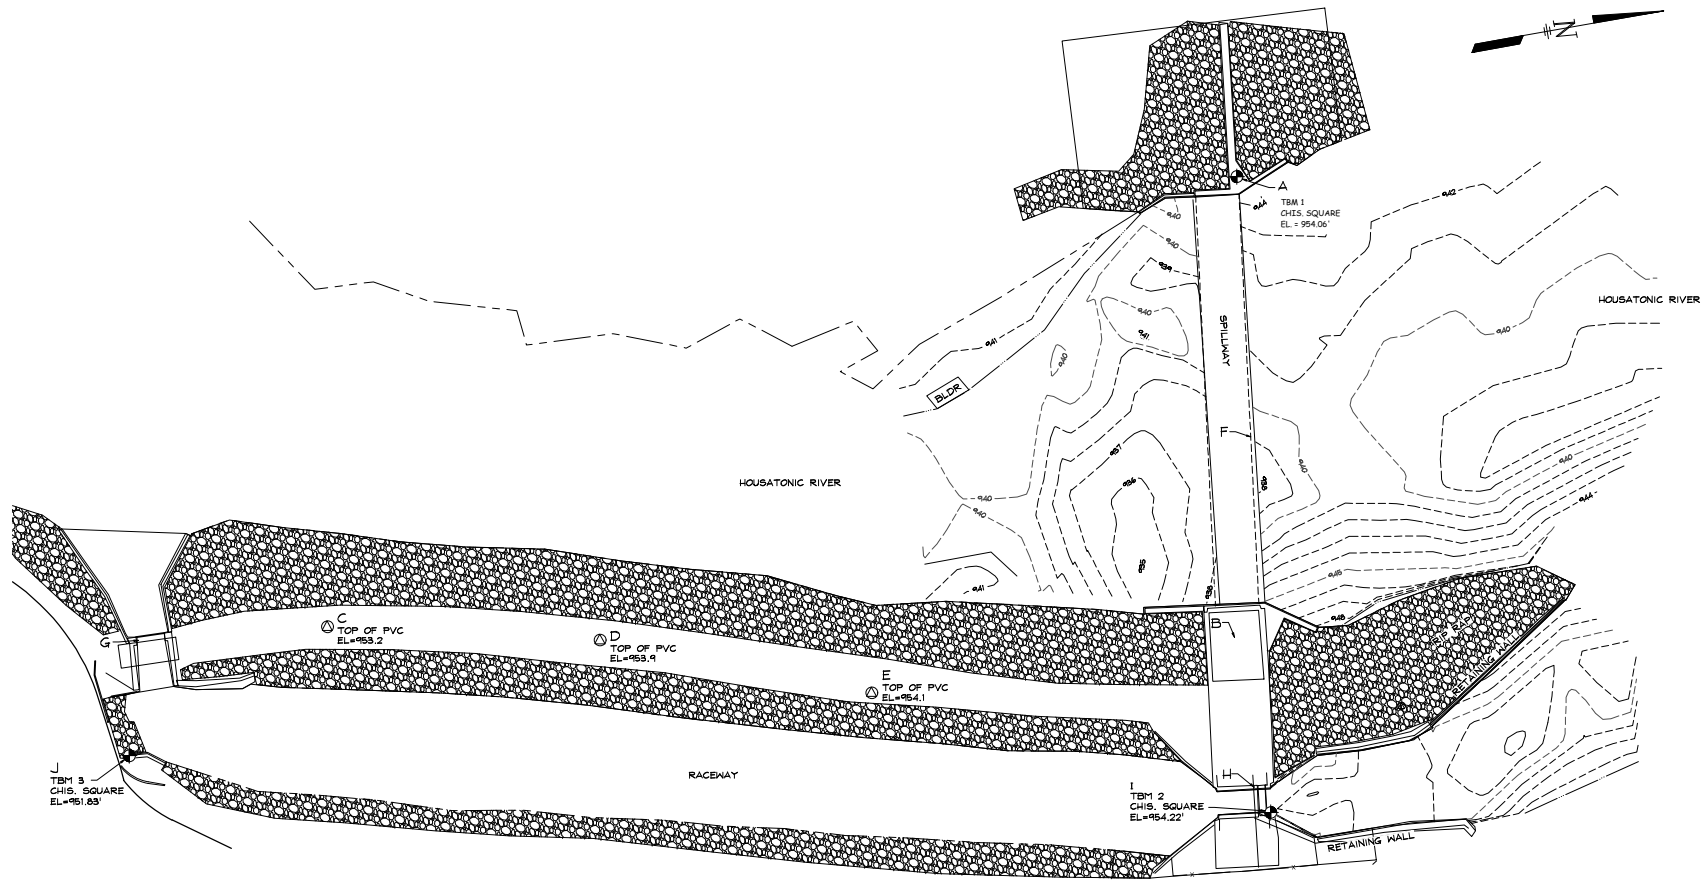
KEY ELEVATIONS TO BE MONITORED
