**Re: GE-Pittsfield/Housatonic River Site
Rest of River (GECD850)
Phase 1 Inspection/Evaluation Report for Woods Pond Dam**

WOODS POND DAM
PHASE 1
INSPECTION / EVALUATION REPORT

Dam Name: Woods Pond Dam

Date of Inspection: August 12, 2025

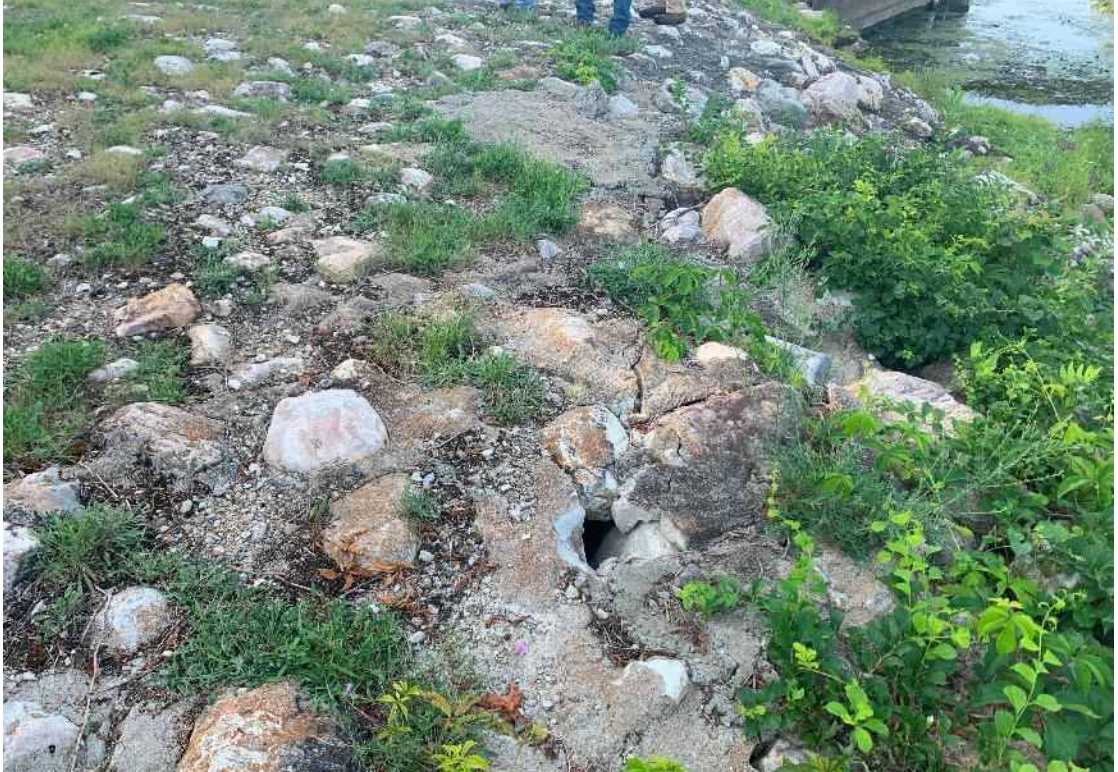
| Photo No. 7 | Date: 8/12/2025 | | |

7. Relatively small holes/gaps (two to four inches in maximum plan dimension) were observed in the slush-grouted riprap on the raceway embankment crest upstream of the Dam. These observations are generally consistent with those in recent prior inspections.

| Description: Close-up of previously observed holes and cracks within the slush-grouted riprap on the raceway embankment upstream of the dam. | | | |

| Recommendation | Current Status/Schedule |
|---|--|
| <p>3. Repair / fill in the relatively small holes/gaps in the slush-grouted riprap on the raceway embankment crest upstream of the dam.</p> | <p>Repairs will be made to the slush-grouted riprap on the raceway embankment crest upstream of the Dam prior to the next Phase 1 inspection, to be conducted in 2027.</p> |

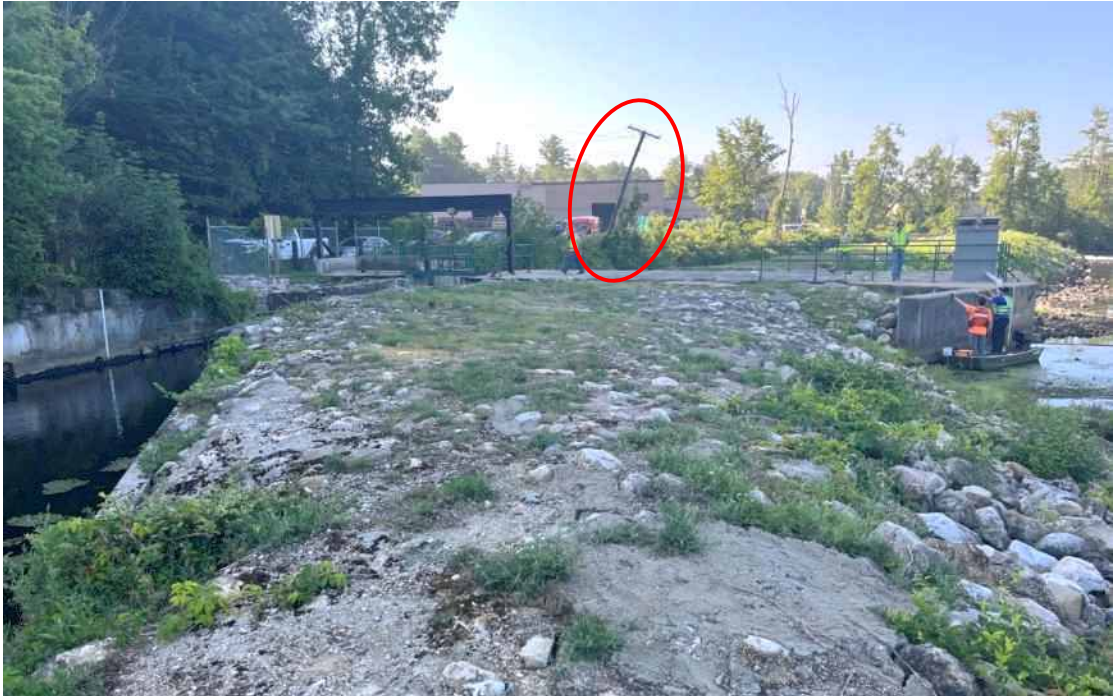
| Photo No. 8 | Date: 8/12/2025 | | |

4. On the eastern side slope of the raceway outside GE property, a utility pole was seen to be leaning toward the channel. This condition has been observed in prior inspections and does not present any issues relating to dam safety.

| Description: Overview of the raceway embankment upstream of the dam. Note the utility pole leaning towards the raceway channel (red circle; also see Photo 9). | | | |

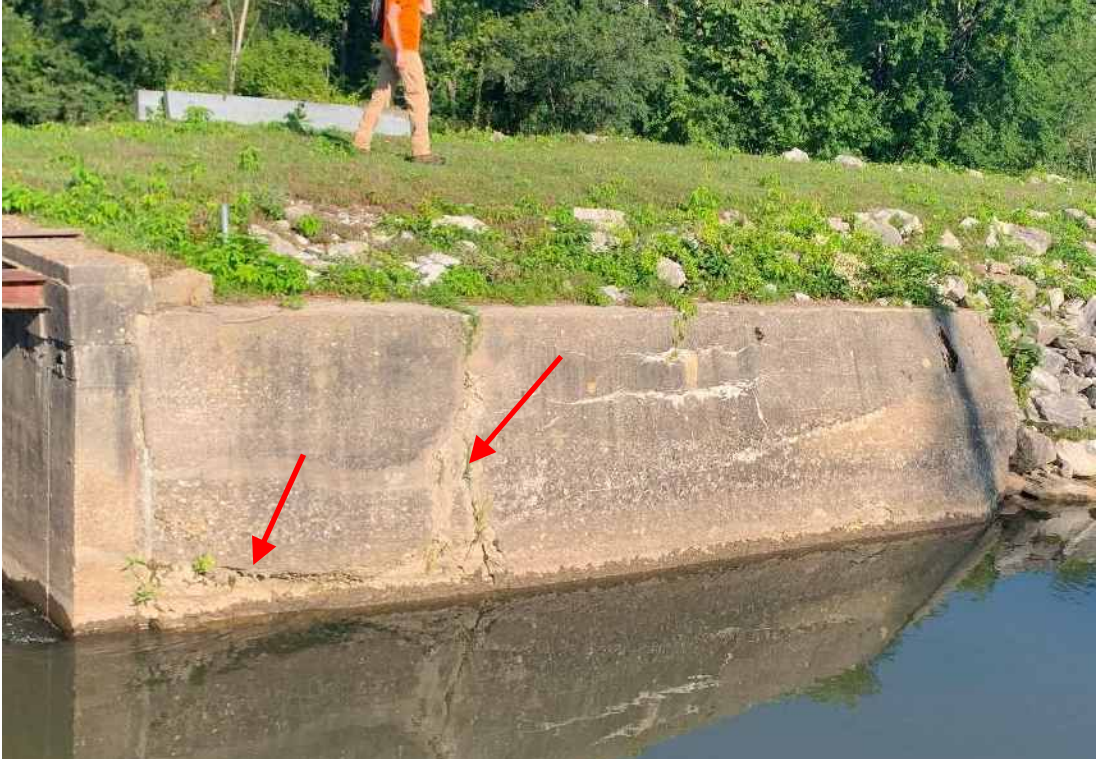
| Photo No. 21 | Date: 8/12/2025 | | |

8. There is a vertical crack and horizontal area of eroded concrete in the right upstream training wall of the raceway stoplog sluice structure (downstream control structure). These areas appear to have been previously repaired.

| Description: The right upstream training wall of the raceway stoplog sluice structure (downstream control structure). Note vertical crack and horizontal area of eroded concrete (red arrows). | | | |

| Recommendation | Current Status/Schedule |
|---|---|
| <p>5. Monitor the vertical crack and horizontal area of eroded concrete in the right upstream training wall of the raceway stoplog sluice structure (downstream control structure).</p> | <p>This area is and will continue to be monitored during quarterly and biennial inspections. Special attention will be paid to this area during periods of low flow.</p> |

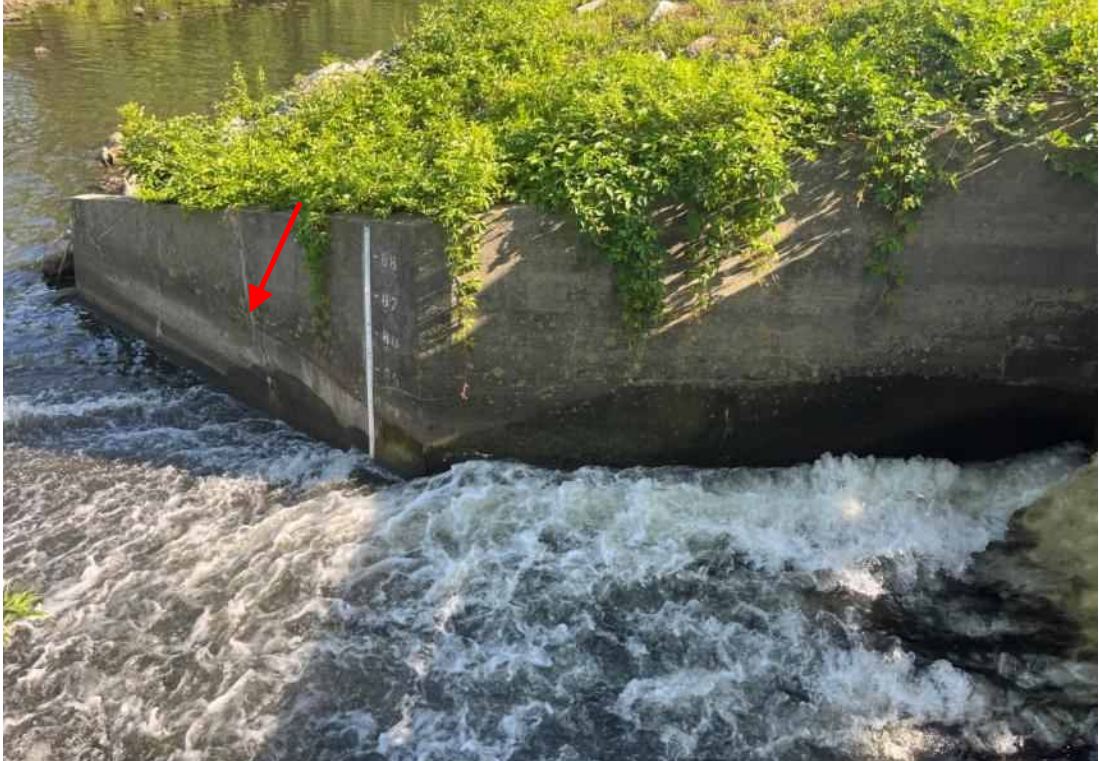
| Photo No. 23 | Date: 8/12/2025 | | |

9. Minor cracking, efflorescence, and wet spots were observed on the downstream training walls of the raceway stoplog sluice structure (downstream closure), as was the case in some prior inspections. This condition continues to be monitored with little change and appears to be a stable condition.

| Description: Right downstream training wall of stoplog sluice structure (downstream control structure). Note vertical crack in the concrete (red arrow). | | | |

| Recommendation | Current Status/Schedule |
|--|---|
| <p>6. Continue to monitor the minor cracking, efflorescence, and wet spots observed on the downstream training walls of the raceway stoplog sluice structure (downstream closure). Continue to look for signs of seepage at this location.</p> | <p>This area is and will continue to be monitored during quarterly and biennial inspections.</p> |
