**Re: GE-Pittsfield/Housatonic River Site
Rest of River (GECD850)
Rising Pond Dam - 2025 Penstock Investigations – End-of-Year Report**

2025 PENSTOCK INVESTIGATIONS END-OF-YEAR REPORT Rising Pond Dam (MA00250) Great Barrington, Massachusetts

January 9, 2026
File No.: 01.0019896.81

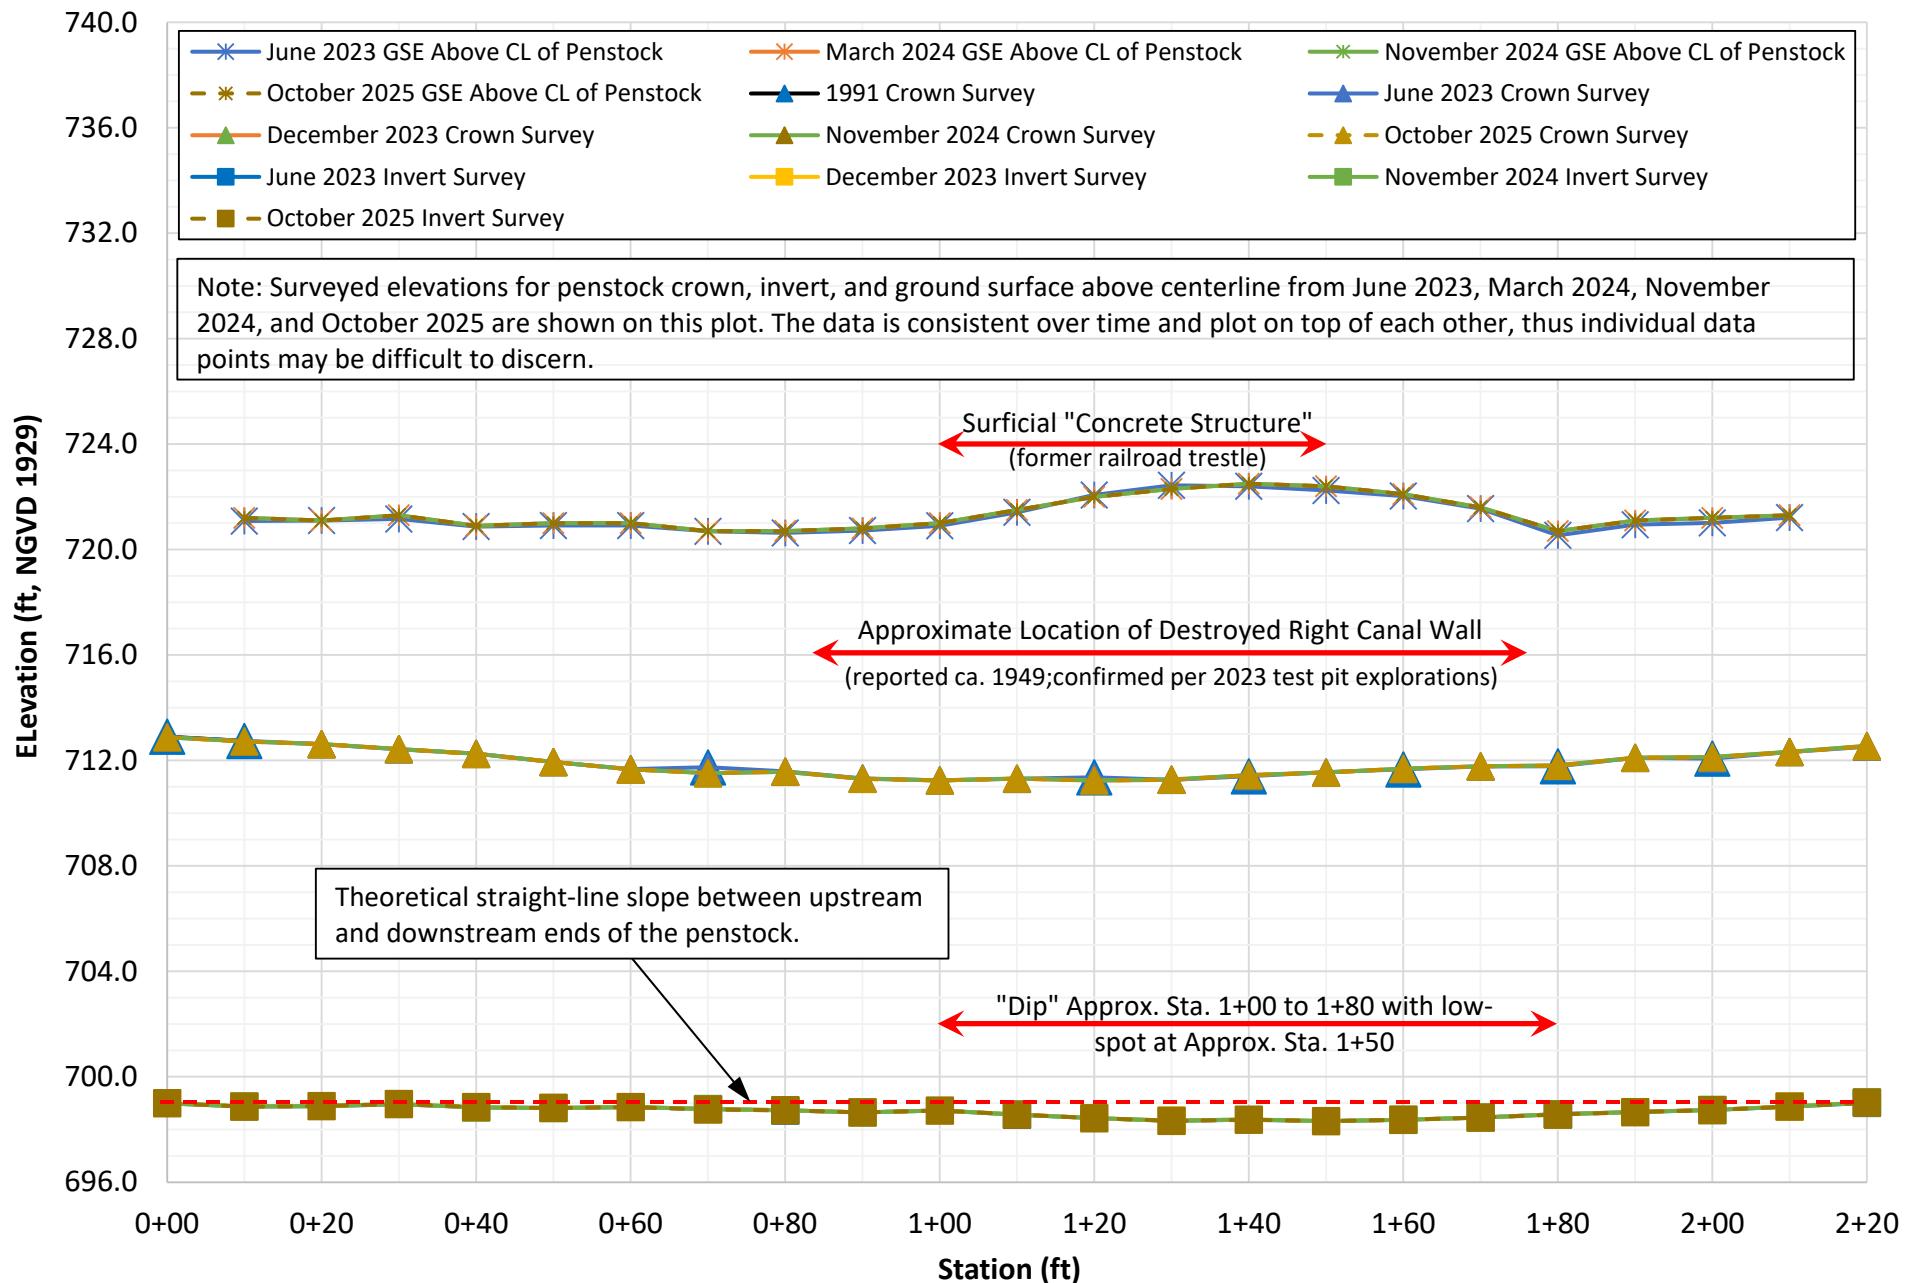
Figure 4
Rising Pond Dam Penstock Investigations
Ground Surface Elevations (GSE) Survey Results

- There were no visible signs of continued ground surface settlement in the area above the penstock or displacement of adjacent structures observed during the October 2025 investigations. See discussion below for November 2025 observations of the ground surface above the penstock.

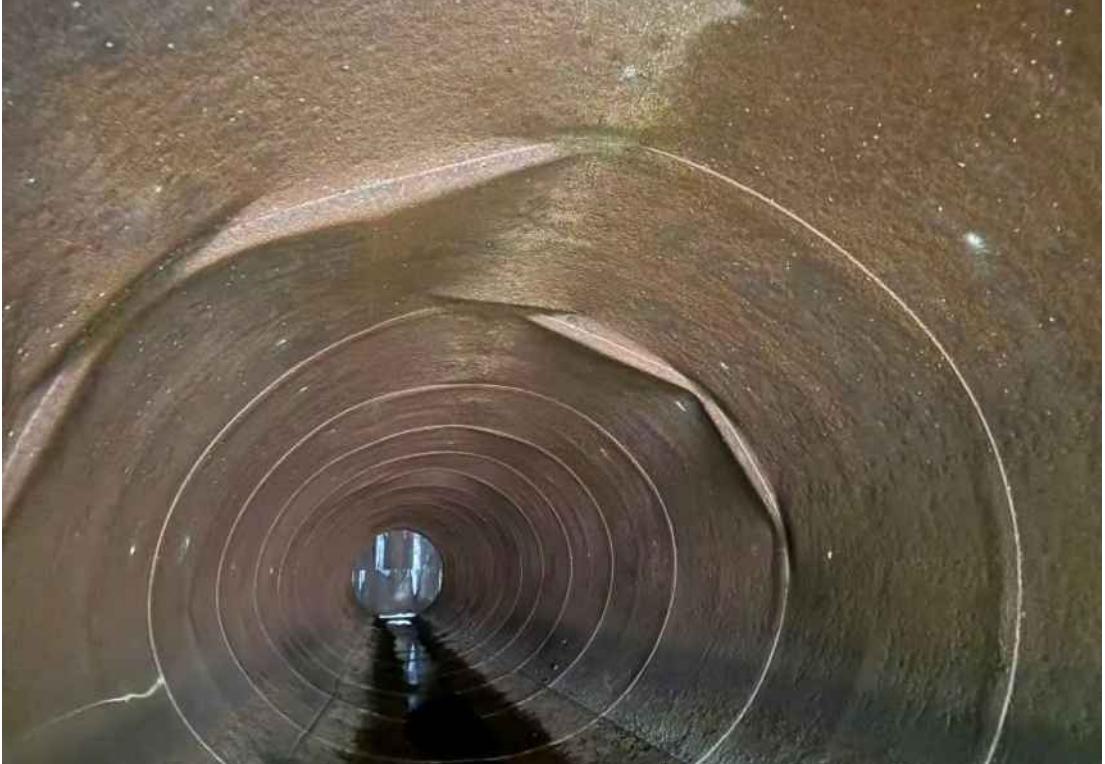
Client Name: General Electric Company	Site Location: Rising Pond Dam – Great Barrington, MA October 2025 Penstock Investigations	Project No. 01.019896.81
Photo No. 3 Date: 10/23/2025 Direction Photo Taken: Upstream

- The intake gate was observed to be in the fully closed position, with little to no leakage through the gate. It is noted that minor leakage through the gate was observed in the previous two years.

Description: Overview of the inside of the penstock. Note: Penstock crown deformations and minimal to no gate leakage. Minor leakage was observed during previous year's inspections (refer to the Appendix D of 2023 and 2024 End-of-Year Report).

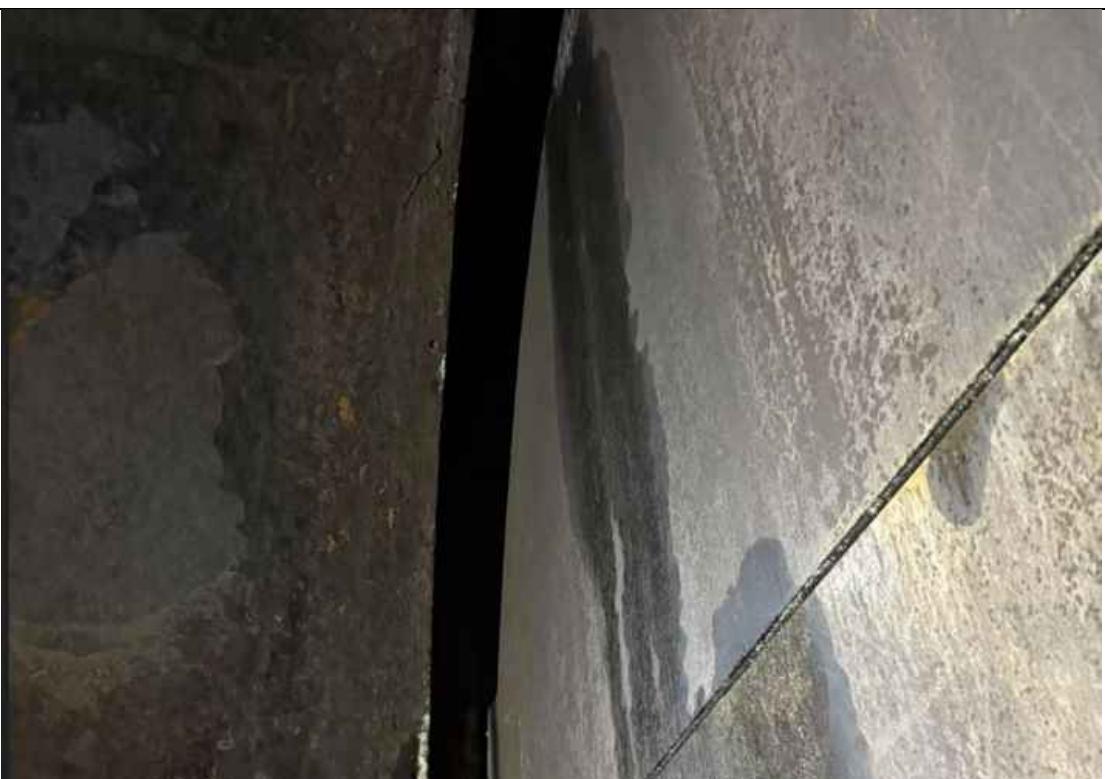
Photo No. 4 Date: 10/23/2025 Direction Photo Taken: Right and up (upstream is to photo right / downstream is to photo left).

Description: Interface and seal between penstock (photo left) and gate (photo right); approx. Sta. 0+00.

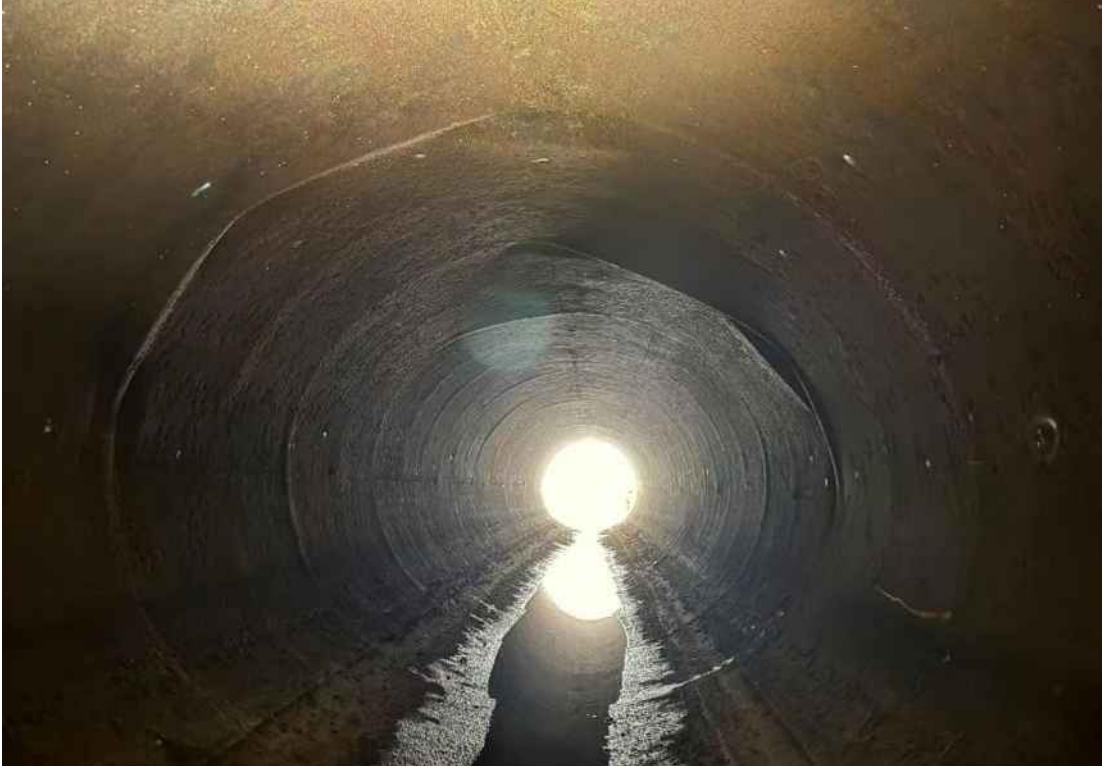
Client Name: General Electric Company	Site Location: Rising Pond Dam – Great Barrington, MA October 2025 Penstock Investigations	Project No. 01.019896.81
Photo No. 5 Date: 10/23/2025 Direction Photo Taken: Downstream

Description: Overview of the inside of the penstock looking downstream. Note: Crown deformations.

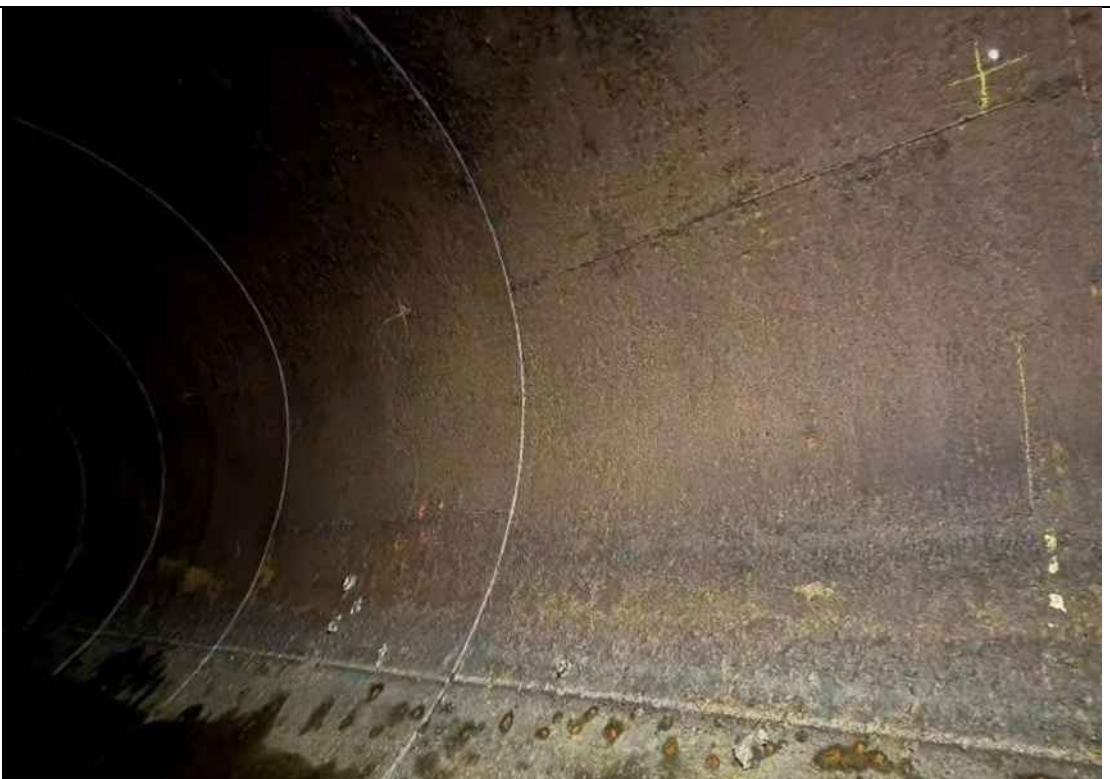
Photo No. 6 Date: 10/23/2025 Direction Photo Taken: Upstream

- General observations of the penstock's interior indicated minor to moderate surficial rusting or pitting of the penstock's steel shell, the presence of a low area or "belly" at the invert of the penstock and inward "bulge" of the penstock crown and upper sidewalls between approximate Stations 1+10 and 1+50, and a general out of-roundness/ovalized shape of the penstock throughout most of its length. These conditions are consistent with previous internal penstock inspections and survey/ovality measurements.

Description: Typical condition of the penstock interior. Photo taken between invert and springline. Note: Minor to moderate surface rusting, corrosion, and pitting.

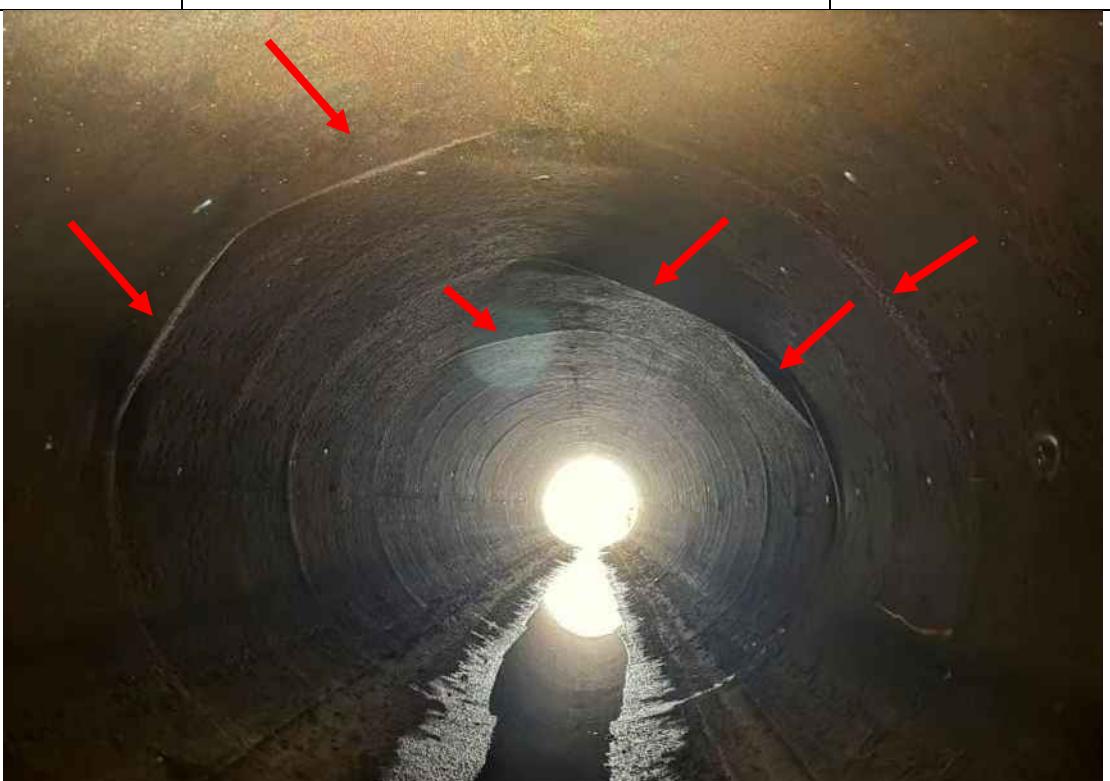
Client Name: General Electric Company		Site Location: Rising Pond Dam – Great Barrington, MA October 2025 Penstock Investigations	Project No. 01.019896.81
Photo No. 7	Date: 10/23/2025	Direction Photo Taken: Downstream

Description: Deformation/bulge near the Penstock crown near Station 1+10.			
Photo No. 8	Date: 11/20/2025	Direction Photo Taken: Downstream

3. Structural lining of the penstock is the preferred repair alternative for the penstock. Non-structural lining is not preferred as it relies on the existing penstock for structural support. A spray-on lining is preferable to sliplining due to site constraints and maintaining pipe cross-sectional area. Applicability of this repair methodology should be confirmed during the monitoring and design steps outlined in Section 4.0.

Based on the findings and conclusions from the penstock investigations, GZA recommends repairing the penstock using a structural lining system (e.g., geopolymers or mortar lining). GZA also recommends continuing to monitor the penstock until repairs are performed to confirm that the penstock is not undergoing additional movement or deformation that could interfere with the selected repair program. Specifically, GZA recommends the following next steps:

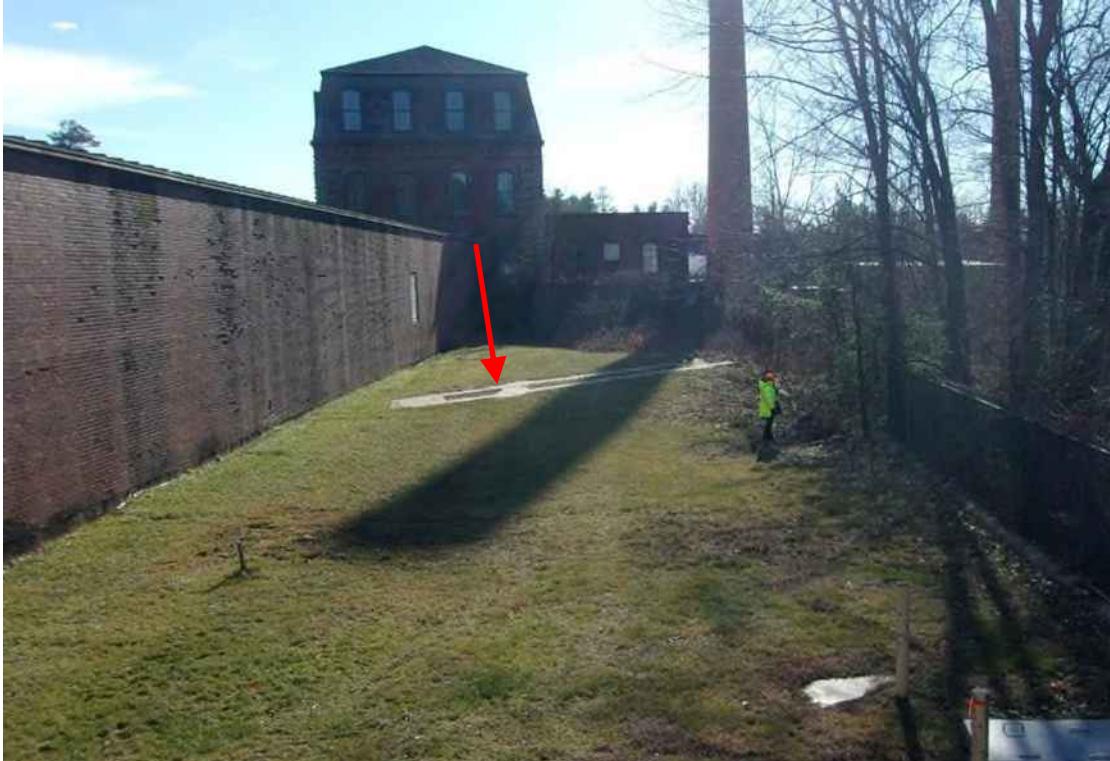
During the November 20, 2025 Phase 1 inspection of Rising Pond Dam, GZA's inspection team observed a depression in the area above and to the left of the penstock adjacent to the concrete grade beam structure (former railroad crossing) at about Station 1+30. The depression was located about 4½ feet left of the penstock springline (sidewall). The depression measured up to two feet deep and one to two feet in plan dimensions. The depression was vertical sided and triangular-shaped (in plan view), likely due to the geometry of the adjacent concrete structure. This depression had not been observed during annual penstock inspections (including in October 2025) or during prior quarterly inspections (the most recent of which was conducted in August 2025).

Description: Overview of the area above the penstock during the November 2025 Phase 1 inspection. Red arrow points to location of depression (see photos 9 and 10).

- a. Conduct an additional topographic survey of the area above the penstock, along with visual monitoring (including during quarterly dam inspections) for potential surface depressions near the penstock similar to that observed during the November 2025 Phase 1 inspection;

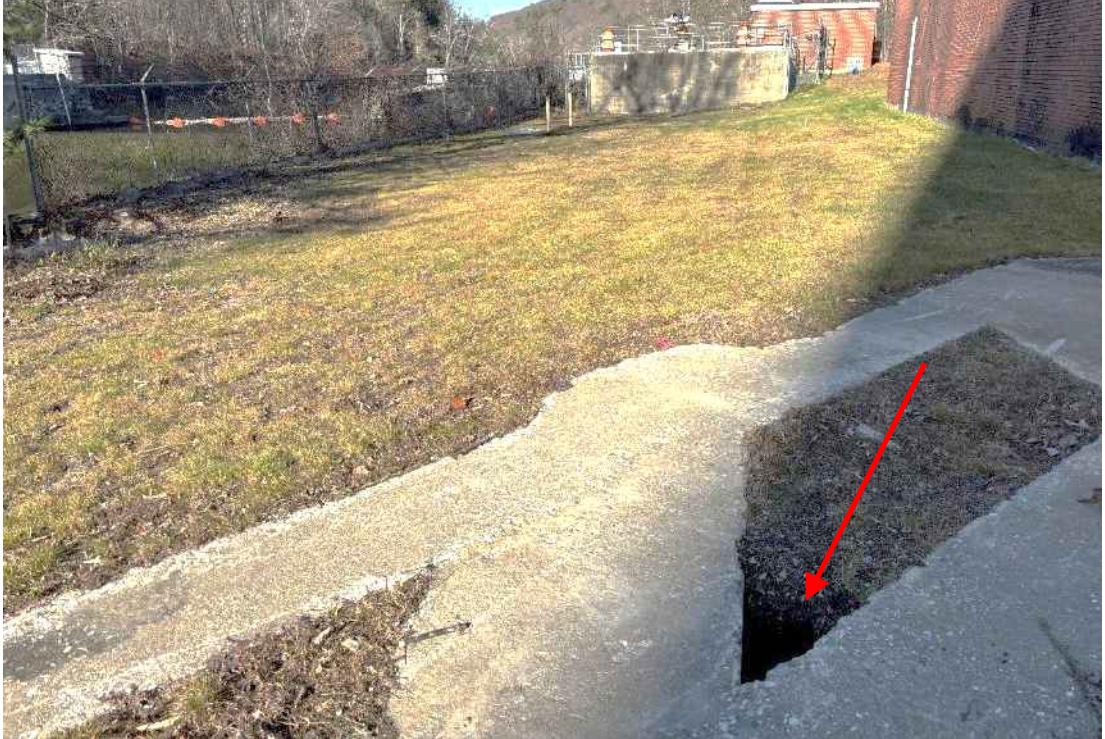
Client Name: General Electric Company		Site Location: Rising Pond Dam – Great Barrington, MA October 2025 Penstock Investigations	Project No. 01.019896.81
Photo No. 9	Date: 11/20/2025	Direction Photo Taken: Upstream

3. The depression observed during the November 20, 2025 Phase 1 inspection of Rising Pond Dam is in a similar location to the depression that was observed during a 20-year-old visual inspection conducted by GZA in December of 2005. Although these depressions were outside of the penstock limits, the locations roughly align with the “low spot/belly” of the penstock. This area should continue to be monitored as described in Section 4.0.
