Kevin Mooney
Senior Project Manager
GE Aerospace
1 Plastics Ave.
Pittsfield, MA 01201
T (413) 553-6610
kevin.mooney@geaerospace.com

Via Electronic Mail

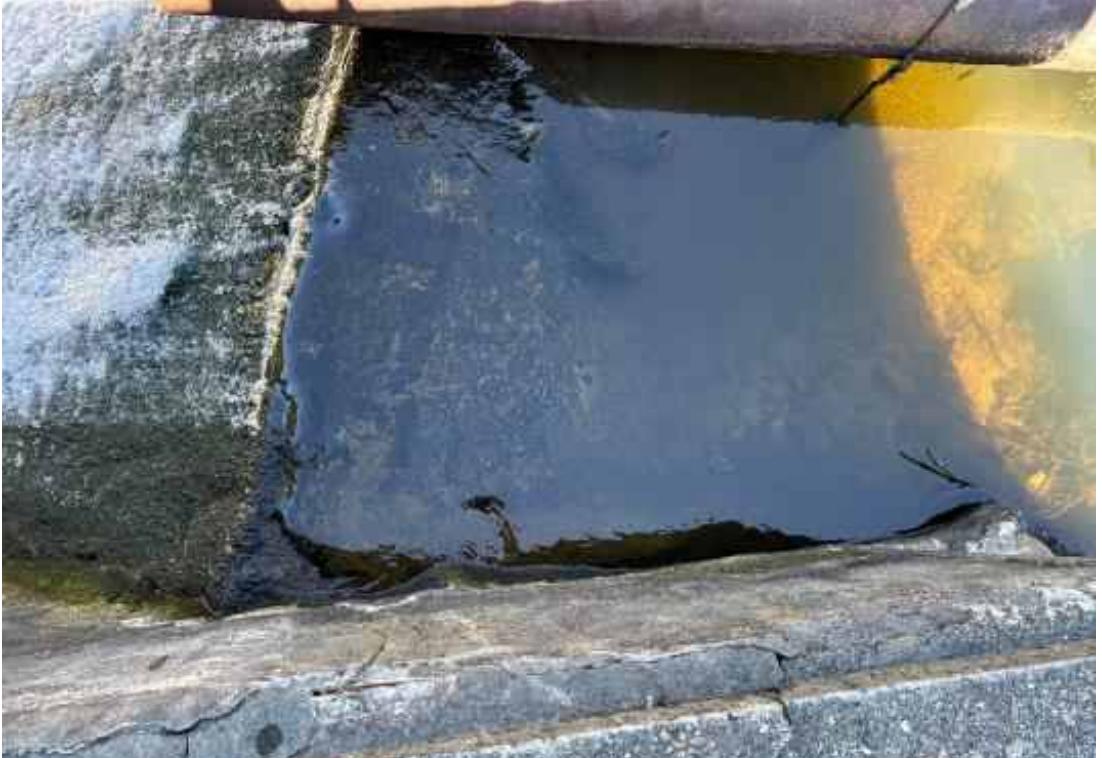
Direction Photo Taken: Downward.			
Description: Area where upstream vortex was observed on August 17, 2022. Temporary repairs performed on July 29 and 30, 2024. Repairs appeared intact.

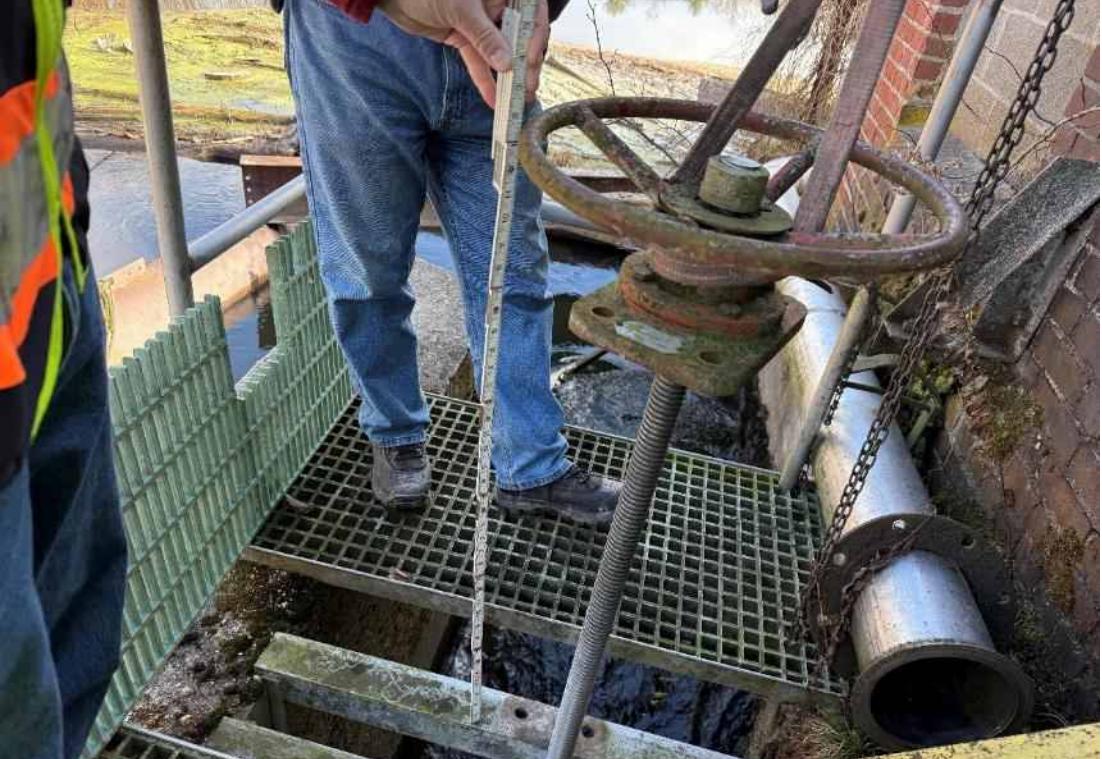
Direction Photo Taken: Upstream.		
Description: The sluiceway gate was subsequently operated to its fully open position during the current inspection. Sediment buildup was estimated to be about $\frac{1}{2}$ - to 1-inch thick (within about 1- to 2-feet upstream of the gate).

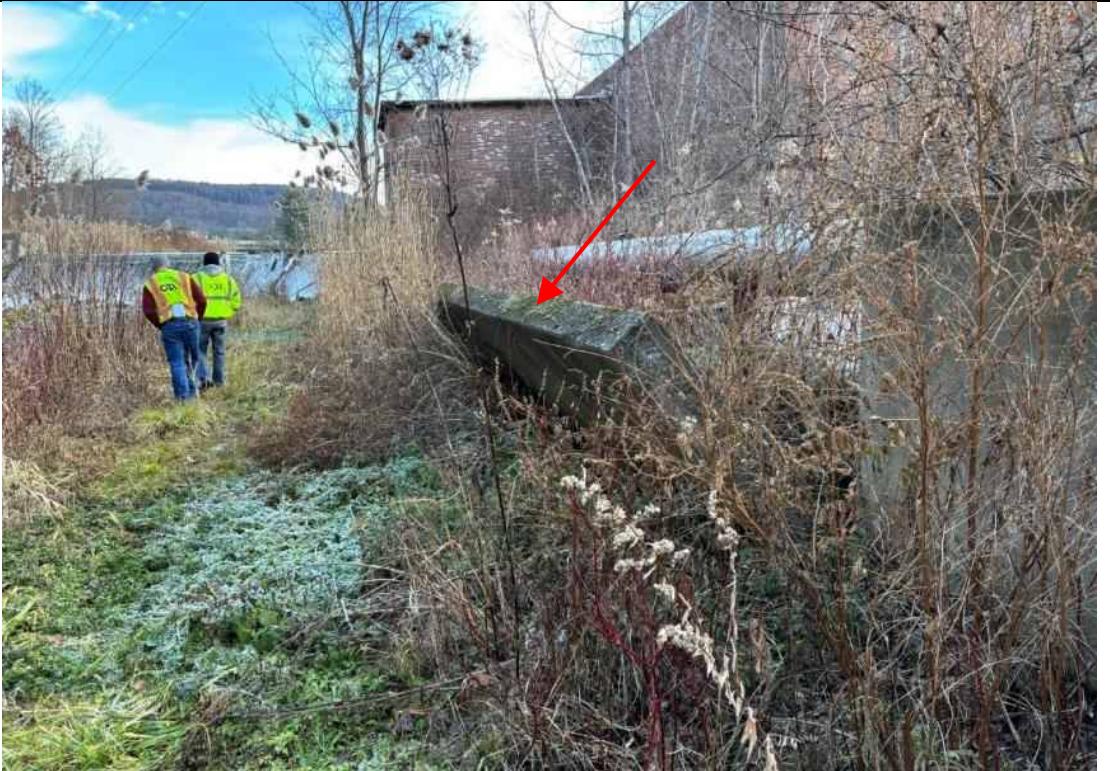
Description: Access path along left bank of the river to the downstream left toe of the dam. Note: The tilted and partially failed concrete retaining wall (red arrow) did not appear to be hindering access.

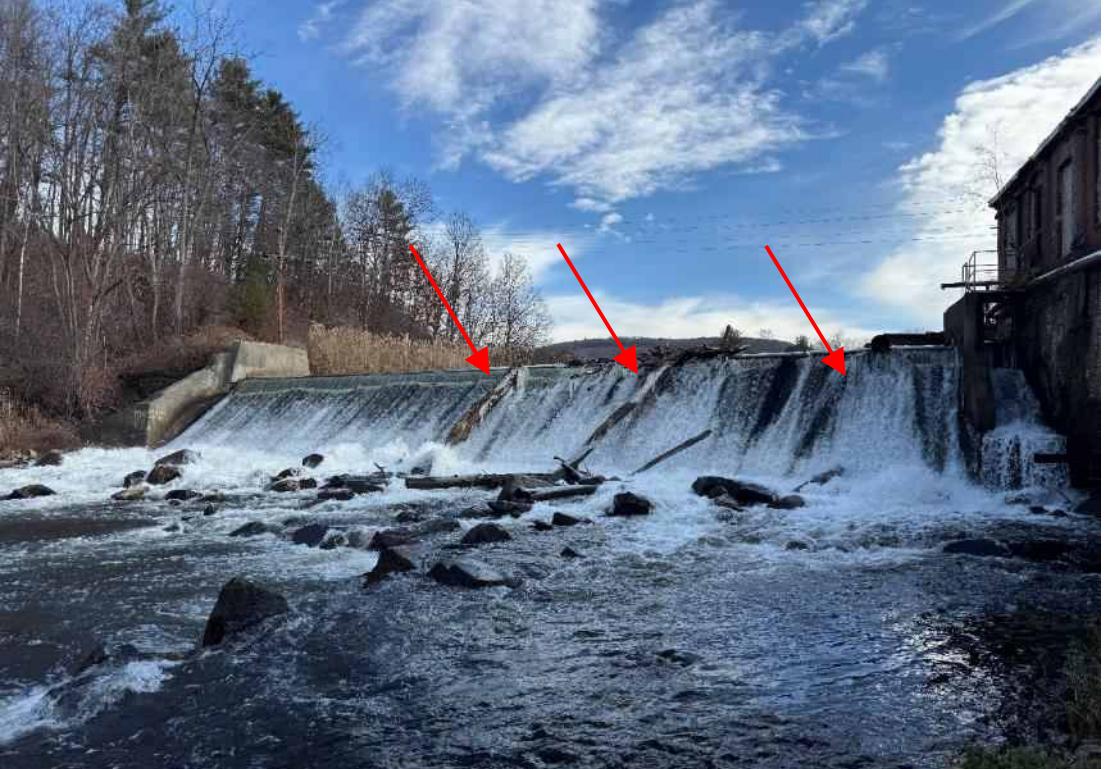
Description: Downstream face of the spillway. About 6-inches of water was flowing over the spillway crest at the time of the inspection. Note logs on spillway downstream face at the center and on the left side (photo right).

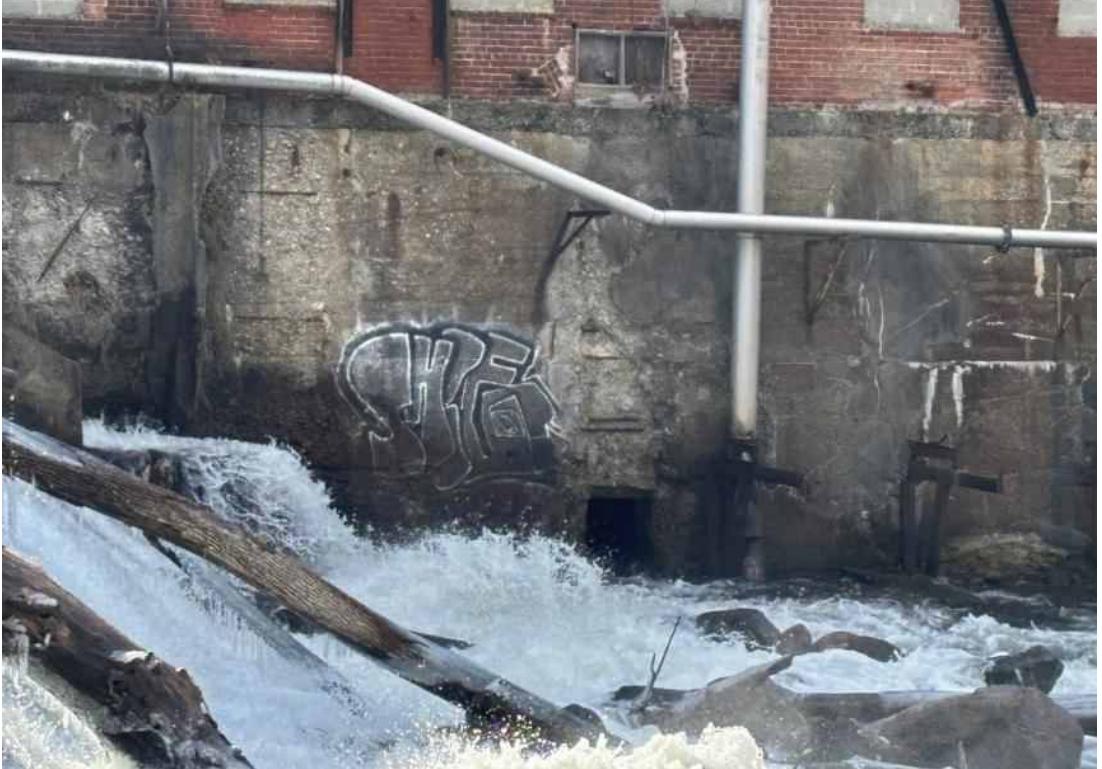
Direction Photo Taken: Left.			
Description: Mill building exterior wall downstream of the dam. Note moderate spalling of the concrete and exposed reinforcing steel of the mill building wall.

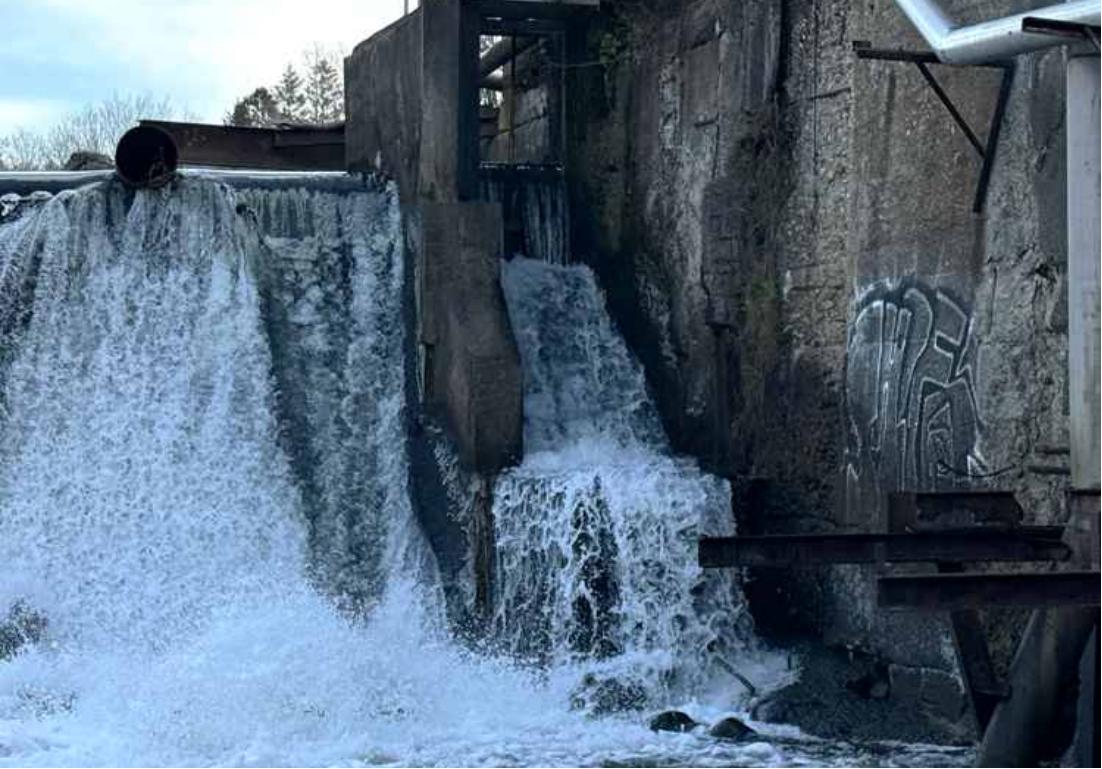
Photo No. 12	Date: 11/20/2025		
Direction Photo Taken: Upstream.			
Description: Downstream side of the sluiceway. Note: Previously observed diagonal crack on downstream face obscured by flow.

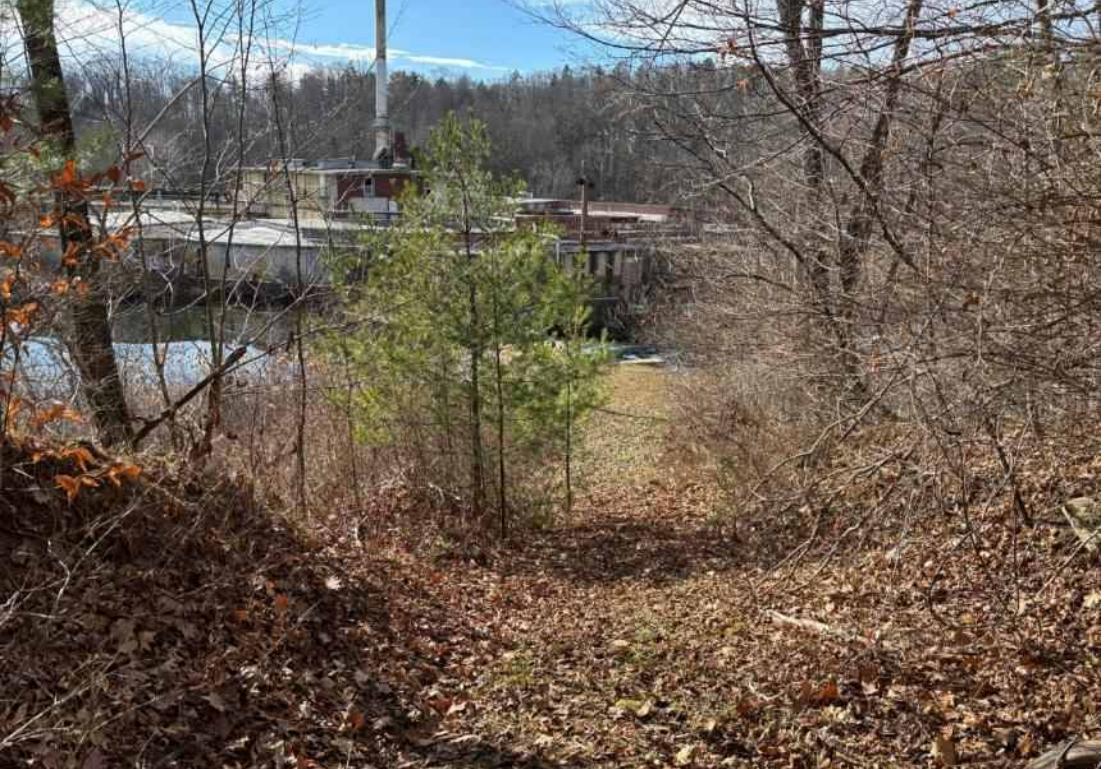
Photo No. 14 Date: 11/20/2025 Direction Photo Taken: Left.

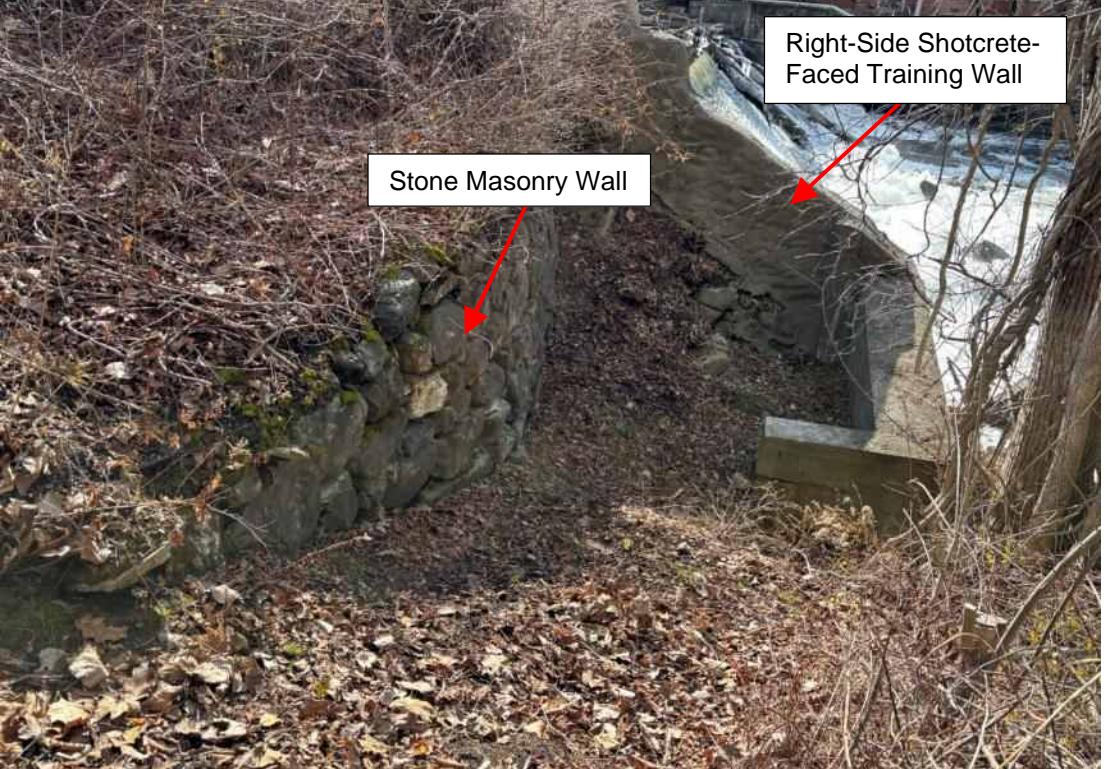
<p>Right-Side Shotcrete-Faced Training Wall</p> <p>Stone Masonry Wall</p>
Direction Photo Taken: Left.		
Description: Downstream slope of the right embankment. Note slight “bulge” in center of stone masonry wall. No apparent signs of tilting, offset, displacement, or missing stone masonry pieces noted.

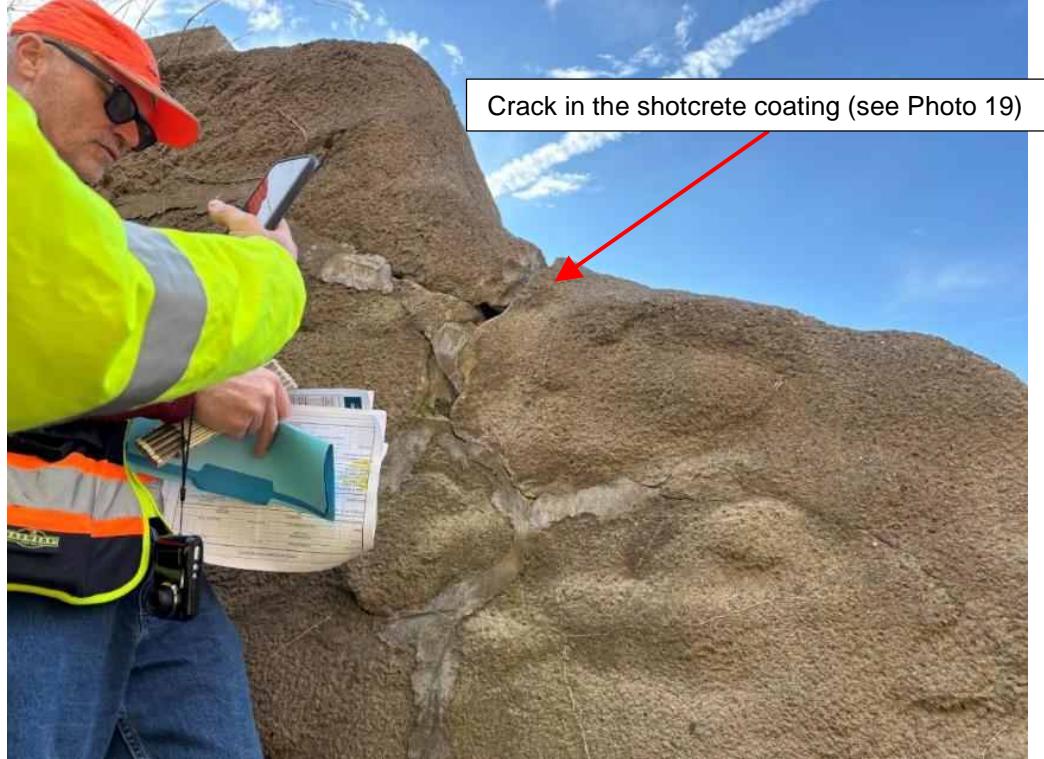
<p>Crack in the shotcrete coating (see Photo 19)</p>
Direction Photo Taken: Left.		
Description: Right-side downstream right training wall. The wall appears to have been constructed of stone masonry and then faced with shotcrete.

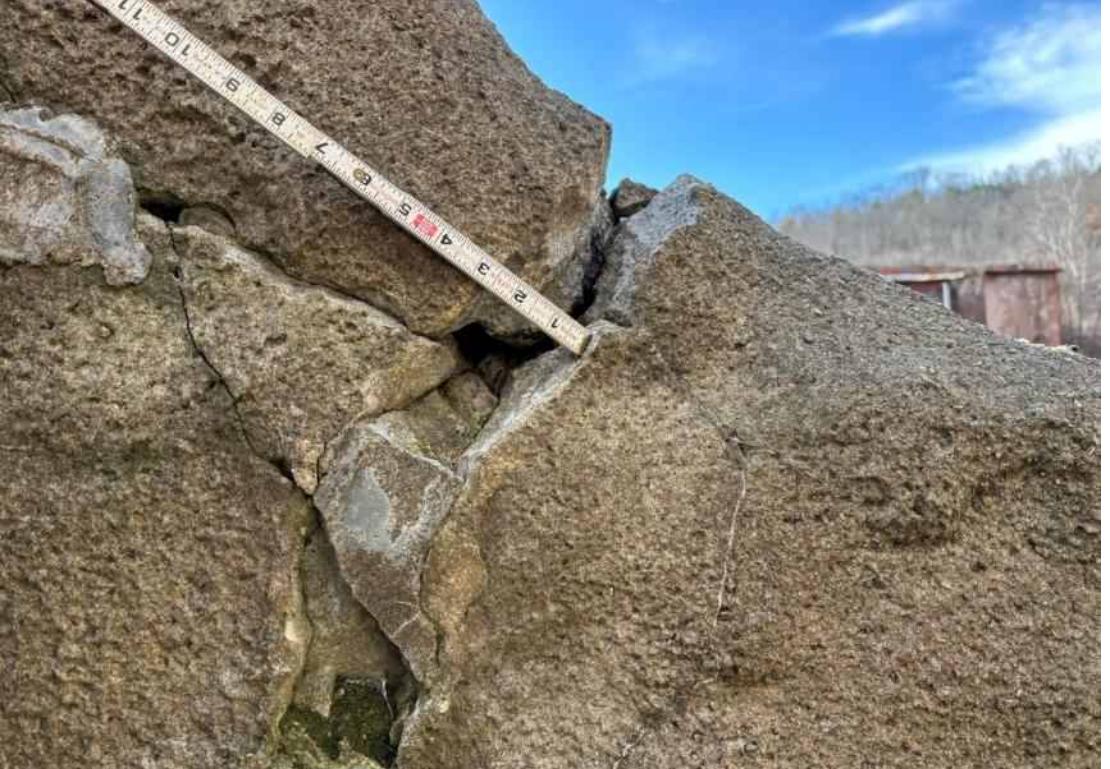
<p>A close-up photograph of a vertical concrete wall. A metal tape measure is placed diagonally across a horizontal crack in the wall, extending from the top left towards the bottom right. The tape measure shows markings from 0 to 10 inches. The wall has a rough, textured surface with some moss or algae growth. The background shows a clear blue sky and a distant building.</p>	
Direction Photo Taken: Left.			
Description: Closeup of the crack in the right-side training wall shotcrete coating. See Photo 18 for location.

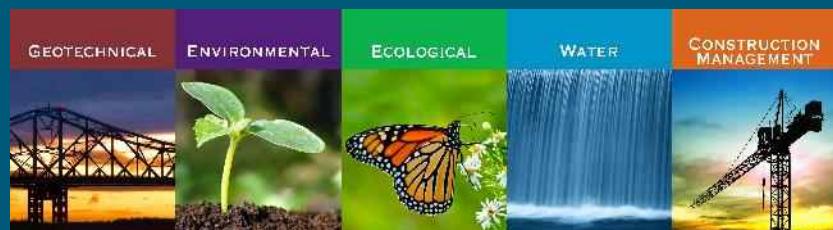
GZA GeoEnvironmental, Inc.
