Rachel Leary
Sr Specialist, EHS Services
GE Aerospace
1 Plastics Ave.
Pittsfield, MA 01201
T (413) 741-0933
Rachel.leary@geaerospace.com

Via Electronic Mail

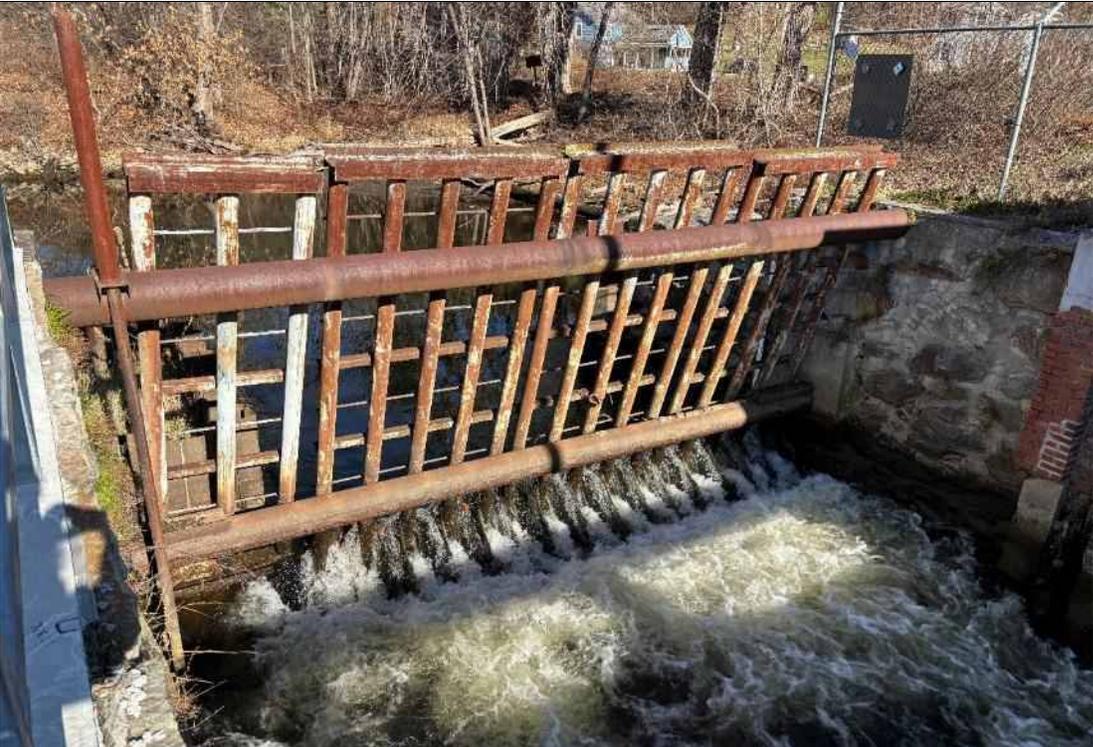
Direction Photo Taken: Upstream			
Description: Forebay trashracks. Note minor surficial rusting of the steel.

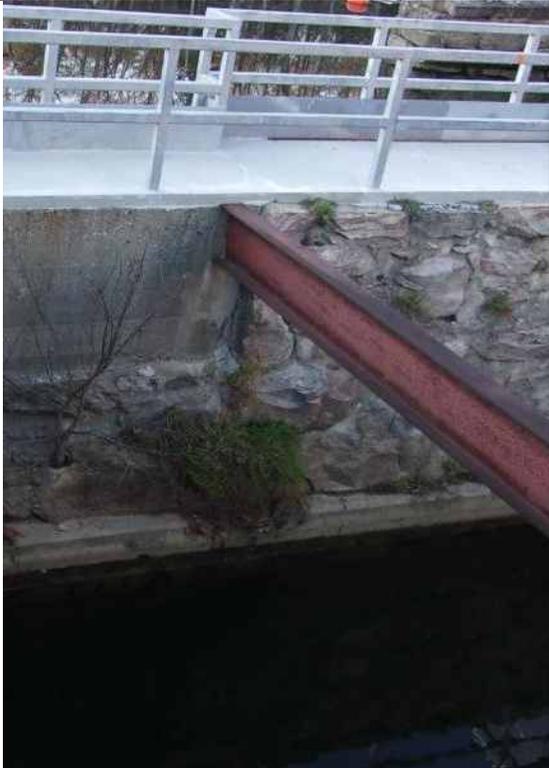
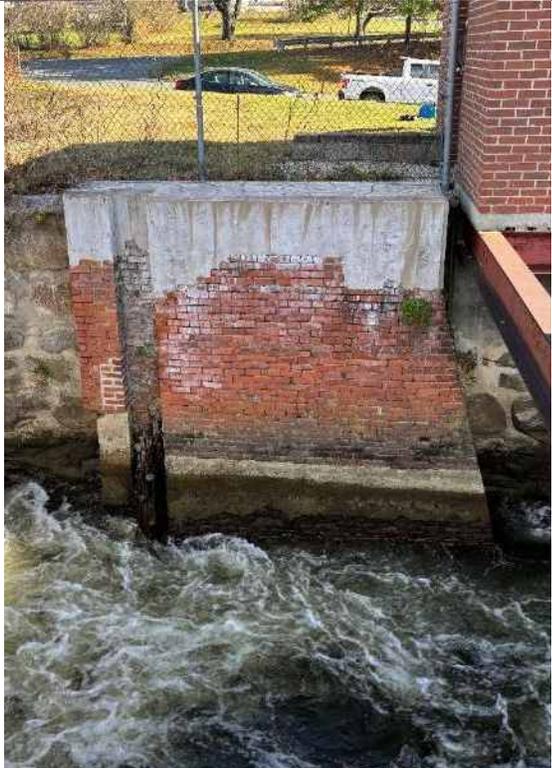
Direction Photo Taken: Left Photo: Right Right Photo: Left			
Description: (Left Photo): Right forebay wall. Note vegetation growth in the right stone masonry wall. (Right Photo): Left forebay brick wall. Note, repairs made to the wall in the fall of 2023. Repairs appeared to be intact.

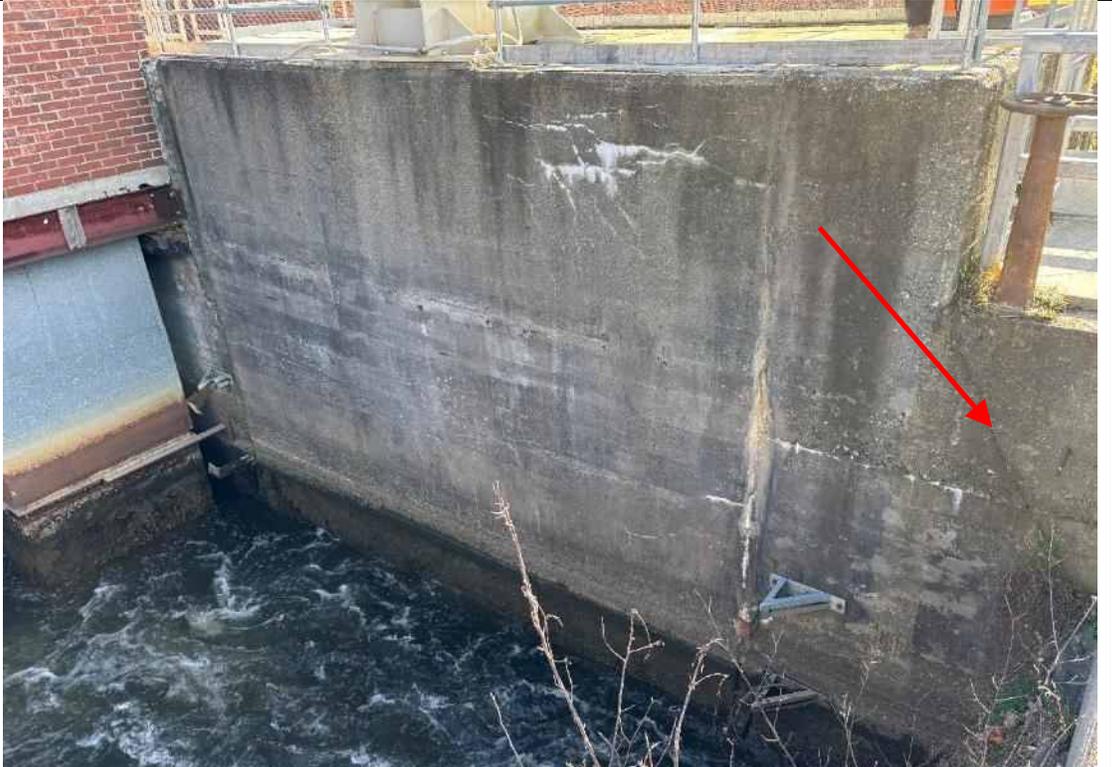
Direction Photo Taken: Downstream		
Description: Upstream face of the low-level outlet gate platform concrete structure. Note the minor crack in the concrete face below the abandoned operator (red arrow).

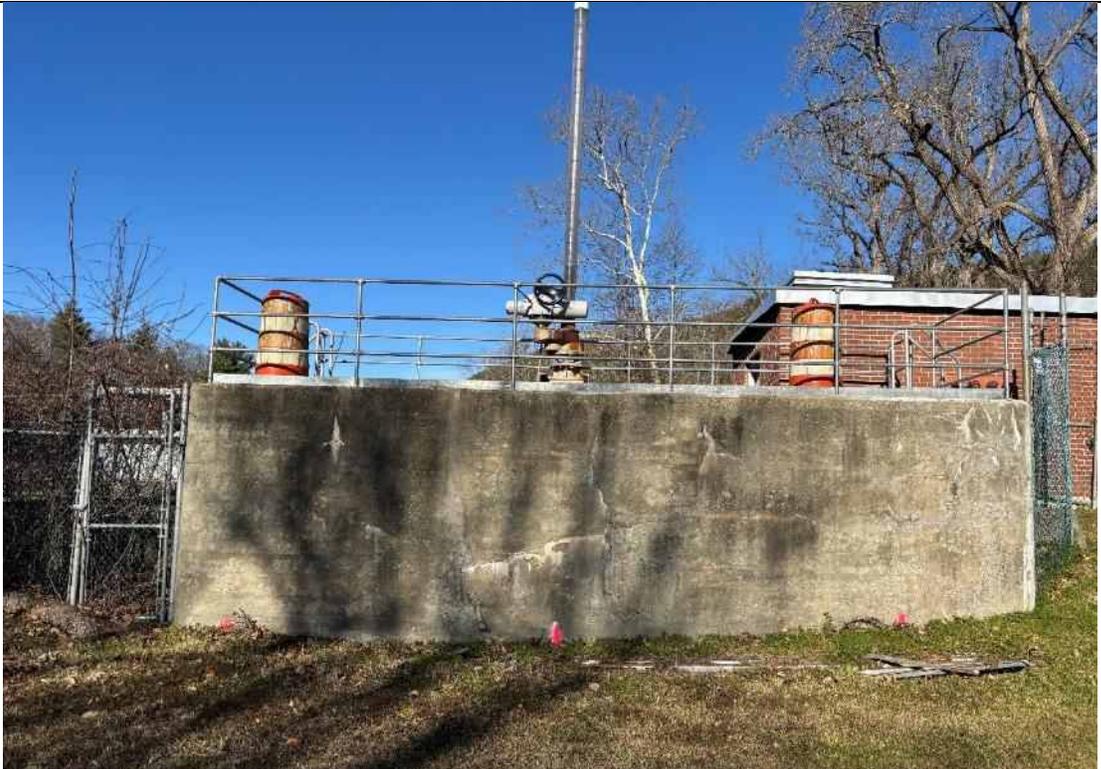
Direction Photo Taken: Upstream			
Description: Downstream face of the low-level outlet gate platform concrete structure. Note minor cracking and efflorescence in the concrete face.

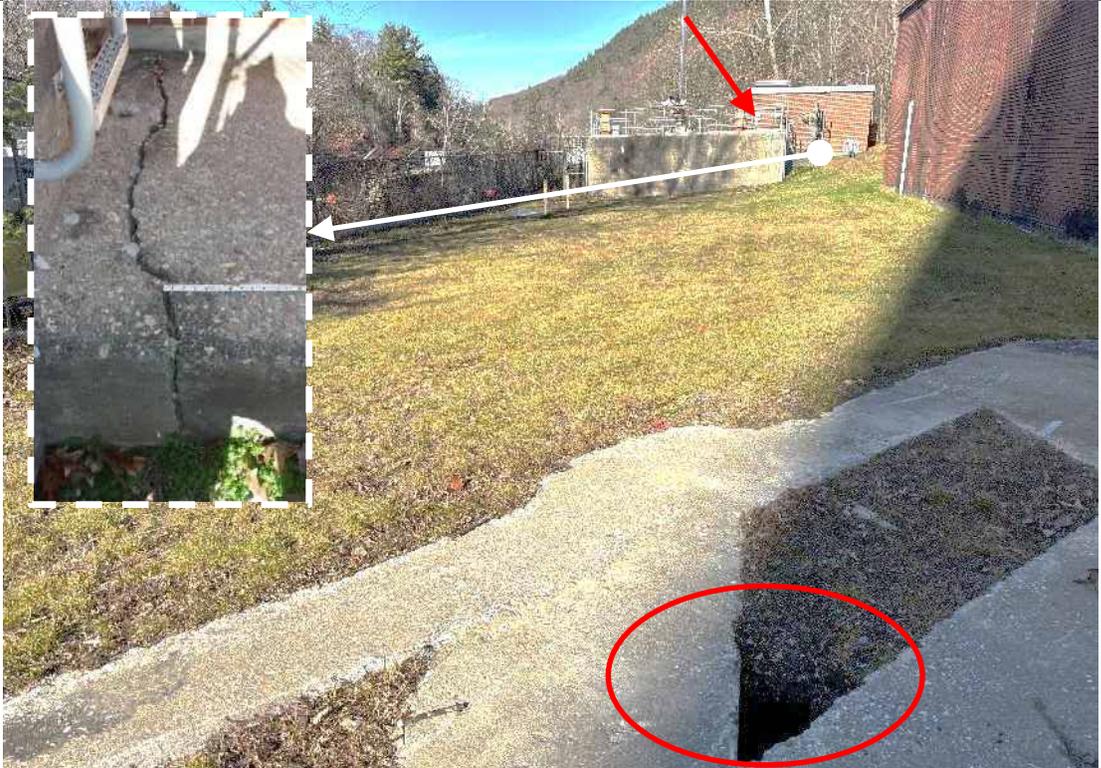
Direction Photo Taken: Upstream			
Description: Area above the penstock. (Inset): Crack in the concrete step to the left of the forebay platform. (Red Arrow): Diagonal crack in the pumphouse brick wall (see Photo 8). (Red Circle): Depression in the area above and to the left of the penstock (see Photo 9).

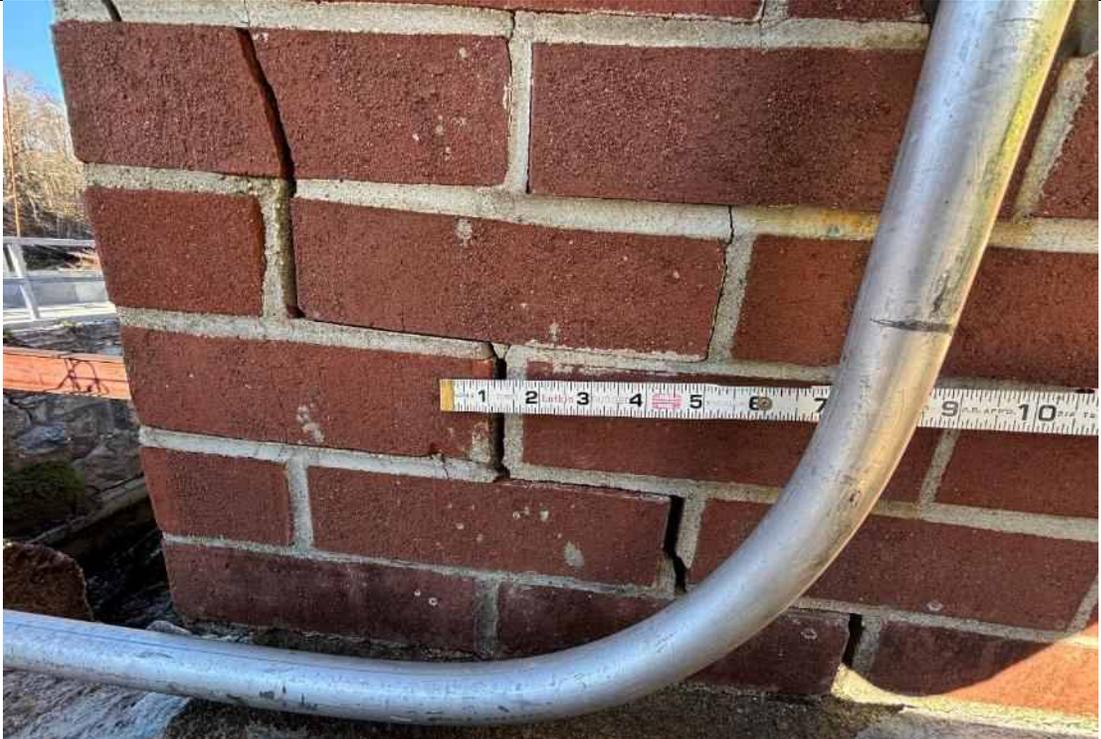
Direction Photo Taken: Upstream		
Description: Closeup of the approximately 0.4-inch wide diagonal crack in the lower six courses of the pumphouse downstream brick wall near the right corner.

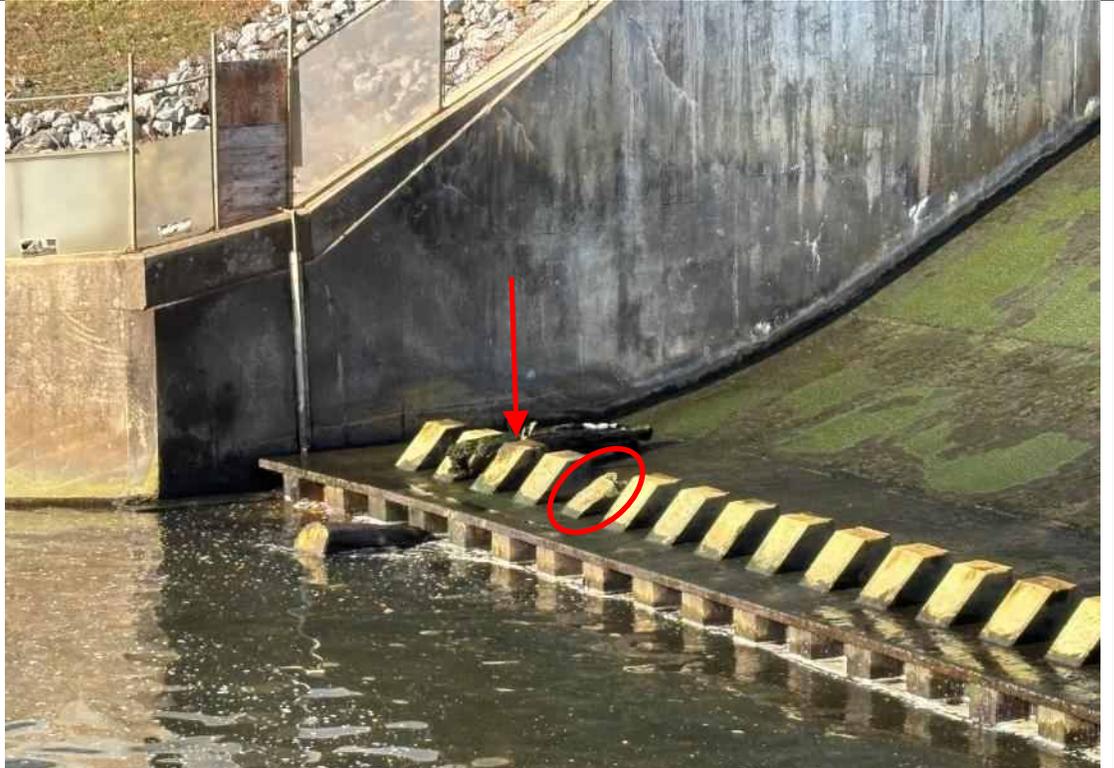
Direction Photo Taken: Right			
Description: Right downstream spillway apron. Note damaged energy dissipator (red circle) and log caught in the energy dissipators (red arrow).

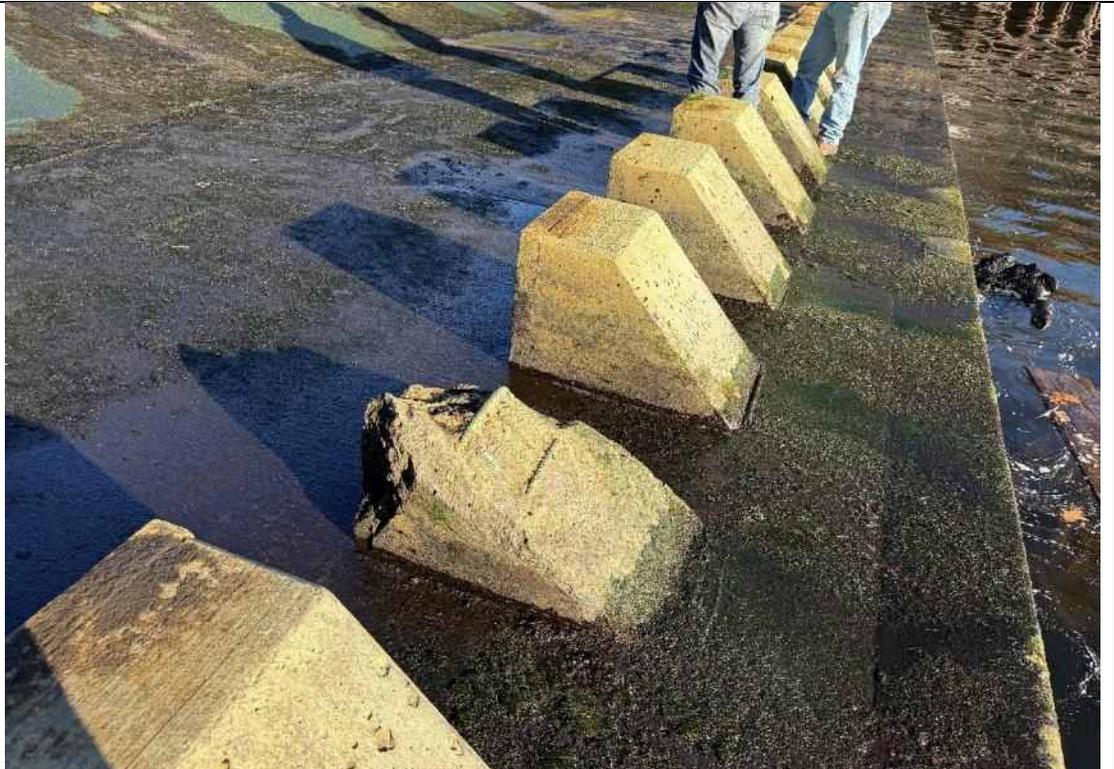
Direction Photo Taken: Left			
Description: Closeup of the broken energy dissipator.

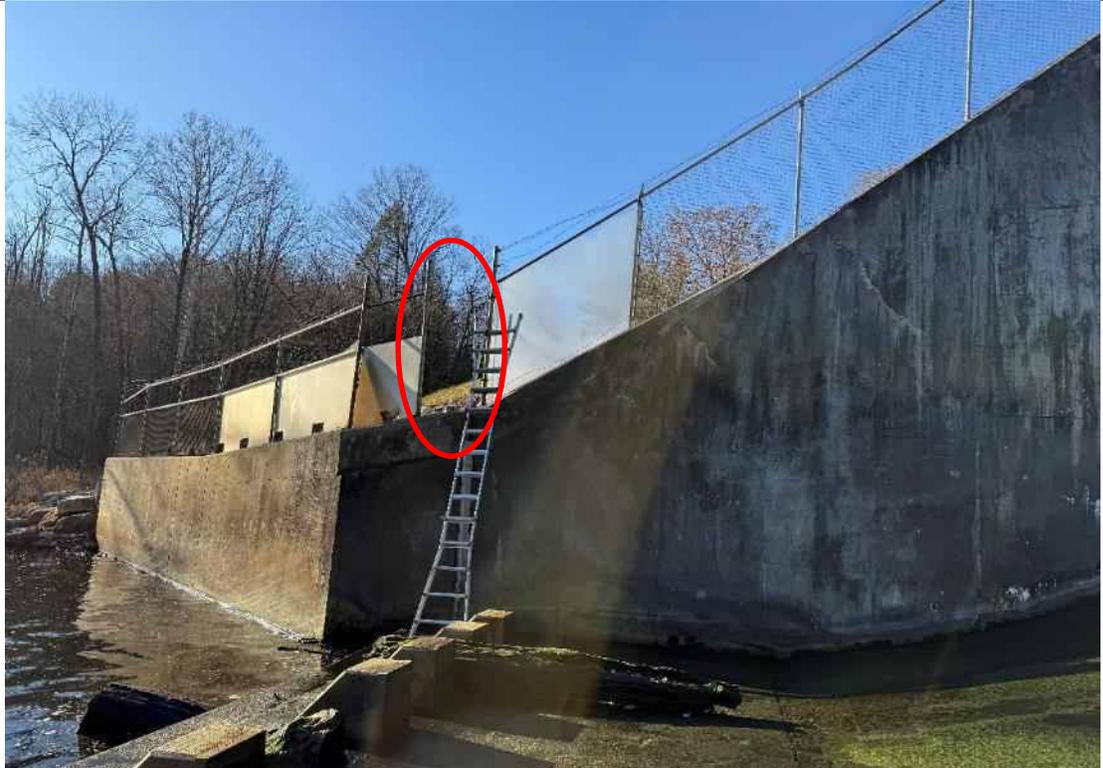
Direction Photo Taken: Right			
Description: Right downstream spillway training wall. Note missing fence gate (red circle). Prior to inspection and after inspection, the gate opening was secured with plywood.

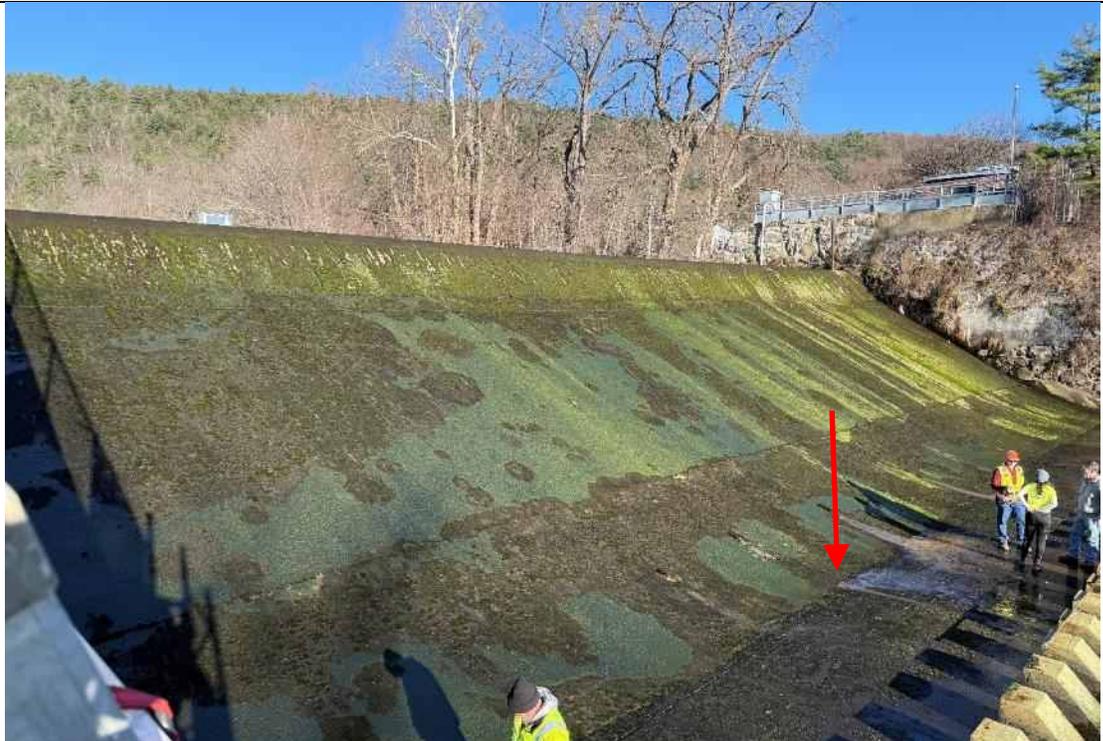
Direction Photo Taken: Upstream and left			
Description: Downstream face of the spillway. Note location of horizontal crack/joint in the downstream face of the spillway (red arrow); see Photo 19.

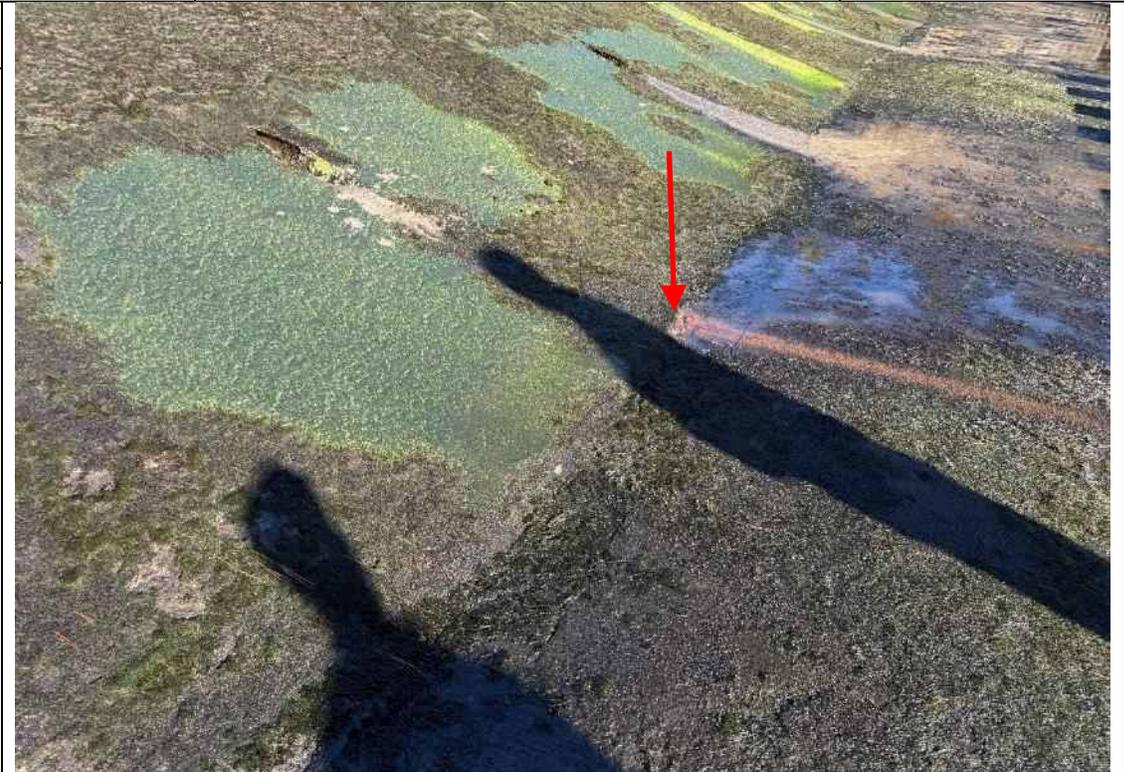
Photo No. 20	Date: 11/20/2025
------------------------	----------------------------

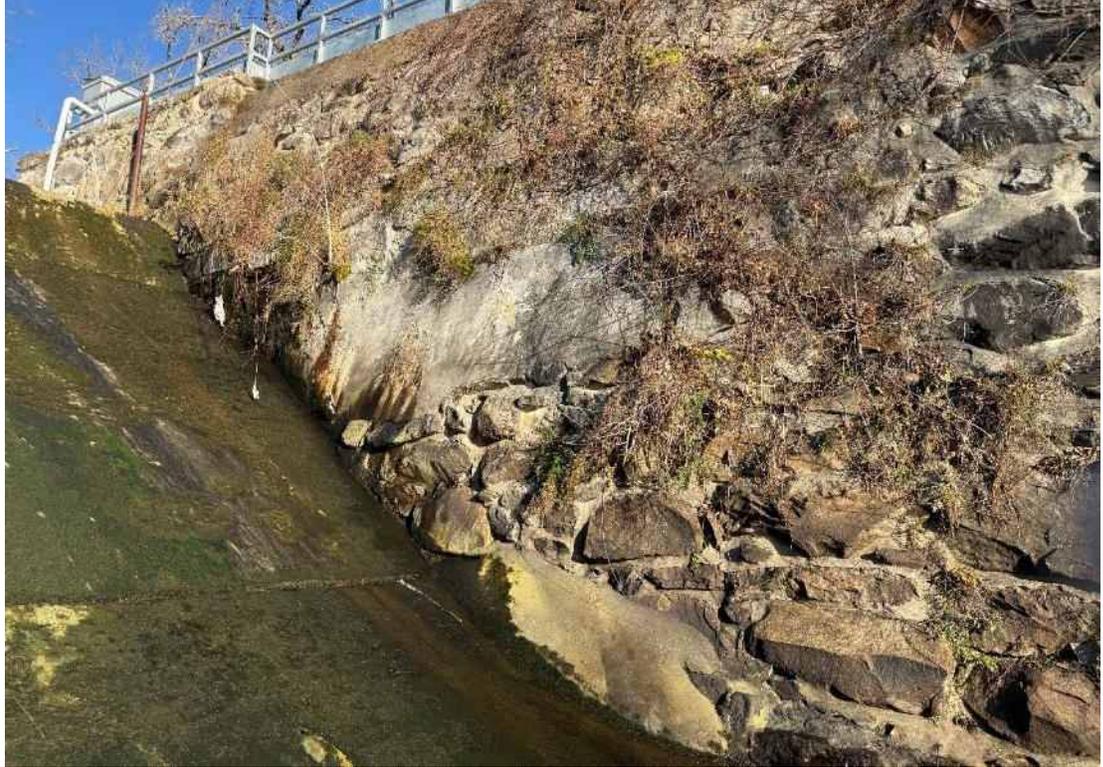
Direction Photo Taken: Left			
Description: Minor diffuse leakage was observed emanating from the downstream left masonry training wall with frequency and seepage rate increasing towards the downstream end of the spillway. The leakage was clear with total estimated flow rate less than about 1- to 2-gpm.

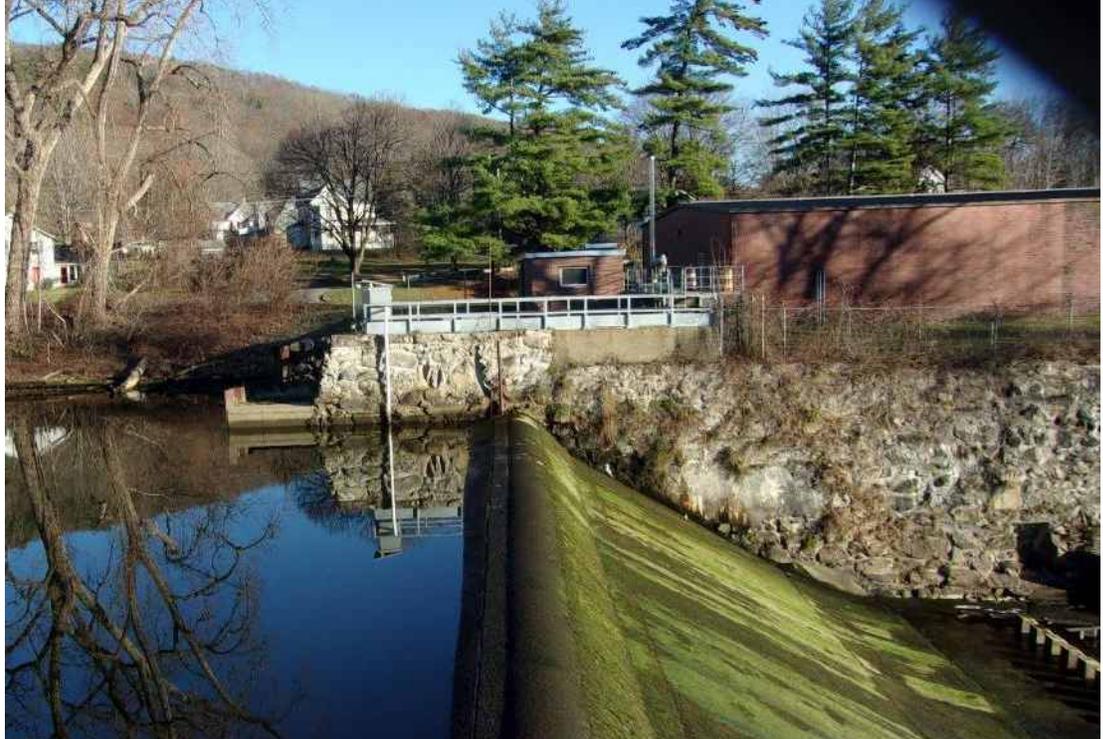
Direction Photo Taken: Left			
Description: Left abutment and spillway training walls. The two areas of leakage through the stone masonry left training wall observed during previous site visits were not observed during the dewatered Phase 1 inspection.

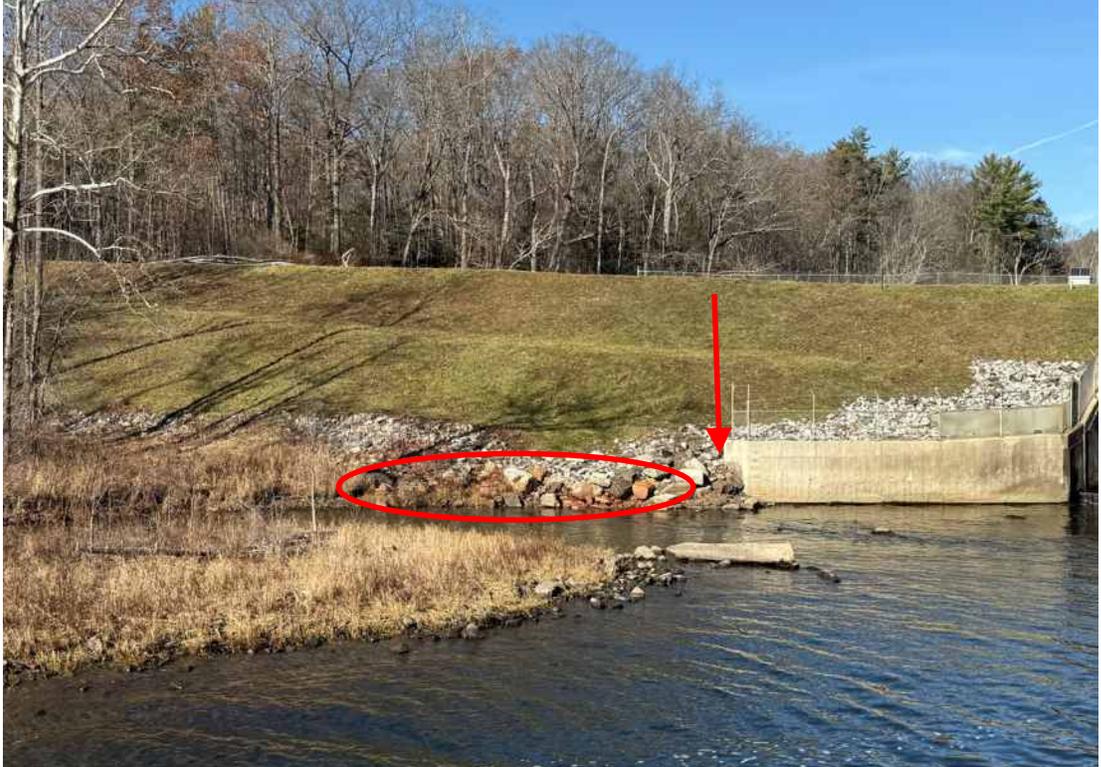
Direction Photo Taken: Upstream			
Description: Downstream slope of the right embankment. (Red arrow): minor sloughing of riprap at the end of the right downstream training wall (see Photo 24). (Red circle): iron staining along the right downstream shoreline.

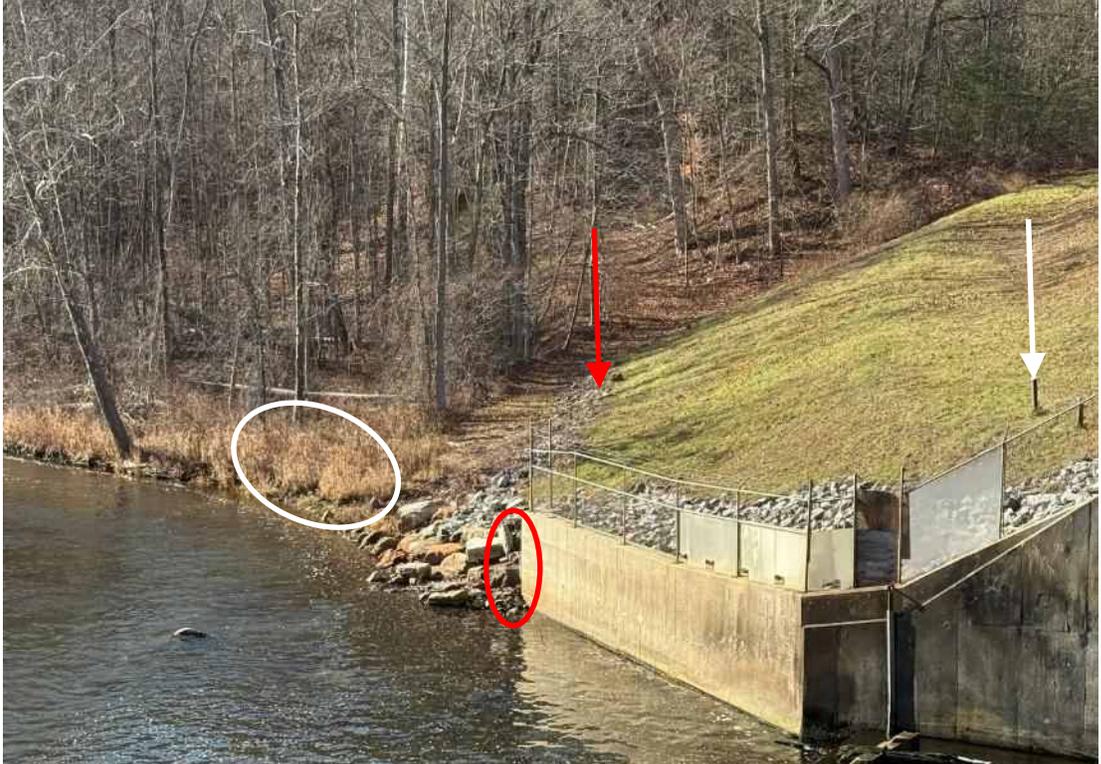
Direction Photo Taken: Downstream/Right			
Description: Toe of the right embankment. (Red arrow): "Low area" (see Photo 25). (Red circle): minor sloughing of riprap at the end of the right downstream training wall (see Photo 23). (White circle): area of standing water. (White arrow): Tilted piezometer GZ-6 casing.

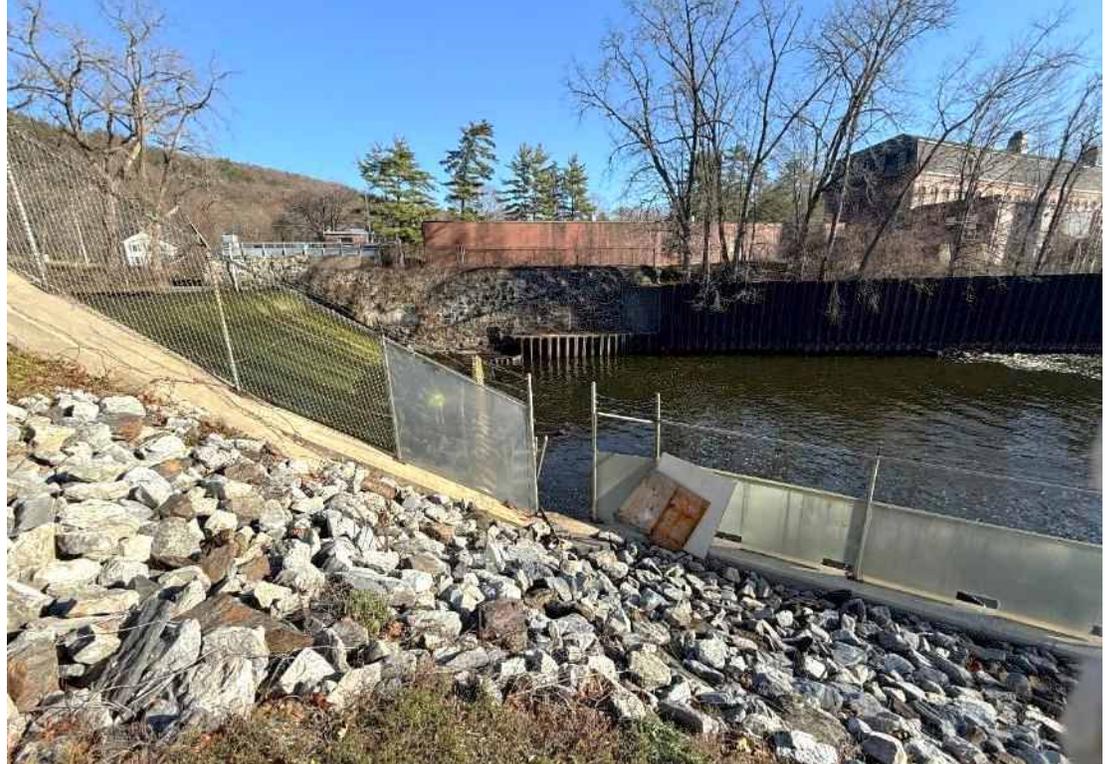
Direction Photo Taken: Left.			
Description: Fence along the top of the right spillway training wall. Note broken gate (plywood blocking temporarily removed to allow access). Plywood re-installed across opening at end of inspection.

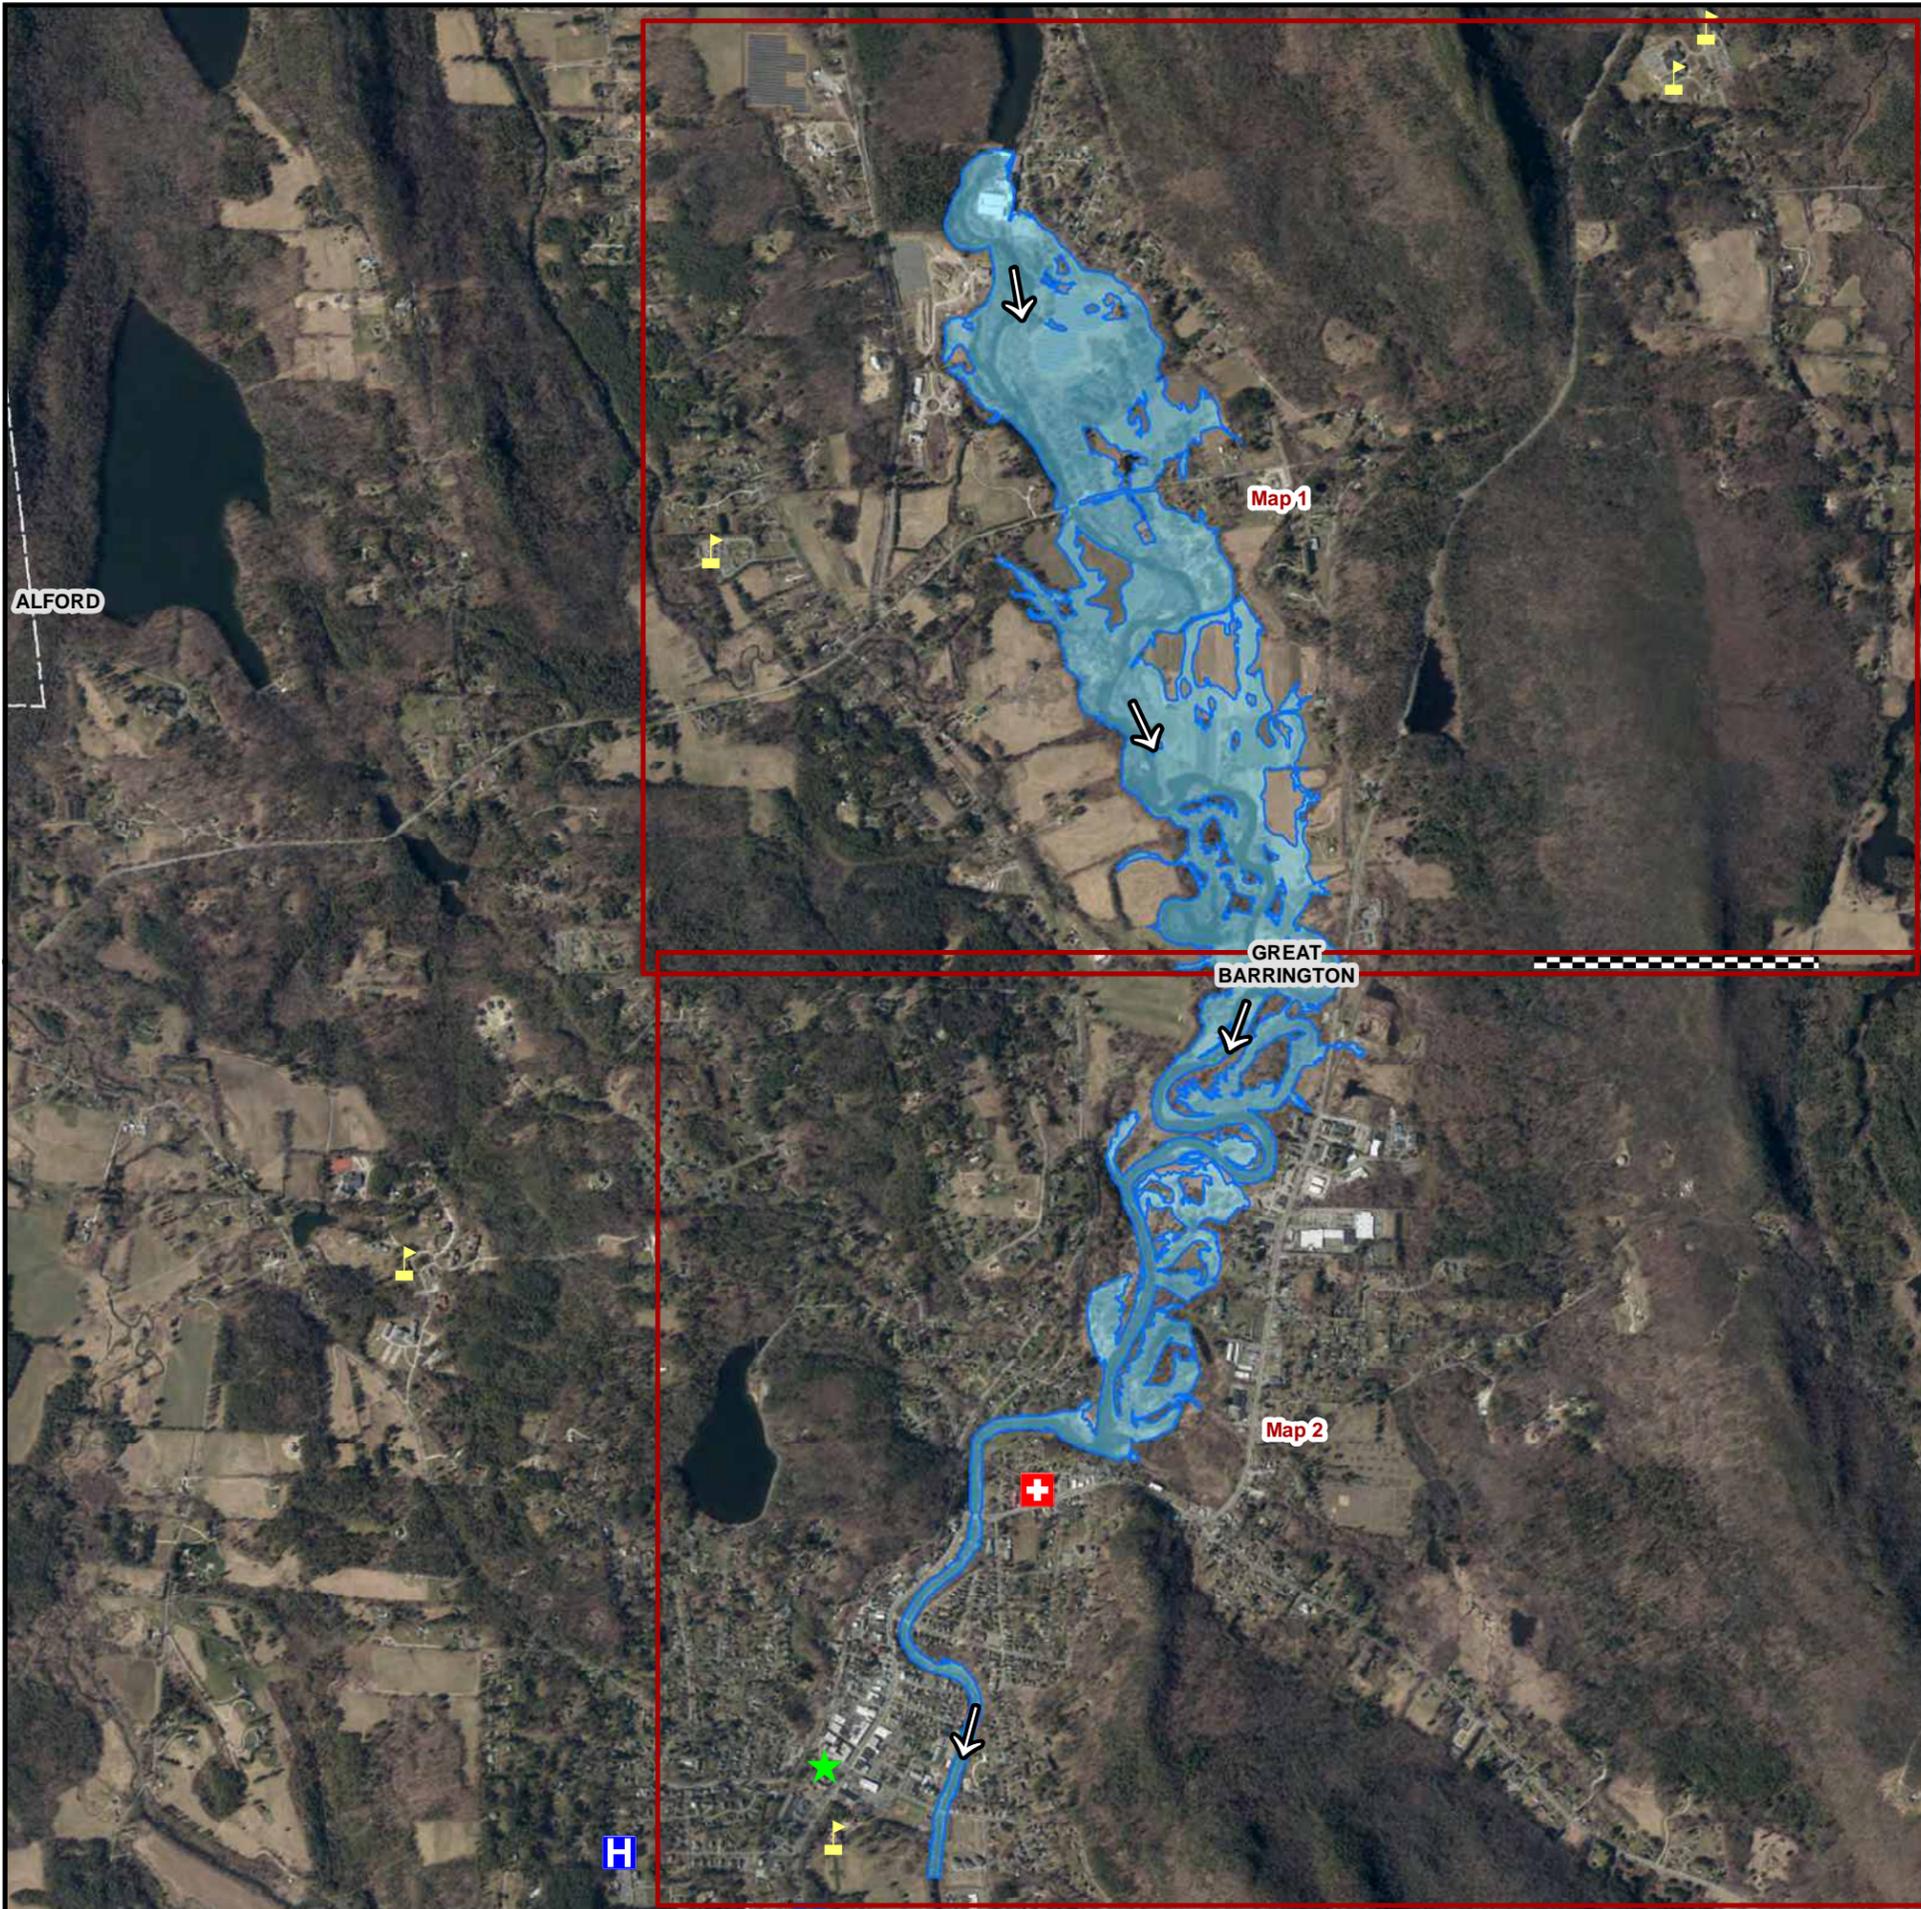
APPENDIX F3 – INUNDATION MAPS (BASED ON GZA’S 2024 DAM BREAK ANALYSIS)

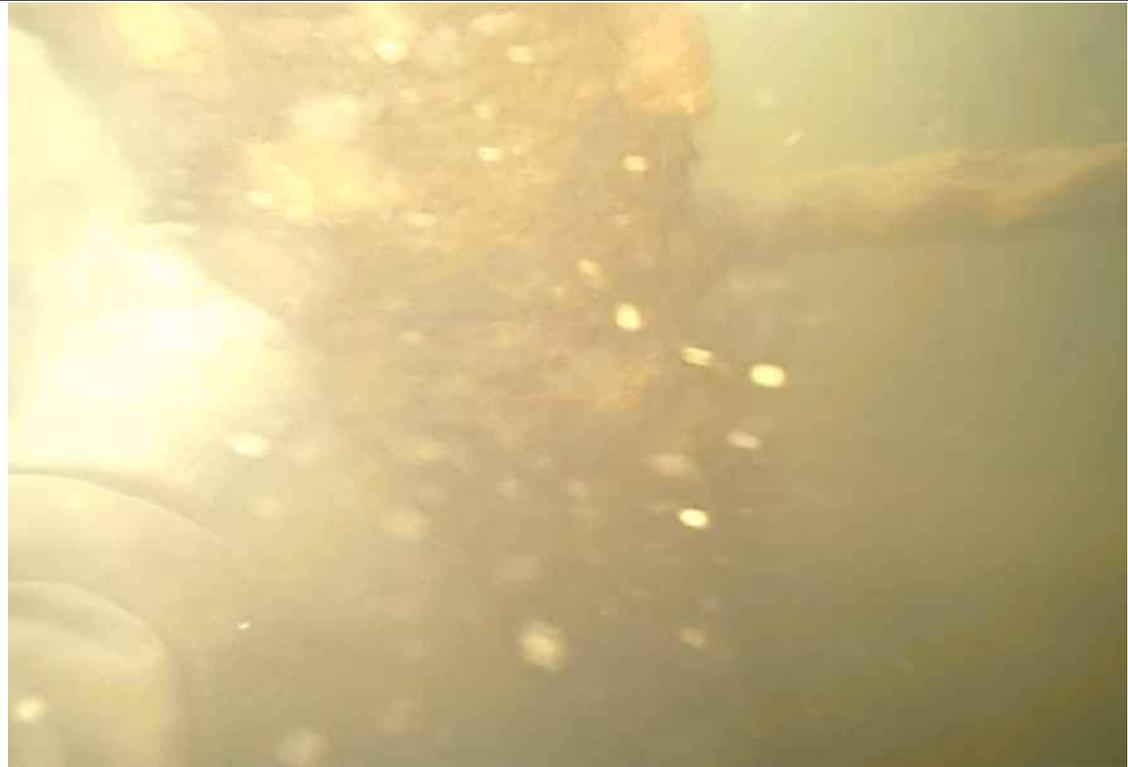
Direction Photo Taken: Upstream			
Description: Typical condition of the trash rack in the forebay. Note marine growth and minor surficial rusting.

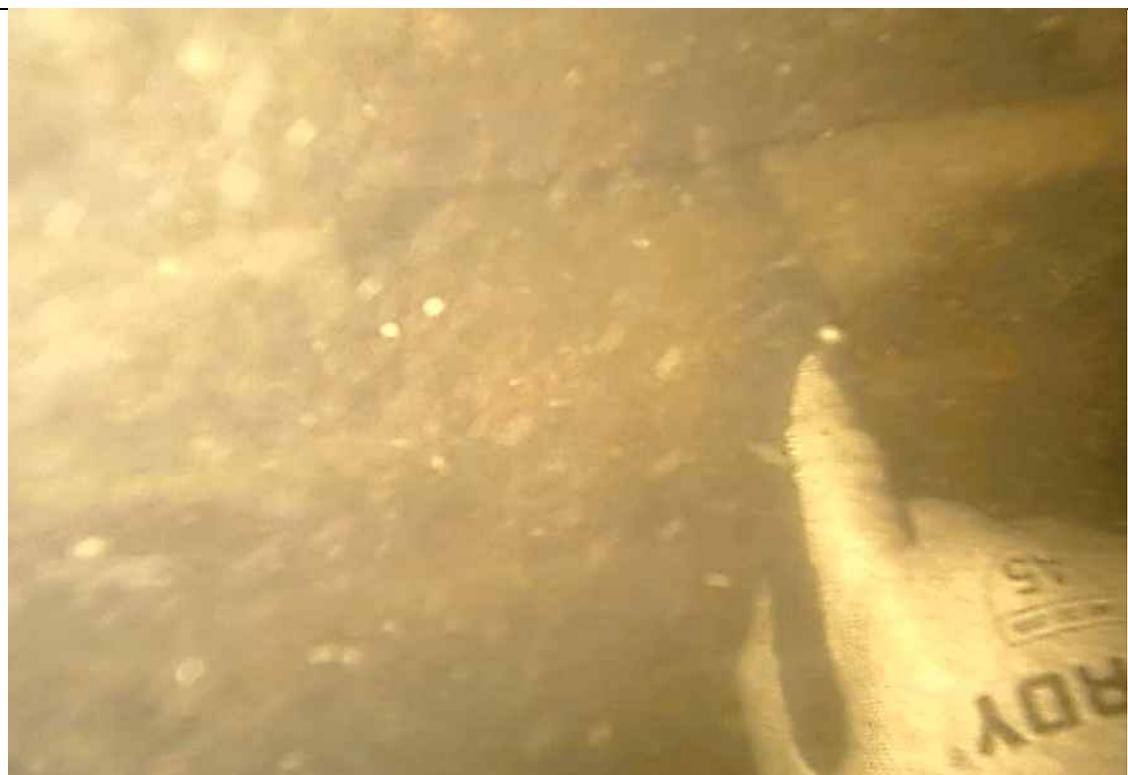
Direction Photo Taken: Left			
Description: Missing brick in the left forebay wall at about 8 to 10 feet below the water surface.

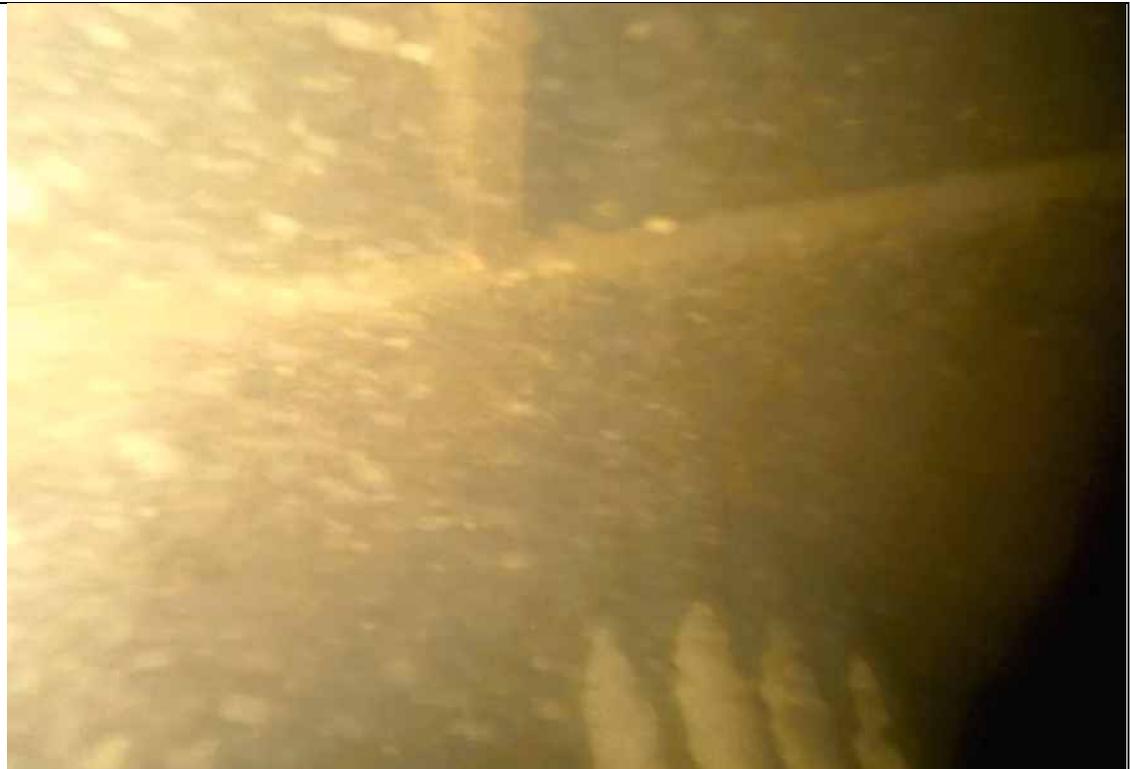
Direction Photo Taken: Downstream			
Description: Upstream face of the gate at the invert, about 19-ft depth. Note minimal- to no-gate leakage.

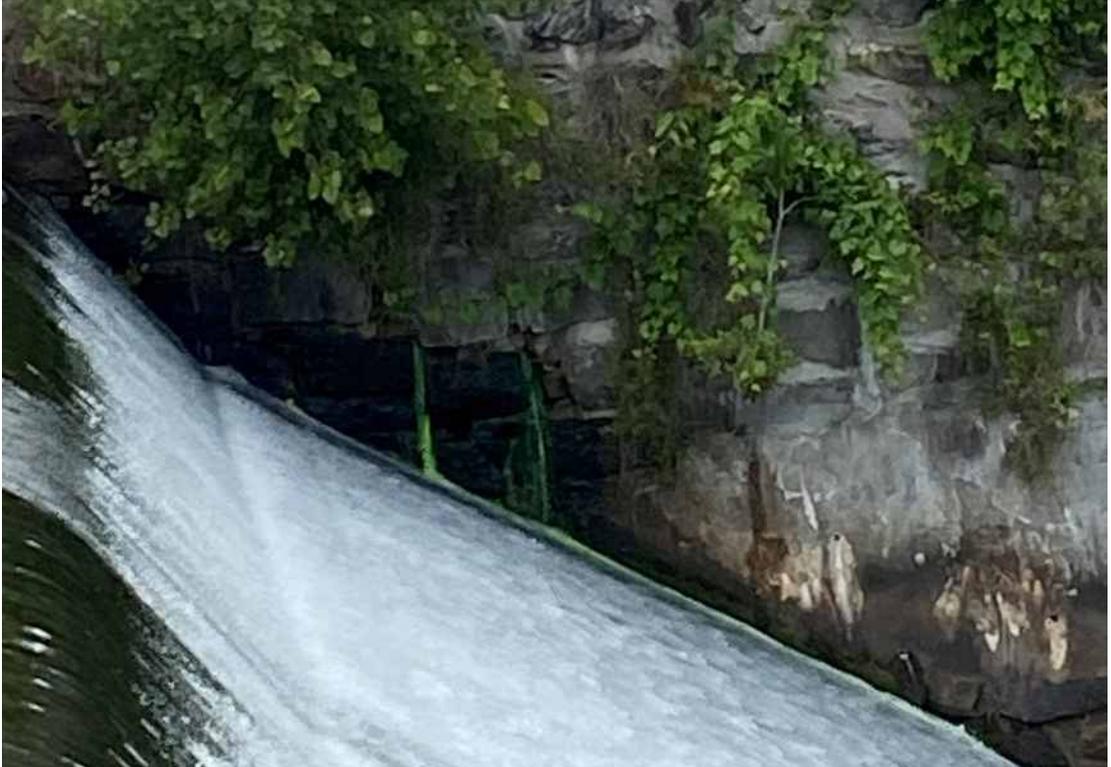
Direction Photo Taken: Left			
Description: Location of dye leaking through the left spillway training wall. See Photos 7 and 8 for location where dye was introduced in the right forebay wall.

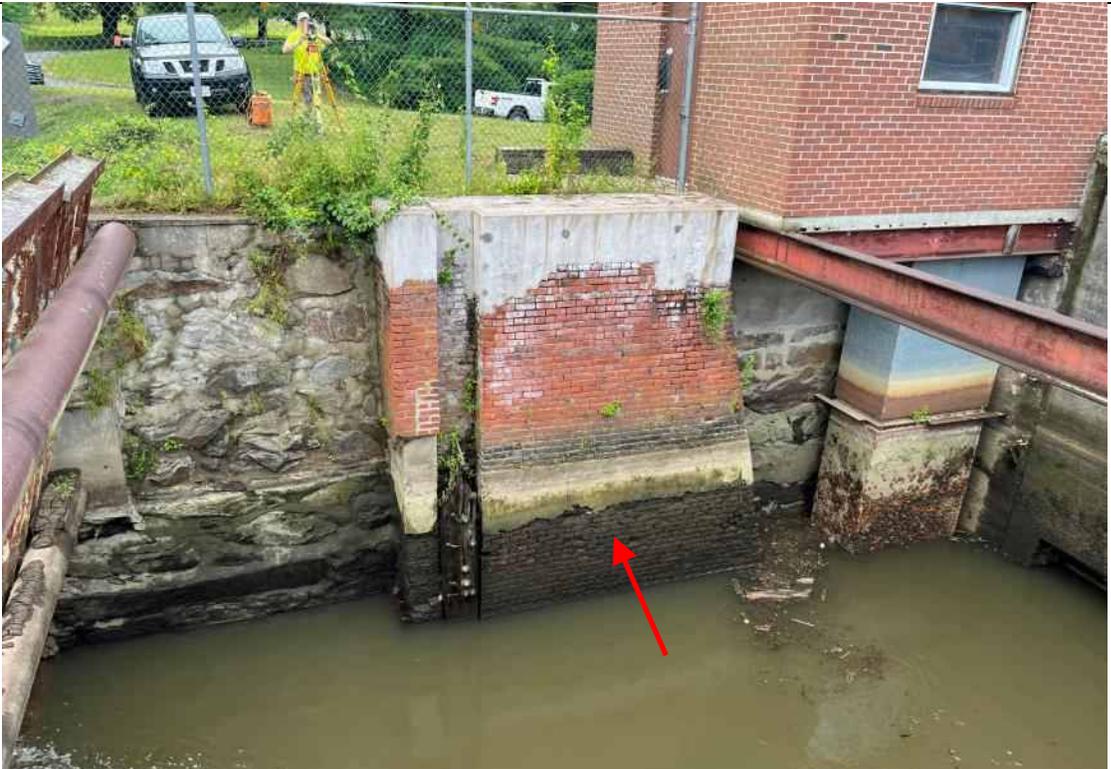
Direction Photo Taken: Left			
Description: Left forebay wall, lower water elevation. Deterioration of the exposed brick below the normal water level (red arrow).
