Rachel Leary
Sr Specialist, EHS Services
GE Aerospace
1 Plastics Ave.
Pittsfield, MA 01201
T (413) 741-0933
Rachel.leary@geaerospace.com

Via Electronic Mail

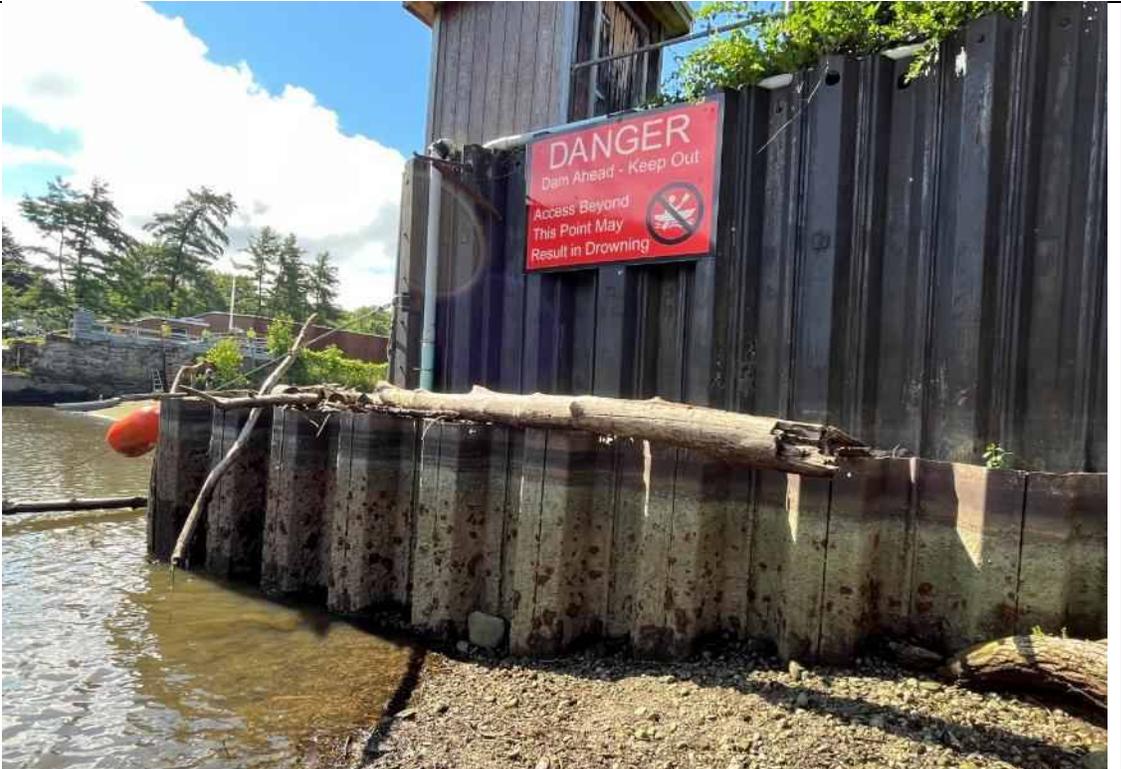
Direction Photo Taken: Downstream and left			
Description: Upstream face of the sheetpiles at the right embankment/instrumentation shed with lowered pool level. Minor surface rusting and corrosion of the sheetpiles.

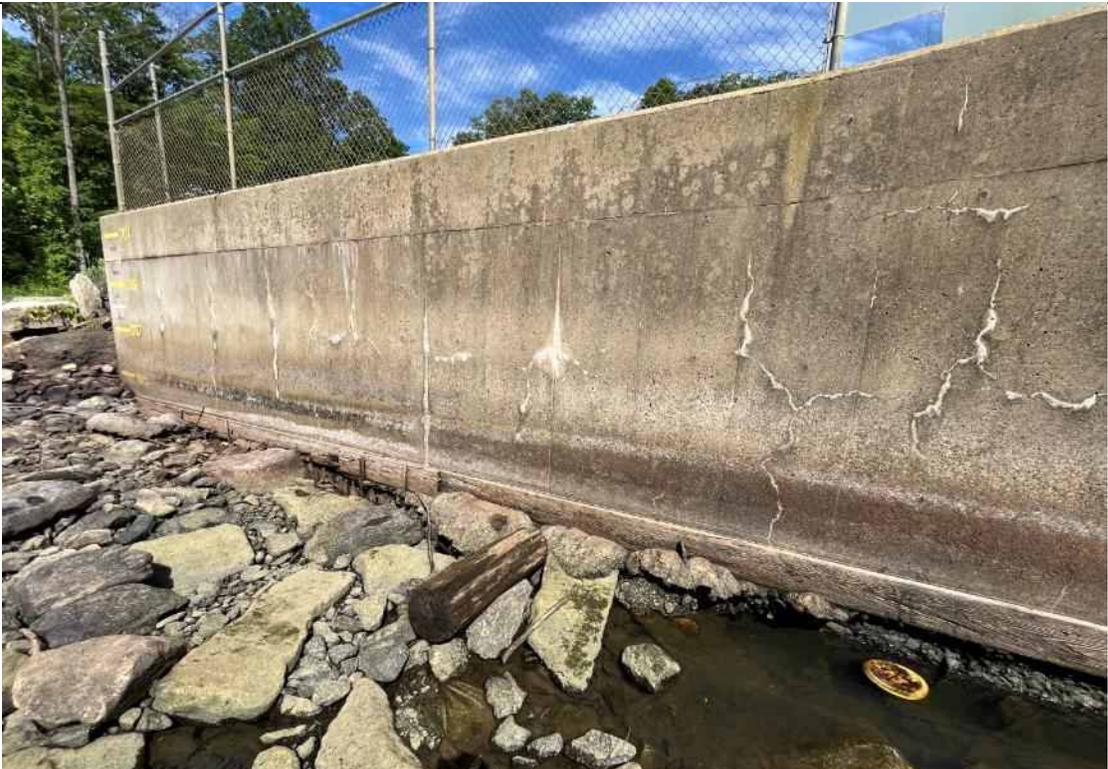
Direction Photo Taken: Right		
Description: Right downstream training wall with lowered pool level. Note good contact at the base of the wall; no scoured or undermined areas observed.

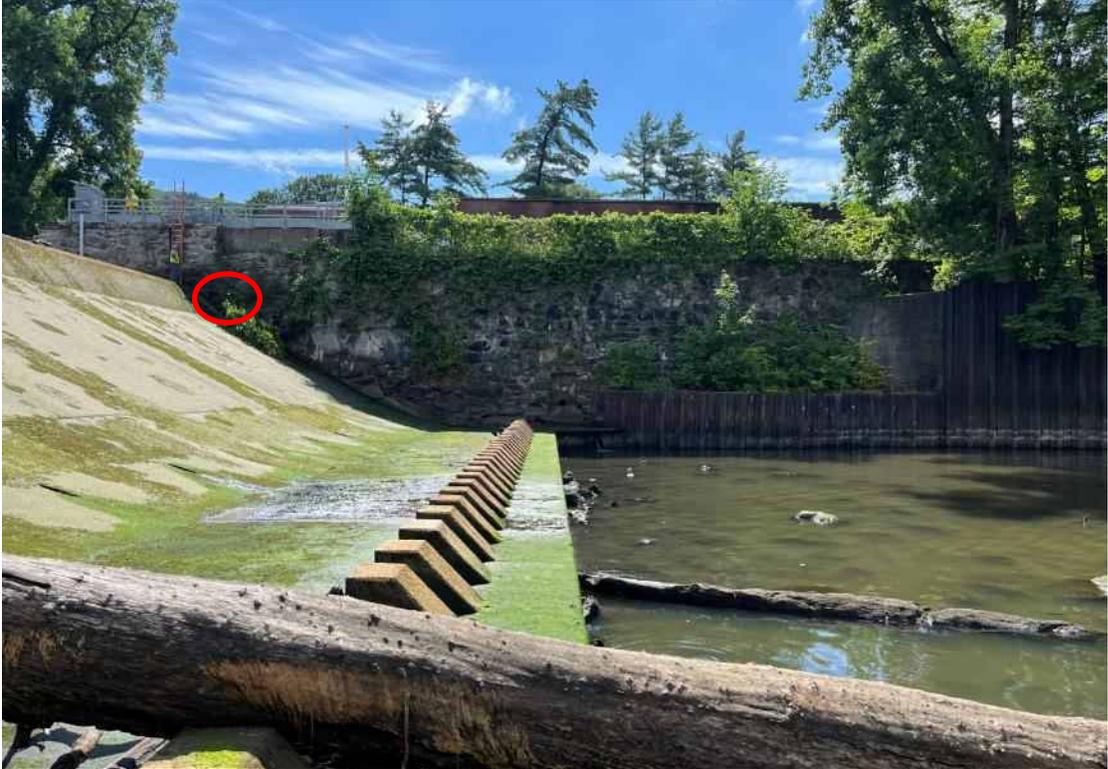
Direction Photo Taken: Left			
Description: Alignment along the downstream toe of the spillway. Red circle is the approximate exit point of the tracer dye that was introduced to the horizontal joint/crack within the forebay (see Photos 8 and 9).

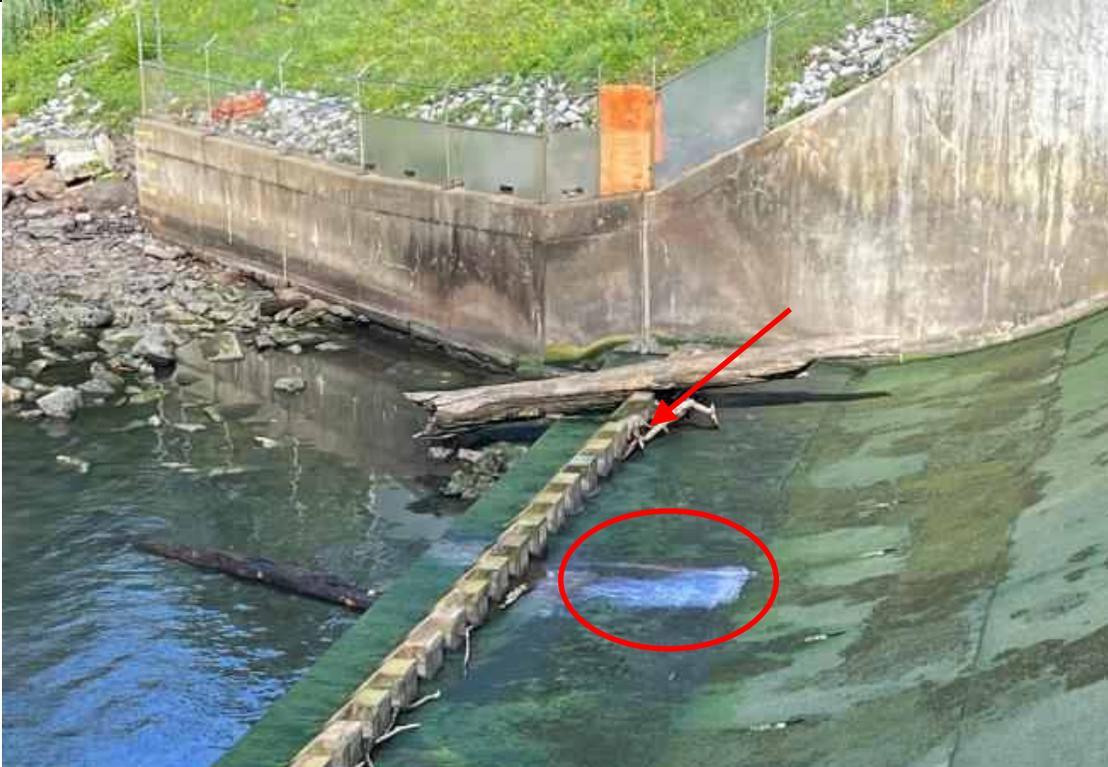
Direction Photo Taken: Downstream and right			
Description: Downstream toe of the spillway, lower water elevation. Note broken energy dissipator (red arrow) and minor leakage (red circle). See Photos 21 and 22 for more detail.

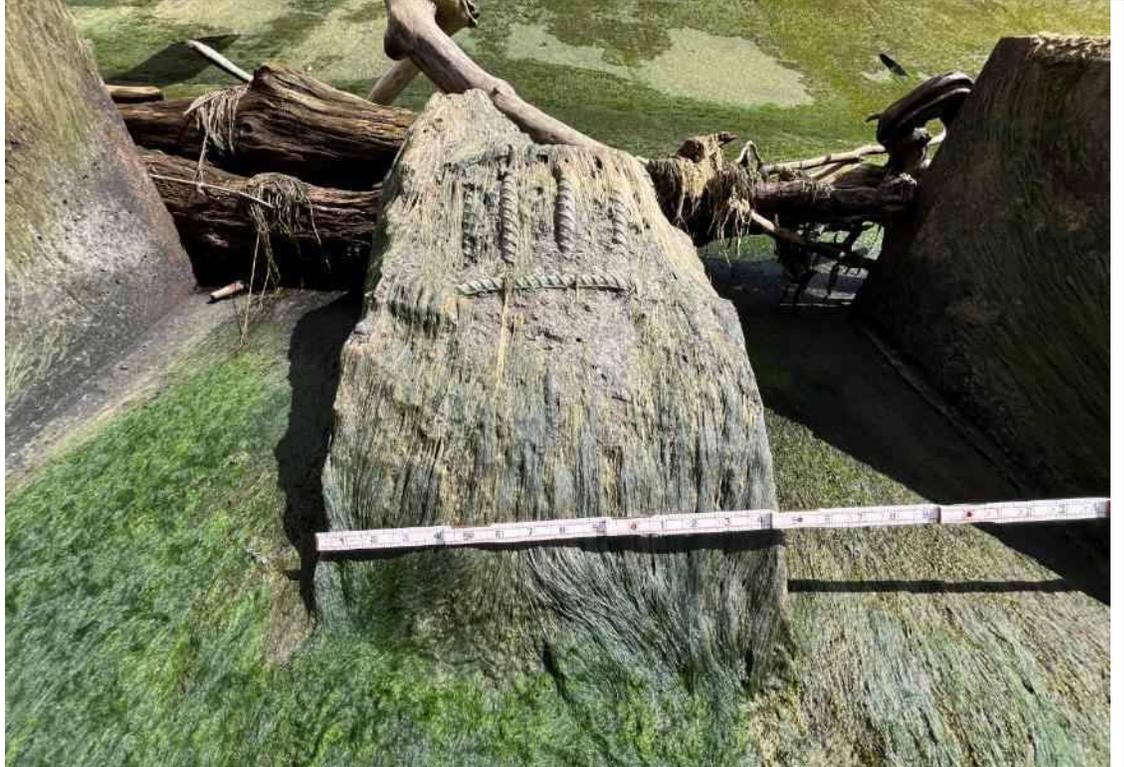
Direction Photo Taken: Upstream			
Description: Broken energy dissipator (5 th from right) at the toe of the spillway.

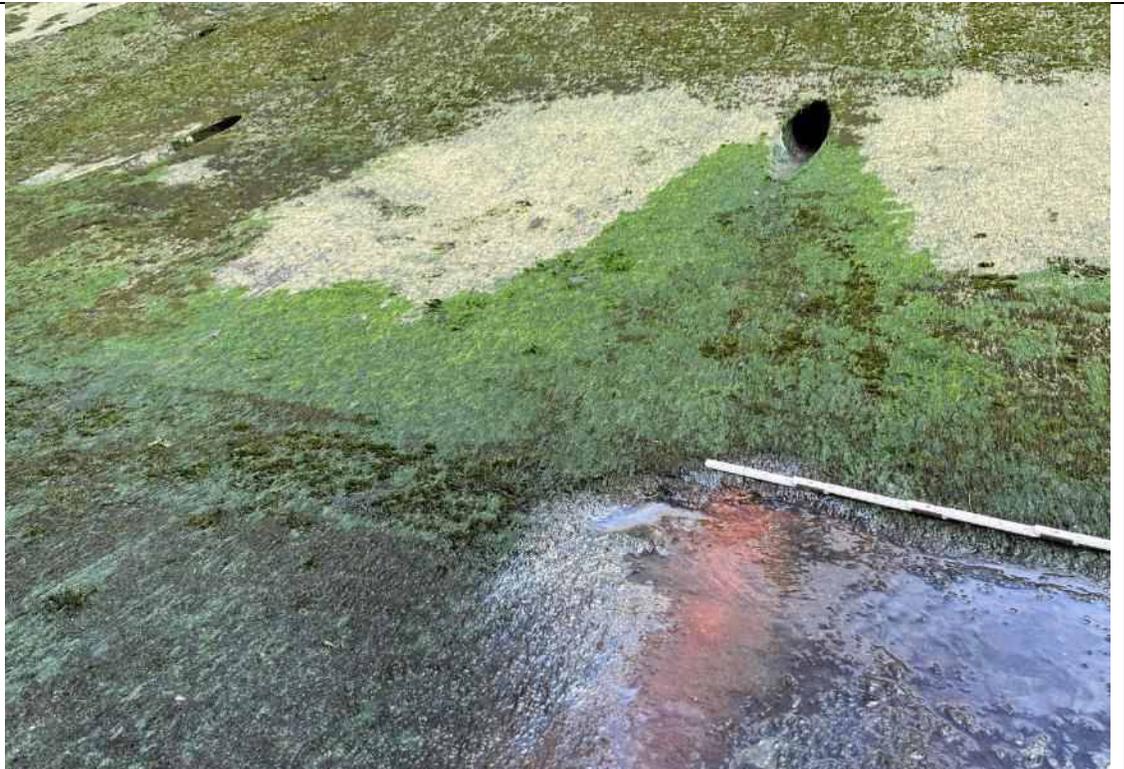
Direction Photo Taken: Upstream		
Description: Minor horizontal joint or crack and leakage at the slope transition at the downstream toe of the spillway. Crack was about 4 inches long and leakage was clear and less than 1 gpm.

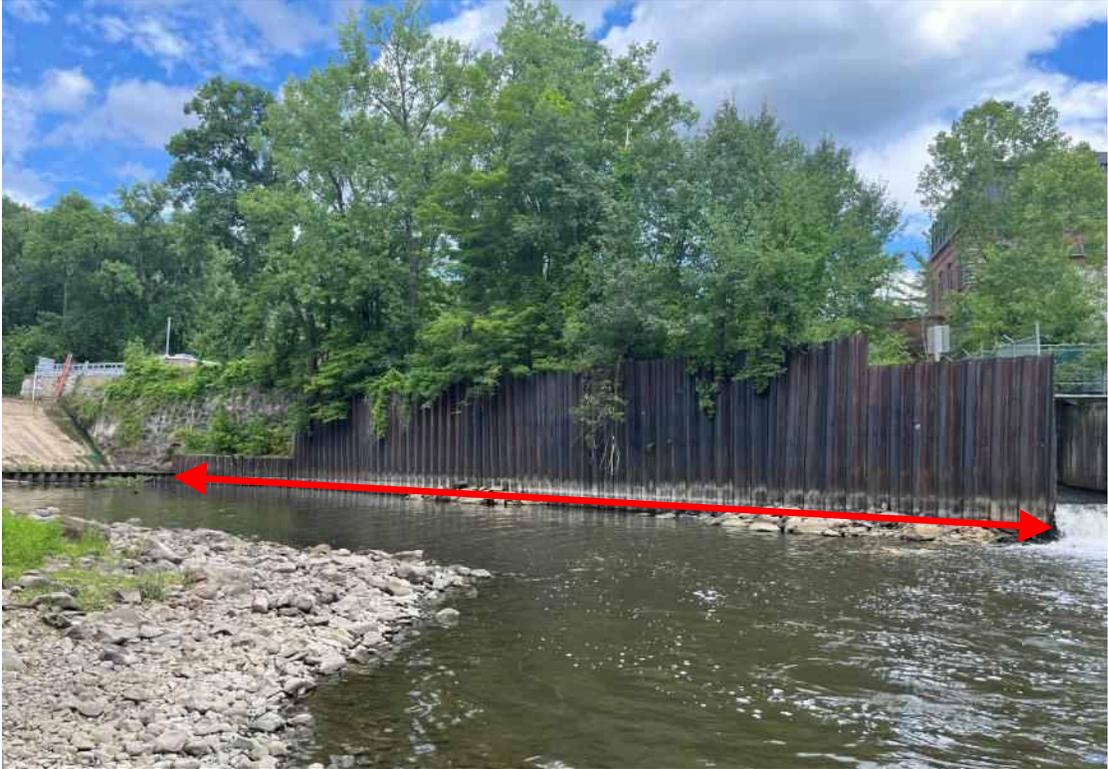
Direction Photo Taken: Left			
Description: Left bank sheetpile wall downstream of dam. Diver walked the length of the sheetpiles (red arrows). Contact along the length of the sheetpiles was intact, no undermining, scour or sheetpile deterioration was observed.

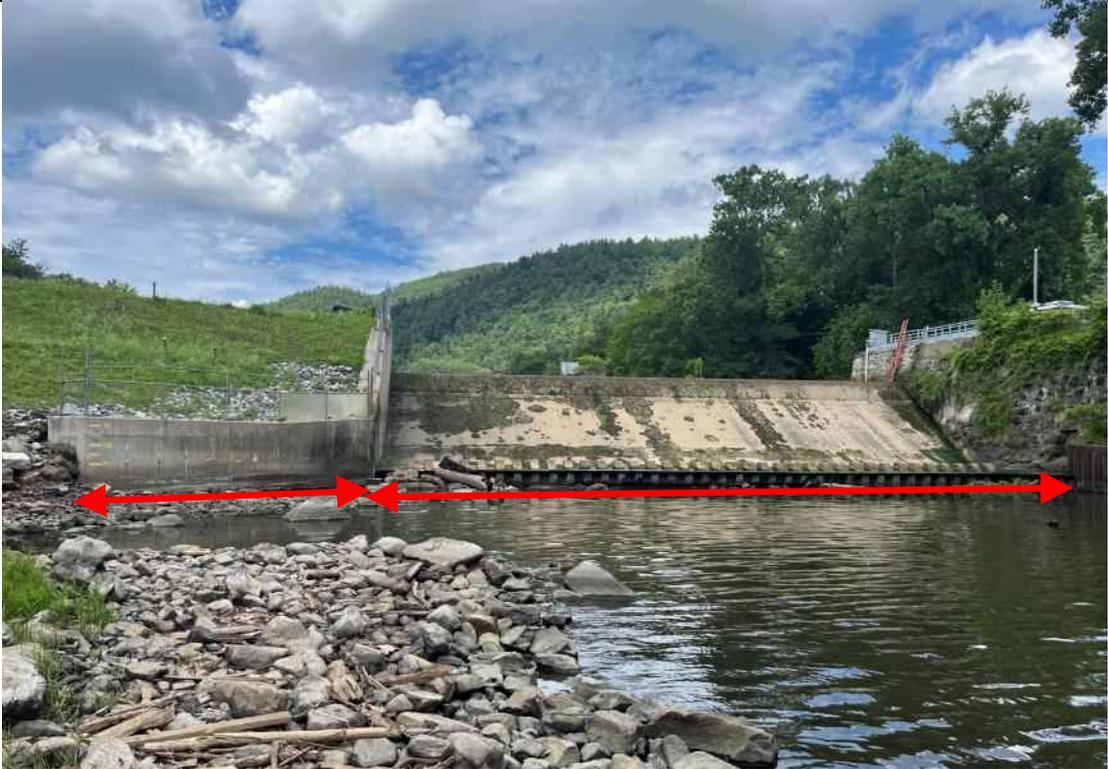
Direction Photo Taken: Upstream			
Description: Downstream face of the spillway and right training wall. Diver walked the length of the training wall and spillway apron (red arrows). Contact along the length of the structures was intact, no undermining, scour or significant deterioration was observed.
