**FOCUS FEASIBILITY STUDY DATA EVALUATION
BLUE SPRUCE INTERNATIONAL, INC.
BOUND BROOK, NEW JERSEY**

**TECHNICAL DIRECTIVE DOCUMENT NO. 02-8502-02B
CONTRACT NO. 68-01-6699**

**ENVIRONMENTAL SERVICES DIVISION
U.S. ENVIRONMENTAL PROTECTION AGENCY**

NOVEMBER 4, 1985

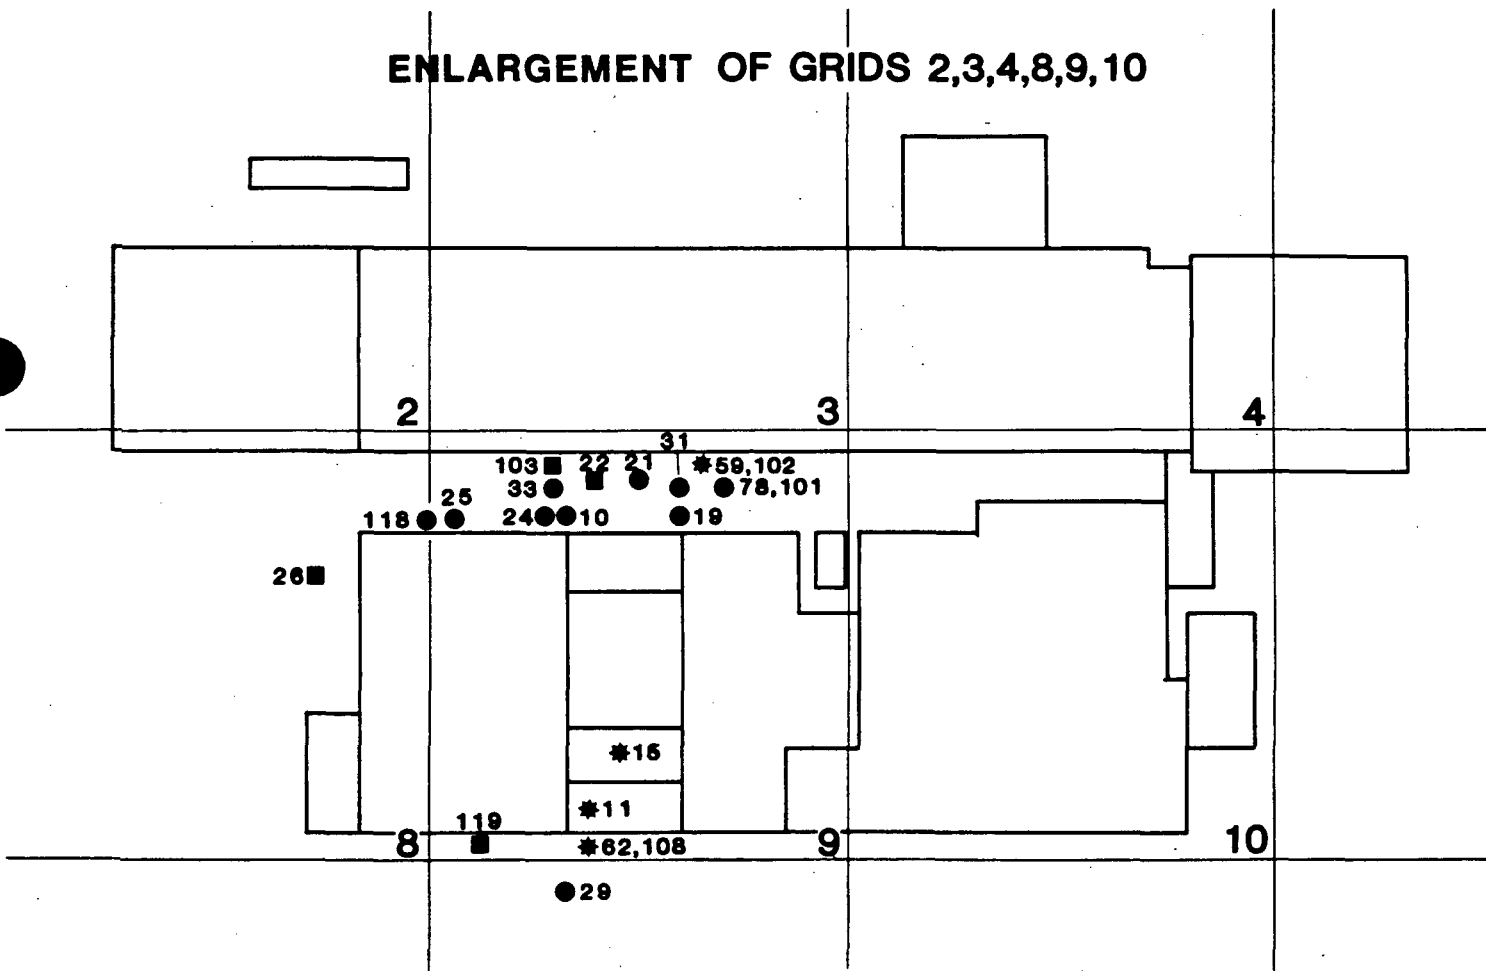
FIGURE 3-3

Figure 3-3, a positive 2,3,7,8-TCDD sample location map, summarizes the findings of the study. 2,3,7,8-TCDD was detected in 22 surface soil samples. Two samples, Number 11 collected in the basement and Number 15 collected in Room 3 of the building, contained 6.1 and 5.7 parts per billion (ppb) of 2,3,7,8-TCDD respectively. Nineteen samples with detectable concentrations of 2,3,7,8-TCDD were located in the alleyway north of the building and adjacent to the south door of the building. Fifteen of these samples had 2,3,7,8-TCDD concentrations greater than 1 ppb; three samples had concentrations greater than 5 ppb. Sample Number 92, positive for 2,3,7,8-TCDD, was located adjacent to the Lehigh Valley Railroad tracks.

As a result of this study, the following temporary interim remedial measures have been taken: the building has been secured and is not accessible to persons without personal protective equipment, a temporary fence has been erected at the entrance to the alleyway to prevent vehicular and pedestrian traffic and to minimize the spread of contaminated soil, and a portion of the alleyway along the building wall was covered with asphalt.

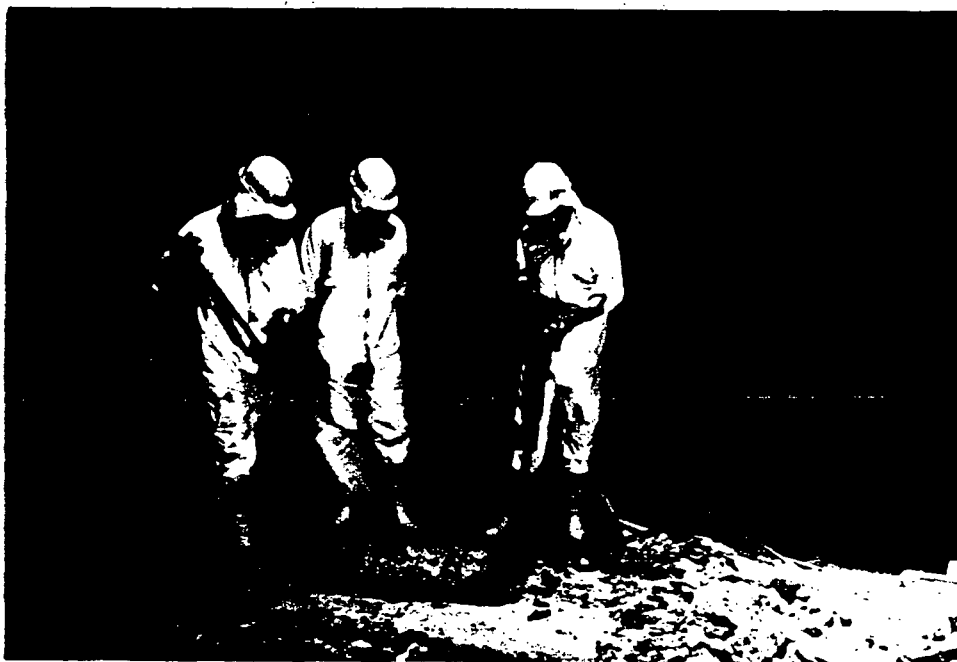
The highest concentration of 2,3,7,8-TCDD in the building, 99.5 ppb, was found in the brick subfloor in Room 2, sample NJP3-47. Three other samples in Room 2 contained detectable levels of 2,3,7,8-TCDD. The three wall samples collected from Room 2 had herbicide concentrations between 1.49 and 15.9 ppm. The wood subflooring sample collected from Room 2, NJP3-43 did not pass EPA QA requirements.

76. June 27, 1985 1425
Collection of subsurface brick floor sample NJP3-47-rm #2.

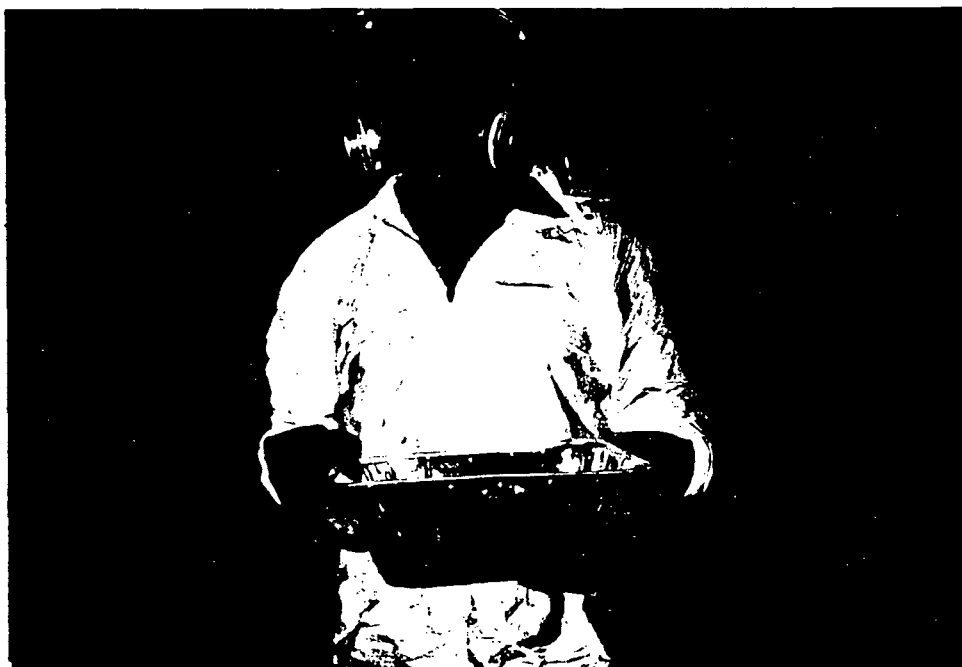
77. June 27, 1985 1450
Sample NJP3-47.
