**Superfund Five-Year Review Report  
Syncon Resins Superfund Site  
Kearny, Hudson County, New Jersey**

**Prepared by:  
U.S. Environmental Protection Agency  
Region 2  
New York, New York**

**August 2011**

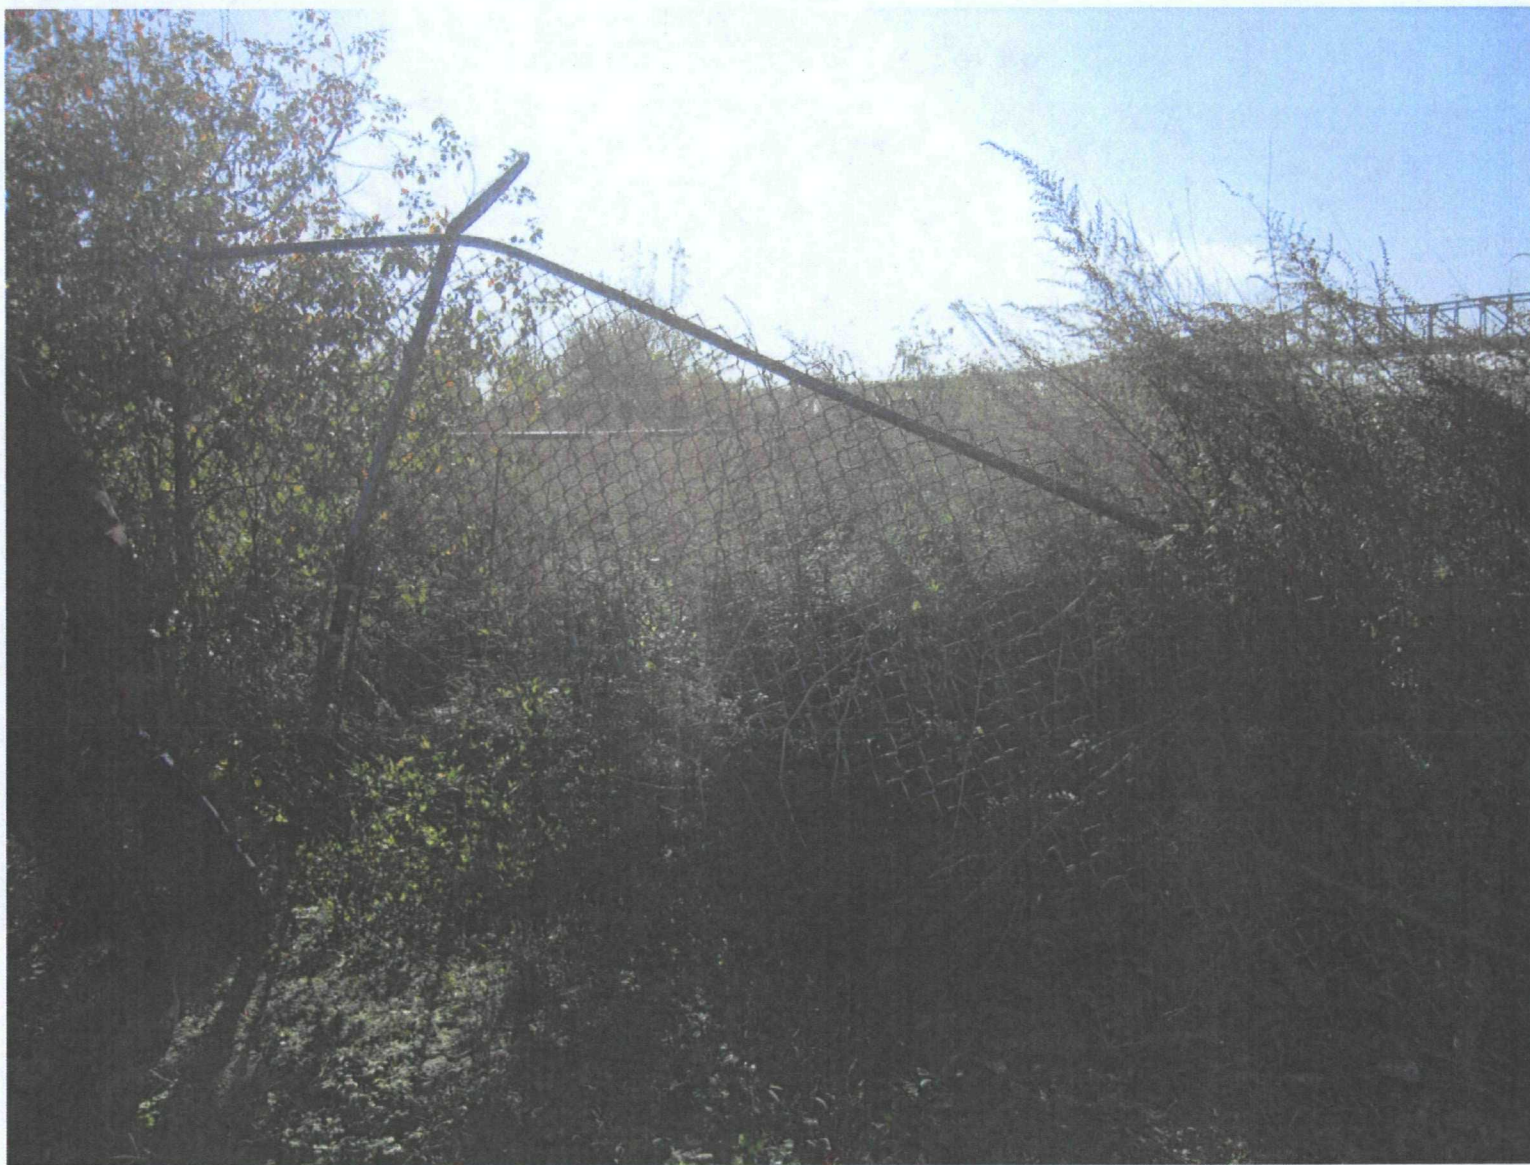
Currently, the Site is mostly fenced. However, trespassers have had access to the Site as evidence such as graffiti on Site buildings has been observed. Since contaminated above-ground structures were decontaminated and/or disposed of off-site, lagoon sediments and highly contaminated soils were removed and disposed of off-site, a permeable cover layer was placed over the ground surface, and groundwater is not currently used or expected to be used for drinking water in the future, the direct contact exposure to contaminated surface soils and groundwater at the Site have been interrupted. Additionally, with regard to direct contact exposure to subsurface soils and groundwater, no construction/utility work is anticipated in the next five years, the timeframe considered in this review; therefore, the current remedy is considered protective.

Figure 4 - Damaged Fence

NJDEP needs to continue the operation, maintenance and monitoring of the OU1 remedy. Access controls need to be improved and continued to be maintained and the Site use must remain restricted to ensure that the public is not exposed to site-related contaminants.

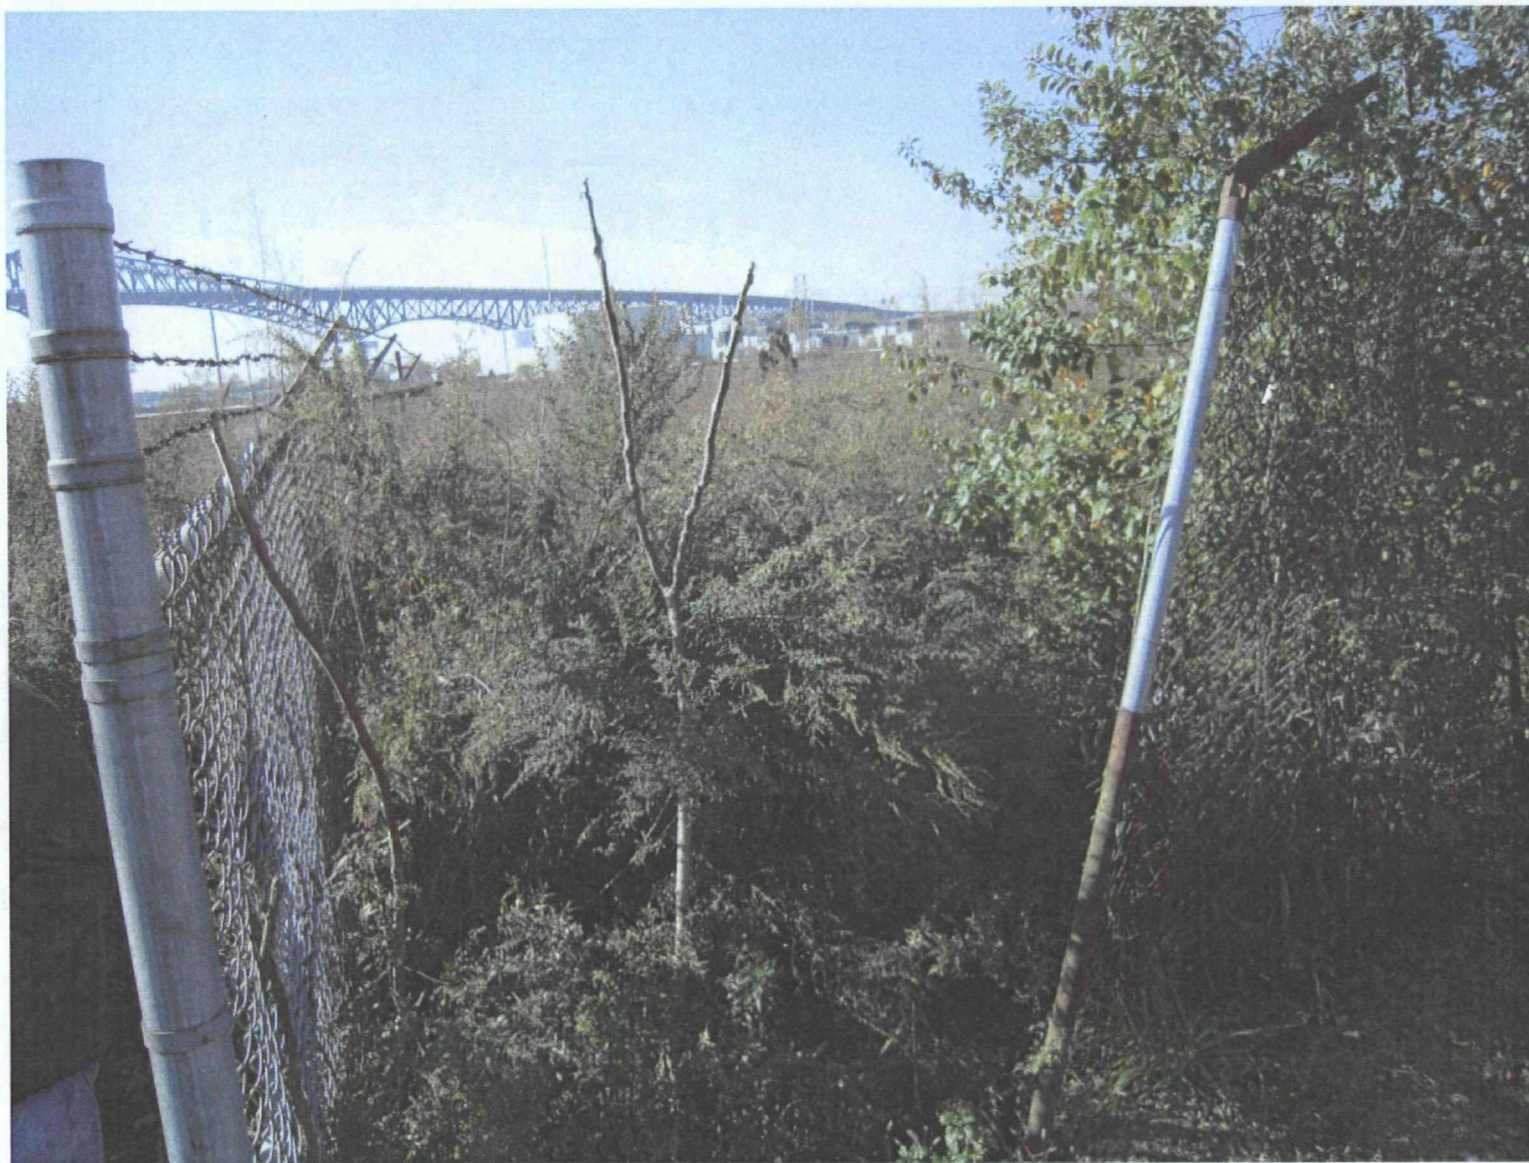
**Figure 5 - Gap in Fence**
