**THIRD FIVE-YEAR REVIEW REPORT FOR  
LEY CREEK PCB DREDGINGS SUBSITE  
ONONDAGA LAKE SUPERFUND SITE  
ONONDAGA COUNTY, NEW YORK**

**U.S. Environmental Protection Agency  
Region 2  
New York, New York**

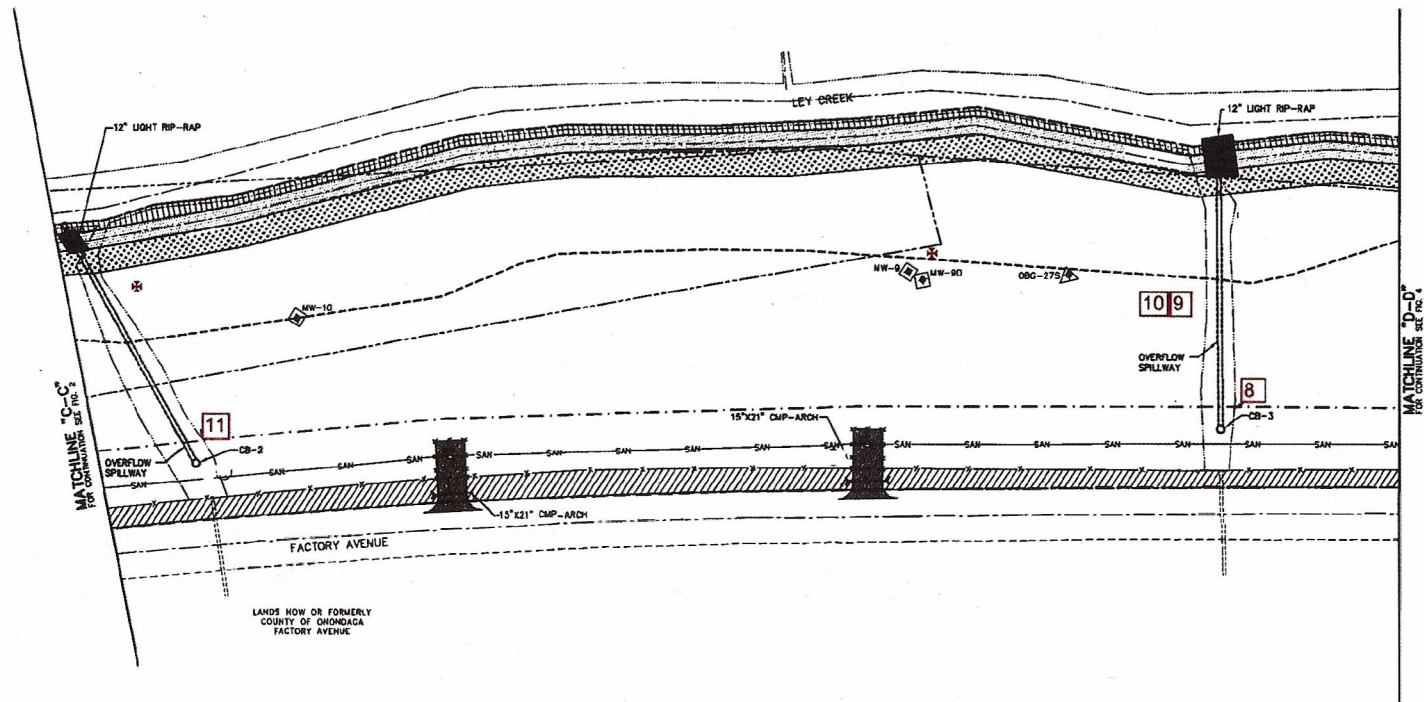
FIGURE 4

A PCB aroclor, Aroclor-1242, was detected at a concentration of 0.41 micrograms per liter ( $\mu\text{g/L}$ ) in a sample collected from OBG-27S (see Figure 4). The result was noted with the data qualifier "L," indicating that the identification of the analyte is acceptable; the reported value may be biased low. The reported value exceeds the groundwater screening criterion for total PCBs of 0.09  $\mu\text{g/L}$  in NYSDEC's June 1998 Division of Water Technical and Operational Guidance Series 1.1.1 Ambient Water Quality Standards and Guidance Values and Ground Water Effluent Limitations. PCBs were not detected in any of the other groundwater samples.

A PCB aroclor, Aroclor-1242, was detected at a concentration of 0.41 micrograms per liter ( $\mu\text{g/L}$ ) in a sample collected from OBG-27S (see Figure 4), which exceeds the groundwater screening criterion for total PCBs of 0.09  $\mu\text{g/L}$ . However, PCBs were not detected in any of the other groundwater samples.
