FINAL FOURTH FIVE-YEAR REVIEW

NAVAL WEAPONS STATION EARLE COLTS NECK, NEW JERSEY

March 2018

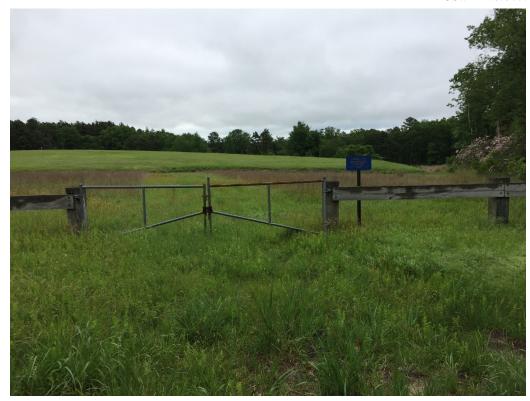
View looking east across Site 4 Landfill from main cap gate.

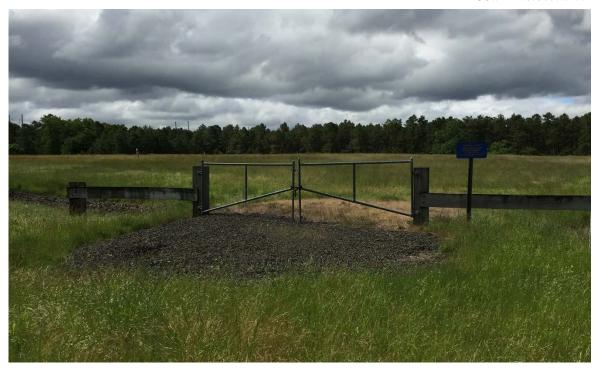
View looking south across Site 5 Landfill from northern cap gate.

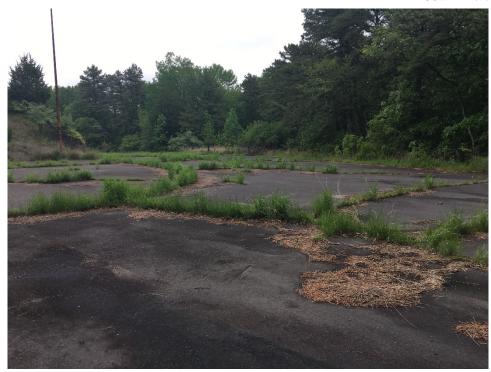
South portion of Site 19 facing to the northeast

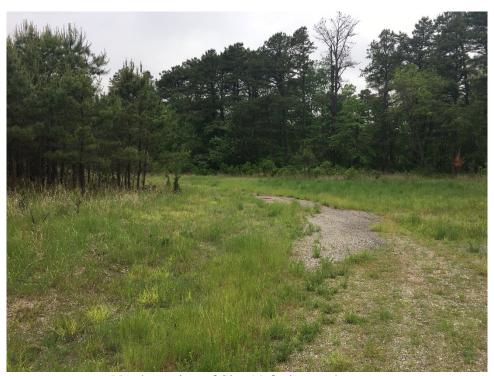
North portion of Site 19 facing to the west

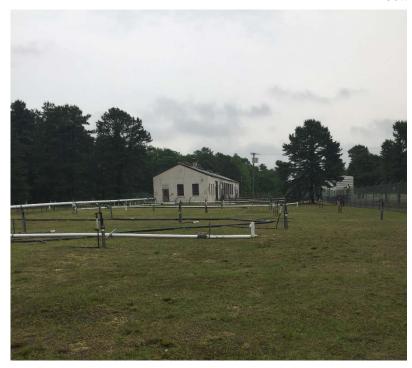
View facing northeast of former treatment system and site building at Site 26.

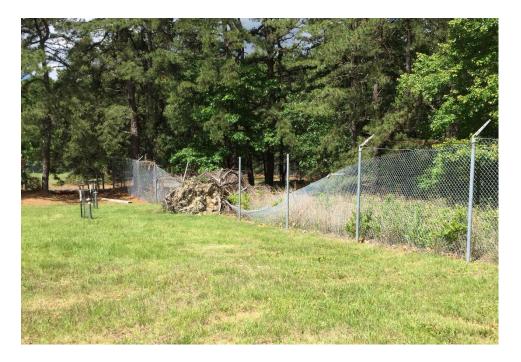
View facing northwest of tree down on Site 26 fence.

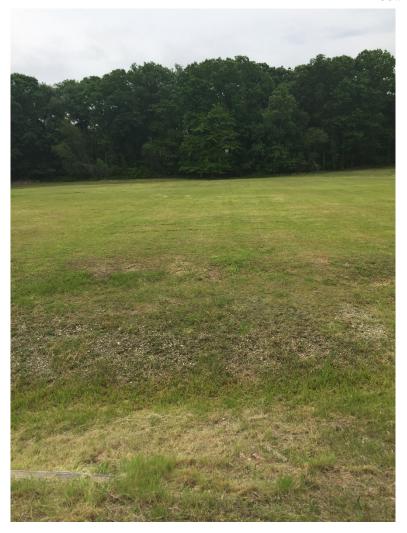
View looking southeast across Site 20 from Midway Road.

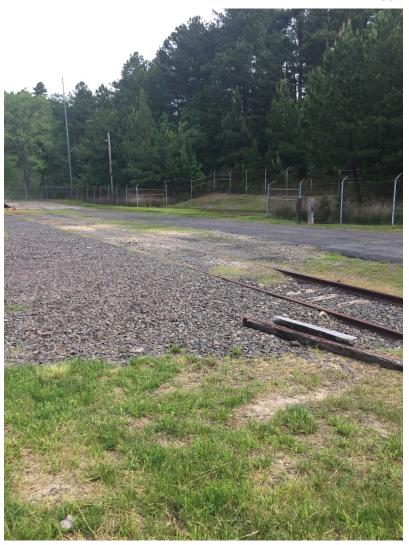
View facing north of Site 23.

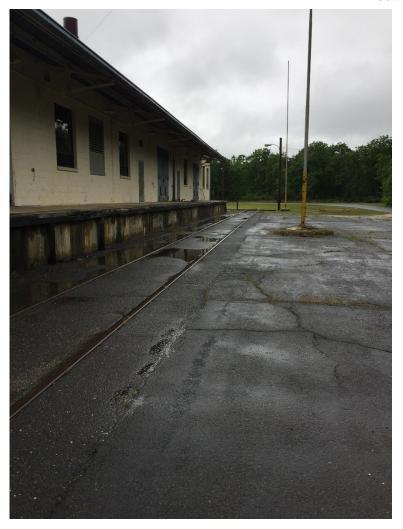
View facing south of Site 27.

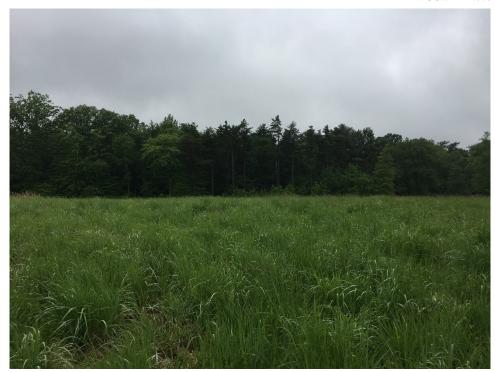
Site 13 landfill cap facing north

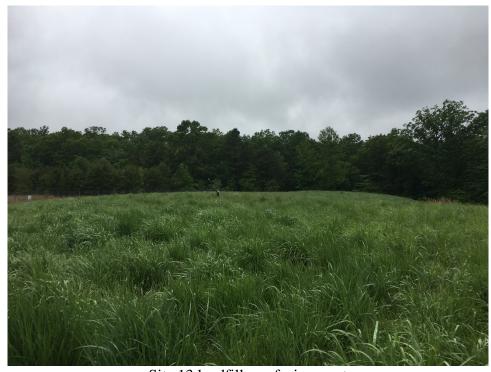
Site 13 landfill cap facing west

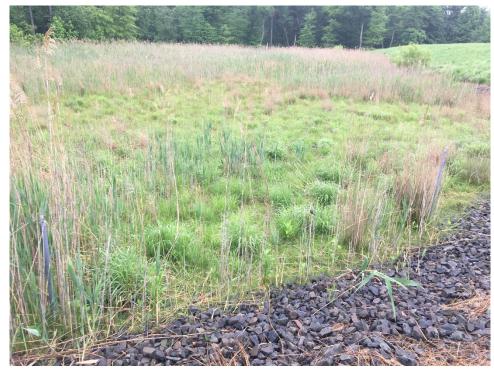
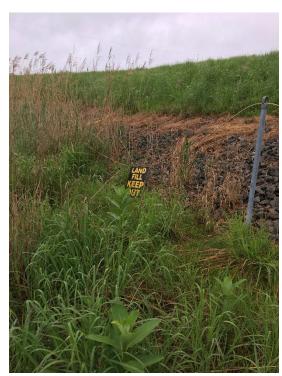
Damaged cable fence at Site 13

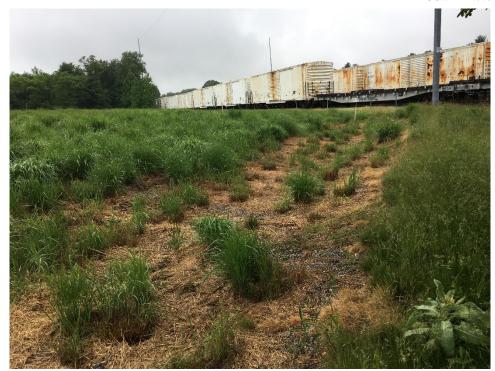
Vegetation growing in rip rap at Site 13

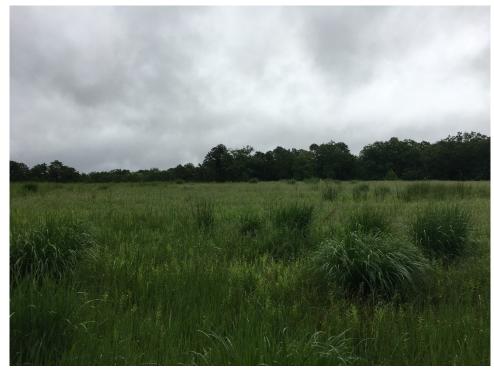
Site 3 landfill cover facing east

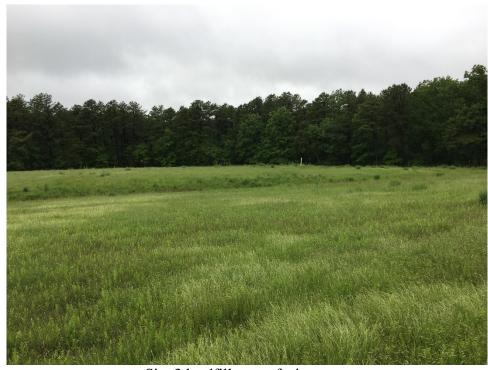
Site 3 landfill cover facing west

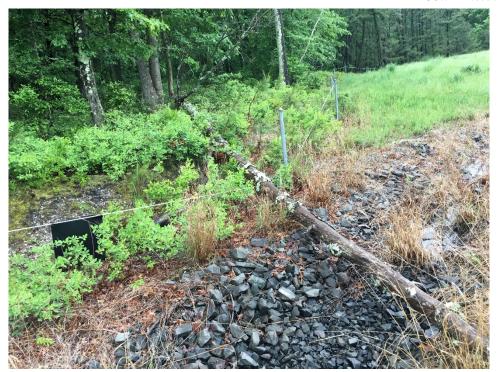
Fallen tree on south portion of cable fence at Site 3

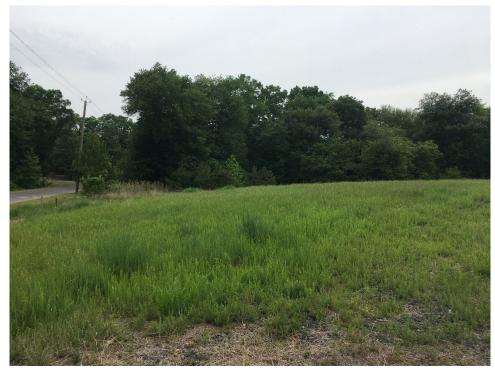
Site 10 landfill cap facing west

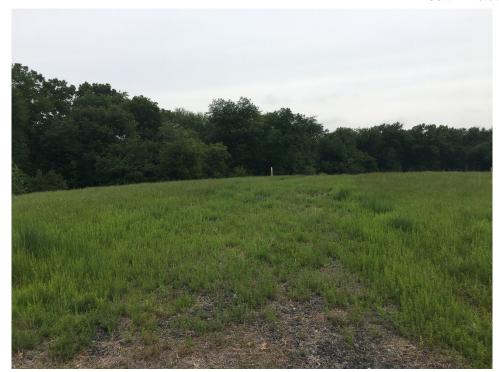
Site 10 gravel road with vegetation growing through gravel.

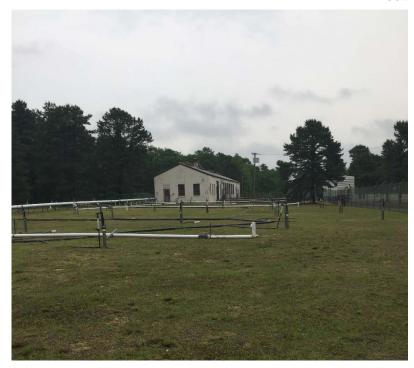
View facing northeast of former treatment system and site building at Site 26.

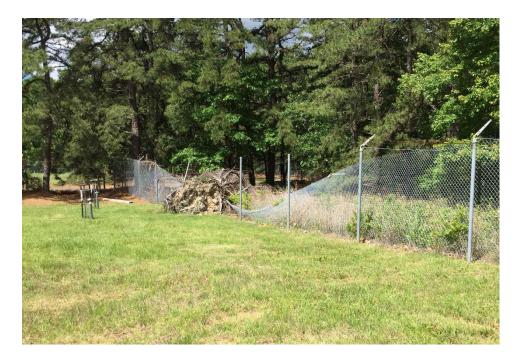
View facing northwest of tree down on Site 26 fence.

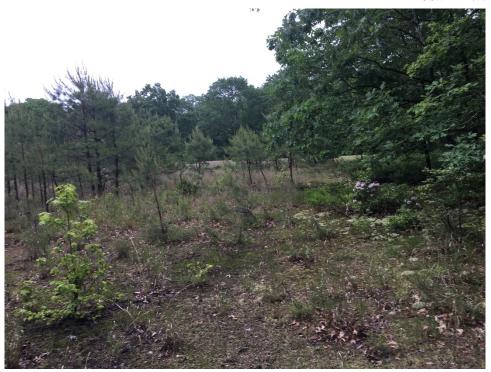
Vegetation at Site 1

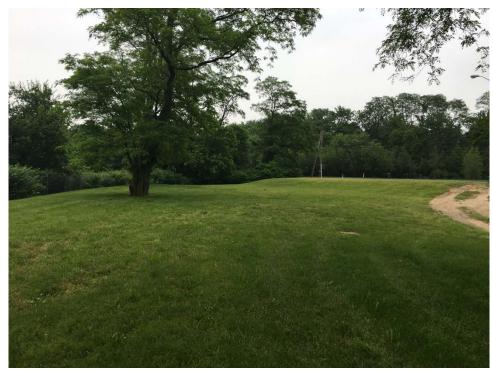
Site 6 facing east

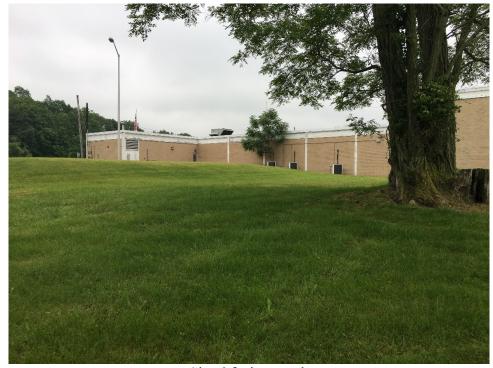
Site 6 facing south

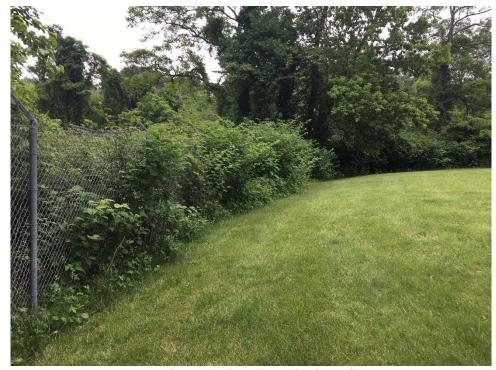
Vegetation growing through Site 6 fence

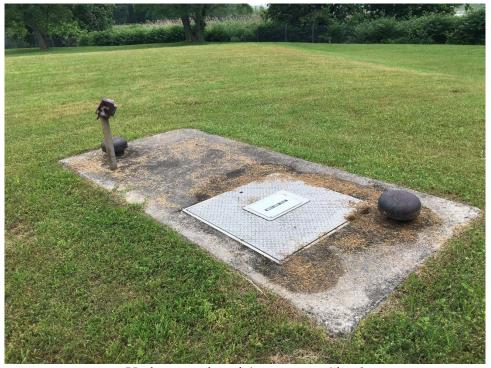
Underground vault/structure at Site 6

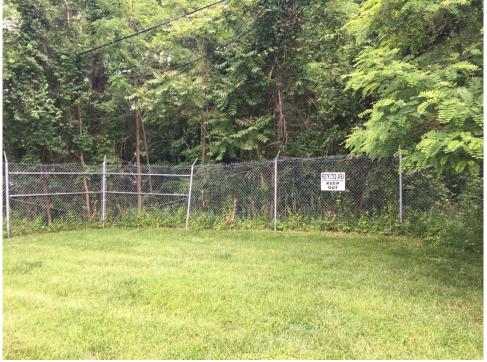
Site 15 facing west

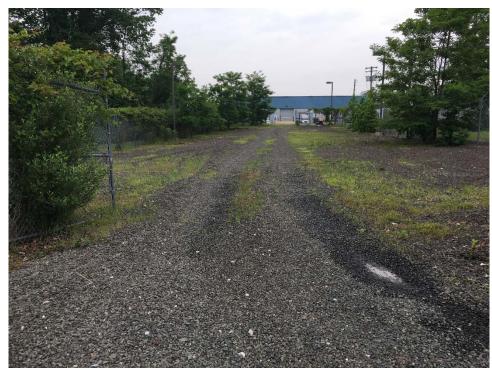
Site 17 facing south

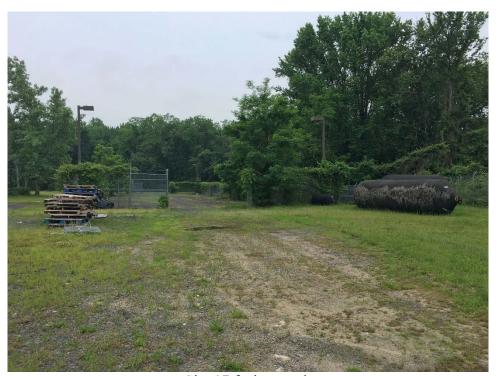
Site 17 facing north

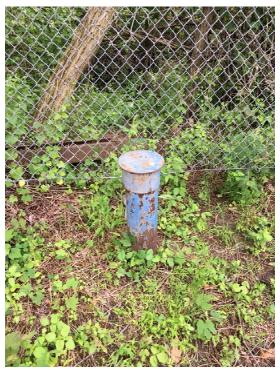
Gap in bottom of fence noted near monitoring well 17MW03 at site 17
