**FIFTH FIVE-YEAR REVIEW REPORT FOR
BARCELONETA LANDFILL SUPERFUND SITE
BARCELONETA, PUERTO RICO**

**U.S. Environmental Protection Agency
Region 2
New York, New York**

April 30, 2025

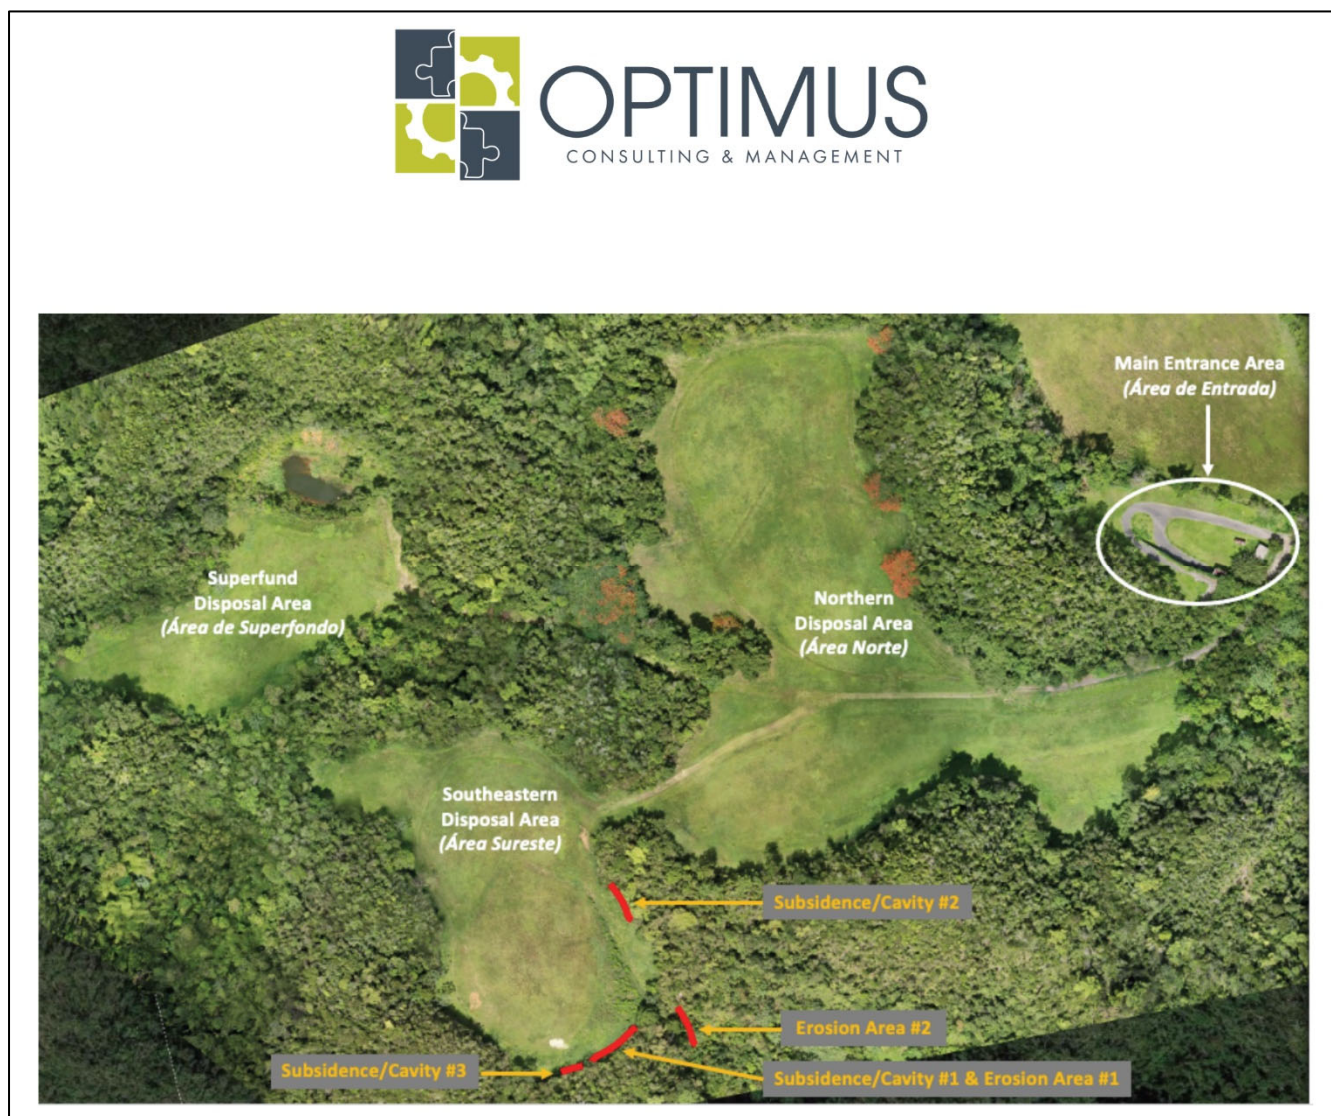
Figure 2: Subsidence/Cavities and Areas of Erosion Site Location Map

- **Subsidence/Cavity #1:** This area of interest was first identified by TrueLand Construction, LLC (former consultant for the municipality of Barceloneta) during June 2022 (2nd Quarter of 2022, April – June 2022). When first identified, the cavity had a length of approximately 20 feet wide and 15 feet deep. During the 2024 2nd Quarter report, the cavity expanded to approximately 132 feet wide along the perimeter of the mogote and a depth of approximately 40 feet deep. This cavity had not been observed during previous FYRs. However, at the end of the cap installation during the Remedial Action in September 2000, a subsidence was observed, and guidelines to address these subsidences in the future were included in the Remedial Action Construction Report, Appendix L – Guidelines for Remediation of Cavities Resulting from Subsidence of Waste Fill. Some of these guidelines are currently being implemented, including limiting access to the area with safety mesh and signage. Also, to limit runoff infiltration a temporary berm had been installed to divert runoff away from this area. A geotechnical engineering firm is being procured by the Barceloneta Municipality to address on-going expansion of the subsidence/cavity.

- **Subsidence/Cavity #2:** This area of interest was first identified by TrueLand Construction, LLC during January 2023 (4th Quarter of 2022, October - December 2022). The cavity was identified and measured approximately 40 feet along the mogote, 6 feet wide, and 5 feet deep. This area was addressed with fill material prior to the site inspection conducted on October 11, 2024.
- **Subsidence/Cavity #3:** This area of interest was first identified by Optimus Consulting & Management in June 2023 (2nd Quarter of 2023, April – June 2023). The subsidence was identified north of Subsidence/Cavity #1, it measured approximately 40 feet along the mogote, 25 feet wide, and 5 feet deep. This area was addressed with fill material and documented in the 2024 2nd Quarter Inspection Report.

- **Erosion Area #1:** This area of interest was first identified by TrueLand Construction, LLC during February 2021 (4th Quarter of 2020). This area was filled/repared with soil and rock material, but it should be closely monitored to confirm the area stabilizes and not further eroded.
- **Erosion Area #2:** This area of interest was first identified by TrueLand Construction, LLC in February 2021 (4th Quarter of 2020). This area was addressed with fill material by the municipality.

During the site inspection, as noted in the Annual Reports for this FYR from the Barceloneta Municipality, EPA observed several areas with subsidence, cavities, and erosion within the south-southeastern portion of the Southeastern Disposal Area between the cap limits and the mogotes. Except for subsidence/cavity #1, the rest of the areas have been addressed and are being monitored. EPA also noted tree stumps within the limits of the cap

During the site inspection, tree stumps and trees were observed within the limits of the cap cover but do not appear to be impacting the cap integrity. However, if left unattended it could affect the cover integrity in the future. Therefore, it is suggested that these tree stumps and trees are removed/cut in the near term. EPA will work with the PRPs to ensure this maintenance continues to prevent vegetative growth from potentially impacting the cap in the future.

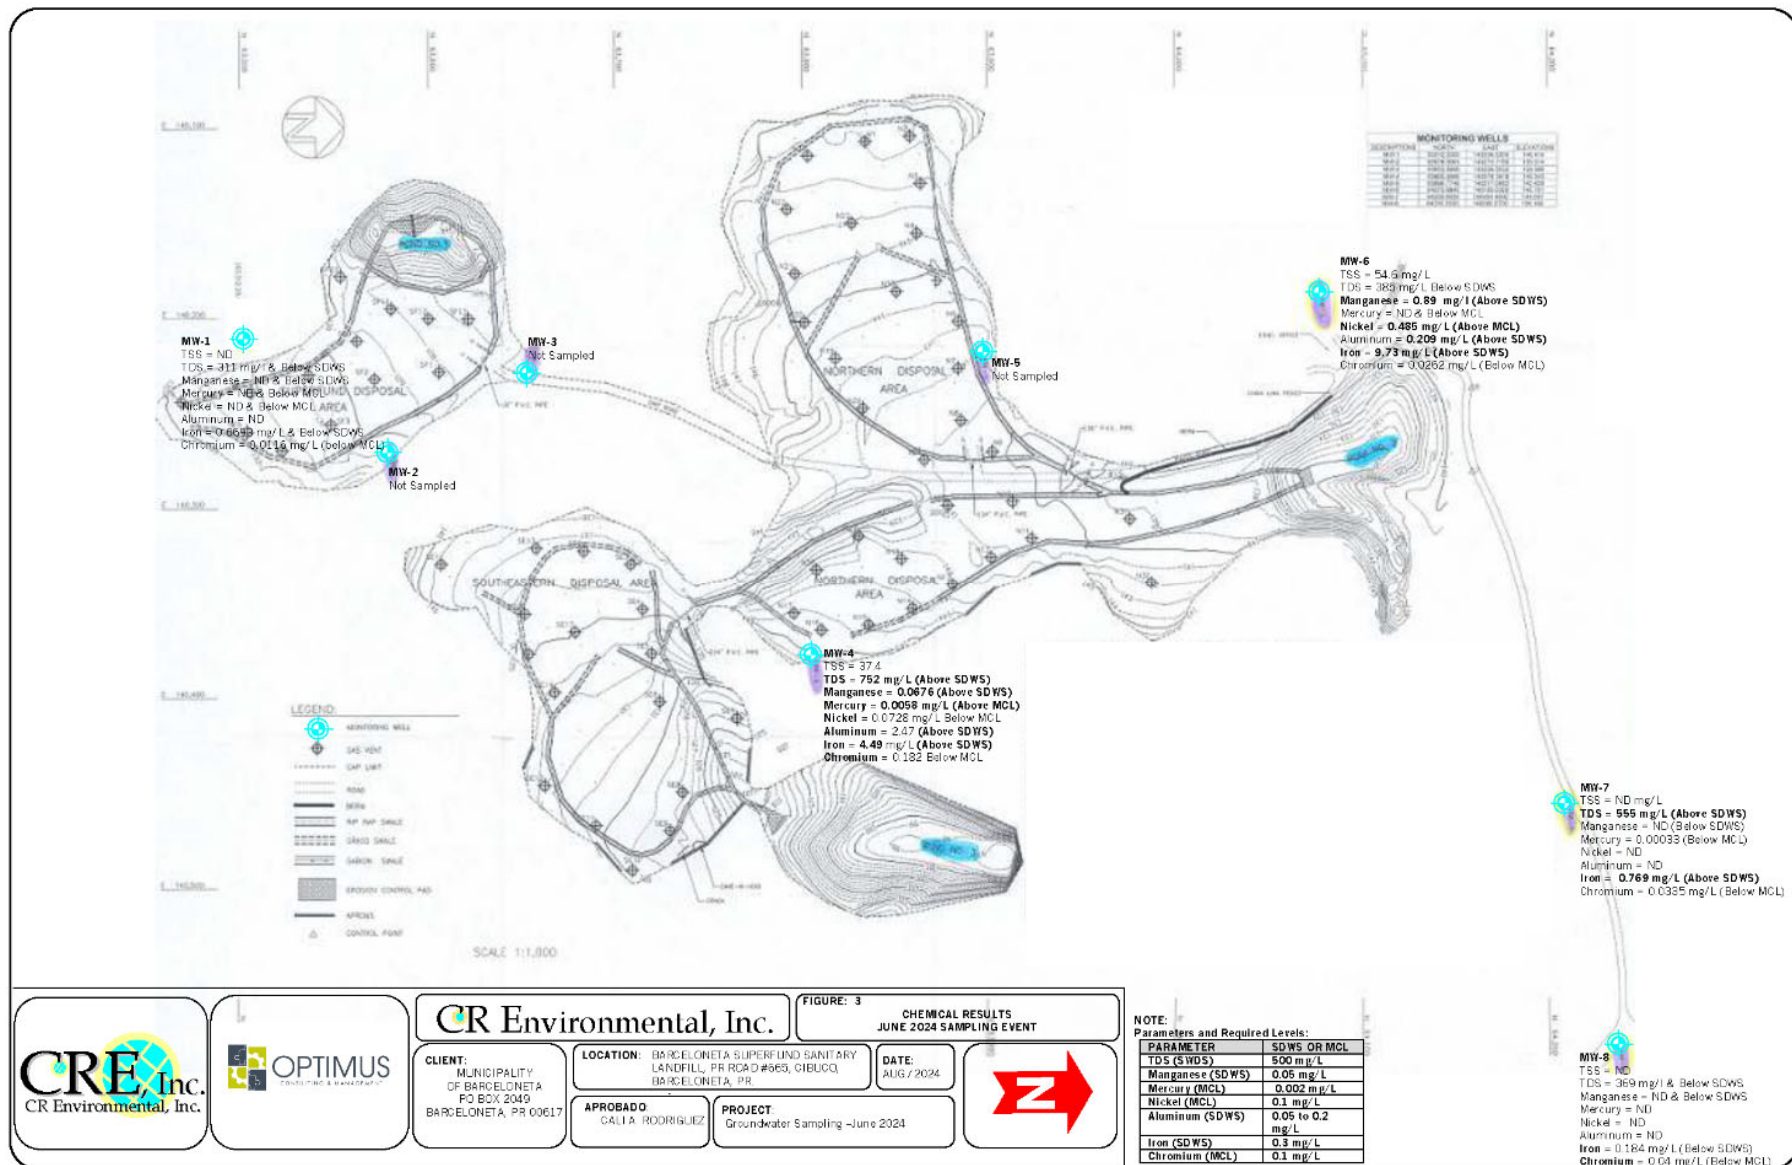
Figure 3: Monitoring Well Groundwater Results

Locations of the monitoring wells and results of the latest June 2024 monitoring well groundwater sampling are included in **Figure 3** of **Appendix B**. Historical results for each well, including for the past five years are included in **Appendix C**.

Overall, the groundwater data showed stable and consistent concentrations when compared to the previous FYR. The only noticeable results were from the June 2022 event in MW-4 where elevated concentrations were observed for manganese, mercury, nickel, aluminum, iron and chromium when compared to historical concentrations. These results, however, largely decreased to historical concentrations during the following sampling event performed in July 2023 although results remained elevated for select compounds and wells compared to historical trends in 2024, particularly within MW-4. The direction of groundwater flow continues to the north. Wells MW-7 and MW-8, further downgradient from MW-4, either showed no impacts in 2024 (MW-8) or iron and TDS results slightly above their respective criteria (MW-7). Residents in the vicinity receive drinking water from a municipal water supply, which is located upgradient of the landfill.
