Five-Year Review Report Naval Station Norfolk Norfolk, Virginia

Final
Five-Year Review Report
Naval Station Norfolk
Norfolk, Virginia

August 2003

This report documents the completion of the five-year review for sites 1, 2, 3, 6, and 20 at Naval Station Norfolk as required by the Comprehensive Environmental Response, Compensation, and Liability Act (CERCLA) in accordance with CERCLA §121(c), as amended, and the National Oil and Hazardous Substances Pollution Contingency Plan (NCP), Part 300.430(f)(4)(ii) of the Code of Federal Regulations (CFR).

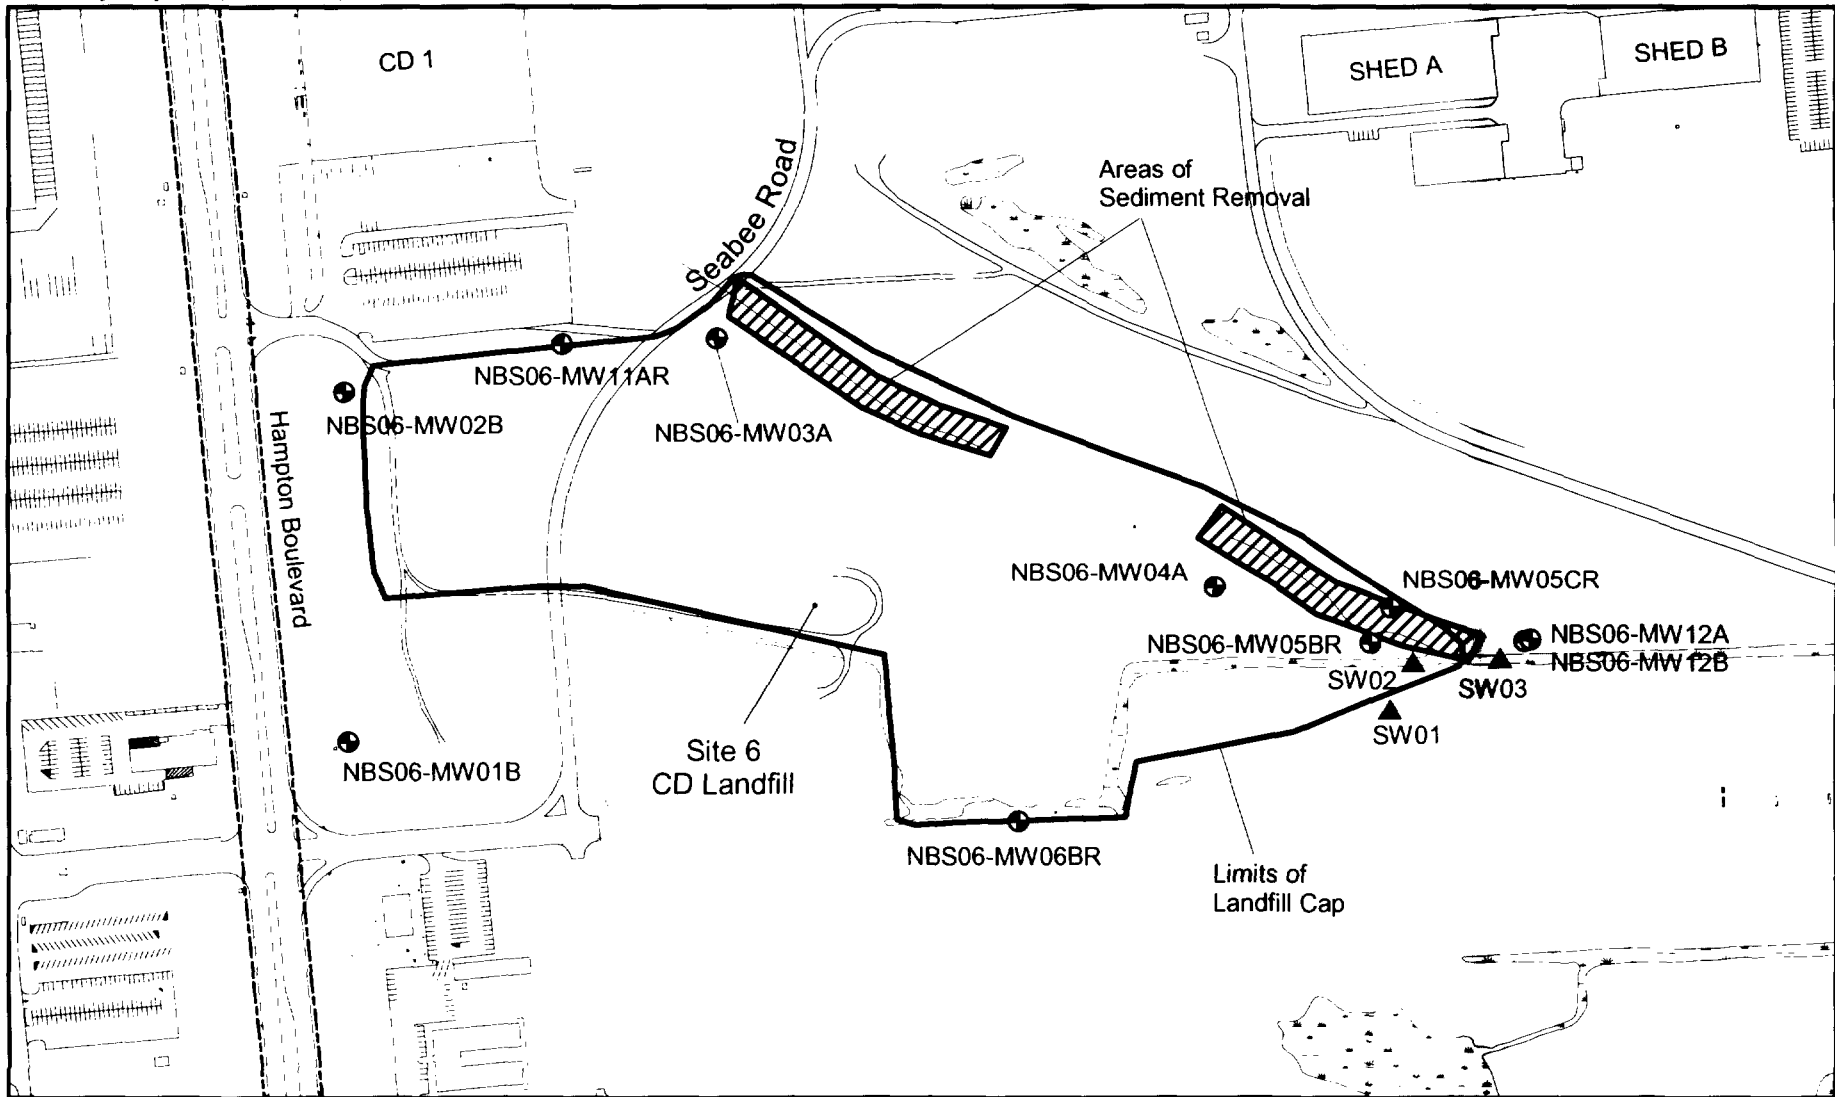
Figure 3-8
Areas of Sediment Removal and Landfill Cap
Site 6 - CD Landfill
Naval Station Norfolk
Norfolk, Virginia

Several minor maintenance issues were noted during the January 2002 annual inspection of the CD Landfill as detailed in the Technical Memorandum (CH2M HILL, January 2002). The site was revisited on July 29, 2002 per the Five-Year Review requirement. Some of the concerns noted in the January inspection could not be verified in July due to heavy vegetative growth at the site. The issues from both inspections are summarized below:

- A portion of the north sideslope of the northernmost channel is steadily eroding, but the landfill cover system is not in jeopardy as the erosion is on the opposite side from the landfill.
- The fence along the eastern side of Seabee Road adjacent to the southern entrance gate is in need of repair. The poles are bent and the top railing is detached.
- There are eroded areas near the downstream ends of the 60- and 36-inch culverts.
- There is a small denuded patch of ground on the southeastern corner of the landfill.
- A number of the drainage net outlet pipes could not be located during the inspection and are likely covered by sediment.

Proposed repairs for the maintenance issues are as follows:

- The denuded and eroded area noted in Section 6 should be repaired by regrading, seeding, and mulching.
- The fence at CD Landfill is damaged but the integrity is intact and it is not a security issue. Reattaching the top railing to the poles should repair the fenceline.
- The pipes covered by sedimentation may cause a problem if water cannot drain from the drainage net leading to saturated slopes and possible slope failure. It is not currently recommended that the pipes be uncovered as there are other visible drain outlets for water to exit the drainage net. However, the condition of the sideslopes should continue to be monitored and further action may be required if a problem arises.

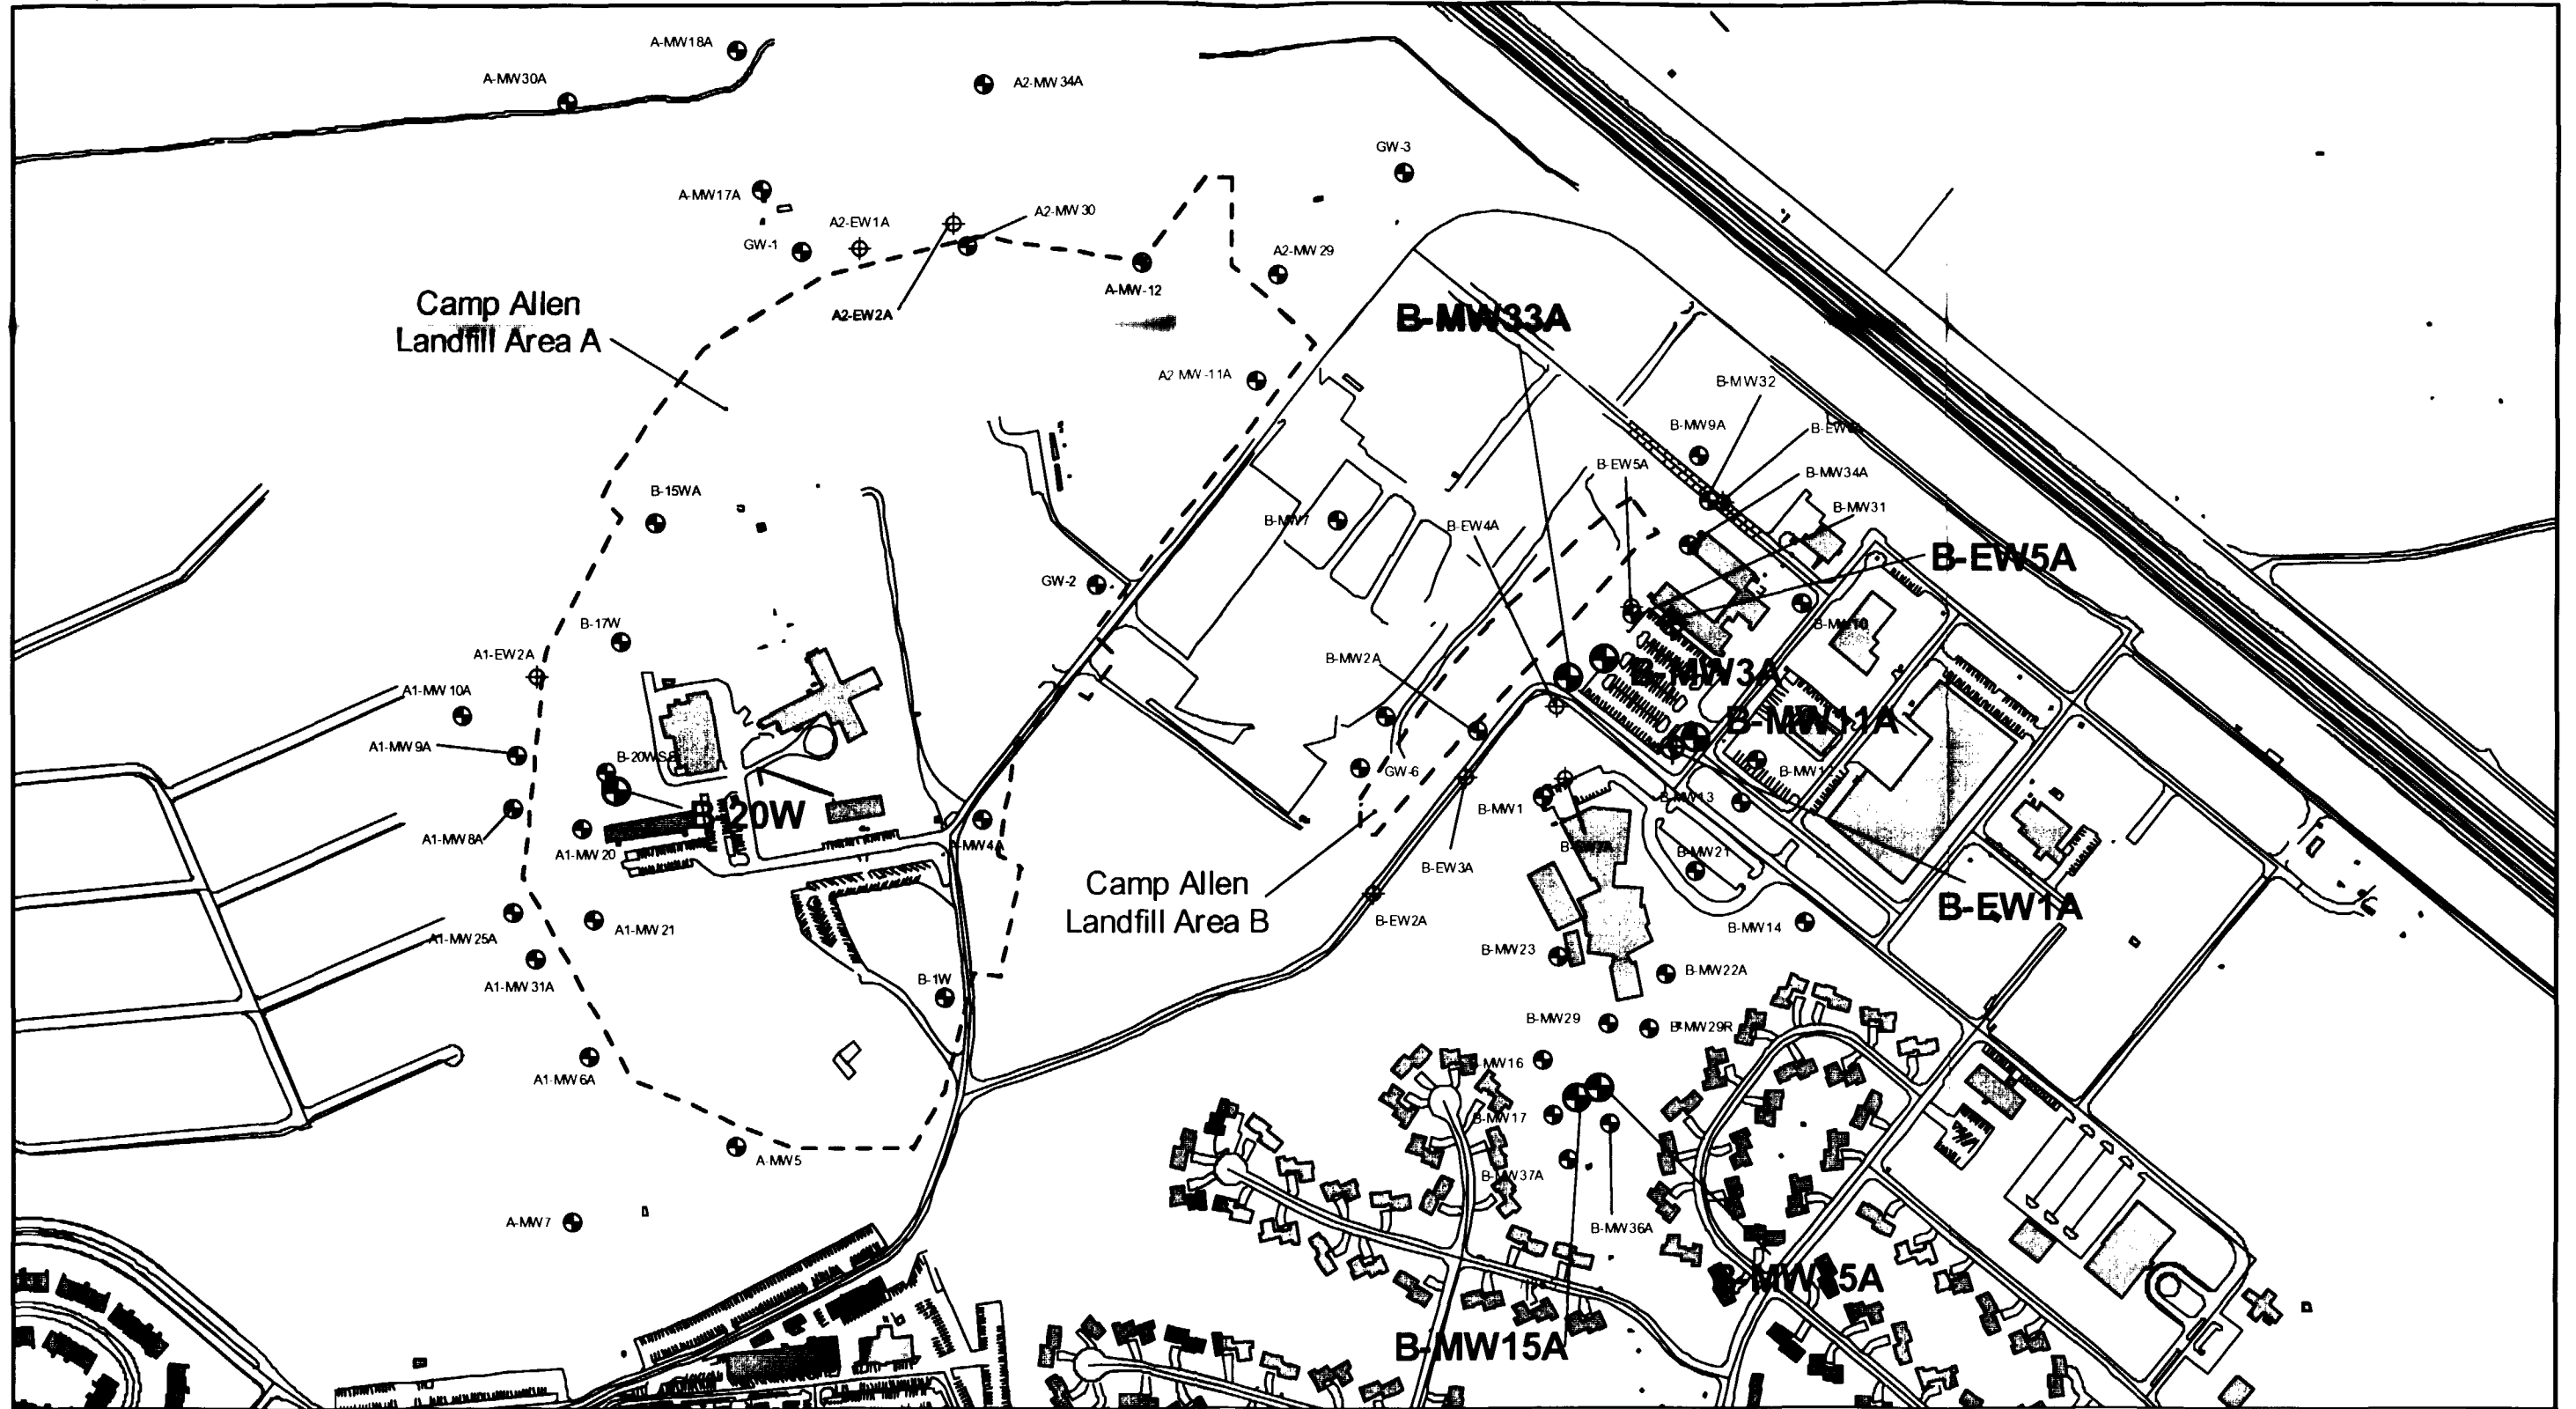
Figure 5-1
 Shallow Monitoring Wells That Exceed Cleanup Criteria
 Areas A and B
 Camp Allen Landfill
 Long-Term Monitoring Program
 Naval Station Norfolk

- A localized area where VOC levels exceed the cleanup goals was observed in the shallow aquifer outside of the capture zone in Area B. The elevated concentrations are observed in monitoring wells B-MW15A and B-MW35A at the southeast of Area B. Although this location is contained by the capture zone of the deep aquifer, it is outside the influence of the shallow extraction wells. Extraction wells are currently being installed to extend the influence of the shallow system.

- A localized area where VOC levels exceed the cleanup goals was observed in the shallow aquifer at well B-20W located proximal to the DPVE system in Area A. Although this location is contained by the capture zone of the deep aquifer, it is outside the influence of the shallow extraction wells. The DPVE system is being evaluated and modified to extend the influence of the shallow system.

- Monitoring well B-20W (the location of the VOC exceeding the cleanup goals west of the brig) will be added to the annual LTM sampling. Though the monitoring well is near the existing DPVE system and contained by the extraction system, more localized groundwater remediation of this specific location is recommended. The feasibility of modifying the existing DPVE system to specifically remediate well B-20W is currently under consideration.

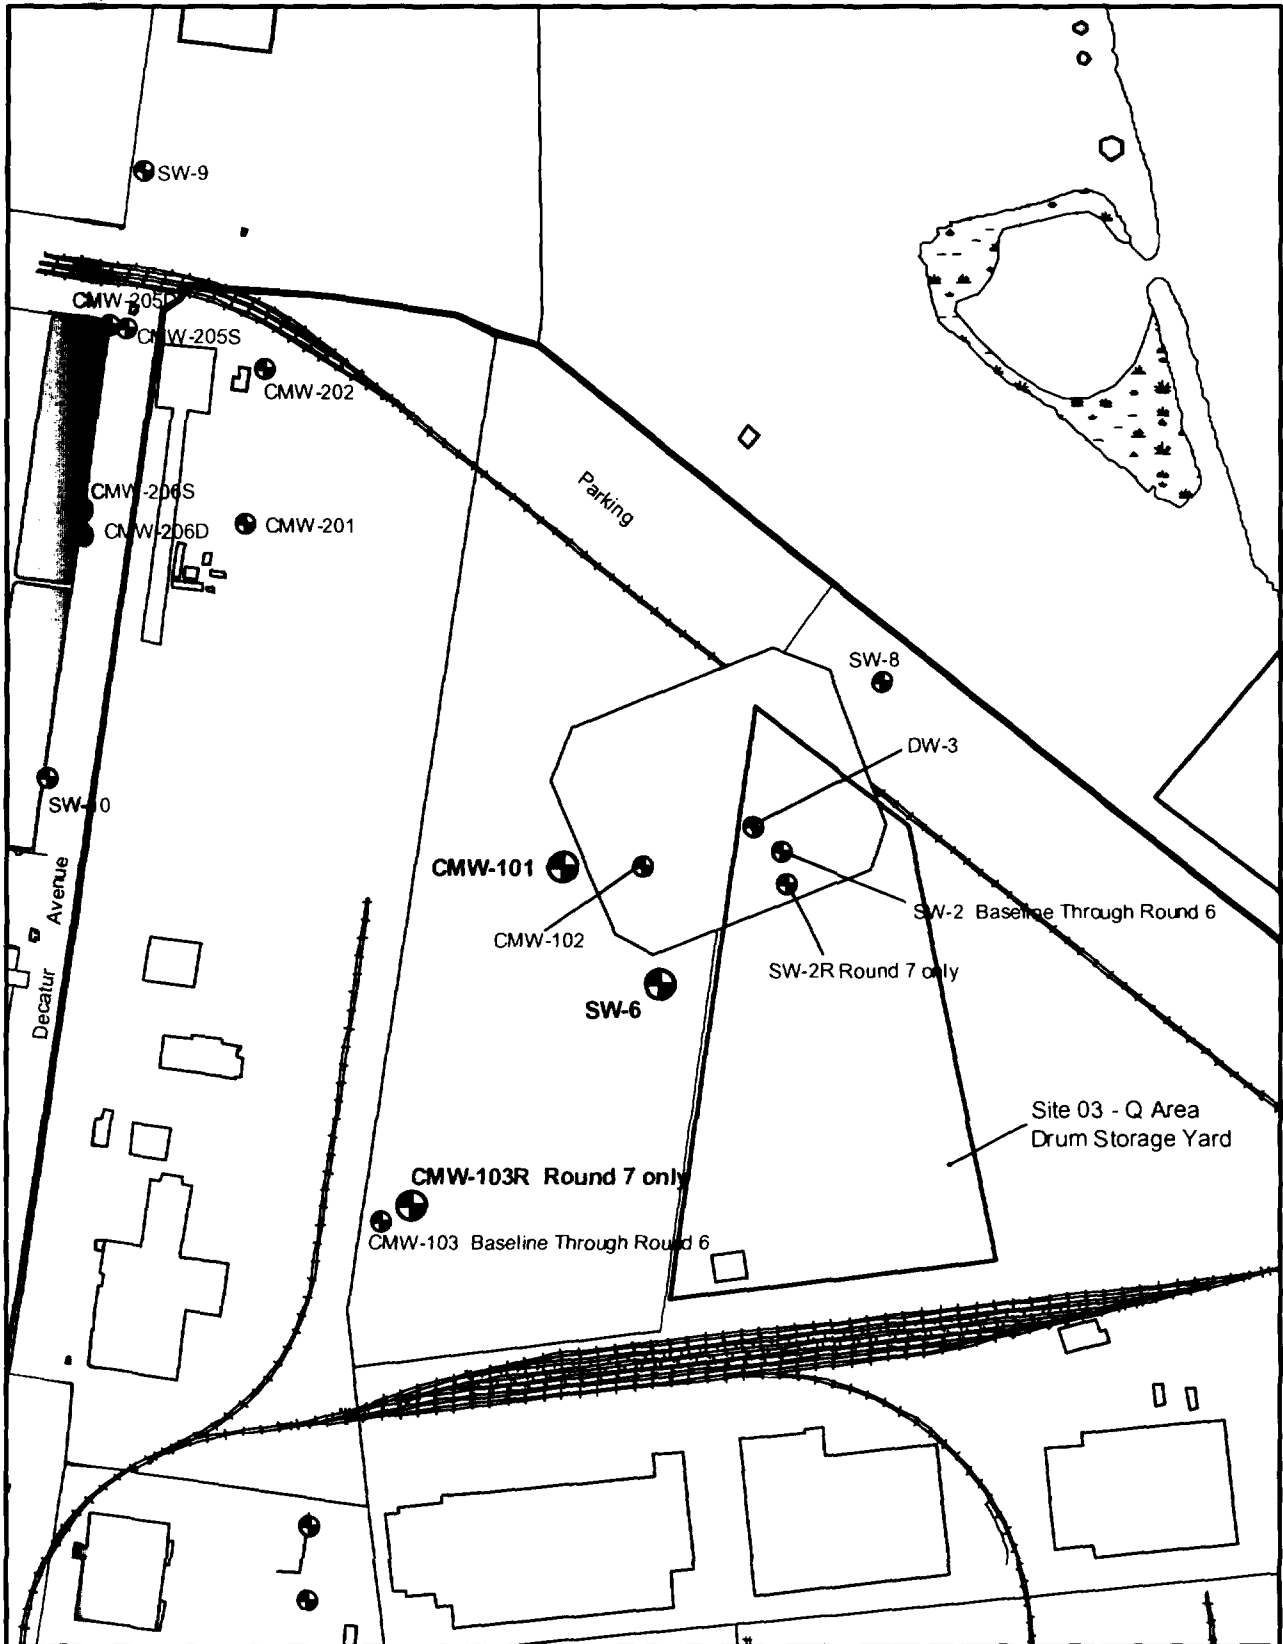
Figure 5-3
Monitoring Wells That Exceed Cleanup Criteria
Q Area Drum Storage Yard - AOC 1
Long-Term Monitoring Program
Naval Station Norfolk

The majority of VOC concentrations have been reduced at AOC 1. However, as a result of the VOC degradation, concentrations of vinyl chloride have increased at locations downgradient of AOC 1. The subgroup has recommended a strategy to extend the AS system to the downgradient locations to accelerate the remediation.

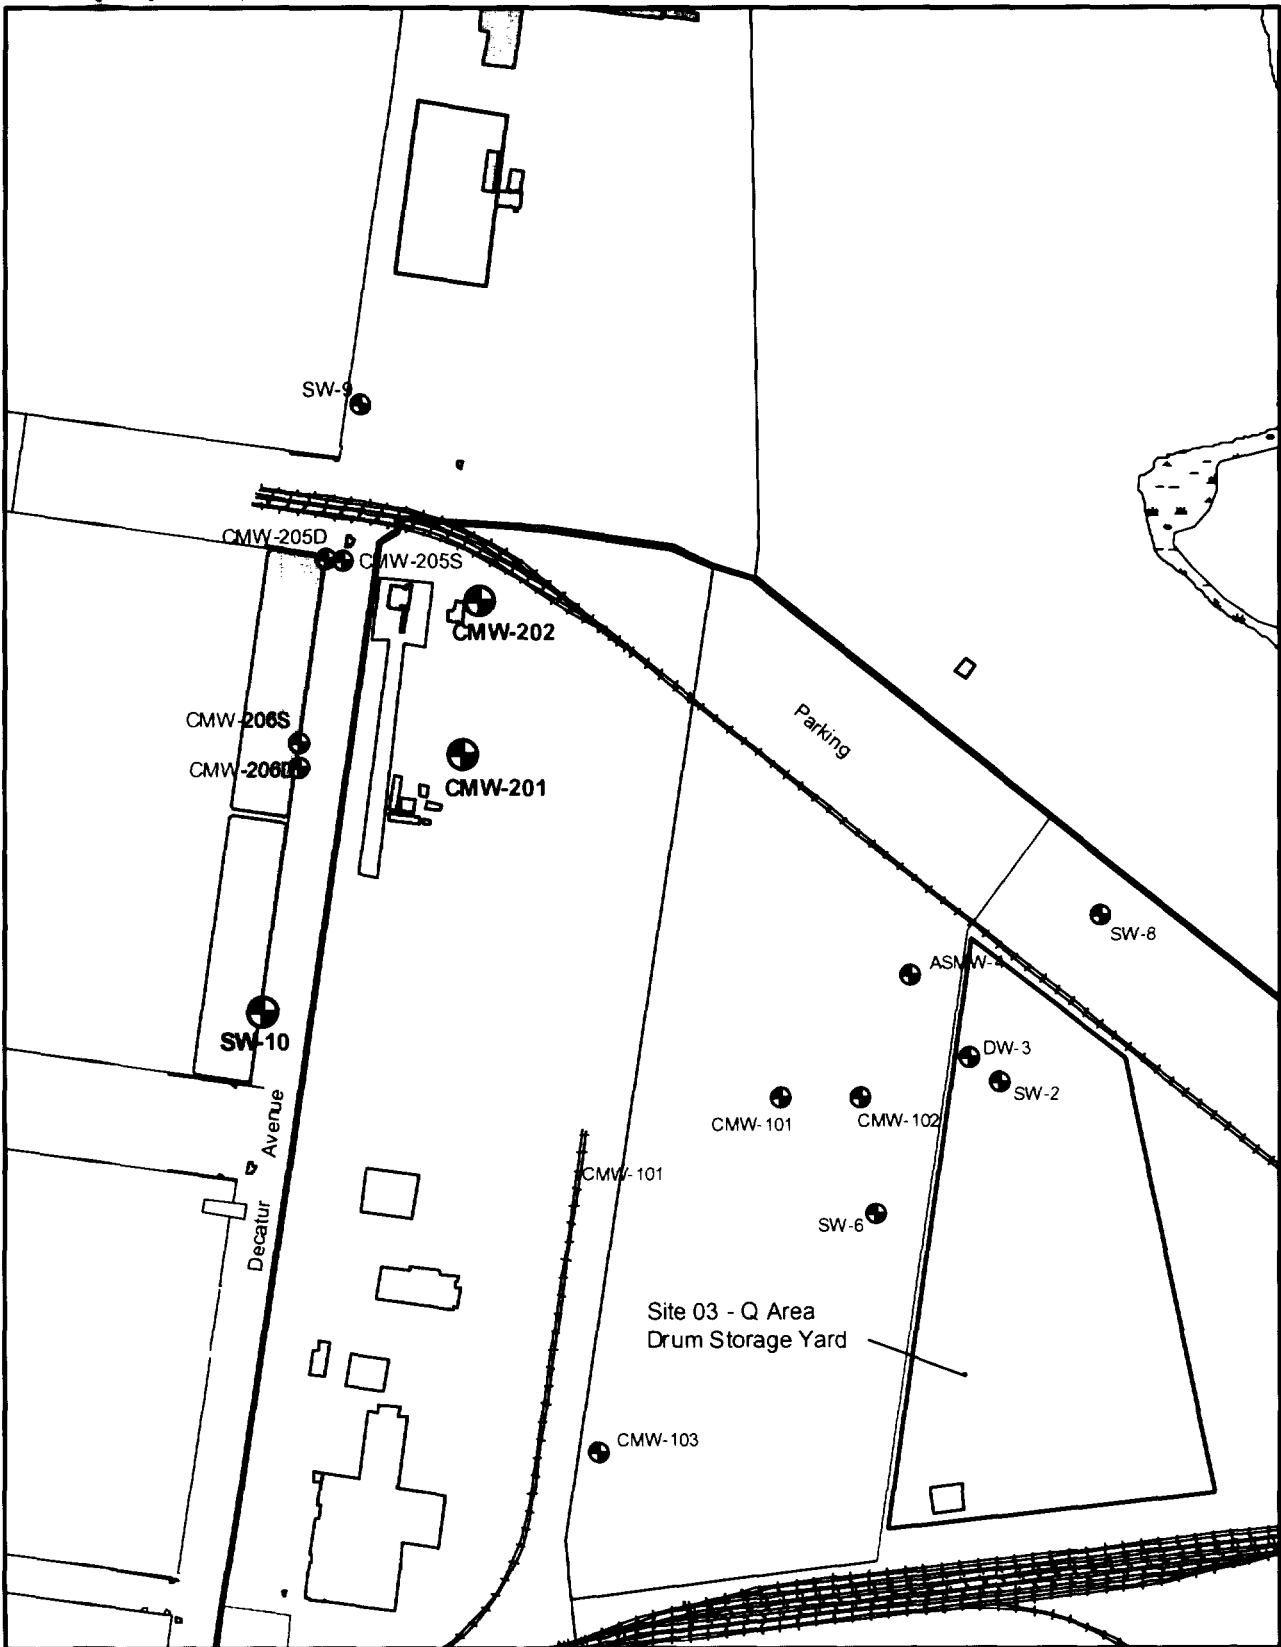
Figure 5-4
 Monitoring Wells That Exceed Cleanup Criteria
 Q Area Drum Storage Yard - AOC 2
 Long-Term Monitoring Program
 Naval Station Norfolk

observed downgradient of the area. The analytical data from AOC 2 demonstrated a decrease or stabilization in the concentration of the majority of the COCs. However, the levels of trichloroethene and vinyl chloride remain above the cleanup goals. Figures 5-3 and 5-4 show the locations of the monitoring wells that exceed the cleanup goals at AOC 1 and AOC 2, respectively.

In addition, several monitoring wells (SW-10, DW-6, SW-9, and DW-5) at AOC 2 were damaged during recent bulkhead construction activities.

The damaged monitoring wells observed at AOC 2 should be repaired during the next drilling event at the Base.

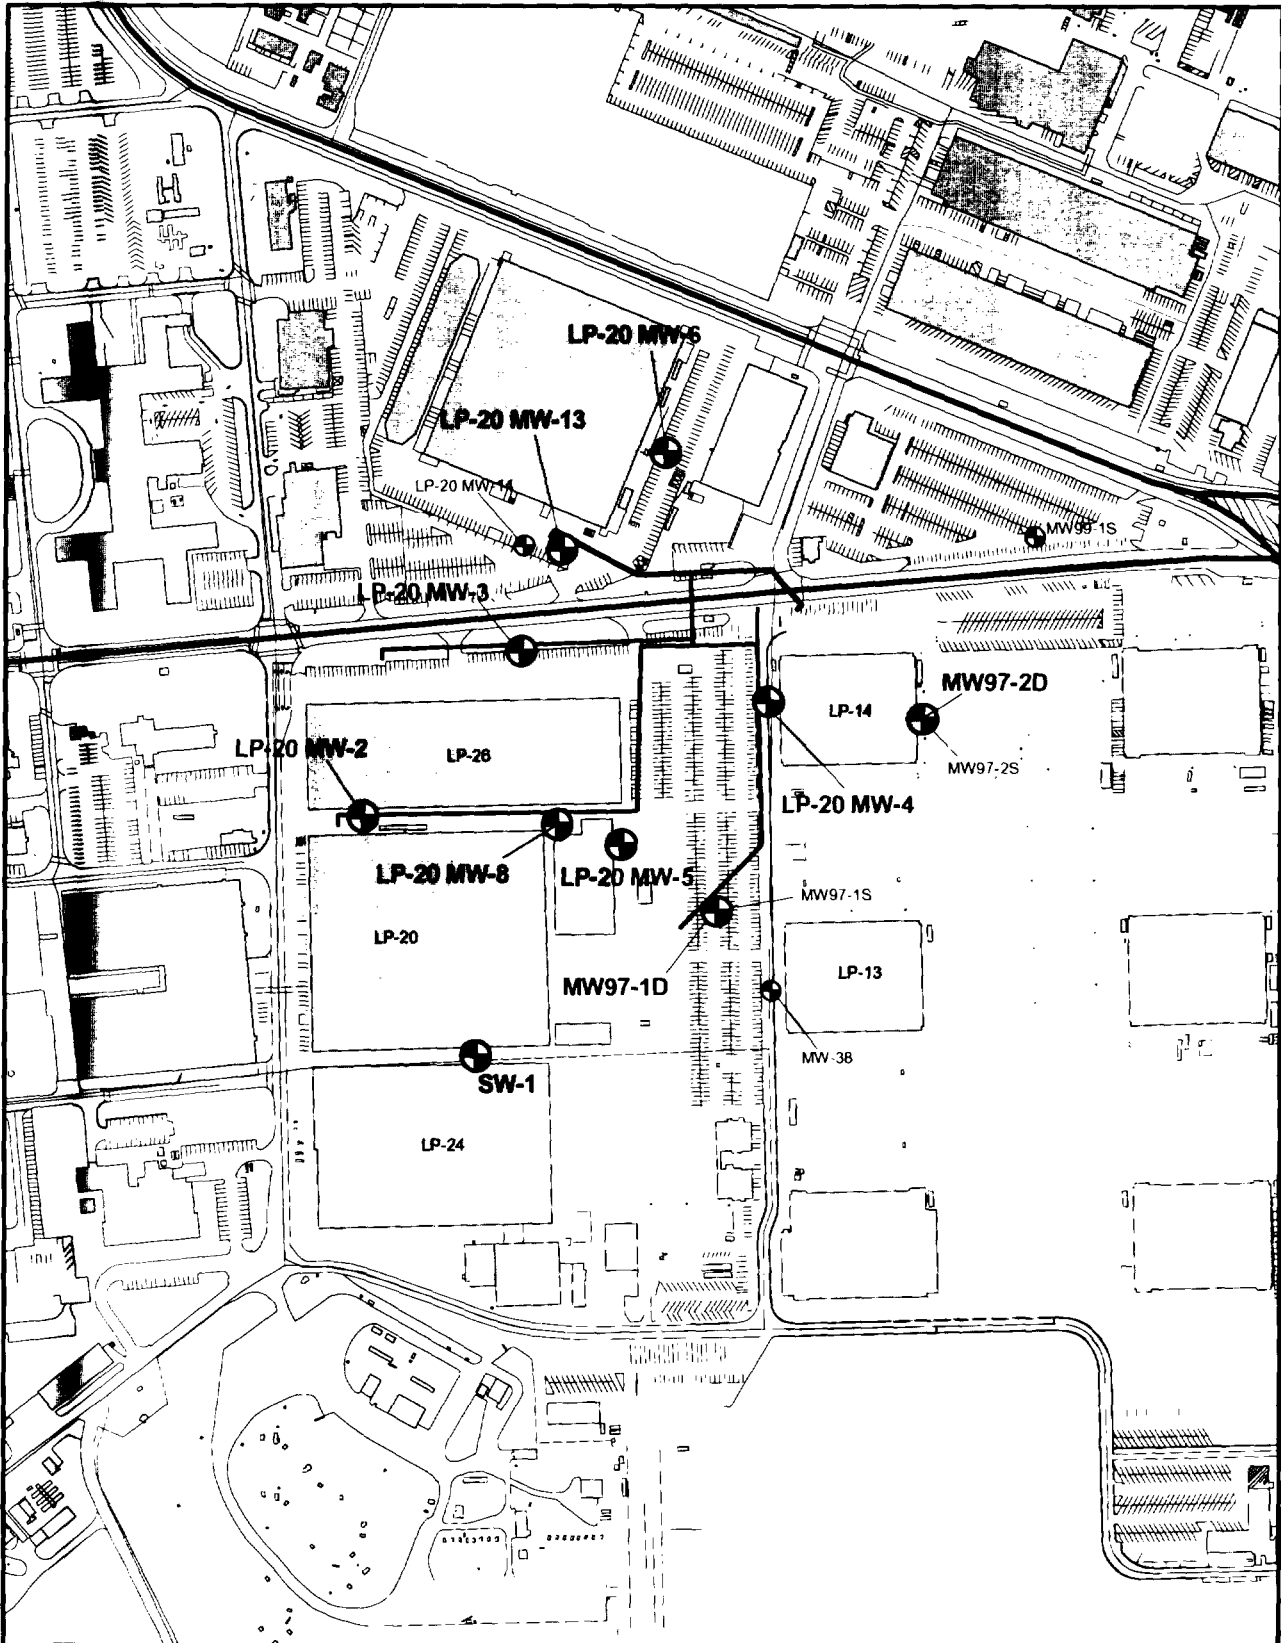
Overall, the concentrations of COCs have decreased from the baseline data. These reduced concentrations indicate that the AS/SVE system is effectively remediating the contaminant plume. However, an increase in some of the COCs (dichloroethene and vinyl chloride) above the cleanup goals was observed at certain wells. The increase in these constituents likely result from the degradation of VOCs at the site. Figure 5-5 shows the locations of the monitoring wells that exceed the cleanup criteria at the LP-20 site.

The concentrations of some VOCs have substantially increased in deep well MW97-2D, indicating some constituents may be migrating downgradient of the treatment system and into the Yorktown aquifer.
