**FIRST FIVE-YEAR REVIEW REPORT FOR
VALMONT TCE SUPERFUND SITE
LUZERNE COUNTY, PENNSYLVANIA**

**U.S. Environmental Protection Agency
Region 3
PHILADELPHIA, PENNSYLVANIA**

AUG 10 2016

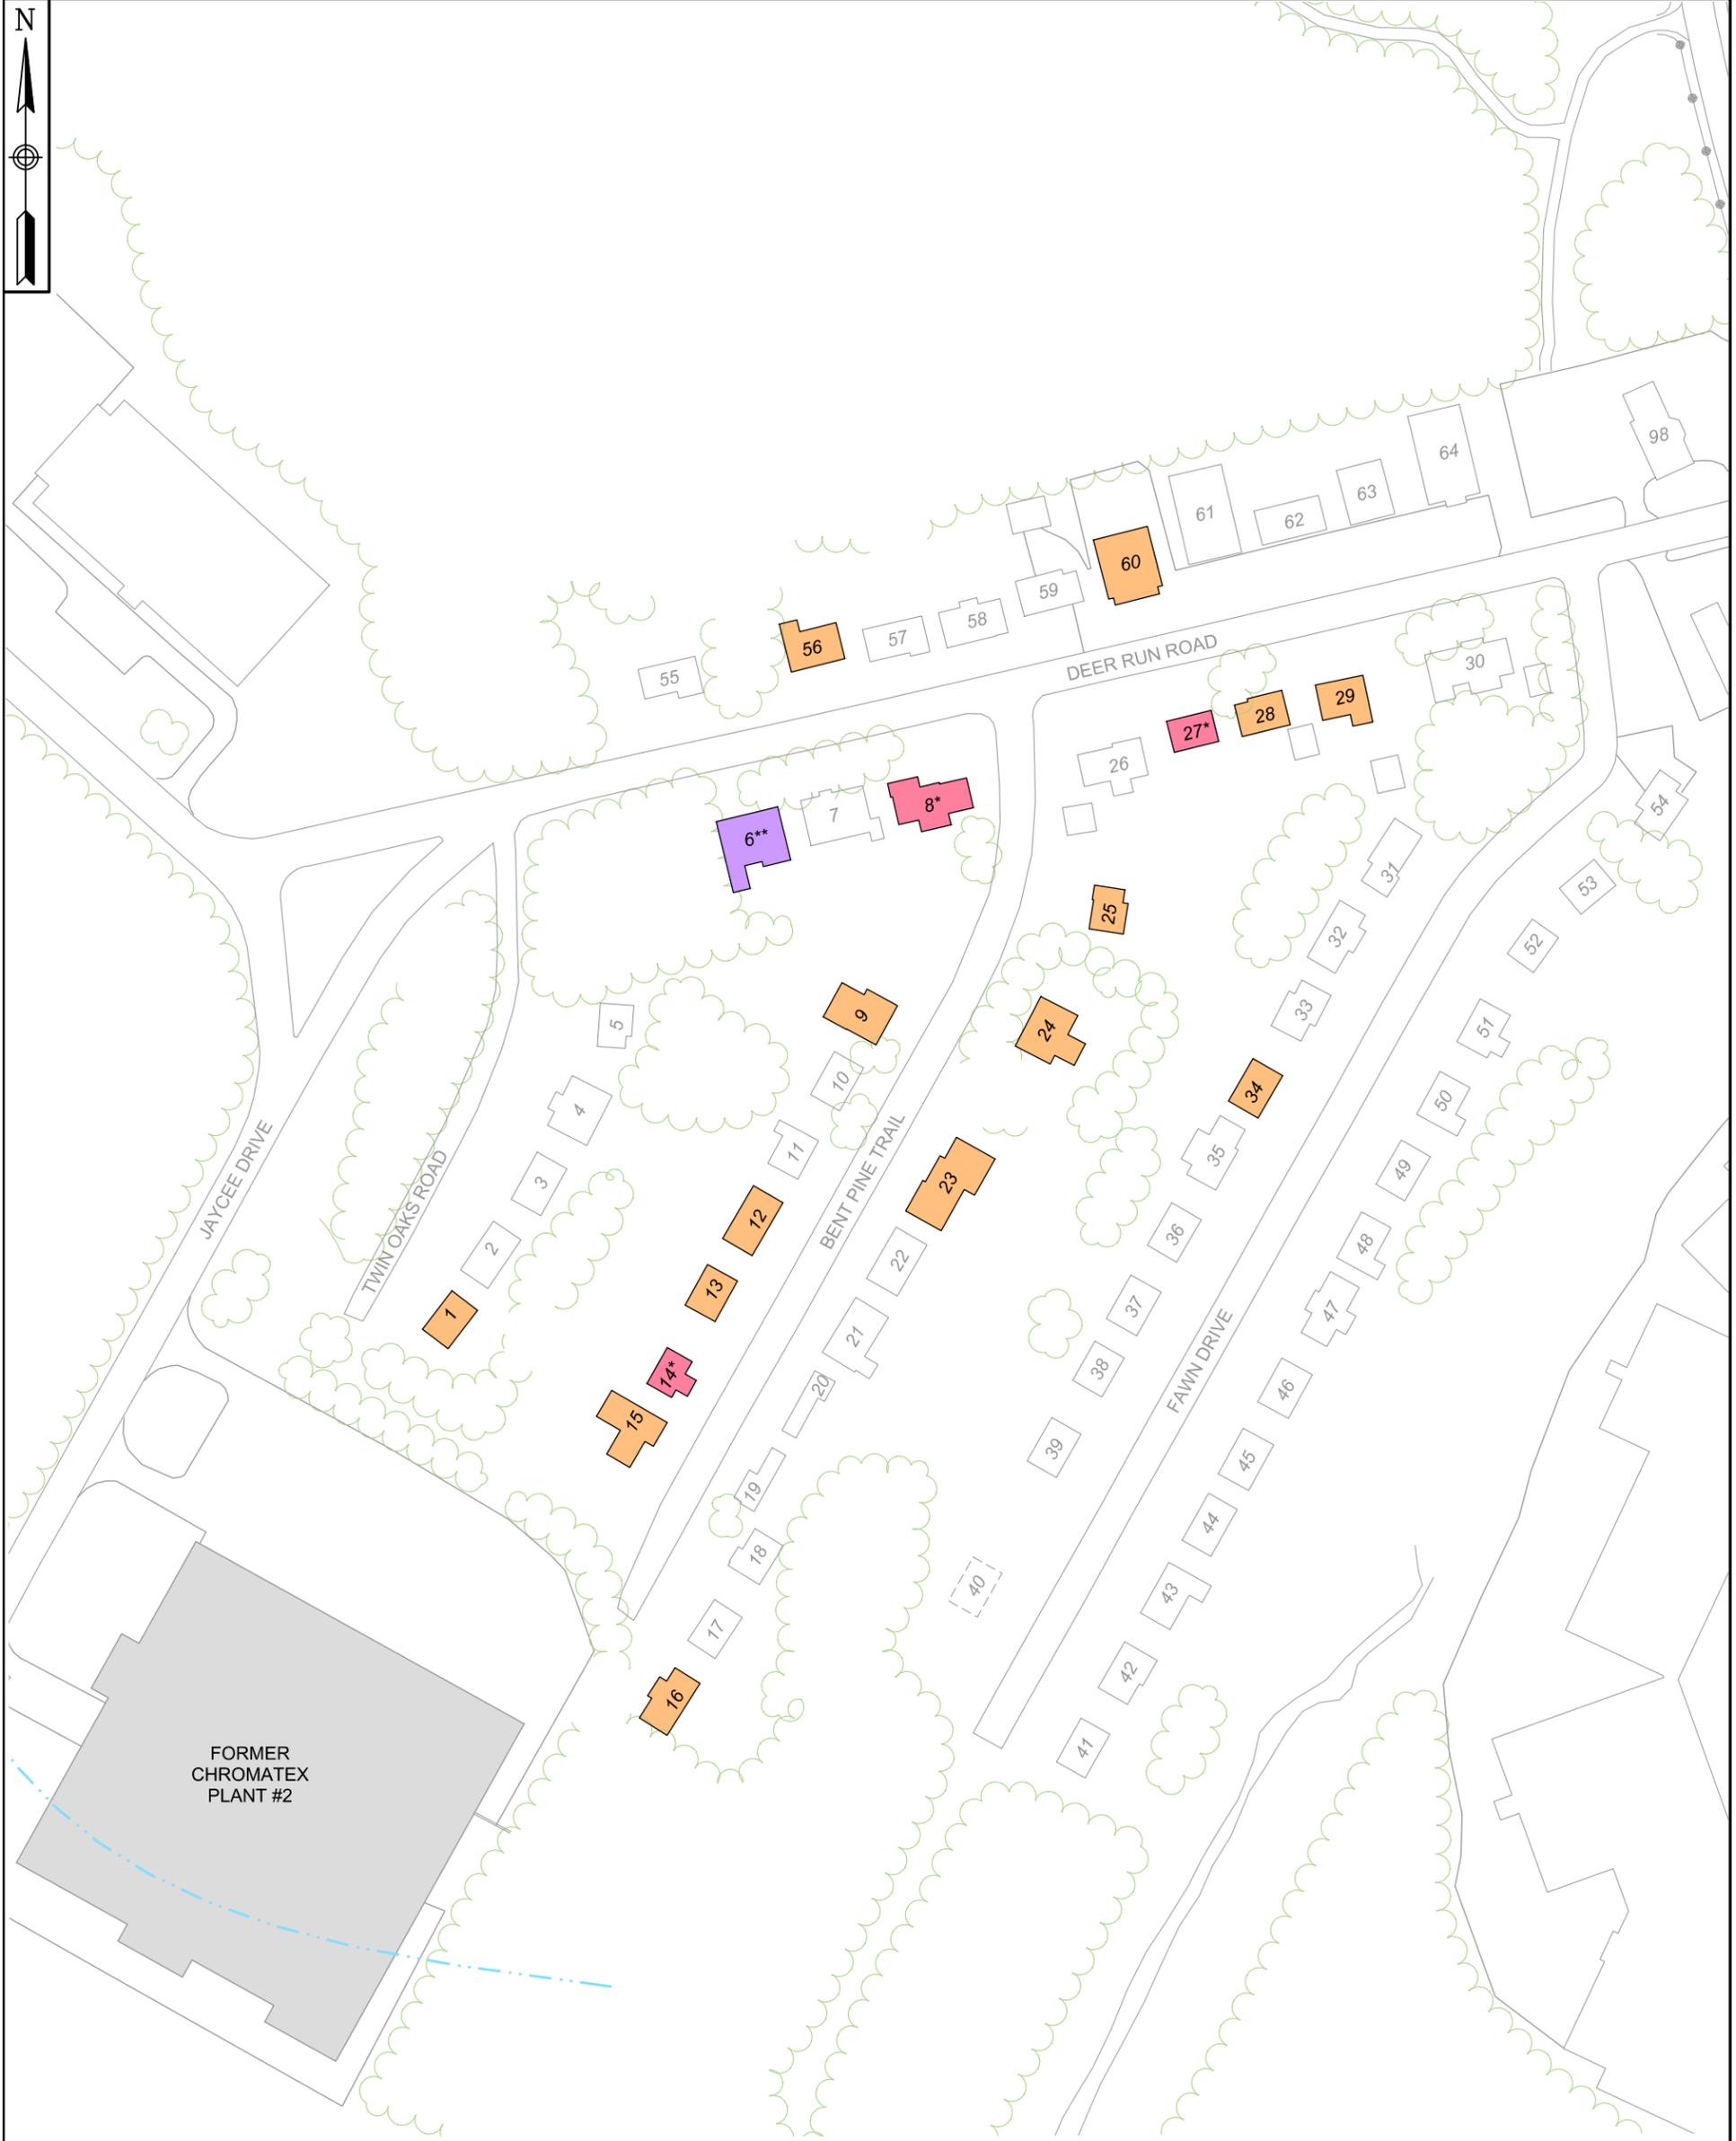
SCALE AS NOTED	
REV 0	DATE 7/28/16
FILE 112G04635GM11	
FIGURE NUMBER FIGURE 3

- In support of an EE/CA for Indoor Air, EPA conducted sub-slab soil gas sampling at residences that overlie the known plume of groundwater contamination. While not all residents granted access for the sampling, EPA was able to assess the majority of properties over the plume. Based on that sampling, EPA identified nine homes, in addition to the original eight homes that already had air filtration devices installed in 2003-2004, that had the potential for vapor intrusion. EPA then initiated a non time-critical removal action to install sub-slab depressurization systems (which are the same as radon systems) in the 17 homes. Shallow groundwater was encountered beneath the basement slab of the ninth home, and EPA was unable to install a depressurization system. EPA subsequently conducted indoor air sampling inside the home, and found no Site-related contamination present. A total of 16 homes currently have depressurization systems installed by EPA, as described above and shown in Figure 3.
