**FOURTH FIVE-YEAR REVIEW REPORT FOR  
EAST MOUNT ZION LANDFILL SUPERFUND SITE  
YORK COUNTY, PENNSYLVANIA**

**U.S. Environmental Protection Agency  
Region 3  
PHILADELPHIA, PENNSYLVANIA**

**MAY 25 2017**

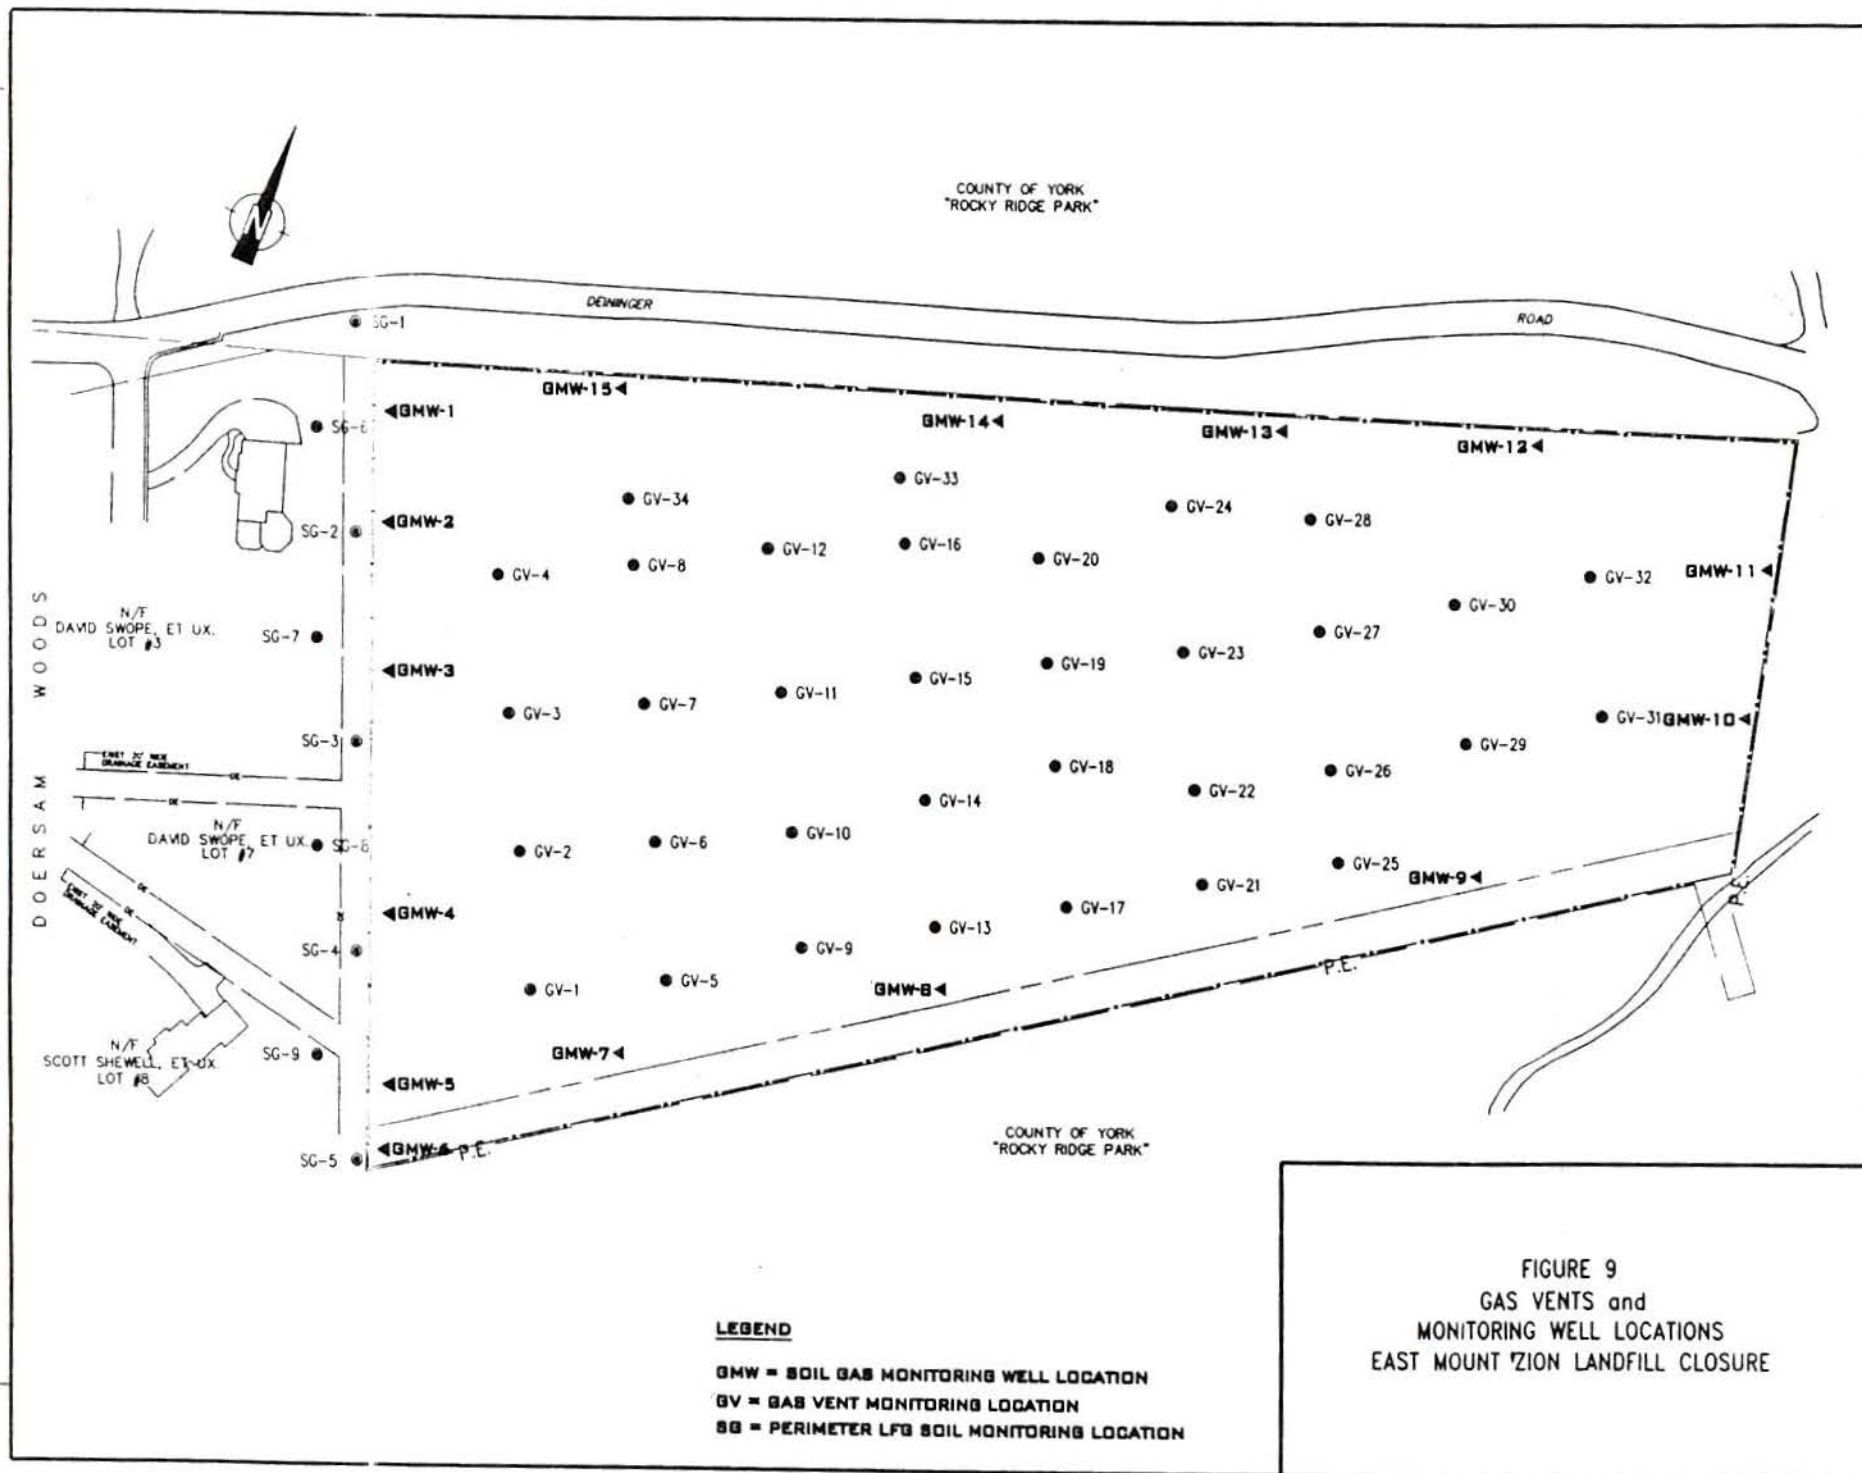
FIGURE 9  
GAS VENTS and  
MONITORING WELL LOCATIONS  
EAST MOUNT ZION LANDFILL CLOSURE

Landfill gas monitoring wells are present at the boundary of the landfill cap, as depicted in Attachment 4. Gas monitoring wells (GMW) 1, 2, 3, 4, 5, and 6 are adjacent to residential housing on the west side of the landfill. Other GMWs are adjacent to woods or a gravel parking lot, picnic and outdoor gym-set play area. Based on a review of the landfill gas monitoring reports from PADEP, methane levels are checked before and after the GMWs are purged. Post-purge sampling of the wells provides a measure of how quickly the methane concentrations rebound, thus an indicator of methane gas generation and potential for migration. GMWs adjacent to residential housing did not exhibit methane above lower explosive level (LEL) in post-purge samples on the west side of the landfill. However, GMWs on the the south side of the landfill, adjacent to a wooded public park, did exhibit methane levels above the LEL in pre-purge and post-purge samples. While above state landfill requirements, the GMWs with the elevated methane are adjacent to an undeveloped, wooded area, therefore they are not currently of concern for protection of human health. In the meantime, EPA and PADEP will continue to verify that the methane concentrations in the landfill gas monitoring wells adjacent to residential housing are below the LEL. Additionally, EPA and PADEP will ascertain if venting can be improved such that all landfill gas monitoring wells exhibit methane concentrations below the LEL.

| | <b>Recommendation:</b> Monitoring will continue to verify methane concentrations on the west side of the landfill remain below lower explosive limits. Continue monitoring methane at landfill boundary, and determine if venting could be improved to maintain methane levels below the LEL. | | | |

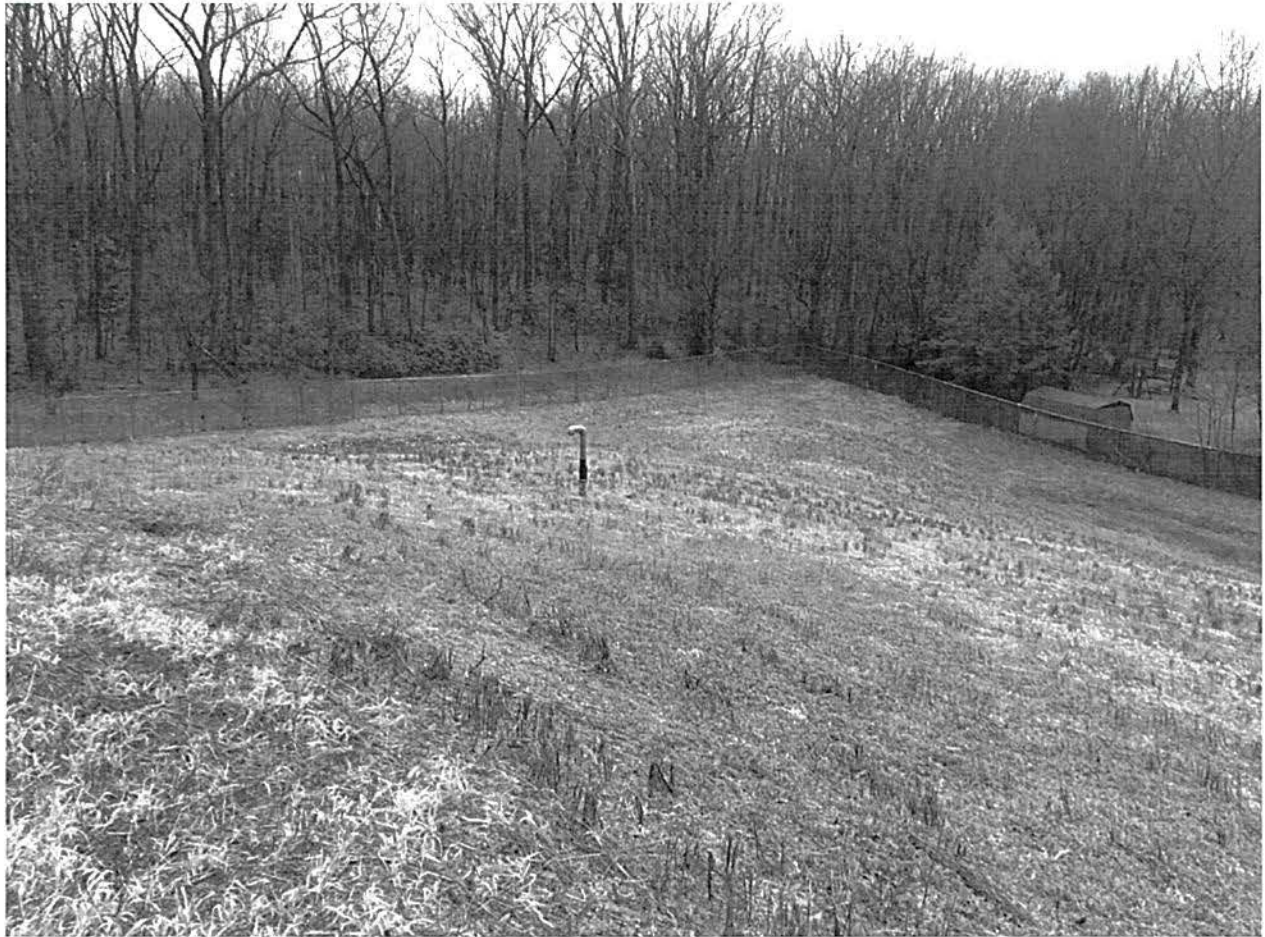
Photograph of southwest corner of landfill. Landfill gas vent in center of photo. View of wooded area to south of landfill in background.

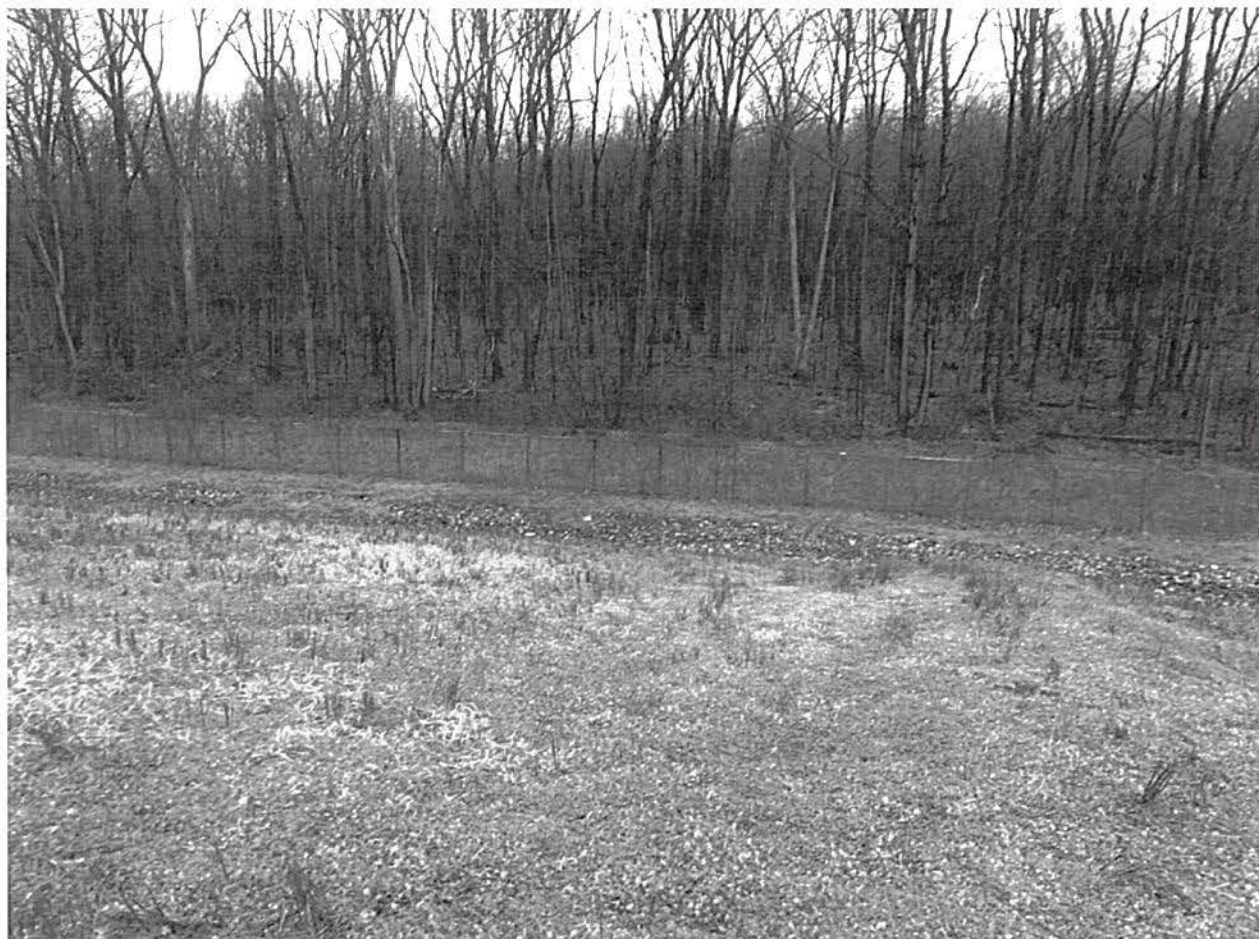
Photograph of south side of landfill. Landfill boundary fence in center of photograph. Wooded area south of the landfill in background.

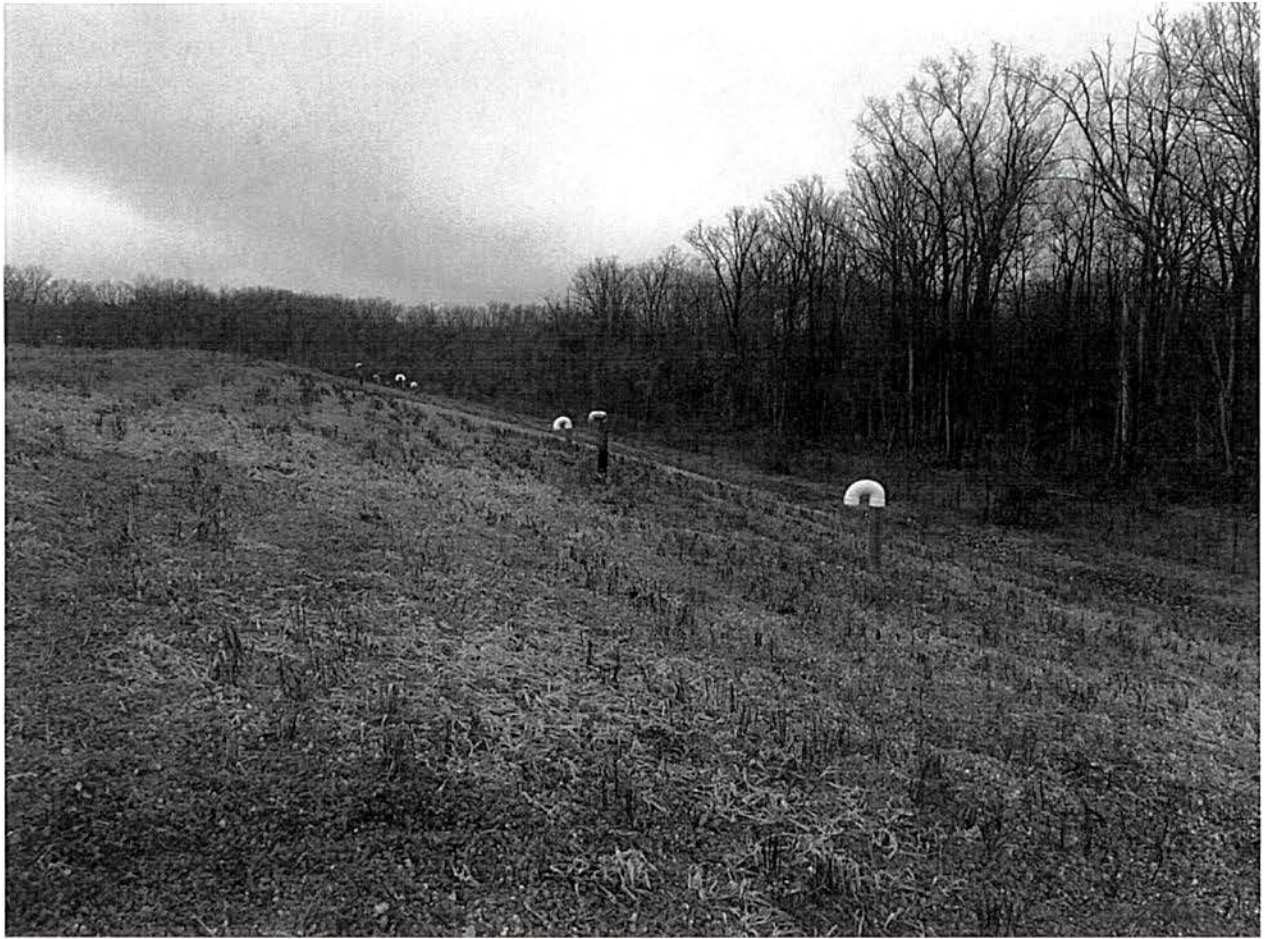
Photograph of south side of landfill. Landfill gas vents are depicted in photograph.

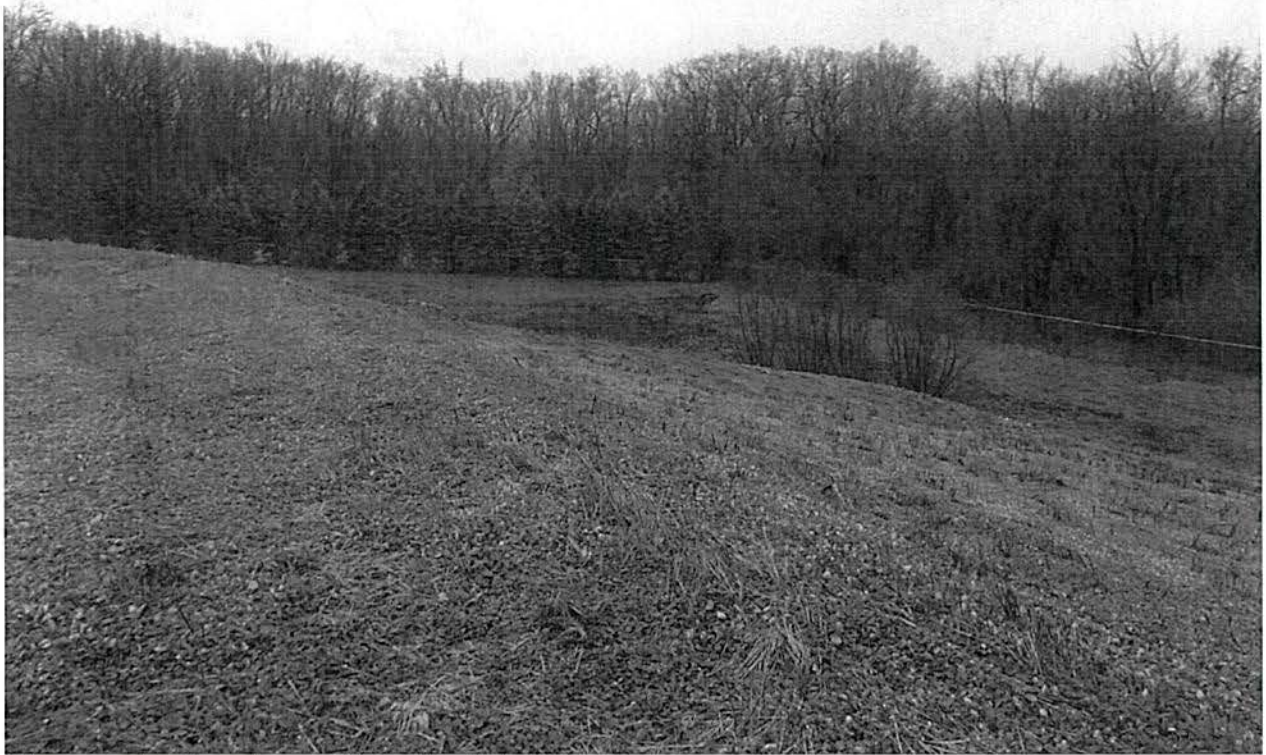
Photograph of southeast side of landfill. Note storm water basin in center of photograph.

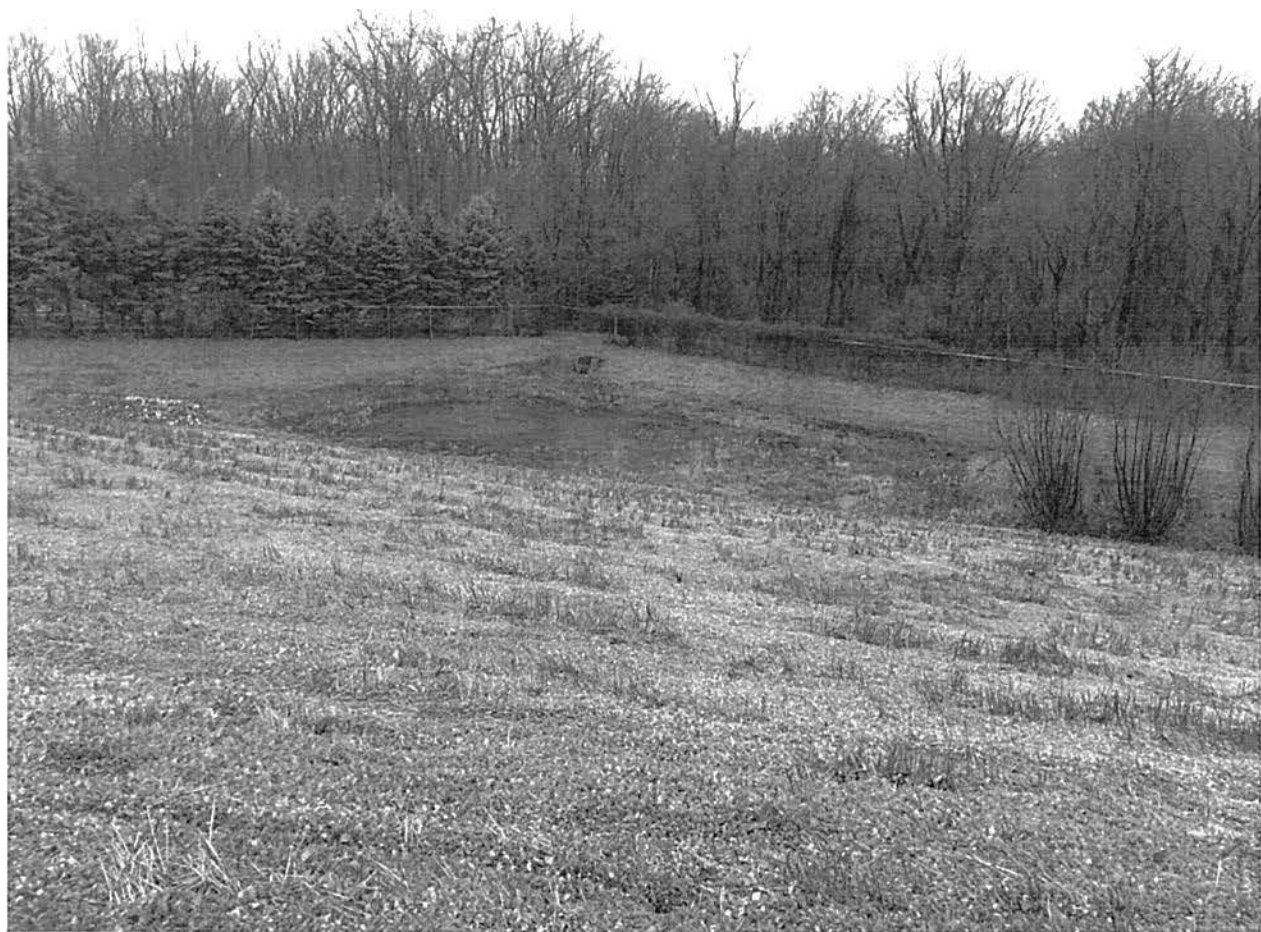
Photograph of southeast side of landfill. Note storm water basin in center of photograph.

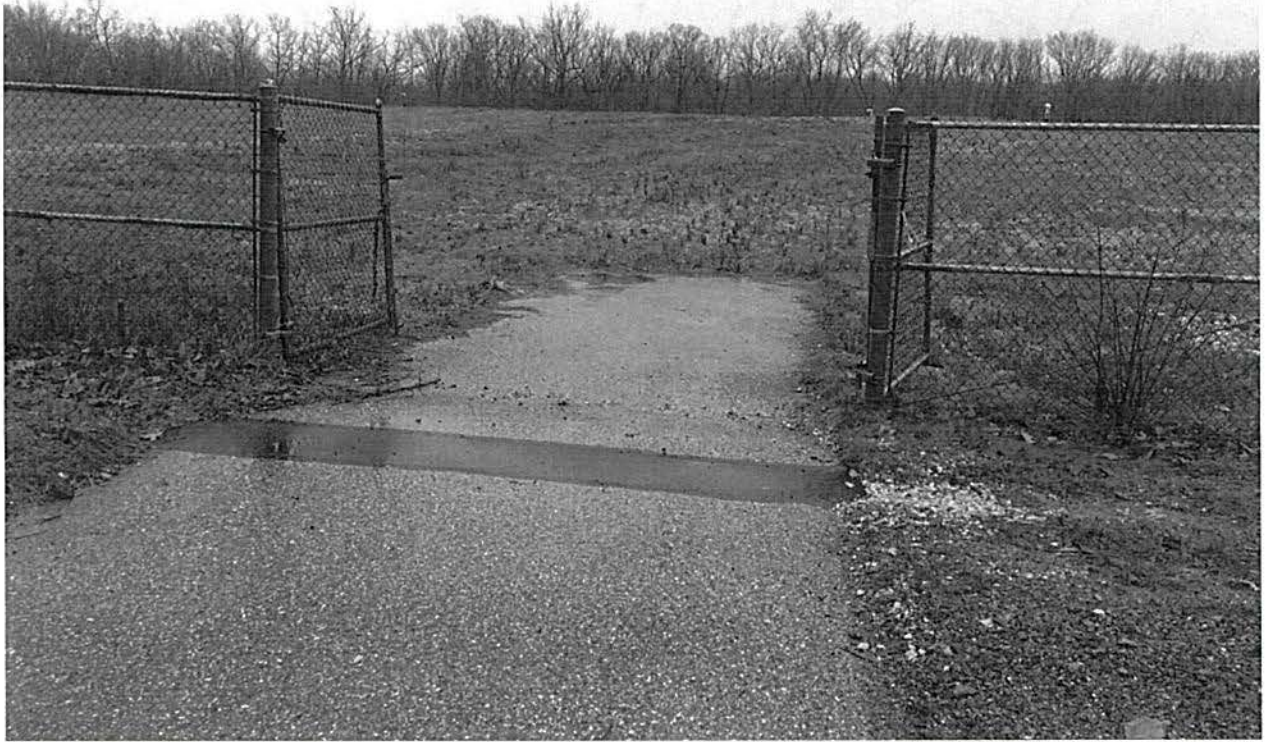
Photograph of main gate to landfill cap.
